Your Ref: TP/IP/42995/2021  
Our Ref : CI/TPD22000333/N

3 March 2022

**Fatal Accident Investigation Team**

**MECHANICAL INSPECTION REPORT OF MOTOR CAR SLQ 6081U**

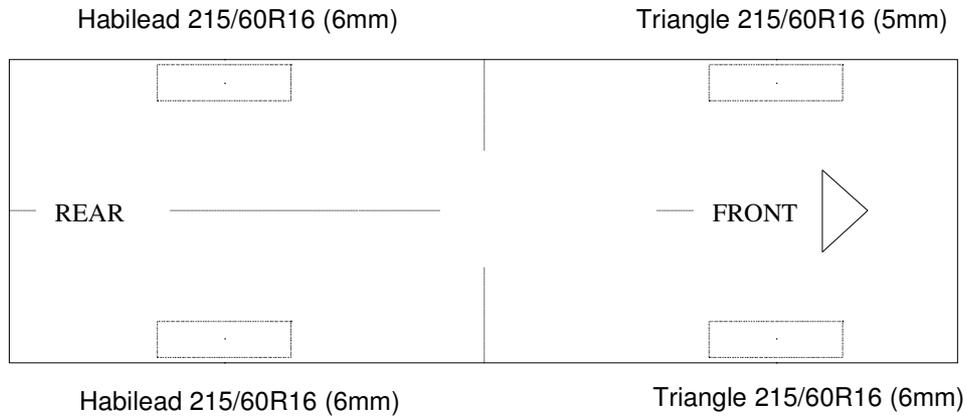
6. The condition of the Motor Car's 4 tyres was observed to be in serviceable condition. We did not find any tear, cut or burst mark(s) on the outer and the inner sidewalls as well as across the tread of the 4 tyres. The 4 tyres were also observed to be sufficiently inflated for vehicular operation. The tyre brand, tyre size and remaining tread depth of the 4 tyres were recorded as follows:-

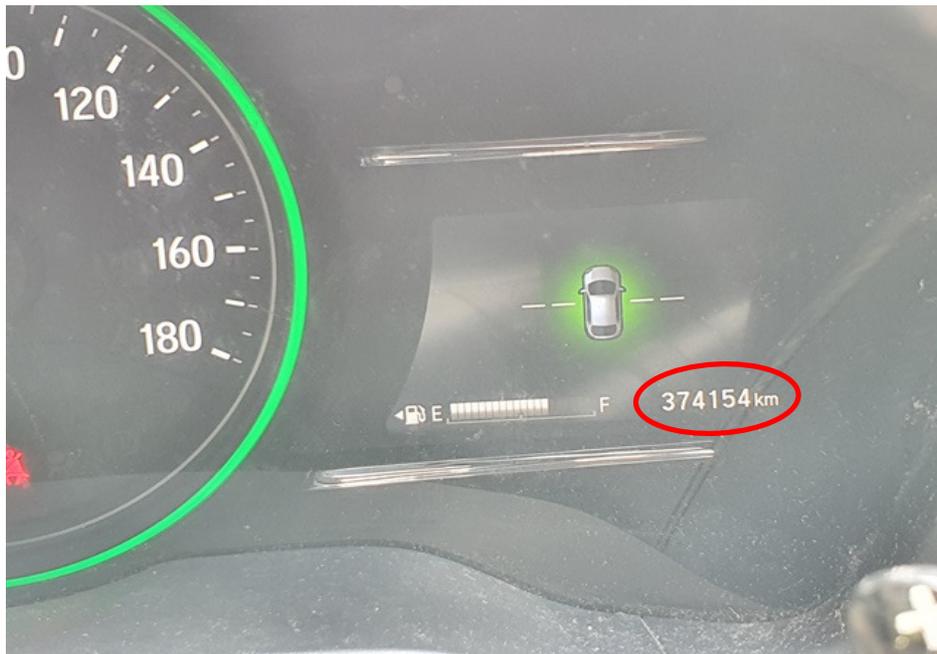
**Photo 1** shows a general view of the instrument cluster of the Motor Car at the time of our inspection. The mileage of the Motor Car was 374,154km (circled).

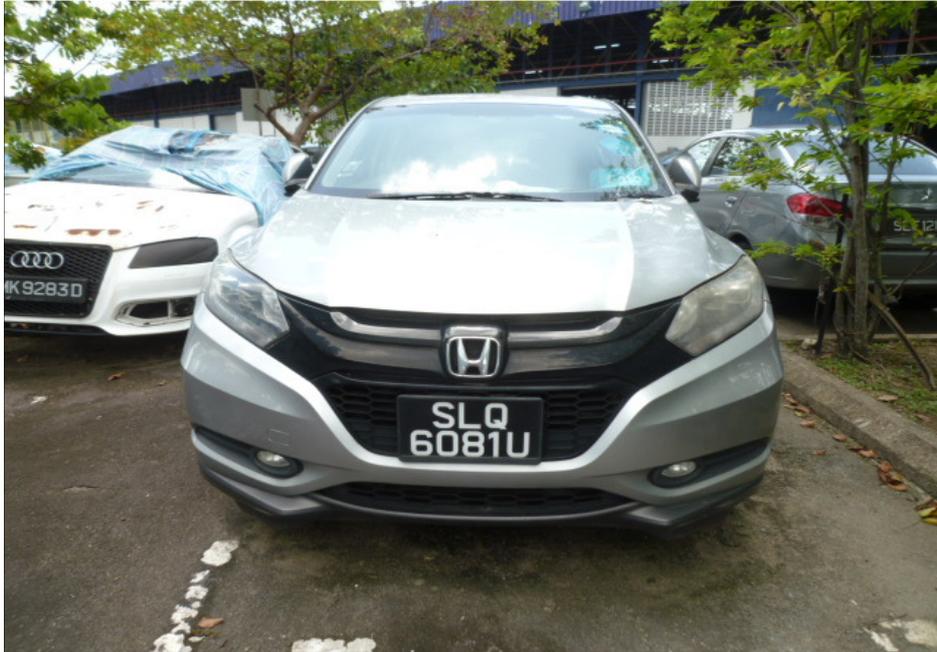
**Photo 2** shows a general view of the frontal portion of the Motor Car at the time of our inspection. The Motor Car was observed to be intact and unaffected by the accident.

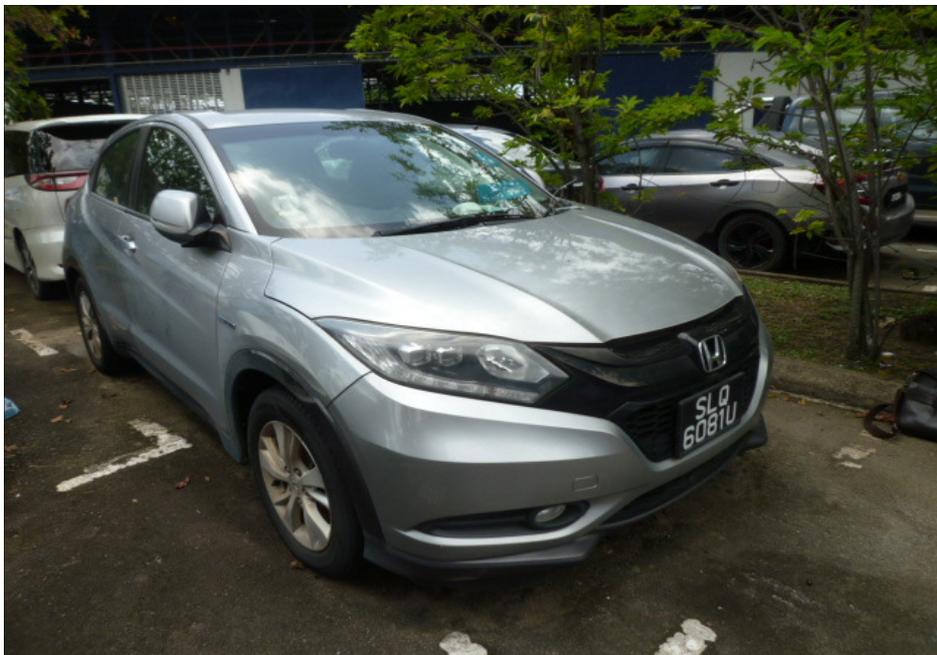
**Photo 3** shows a general view of the right body of the Motor Car at the time of our inspection. The Motor Car was observed to be intact and unaffected by the accident.

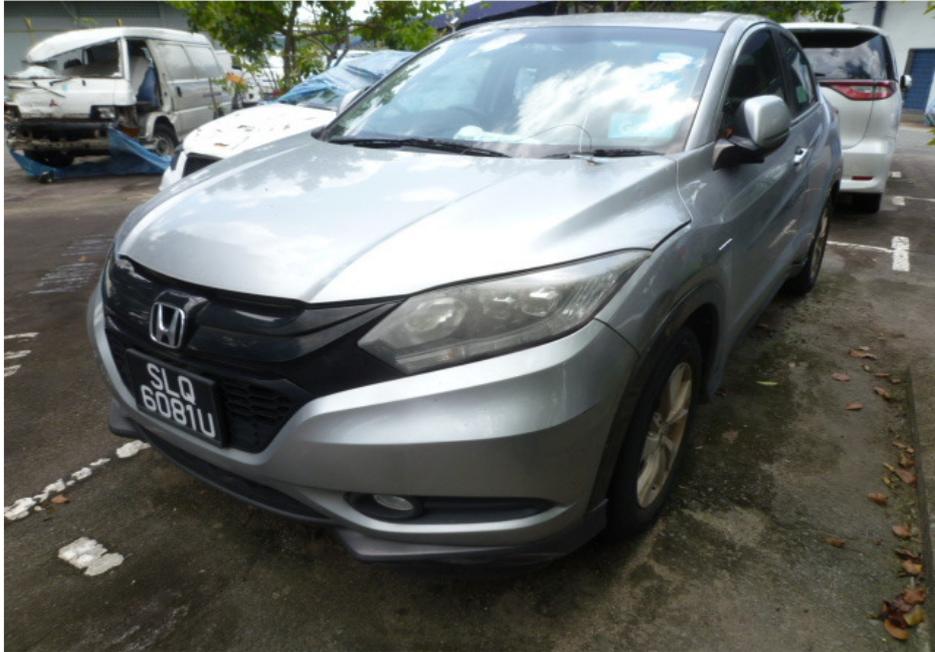
**Photo 4** shows a general view of the left body of the Motor Car at the time of our inspection. The Motor Car was observed to be intact and unaffected by the accident.

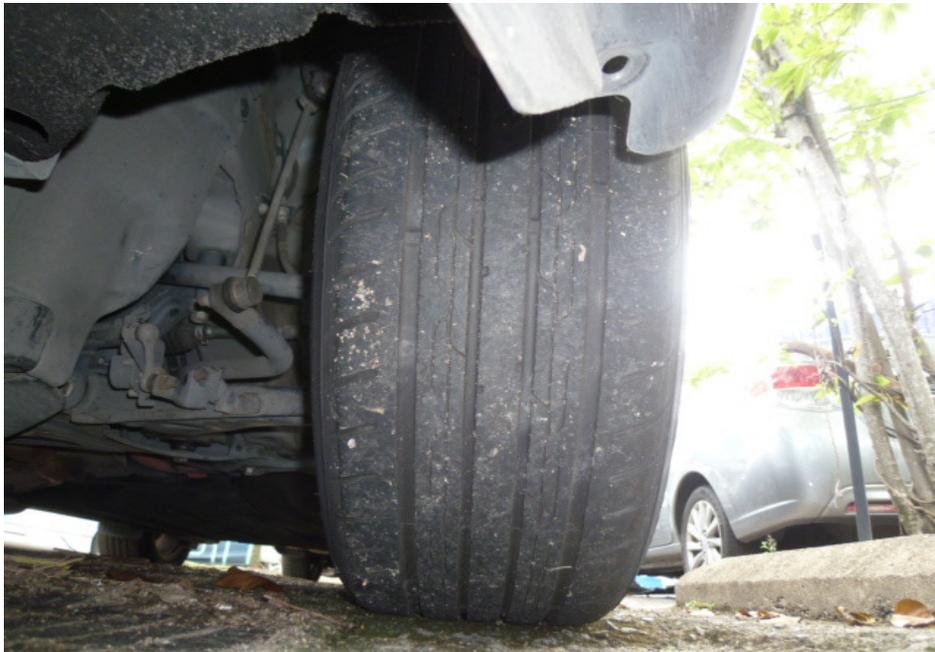
**Photo 5** shows the condition of the front left tyre of the Motor Car, which was observed to be in serviceable condition with remaining tread depth of approximately 5mm. The tyre, which was wrapped around alloy wheel rim, was also observed to be sufficiently inflated for vehicular operation. There was no tear, cut or burst mark(s) on the outer and the inner sidewalls as well as across the tread of the 4 tyres.

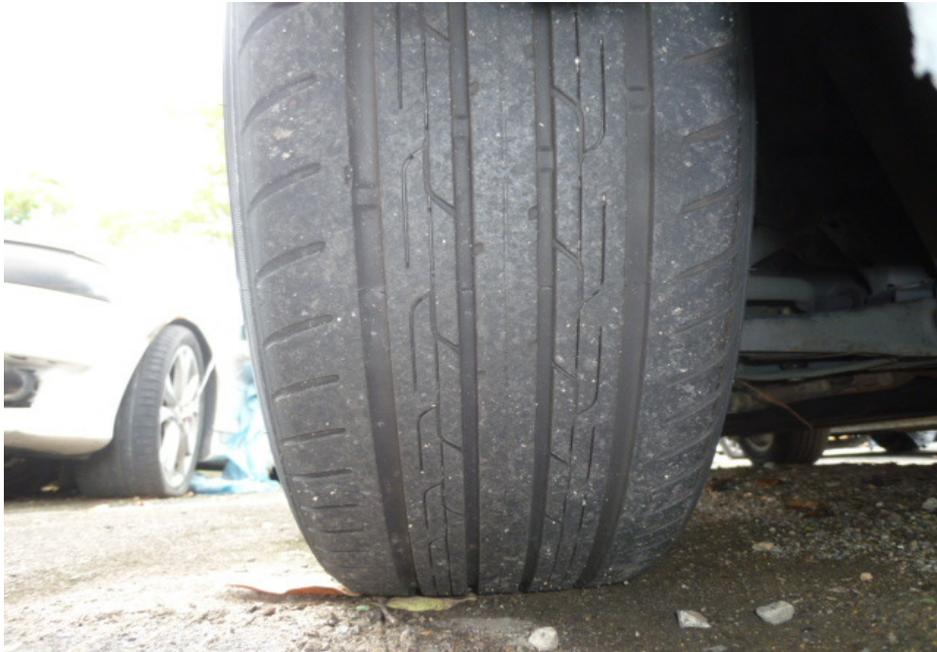
**Photo 6** shows the condition of the front right tyre of the Motor Car, which was observed to be in serviceable condition with remaining tread depth of approximately 6mm. The tyre, which was wrapped around alloy wheel rim, was also observed to be sufficiently inflated for vehicular operation.

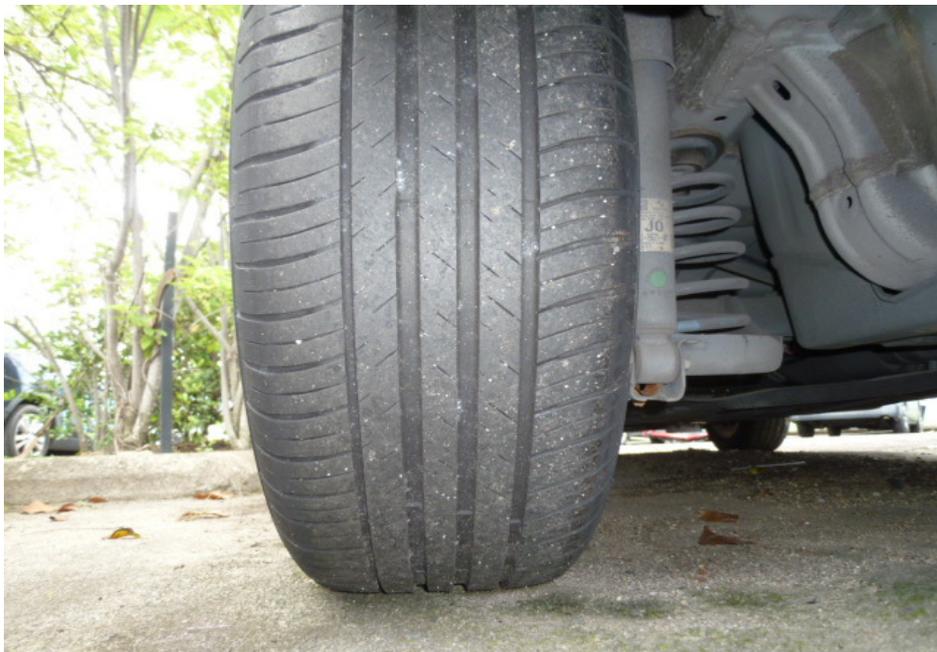
**Photo 7** shows the condition of the rear left tyre of the Motor Car, which was observed to be in serviceable condition with remaining tread depth of approximately 6mm. The tyre, which was wrapped around alloy wheel rim, was also observed to be sufficiently inflated for vehicular operation. There was also no damage found on the 4 wheel rims of the Motor Car.

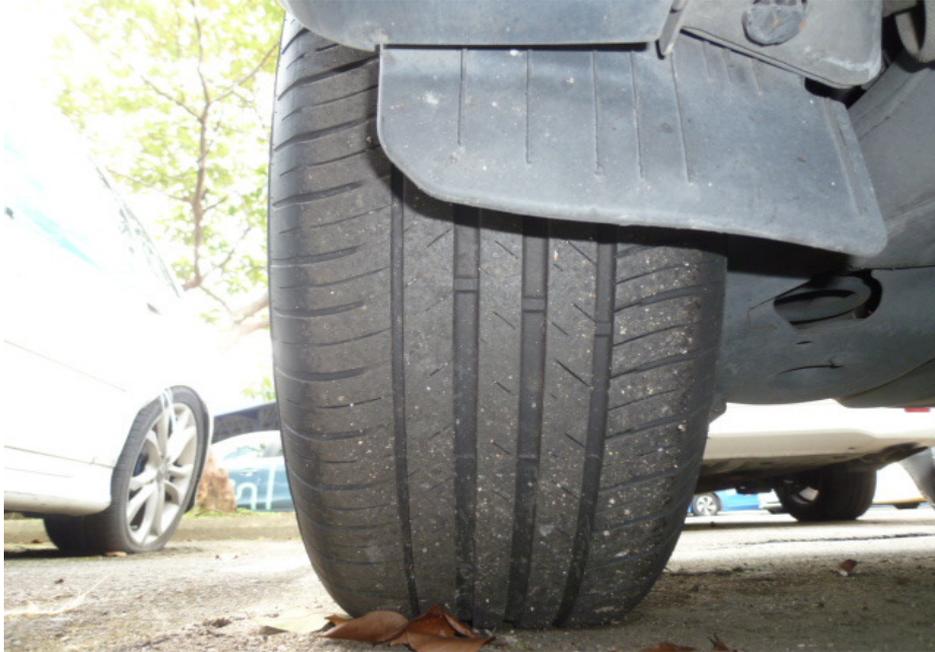
**Photo 8** shows the condition of the rear right tyre of the Motor Car, which was observed to be in serviceable condition with remaining tread depth of approximately 6mm. There was also no tear, cut or burst mark(s) on the outer and the inner sidewalls as well as across the tread of the 4 tyres.

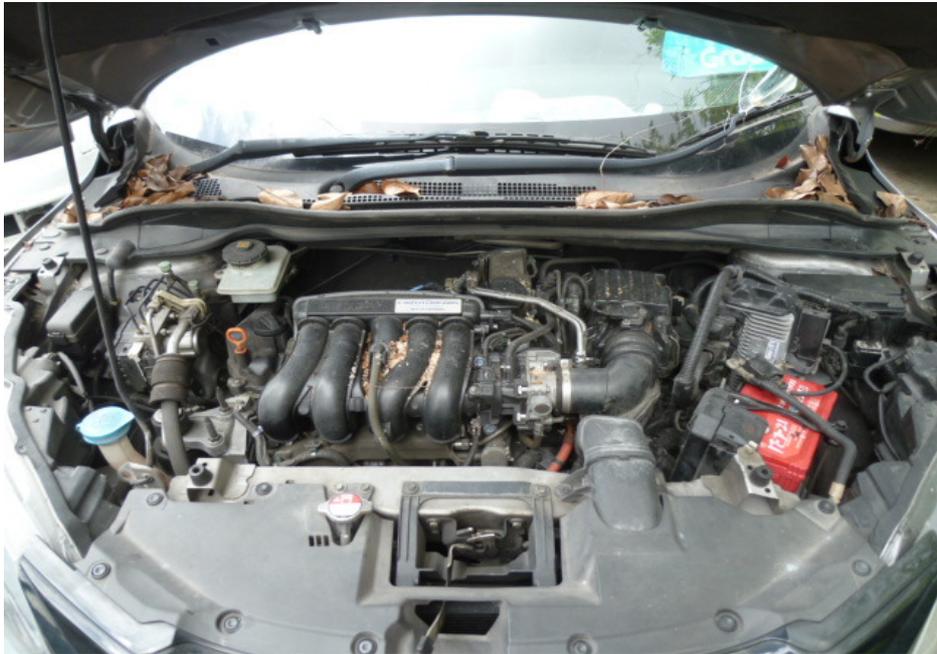
**Photo 9** shows a general view of the Motor Car's engine compartment. The various parts and components inside the engine compartment were unaffected by the accident. There was also no sign(s) or indication(s) of fluid leakage and/or fluid stain within the engine compartment.

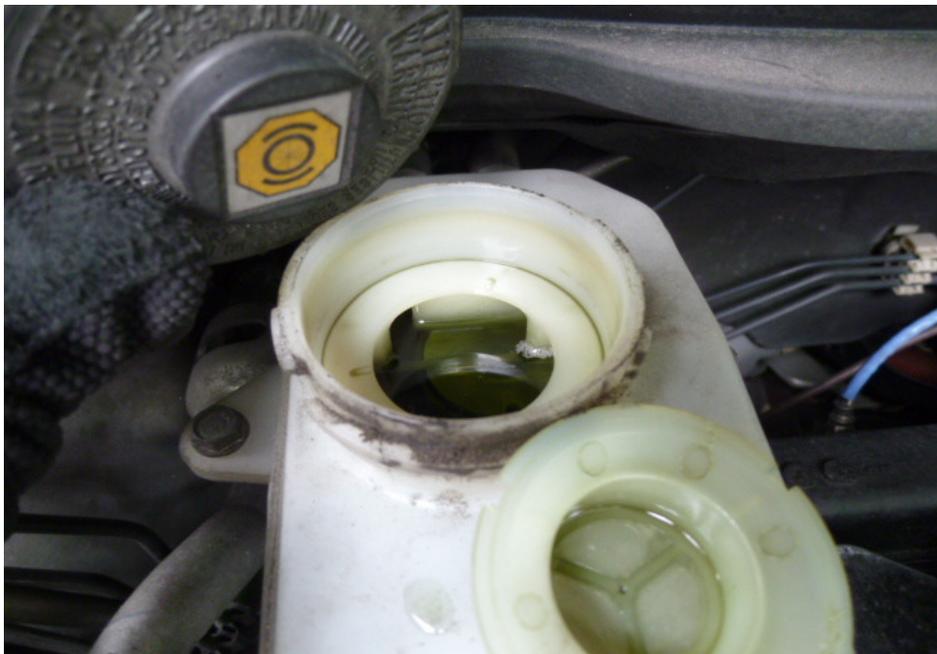
**Photo 10** shows the brake fluid reservoir of the Motor Car at the time of our inspection. The brake fluid was observed to be of sufficient level and without any visible contamination.

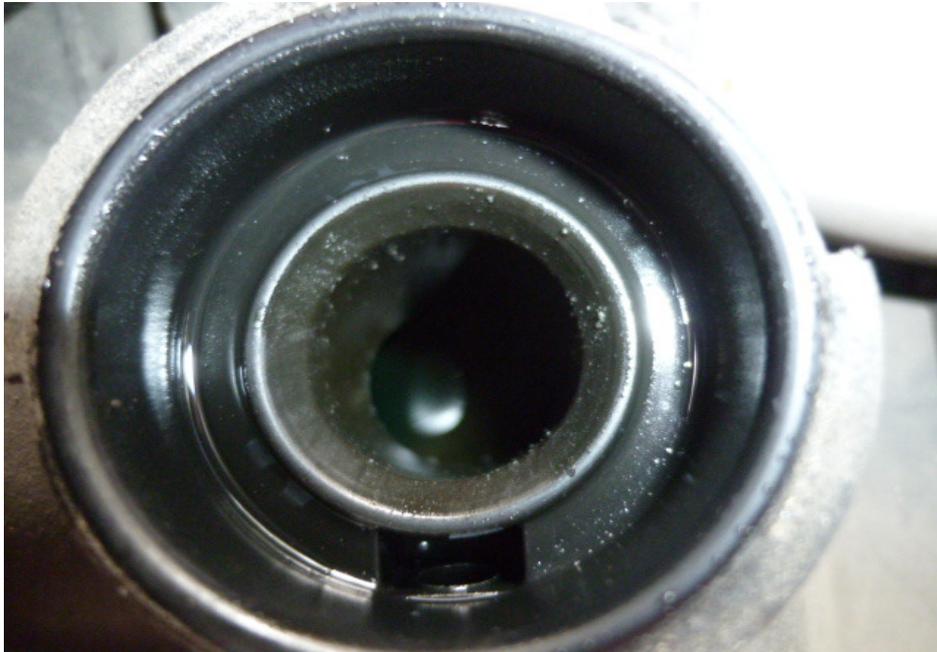
**Photo 11** shows checks being carried out to the engine coolant of the Motor Car at the time of our inspection. The engine coolant was observed to be of sufficient level and without any visible contamination.

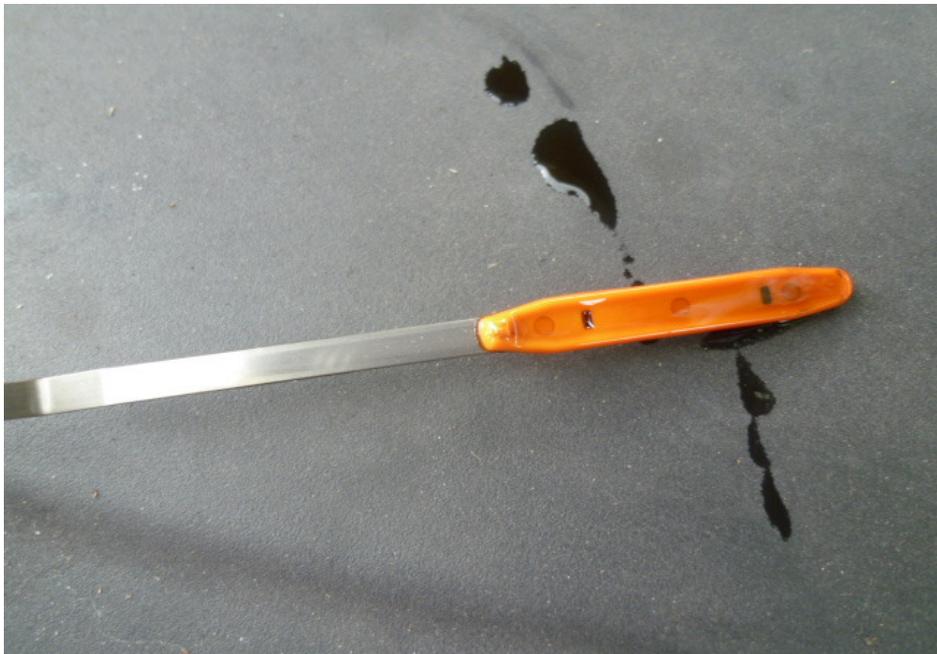
**Photo 12** shows the engine oil dip stick of the Motor Car at the time of our inspection. The engine oil was observed to be of sufficient level and without any visible contamination.

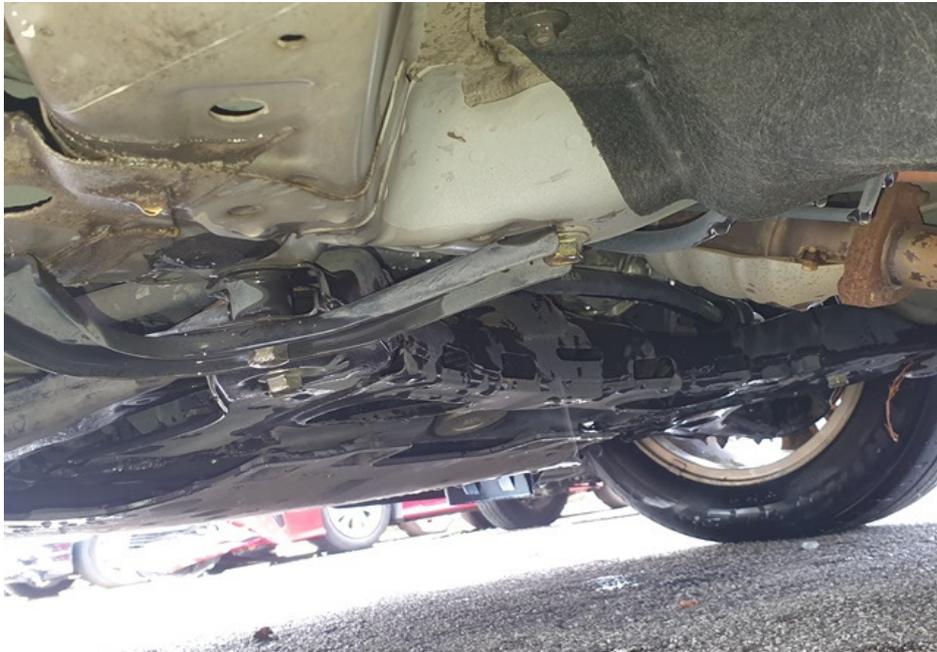
**Photo 13** shows the undercarriage of the Motor Car, at the area where the engine housing and transmission housing are located. We did not find any sign(s) or indication(s) of fluid leak and/or fluid stain(s) on the underside of the Motor Car.

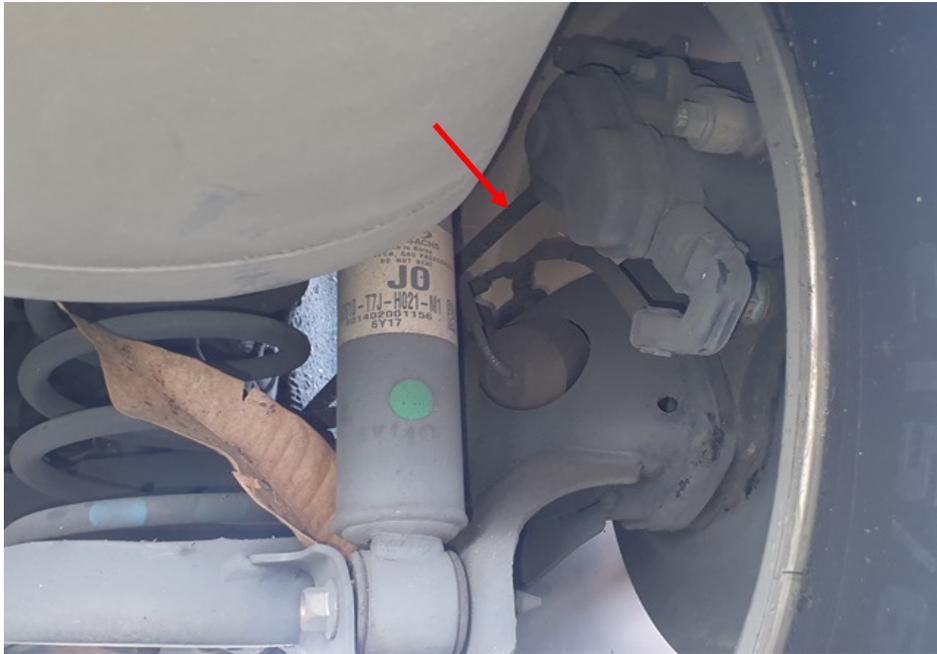
**Photo 14** shows the brake hose/pipe (arrowed) at the rear right wheel of the Motor Car. We did not observe any leakage of brake fluid at the time of our inspection of the Motor Car. Static tests of the Motor Car's braking system had indicated that there was no internal leakage of pressure/vacuum. Hence the braking system was likely to be in serviceable condition at the material time of accident. The undercarriage components of the Motor Car were also all found to be intact and without any visible damage.

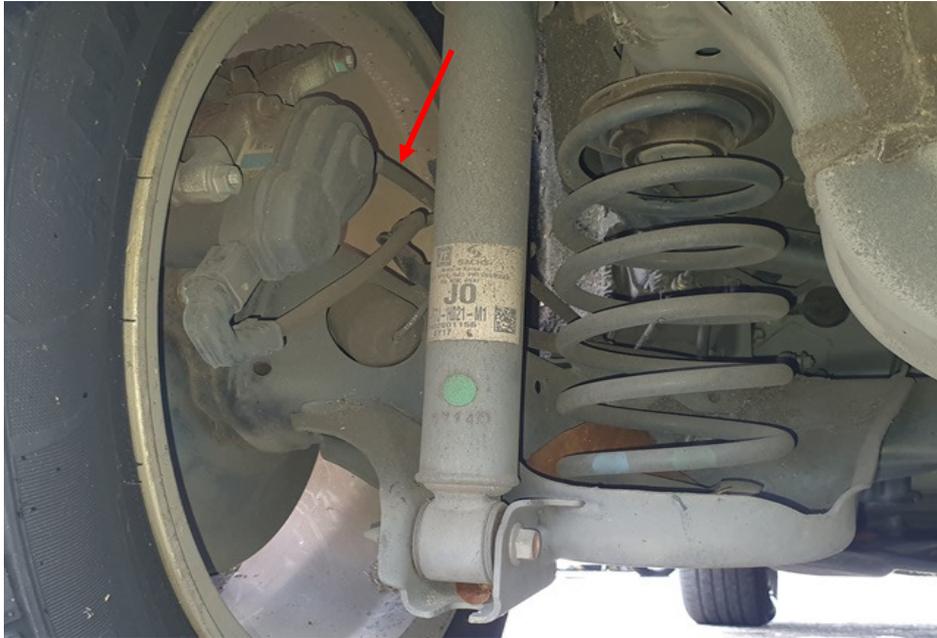
**Photo 15** shows the brake hose/pipe (arrowed) at the rear left wheel of the Motor Car. We did not observe any leakage of brake fluid at the time of our inspection of the Motor Car. Static tests of the Motor Car's braking system had indicated that there was no internal leakage of pressure/vacuum. Hence the braking system was likely to be in serviceable condition at the material time of accident. The undercarriage components of the Motor Car were also all found to be intact and without any visible damage.

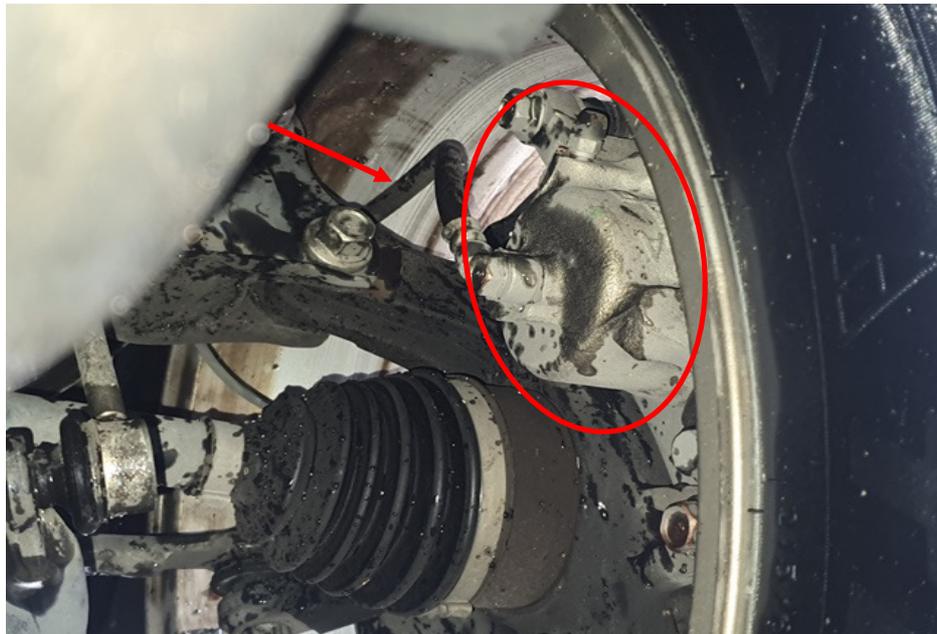
**Photo 16** shows the brake hose/pipe (arrowed) at the front left wheel of the Motor Car. No leakage of brake fluid was observed. Visual examination of the various components of the braking system like the brake caliper (circled), brake pedal etc. had revealed all to be intact and without visible damage.

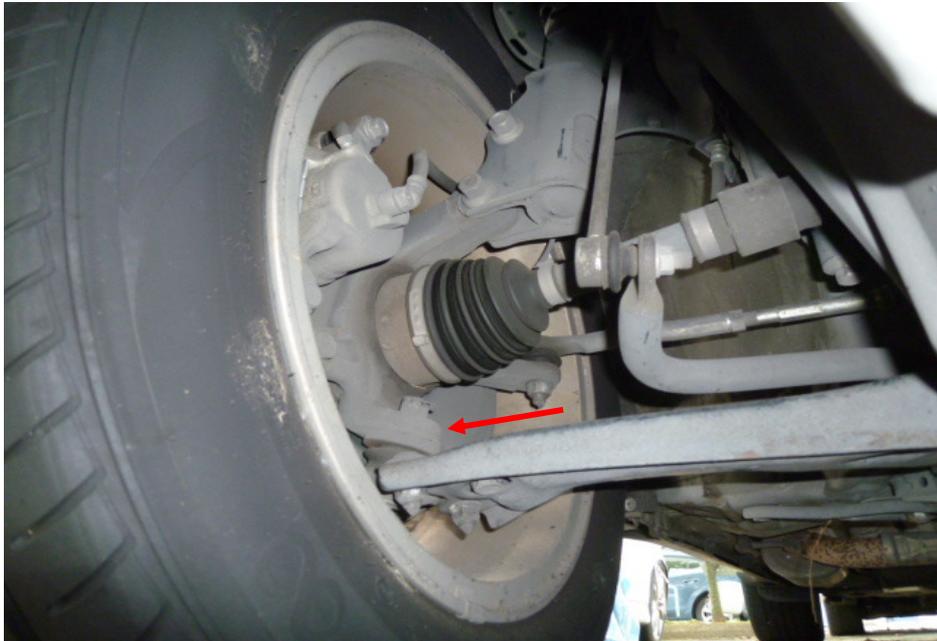
**Photo 17** shows the various undercarriage components at the front right wheel of the Motor Car, in particular the steering tie rod (arrowed). The various steering components were all found to be intact, suggesting that the steering system of the Motor Car was likely to be in serviceable condition at the material time of accident. There was also no sign of fluid stain observed on the various undercarriage components at the front right wheel of the Motor Car.

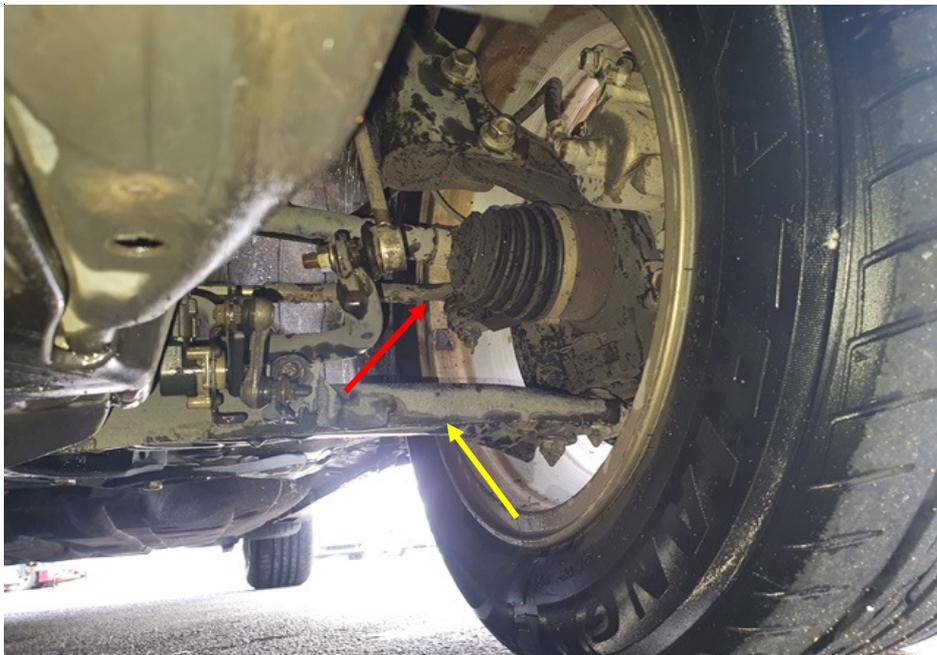
**Photo 18** shows the various undercarriage components at the front left wheel of the Motor Car, which had included the steering tie rod (red arrow) and left drive shaft (yellow arrow). The various undercarriage components of the Motor Car were all found to be intact without any visible damage.

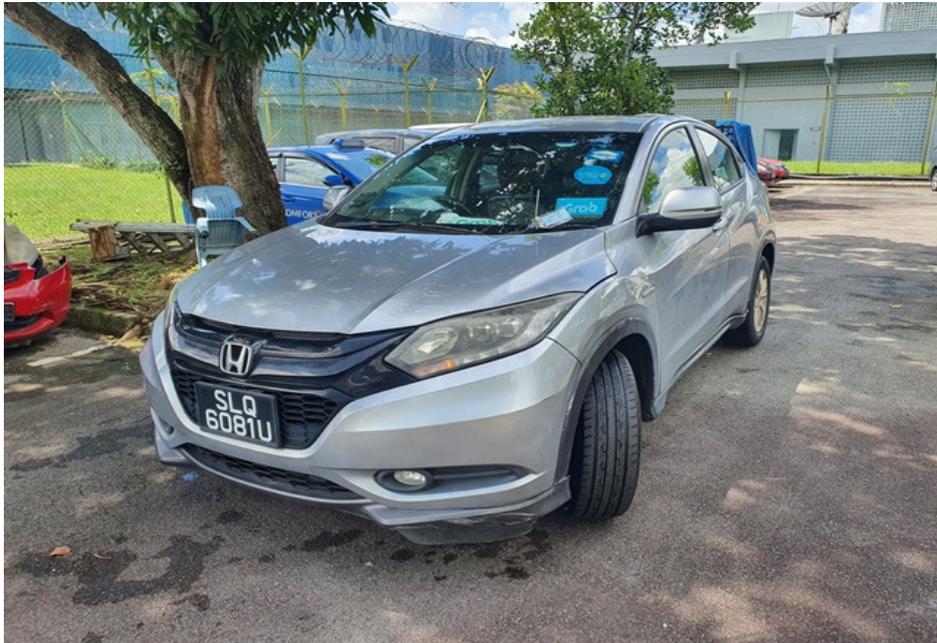
**Photo 19** shows the front left wheel of the Motor Car turned to its full left. During our steering system test, we did not experience any abnormal free play and/or resistance when we had turned the steering wheel towards the left and right. This would suggest that the steering system of the Motor Car was likely to be in serviceable condition at the material time of accident.

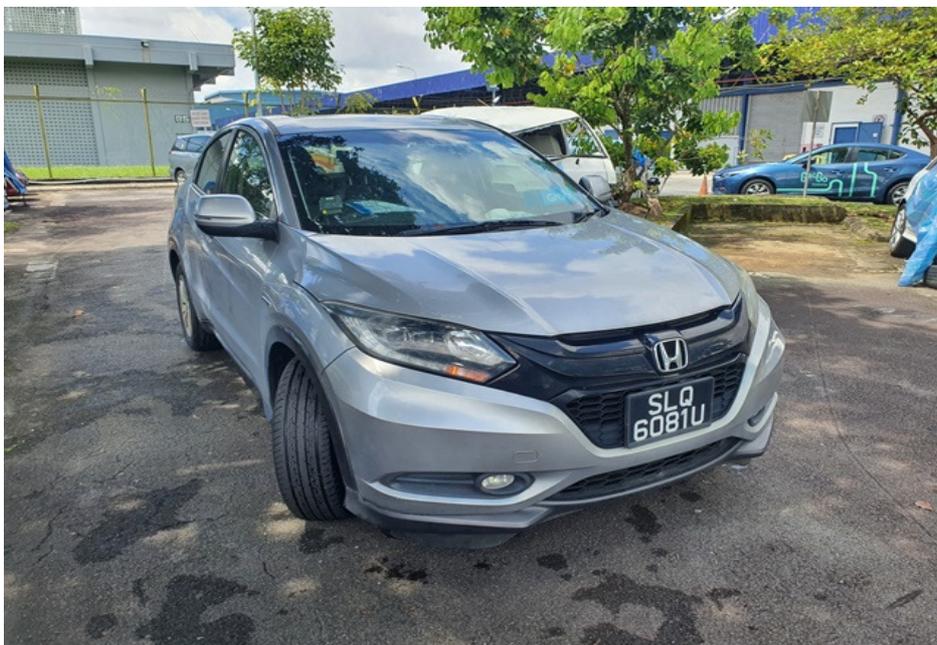
**Photo 20** shows the front right wheel of the Motor Car turned to its full right. During our steering system test, we did not experience any abnormal free play and/or resistance when we had turned the steering wheel towards the left and right. This would suggest that the steering system of the Motor Car was likely to be in serviceable condition at the material time of accident.

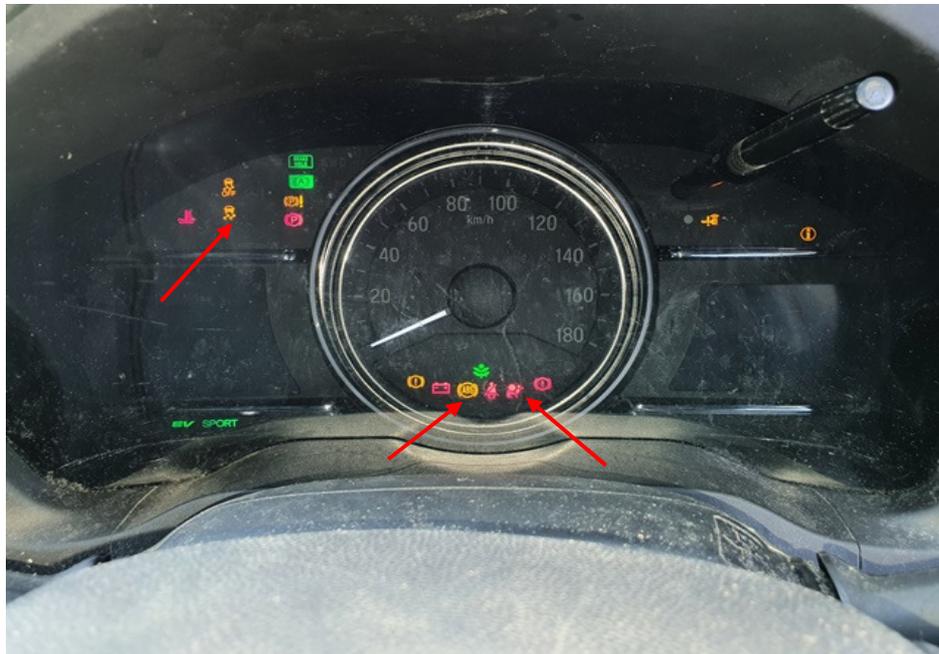
**Photo 21** shows the warning lights for the various electronic operating systems of the Motor Car appearing on its instrument panel during the self-test when the engine is cranked, in particular the ABS light, ESC light and SRS light (arrowed).

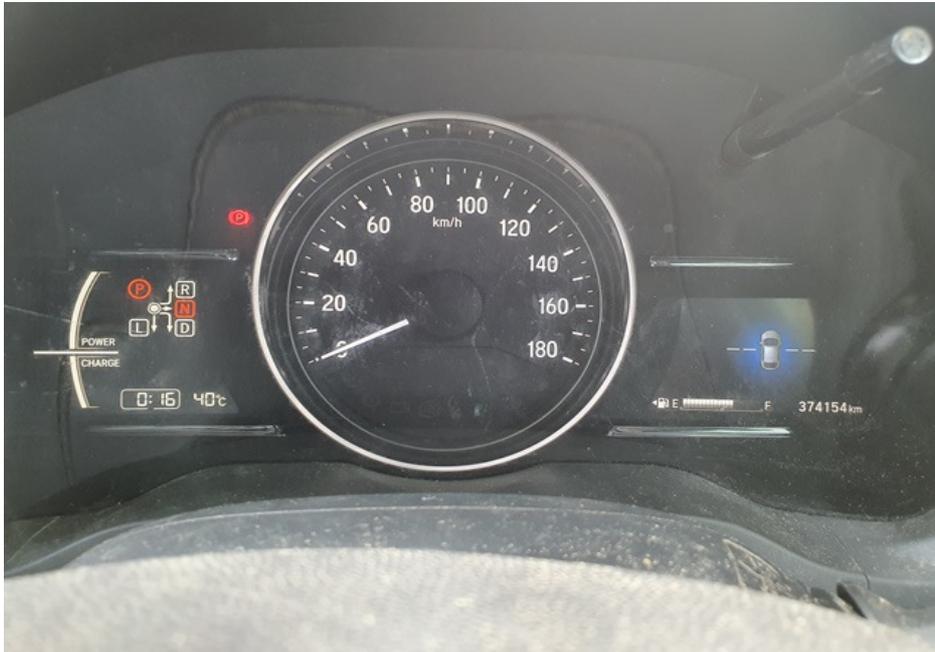
**Photo 22** shows no warning lights illuminated on the instrument panel of the Motor Car after the engine was cranked. This would suggest that there was no abnormality to the various electronic operating systems of the Motor Car, like the ABS, ESC and SRS etc.
