Your Ref: TP/IP/59704/2021  
Our Ref : CI/TPD22000335/P

**Fatal Accident Investigation Team**

**MECHANICAL INSPECTION REPORT OF MOTOR LORRY GBE 1179L**

1. I refer to your request on 10<sup>th</sup> January 2022 to conduct a physical inspection of a Motor Lorry bearing registration number GBE 1179L (herein referred to as "**Motor Lorry**"), which was involved in a road traffic accident on 16<sup>th</sup> December 2021.
2. The objective of this inspection is to determine if there was any possible mechanical failure to the Motor Lorry that may have contributed to the accident.
3. Following the request, I had carried out a physical inspection of the Motor Lorry on 11<sup>th</sup> January 2022 at the premises of Traffic Police vehicle pound, 517 Airport Road Singapore 539942. I now set out below my observations and comments with respect to this inspection.

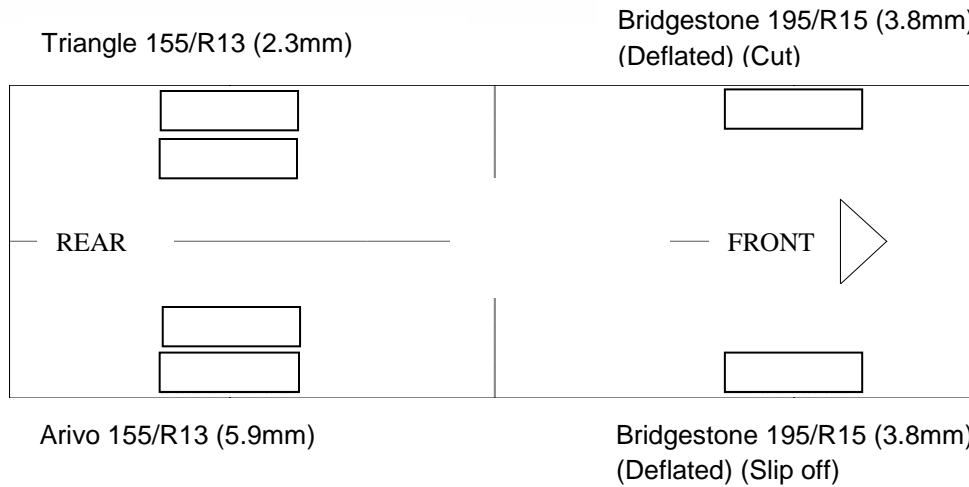
6. The front left tyre was deflated and slipped off the wheel rim while the front right tyre was observed to be cut and deflated as a result of the accident. However, the other rear 4 tyres of the Motor Lorry were observed to be in serviceable condition and sufficiently inflated for vehicular operation. I did not find any tear, cut or burst mark(s) on the outer and the inner sidewalls as well as across the tread of the 5 tyres. The tyre brand, tyre size and remaining tread depth of the 6 tyres of the Motor Lorry were recorded as follows:-

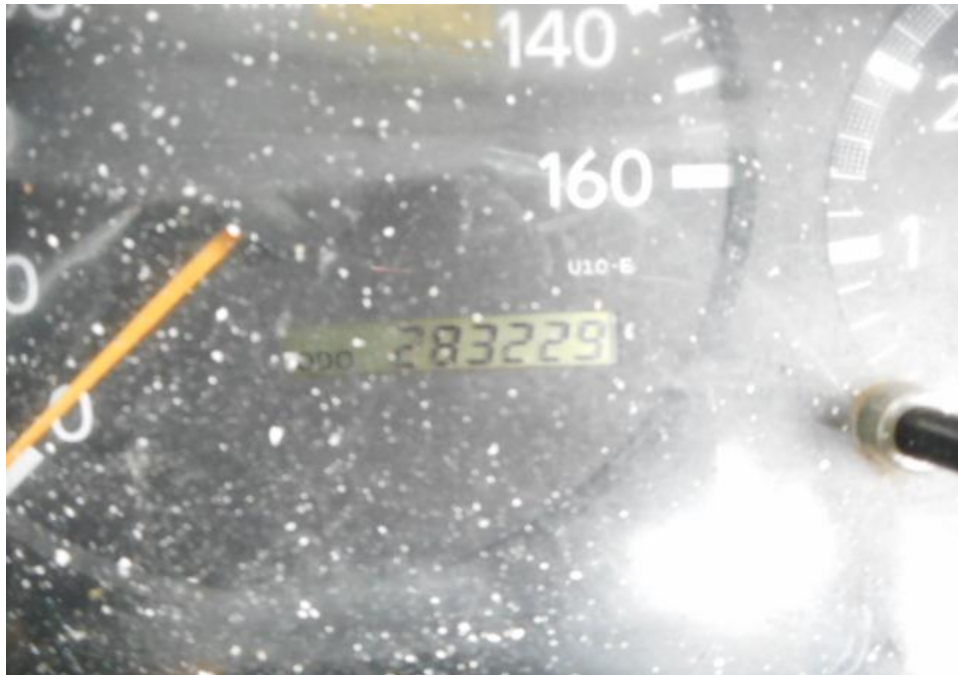
**Photo 1** shows a general view of the instrument cluster of the Motor Lorry at the time of my inspection. The mileage of the Motor Lorry was 283,229km

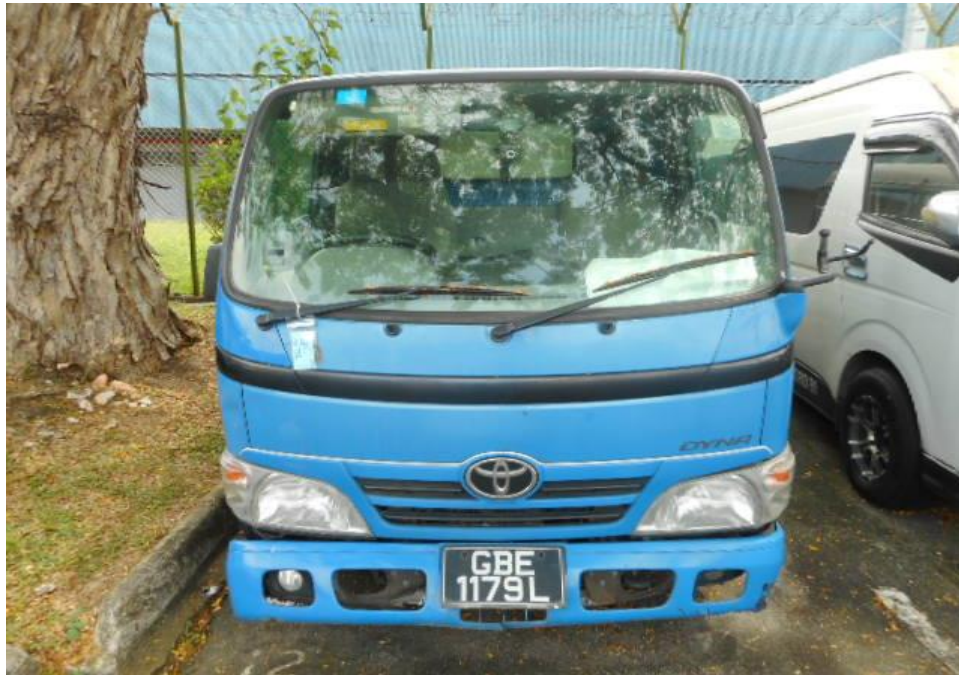
**Photo 2** shows a general view of the Motor Lorry's frontal portion at the time of my inspection. The Motor Lorry was observed to be intact and unaffected by the accident.

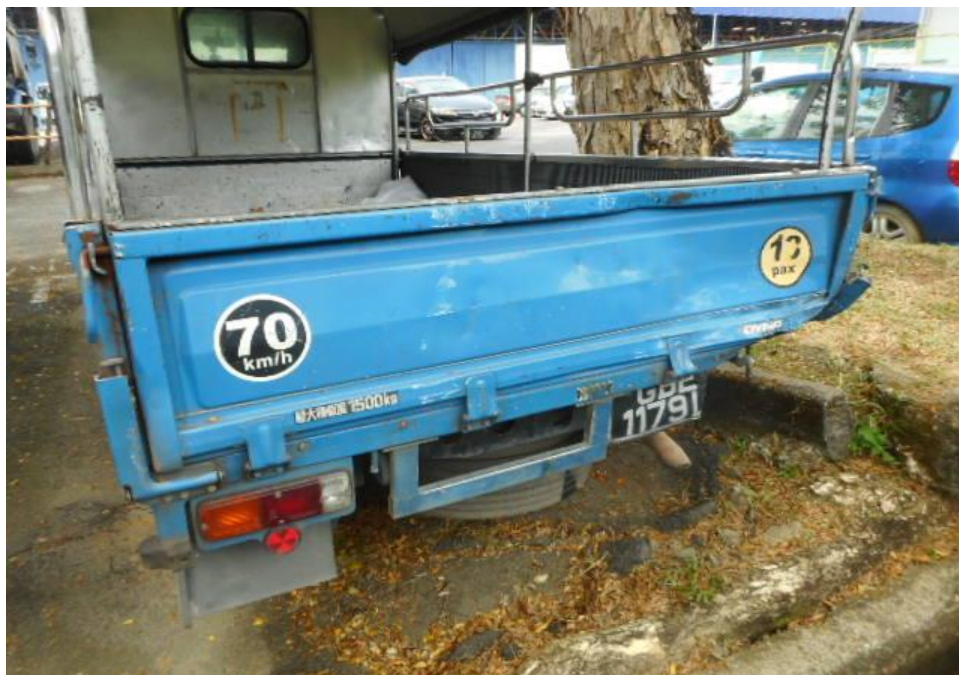
**Photo 3** shows a general view of the rear body of the Motor Lorry at the time of my inspection. The Motor Lorry was observed to sustained damage at its rear portion. Its rear body panel and rear right brake lamp were damage at the time of my inspection as a result of the accident.

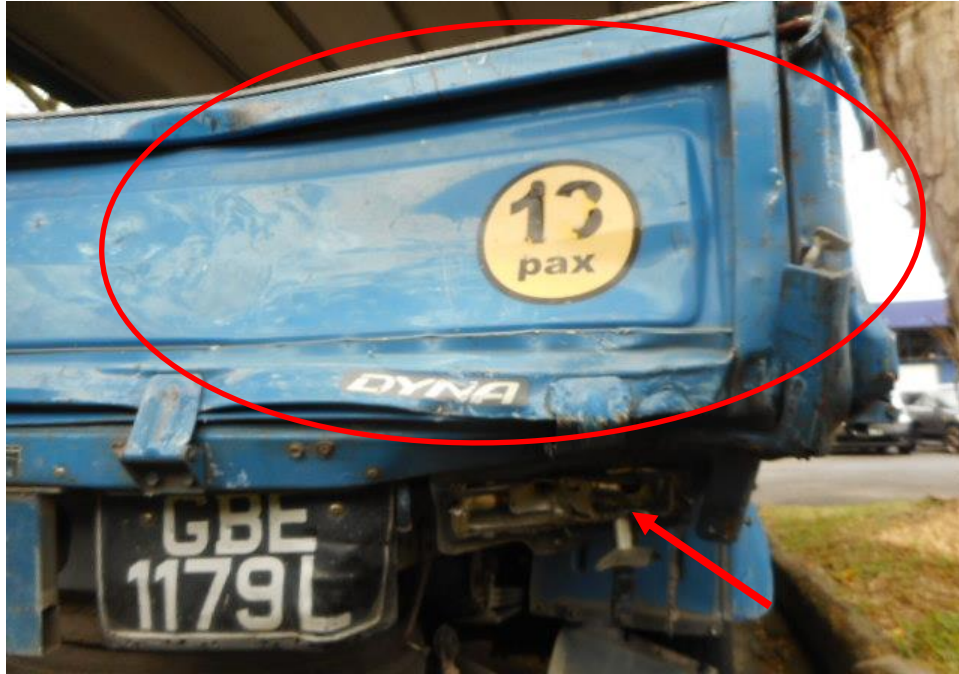
**Photo 4** shows a close up view of the Motor Lorry's rear portion at the time of my inspection. Its rear body panel (circled) and rear right brake lamp (arrowed) was damage at the time of my inspection as a result of the accident.

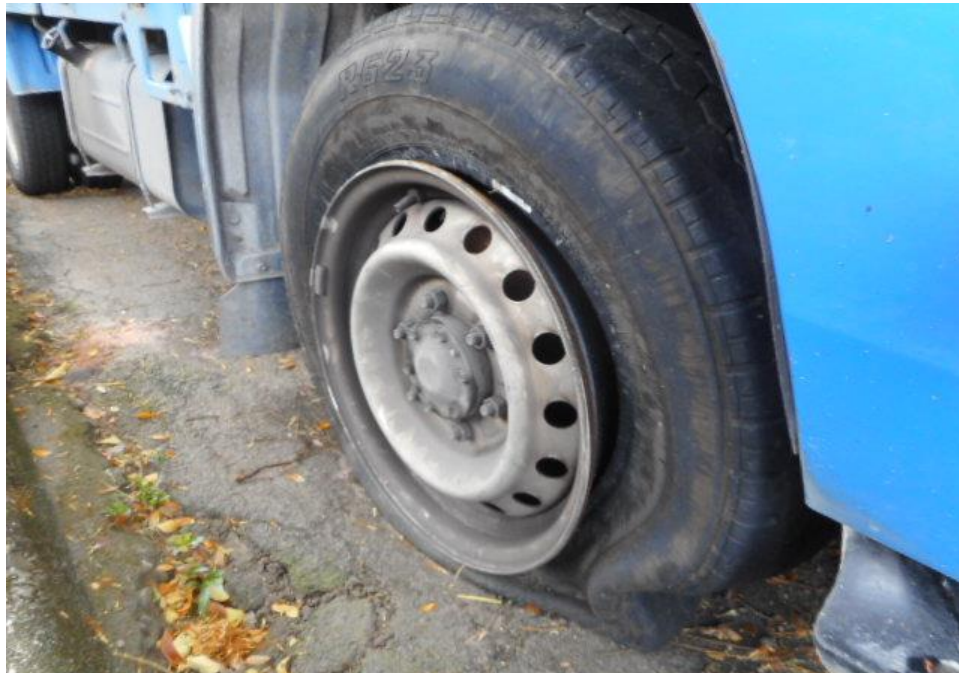
**Photo 5** shows the condition of the front right tyre of the Motor Car, which was observed to be in unserviceable condition with remaining tread depth of approximately 3.8mm. The tyre was observed to be deflated and slip off as a result of the accident.

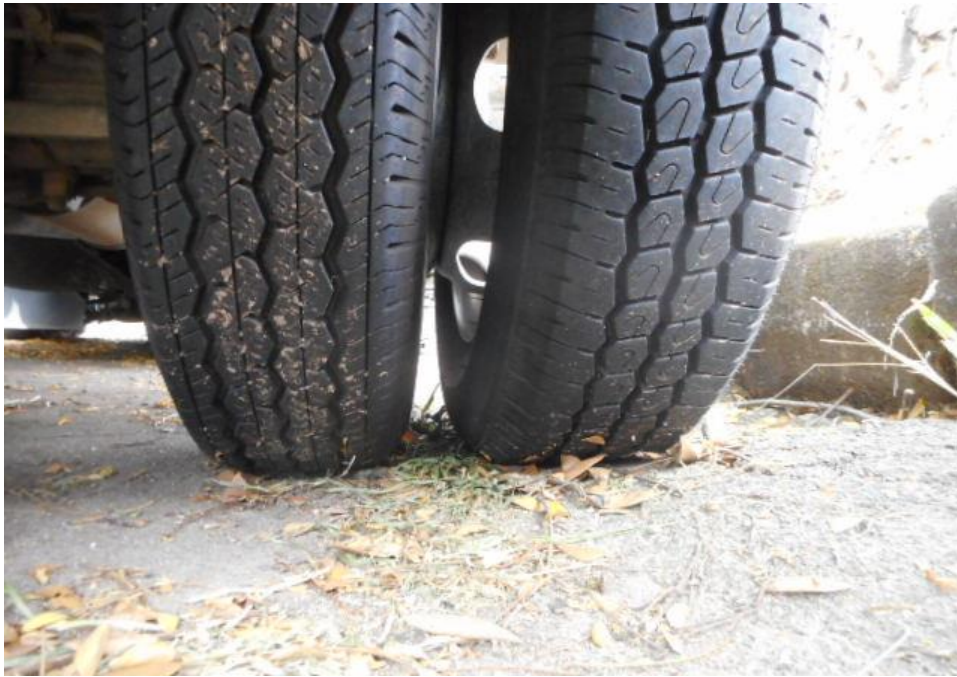
**Photo 6** shows the condition of the rear right tyre of the Motor Lorry, which was observed to be in serviceable condition with remaining tread depth of approximately 5.9mm. The tyre, which was wrapped around standard steel wheel rim, it was observed to be sufficiently inflated for vehicular operation.

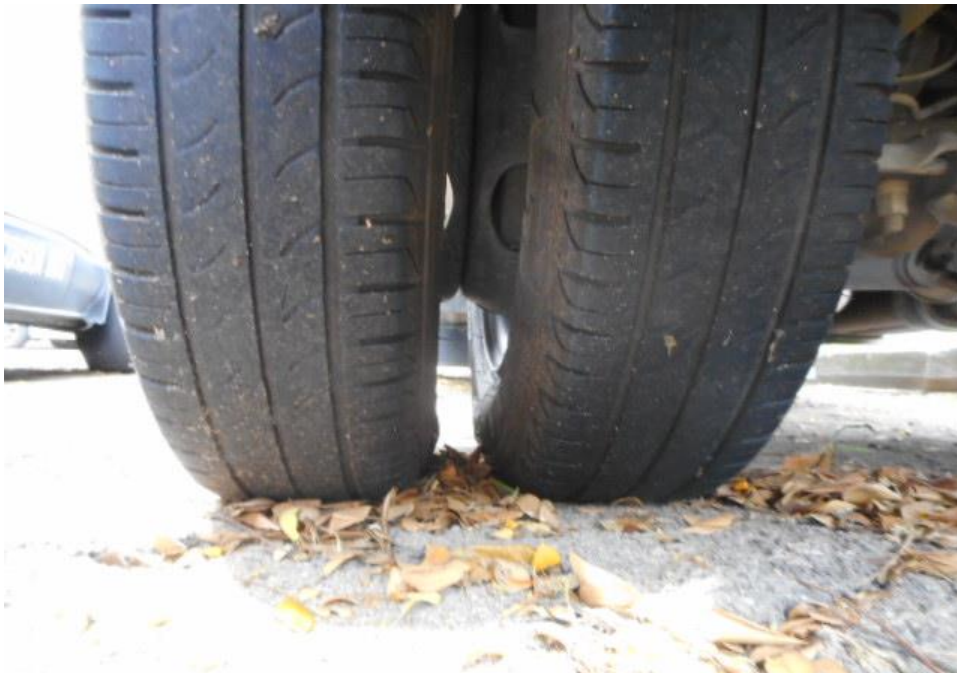
**Photo 7** shows the condition of the rear left tyres of the Motor Lorry, which was observed to be in serviceable condition with remaining tread depth of approximately 2.3mm. The tyres, which were wrapped around standard steel wheel rim, were also observed to be sufficiently inflated for vehicular operation.

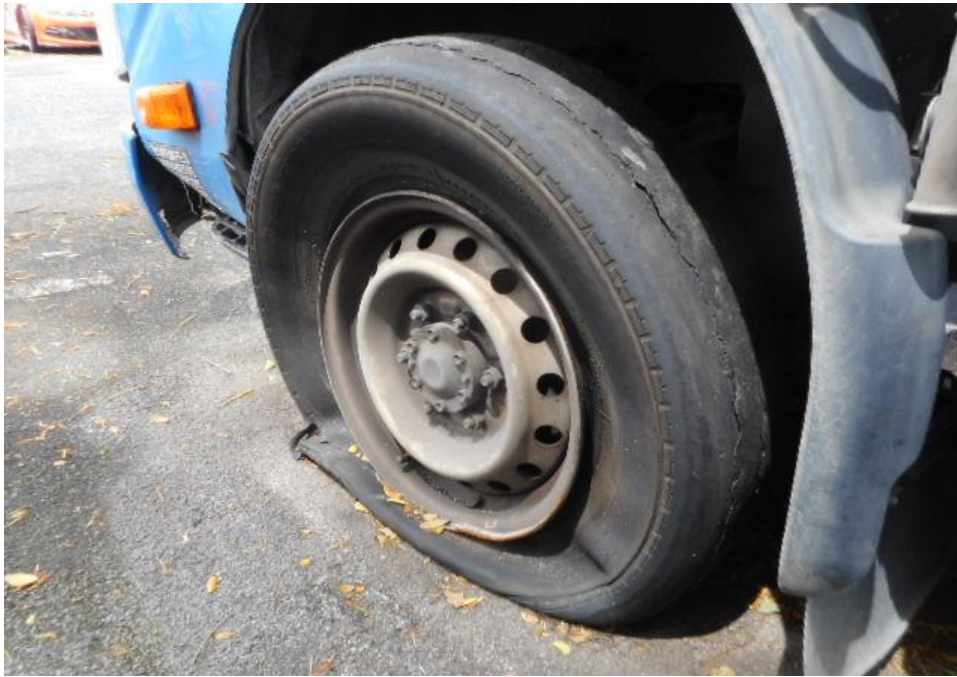
**Photo 8** shows the condition of the front right tyre of the Motor Car, which was observed to be in unserviceable condition with remaining tread depth of approximately 3.8mm. The tyre was observed to be deflated as there was cut mark on the outer sidewall tyre as a result of the accident.

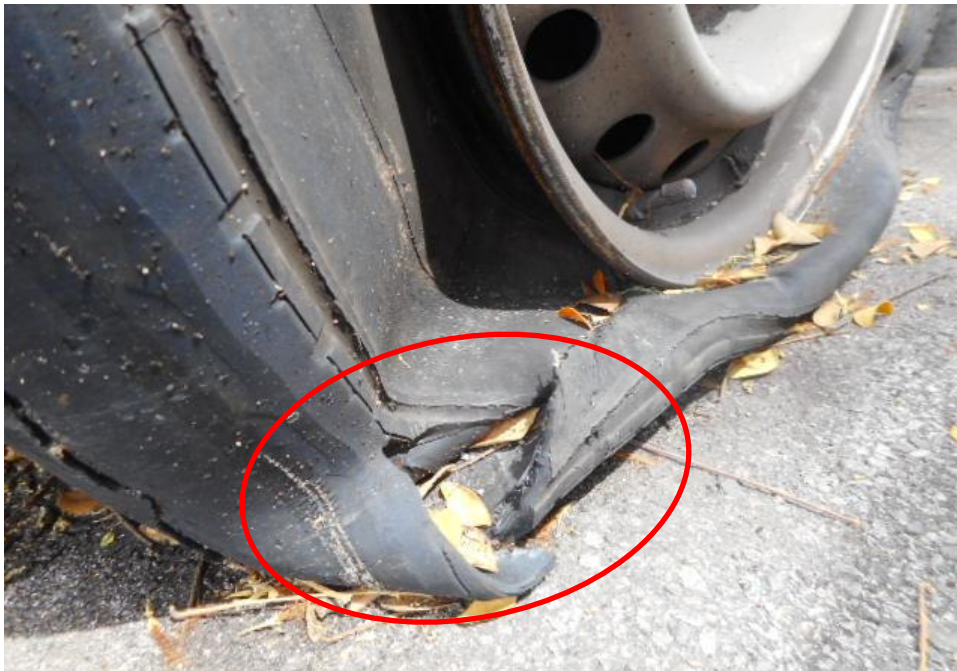
**Photo 9** shows the close up condition of the front right tyre of the Motor Car, the tyre was observed to be deflated as a result of the cut sustained on the outer sidewall of the tyre (circled) as a result of the accident.

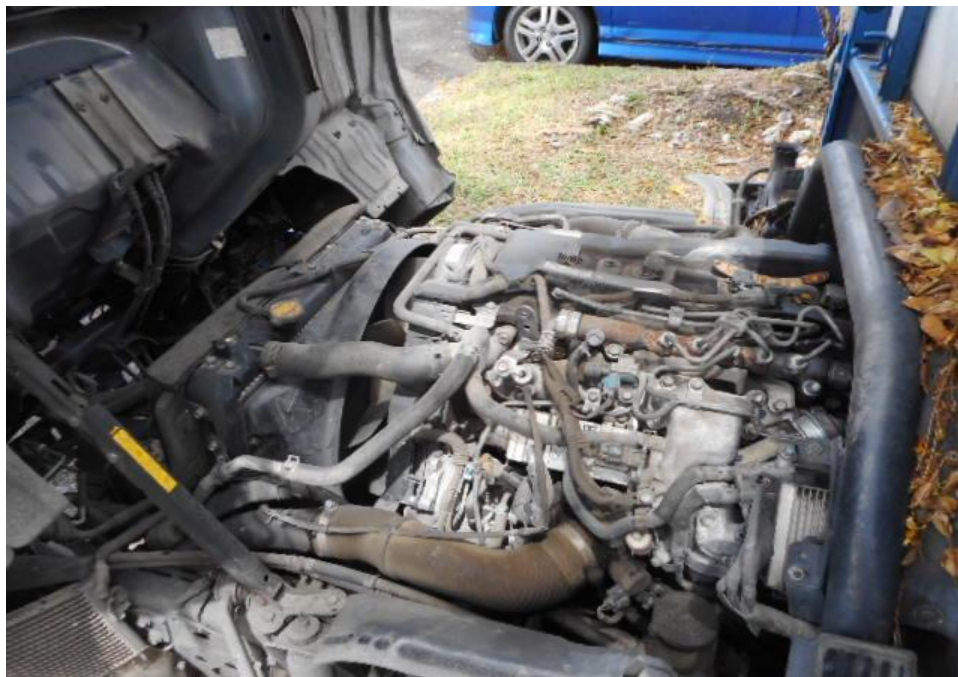
**Photo 10** shows a general view of the Motor Lorry's engine compartment, which was accessed by lifting the front cabin of the Motor Lorry. The various parts and components inside the engine compartment were unaffected by the accident. There was also no sign(s) or indication(s) of fresh fluid leakage and/or fluid stain within the engine compartment

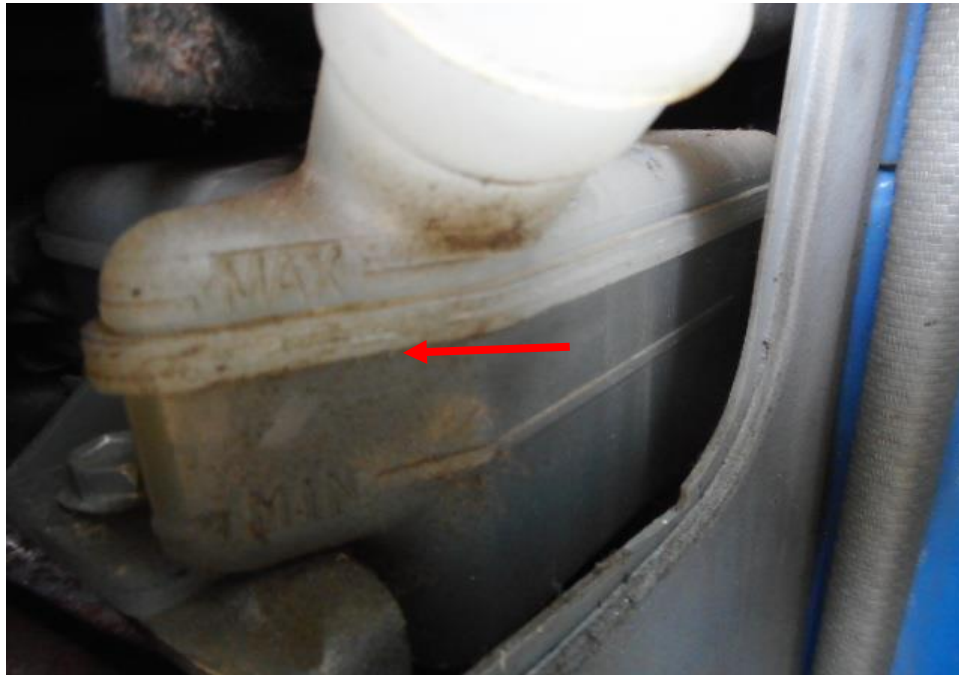
**Photo 11** shows the brake fluid reservoir of the Motor Lorry at the time of my inspection. The brake fluid was observed to be of sufficient level (arrowed) and without any visible contamination.

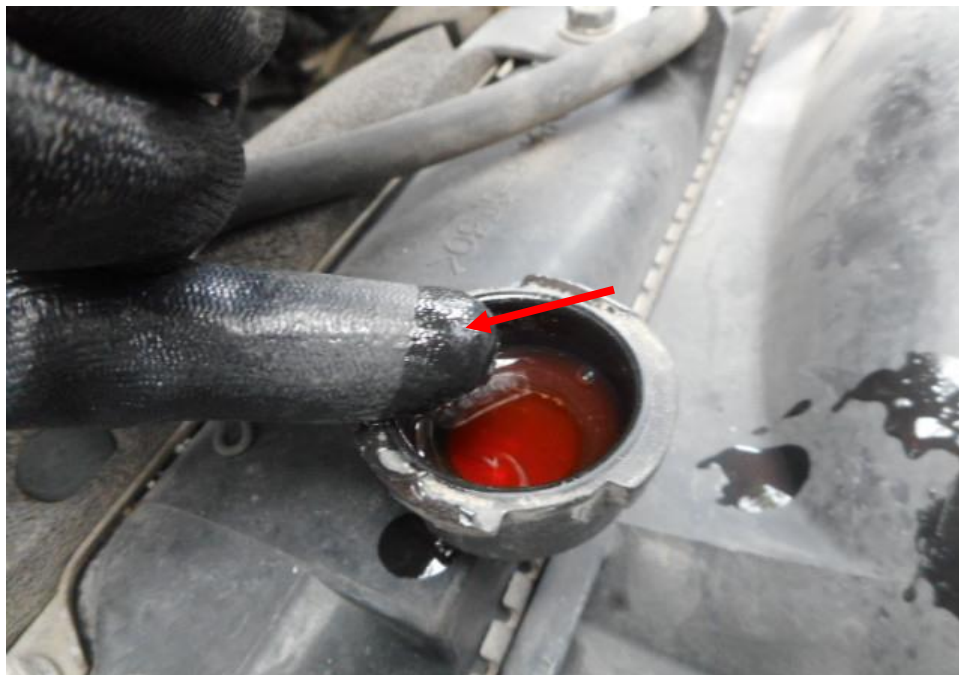
**Photo 12** shows the engine coolant reservoir of the Motor Lorry at the time of my inspection. The engine coolant was observed to be of sufficient level (arrowed) and without any visible contamination.

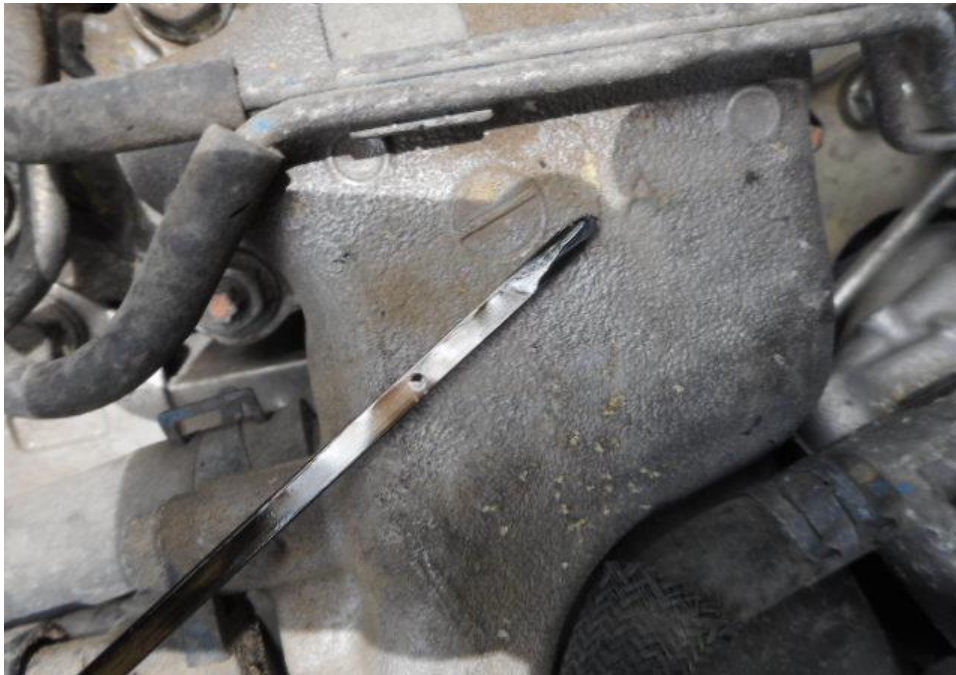
**Photo 13** shows the engine oil dip stick of the Motor Lorry at the time of my inspection. The engine oil was observed to be of sufficient level and without any visible contamination.

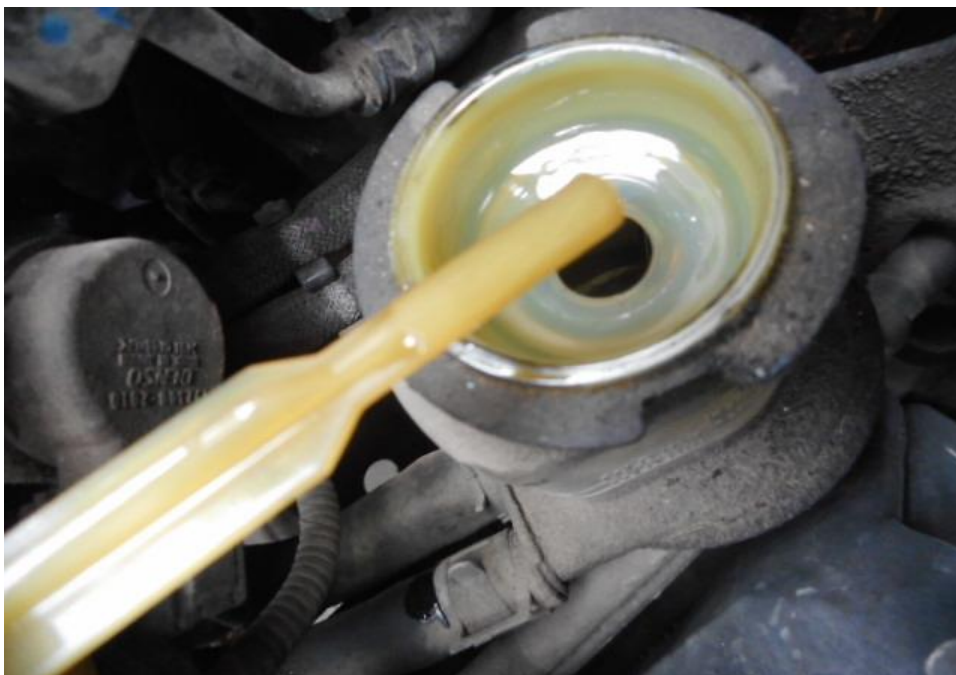
**Photo 14** shows the power steering fluid reservoir of the Motor Lorry at the time of my inspection. The power steering fluid was observed to be of sufficient level and without any visible contamination.

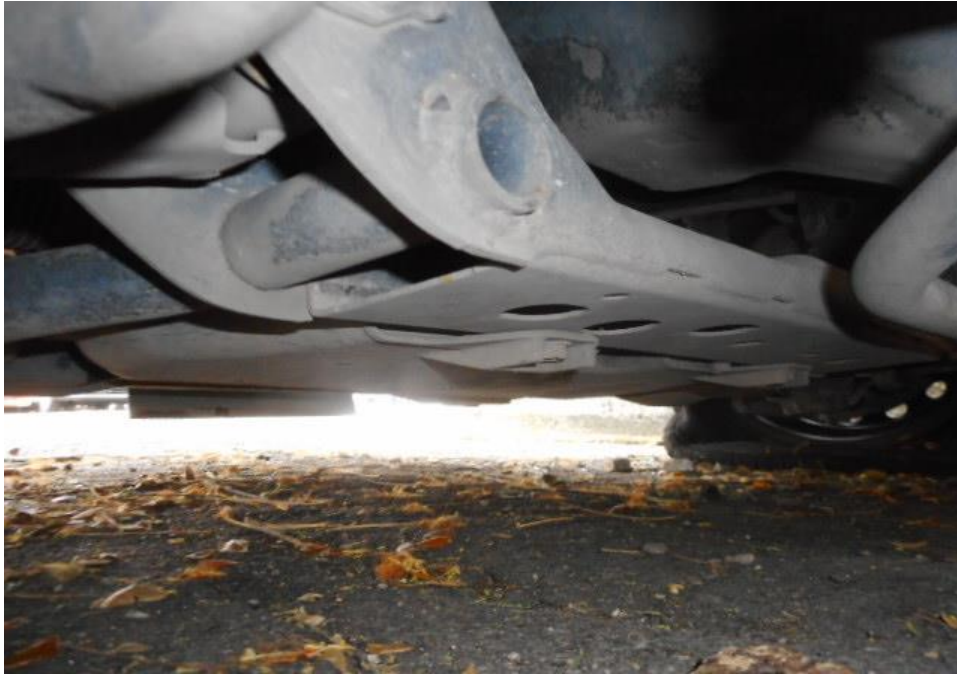
**Photo 15** shows the undercarriage of the Motor Lorry, at the area where the engine housing and transmission housing are located. I did not find any sign(s) or indication(s) of fluid leak and/or fluid stain(s) on the underside of the Motor Lorry.

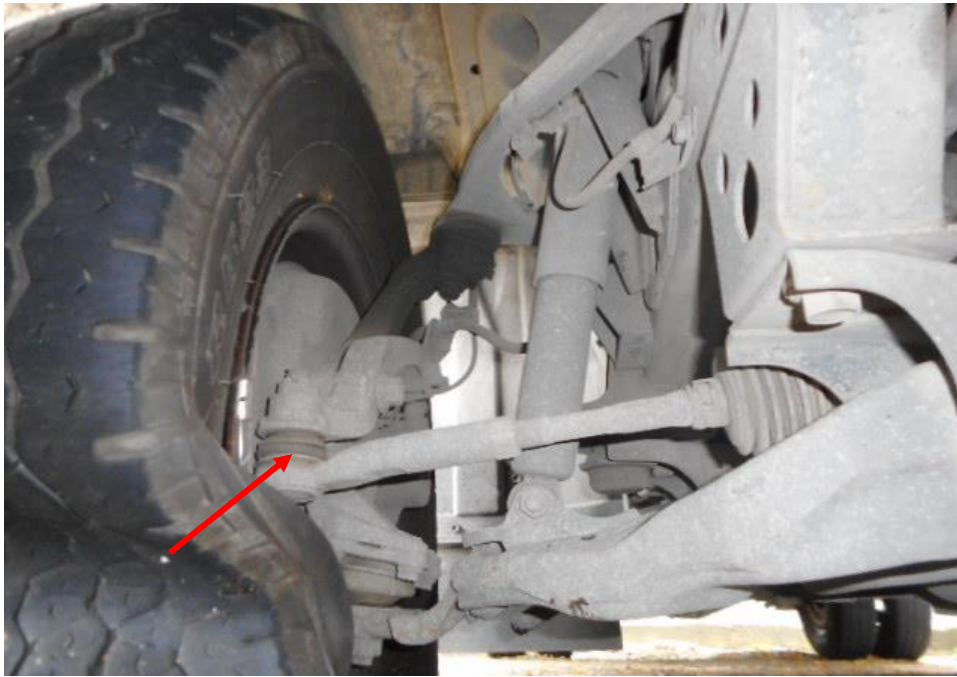
**Photo 16** shows the various undercarriage components at the front right wheel of the Motor Lorry, in particular the steering tie rod end (arrowed). The various steering components were all found to be intact, suggesting that the steering system of the Motor Lorry was likely to be in serviceable condition at the material time of accident. There was also no sign of fluid stain(s) observed on the various undercarriage components.

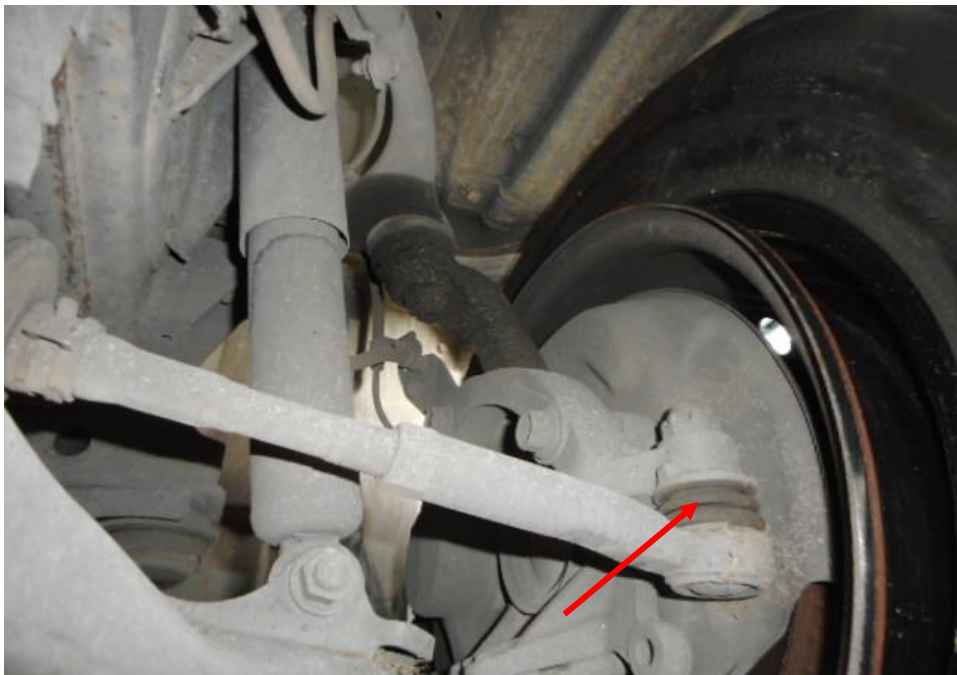
**Photo 17** shows the various undercarriage components at the front left wheel of the Motor Lorry, in particular the steering tie rod end (arrowed). The various undercarriage components of the Motor Lorry were all found to be intact without any visible damage. There was also no sign of fluid stain(s) observed on the various undercarriage components.

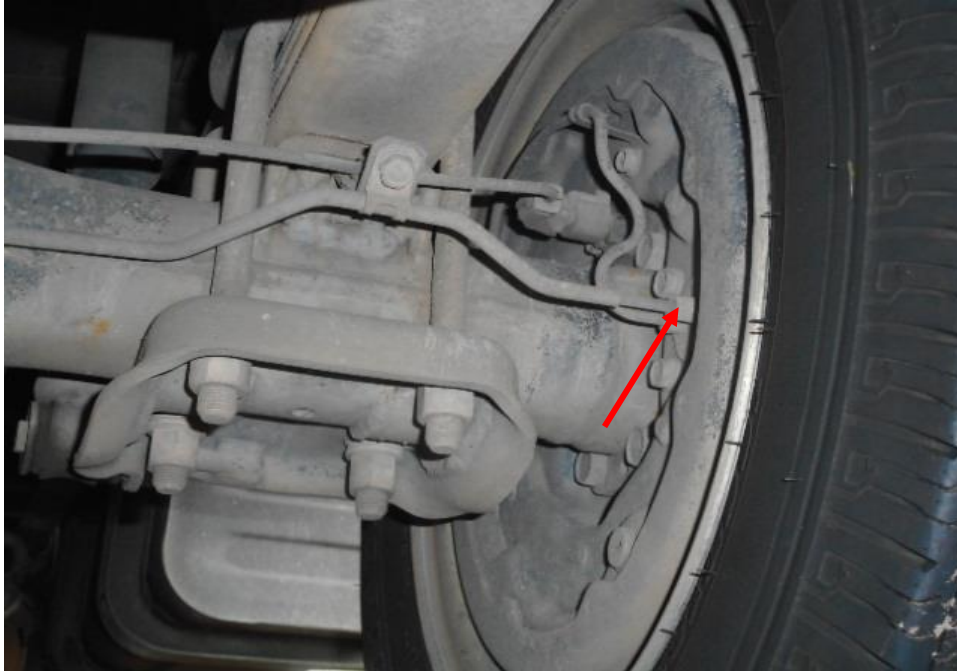
**Photo 18** shows the brake pipe (arrowed) at the rear right wheel of the Motor Lorry. I did not observe any leakage of brake fluid at the time of my inspection of the Motor Lorry. My static tests of the Motor Lorry's braking system, along with my visual examination of the various mechanical components in the braking system, had indicated that there was no internal leakage of pressure/vacuum. Hence the braking system of the Motor Lorry was likely to be in serviceable condition at the material time of accident.

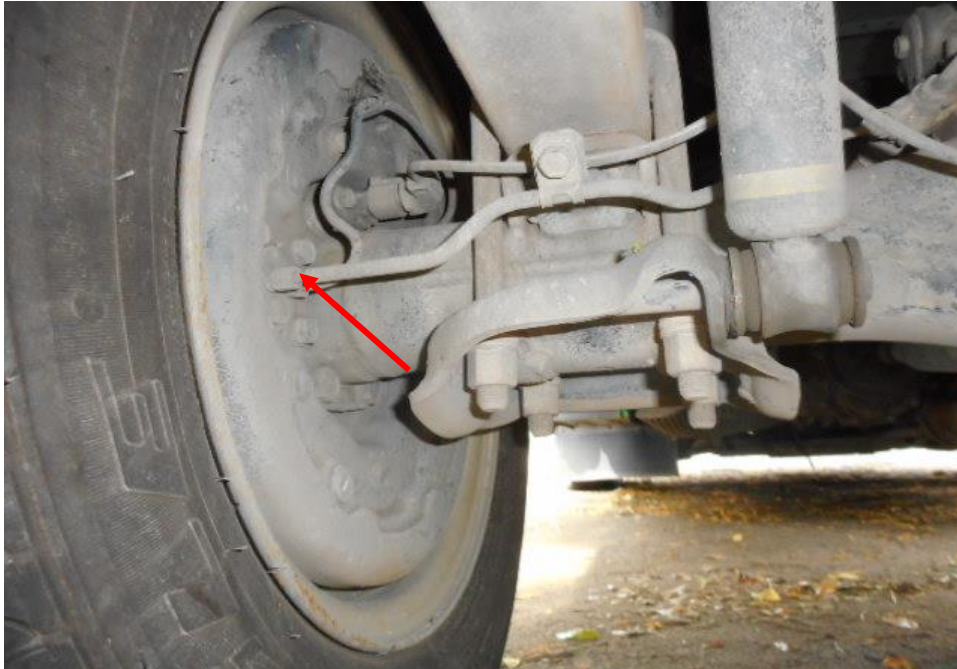
**Photo 19** shows the brake pipe (arrowed) at the rear left wheel of the Motor Lorry. I did not observe any leakage of brake fluid at the time of my inspection of the Motor Lorry. My static tests of the Motor Lorry's braking system, along with my visual examination of the various mechanical components in the braking system had indicated that there was no internal leakage of pressure/vacuum. Hence the braking system of the Motor Lorry was likely to be in serviceable condition at the material time of accident.

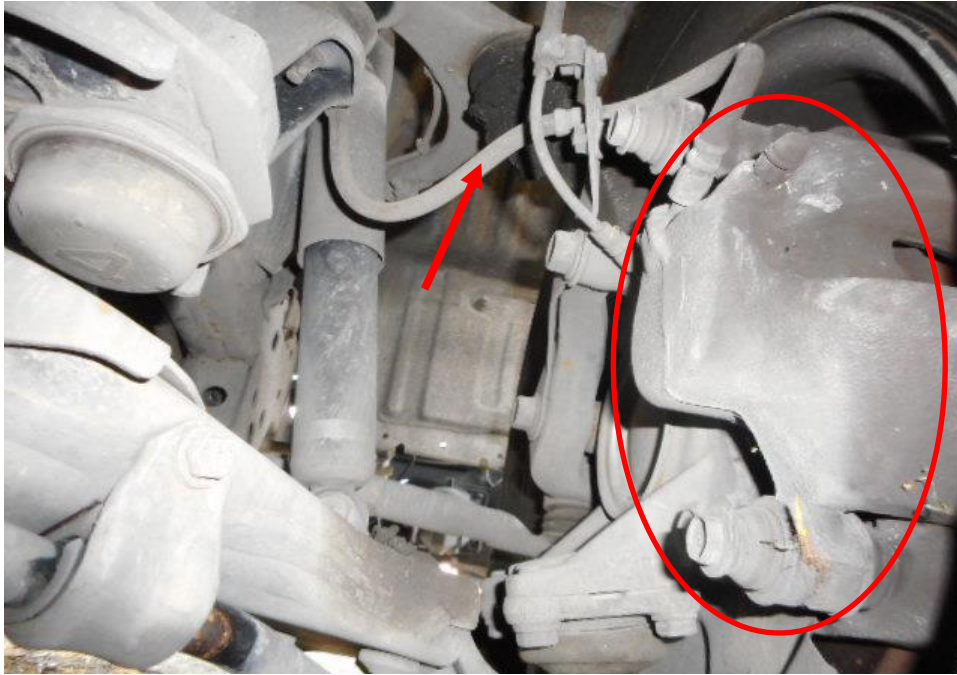
**Photo 20** shows the brake hose/pipe (arrowed) at the front right wheel of the Motor Lorry. No leakage of brake fluid was observed. Visual examination of the various components of the braking system like the brake caliper (circled), brake booster, brake pedal etc had revealed all to be intact and without visible damage at the time of accident. There was also no sign of fluid stain(s) observed on the various undercarriage components.

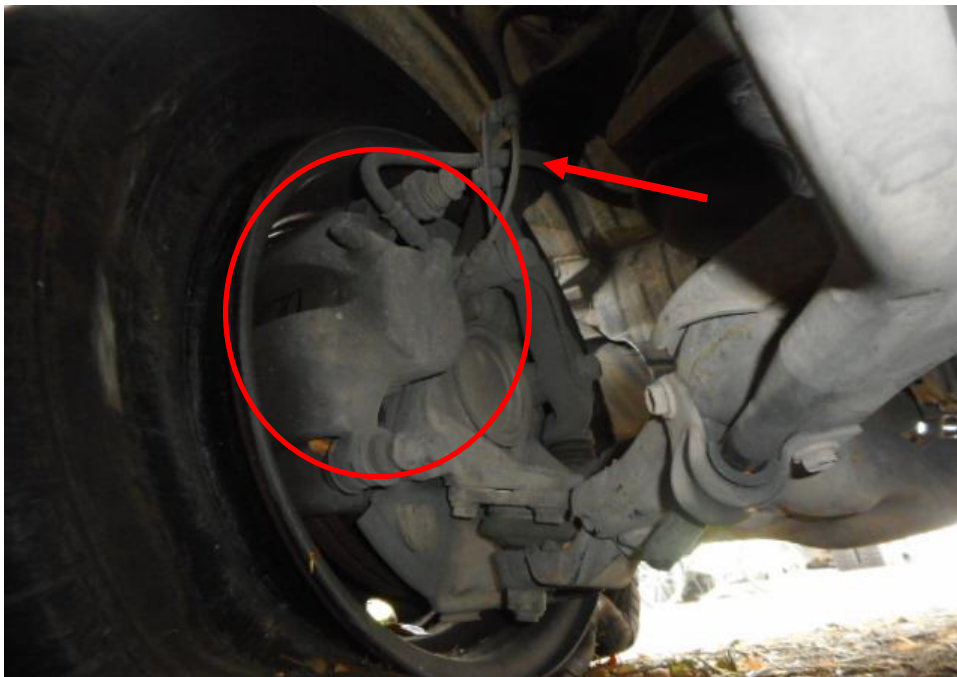
**Photo 21** shows the brake hose/pipe (arrowed) at the front left wheel of the Motor Lorry. No leakage of brake fluid was observed. Visual examination of the various components of the braking system like the brake caliper (circled), brake booster, brake pedal etc had revealed all to be intact and without visible damage at the time of accident. There was also no sign of fluid stain(s) observed on the various undercarriage components.

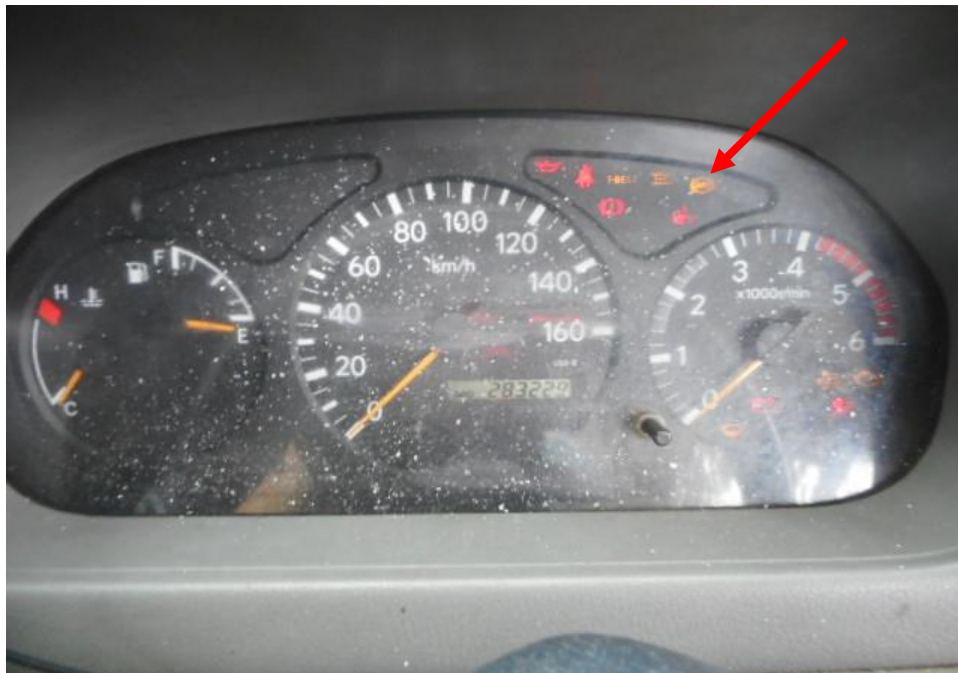
**Photo 22** shows the warning light for Supplemental Restraint System (SRS) (arrowed) appearing on the instrument panel of the Motor Car during the self-test of its various electronic operating systems when its engine was cranked.

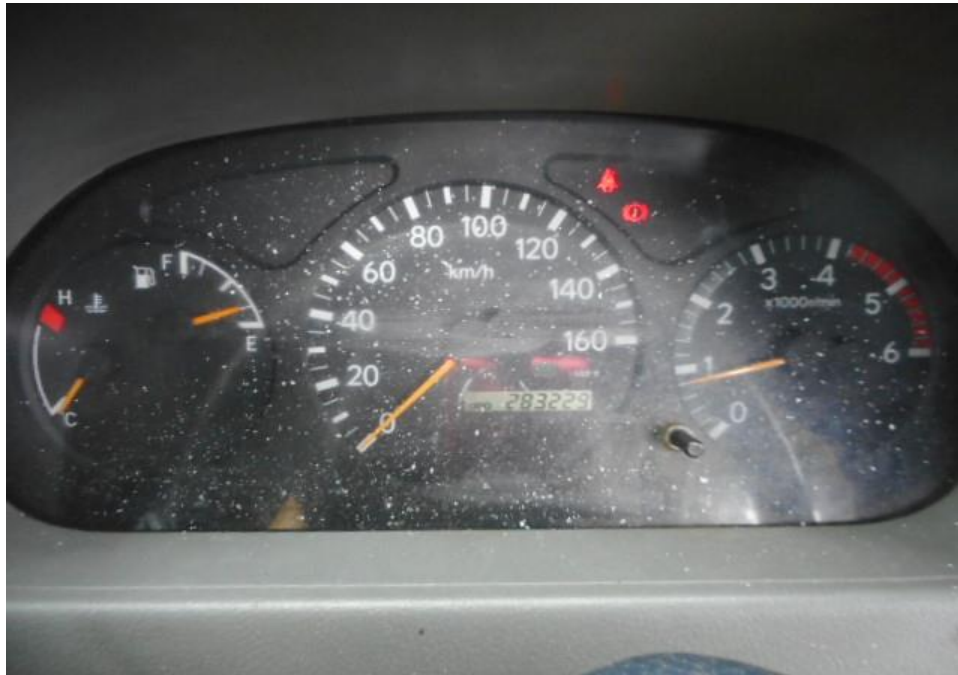
**Photo 23** shows no warning lights illuminated on the instrument panel of the Motor Car after the engine was cranked. This would suggest that there was no abnormality to the electronic operating system of the Motor Car, like the SRS and etc.
