You're Ref: TP/IP/00007/2022  
Our Ref: CI/TPD22000336/P

12<sup>th</sup> January 2022

**Fatal Accident Investigation Team**

**MECHANICAL INSPECTION REPORT OF MOTOR CAR SKX 5940Y**

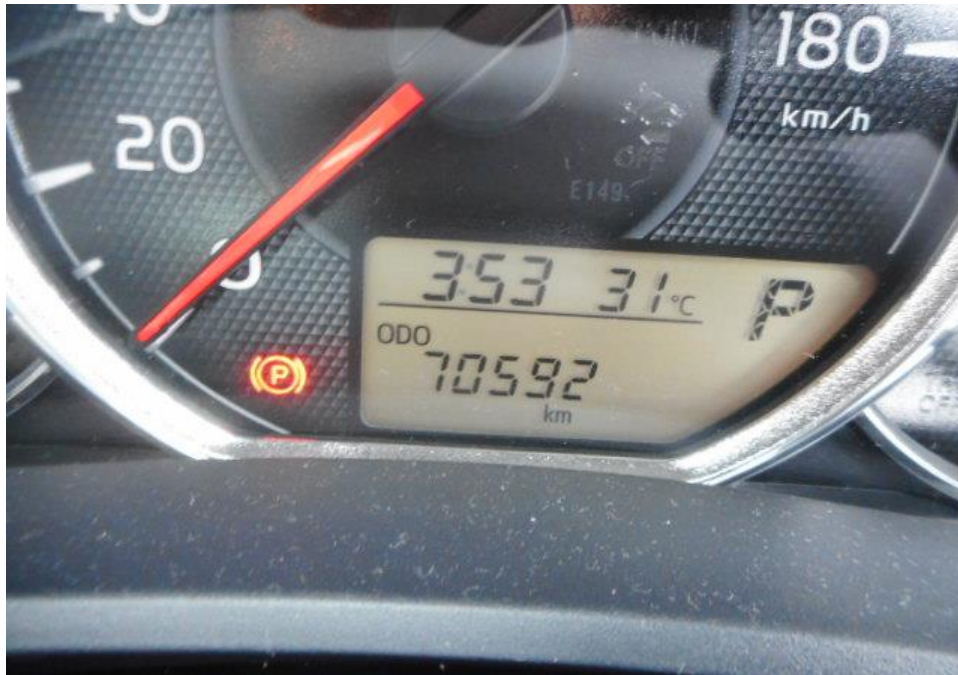
**Photo 1** shows the mileage of the Motor Car at the time of my inspection. The mileage observed was 70,592km.

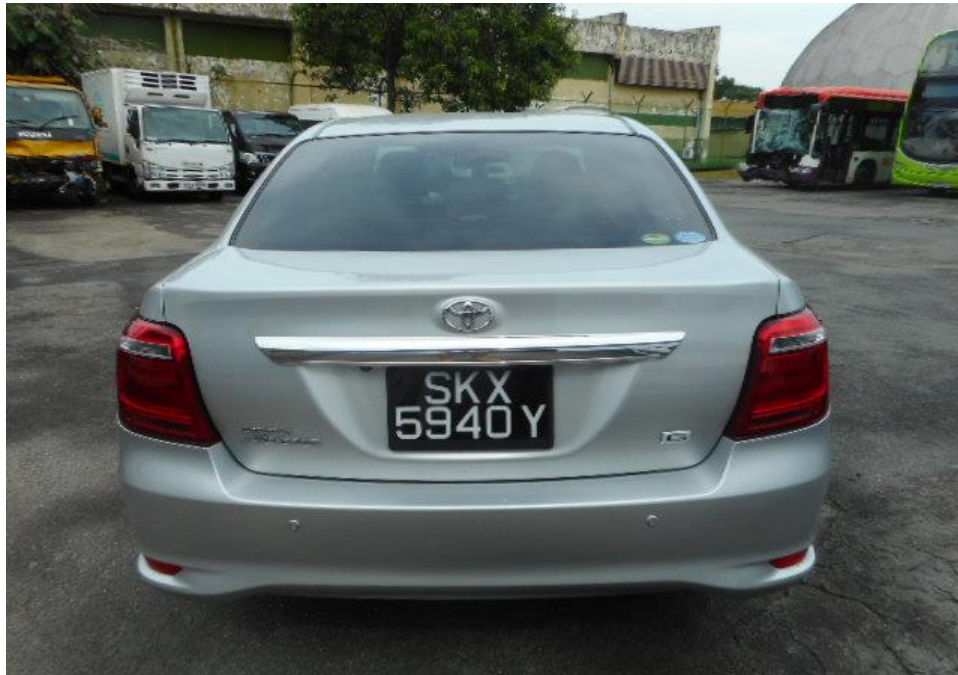
**Photo 2** shows the general view of the Motor Car's rear body at the time of my inspection. The Motor Car rear was observed to be unaffected by the accident.

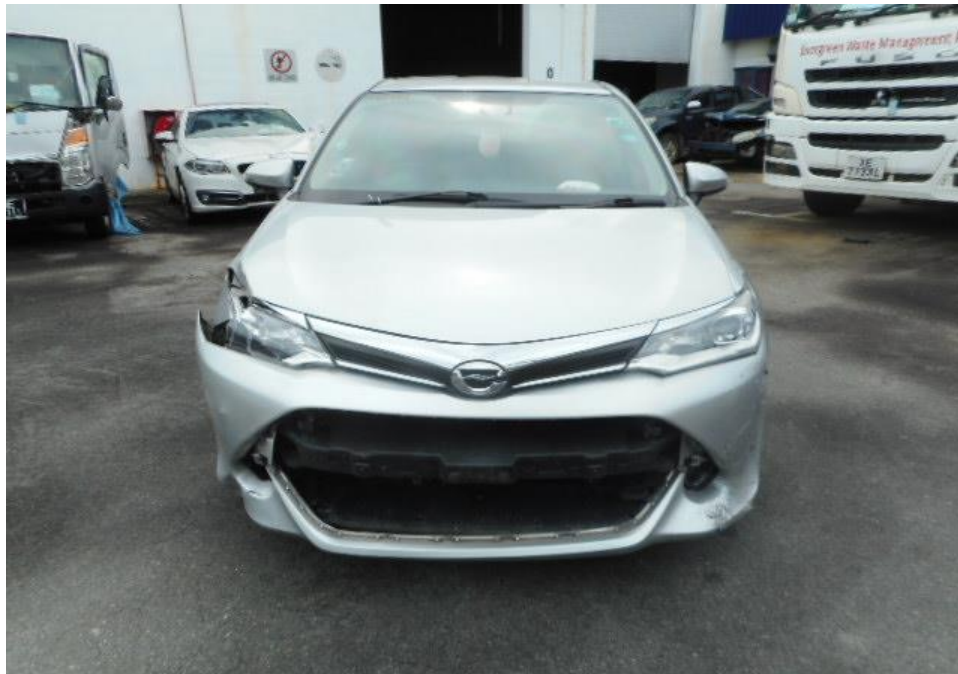
4. The mileage of the Motor Car at the time of my inspection was 70,592km.
5. The Motor Car was observed to have sustained damage at its front and left portion. Its front bumper, front right headlamp and its front right fender as well as its left door panel were amongst the body parts that were damaged as a result of the accident.

**Photo 3** shows a general view of the Motor Car's front body at the time of my inspection. The Motor Car was observed to have sustained damage at its front and left portion. Its front bumper, front right headlamp and its front right fender as well as its left door panel were amongst the body parts that were damaged as a result of the accident.

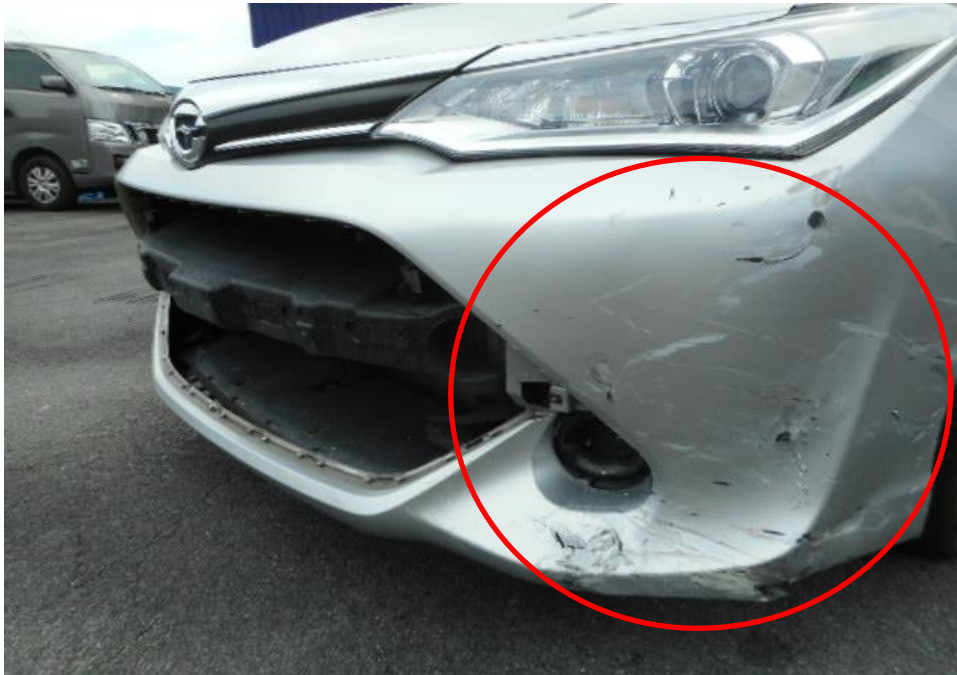
**Photo 4** shows a close up view of the Motor Car's front body at the time of my inspection. The front portion of the Motor Car was observed to have sustained damage. Its front bumper (circled) was the body parts that were damaged as a result of the accident.

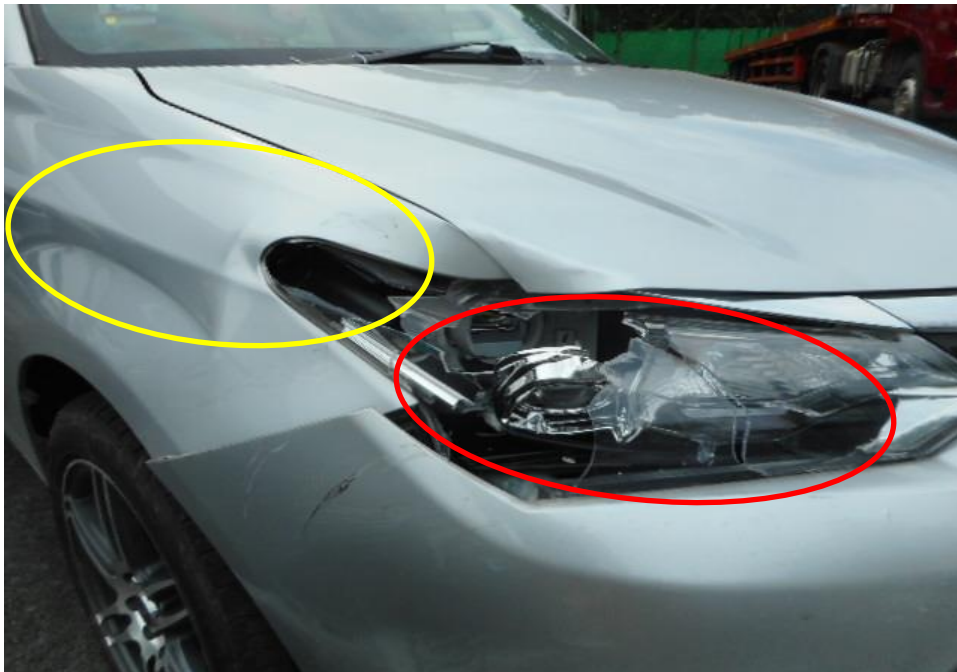
**Photo 5** shows a close up view of the Motor Car's front body at the time of my inspection. The front portion of the Motor Car was observed to have sustained damage. Its front right fender (yellow circle) and front right headlamp (red circle) was the body parts that were damaged as a result of the accident.

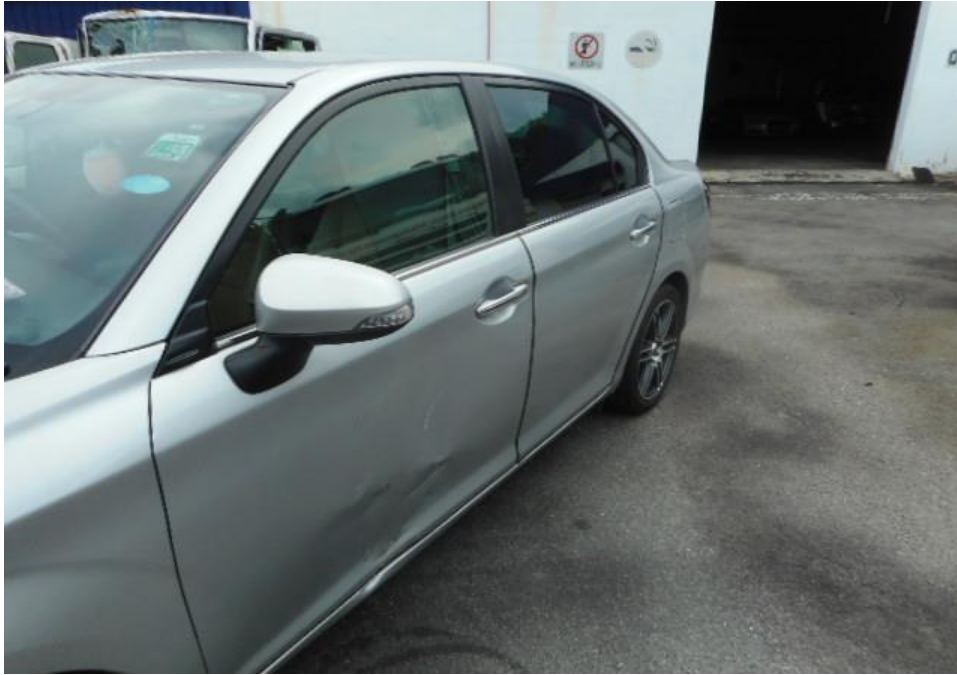
**Photo 6** shows a general view of the Motor Car's left body at the time of my inspection. The left portion of the Motor Car was observed to have sustained damage. Its left door panel was the body parts that were damaged as a result of the accident.

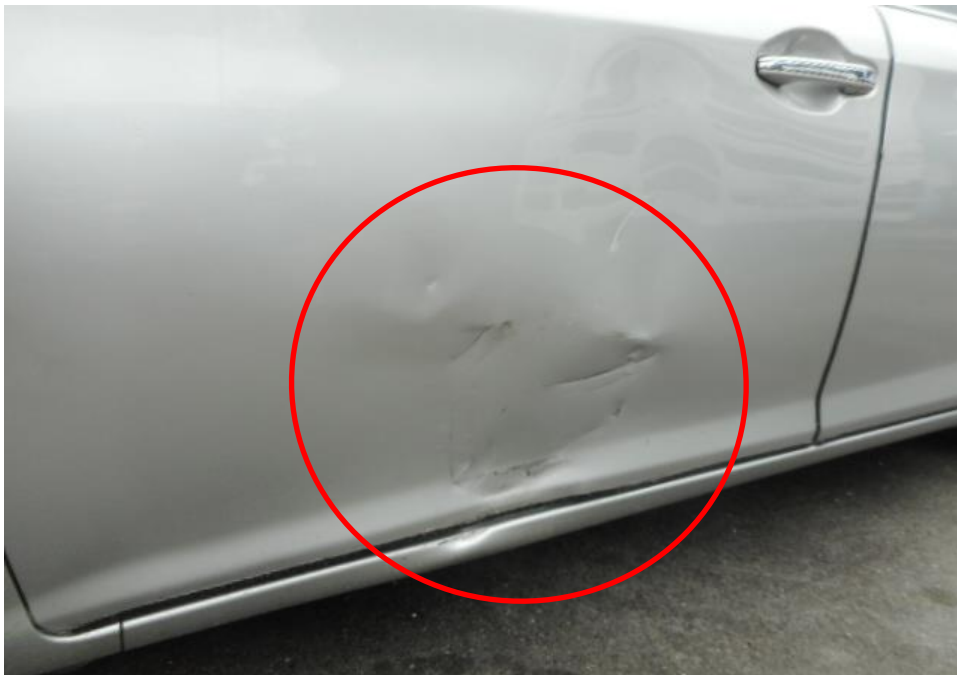
**Photo 7** shows a close up view of the Motor Car's left body at the time of my inspection. The left portion of the Motor Car was observed to have sustained damage. Its left door panel was the body parts that were damaged as a result of the accident.

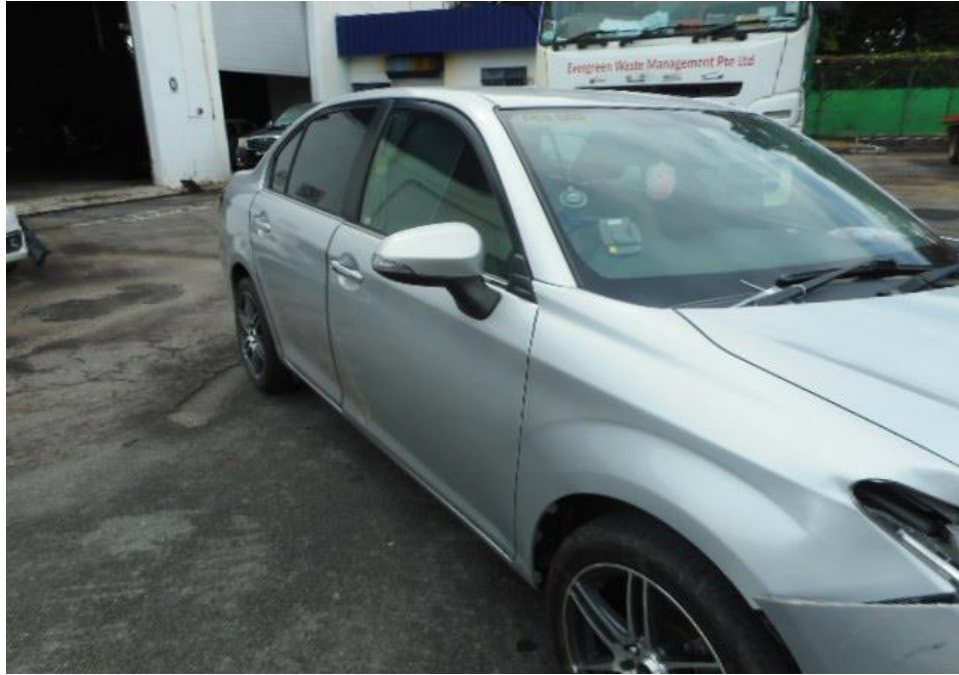
**Photo 8** shows a general view of the Motor Car's right body at the time of my inspection. The right portion of the Motor Car was observed to have been unaffected by the accident.

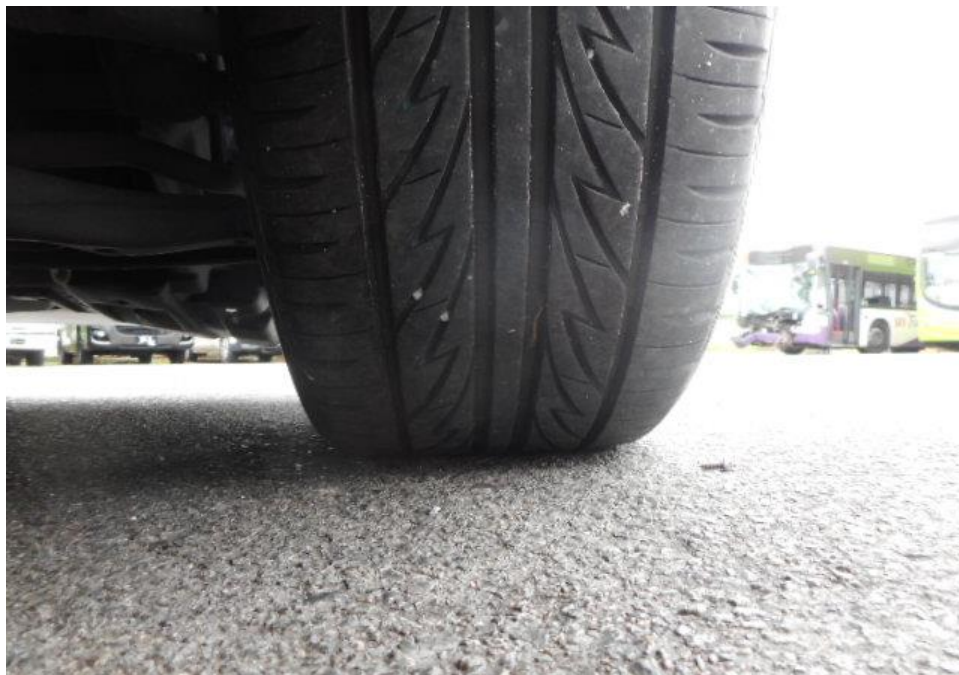
**Photo 9** shows the condition of the front right tyre of the Motor Car, which was observed to be in serviceable condition with remaining tread depth of approximately 5.2mm. The tyre was sufficiently inflated for vehicular operation with no tear, cut or burst mark(s) on the outer and the inner sidewalls as well as across the tread. The 4 tyres of the Motor Car were wrapped around standard steel wheel rims without any damage.

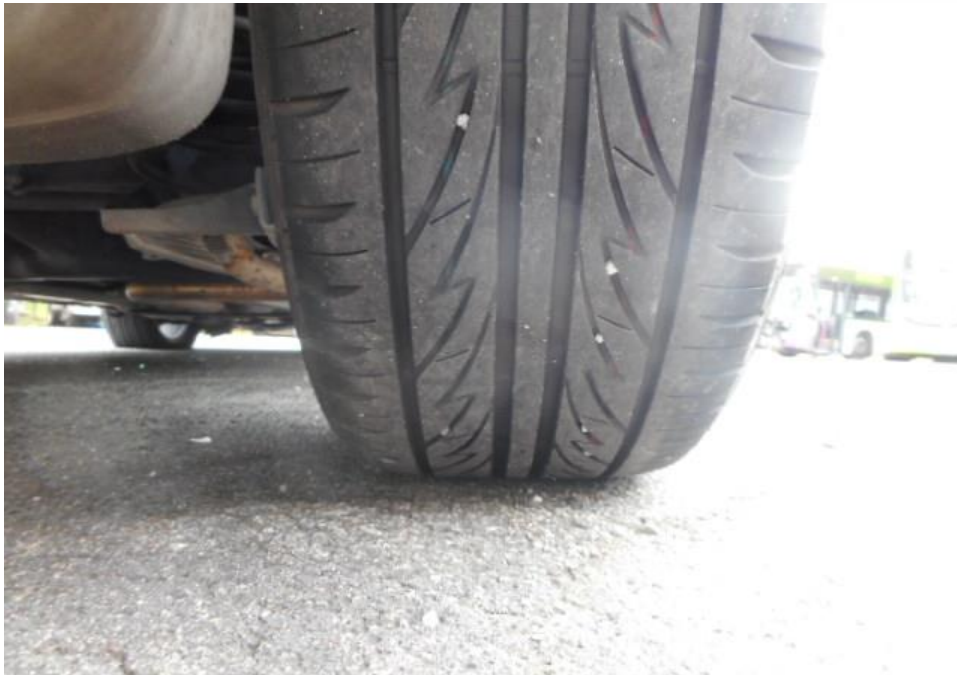
**Photo 10** shows the condition of the rear right tyre of the Motor Car, which was observed to be in serviceable condition with remaining tread depth of approximately 4.4mm. The tyre was also observed to be sufficiently inflated for vehicular operation with no tear, cut or burst mark(s).

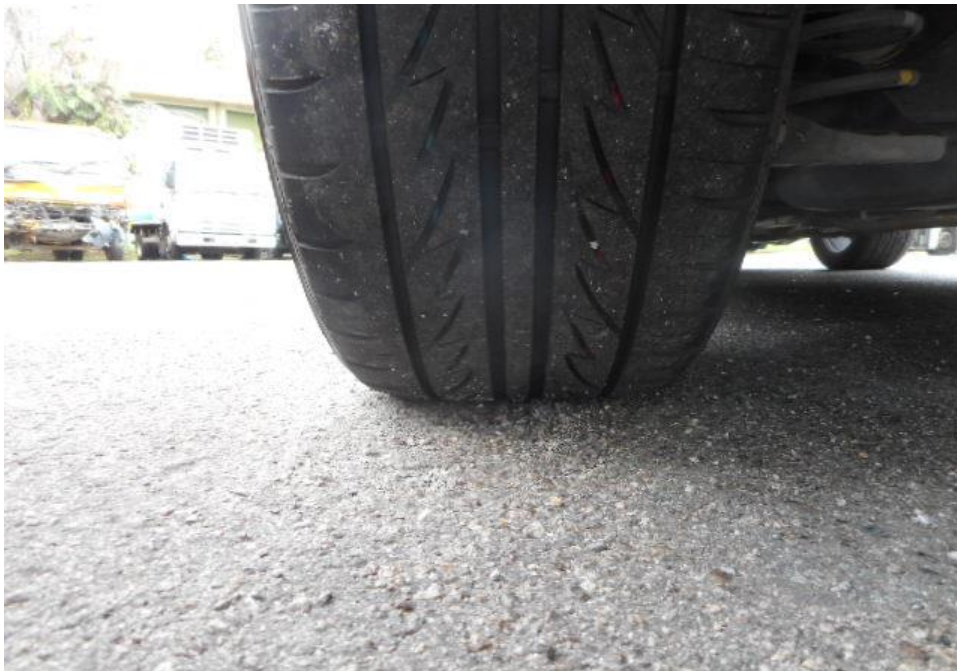
**Photo 11** shows the condition of the rear left tyre of the Motor Car, which was observed to be in serviceable condition with remaining tread depth of approximately 3.4mm. The tyre, which was wrapped around steel wheel rim, was also observed to be sufficiently inflated for vehicular operation. The 4 tyres of the Motor Car were wrapped around standard steel wheel rims.

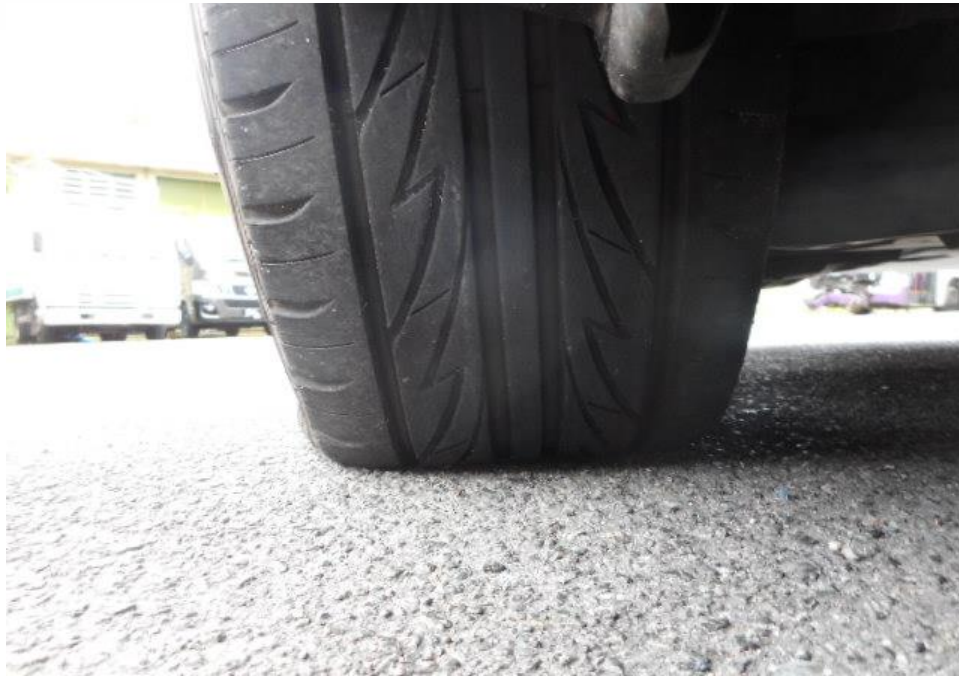
**Photo 12** shows the condition of the front left tyre of the Motor Car, which was observed to be in serviceable condition with remaining tread depth of approximately 4.6mm. There was also no tear, cut or burst mark(s) on the outer and the inner sidewalls as well as across the tread of the Motor Car's 4 tyres.

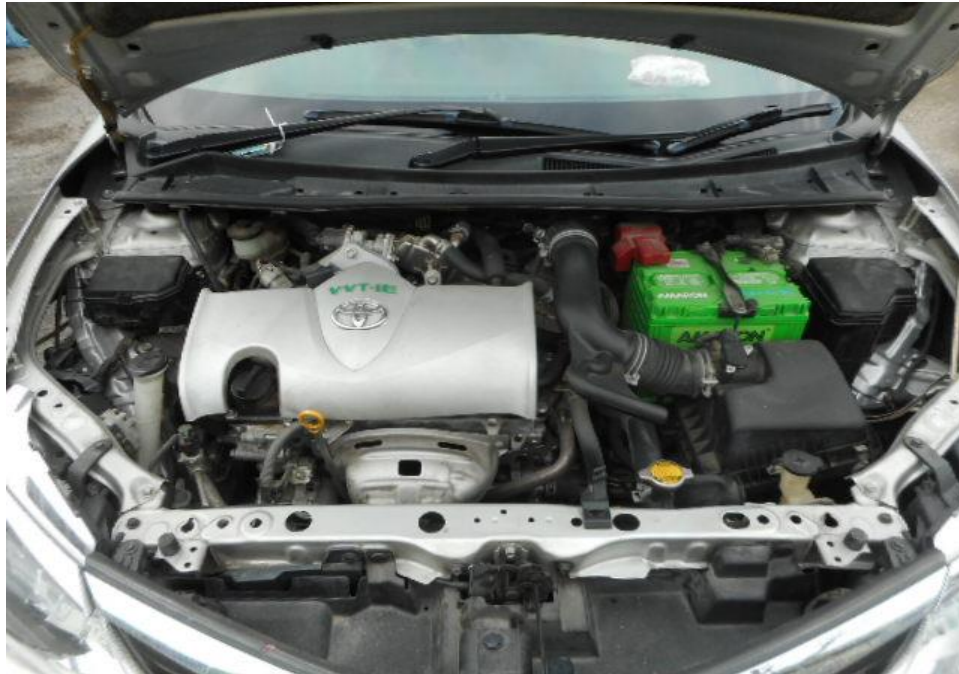
**Photo 13** shows a general view of the Motor Car's engine compartment. The various parts and components inside the engine compartment were unaffected by the accident. There was also no sign(s) or indication(s) of fluid leakage and/or fluid stain within the engine compartment.

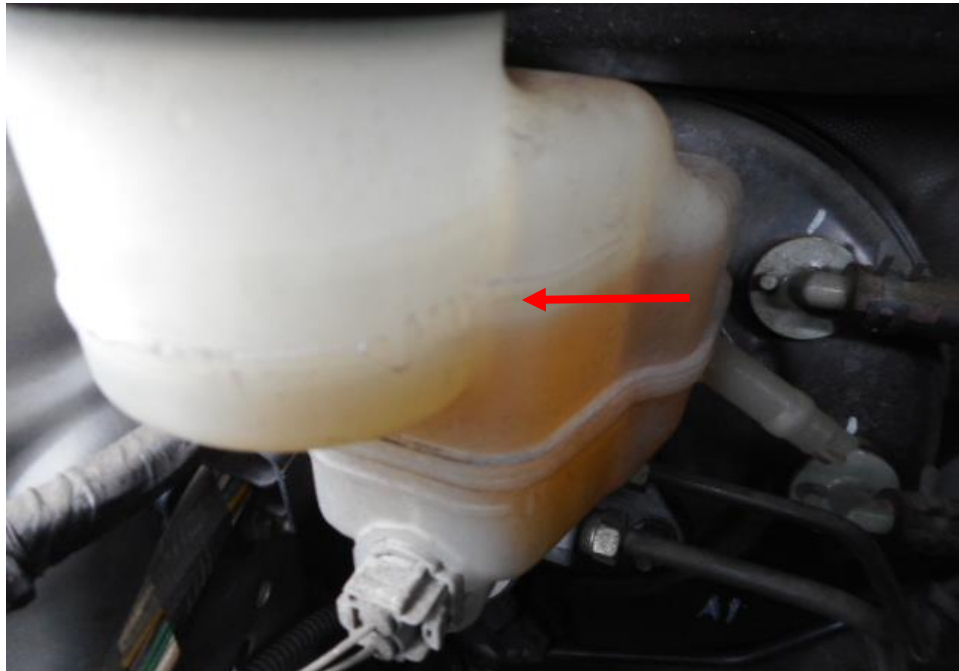
**Photo 14** shows the brake fluid reservoir of the Motor Car at the time of my inspection. The brake fluid was observed to be of sufficient level (arrowed) and without any visible contamination.

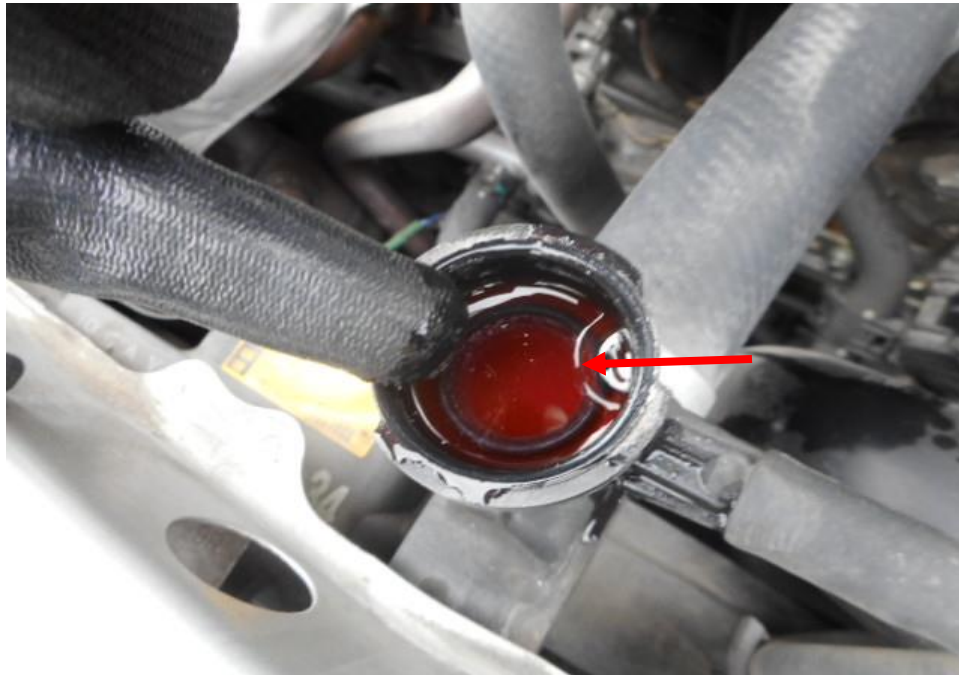
**Photo 15** shows checks being carried out to the engine coolant of the Motor Car at the time of my inspection. The engine coolant was observed to be of sufficient level (arrowed) and without any visible contamination.

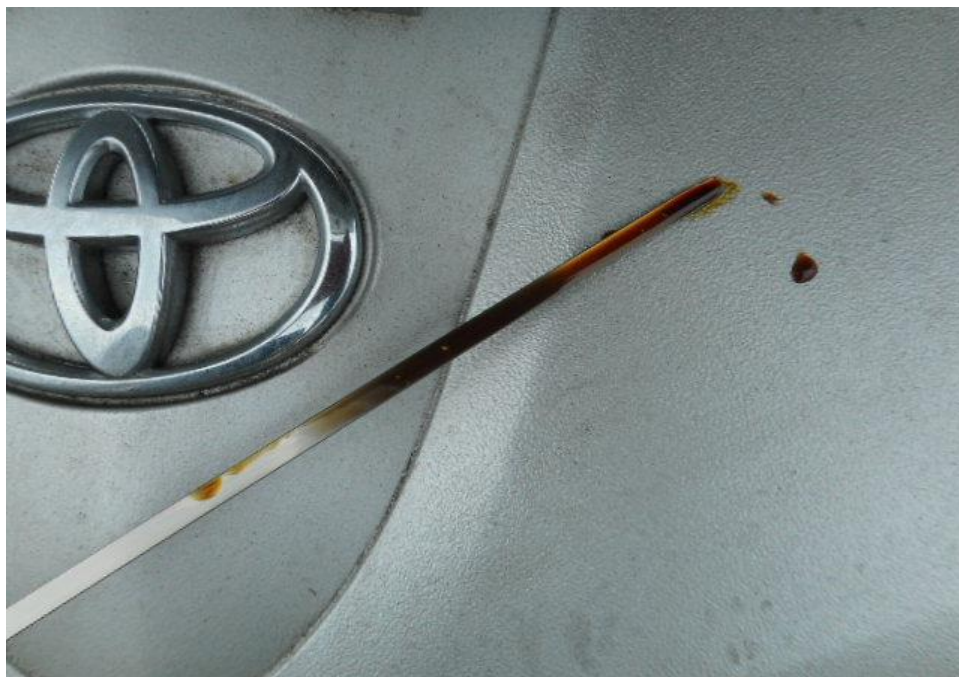
**Photo 16** shows the engine oil dipstick of the Motor Car at the time of my inspection. The engine oil was observed to be of sufficient level and without any visible contamination.

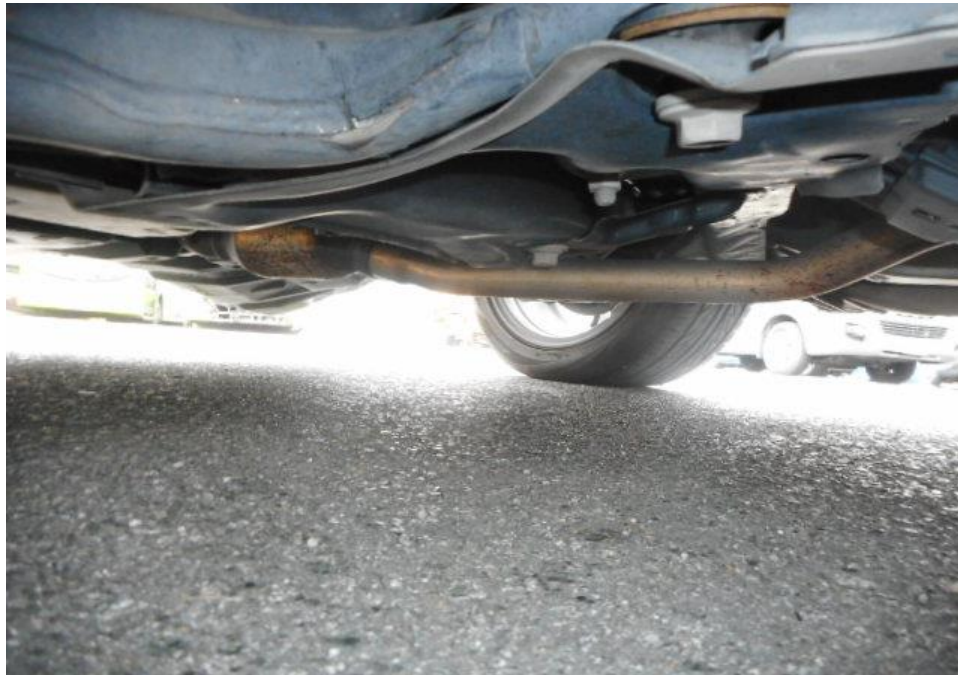
**Photo 17** shows the undercarriage of the Motor Car, at the area where the engine housing and transmission housing are located. I did not find any sign(s) or indication(s) of fluid leak and/or fluid stain(s) on the underside of the Motor Car.

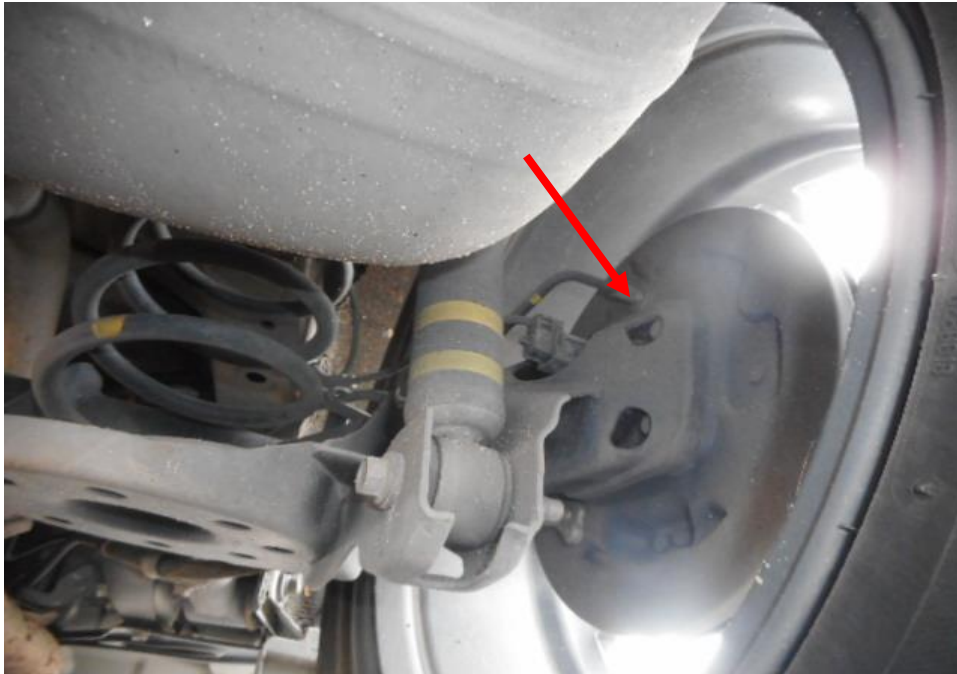
**Photo 18** shows the brake hose/pipe (arrowed) at the rear right wheel of the Motor Car. No leakage of brake fluid was observed. Visual examination of the various components of the braking system like the drum brake, brake booster, brake pedal etc. had revealed all to be intact and without visible damage.

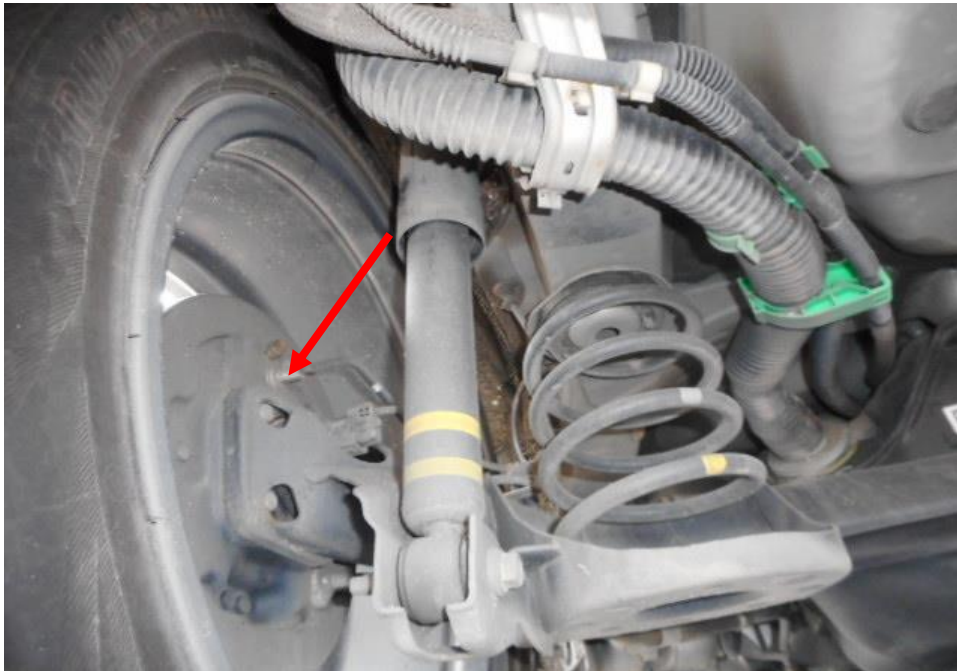
**Photo 19** shows the brake hose/pipe (arrowed) at the rear left wheel of the Motor Car. I did not observe any leakage of brake fluid at the time of my inspection of the Motor Car. Static tests of the Motor Car's braking system had indicated that there was no internal leakage of pressure/vacuum. The undercarriage components of the Motor Car were also all found to be intact and without any visible damage.

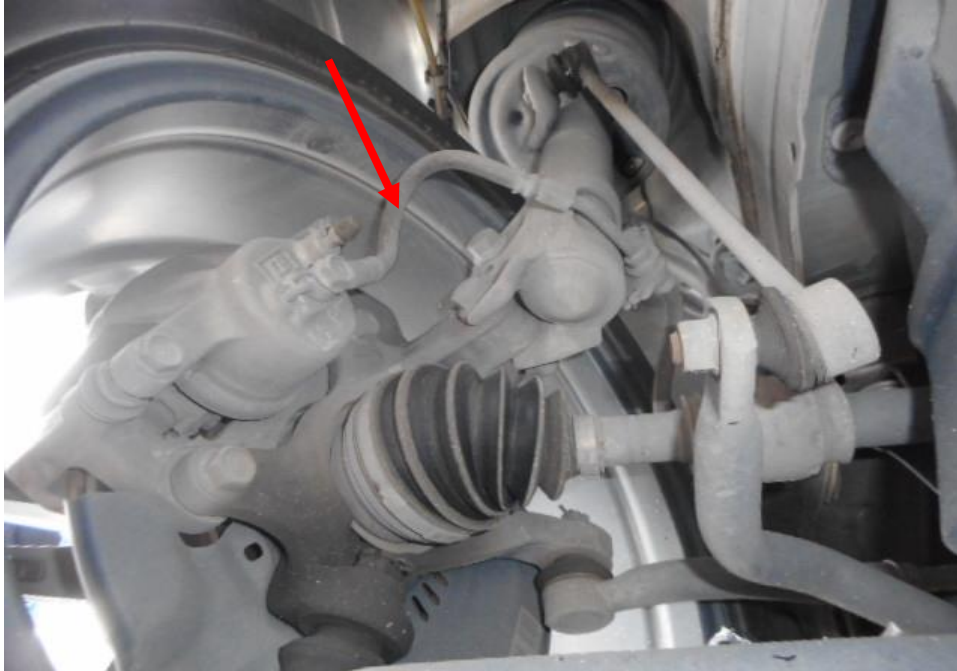
**Photo 20** shows the brake hose/pipe (arrowed) at the front right wheel of the Motor Car. I did not observe any leakage of brake fluid at the time of my inspection of the Motor Car. Static tests of the Motor Car's braking system had indicated that there was no internal leakage of pressure/vacuum. The undercarriage components of the Motor Car were also all found to be intact and without any visible damage.

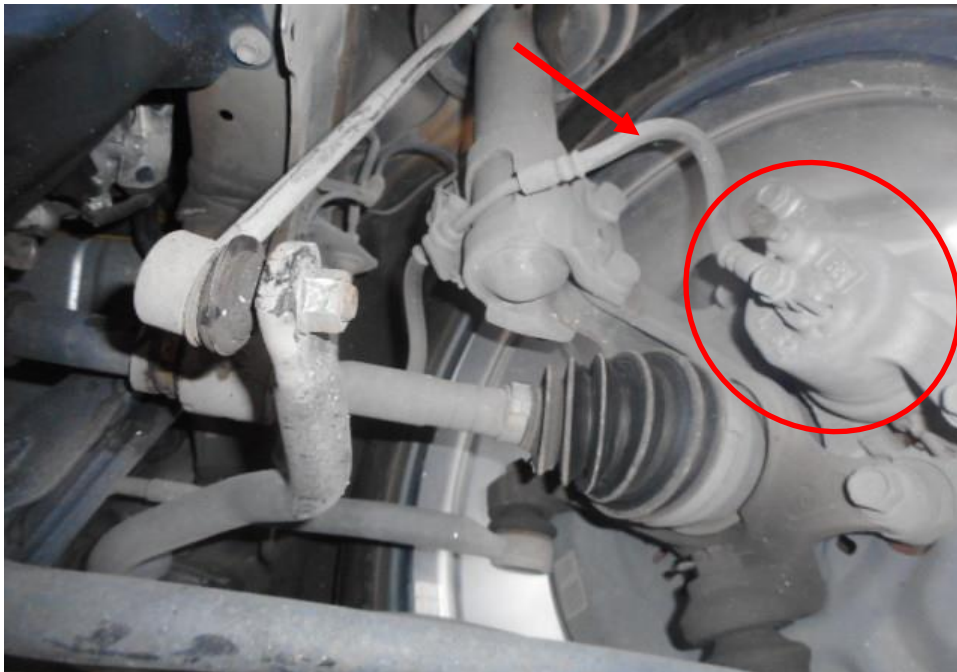
**Photo 21** shows the brake hose/pipe (arrowed) at the front left wheel of the Motor Car. No leakage of brake fluid was observed. Visual examination of the various components of the braking system like the brake caliper (circled), brake booster, brake pedal etc had revealed all to be intact and without visible damage.

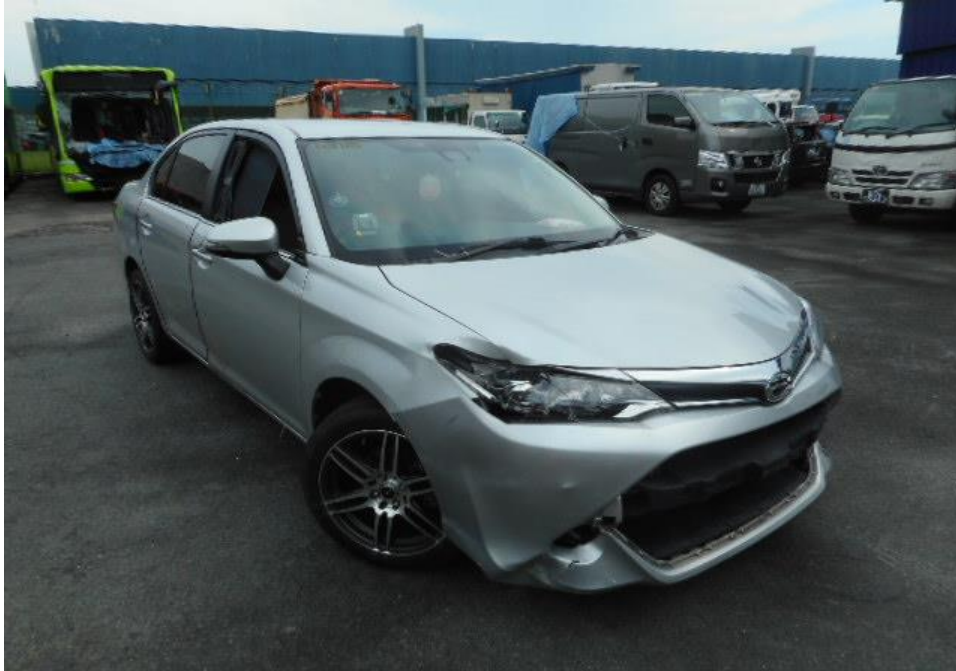
**Photo 22** shows the front right wheel of the Motor Car turned to its full left. During my steering system test, I did not experience any abnormal free play and/or resistance when I had turned the steering wheel towards the left and right. This would suggest that the steering system of the Motor Car was likely to be in serviceable condition at the material time of accident.

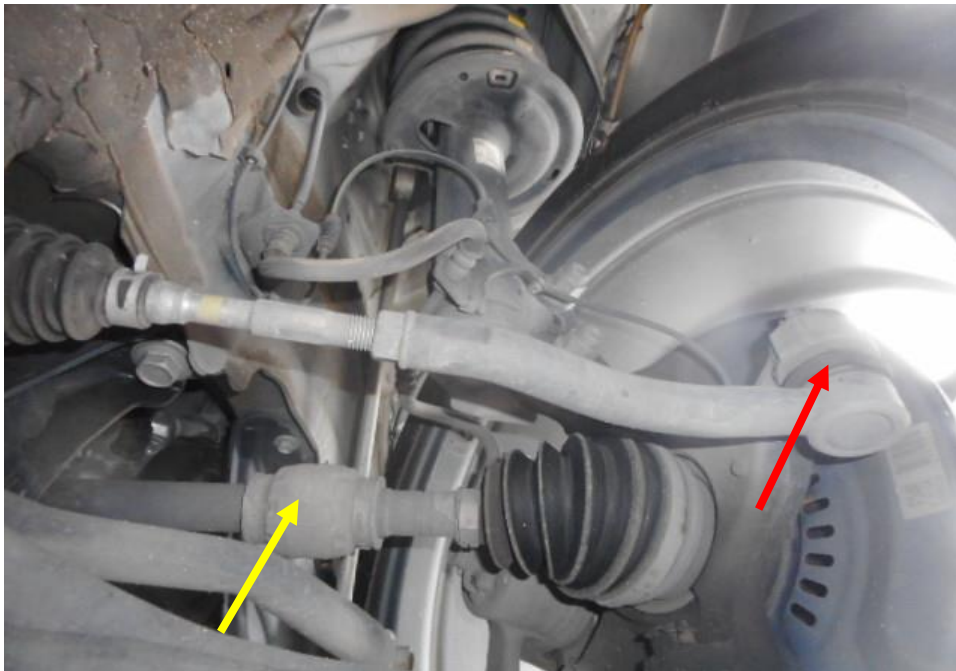
**Photo 23** shows the various undercarriage components at the front right wheel of the Motor Car, in particular the steering tie rod (red arrow) and drive shaft (yellow arrow). The various steering components were all found to be intact, suggesting that the steering system of the Motor Car was likely to be in serviceable condition at the material time of accident. There was also no sign of fluid stain observed on the various undercarriage components at the front right wheel of the Motor Car.

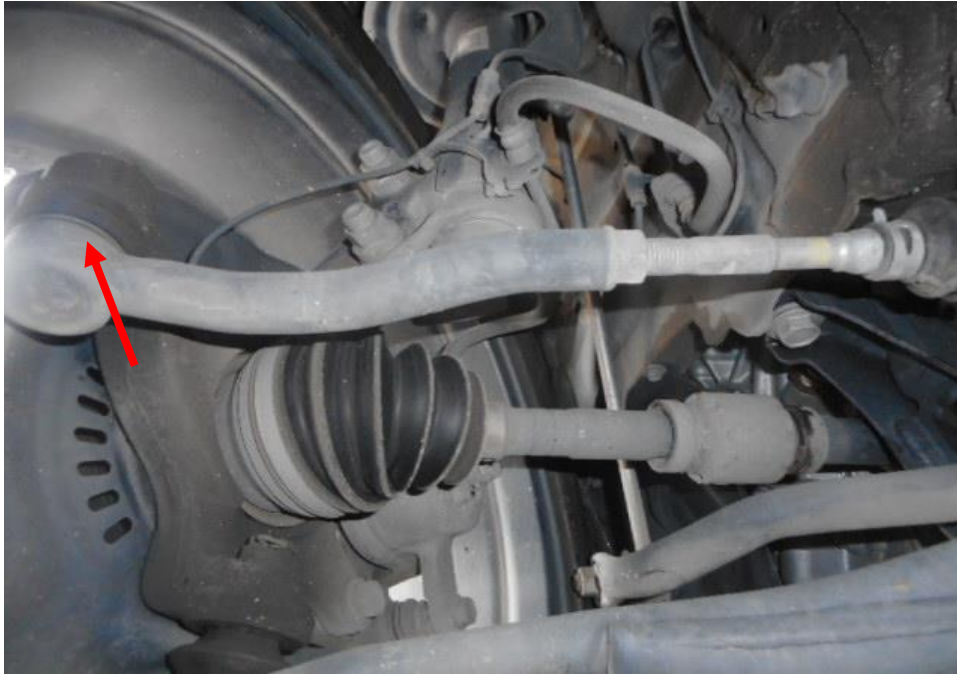
**Photo 24** shows the various undercarriage components at the front left wheel of the Motor Car, which had included the steering tie rod (red arrow). The various undercarriage components of the Motor Car were all found to be intact without any visible damage.

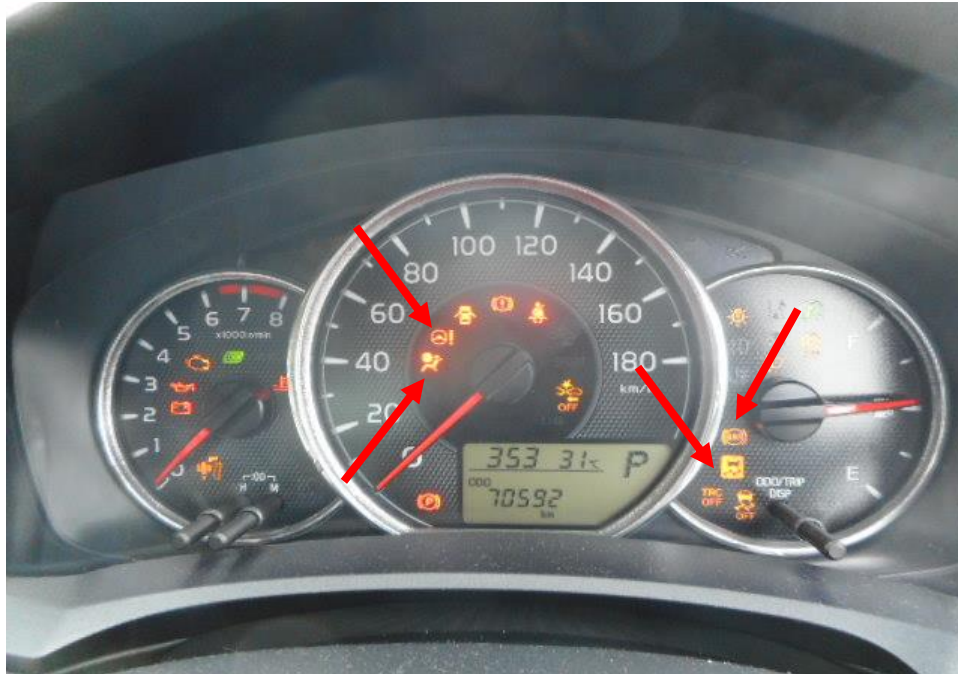
**Photo 25** shows the warning light for Anti-Lock Brake System (ABS), Electric Power Steering System (EPS), Traction Control System (TCS) and Supplemental Restraint System (SRS) (arrowed) appearing on the instrument panel of the Motor Car during the self-test of its various electronic operating systems when its engine was cranked.

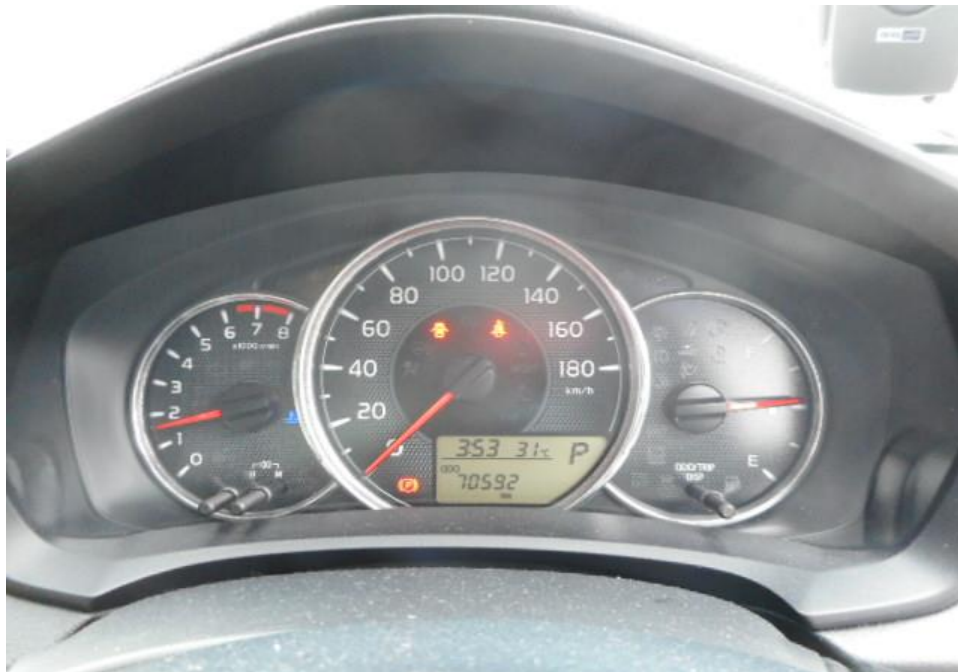
**Photo 26** shows no warning lights illuminated on the instrument panel of the Motor Car after the engine was cranked. This would suggest that there was no abnormality to the electronic operating system of the Motor Car, like the ABS, EPS, TCS and SRS etc.
