Vehicle No. SLD 3662G
Insured Veh. SJG 301B
Claim No. SNM21D207694/C02
Policy No. DMPCSNW00264512100
Accident Date 29/12/2021
Inspection Date 10/01/2022

ADJUSTMENT ON REPAIR COST FOR VEHICLE NO. SLD 3662G

Report Ref No. CC6/CTI22000392/Aea3q2

PHOTOGRAPHS FOR VEHICLE NO. SLD 3662G

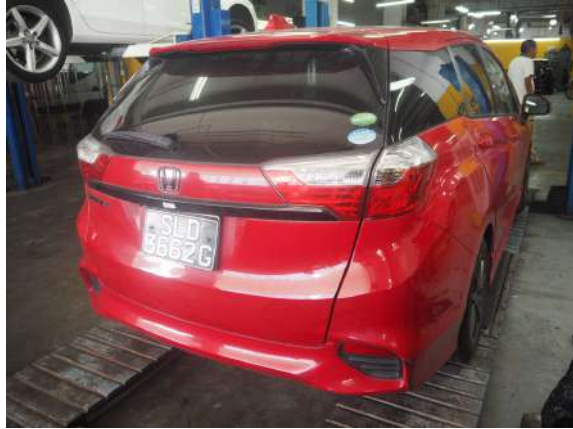
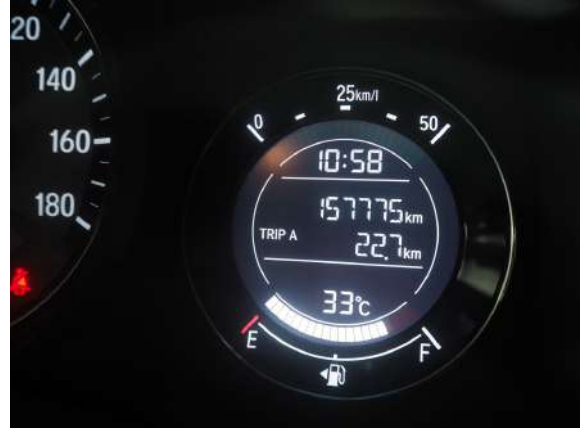
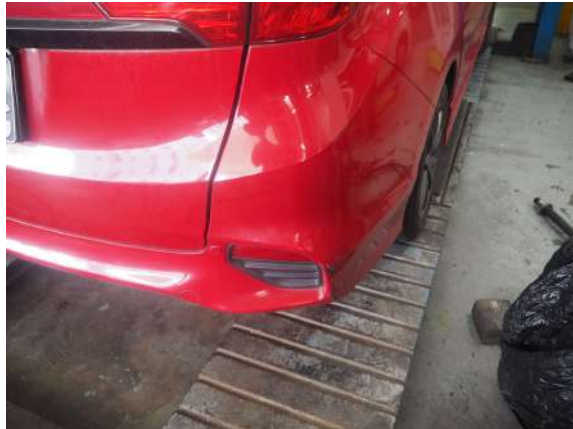
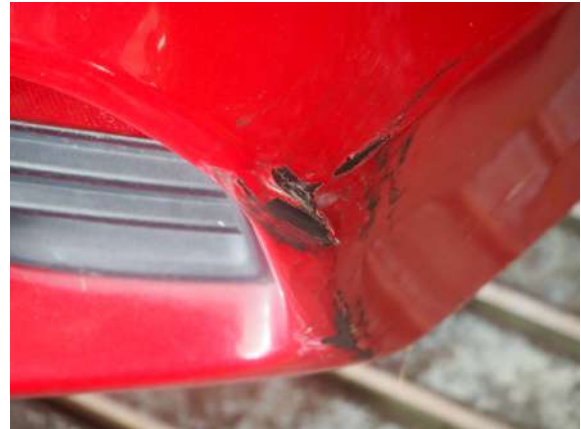
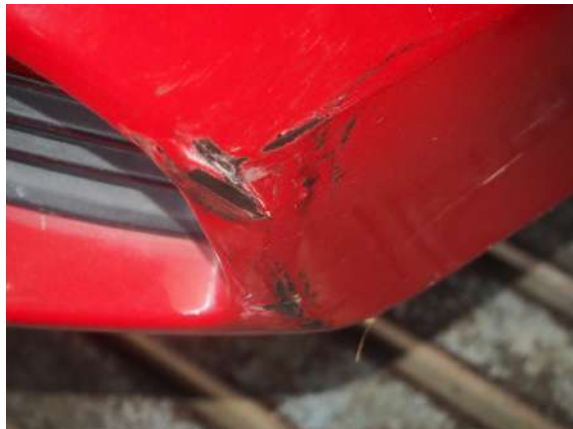
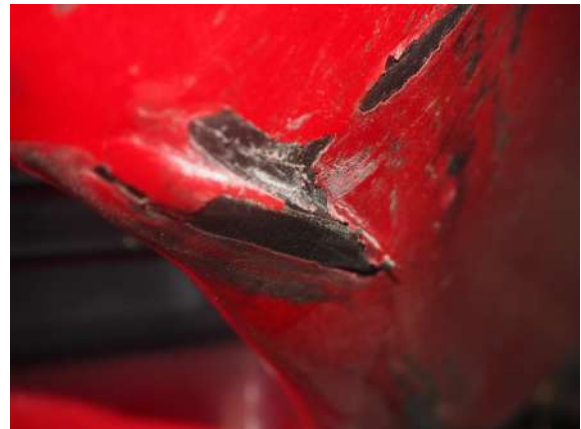
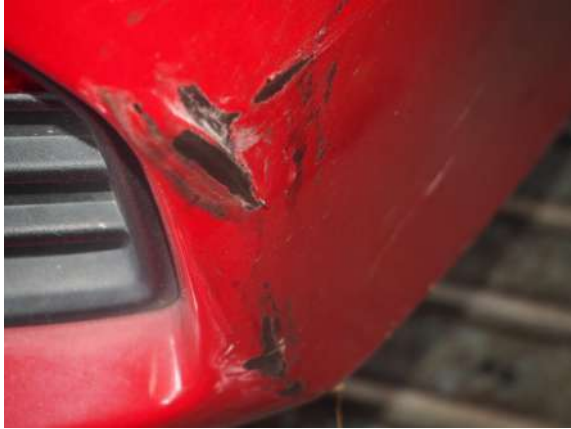
INSPECTION

| Affiliated to Federation Internationale Des Experts En Automobile | | | | |
|---|--|---|--|--|
| THE VEHICLE SUSTAINED DAMAGES AT THE REAR O/S PORTION. DAMAGES SEE DETAILS. | | | | |
