ICOBOT TECH PTE LTD

Re : Finding Report of the Damaged TMA Blade Series Number 2021-Mounted on Vehicle Number XD6073U .

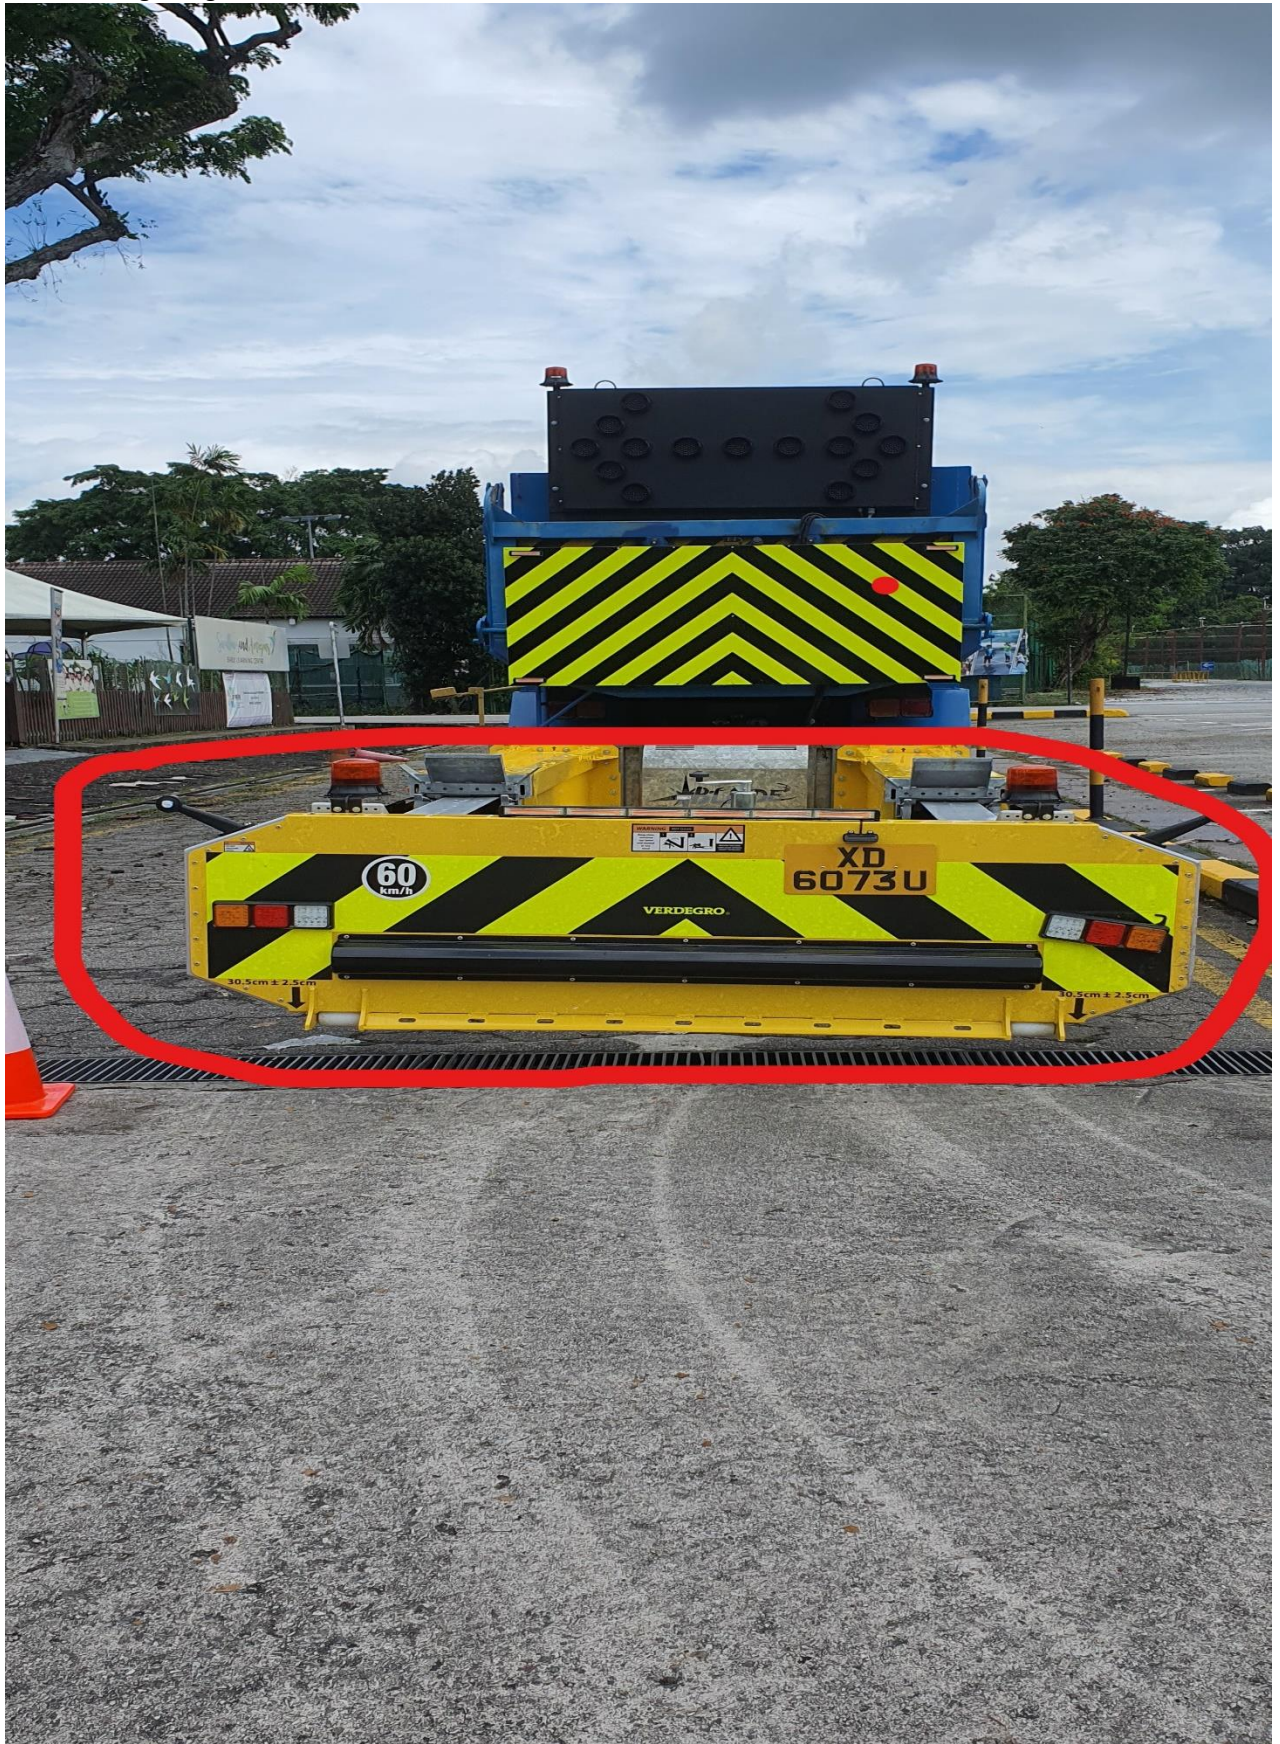
1. This Picture shown that the TMA had slid to one side towards the right of the driver side and the Tailgate light is broken.

We refer to your damaged TMA Blade with series nos. 2021-BC18 attached to Vehicle Nos. XD6073U. We wish to inform you that the main structure are bended and twisted and is impossible to repair. As TMA are a safety equipment's to protect life ,therefore in this case, we recommended changing the whole attenuator cartridge.

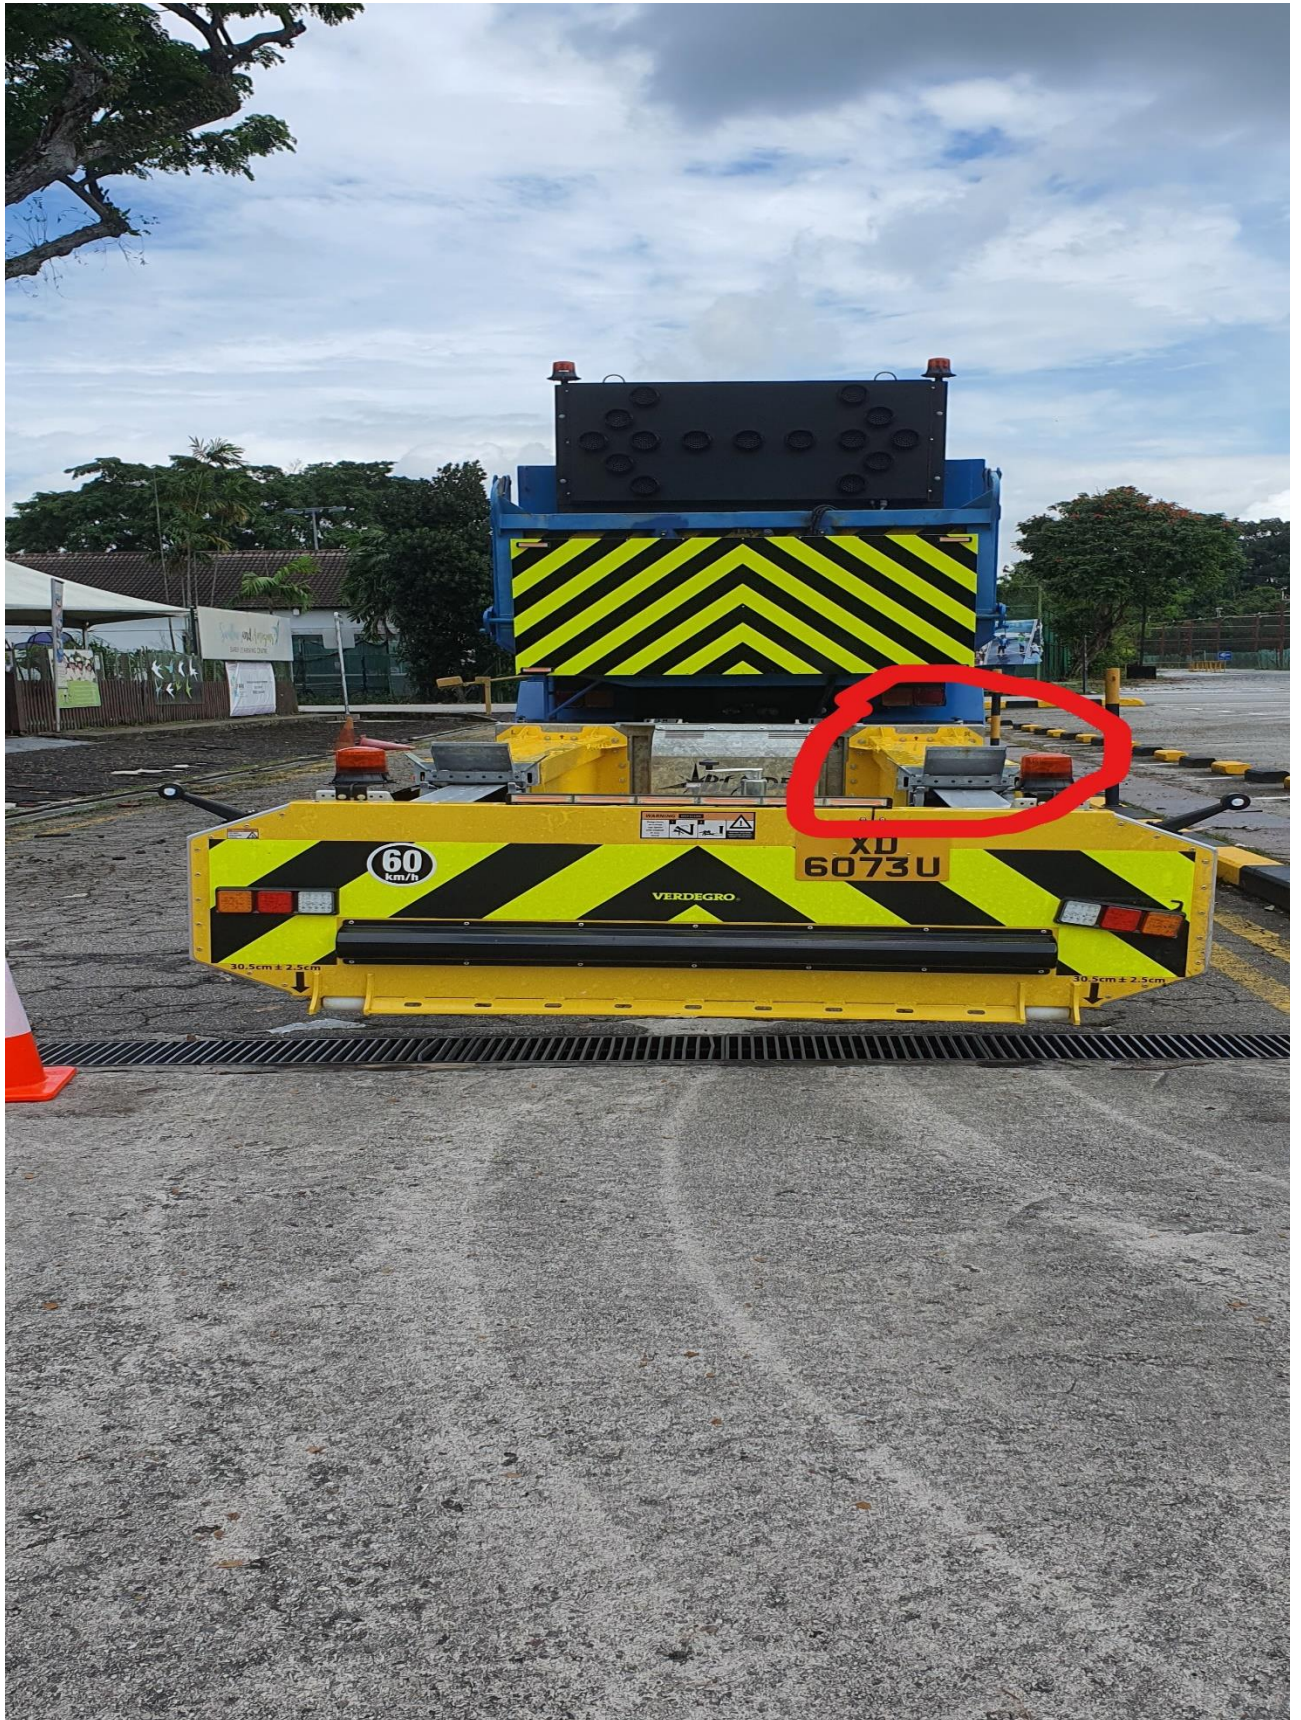
2. The Yellow Tube are bend

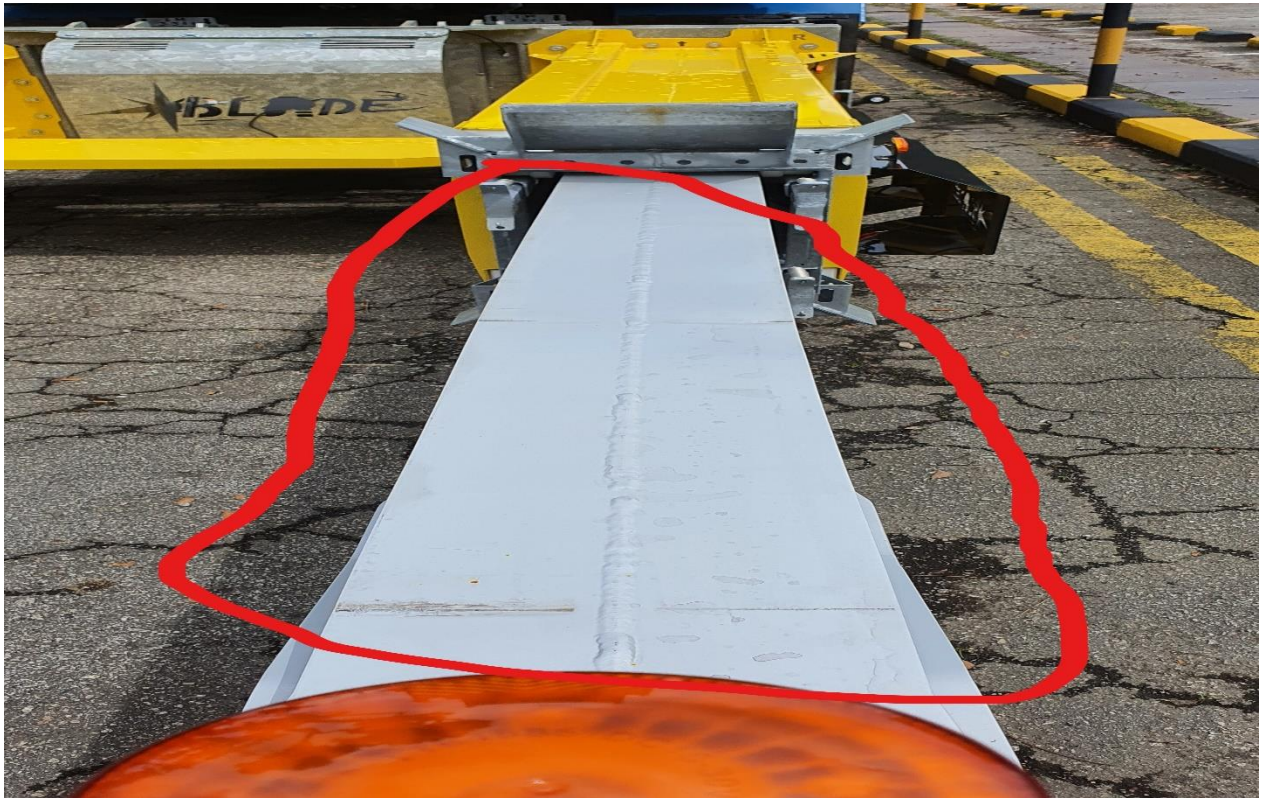
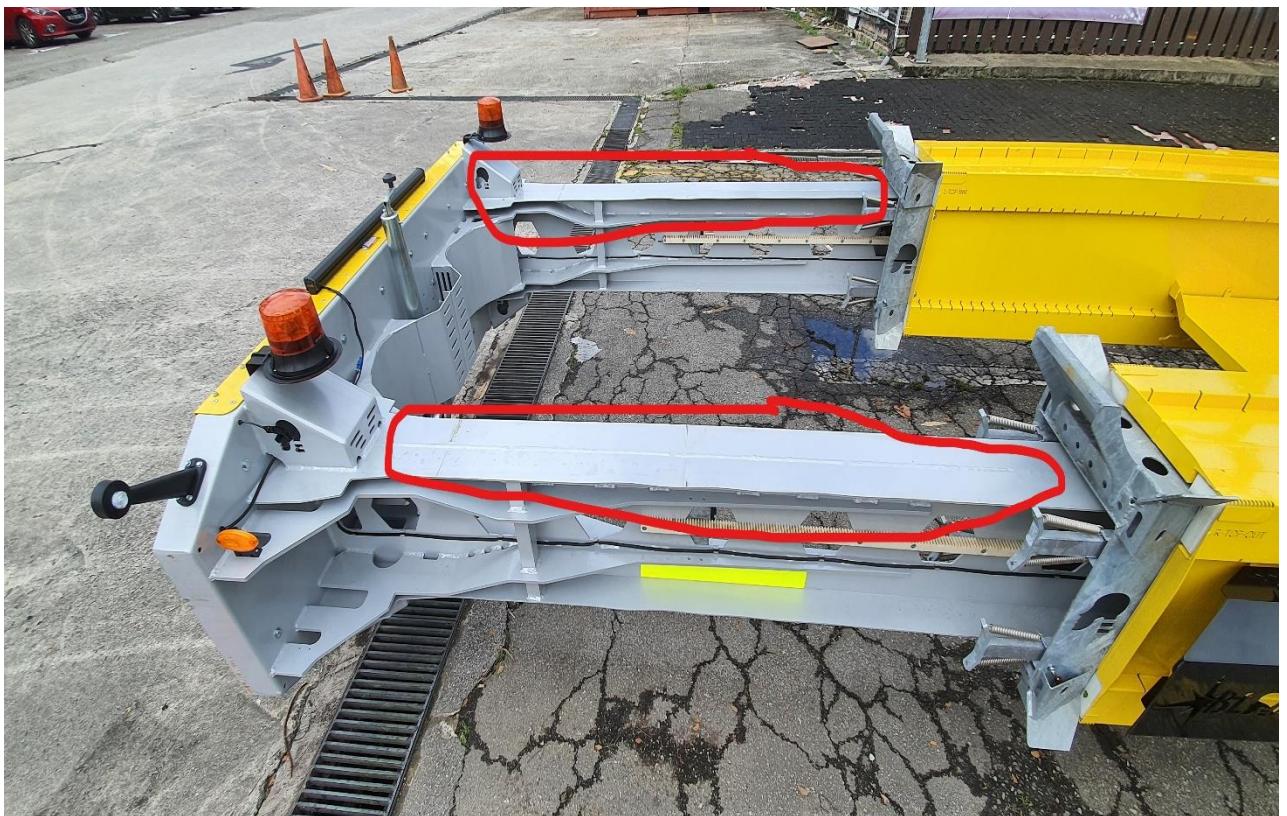
The H Beam Both Left and Right Side are bend and twisted

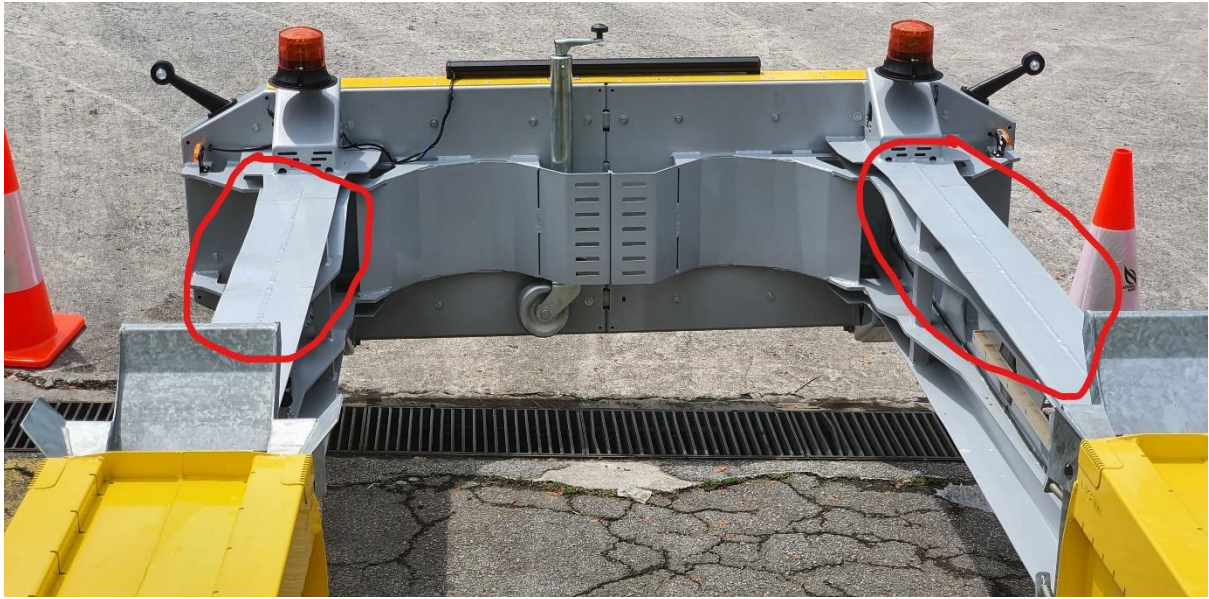
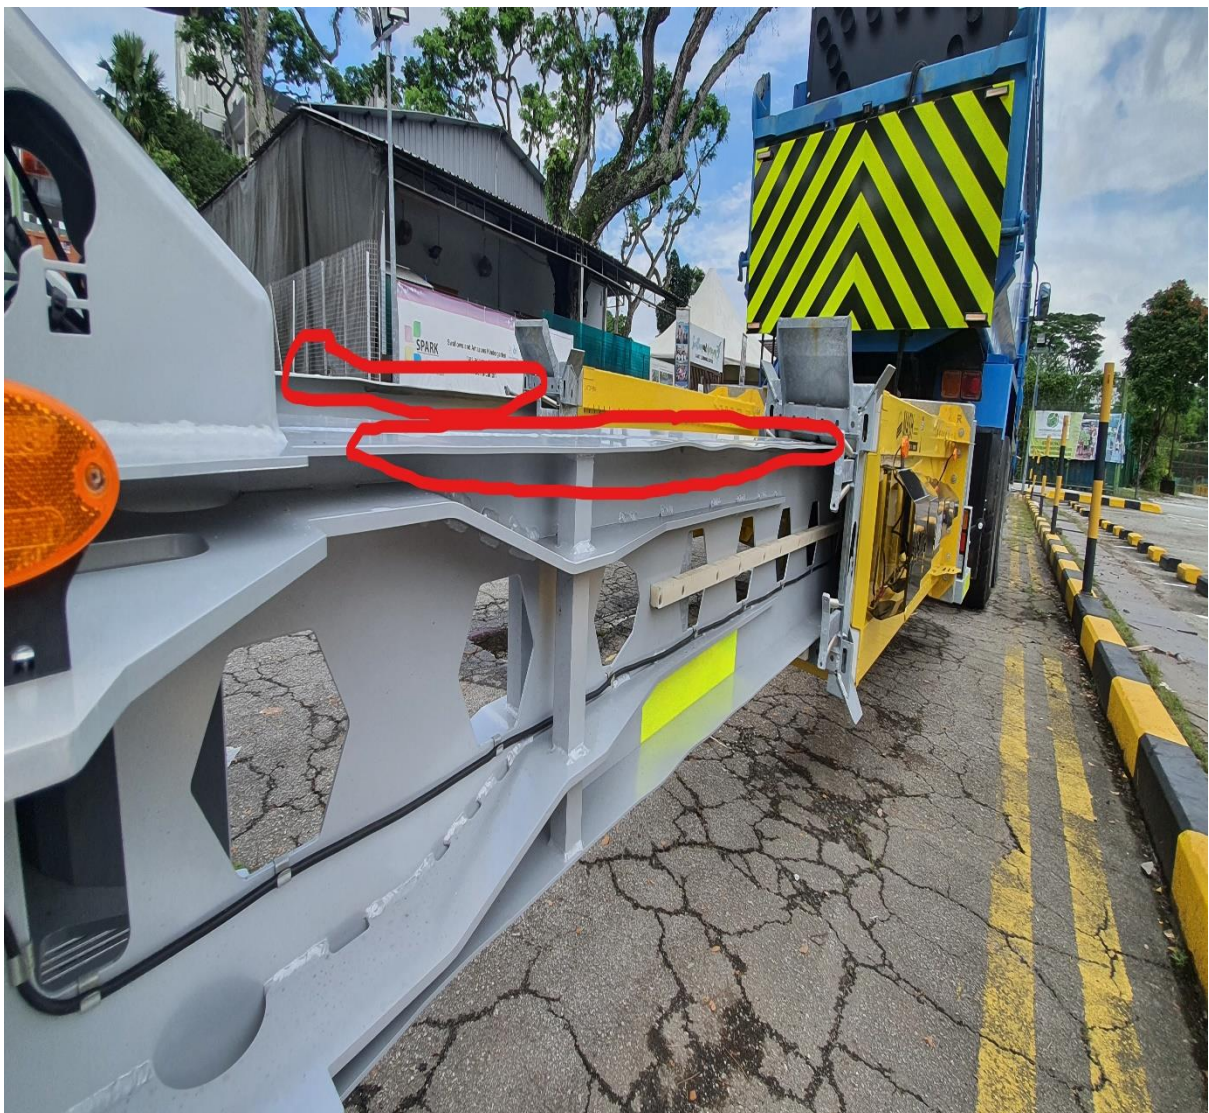
The H Beam Both Left and Right Side are bend and twisted
