Our Ref : 22/0004/TP
Your Ref : Not Advised

ACCIDENT DAMAGED VEHICLE INSPECTION REPORT (WITHOUT PREJUDICE)

Registration Number	: SJR 5039 T	Mileage	: 350,461 km
Make & Model	: Hyundai HD Avante 1.6 A	Chassis Number	: KMHDU41BR9U771216
Date of Registration	: 26 June 2009	Engine Number	: G4FC9U661672
Colour	: Silver	Engine Capacity	: 1,591 cc

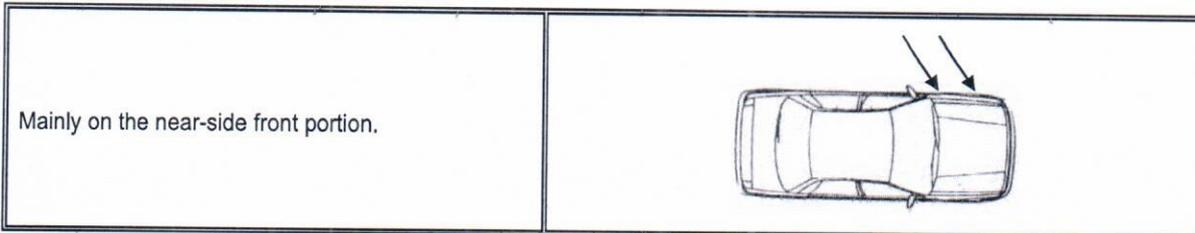
(5) POINT OF IMPACT

The impact of the collision has damaged/affected the left front fender, left front wheelhouse reinforcement, left front door, left front wheel, left front undercarriage and front bumper face etc.

We have inspected thoroughly the actual damages found on the vehicle before we conclude as to whether the parts needed replacement or repairs. The estimated cost of repair submitted by the repairer is **\$6,789.20**. We have adjusted the cost to **\$6,086.44** and recommend that the repairs to be taken on a lump sum basis of **\$4,870.00**. In our opinion, the damaged parts are consistent with that caused by the accident.
