ACCIDENT DAMAGED VEHICLE INSPECTION REPORT (WITHOUT PREJUDICE)

Registration Number	: SJR 5039 T	Mileage	: 350,461 km
Make & Model	: Hyundai HD Avante 1.6 A	Chassis Number	: KMHDU41BR9U771216
Date of Registration	: 26 June 2009	Engine Number	: G4FC9U661672
Colour	: Silver	Engine Capacity	: 1,591 cc

REPAIR DETAILS (SJR 5039 T)

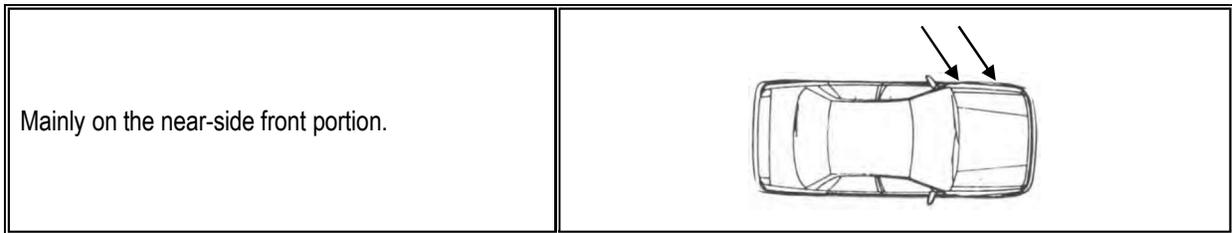
(5) POINT OF IMPACT

The impact of the collision has damaged/affected the left front fender, left front wheelhouse reinforcement, left front door, left front wheel, left front undercarriage and front bumper face etc.
