Your Ref: SFD 10D
Our Ref : CI/TP22000478/D

AUTOMOBILE INSPECTION REPORT OF MOTOR CAR SFD 10D

Vehicle Registration No.	: SFD 10D
Make / Model	: Mazda Efini RX7 A
Chassis No	: FD3S100079
Year of Registration	: 1992 (February)
Mileage	: 90,149km

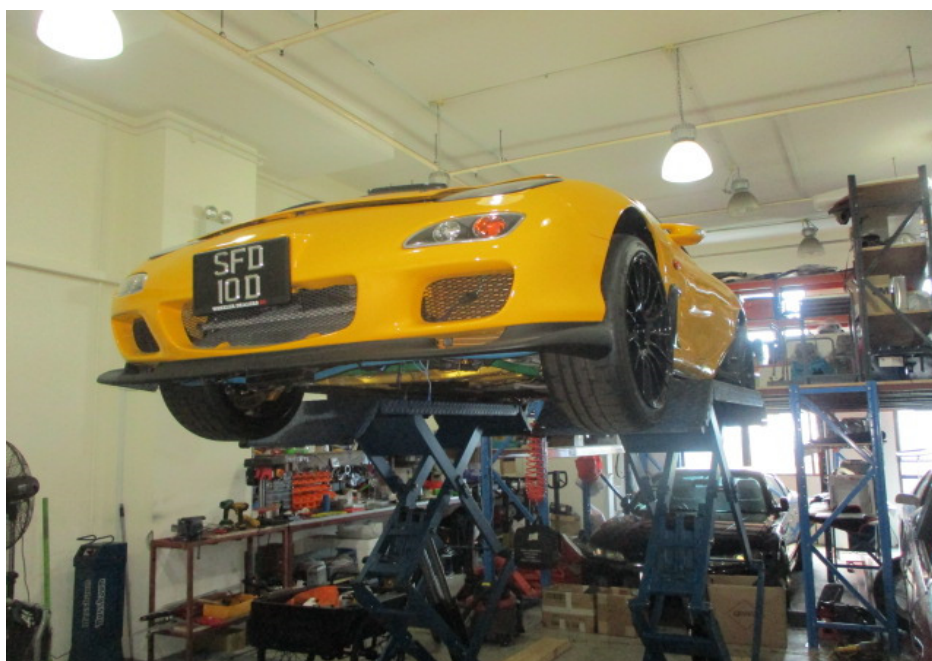
Photo 1 shows the Motor Car hoisted up at the time of my inspection. The mileage of the Motor Car recorded was 90,149km.

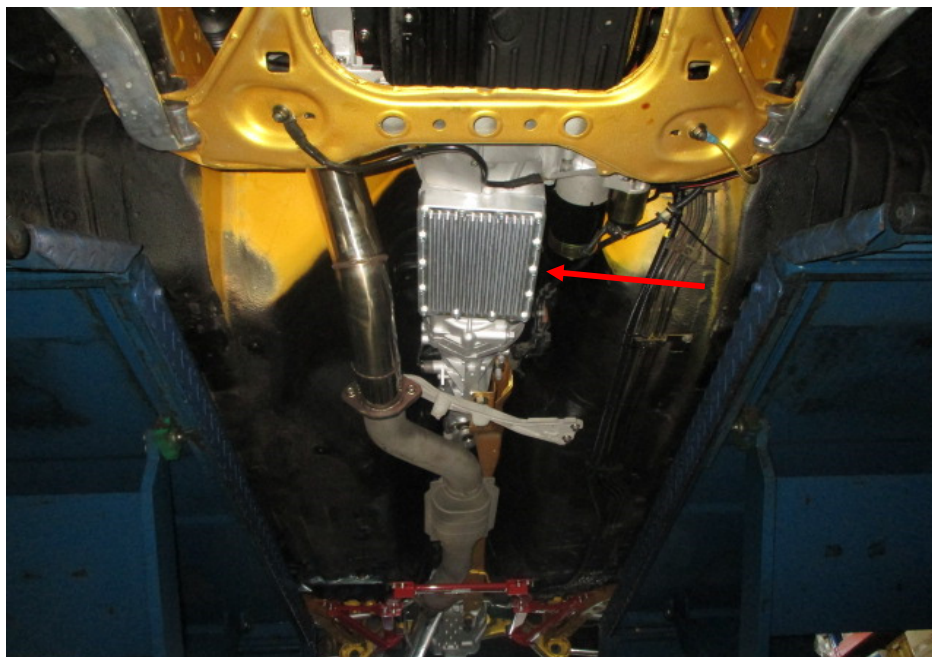
Photo 2 shows a general view of the transmission (arrowed) that was fitted on the Motor Car, as viewed from a front to rear perspective. The front (input) side of the transmission was observed to be bolted to the crankshaft side (torque convertor) of the engine block while the rear (output) side of the transmission was connected to the propeller shaft, which links to the rear differential of the Motor Car, providing the drive to the rear wheels. There was no visible crack(s) and/or hole observed on the transmission housing.

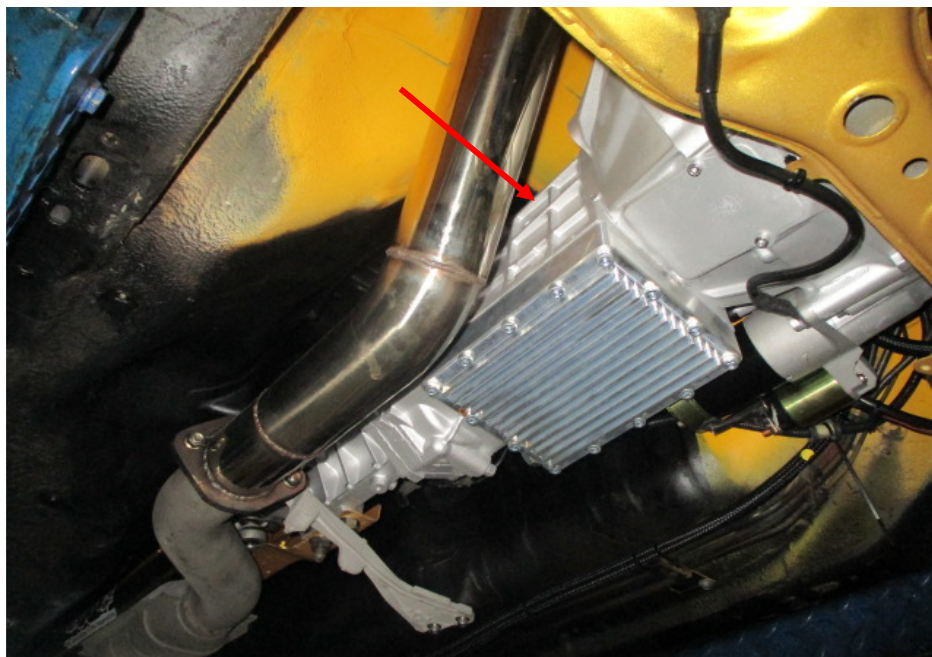
Photo 3 shows another view of the transmission (arrowed) that was fitted on the Motor Car. There was no crack and/or hole observed on the transmission housing.

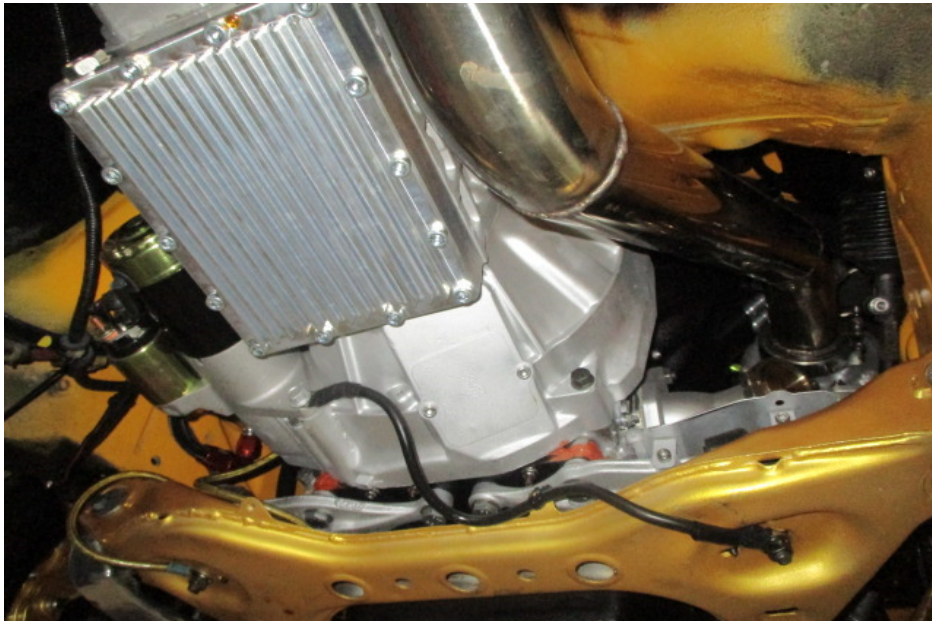
Photo 4 shows the front (input) side of the Motor Car's transmission, which was observed to be bolted to the crankshaft side (torque converter) of the engine block. The transmission is supported by its direct bolt on onto the crankshaft side of the engine block, and connection of the propeller shaft to the rear differential (refer to photograph 6, 7 & 9 below).

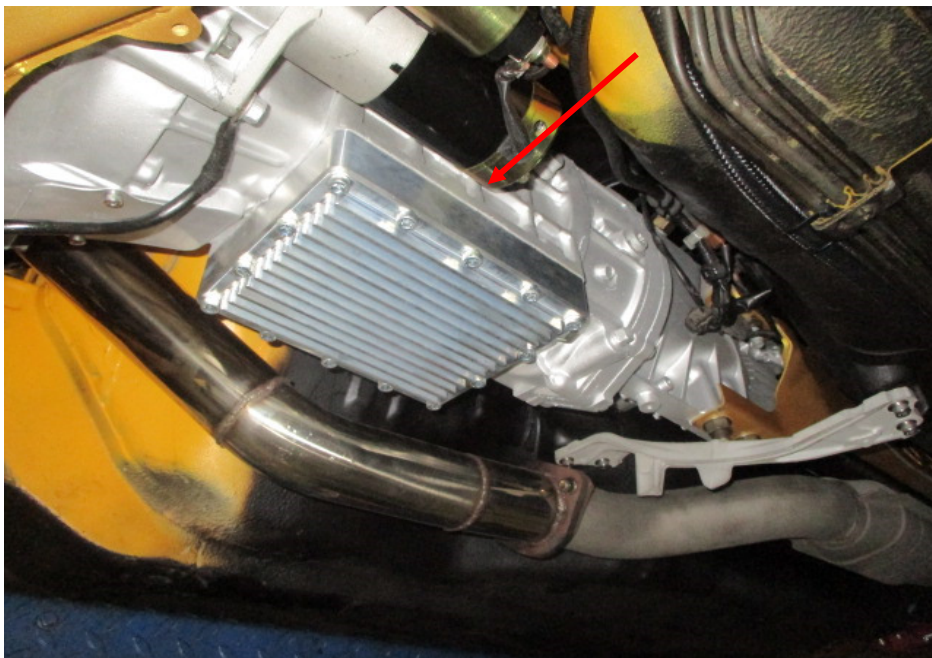
Photo 5 shows another view of the transmission (arrowed) that was fitted on the Motor Car, as viewed from a left to right angled perspective. The front (input) side of the transmission was observed to be bolted to the crankshaft side (torque converter) of the engine block while the rear (output) side of the transmission was connected to the propeller shaft, which links to the rear differential of the Motor Car, providing the drive to the rear wheels. There was no visible crack(s) and/or hole observed on the transmission housing.

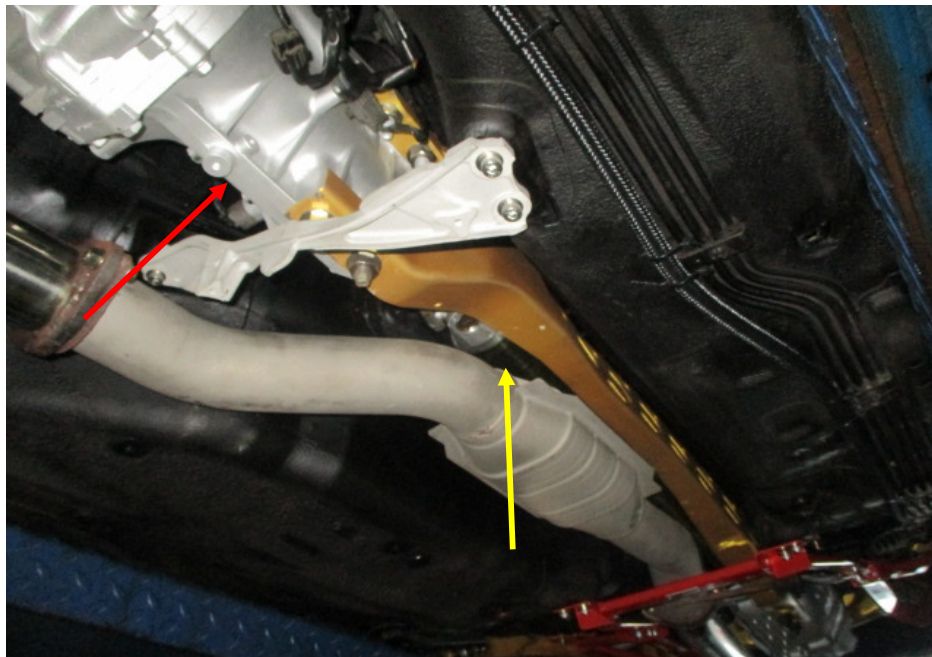
Photo 6 shows the rear (output) side of the Motor Car's transmission, highlighted by the red arrow. The rear side of the transmission connects to the propeller shaft (yellow arrow), which links to the rear differential of the Motor Car, providing the drive to the rear wheels.

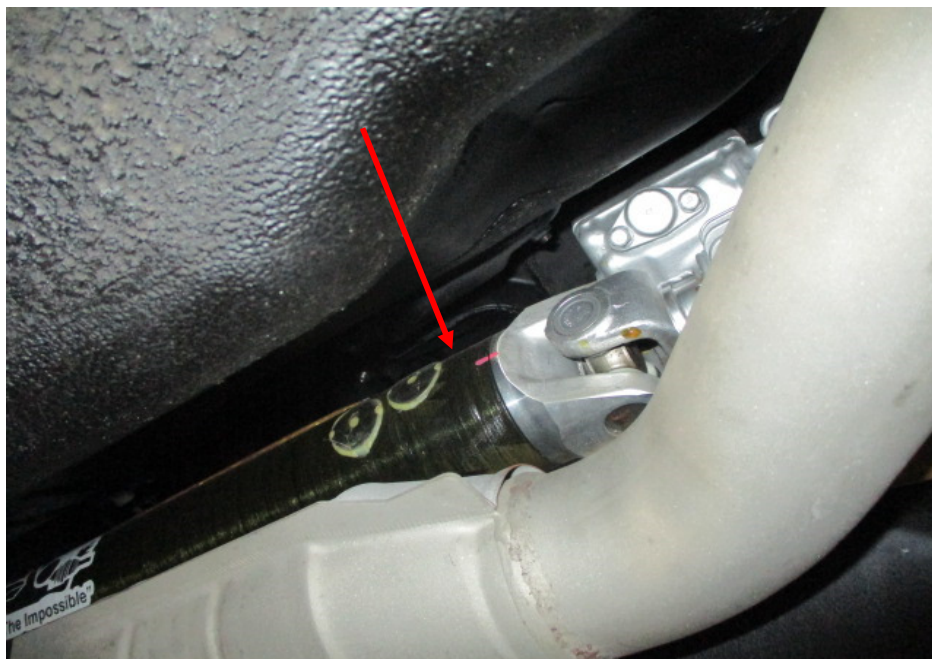
Photo 7 shows the propeller shaft (arrowed) of the Motor Car. The rear (output) side of the Motor Car's transmission (refer to photograph 6 above) connects to this propeller shaft, linking to the rear differential of the Motor Car, providing the drive to the rear wheels.

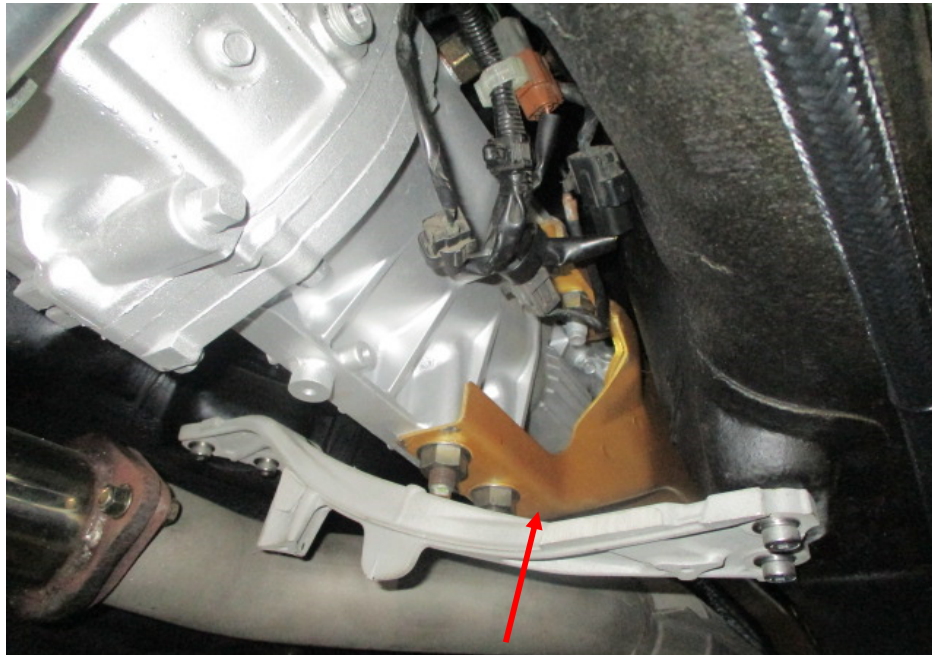
Photo 8 shows the rear (output) side of the Motor Car's transmission. The support of the transmission is reinforced by a bracket (arrowed) bolted onto the rear (output) side of the transmission at one end, and onto the rear differential at the other end (refer to photograph 10 below). This bracket is fixed parallel to the propeller shaft, along a longitudinal axis of the Motor Car.

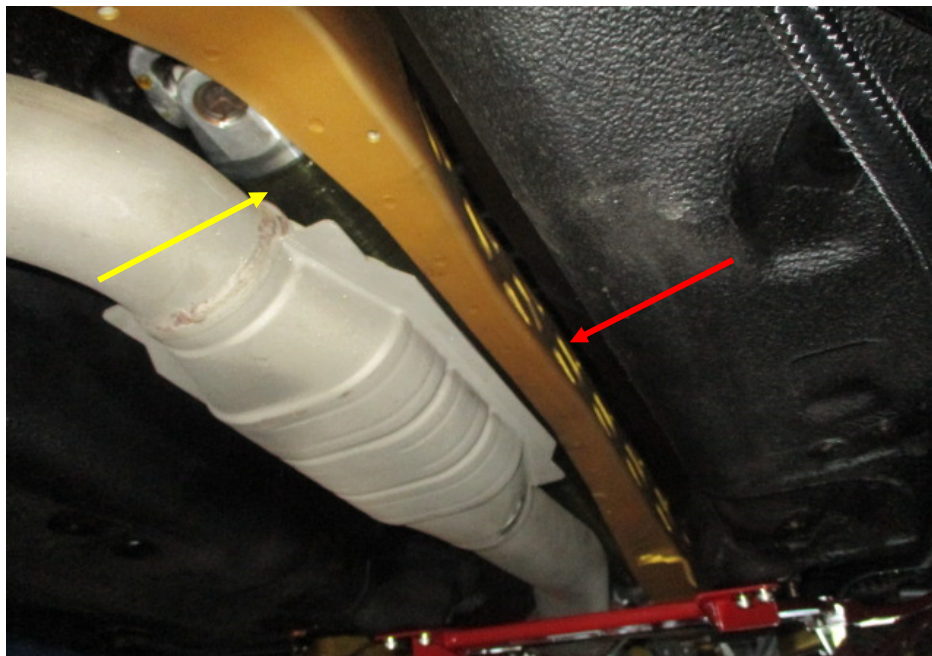
Photo 9 shows the bracket (red arrow) that was bolted onto the rear (output) side of the transmission at one end, and onto the rear differential at the other end. This bracket reinforces the support to the Motor Car's transmission and is fixed parallel to the propeller shaft (yellow arrow), along a longitudinal axis of the Motor Car.

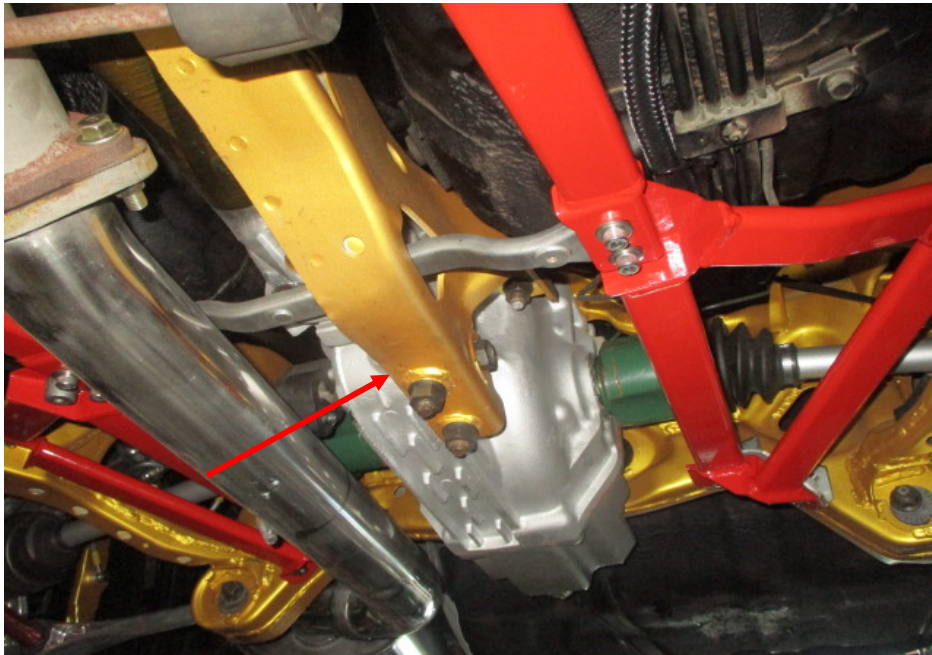
Photo 10 shows the rear differential of the Motor Car. The support of the transmission is reinforced by a bracket (arrowed) bolted onto the rear (output) side of the transmission at one end (refer to photograph 8 above), and onto this rear differential at the other end.

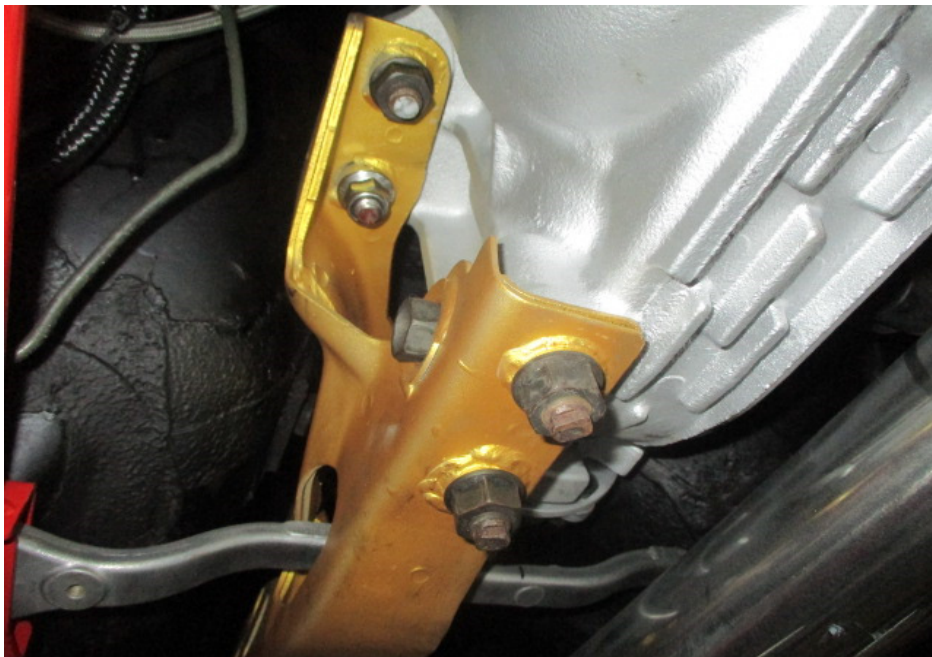
Photo 11 shows a closer view of the bracket that reinforces the support of the Motor Car's transmission. This was at the end that bolts onto the Motor Car's rear differential.

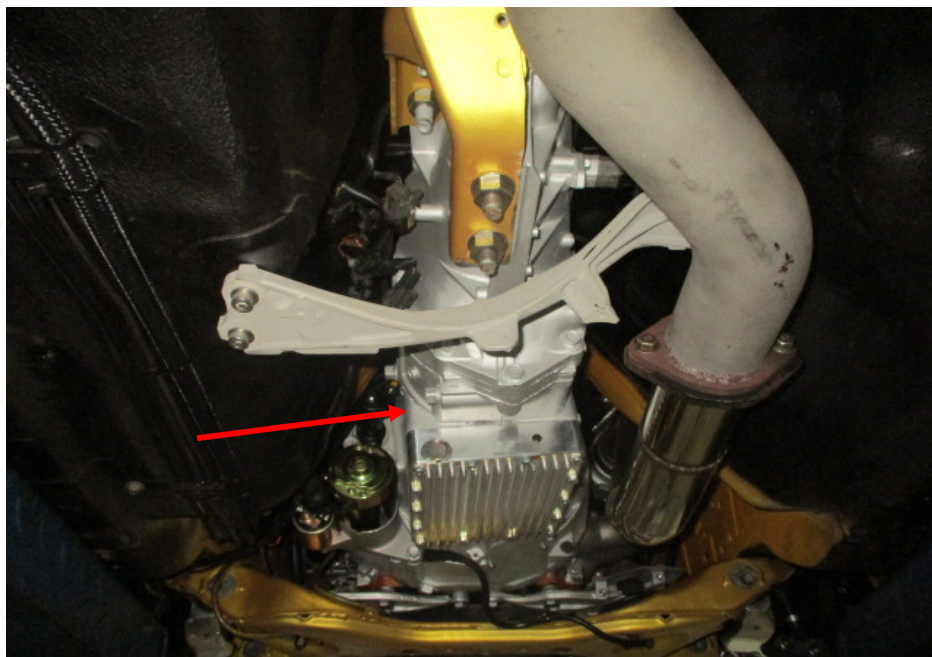
Photo 12 shows a general view of the transmission (arrowed) that was fitted on the Motor Car, as viewed from the rear to front perspective of the Motor Car. Overall, I had found the transmission of the Motor Car to be secured properly. The fitting of the manual transmission system, as at the time of my inspection, did not compromise the structural integrity of the Motor Car.

11. In summary, the transmission of the Motor Car was found to be secured properly. The fitting of the manual transmission system, as at the time of my inspection, did not compromise the structural integrity of the Motor Car.

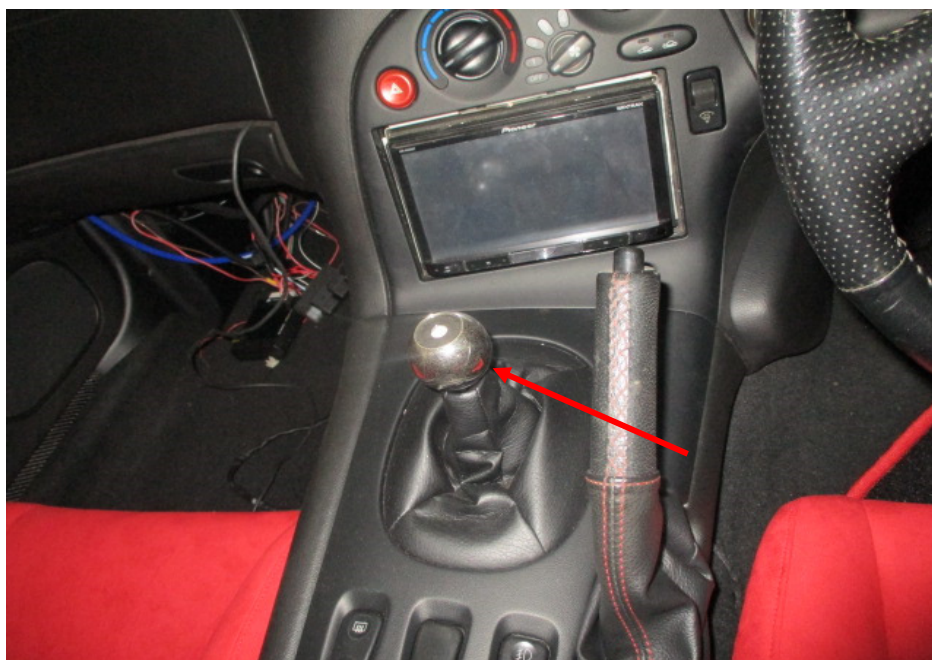
Photo 13 shows the gear shifter (arrowed) that was fitted on the Motor Car, for manually selecting the transmission gear to be engaged. The gear selector fork from the transmission of the Motor Car connects to this gear shifter through the floorboard of the Motor Car.

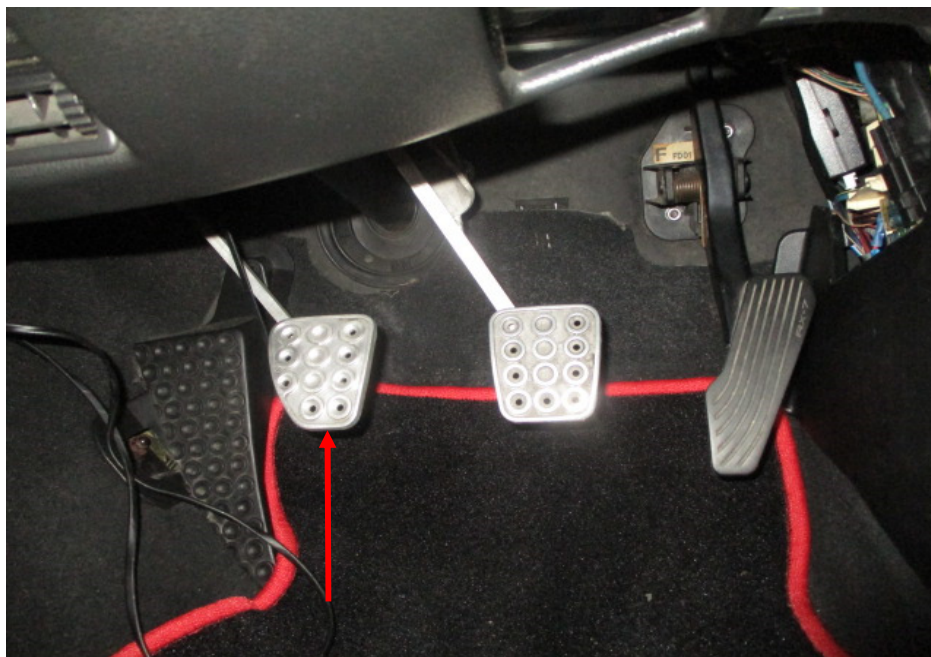
Photo 14 shows the clutch pedal (arrowed) of the Motor Car, for engaging and disengaging the transmission gears.
