Ref No	: 2021/7001	Date of Report	: 11/10/2021
Claim Type	: Third Party	Date of Request	: 1/7/2021
Third party vehicle	: PC5988L	Date of Accident	: 30/6/2021
Insured Vehicle	:	Date of Inspection	: 1/7/2021
Your Reference No	: -

Registration Plate No	: PC5988L	Engine Modification	: NIL
Model / Make	: ISUZU LT434P	Pre-accident damage	: NIL
Colour	: Multicolor	General Condition	: Good
Manufacturing Year	: 2016	General Paint Work	: Good
Engine No	: 6HK1684780	Steering	: Serviceable
Engine Capacity	: 7800 cc	Handbrake	: Serviceable
Chassis No	: JALLT434PG7000064	Footbrake	: Serviceable
Odometer No	: 254062		
Transmission	: Auto

DESCRIPTION OF DAMAGE

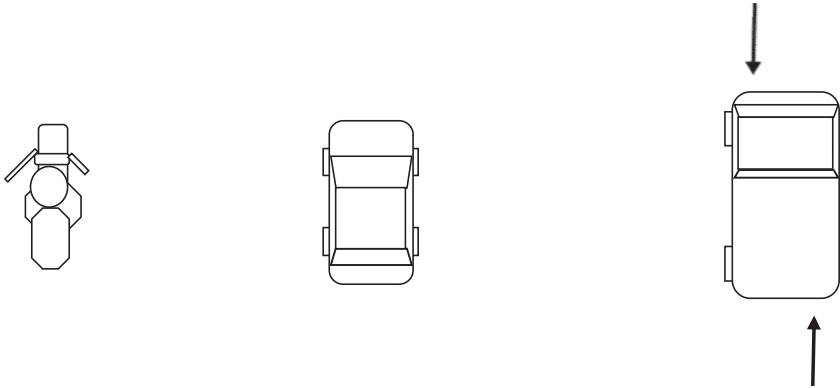
At the time of inspection, this vehicle sustained damages to the **Front Lh Portion and Rear Rh Portion**.

Front bumper, front panel , floor board dented/ crack. Lh wing mirror crack. Rear bumper, rear rh pillar, rear end panel , rear bonnet, rear rh panel dented/ broken. Rear windscreen, rear rh side glass broken, engine mis align, rear chassis bent etc.

We have not authorised repair. Under normal circumstances, estimated **90** working days are required to repair the vehicle.

The final adjusted Lump Sum contract amount is **S\$152,400.**

Under normal circumstances, the repair period would be about **90** working days.
