Your Ref: MTS2022D0000140

Our Ref : CI/III22000729/P

**TECHNICAL INVESTIGATION REPORT OF WARRANTY CLAIM INVOLVING
THE INSURED VEHICLE SDU 161K ON 10th January 2022**

Vehicle Registration No.	: SDU 161K
Make / Model	: MERCEDES BENZ E250
Chassis No	: WDD2074472F155484
Year of Registration	: FEB 2012
Mileage	: 112,589KM

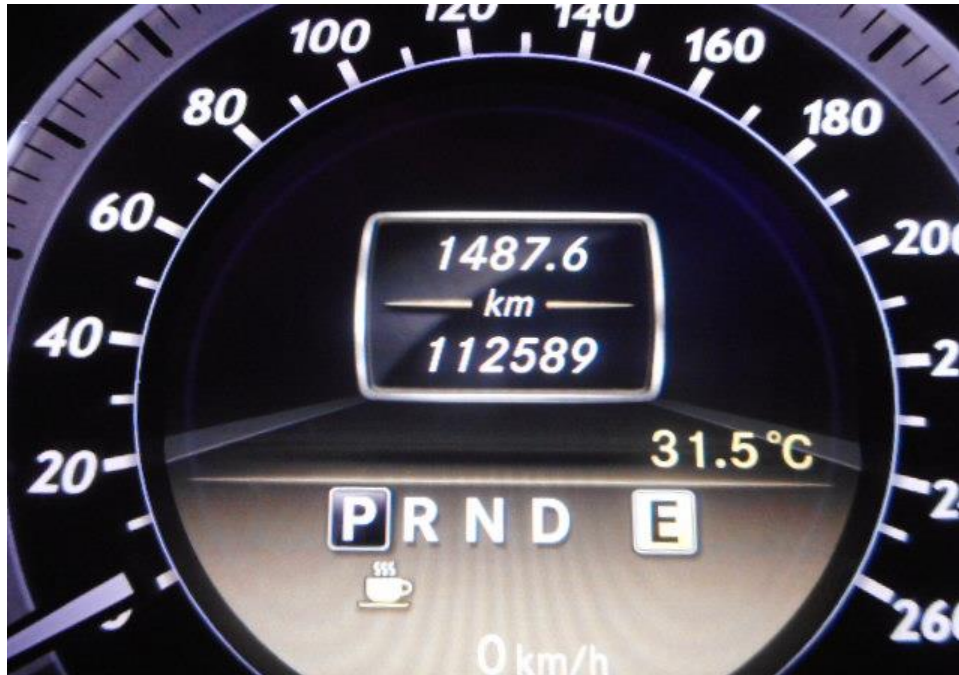
Photo 1 shows the mileage of the Insured Vehicle recorded at the time inspection at 112,589KM

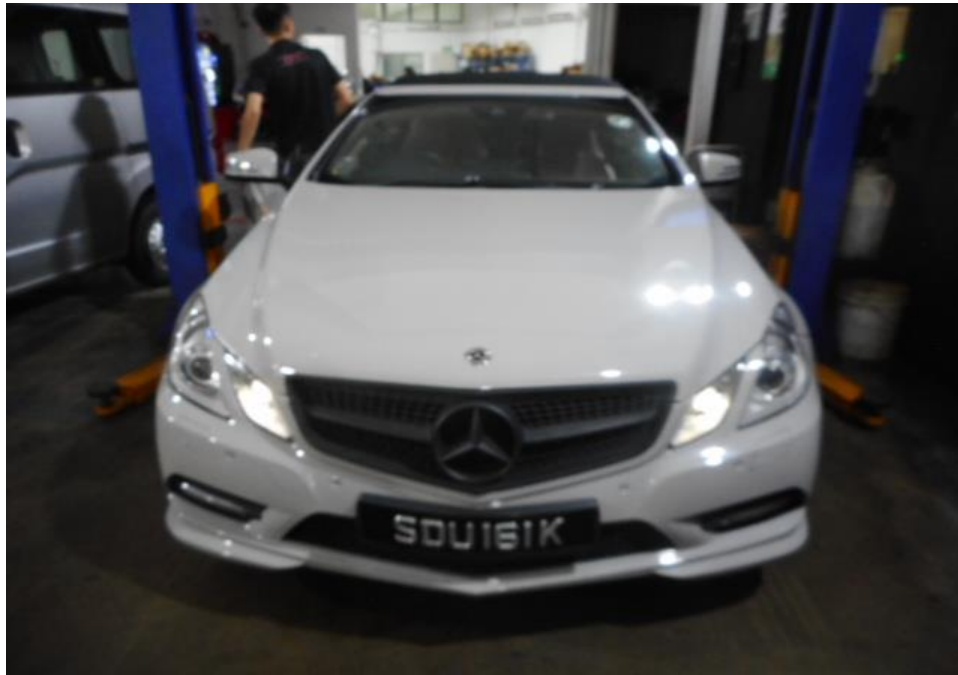
Photo 2 shows the general view of the front portion of the Insured Vehicle at the time of our inspection. The Insured Vehicle is observed to be unaffected by any signs of accident.

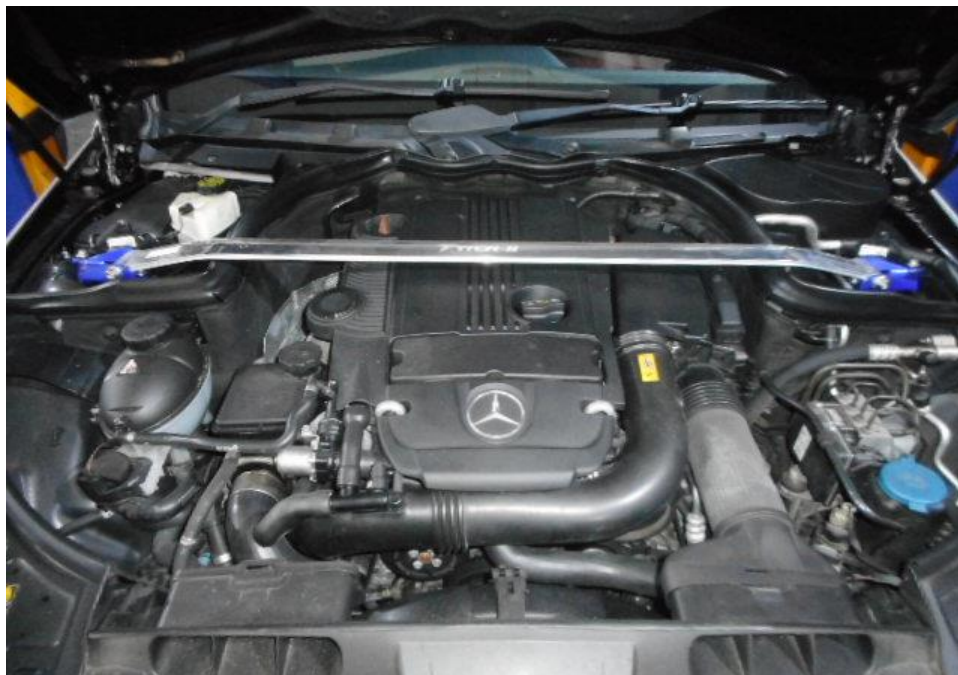
Photo 3 shows the general view of the engine portion of the Insured Vehicle at the time of our inspection. The engine compartment is observed to be unaffected by any signs of accident.

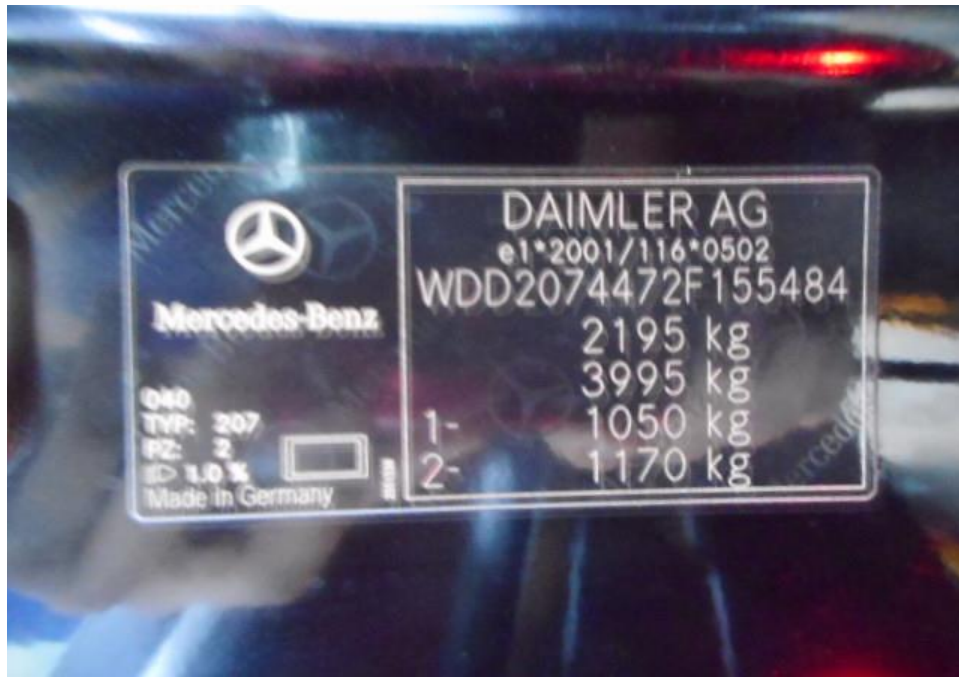
Photo 4 shows the chassis number of the Insured Vehicle at the time of our inspection.

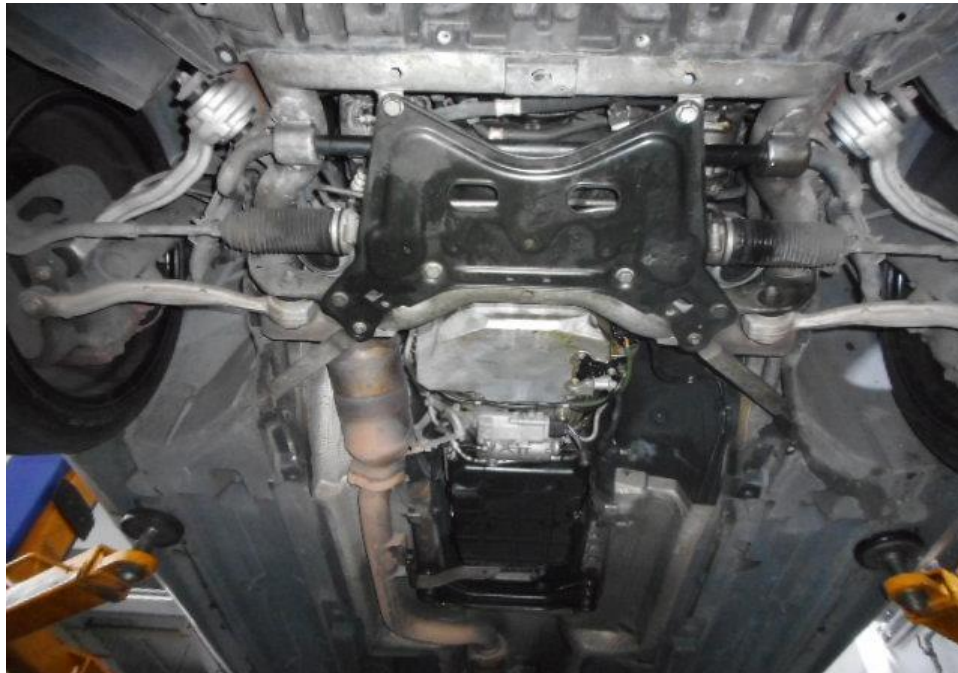
Photo 5 shows the general view of the engine underside portion of the Insured Vehicle at the time of our inspection. The engine underside compartment is observed to be unaffected and by any signs of accident.

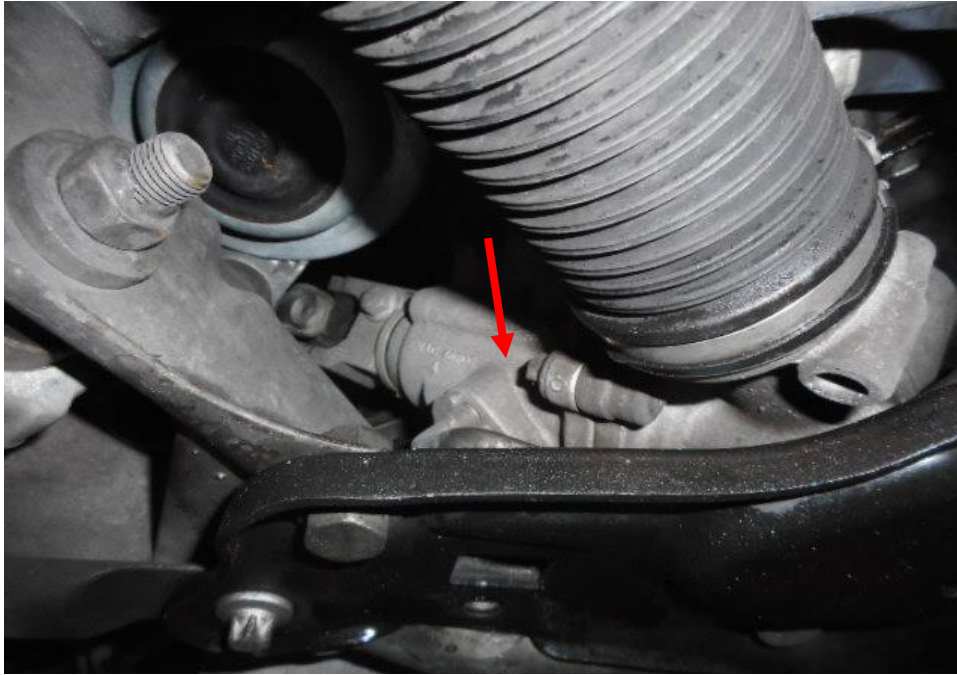
5. The complaint on the Insured Vehicle was noted be to knocking noise from steering rack and pinion when turning the steering wheel and when the vehicle is driving over bumps and uneven road surfaces. There is a recommendation by the workshop to replace the steering rack and pinion unit. The vehicle was observed to be unaffected by any signs of accident.

Photo 6 shows the close up view of the power steering portion of the Insured Vehicle at the time of our inspection. The Electronic Power Steering unit and its steering rack and pinion component is observed to be unaffected and by any signs of accident.

8. We did not find any evidence which had suggested that the cause of abnormalities to the Insured Vehicle was due to poor maintenance and/or recurring problem.
9. The recommendation to replace the Power steering rack and pinion unit at \$3,514.95 is justifiable as all the relevant checks has been conducted.

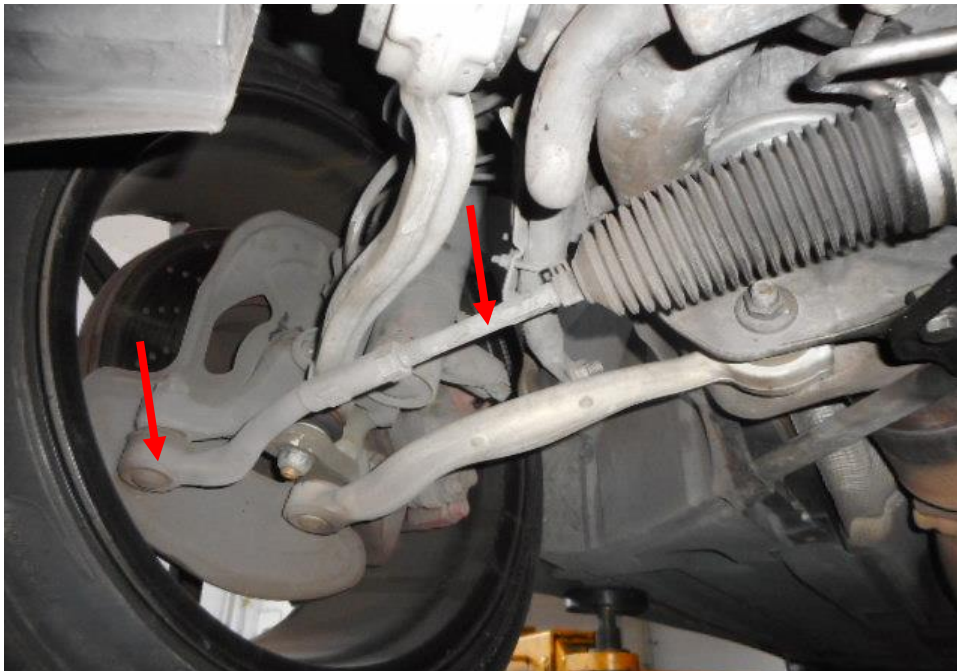
Photo 7 shows the close up view of the front left wheel of the Insured Vehicle at the time of our inspection. The steering tie rod (arrowed) is observed to be unaffected and by any signs of accident.

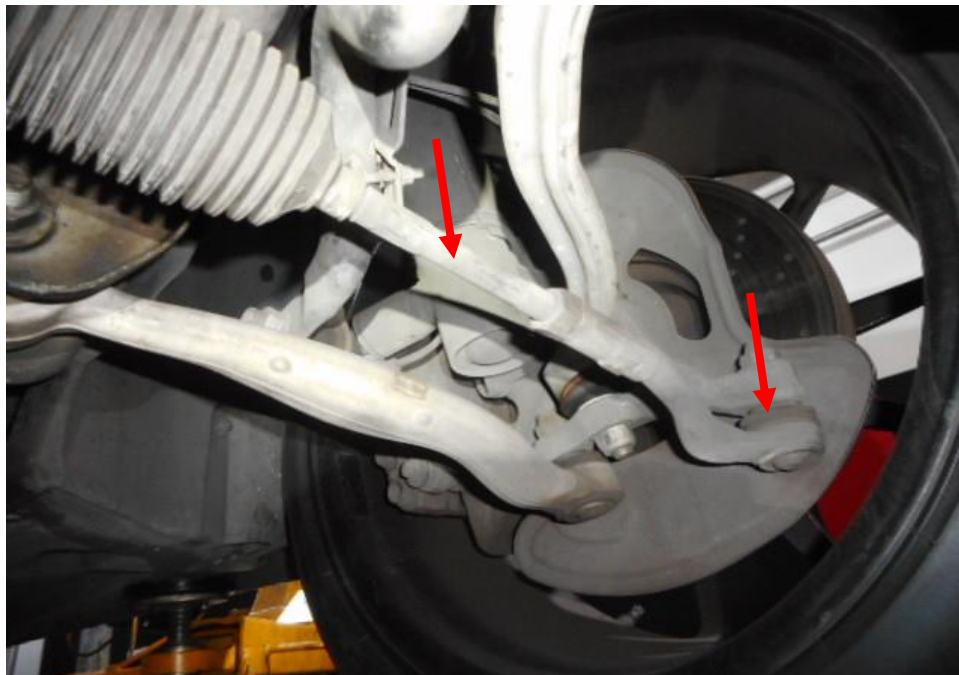
Photo 8 shows the close up view of the front right wheel of the Insured Vehicle at the time of our inspection. The steering tie rod (arrowed) is observed to be unaffected and by any signs of accident.

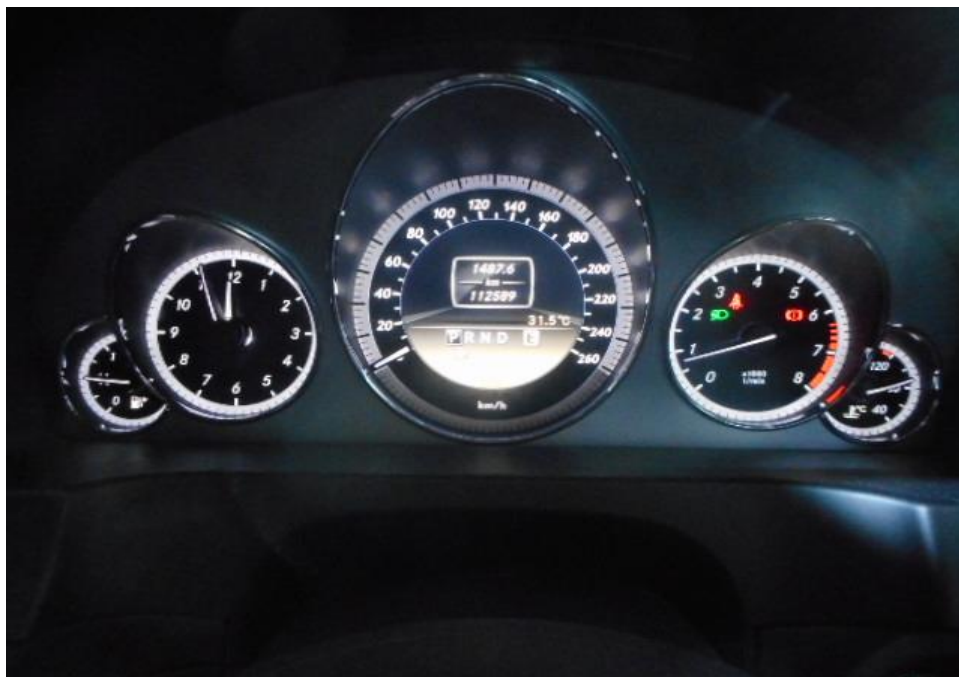
Photo 9 shows the conducted ECU diagnosis of the Insured Vehicle at the time of our inspection. There was no electronic error on the Electronic Power Steering of the Insured Vehicle.
