Your Ref: BM M2 Coupe
(chassis number WBS2U720607D89541)
Our Ref : CI/TP22000739/D

22 January 2022

INSPECTION REPORT OF AN UNREGISTERED BMW M2 COUPE MOTOR CAR WITH CHASSIS NUMBER WBS2U720607D89541

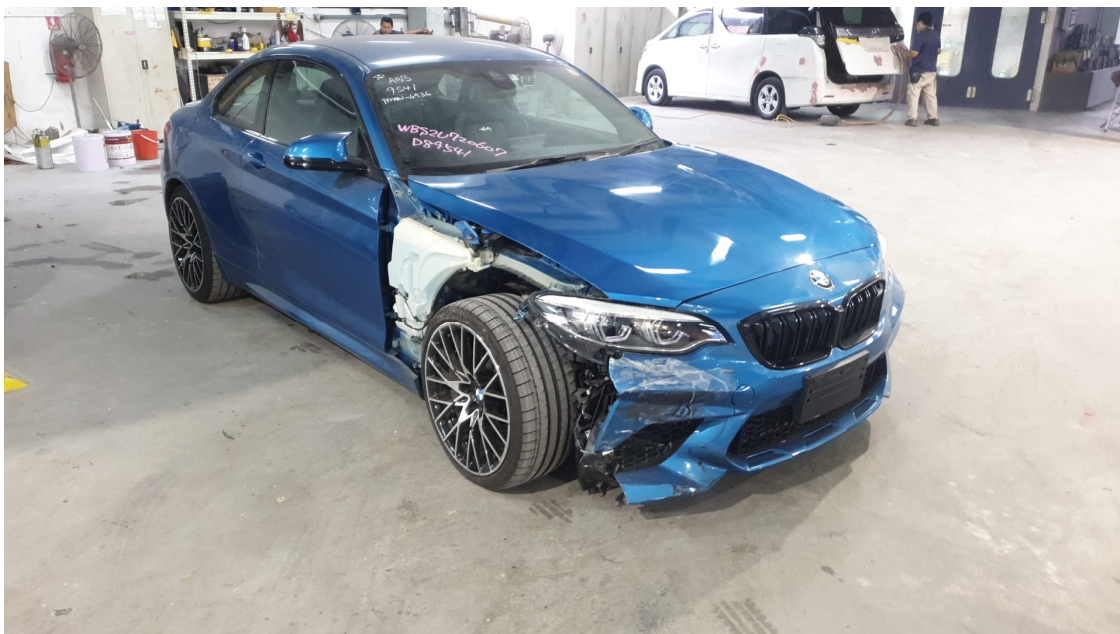
3. The photographs provided to me had showed damage to the front right portion of the Motor Car. Body parts damaged include the front bumper, front bumper right lower grille, front bumper right bracket, front right headlamp, front right fender and front right fender inner shield amongst others.
4. Apart for the front right portion, there was no physical damage observed to other areas of the Motor Car. The airbag(s) of the Motor Car was not deployed as seen from the photographs that were provided to me. See photo 1 – 5 below.

Photo 1 shows the front right body of the Motor Car (photograph provided to me). The photographs provided to me had showed damage to the front right portion of the Motor Car. The front bumper, front bumper right lower grille, front bumper right bracket, front right headlamp, front right fender and front right fender inner shield were amongst the body parts that were observed to have been damaged.

22. The body parts at the front right portion of the Motor Car were visually examined and it was noted that the repair/restoration works carried out to the damaged area of the Motor Car (refer to photograph 1 & 2 above) were reasonably adequate and in order.

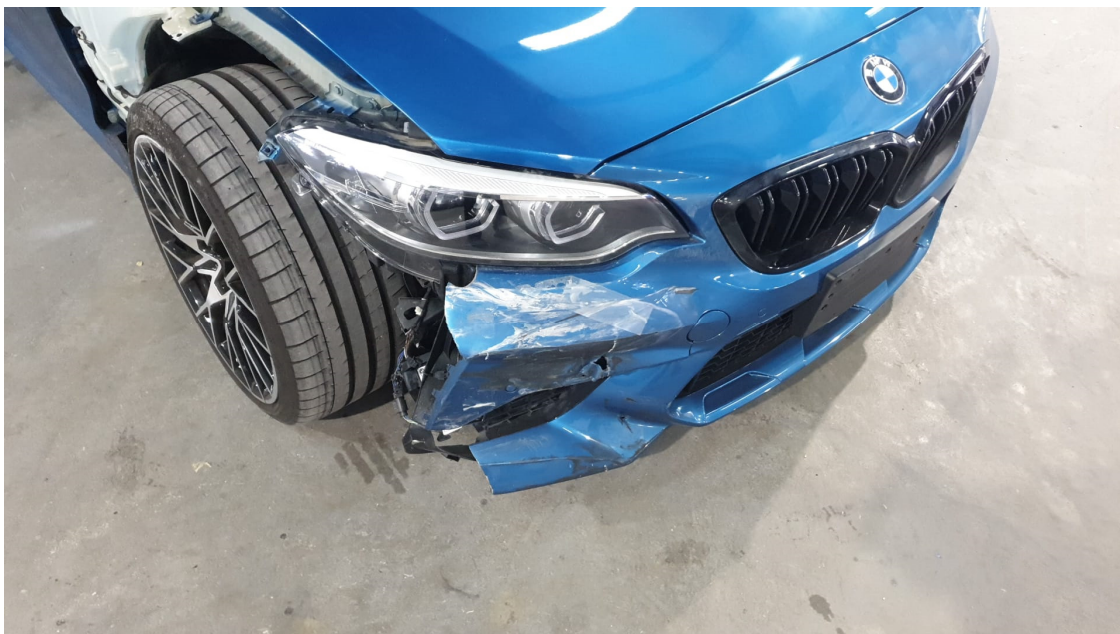
Photo 2 shows a closer view of the damaged front right portion of the Motor Car (photograph provided to me). The front bumper, front bumper right lower grille, front bumper right bracket, front right headlamp, front right fender and front right fender inner shield were amongst the body parts that were observed to have been damaged.

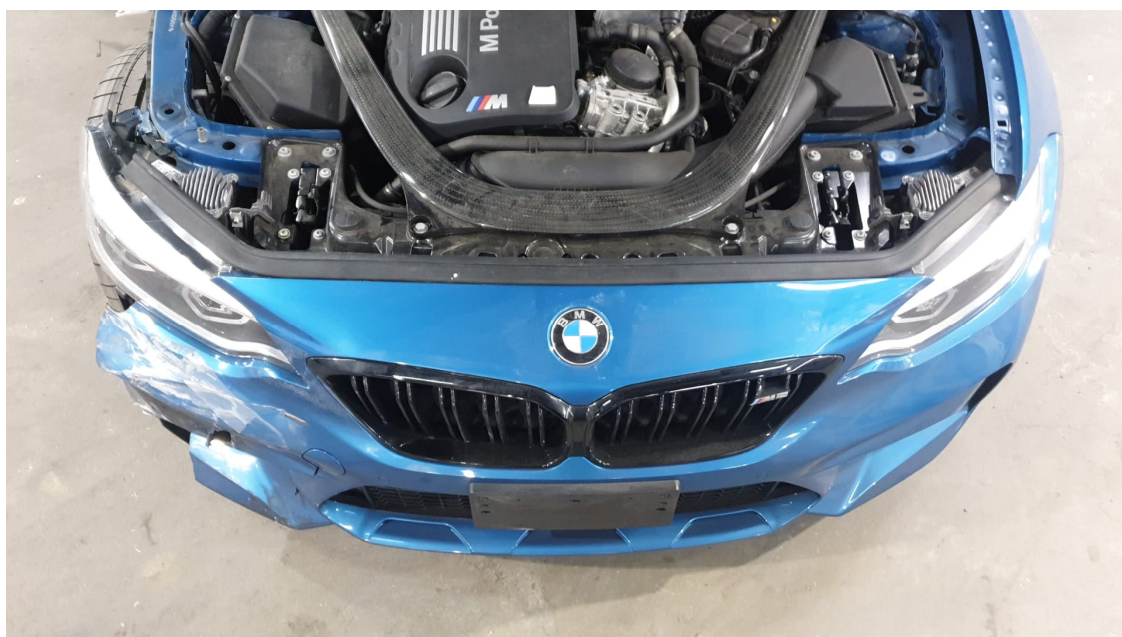
Photo 3 shows the engine compartment of the Motor Car (photograph provided to me). The various parts and components within the engine compartment were all intact and unaffected.

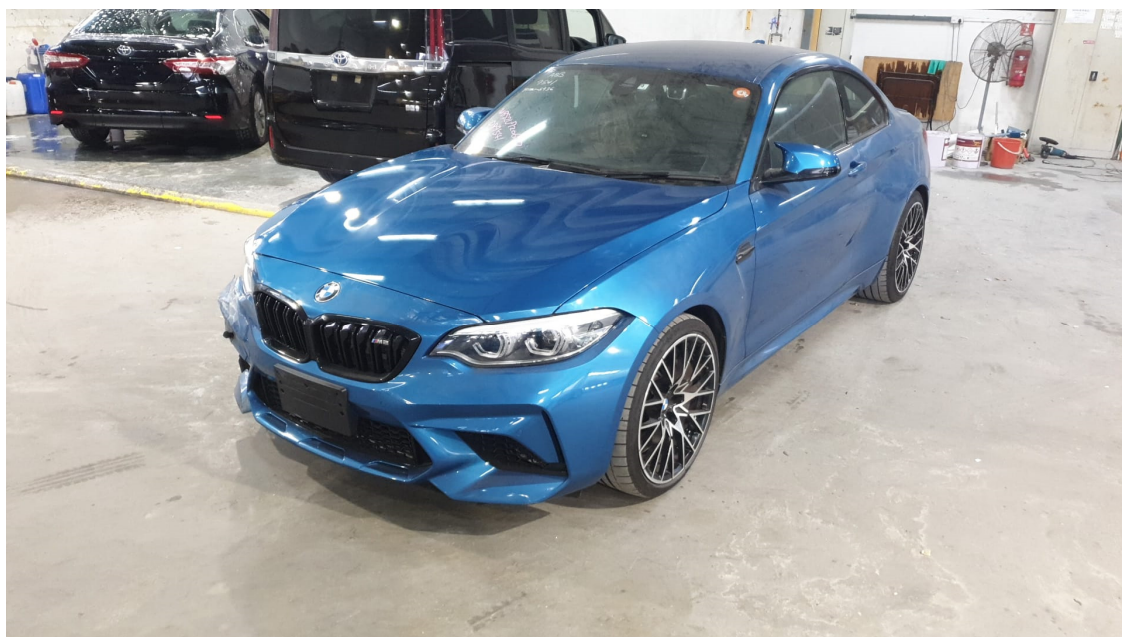
Photo 4 shows the front left body of the Motor Car (photograph provided to me). Apart for the front right portion, there was no physical damage observed to other areas of the Motor Car. The airbag(s) of the Motor Car was not deployed as seen from the photographs that were provided to me.

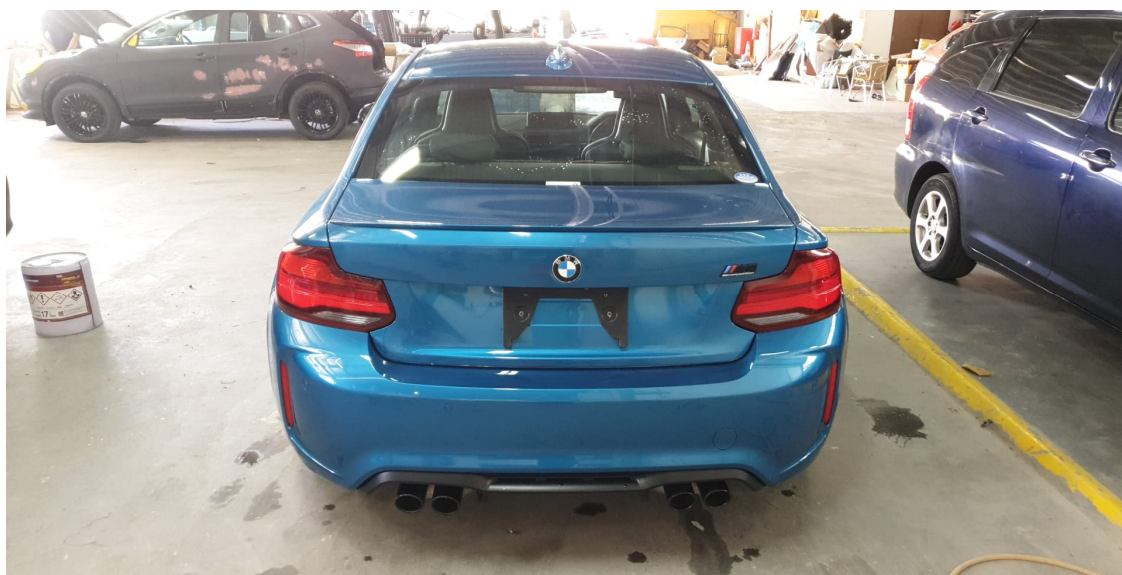
Photo 5 shows the rear body of the Motor Car (photograph provided to me). Apart for the front right portion, there was no physical damage observed to other areas of the Motor Car. The airbag(s) of the Motor Car was not deployed as seen from the photographs that were provided to me.

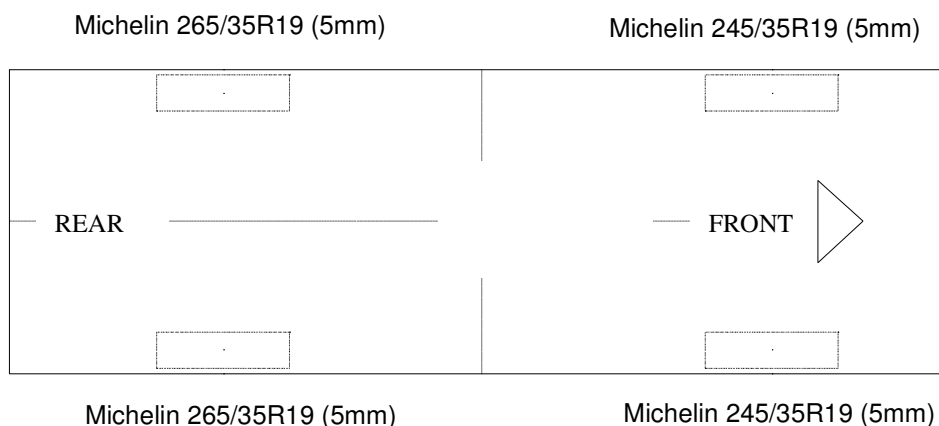
8. It was fitted with 19inch sport wheel rims that were wrapped with tyres that were observed to be of serviceable condition. The tyres were also sufficiently inflated for vehicular operation. The tyre brand, tyre size and approximate remaining tread depth of the 4 tyres of the Motor Car were recorded as follows: -

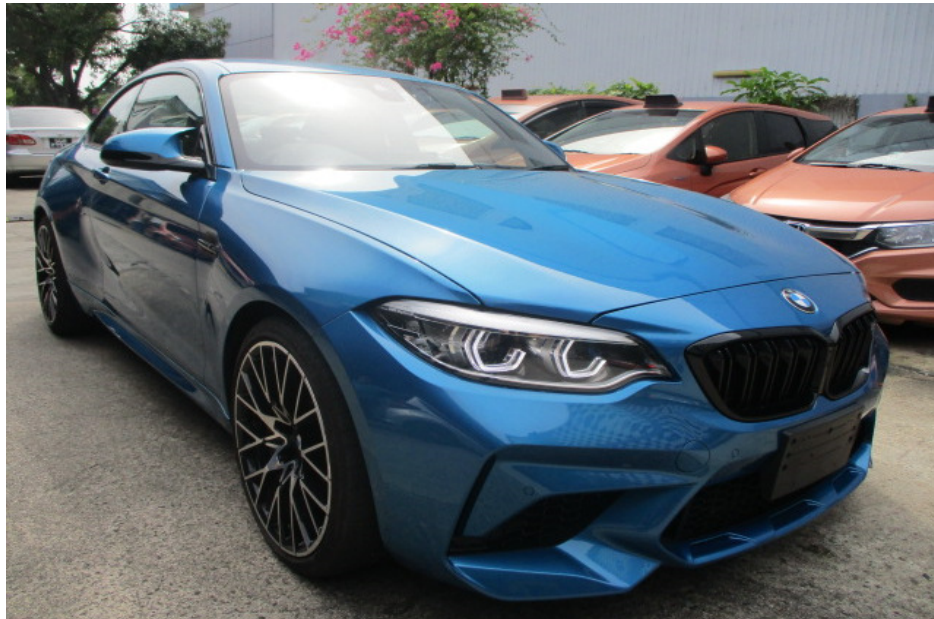
Photo 6 shows a general view of the front right body of the Motor Car at the time of my inspection. The Motor Car was observed to be in a relatively good general condition with no loose exterior fittings observed. The body parts at the front right portion of the Motor Car were visually examined and it was observed that the repair/restoration works carried out to the damaged area of the Motor Car (refer to photograph 1 & 2 above) were reasonably adequate and in order.

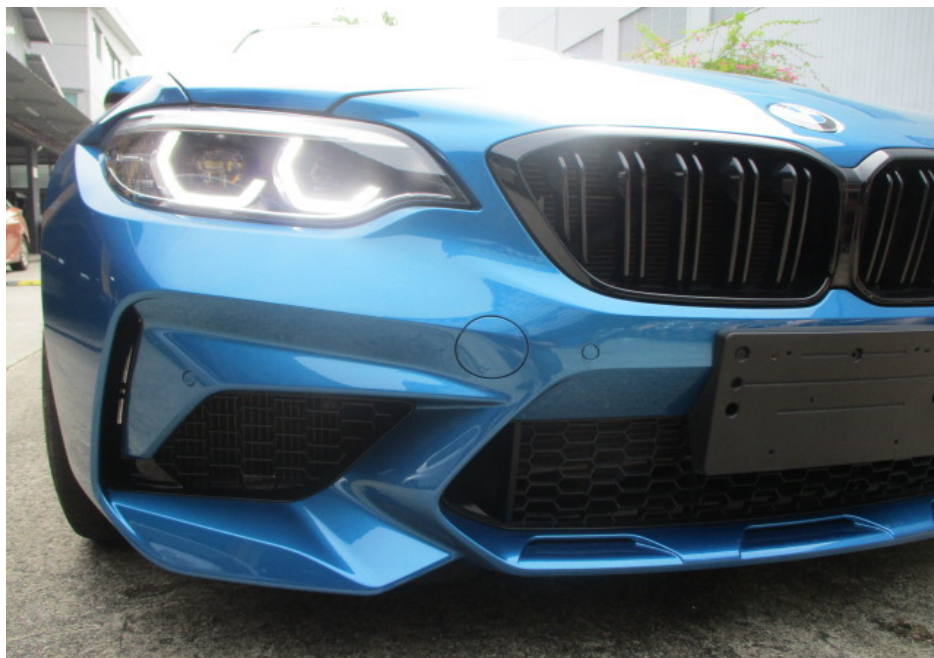
Photo 7 shows a closer view of the Motor Car's front bumper, front bumper right lower grille, front right headlamp and radiator grilles at the time of my inspection. The body parts at the front right portion of the Motor Car were visually examined and it was observed that the repair/restoration works carried out to the damaged area of the Motor Car (refer to photograph 1 & 2 above) were reasonably adequate and in order.

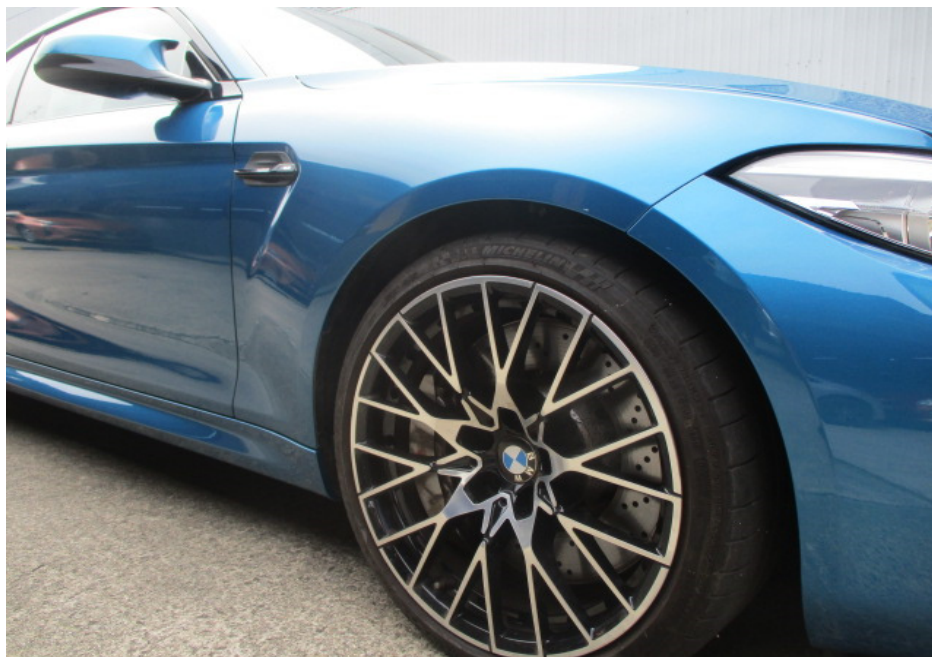
Photo 8 shows a closer view of the Motor Car's front right headlamp, front right fender, front right wheel rim and front right door at the time of my inspection. The body parts at the front right portion of the Motor Car were visually examined and it was observed that the repair/restoration works carried out to the damaged area of the Motor Car (refer to photograph 1 & 2 above) were reasonably adequate and in order.

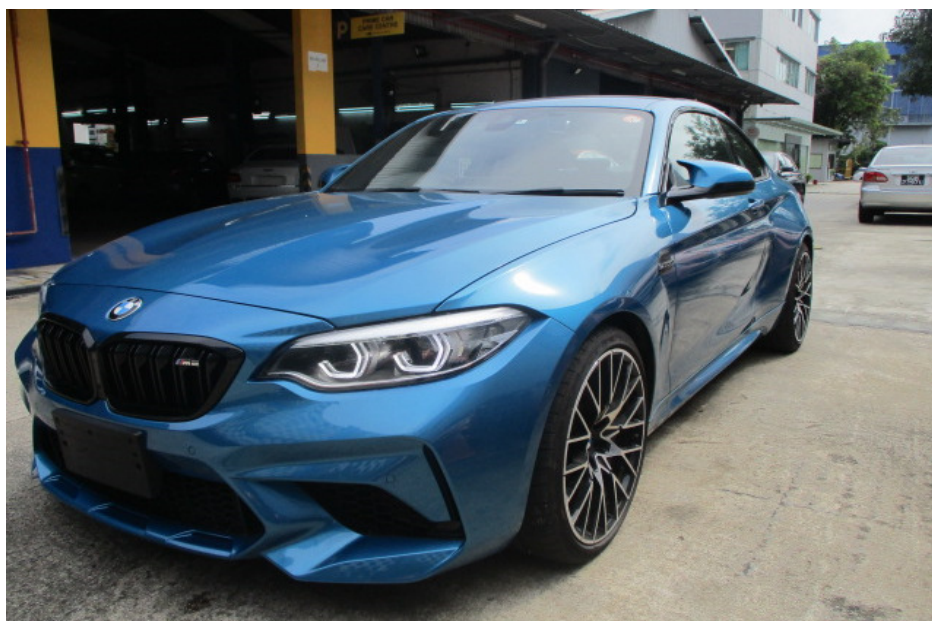
Photo 9 shows a general view of the front left body of the Motor Car at the time of my inspection. The Motor Car was observed to be in a relatively good general condition with no loose exterior fittings observed. The body parts at the front right portion of the Motor Car were visually examined and it was observed that the repair/restoration works carried out to the damaged area of the Motor Car (refer to photograph 1 & 2 above) were reasonably adequate and in order.

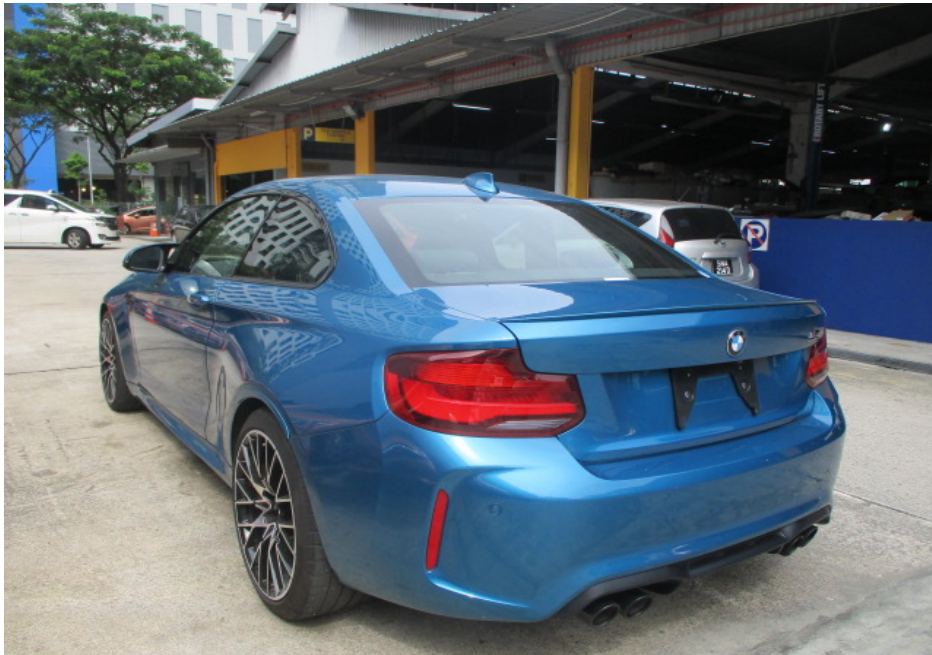
Photo 10 shows a general view of the rear left body of the Motor Car at the time of my inspection. The Motor Car was observed to be in a relatively good general condition with no loose exterior fittings observed. The mileage of the Motor Car recorded at the time of my inspection was 40,786km.

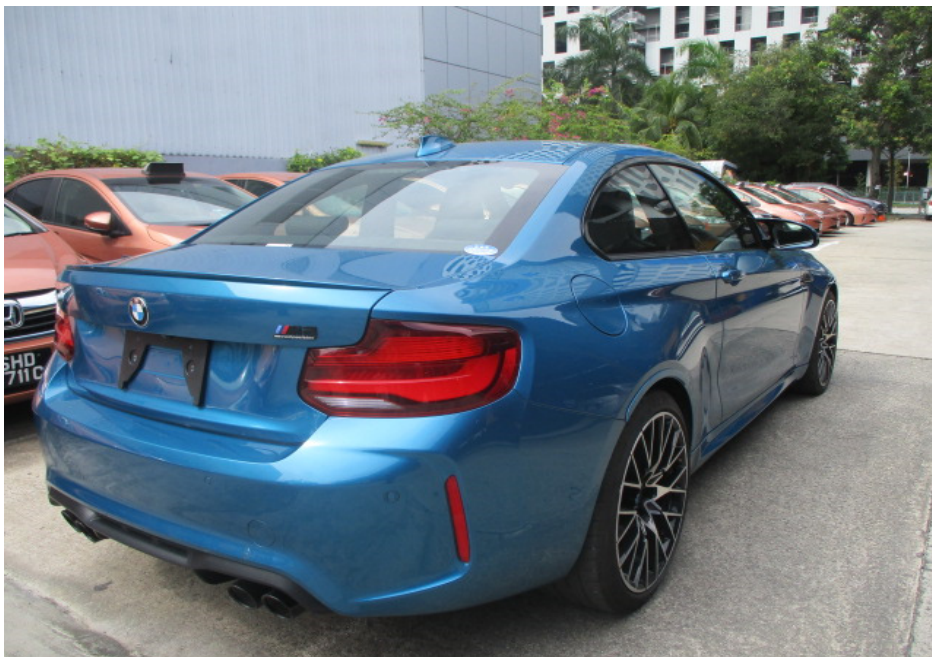
Photo 11 shows a general view of the rear right body of the Motor Car at the time of my inspection. The Motor Car was observed to be in a relatively good general condition with no loose exterior fittings observed. The mileage of the Motor Car recorded at the time of my inspection was 40,786km

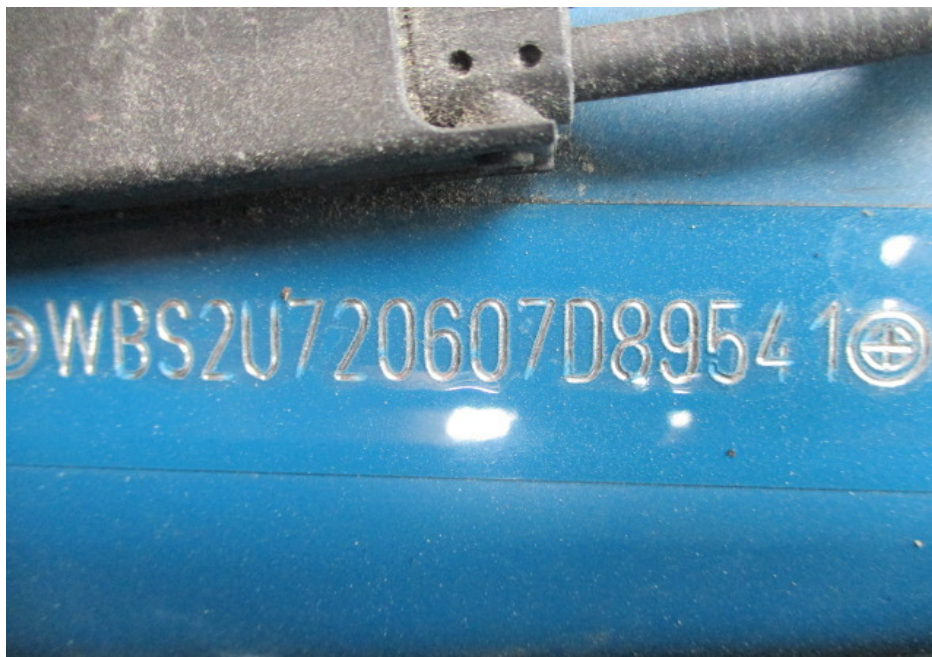
Photo 12 shows the chassis number of the Motor Car. The chassis number recorded was WBS2U720607D89541.

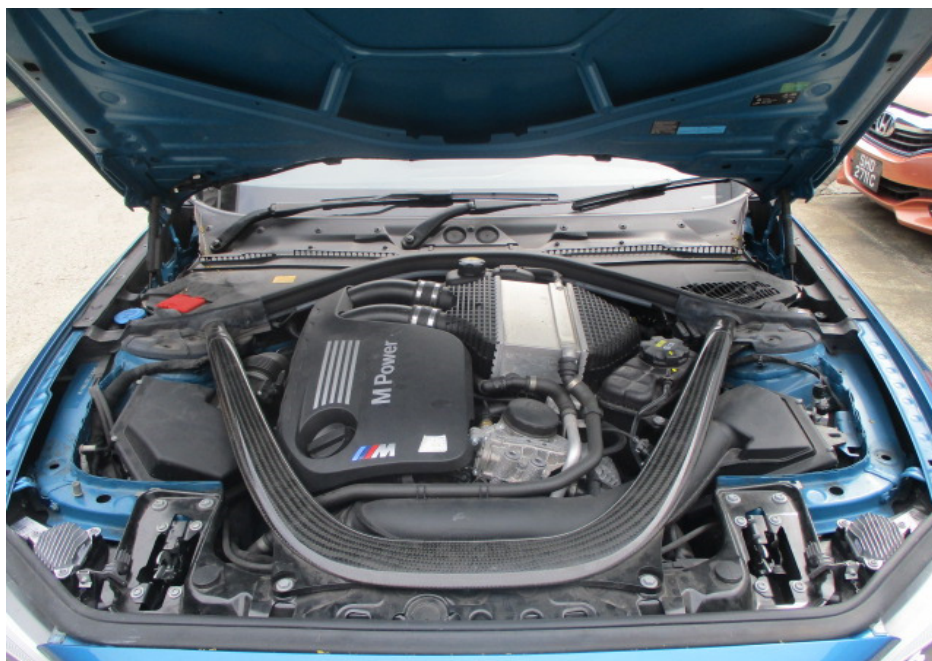
14. My examination of the engine compartment of the Motor Car revealed that the various parts and components inside the engine compartment were all intact and properly fitted. The engine oil, brake fluid and engine coolant were all found to be of sufficient level for operating purposes. Visually, there was also no contamination found to these fluids.
15. My checks on the underside of the Motor Car revealed no sign(s) or indication(s) of fluid leakage and/or fluid stain(s). The engine block and automatic transmission assembly were both secured properly. All undercarriage components of the Motor Car were also observed to be intact and secured in an appropriate manner.

Photo 13 shows a general view of the engine compartment of the Motor Car at the time of my inspection. The various parts and components inside the engine compartment were all observed to be intact and properly fitted. There was also no sign(s) or indication(s) of fluid leak and/or fluid stain found inside the engine compartment.

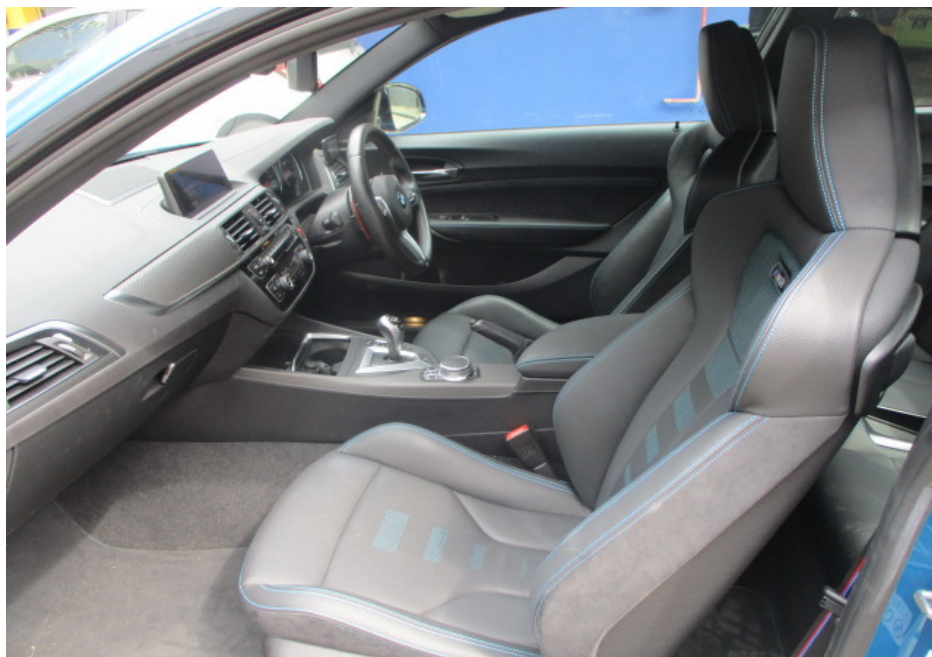
Photo 14 shows the interior compartment of the Motor Car at the time of my inspection. The various parts and components, trims, carpet, and upholstery inside the interior compartment were all observed to be intact and properly fitted.

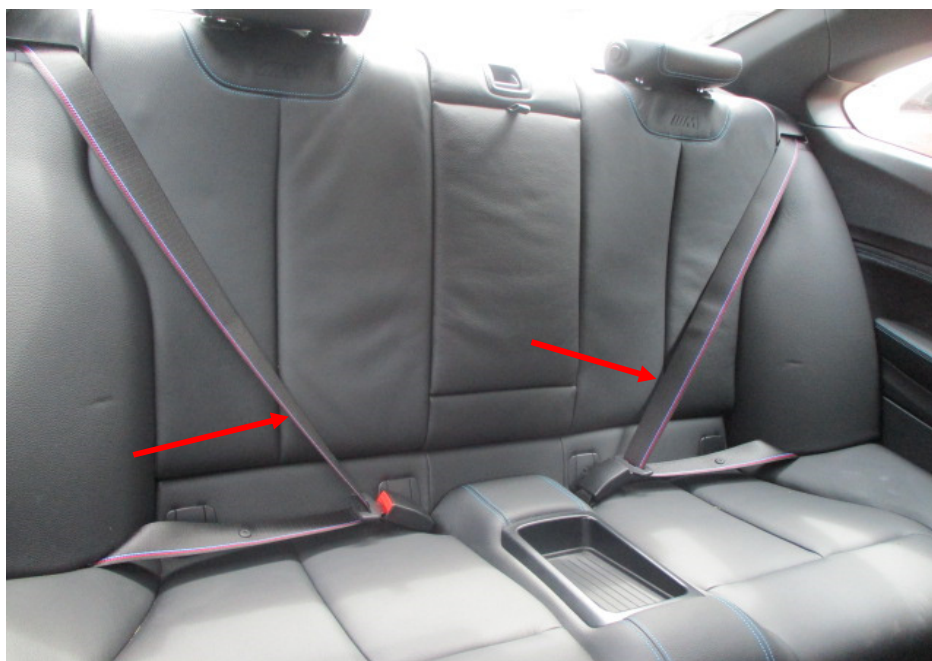
12. The seats of the Motor Car were found to be secured to the floorboard of the Motor Car via seat rails bolted onto the floorboard. Retractable seat belt reels and pre-tensioners were fitted on all seats of the Motor Car. The seat belts were tested and were able to be fastened securely into the respective pre-tensioners that were fixed to the side of all the seats.

Photo 15 shows the rear seats of the Motor Car. All the seats of the Motor Car were secured via seat rails to the floorboard. They were also fitted with a retractable seat belt reel and a pre-tensioner. The seat belts (arrowed) were tested and were able to be fastened into the respective pre-tensions that were fitted on the side of each individual seat.

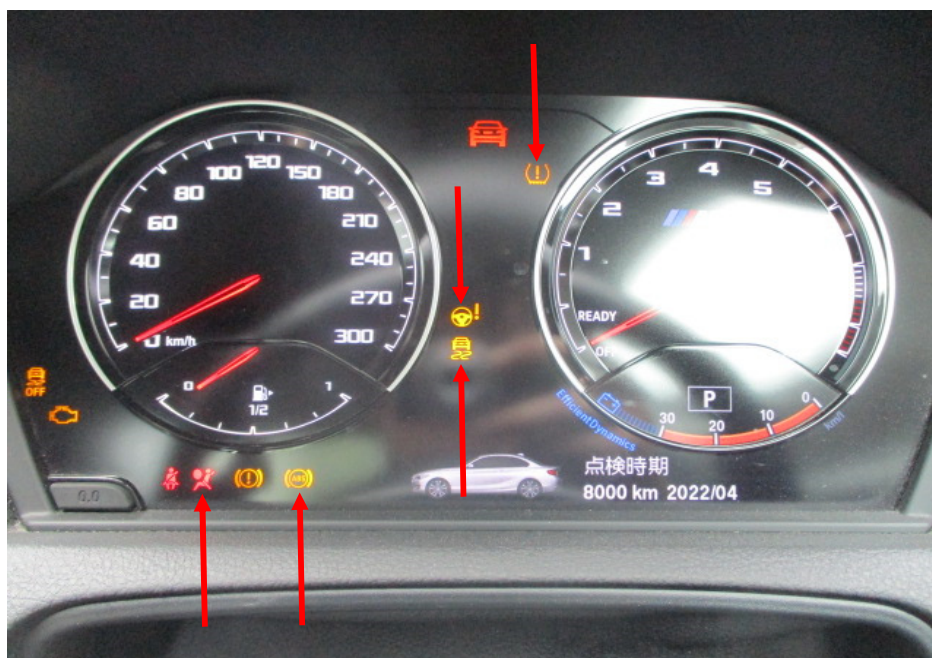
Photo 16 shows the warning lights for the various electronic safety features appearing on the instrument panel of the Motor Car during its self-test when the engine is cranked, in particular the ABS, SRS, IAS, TPM and DSC lights (arrowed).

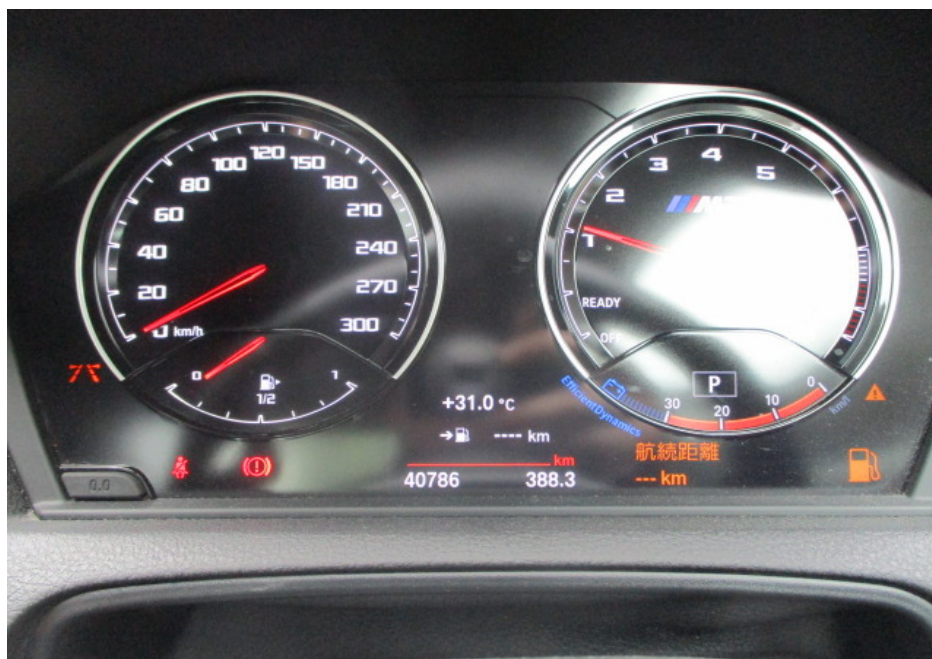
13. The Motor Car's automatic self-test of the functionality of its various electronic safety features like the Anti-Lock Brake System (ABS), Supplemental Restraint System (SRS), Integral Active Steering (IAS), Tyre Pressure Monitor (TPM) and Dynamic Stability Control (DSC) during cranking of the engine had indicated that these electronic systems were in working condition. This was determined from the respective warning lights disappearing from the instrument panel after the self-test.

Photo 17 shows the respective warning lights no longer illuminated, indicating that there is no fault detected to the ABS, SRS, IAS, TPM and DSC systems of the Motor Car during the self-test. These electronic systems were hence in working condition at the time of my inspection.

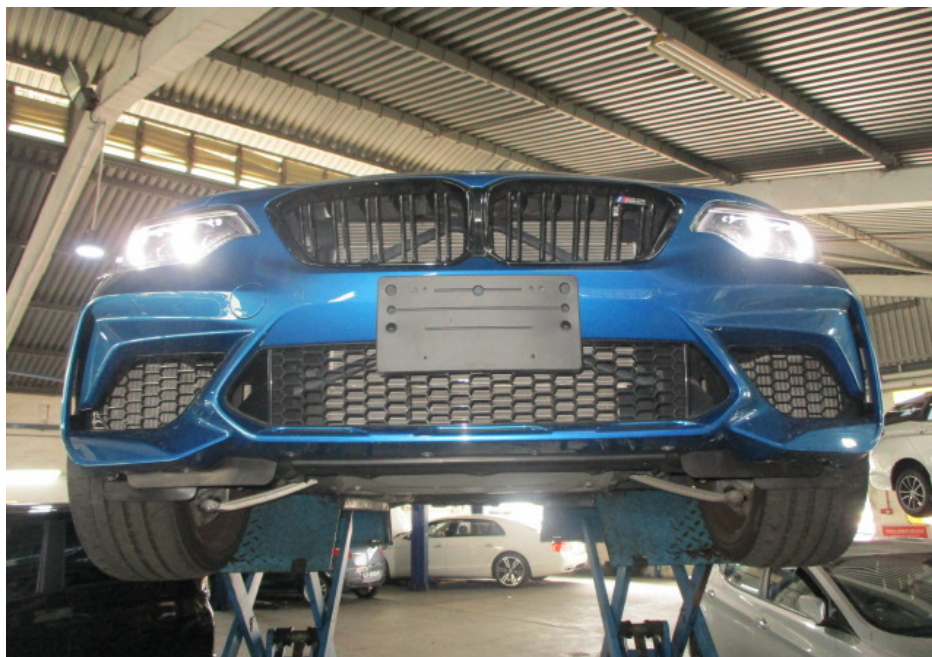
Photo 18 shows the Motor Car hoisted up for checks on its undercarriage. There was no sign(s) or indication(s) of fluid leakage and/or fluid stain(s) on the underside of the Motor Car. The undercarriage components of the Motor Car were also all observed to be intact and secured in an appropriate manner.

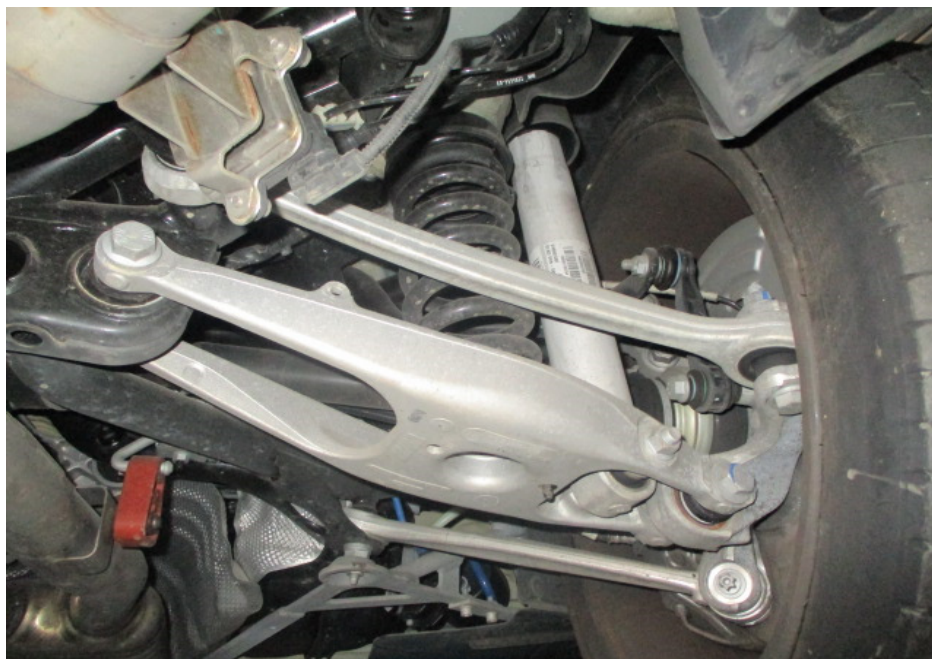
Photo 19 shows a general view of the control arms and linkages at the rear right wheel of the Motor Car. I did not observe any fluid leak and/or fluid stain on the underside of the Motor Car. All of the Motor Car's undercarriage components were observed to be intact and secured in an appropriate manner.

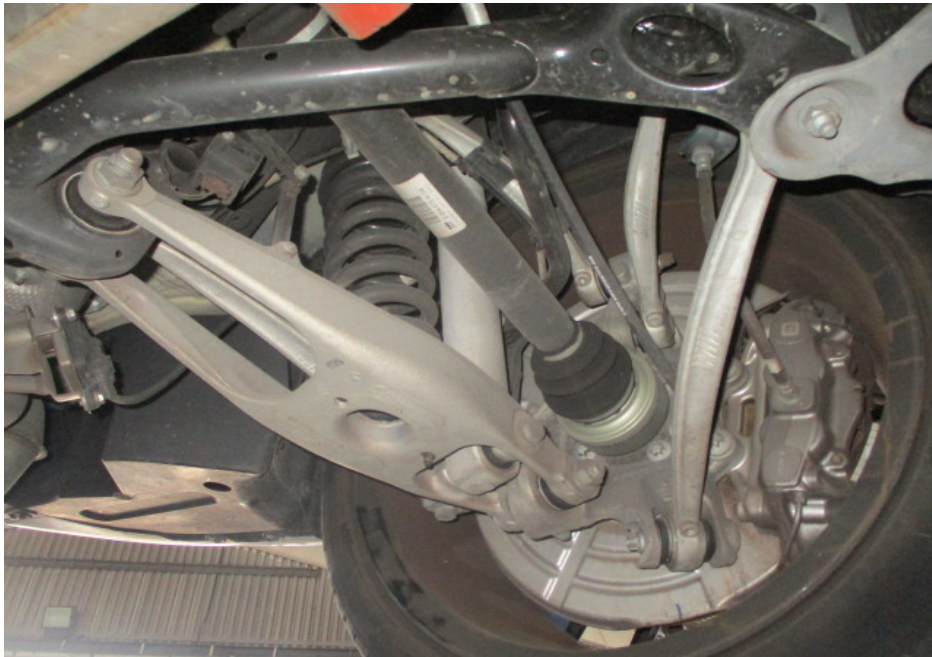
Photo 20 shows a general view of the control arms and linkages at the rear left wheel of the Motor Car. I did not observe any fluid leak and/or fluid stain on the underside of the Motor Car. All of the Motor Car's undercarriage components were observed to be intact and secured in an appropriate manner.

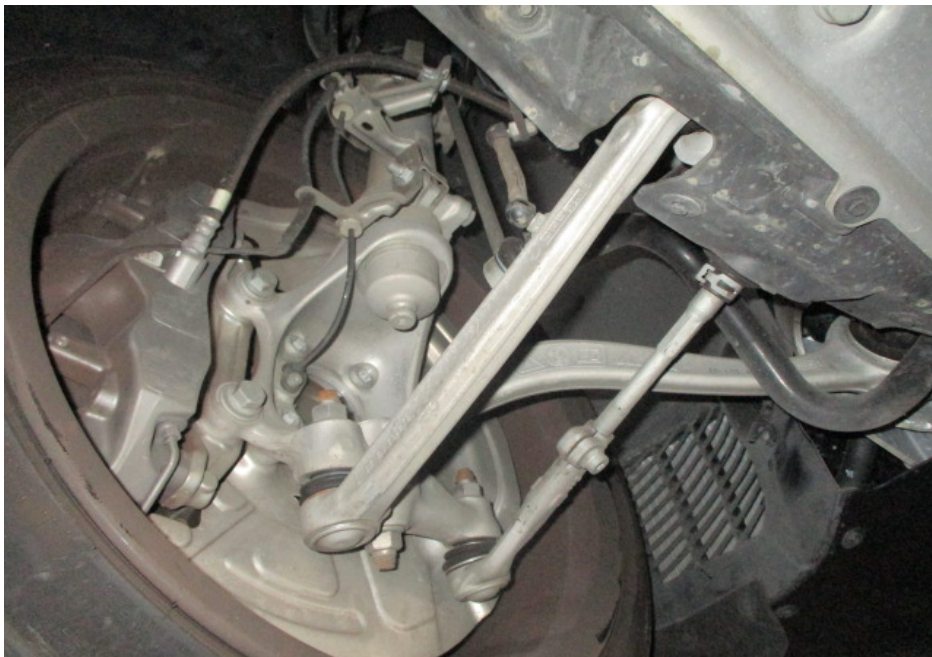
Photo 21 shows the various undercarriage components at the front left wheel of the Motor Car. The mechanical components, control arms and linkages were all found to be intact and secured in an appropriate manner.

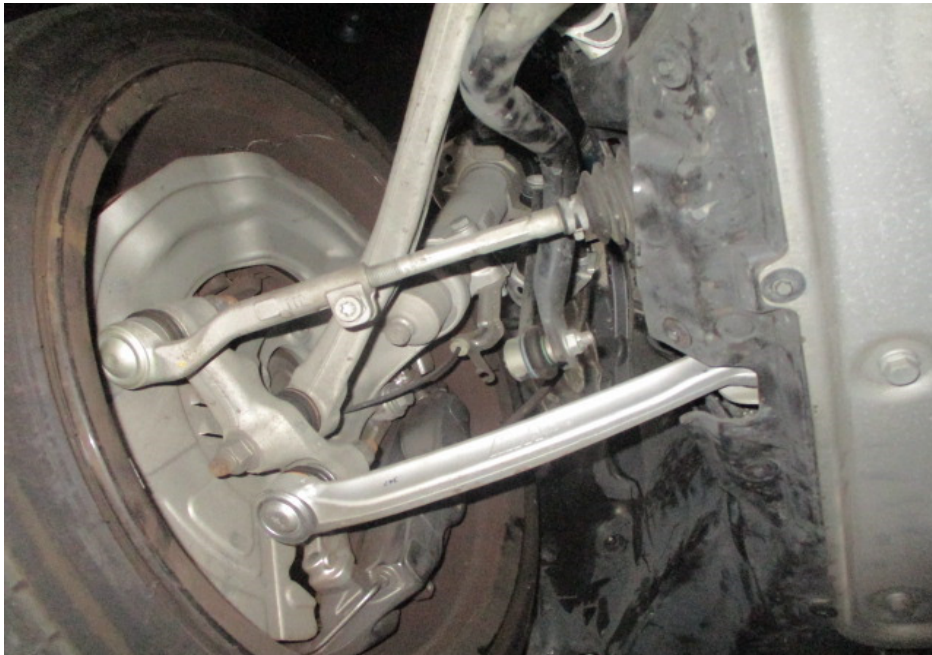
Photo 22 shows the various undercarriage components at the front right wheel of the Motor Car. The mechanical components, control arms and linkages were all found to be intact and secured in an appropriate manner. I also did not observe any fluid leak and/or fluid stain on the underside of the Motor Car.

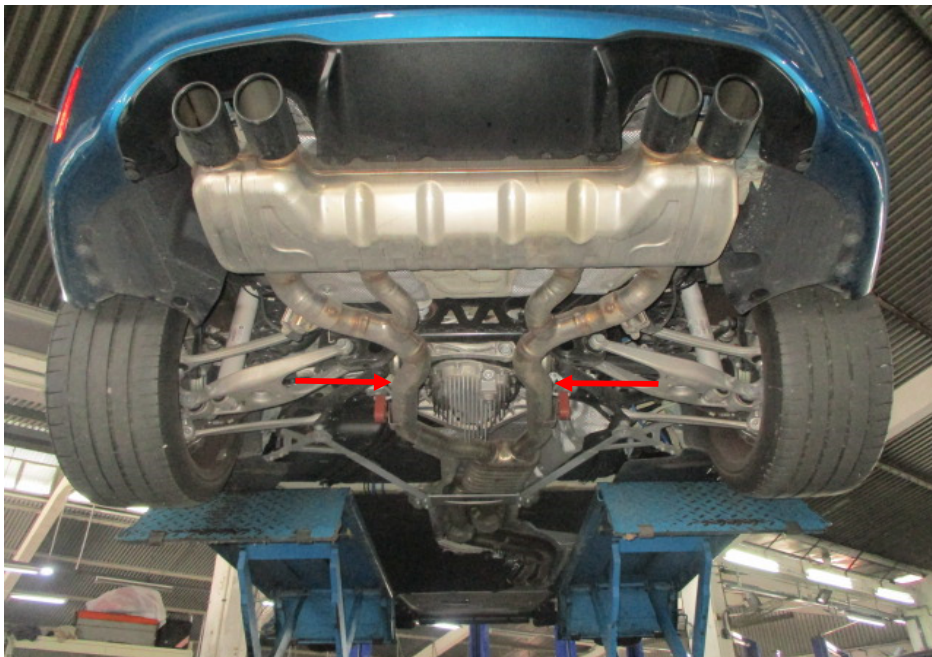
Photo 23 shows the rear section of the Motor Car's exhaust system. My examination of the Motor Car's exhaust system revealed no sign(s) or indication(s) of any cut or weld marks along its exhaust pipes (arrowed), on its rear muffler, on its centre resonator boxes and on its catalytic converters.

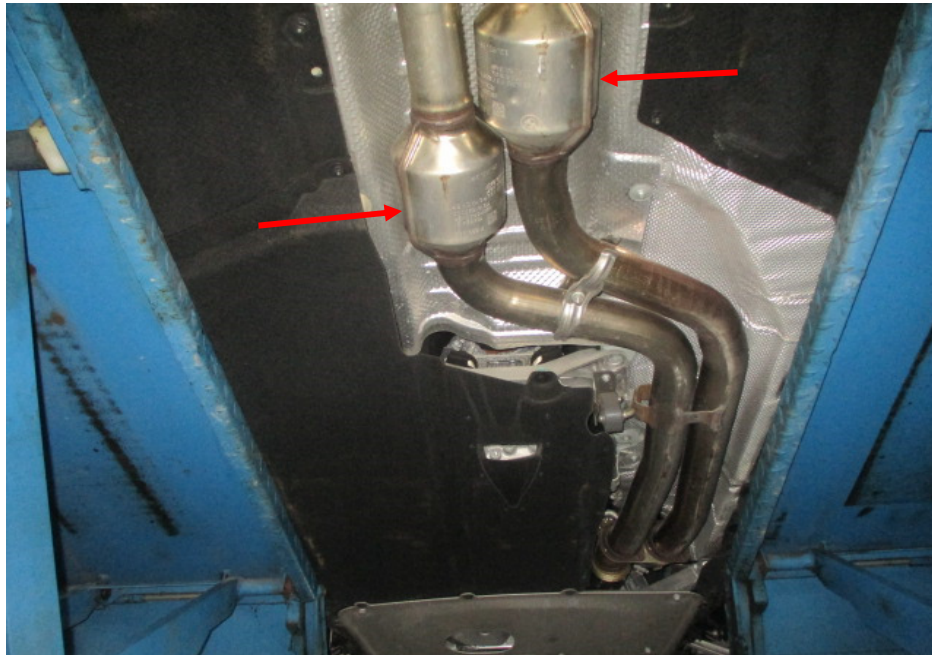
Photo 24 shows the front section of the Motor Car's exhaust system. My examination of the Motor Car's exhaust system revealed no sign(s) or indication(s) of any cut or weld marks along its exhaust pipes, on its rear muffler, on its centre resonator boxes (arrowed) and on its catalytic converters.

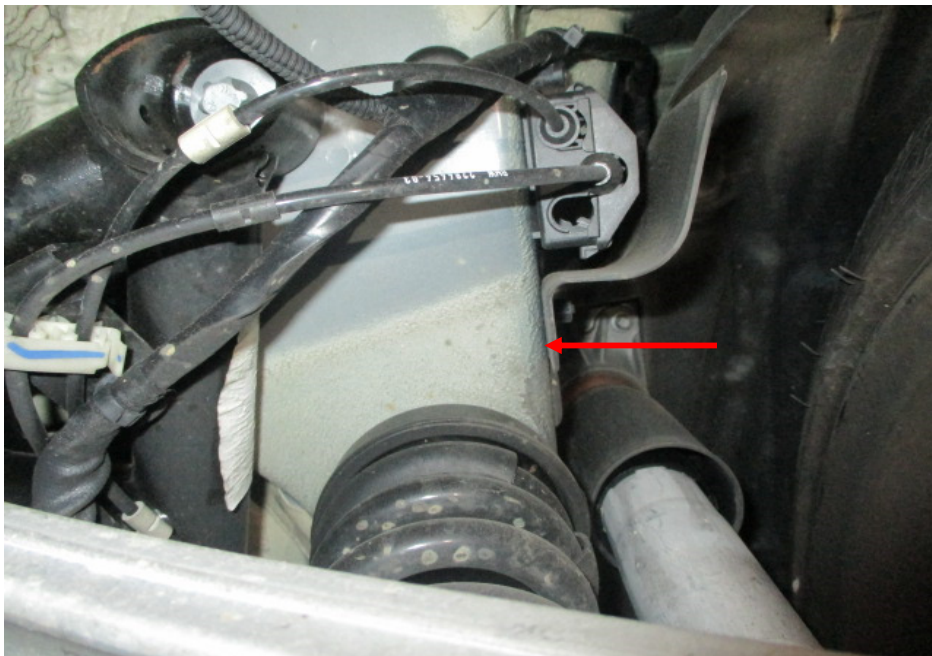
Photo 25 shows the chassis/structural body at the underside rear right of the Motor Car. I did not find any weld marks other than original spot weld marks on the chassis/structural body of the Motor Car. The original factory sealant (arrowed) at the joints along the chassis/structural body was untouched, indicating no work was done on the chassis/structural body of the Motor Car and that the chassis/structural body was originally fitted.

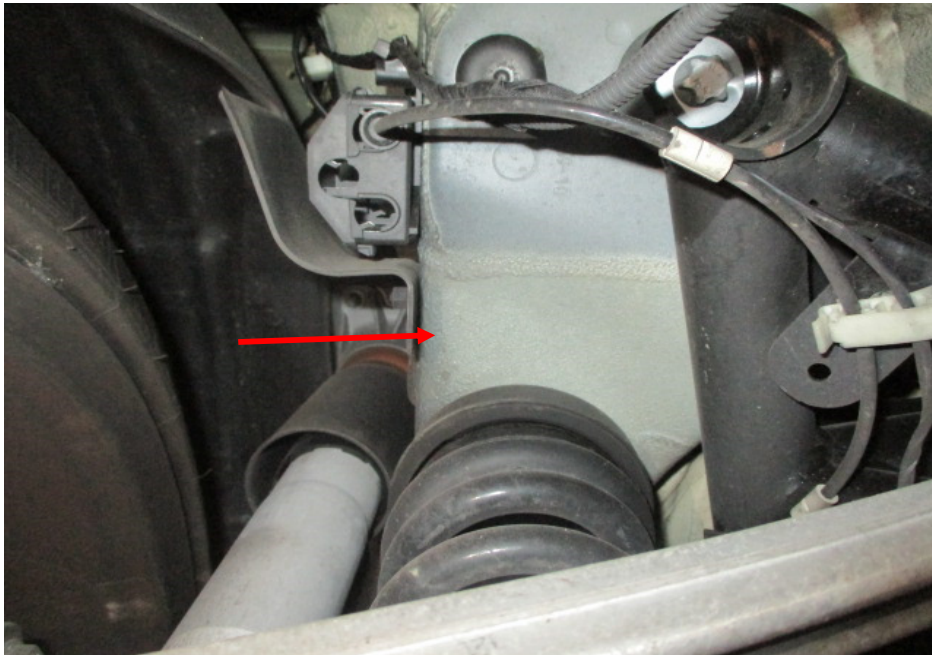
Photo 26 shows the chassis/structural body at the underside rear left of the Motor Car. The original factory sealant (arrowed) at the joints along the chassis/structural body was observed to be untouched. In general, I had found no work was carried out on the chassis/structural body of the Motor Car. The chassis/structural body of the Motor Car was originally fitted.

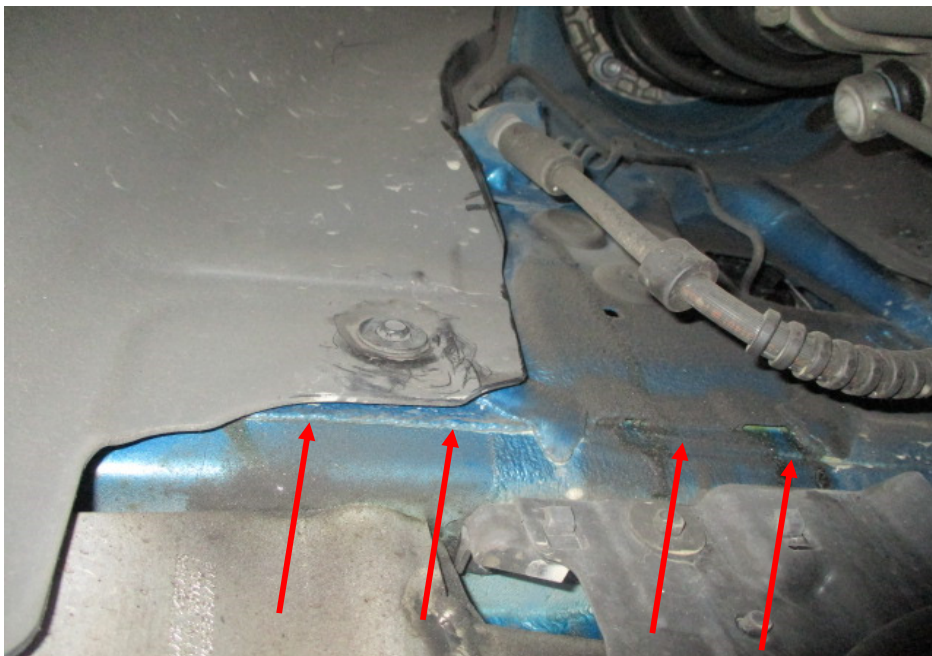
Photo 27 shows the chassis/structural body at the underside front left of the Motor Car. I did not find any weld marks other than original spot weld marks on the chassis/structural body of the Motor Car. The original factory sealant (arrowed) at the joints along the chassis/structural body was untouched, indicating no work was done on the chassis/structural body of the Motor Car and that the chassis/structural body was originally fitted.

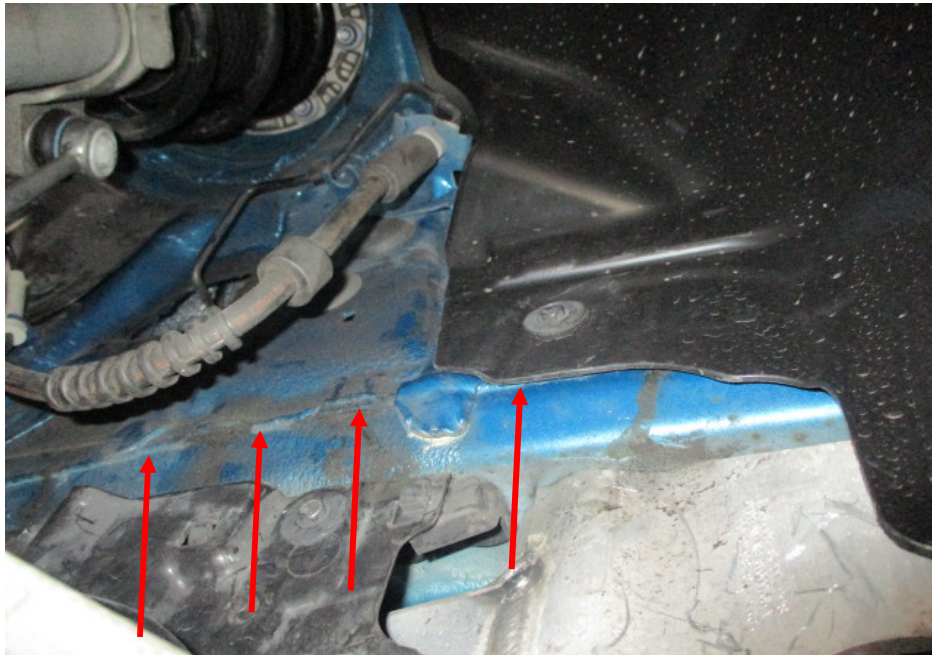
Photo 28 shows the chassis/structural body at the underside front right of the Motor Car. The original factory sealant (arrowed) at the joints along the chassis/structural body was observed to be untouched. In general, I had found no work was carried out on the chassis/structural body of the Motor Car. The chassis/structural body of the Motor Car was originally fitted.

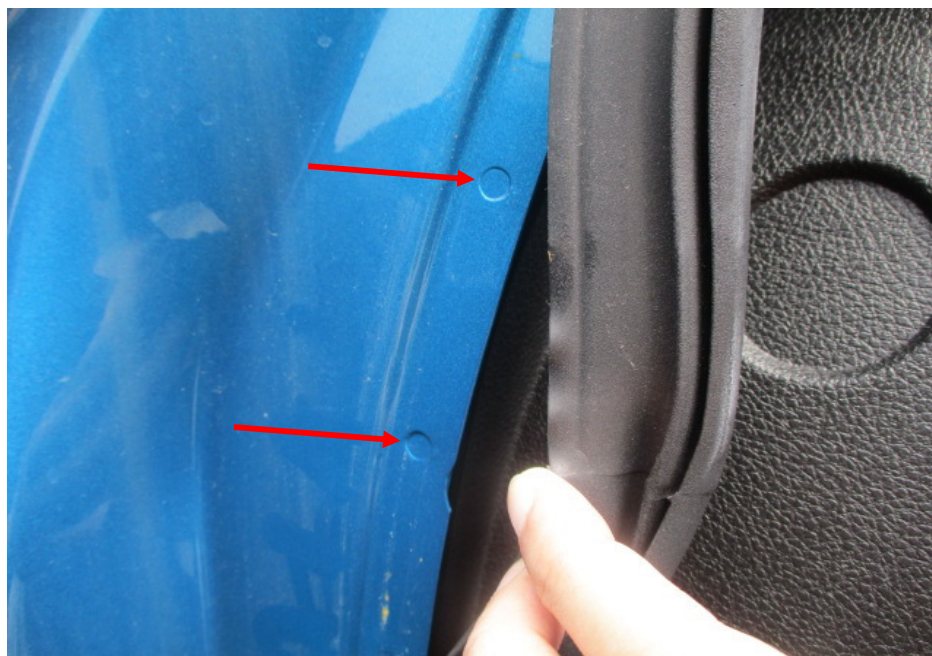
Photo 29 shows the left side "A" pillar of the Motor Car. I did not find any weld marks other than original spot weld marks (arrowed) on the left side "A" pillar of the Motor Car which, indicates that there was no re-welding works carried out. In general, I had found all the non-detachable body panels of the Motor Car to be originally fitted at the time of my inspection.

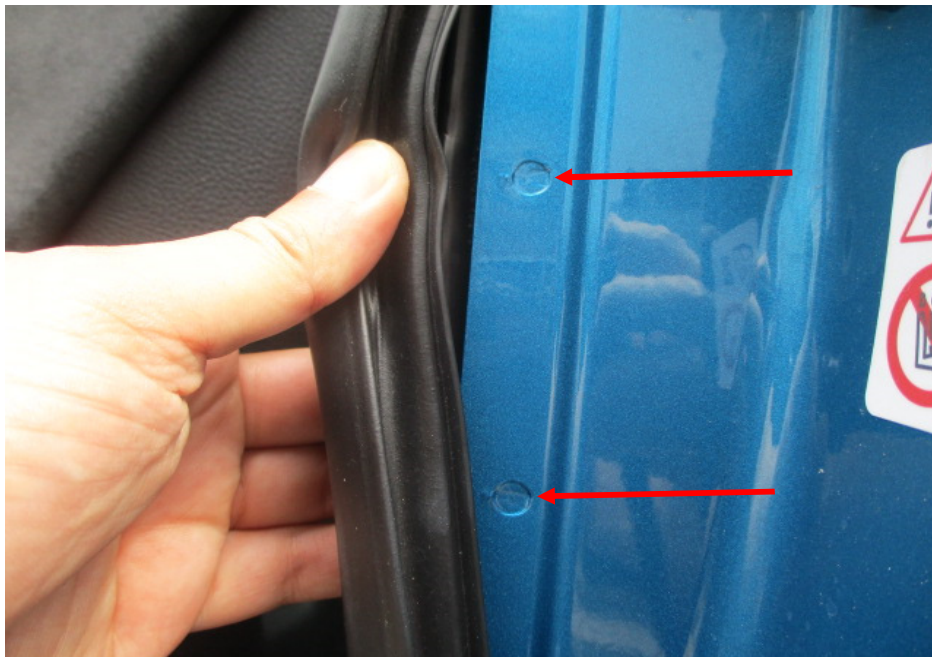
Photo 30 shows the rear left body panel of the Motor Car. I did not find any weld marks other than original spot weld marks (arrowed) on the rear left body panel of the Motor Car which, indicates that there was no re-welding works carried out. In general, I had found all the non-detachable body panels of the Motor Car to be originally fitted at the time of my inspection.
