Your Ref: BM M2 Coupe
(chassis number WBS2U720607D89541)
Our Ref : CI/TP22000739/D

22 January 2022

INSPECTION REPORT OF AN UNREGISTERED BMW M2 COUPE MOTOR CAR WITH CHASSIS NUMBER WBS2U720607D89541

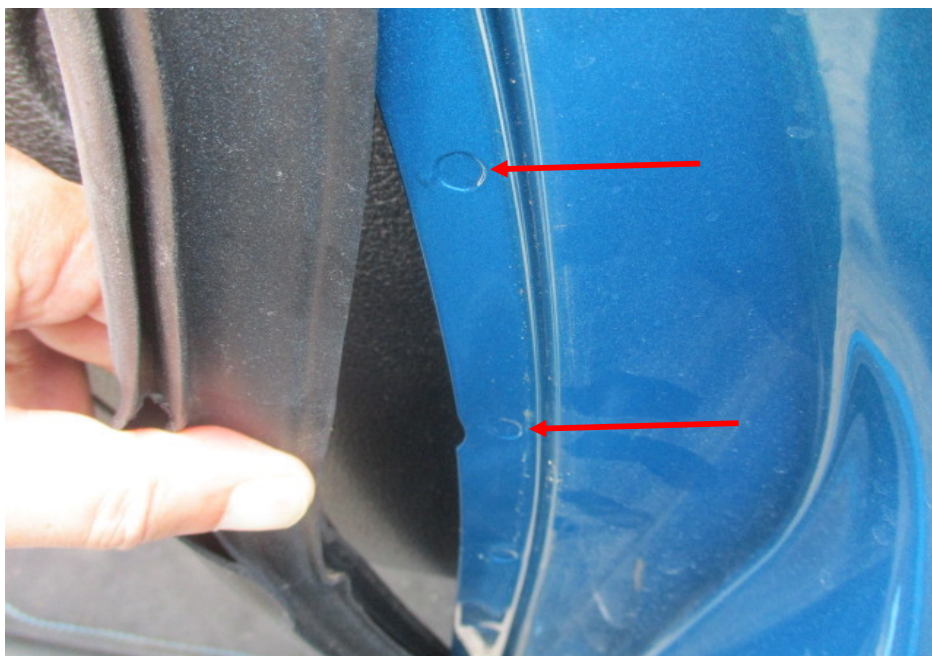
Photo 31 shows the right side "A" pillar of the Motor Car. I did not find any weld marks other than original spot weld marks (arrowed) on the right side "A" pillar of the Motor Car which, indicates that there was no re-welding works carried out. In general, I had found all the non-detachable body panels of the Motor Car to be originally fitted at the time of my inspection.

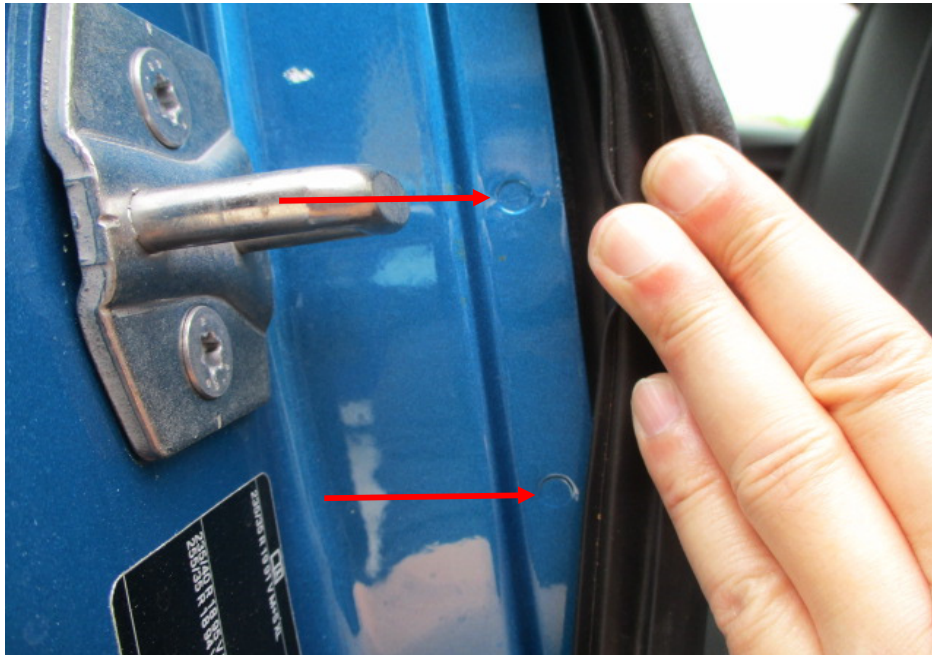
Photo 32 shows the rear right body panel of the Motor Car. I did not find any weld marks other than original spot weld marks (arrowed) on the rear right body panel of the Motor Car which, indicates that there was no re-welding works carried out. In general, I had found all the non-detachable body panels of the Motor Car to be originally fitted at the time of my inspection.
