Your Ref: Audi RS6  
(chassis number WUAZZZF22LN901049)  
Our Ref : CI/TP22000936/D

**INSPECTION REPORT OF AN UNREGISTERED AUDI RS6 MOTOR CAR  
WITH CHASSIS NUMBER WUAZZZF22LN901049**

1. I refer to your request on 14 January 2022 to conduct a physical inspection of an unregistered Audi RS6 motor car bearing chassis number WUAZZZF22LN901049 (herein referred to as "**Motor Car**").
2. The purpose of this inspection is to primarily determine: -
  - a) the general road worthiness of the Motor Car, whether there is any possible mechanical problem(s) and/or operational issue(s) to the various operating systems of the Motor Car;
  - b) whether there was any work (repair) done to the chassis/structural body of the Motor Car, and if yes, whether all major components, welding and critical points of the Motor Car has been properly restored.

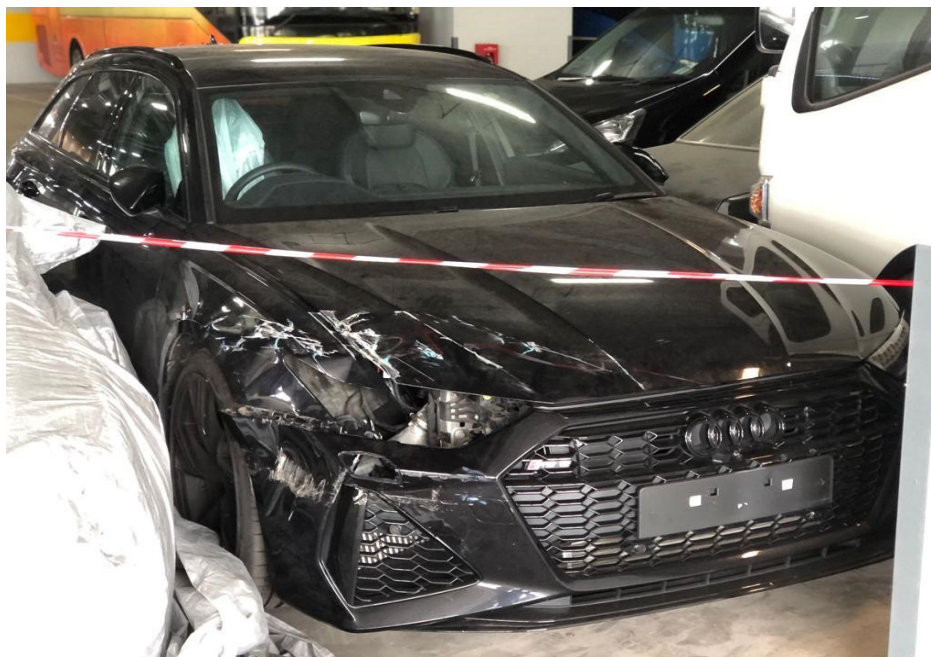
3. The photographs provided to me had showed damage to the front right portion of the Motor Car. Body parts damaged include the front bumper, front bumper right lower grille, front bumper tow hook cover, front bonnet and front right fender amongst others. The front right headlamp and front right headlamp washer nozzle cover were seen to be damaged/dislodged/missing.
4. Apart for the front right portion, there was no physical damage observed to other areas of the Motor Car. The airbag(s) was not deployed as seen from the photographs that were provided to me. See photo 1 – 4 below.

**Photo 1** shows the front right body of the Motor Car (photograph provided to me). The photographs provided to me had showed damage to the front right portion of the Motor Car. The front bumper, front bumper right lower grille, front bumper tow hook cover, front bonnet and front right fender were amongst the body parts that were observed to have been damaged.

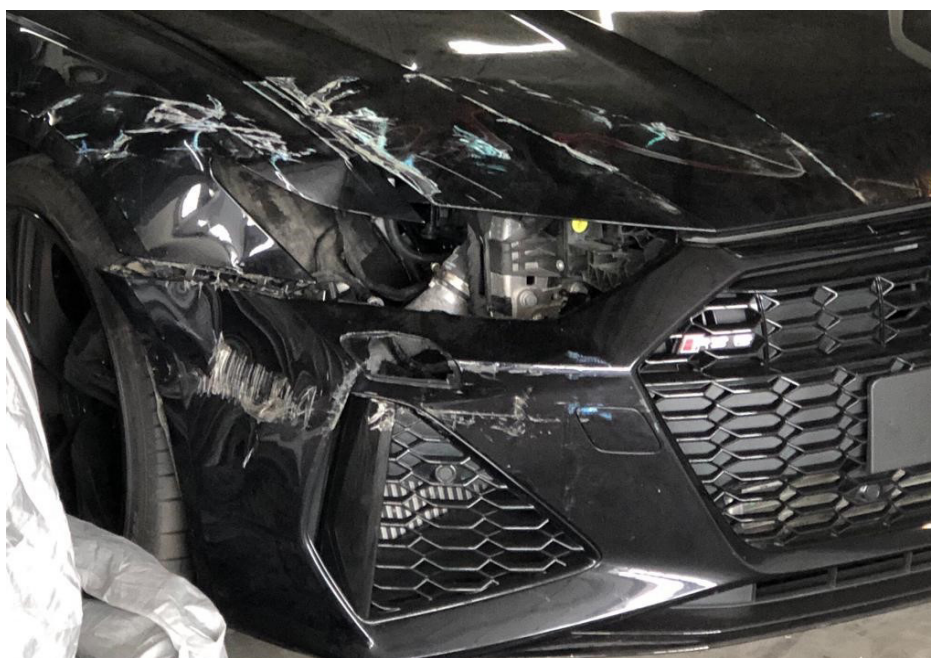
**Photo 2** shows a closer view of the damaged front right portion of the Motor Car (photograph provided to me). Body parts damaged include the front bumper, front bumper right lower grille, front bumper tow hook cover, front bonnet and front right fender amongst others. The front right headlamp and front right headlamp washer nozzle cover were seen to be damaged/dislodged/missing.

22. The body parts at the front right portion of the Motor Car were visually examined and it was noted that the repair/restoration works carried out to the damaged area of the Motor Car (refer to photograph 1 & 2 above) were reasonably adequate and in order.

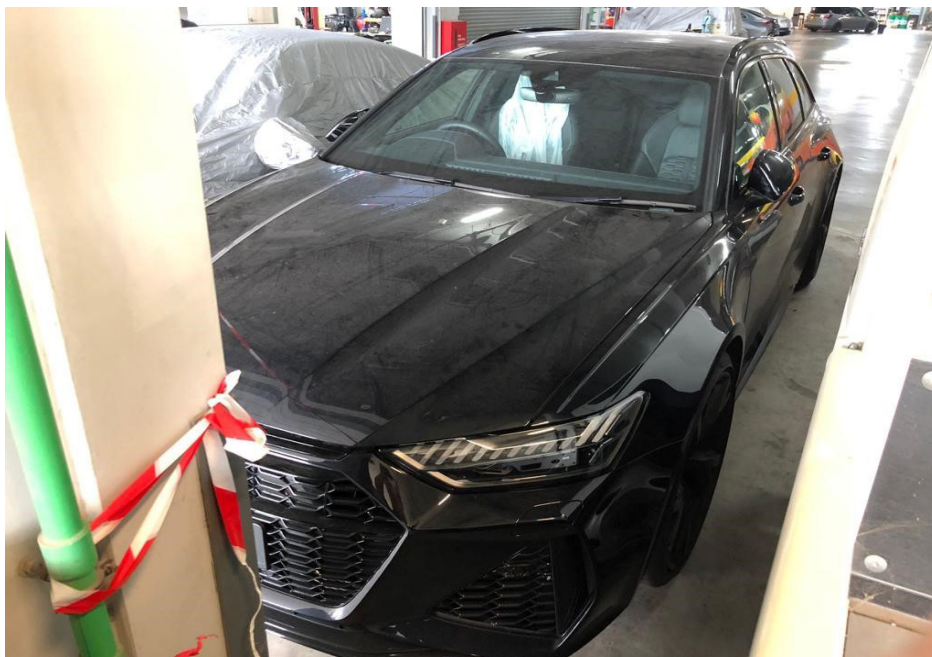
**Photo 3** shows the front left body of the Motor Car (photograph provided to me). Apart for the front right portion, there was no physical damage observed to other areas of the Motor Car. The airbag(s) was not deployed as seen from the photographs that were provided to me.

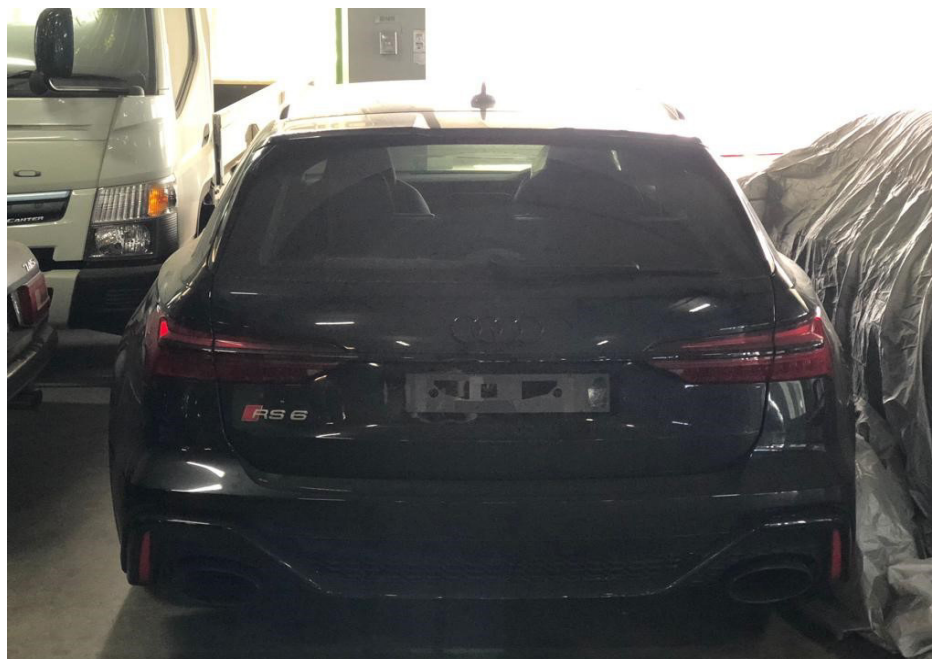
**Photo 4** shows the rear body of the Motor Car (photograph provided to me). Apart for the front right portion, there was no physical damage observed to other areas of the Motor Car. The airbag(s) was not deployed as seen from the photographs that were provided to me.

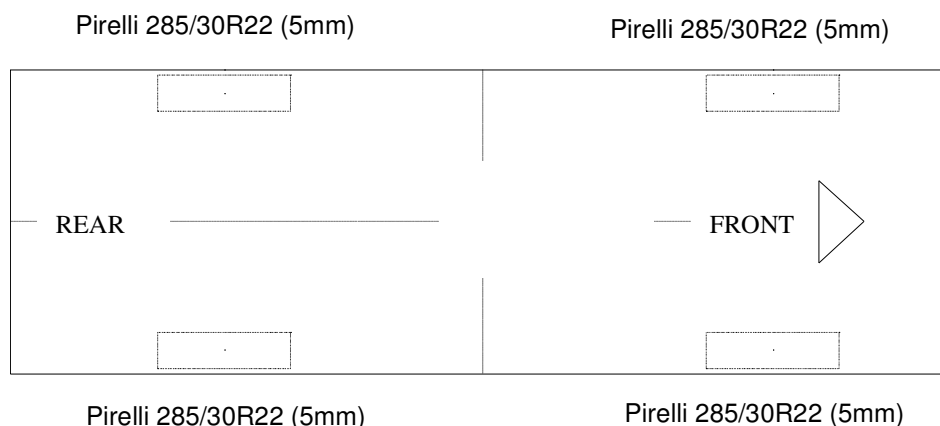
8. It was fitted with 22inch sport wheel rims that were wrapped with tyres that were observed to be of serviceable condition. The tyres were also sufficiently inflated for vehicular operation. The tyre brand, tyre size and approximate remaining tread depth of the 4 tyres of the Motor Car were recorded as follows: -

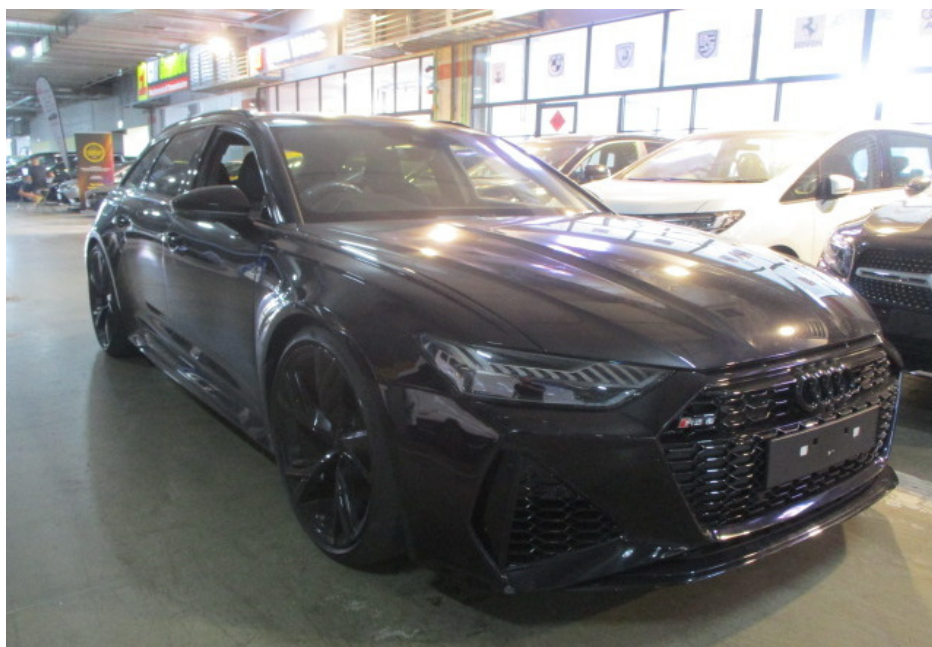
**Photo 5** shows a general view of the front right body of the Motor Car at the time of my inspection. The Motor Car was observed to be in a relatively good general condition with no loose exterior fittings observed. The body parts at the front right portion of the Motor Car were visually examined and it was observed that the repair/restoration works carried out to the damaged area of the Motor Car (refer to photograph 1 & 2 above) were reasonably adequate and in order.

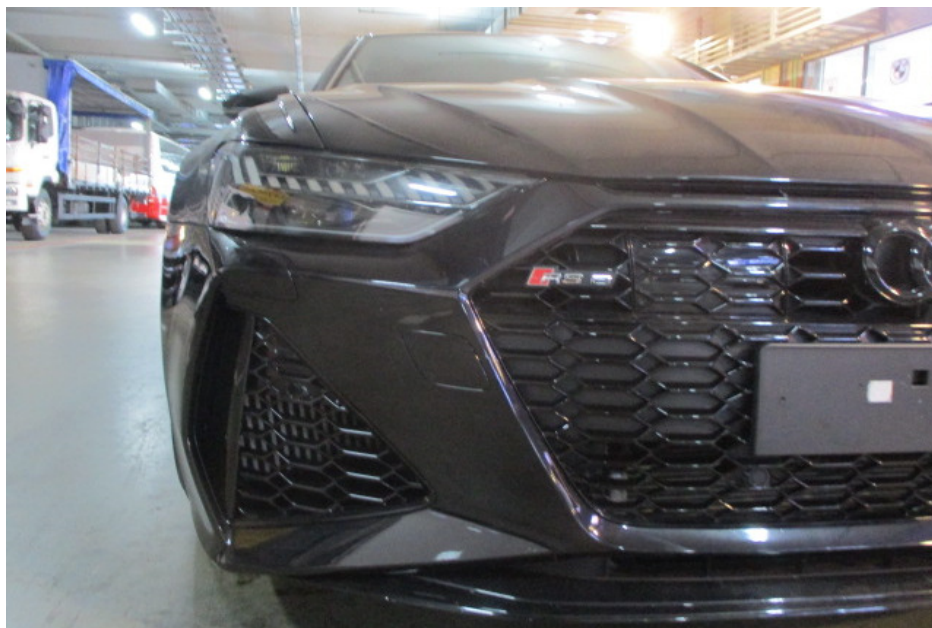
**Photo 6** shows a closer view of the Motor Car's front bumper, front bumper right lower grille, front right headlamp and radiator grille at the time of my inspection. The body parts at the front right portion of the Motor Car were visually examined and it was observed that the repair/restoration works carried out to the damaged area of the Motor Car (refer to photograph 1 & 2 above) were reasonably adequate and in order.

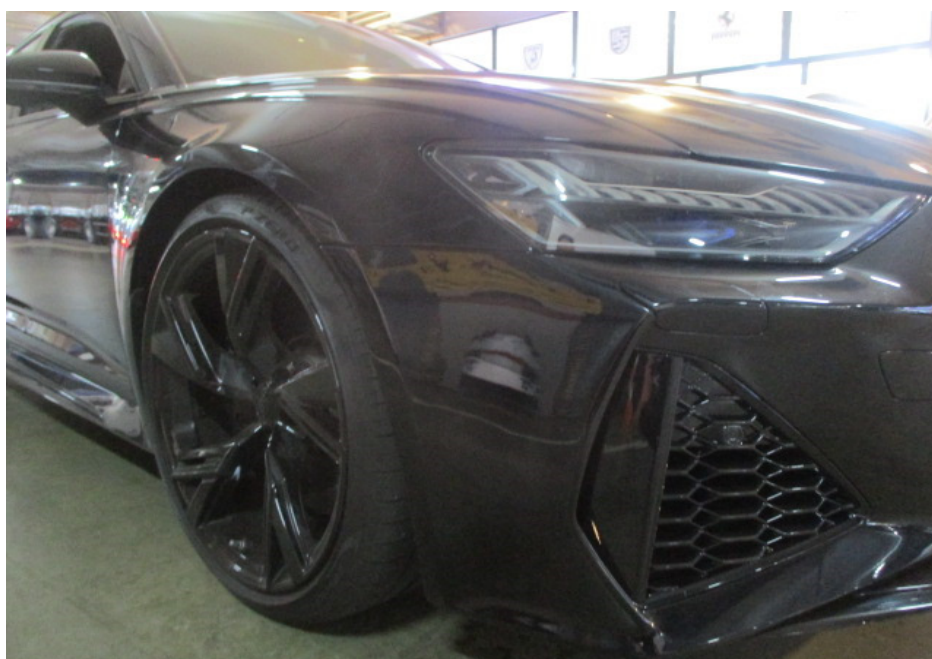
**Photo 7** shows a closer view of the Motor Car's front bumper, front bumper right lower grille, front right headlamp and front right fender at the time of my inspection. The body parts at the front right portion of the Motor Car were visually examined and it was observed that the repair/restoration works carried out to the damaged area of the Motor Car (refer to photograph 1 & 2 above) were reasonably adequate and in order.

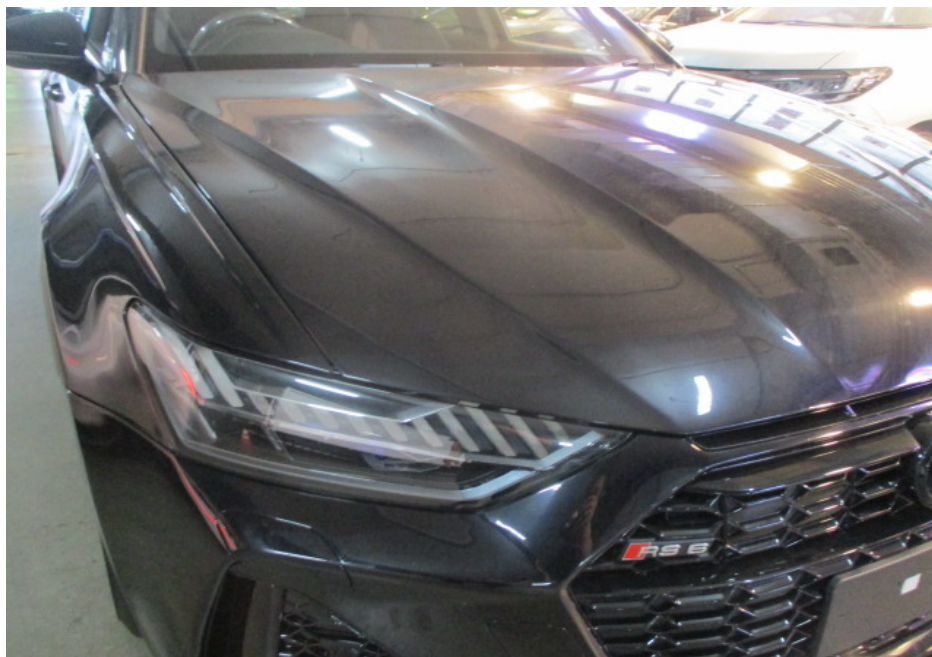
**Photo 8** shows a closer view of the Motor Car's front bonnet, front right headlamp and front right fender at the time of my inspection. The body parts at the front right portion of the Motor Car were visually examined and it was observed that the repair/restoration works carried out to the damaged area of the Motor Car (refer to photograph 1 & 2 above) were reasonably adequate and in order.

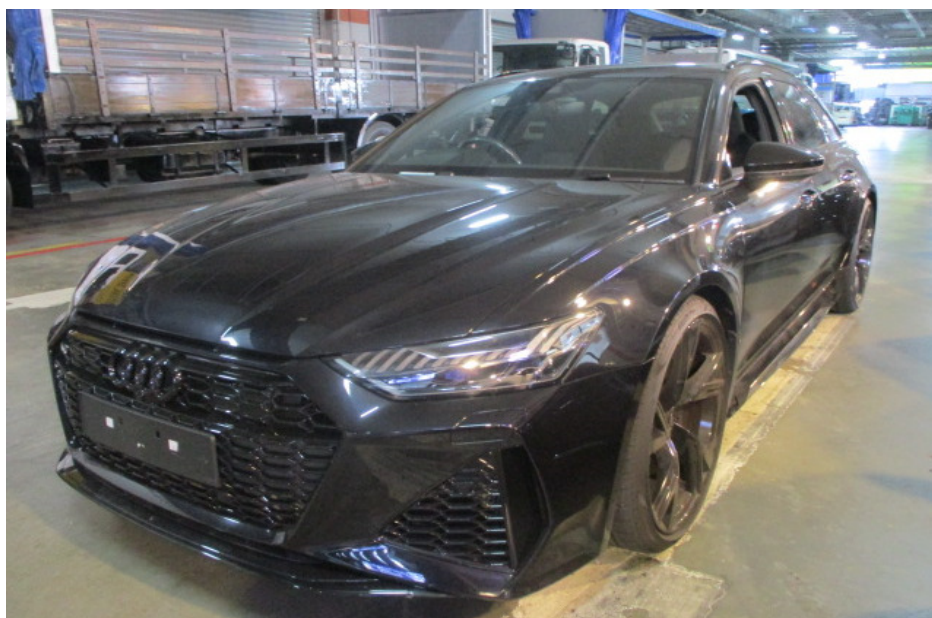
**Photo 9** shows a general view of the front left body of the Motor Car at the time of my inspection. The Motor Car was observed to be in a relatively good general condition with no loose exterior fittings observed. The body parts at the front right portion of the Motor Car were visually examined and it was observed that the repair/restoration works carried out to the damaged area of the Motor Car (refer to photograph 1 & 2 above) were reasonably adequate and in order.

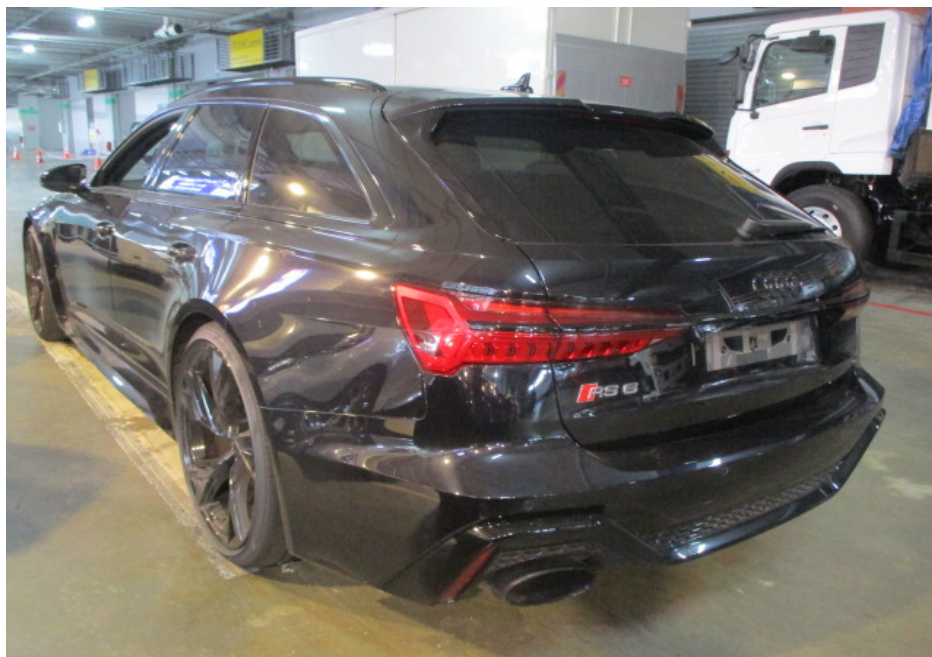
**Photo 10** shows a general view of the rear left body of the Motor Car at the time of my inspection. The Motor Car was observed to be in a relatively good general condition with no loose exterior fittings observed. The mileage of the Motor Car recorded at the time of my inspection was 7,500km.

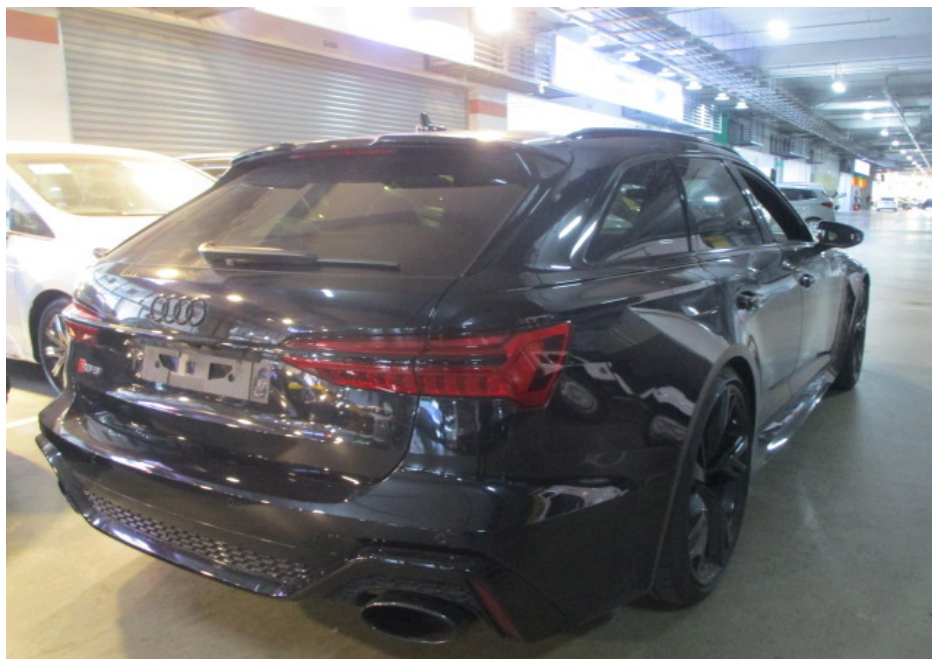
**Photo 11** shows a general view of the rear right body of the Motor Car at the time of my inspection. The Motor Car was observed to be in a relatively good general condition with no loose exterior fittings observed. The mileage of the Motor Car recorded at the time of my inspection was 7,500km.

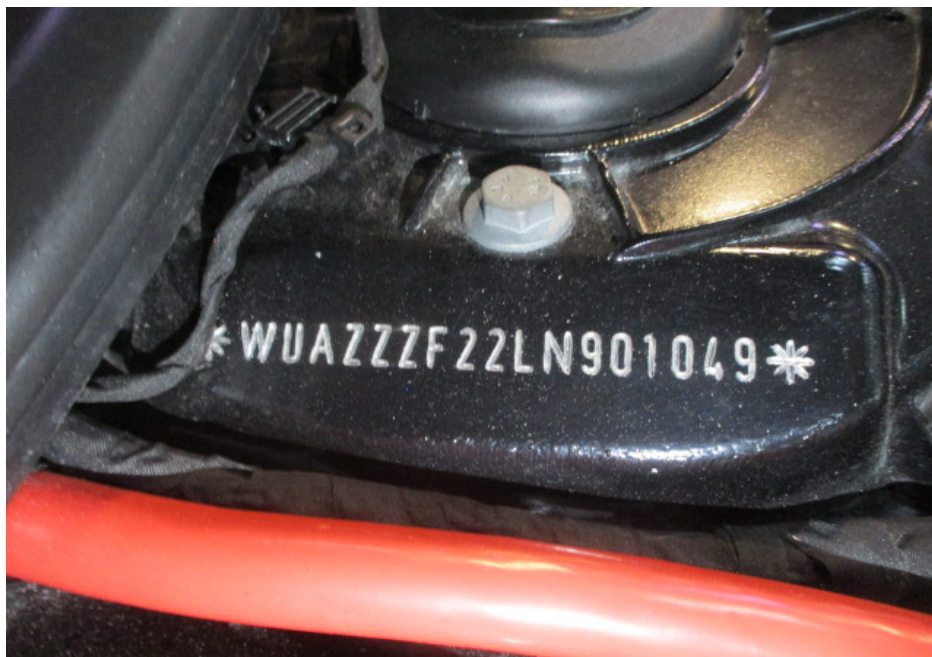
**Photo 12** shows the chassis number of the Motor Car. The chassis number recorded was WUAZZZF22LN901049.

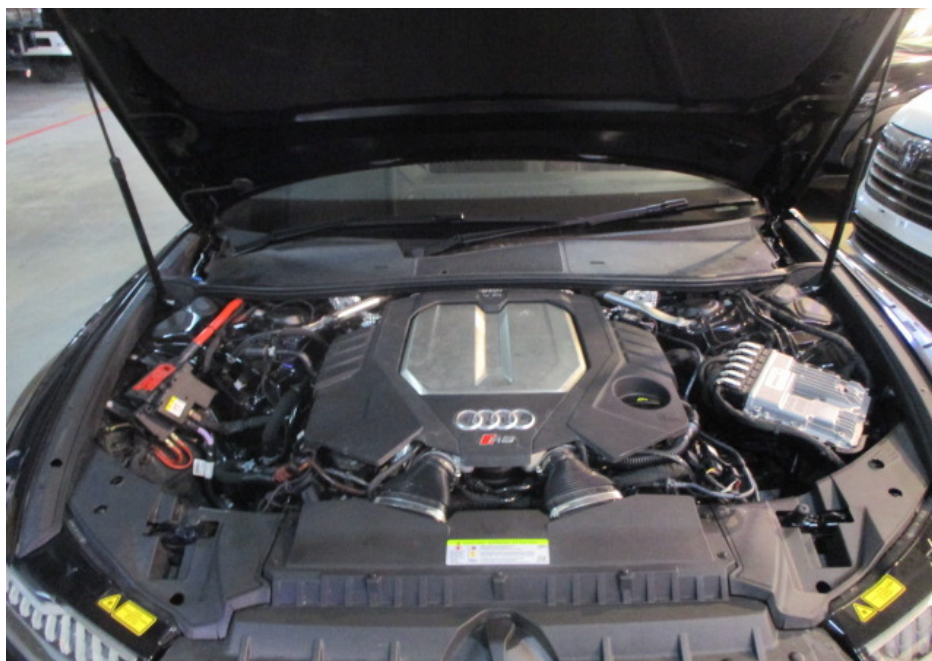
**Photo 13** shows a general view of the engine compartment of the Motor Car at the time of my inspection. The various parts and components inside the engine compartment were all observed to be intact and properly fitted. There was also no sign(s) or indication(s) of fluid leak and/or fluid stain found inside the engine compartment.

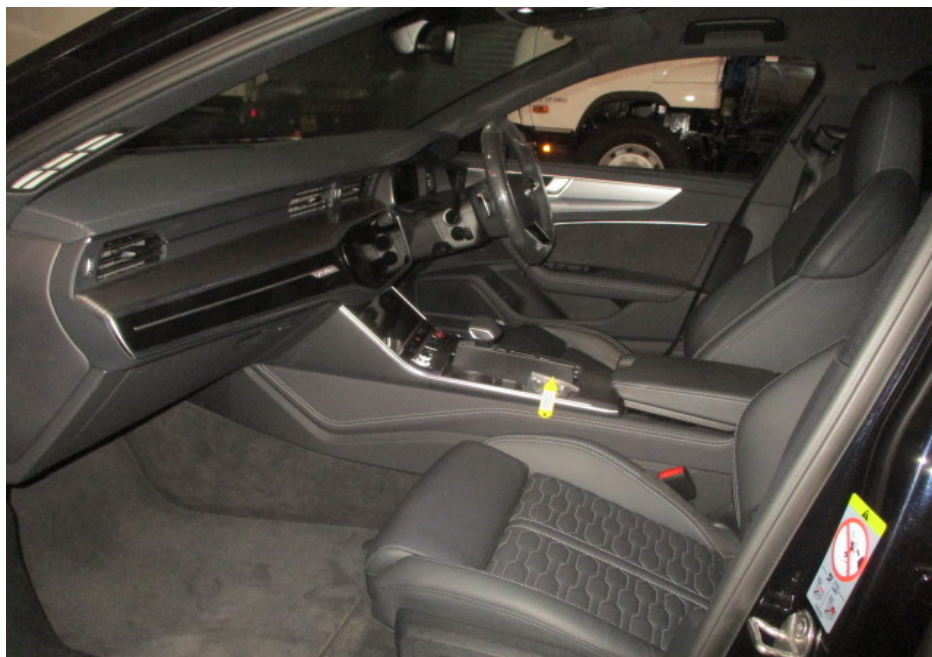
**Photo 14** shows the interior compartment of the Motor Car at the time of my inspection. The various parts and components, trims, carpet, and upholstery inside the interior compartment were all observed to be intact and properly fitted.

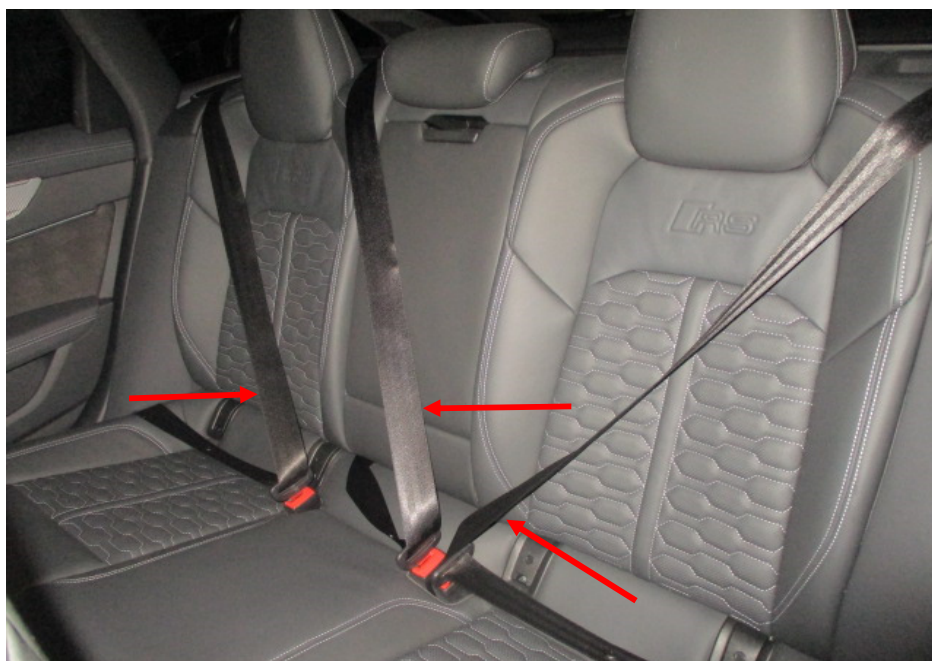
**Photo 15** shows the rear seats of the Motor Car. All the seats of the Motor Car were secured via seat rails to the floorboard. They were also fitted with a retractable seat belt reel and a pre-tensioner. The seat belts (arrowed) were tested and were able to be fastened into the respective pre-tensions that were fitted on the side of each individual seat.

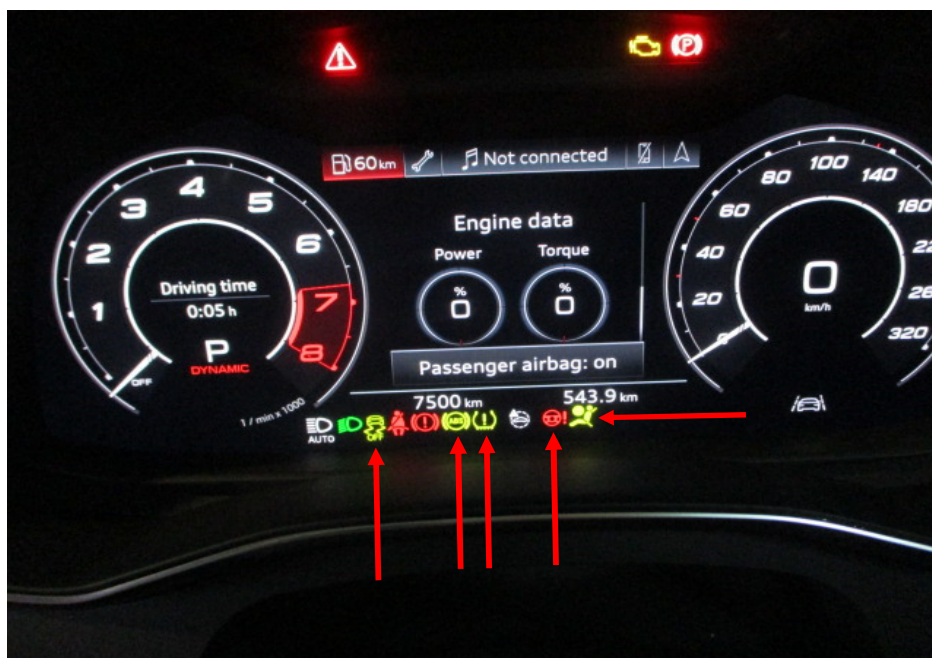
**Photo 16** shows the warning lights for the various electronic safety features appearing on the instrument panel of the Motor Car during its self-test when the engine is cranked, in particular the ABS, SRS, EPS, TPM and ESC lights (arrowed).

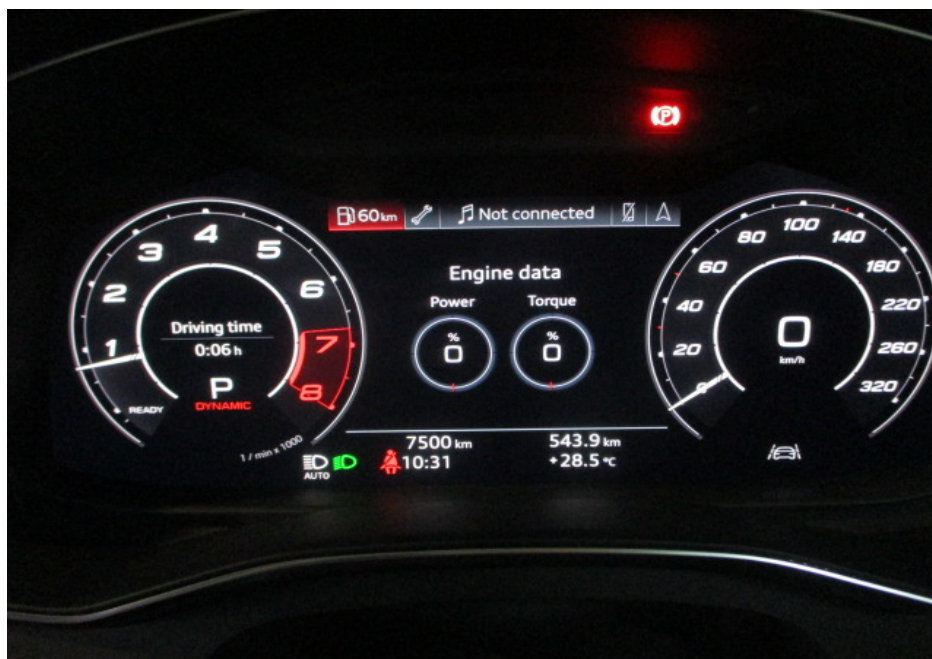
**Photo 17** shows the respective warning lights no longer illuminated, indicating that there is no fault detected to the ABS, SRS, EPS, TPM and ESC systems of the Motor Car during the self-test. These electronic systems were hence in working condition at the time of my inspection.

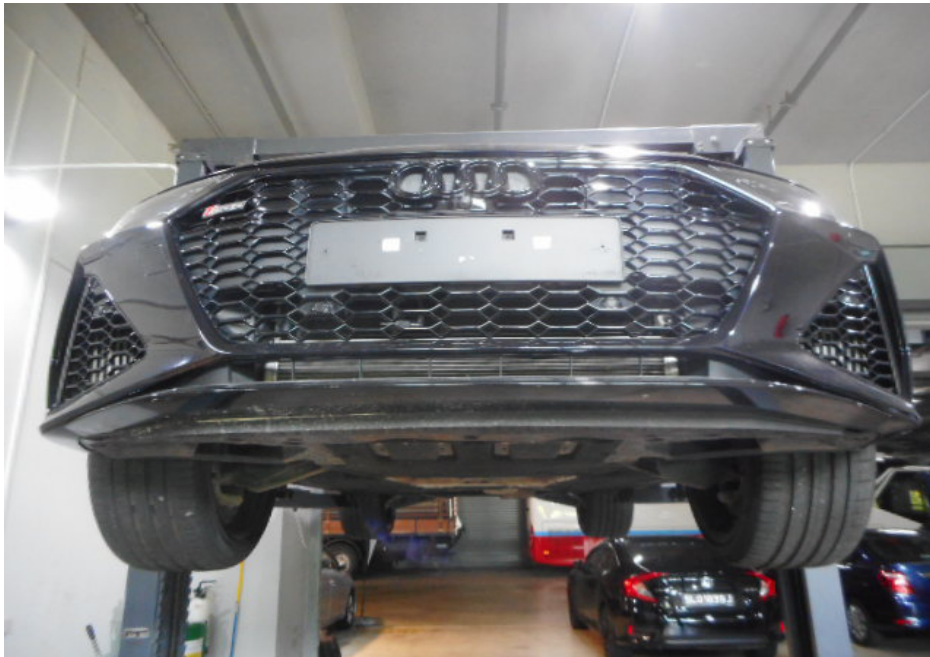
**Photo 18** shows the Motor Car hoisted up for checks on its undercarriage. There was no sign(s) or indication(s) of fluid leakage and/or fluid stain(s) on the underside of the Motor Car. The undercarriage components of the Motor Car were also all observed to be intact and secured in an appropriate manner.

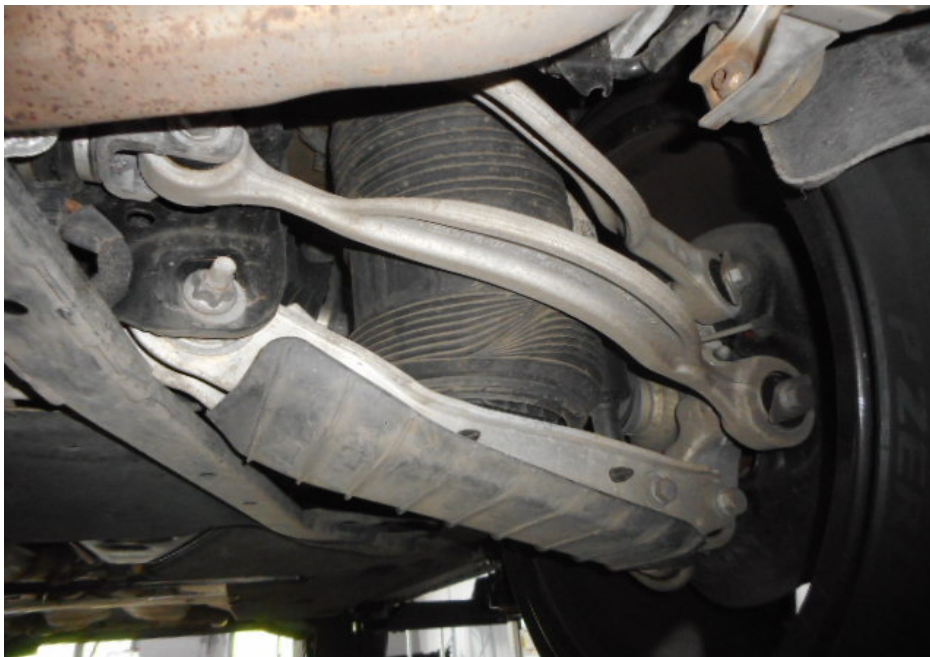
**Photo 19** shows a general view of the control arms and linkages at the rear right wheel of the Motor Car. I did not observe any fluid leak and/or fluid stain on the underside of the Motor Car. All of the Motor Car's undercarriage components were observed to be intact and secured in an appropriate manner.

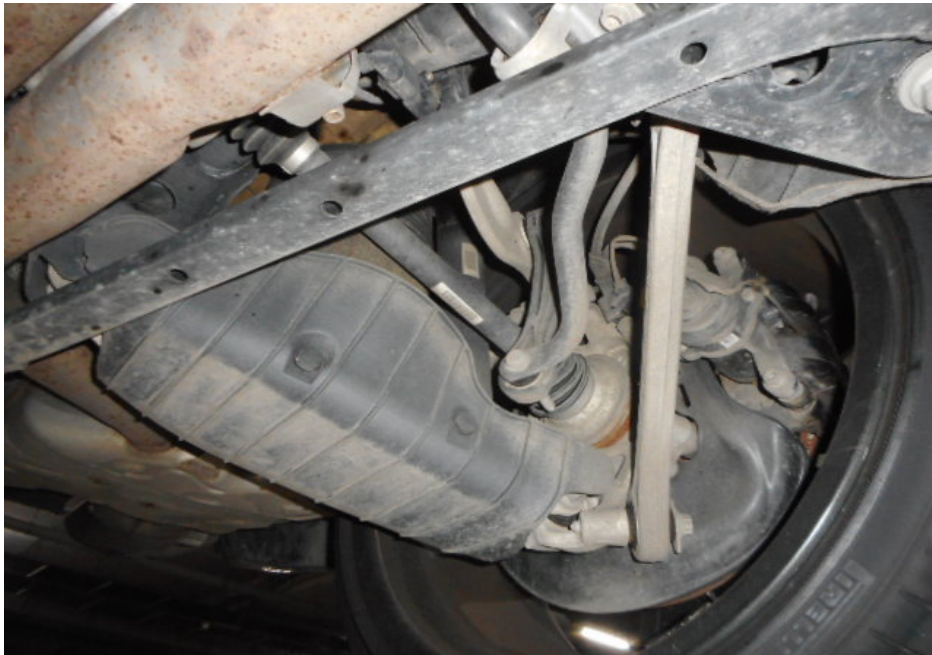
**Photo 20** shows a general view of the control arms and linkages at the rear left wheel of the Motor Car. I did not observe any fluid leak and/or fluid stain on the underside of the Motor Car. All of the Motor Car's undercarriage components were observed to be intact and secured in an appropriate manner.

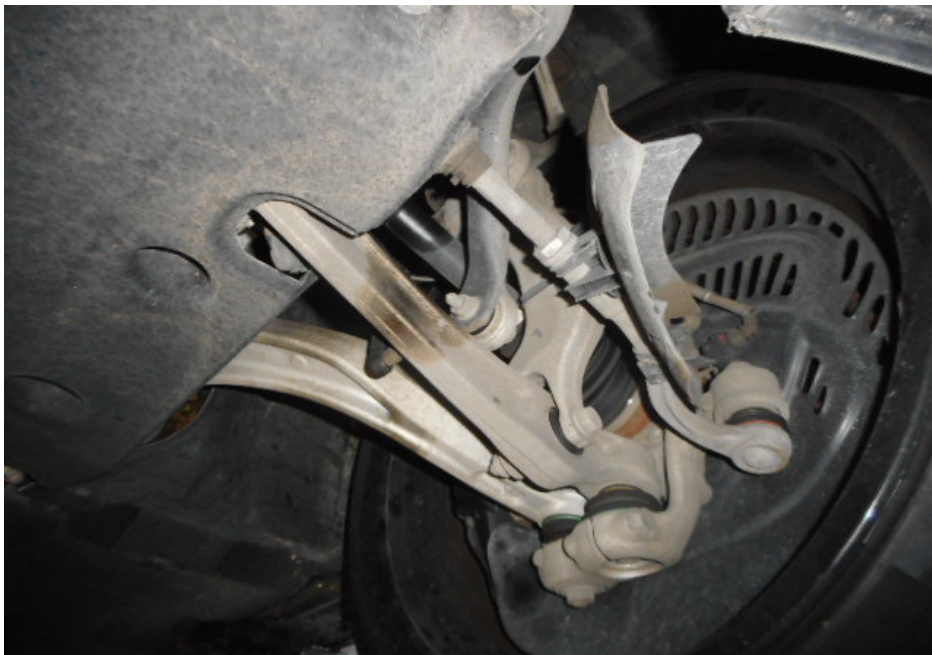
**Photo 21** shows the various undercarriage components at the front left wheel of the Motor Car. The mechanical components, control arms and linkages were all found to be intact and secured in an appropriate manner.

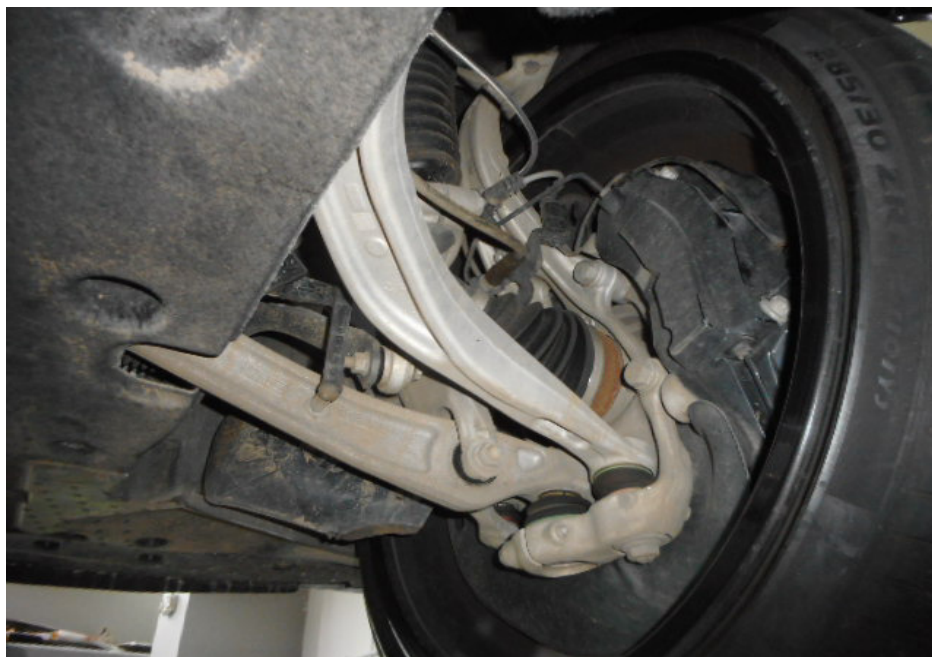
**Photo 22** shows the various undercarriage components at the front right wheel of the Motor Car. The mechanical components, control arms and linkages were all found to be intact and secured in an appropriate manner. I also did not observe any fluid leak and/or fluid stain on the underside of the Motor Car.

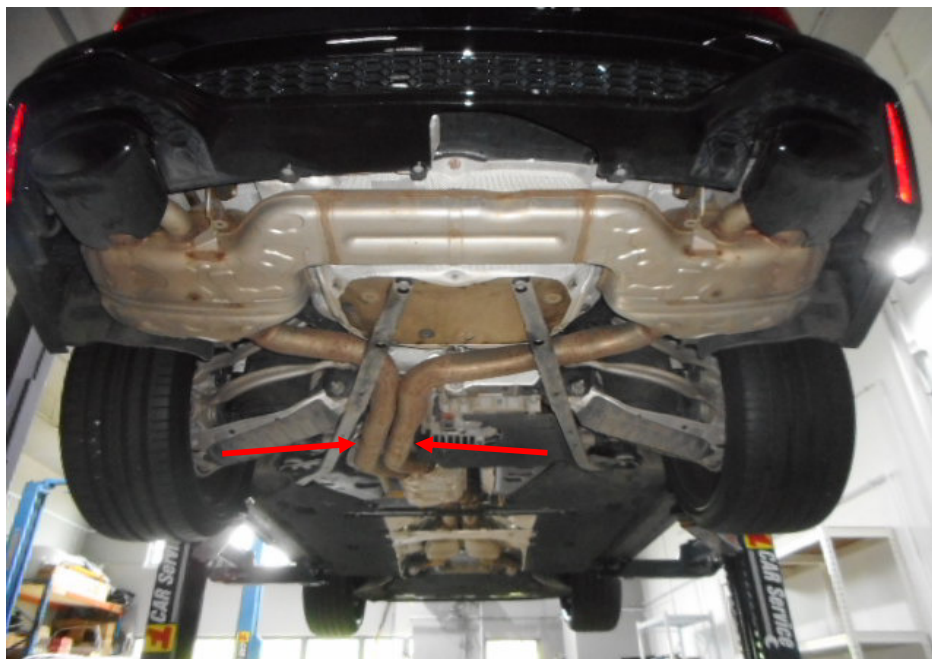
**Photo 23** shows the rear section of the Motor Car's exhaust system. My examination of the Motor Car's exhaust system revealed no sign(s) or indication(s) of any cut or weld marks along its exhaust pipes (arrowed), on its rear muffler, on its centre resonator boxes and on its catalytic converters.

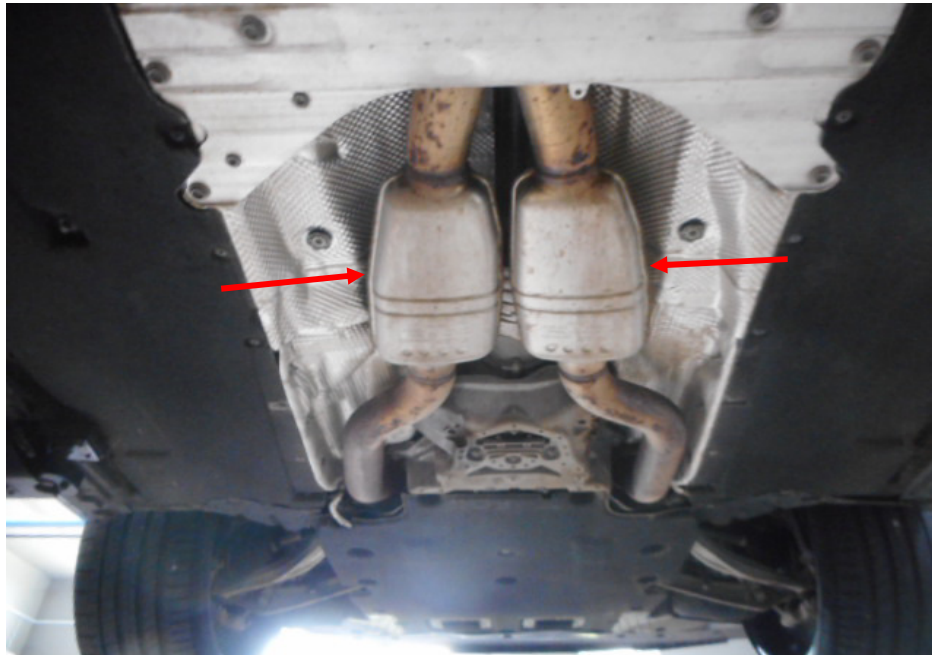
**Photo 24** shows the front section of the Motor Car's exhaust system. My examination of the Motor Car's exhaust system revealed no sign(s) or indication(s) of any cut or weld marks along its exhaust pipes, on its rear muffler, on its centre resonator boxes (arrowed) and on its catalytic converters.

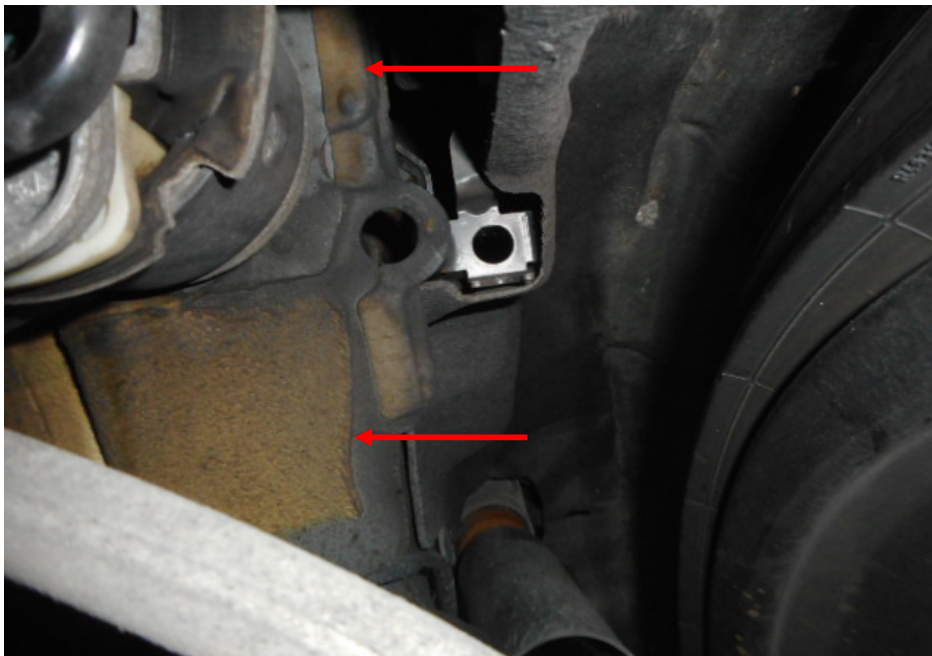
**Photo 25** shows the chassis/structural body at the underside rear right of the Motor Car. I did not find any weld marks other than original spot weld marks on the chassis/structural body of the Motor Car. The original factory sealant (red arrow) at the joints along the chassis/structural body was untouched, indicating no work was done on the chassis/structural body of the Motor Car and that the chassis/structural body was originally fitted.

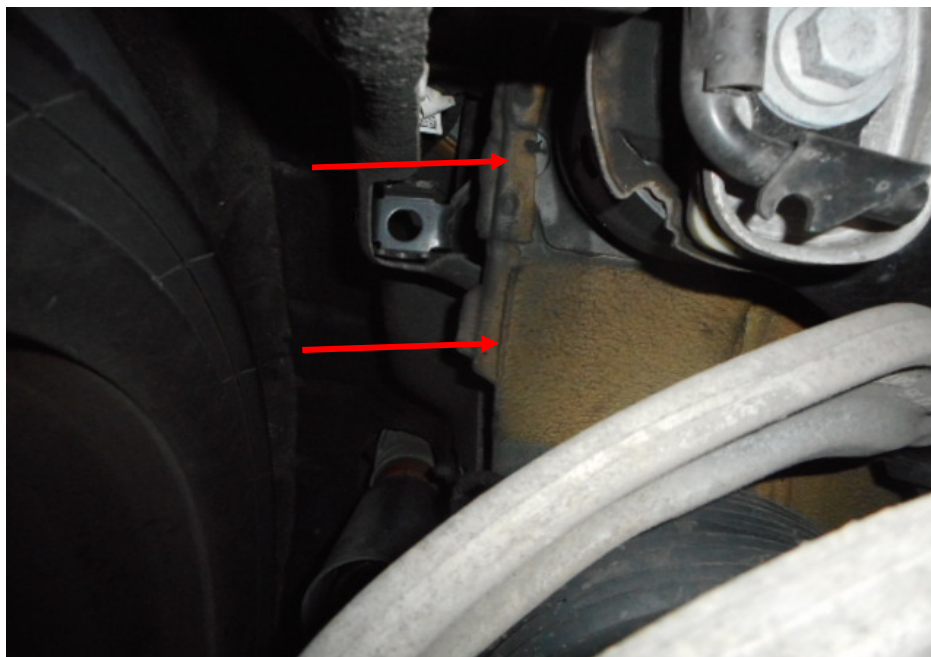
**Photo 26** shows the chassis/structural body at the underside rear left of the Motor Car. The original factory sealant (arrowed) at the joints along the chassis/structural body was observed to be untouched. In general, I had found no work was carried out on the chassis/structural body of the Motor Car. The chassis/structural body of the Motor Car was originally fitted.

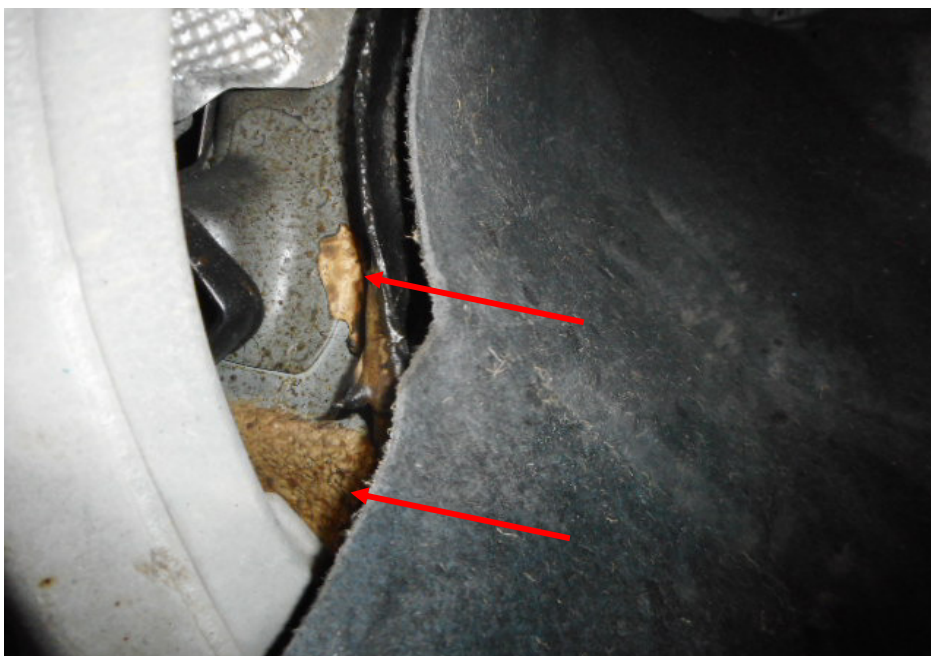
**Photo 27** shows the chassis/structural body at the underside front left of the Motor Car. I did not find any weld marks other than original spot weld marks on the chassis/structural body of the Motor Car. The original factory sealant (arrowed) at the joints along the chassis/structural body was untouched, indicating no work was done on the chassis/structural body of the Motor Car and that the chassis/structural body was originally fitted.

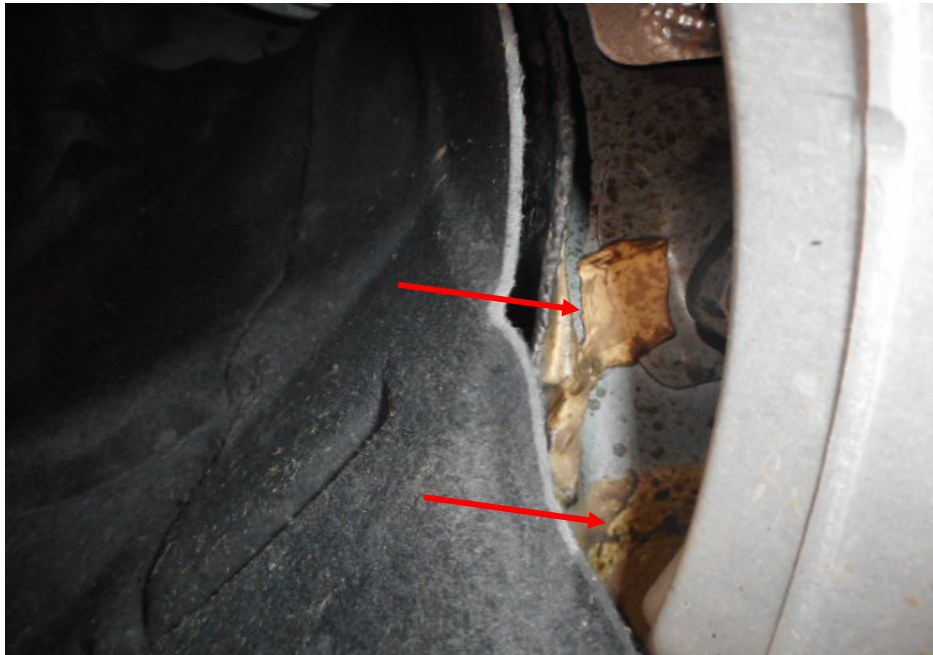
**Photo 28** shows the chassis/structural body at the underside front right of the Motor Car. The original factory sealant (arrowed) at the joints along the chassis/structural body was observed to be untouched. In general, I had found no work was carried out on the chassis/structural body of the Motor Car. The chassis/structural body of the Motor Car was originally fitted.
