Your Ref: Mercedes Benz CLA 200
(chassis number WDD1183872N003245)
Our Ref : CI/TP22000937/D

**INSPECTION REPORT OF AN UNREGISTERED MERCEDES BENZ CLA 200
MOTOR CAR WITH CHASSIS NUMBER WDD1183872N003245**

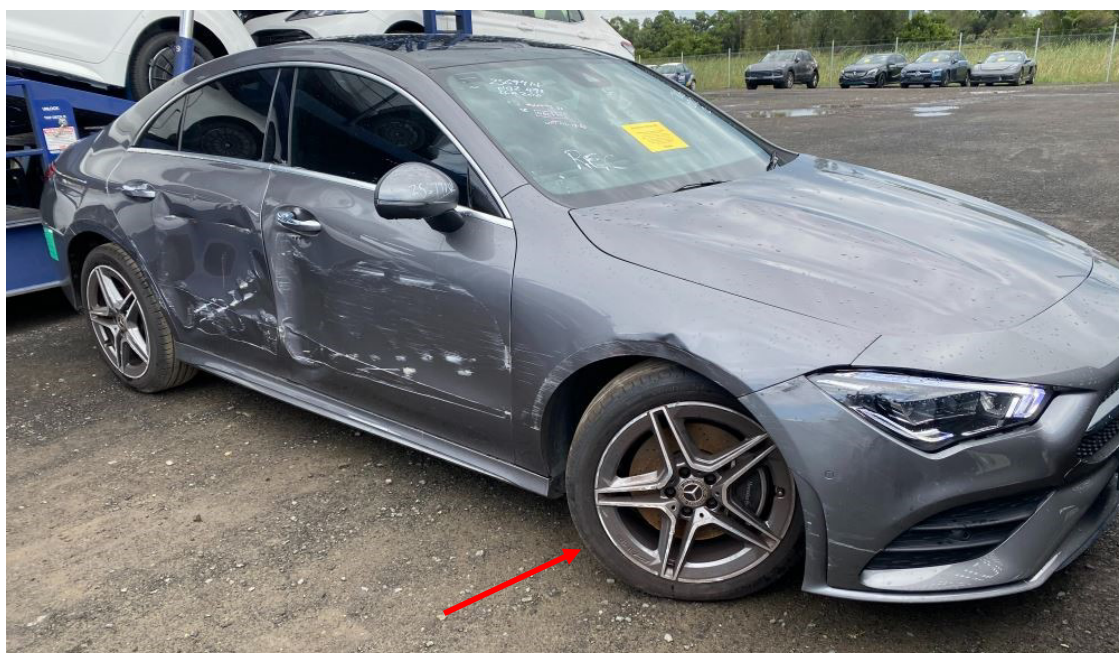
4. The orientation of the front right wheel indicates damage to the front right undercarriage parts of the Motor Car. Undercarriage parts that may possibly be damaged include the front right lower arm, front right steering tie rod and front right knuckle arm amongst others. The airbag(s) was not deployed as seen from the photographs that were provided to me. See photo 1 – 5 below.

Photo 1 shows the front right body of the Motor Car (photograph provided to me). The photographs provided to me had showed damage to the right side portion of the Motor Car. The front bumper, front right fender, front right door, front right door handle, right wing mirror, rear right door and rear right fender were amongst the body parts that were observed to have been damaged. The orientation of the Motor Car's front right wheel (arrowed) as compared to the orientation of the front left wheel (refer to photograph 4 below) indicates damage to the front right undercarriage parts of the Motor Car.

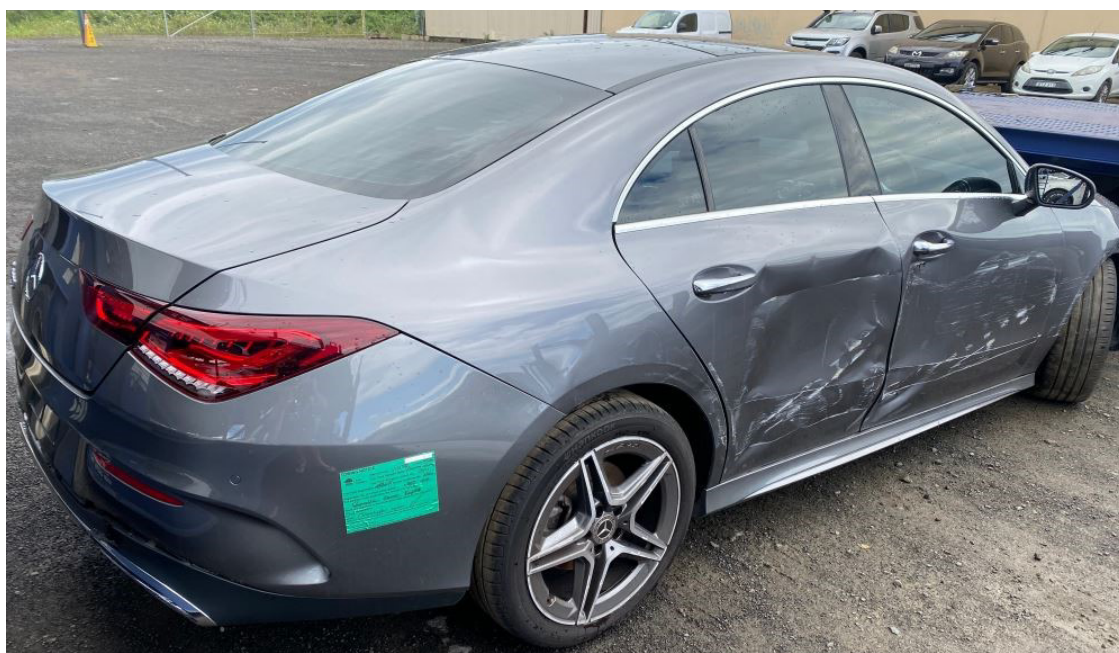
Photo 2 shows the rear right body of the Motor Car (photograph provided to me). The photographs provided to me had showed damage to the right side portion of the Motor Car. The front right door, front right door handle, right wing mirror, rear right door and rear right fender were amongst the body parts that were observed to have been damaged.

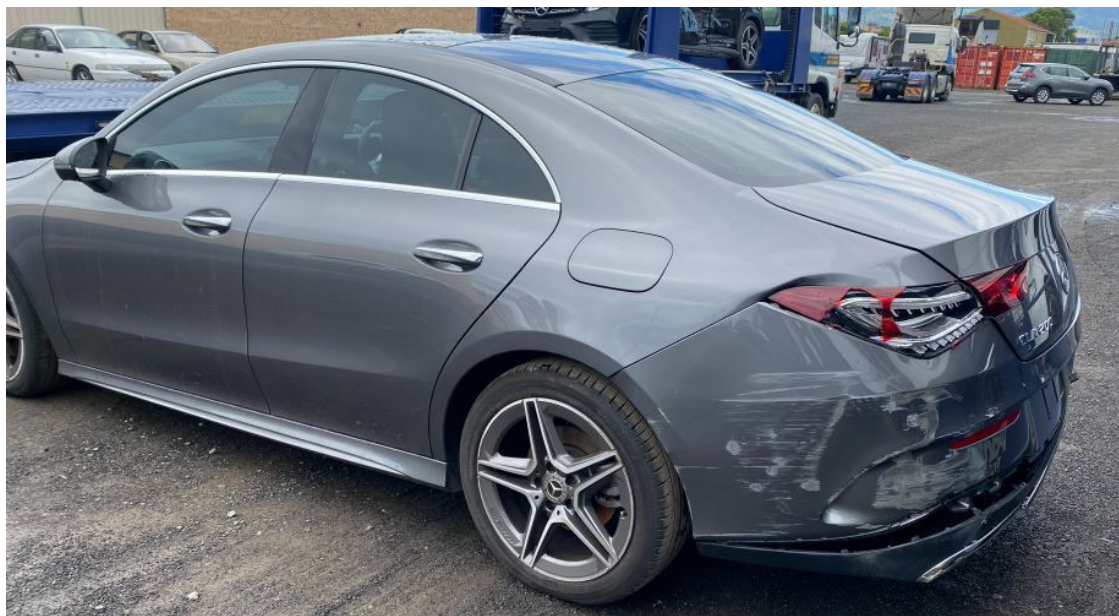
Photo 3 shows the rear left body of the Motor Car (photograph provided to me). Apart for the right side portion, I had also observed damage to the rear left portion of the Motor Car. The rear bumper, rear bumper lower cover, rear bumper lower chrome moulding, rear left taillamp and rear left fender were amongst the body parts that were observed to have been damaged.

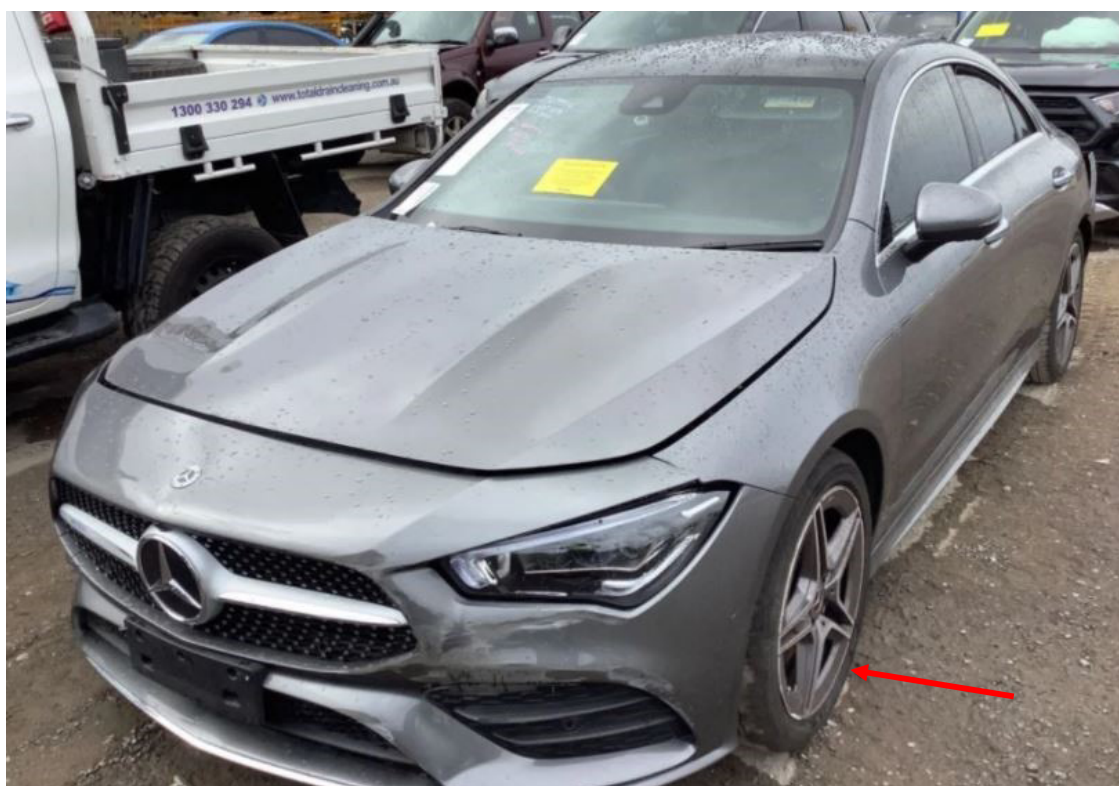
Photo 4 shows the front left body of the Motor Car (photograph provided to me). Marks of grazing nature were also seen at the left side of the Motor Car's front bumper. The orientation of the Motor Car's front left wheel (arrowed) as compared to the orientation of the front right wheel (refer to photograph 1 above) indicates damage to the front right undercarriage parts of the Motor Car.

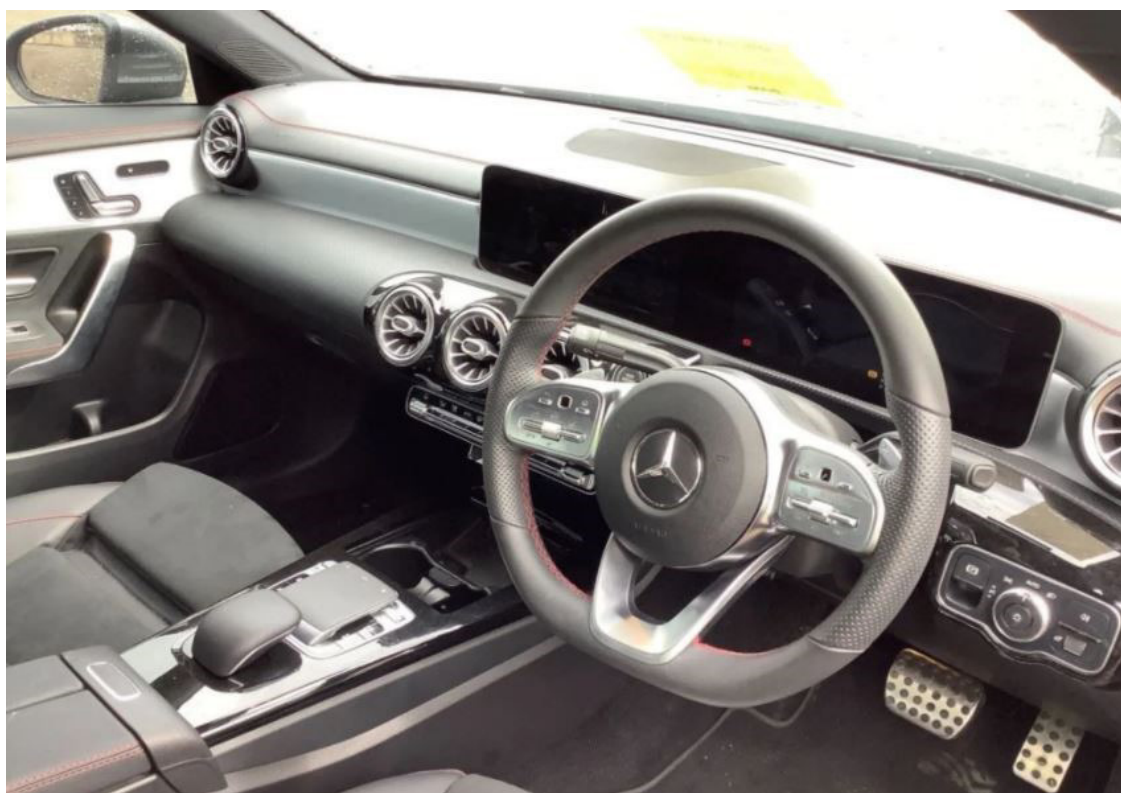
Photo 5 shows the interior compartment of the Motor Car (photograph provided to me). Parts and components within the interior compartment were observed to be unaffected. The airbag(s) of the Motor Car was also not deployed as seen from the photographs that were provided to me.

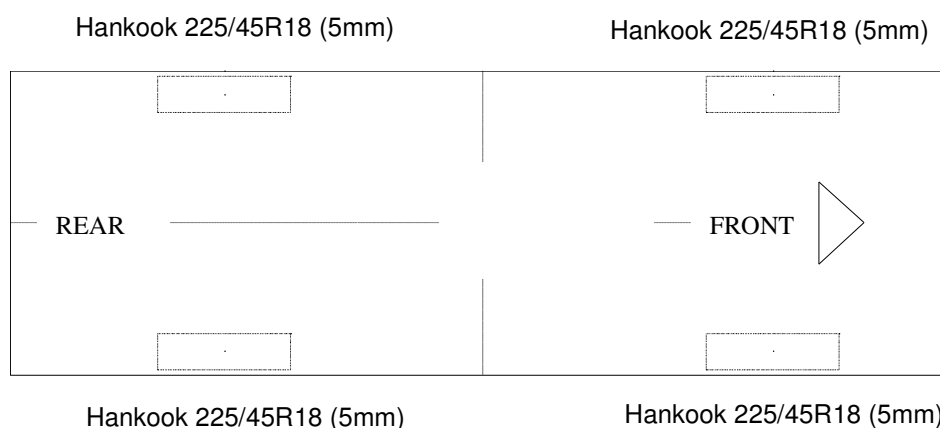
8. It was fitted with 18inch sport wheel rims that were wrapped with tyres that were observed to be of serviceable condition. The tyres were also sufficiently inflated for vehicular operation. The tyre brand, tyre size and approximate remaining tread depth of the 4 tyres of the Motor Car were recorded as follows: -

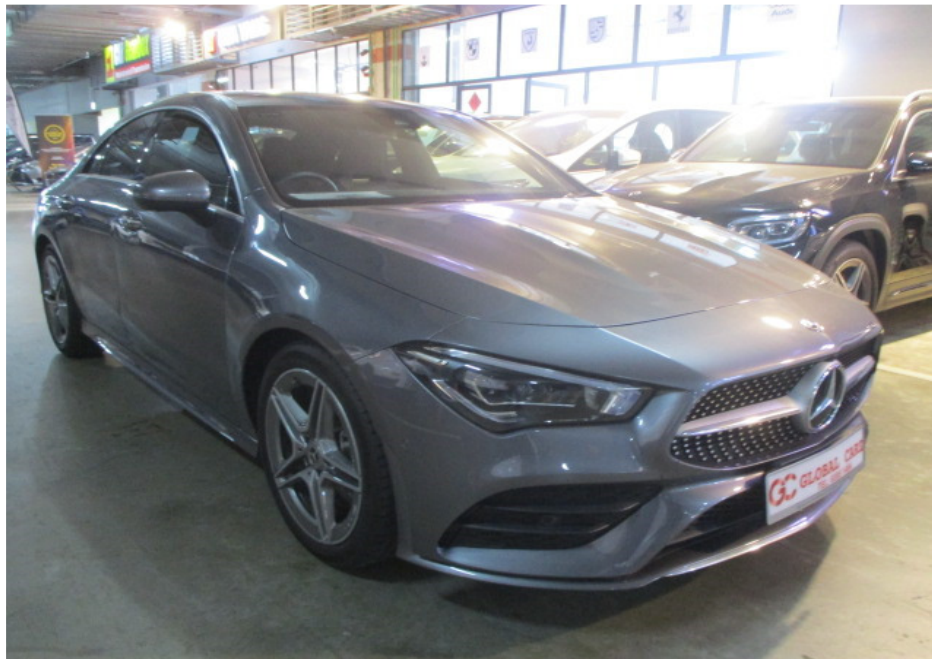
Photo 6 shows a general view of the front right body of the Motor Car at the time of my inspection. The Motor Car was observed to be in a relatively good general condition with no loose exterior fittings observed. The body parts at the right side portion of the Motor Car were visually examined and it was observed that the repair/restoration works carried out to the damaged area of the Motor Car (refer to photograph 1 & 2 above) were reasonably adequate and in order.

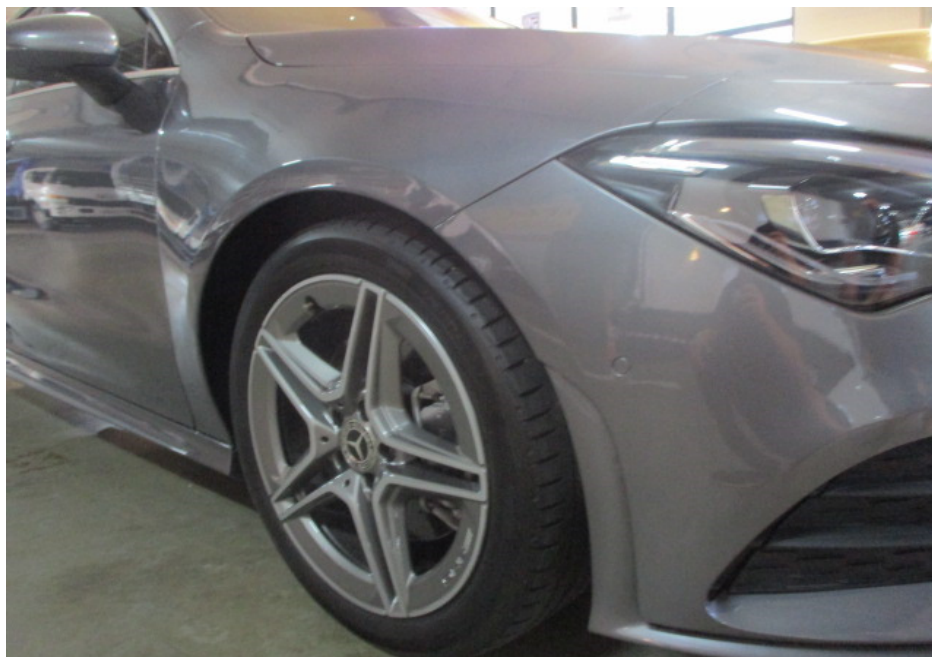
Photo 7 shows a closer view of the Motor Car's front bumper, front right headlamp, front right wheel rim and front right fender at the time of my inspection. The body parts at the right side portion of the Motor Car were visually examined and it was observed that the repair/restoration works carried out to the damaged area of the Motor Car (refer to photograph 1 & 2 above) were reasonably adequate and in order.

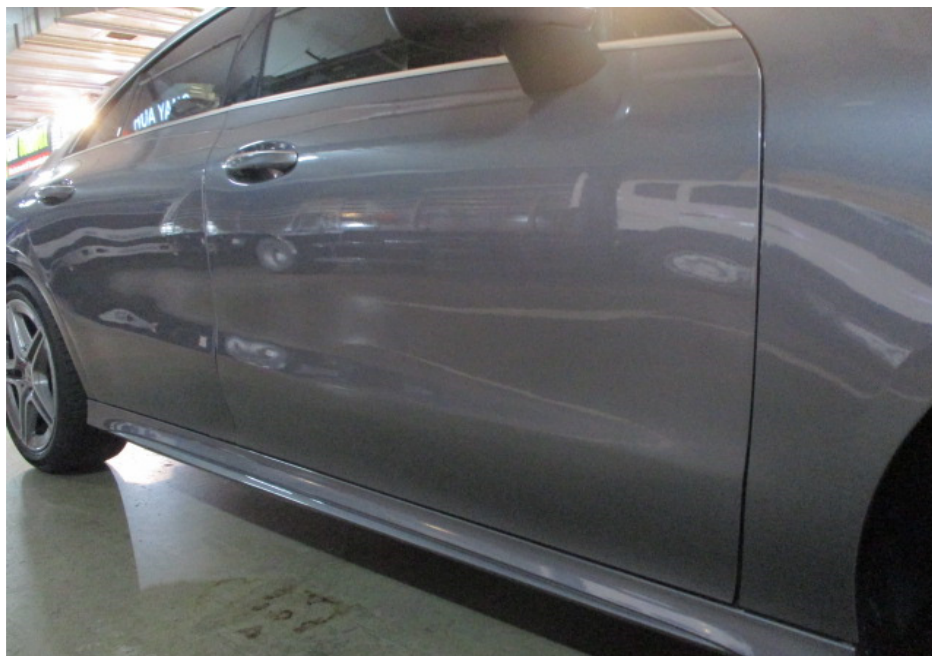
Photo 8 shows a closer view of the Motor Car's front right door, front right door handle and right side rocker panel garnish. The body parts at the right side portion of the Motor Car were visually examined and it was observed that the repair/restoration works carried out to the damaged area of the Motor Car (refer to photograph 1 & 2 above) were reasonably adequate and in order.

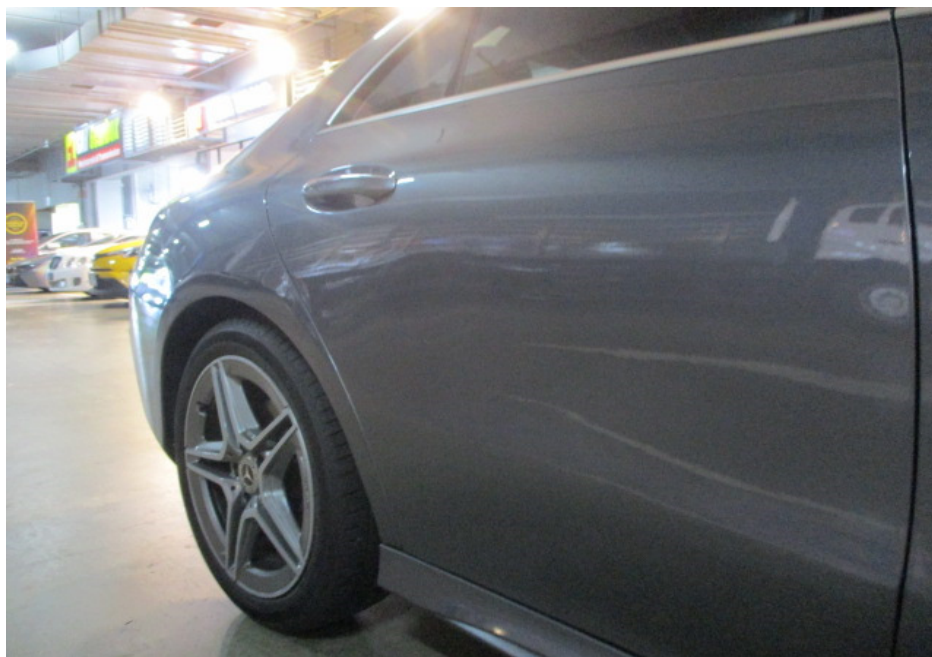
Photo 9 shows a closer view of the Motor Car's rear right door, rear right fender and rear right wheel rim at the time of my inspection. The body parts at the right side portion of the Motor Car were visually examined and it was observed that the repair/restoration works carried out to the damaged area of the Motor Car (refer to photograph 1 & 2 above) were reasonably adequate and in order.

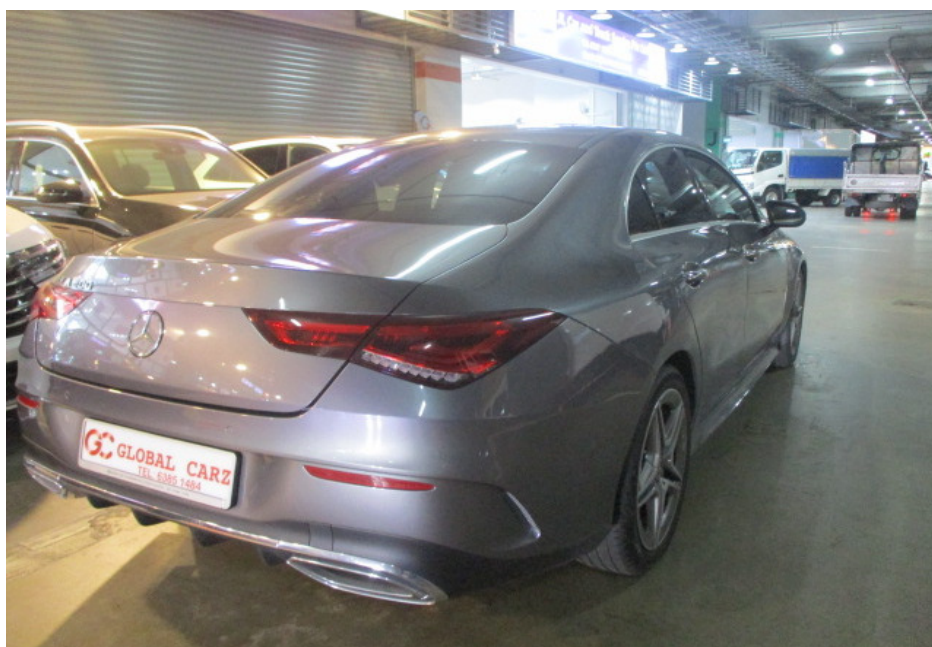
Photo 10 shows a general view of the rear right body of the Motor Car at the time of my inspection. The Motor Car was observed to be in a relatively good general condition with no loose exterior fittings observed. The body parts at the right side portion of the Motor Car were visually examined and it was observed that the repair/restoration works carried out to the damaged area of the Motor Car (refer to photograph 1 & 2 above) were reasonably adequate and in order.

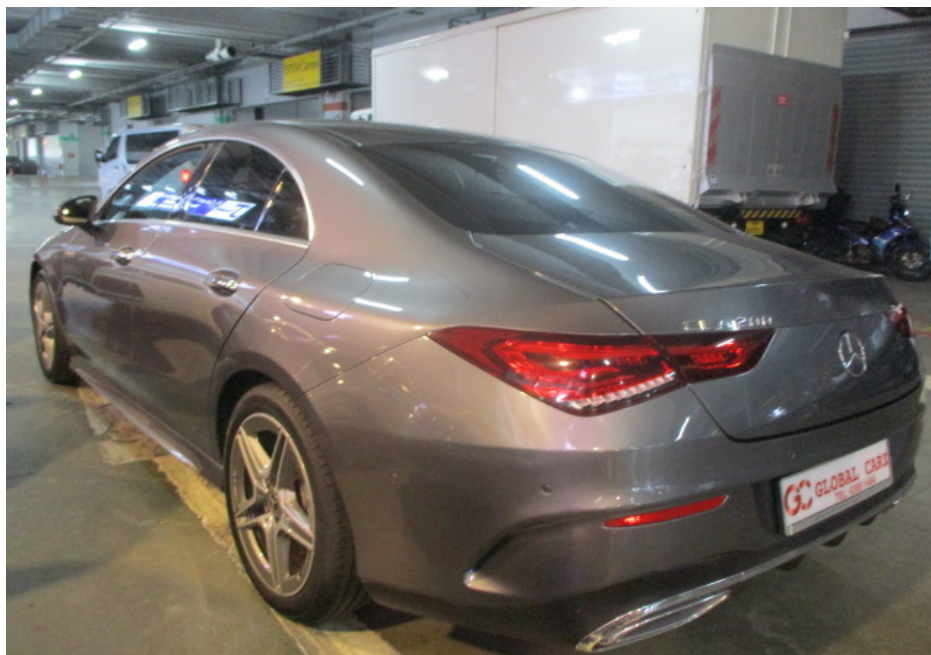
Photo 11 shows a general view of the rear left body of the Motor Car at the time of my inspection. The Motor Car was observed to be in a relatively good general condition with no loose exterior fittings observed. The body parts at the rear left portion of the Motor Car were visually examined and it was observed that the repair/restoration works carried out to the damaged area of the Motor Car (refer to photograph 3 above) were reasonably adequate and in order.

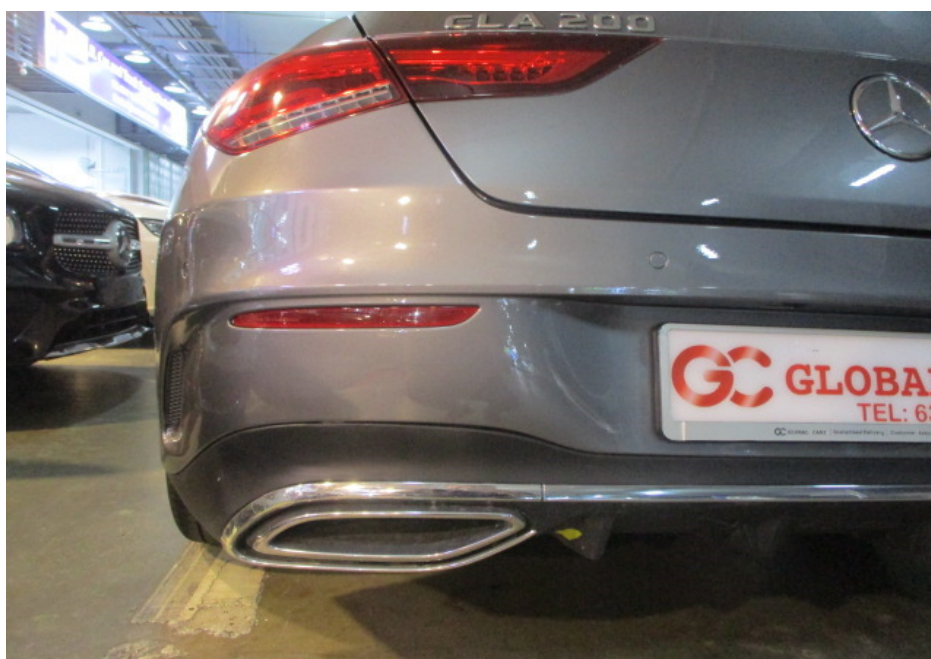
Photo 12 shows a closer view of the Motor Car's rear bumper, rear bumper lower cover, rear bumper lower chrome moulding and rear left taillamp at the time of my inspection. The body parts at the rear left portion of the Motor Car were visually examined and it was observed that the repair/restoration works carried out to the damaged area of the Motor Car (refer to photograph 3 above) were reasonably adequate and in order.

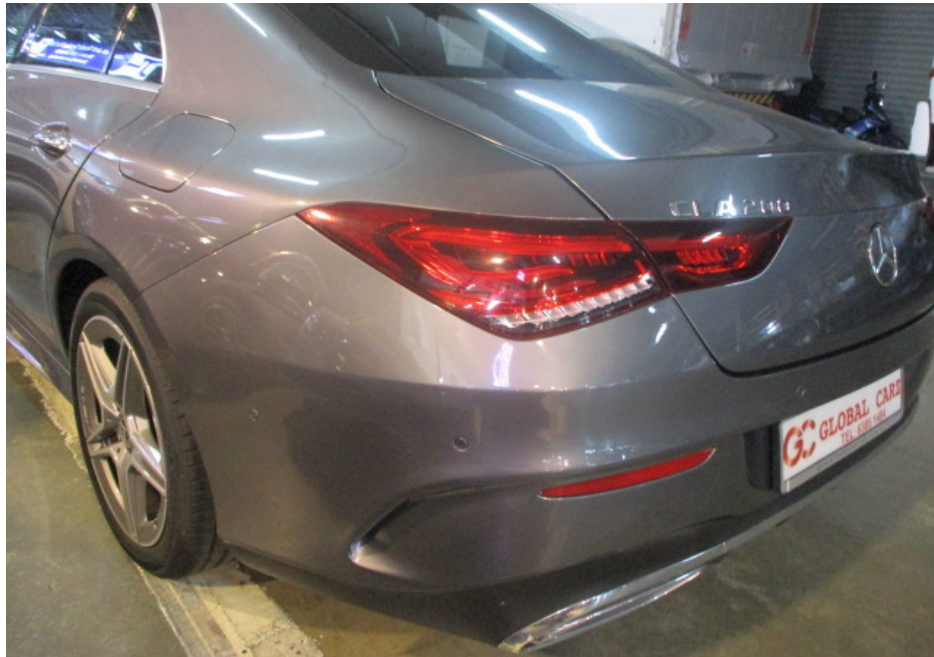
Photo 13 shows a closer view of the Motor Car's rear bumper, rear left taillamp and rear left fender at the time of my inspection. The body parts at the rear left portion of the Motor Car were visually examined and it was observed that the repair/restoration works carried out to the damaged area of the Motor Car (refer to photograph 3 above) were reasonably adequate and in order.

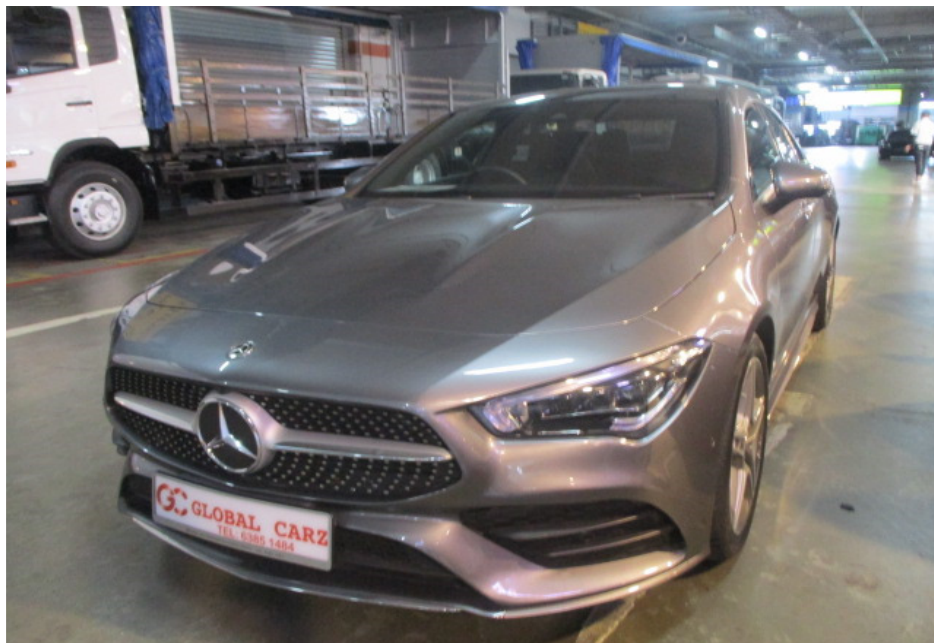
Photo 14 shows a general view of the front left body of the Motor Car at the time of my inspection. The Motor Car was observed to be in a relatively good general condition with no loose exterior fittings observed. The body parts at the front left portion of the Motor Car were visually examined and it was observed that the repair/restoration works carried out to the damaged area of the Motor Car (refer to photograph 4 above) were reasonably adequate and in order.

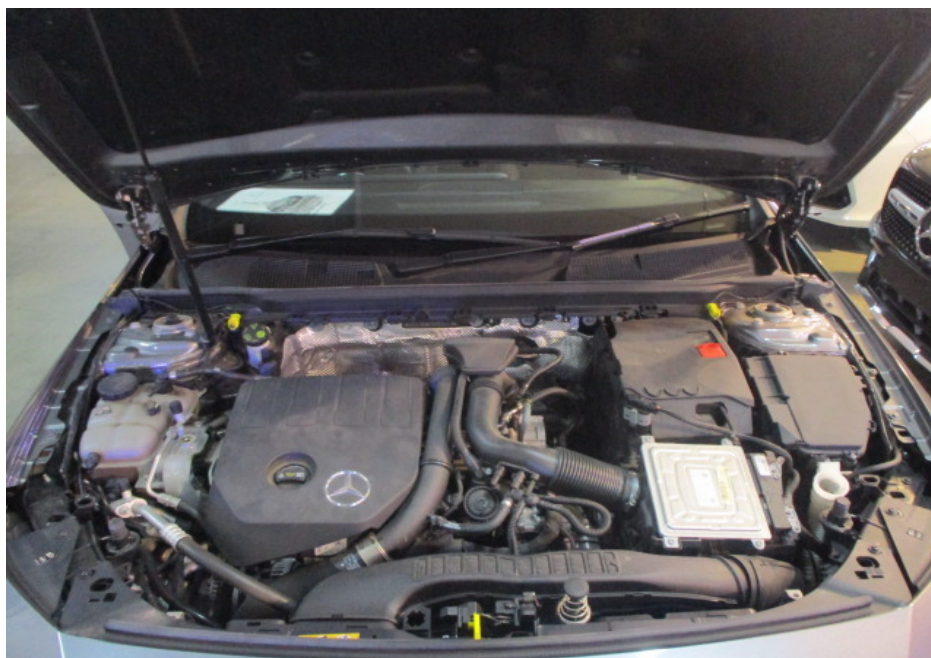
Photo 16 shows a general view of the engine compartment of the Motor Car at the time of my inspection. The various parts and components inside the engine compartment were all observed to be intact and properly fitted. There was also no sign(s) or indication(s) of fluid leak and/or fluid stain found inside the engine compartment.

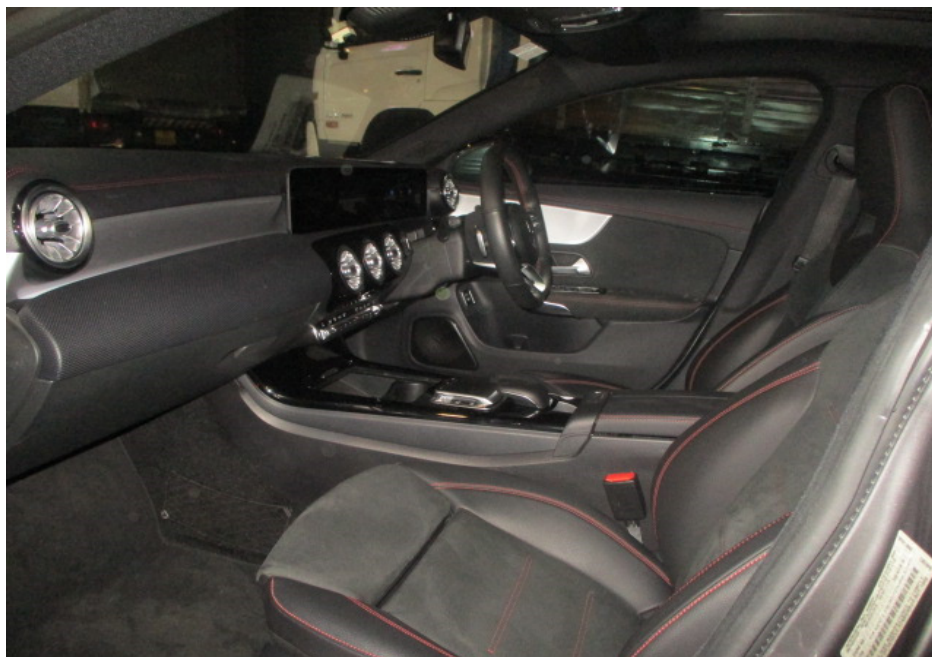
Photo 17 shows the interior compartment of the Motor Car at the time of my inspection. The various parts and components, trims, carpet, and upholstery inside the interior compartment were all observed to be intact and properly fitted.

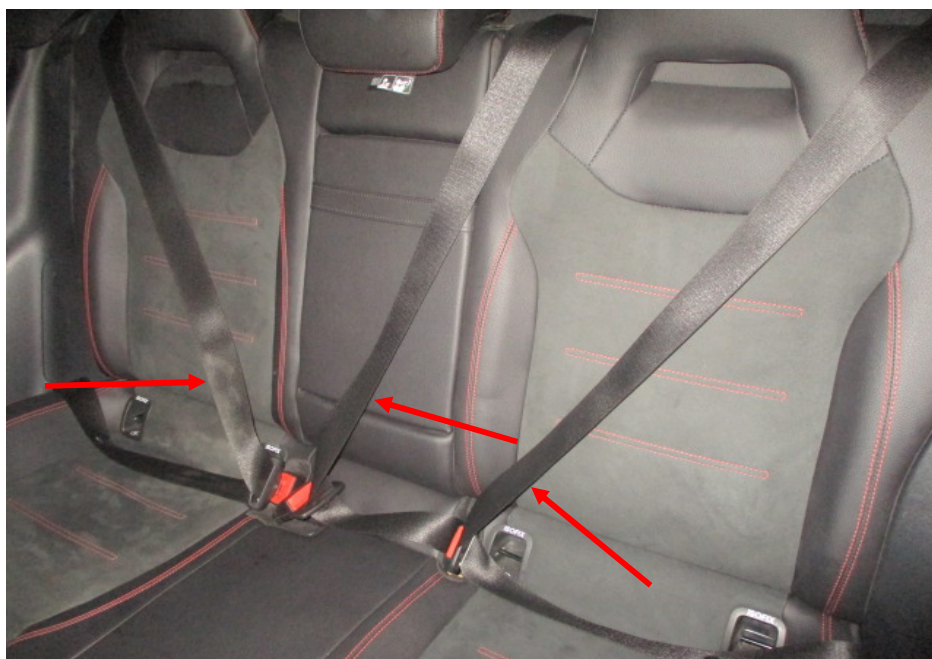
Photo 18 shows the rear seats of the Motor Car. All the seats of the Motor Car were secured via seat rails to the floorboard. They were also fitted with a retractable seat belt reel and a pre-tensioner. The seat belts (arrowed) were tested and were able to be fastened into the respective pre-tensions that were fitted on the side of each individual seat.

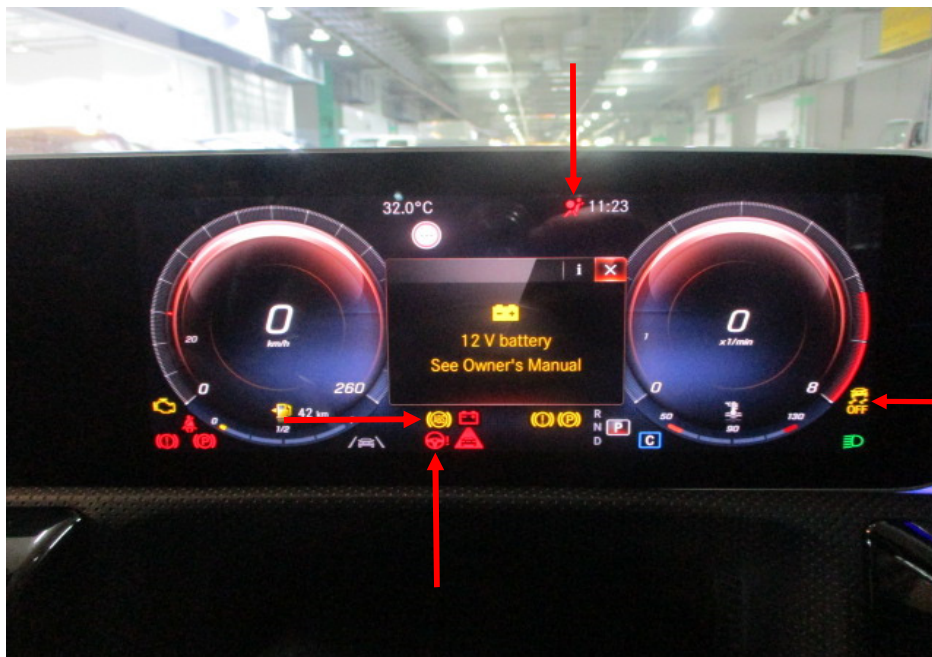
Photo 19 shows the warning lights for the various electronic safety features appearing on the instrument panel of the Motor Car during its self-test when the engine is cranked, in particular the ABS, SRS, EPS and TCS lights (arrowed).

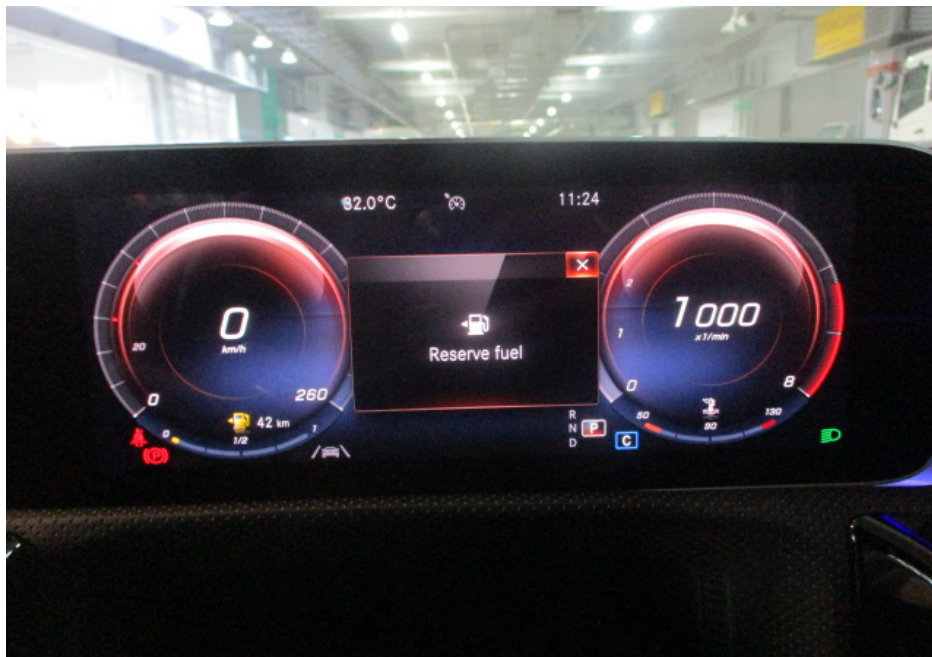
Photo 20 shows the respective warning lights no longer illuminated, indicating that there is no fault detected to the ABS, SRS, EPS and TCS systems of the Motor Car during the self-test. These electronic systems were hence in working condition at the time of my inspection.

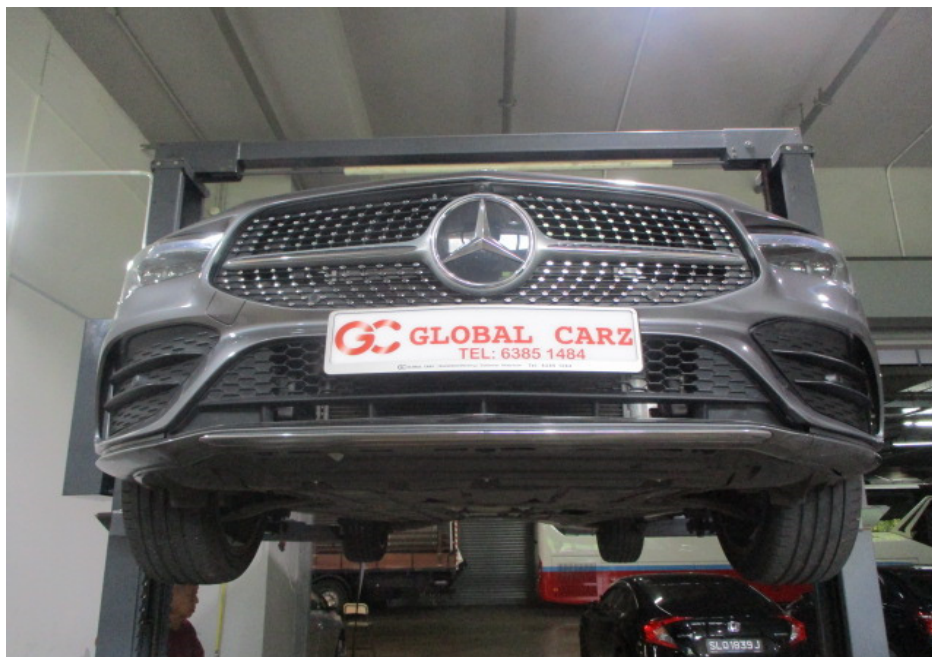
Photo 21 shows the Motor Car hoisted up for checks on its undercarriage. There was no sign(s) or indication(s) of fluid leakage and/or fluid stain(s) on the underside of the Motor Car. The undercarriage components of the Motor Car were also all observed to be intact and secured in an appropriate manner.

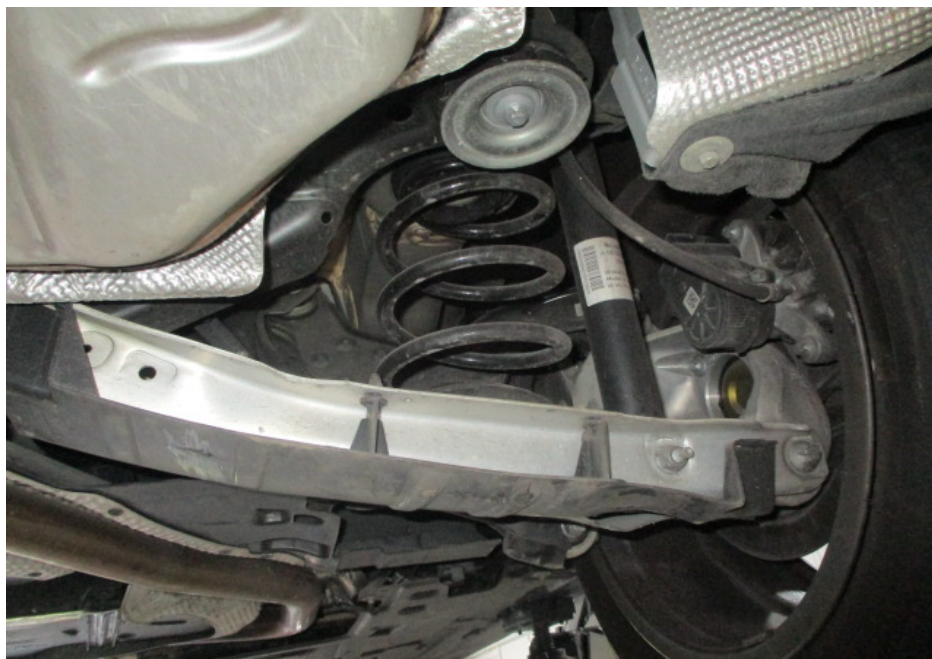
Photo 22 shows a general view of the control arms and linkages at the rear right wheel of the Motor Car. I did not observe any fluid leak and/or fluid stain on the underside of the Motor Car. All of the Motor Car's undercarriage components were observed to be intact and secured in an appropriate manner.

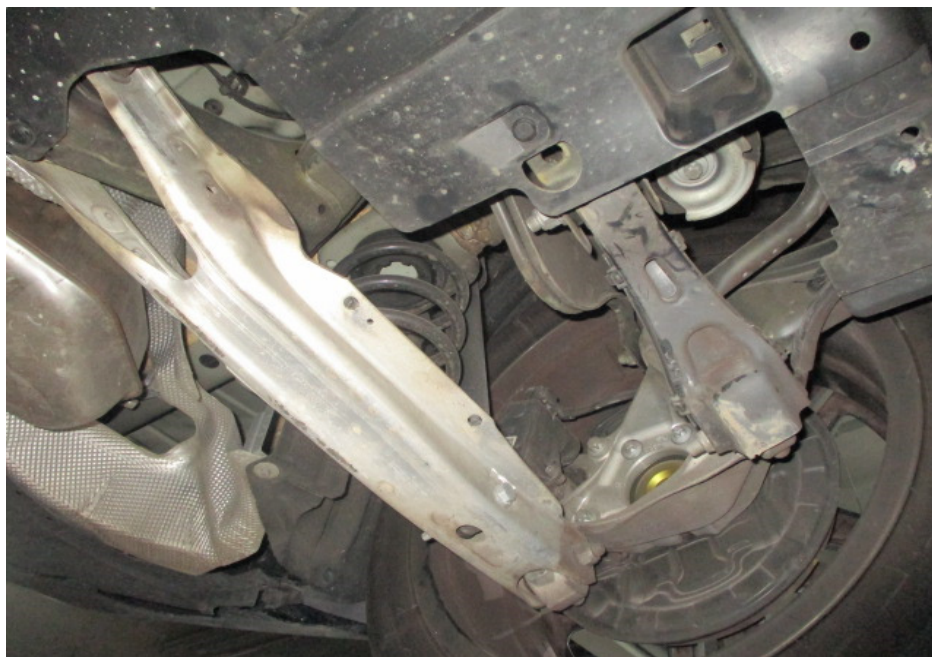
Photo 23 shows a general view of the control arms and linkages at the rear left wheel of the Motor Car. I did not observe any fluid leak and/or fluid stain on the underside of the Motor Car. All of the Motor Car's undercarriage components were observed to be intact and secured in an appropriate manner.

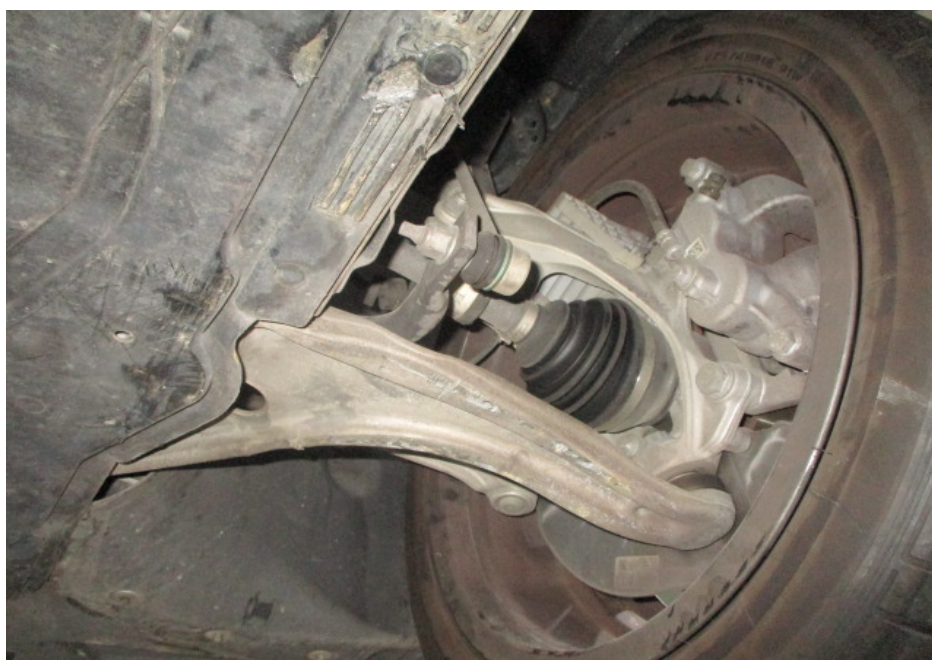
Photo 24 shows the various undercarriage components at the front left wheel of the Motor Car. The mechanical components, control arms and linkages were all found to be intact and secured in an appropriate manner.

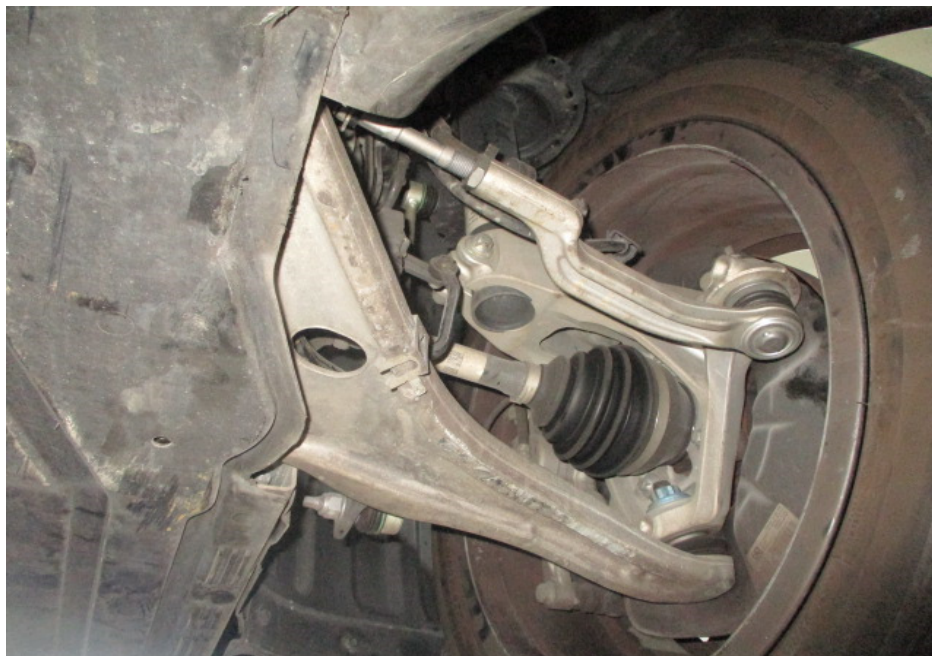
Photo 25 shows the various undercarriage components at the front right wheel of the Motor Car. The mechanical components, control arms and linkages were all found to be intact and secured in an appropriate manner. I also did not observe any fluid leak and/or fluid stain on the underside of the Motor Car.

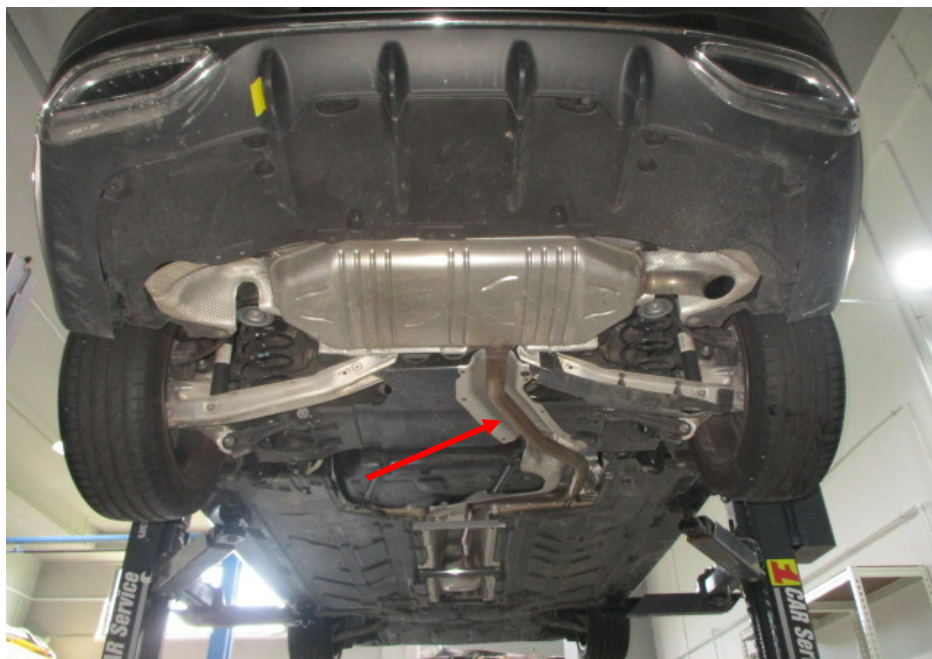
Photo 26 shows the rear section of the Motor Car's exhaust system. My examination of the Motor Car's exhaust system revealed no sign(s) or indication(s) of any cut or weld marks along its exhaust pipes (arrowed), on its rear muffler, on its centre resonator box and on its catalytic converter.

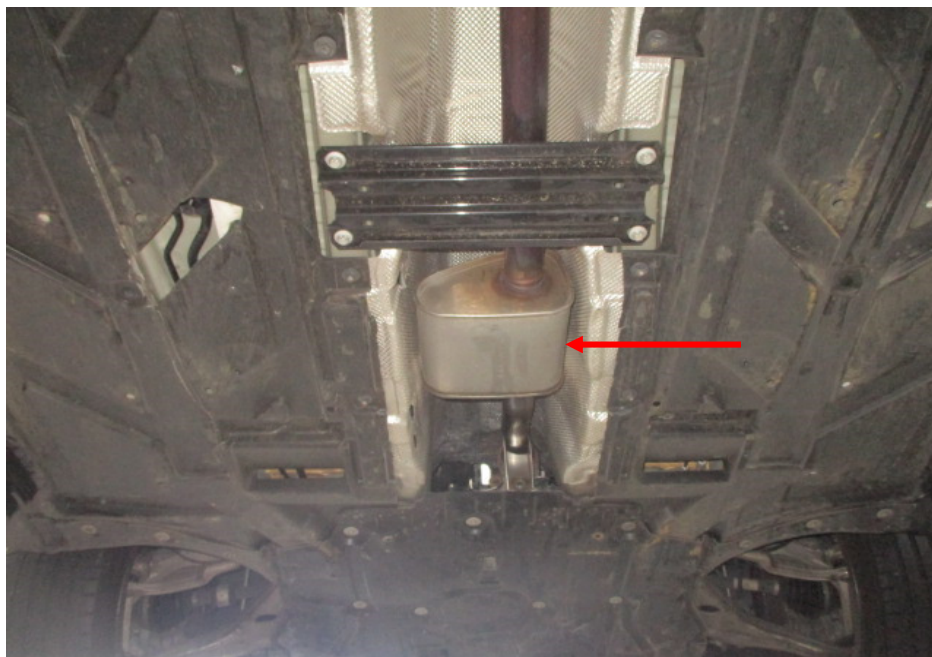
Photo 27 shows the front section of the Motor Car's exhaust system. My examination of the Motor Car's exhaust system revealed no sign(s) or indication(s) of any cut or weld marks along its exhaust pipes, on its rear muffler, on its centre resonator box (arrowed) and on its catalytic converter.

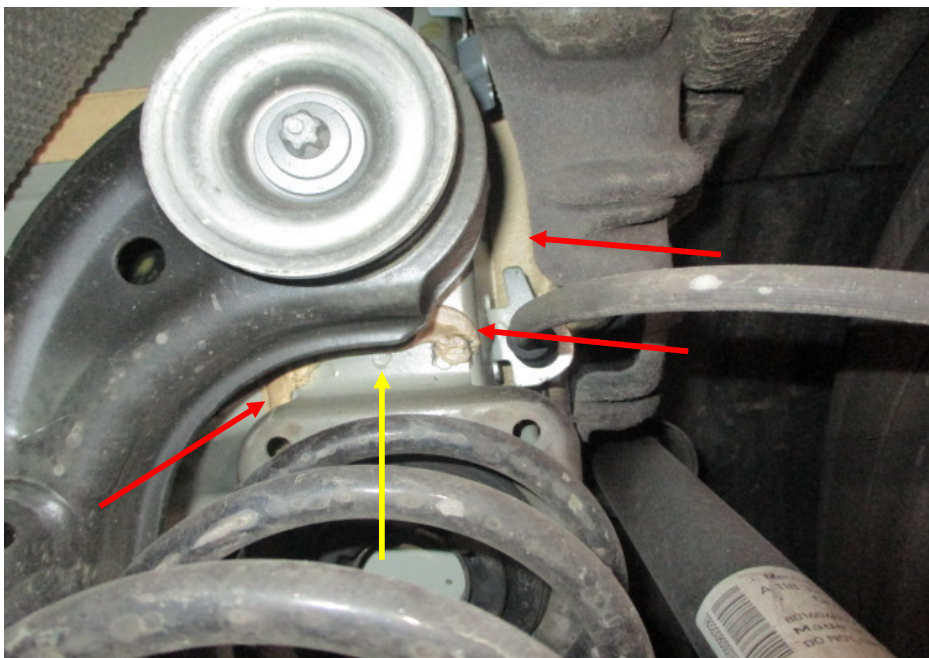
Photo 28 shows the chassis/structural body at the underside rear right of the Motor Car. I did not find any weld marks other than original spot weld marks (yellow arrow) on the chassis/structural body of the Motor Car. The original factory sealant (red arrow) at the joints along the chassis/structural body was untouched, indicating no work was done on the chassis/structural body of the Motor Car and that the chassis/structural body was originally fitted.

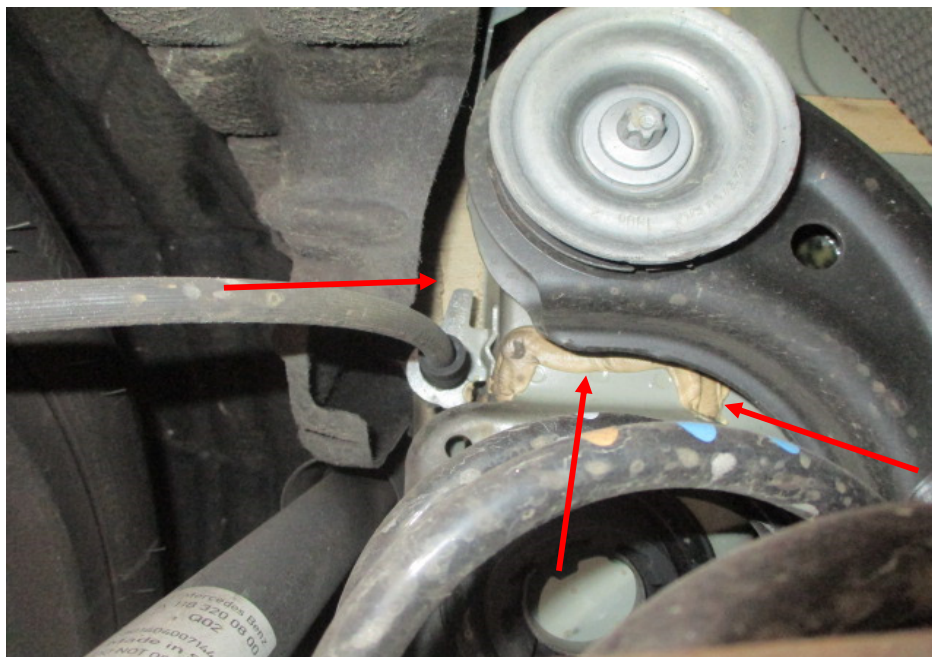
Photo 29 shows the chassis/structural body at the underside rear left of the Motor Car. The original factory sealant (arrowed) at the joints along the chassis/structural body was observed to be untouched. In general, I had found no work was carried out on the chassis/structural body of the Motor Car. The chassis/structural body of the Motor Car was originally fitted.

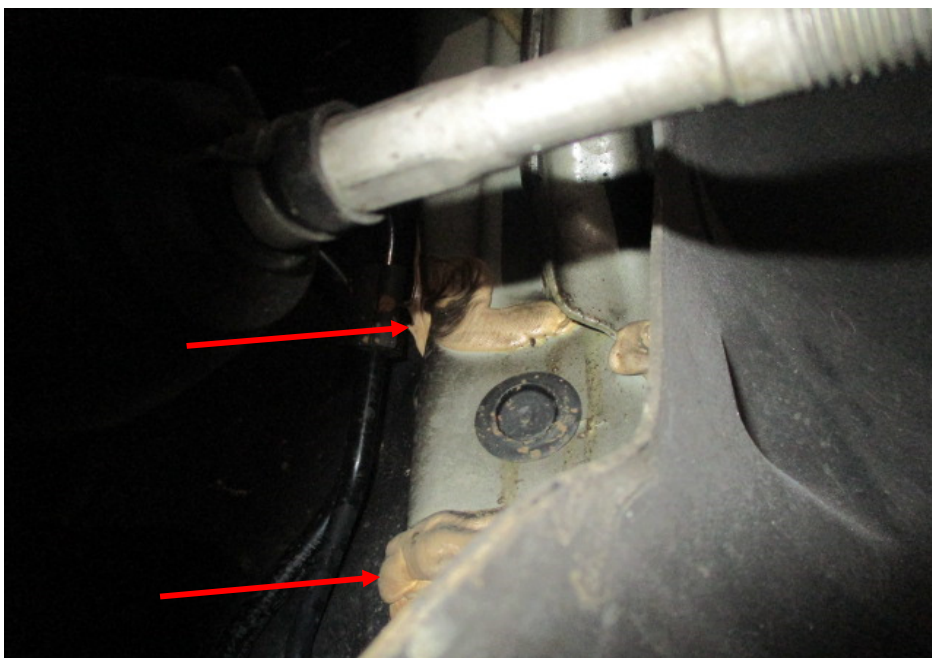
Photo 30 shows the chassis/structural body at the underside front left of the Motor Car. I did not find any weld marks other than original spot weld marks on the chassis/structural body of the Motor Car. The original factory sealant (arrowed) at the joints along the chassis/structural body was untouched, indicating no work was done on the chassis/structural body of the Motor Car and that the chassis/structural body was originally fitted.

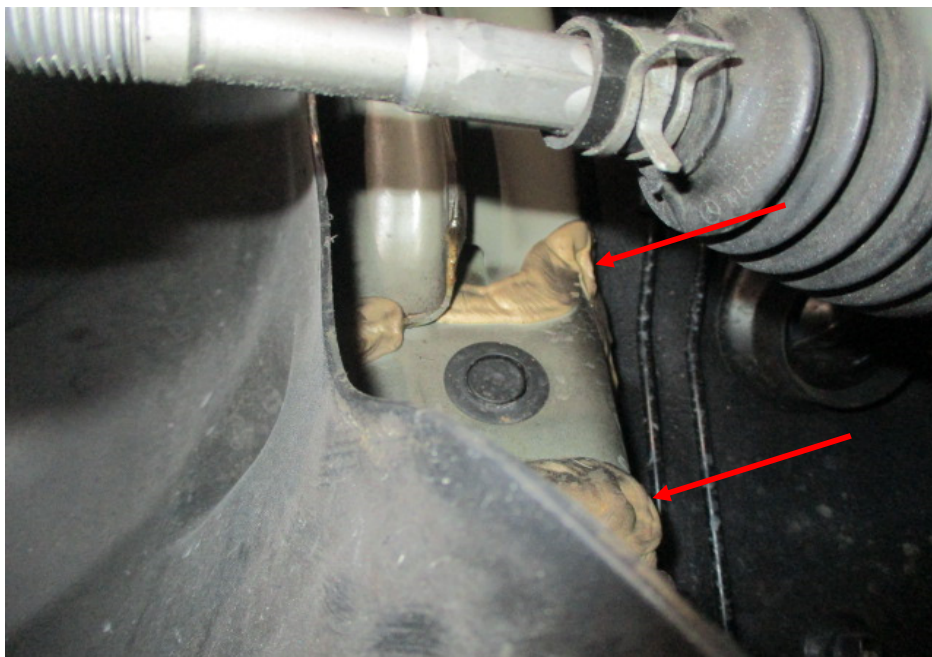
Photo 31 shows the chassis/structural body at the underside front right of the Motor Car. The original factory sealant (arrowed) at the joints along the chassis/structural body was observed to be untouched. In general, I had found no work was carried out on the chassis/structural body of the Motor Car. The chassis/structural body of the Motor Car was originally fitted.
