Your Ref: Mercedes Benz CLA 200
(chassis number WDD1183872N003245)
Our Ref : CI/TP22000937/D

**INSPECTION REPORT OF AN UNREGISTERED MERCEDES BENZ CLA 200
MOTOR CAR WITH CHASSIS NUMBER WDD1183872N003245**

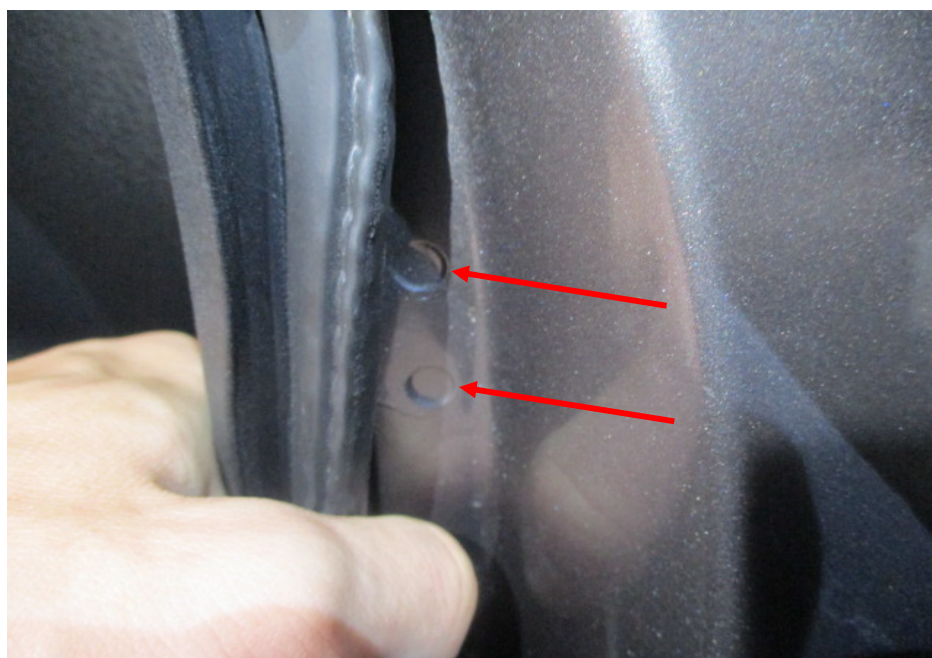
Photo 32 shows the right side "A" pillar of the Motor Car. I did not find any weld marks other than original spot weld marks (arrowed) on the right side "A" pillar of the Motor Car which, indicates that there was no re-welding works carried out. In general, I had found all the non-detachable body panels of the Motor Car to be originally fitted at the time of my inspection.

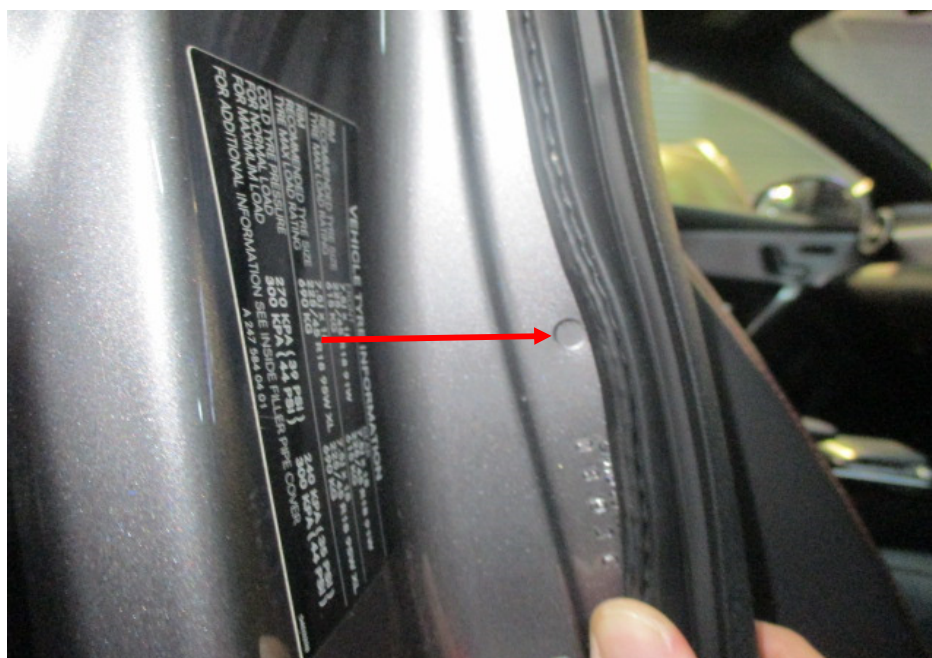
Photo 33 shows the right side “B” pillar of the Motor Car. I did not find any weld marks other than original spot weld marks (arrowed) on the right side “B” pillar of the Motor Car which, indicates that there was no re-welding works carried out. In general, I had found all the non-detachable body panels of the Motor Car to be originally fitted at the time of my inspection.

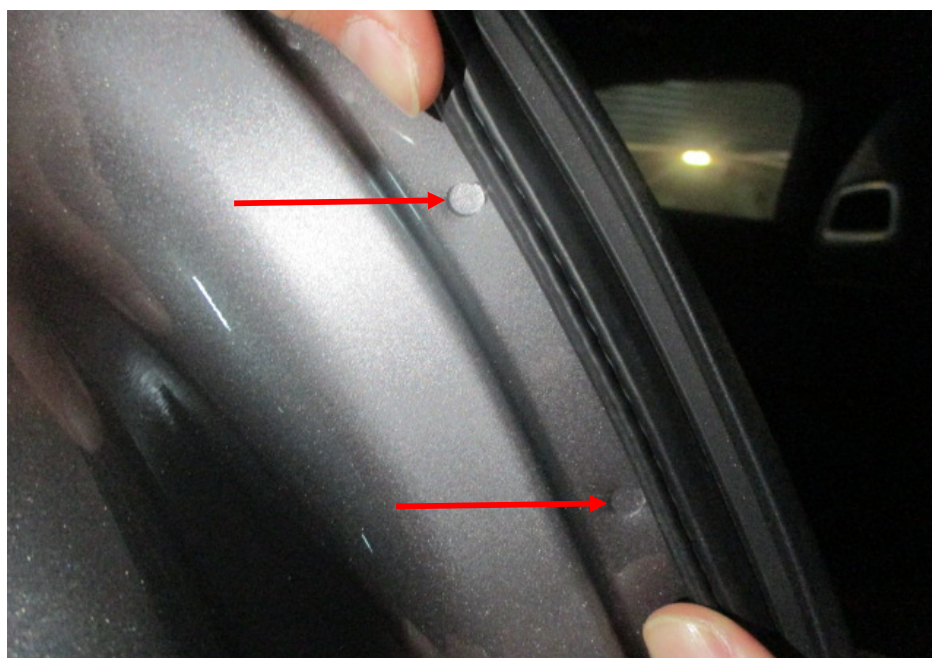
Photo 34 shows the right side “C” pillar of the Motor Car. I did not find any weld marks other than original spot weld marks (arrowed) on the right side “C” pillar of the Motor Car which, indicates that there was no re-welding works carried out. In general, I had found all the non-detachable body panels of the Motor Car to be originally fitted at the time of my inspection.

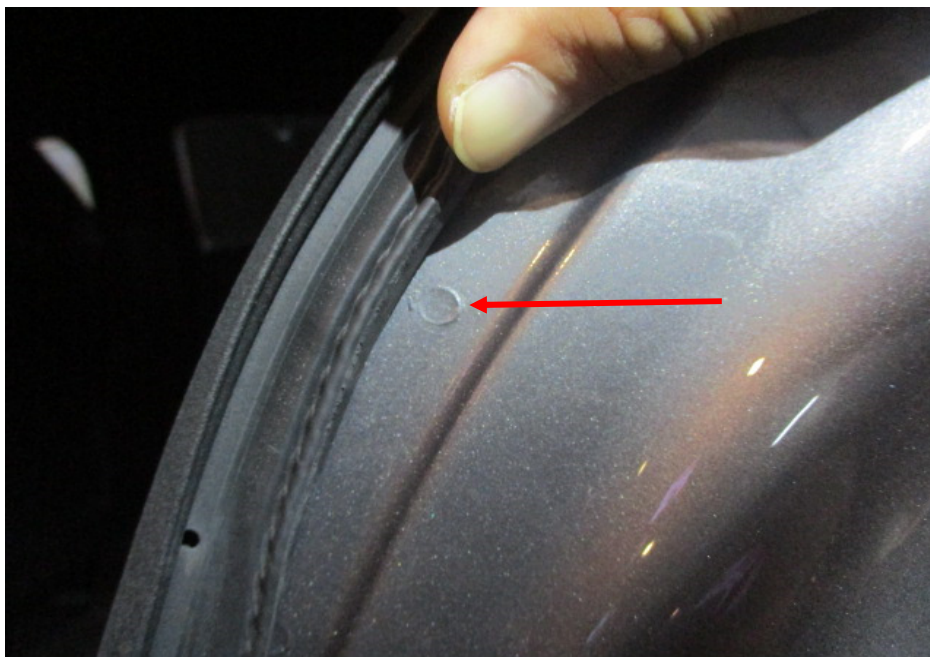
Photo 35 shows the left side "C" pillar of the Motor Car. I did not find any weld marks other than original spot weld marks (arrowed) on the left side "C" pillar of the Motor Car which, indicates that there was no re-welding works carried out. In general, I had found all the non-detachable body panels of the Motor Car to be originally fitted at the time of my inspection.
