Your Ref: Mercedes Benz E53  
(chassis number WDD2130612A613667)  
Our Ref : CI/TP22000938/D

10 February 2022

**Zion Auto Gallery Pte Ltd**  
159 Sin Ming Road #01-04  
Amtech Building  
Singapore 575625

**INSPECTION REPORT OF AN UNREGISTERED MERCEDES BENZ E53  
MOTOR CAR WITH CHASSIS NUMBER WDD2130612A613667**

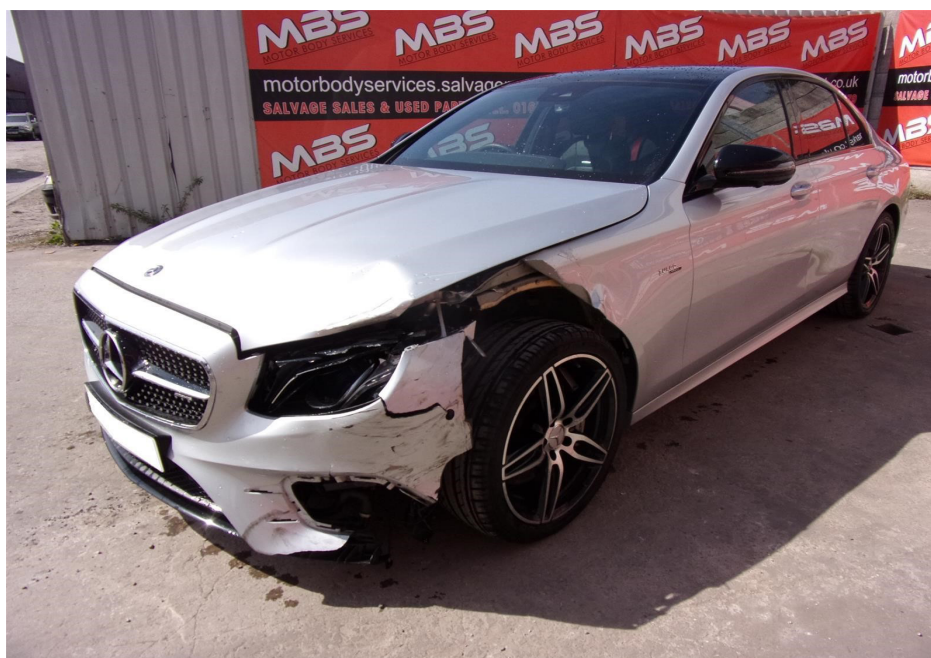
3. The photographs provided to me had showed damage to the front left portion of the Motor Car. Body parts damaged include the front bumper, front bumper left lower grille, front bumper left sensor, front bonnet, front left headlamp, front left fender and front left fender inner shield amongst others.
4. Apart for the front left portion, there was no physical damage observed to other areas of the Motor Car. The airbag(s) was not deployed as seen from the photographs that were provided to me. See photo 1 – 7 below.

**Photo 1** shows the front left body of the Motor Car (photograph provided to me). The photographs provided to me had showed damage to the front left portion of the Motor Car. The front bumper, front bumper left lower grille, front bumper left sensor, front bonnet, front left headlamp, front left fender and front left fender inner shield were amongst the body parts that were observed to have been damaged.

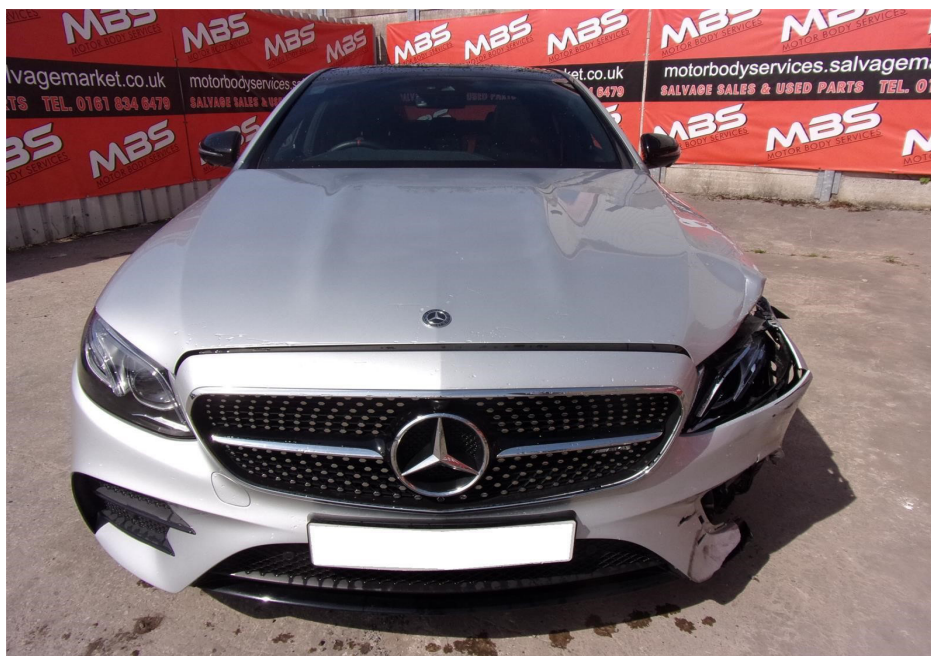
**Photo 2** shows the frontal body of the Motor Car (photograph provided to me). The photographs provided to me had showed damage to the front left portion of the Motor Car. The front bumper, front bumper left lower grille, front bonnet and front left headlamp were amongst the body parts that were observed to have been damaged.

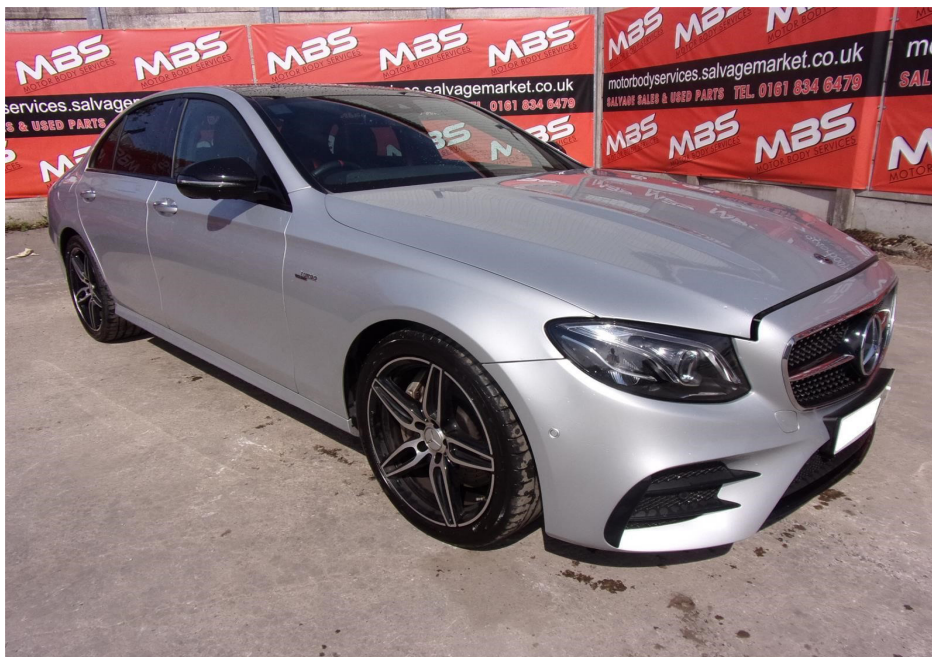
**Photo 3** shows the front right body of the Motor Car (photograph provided to me). Apart for the front left portion, there was no physical damage observed to other areas of the Motor Car. The airbag(s) was not deployed as seen from the photographs that were provided to me.

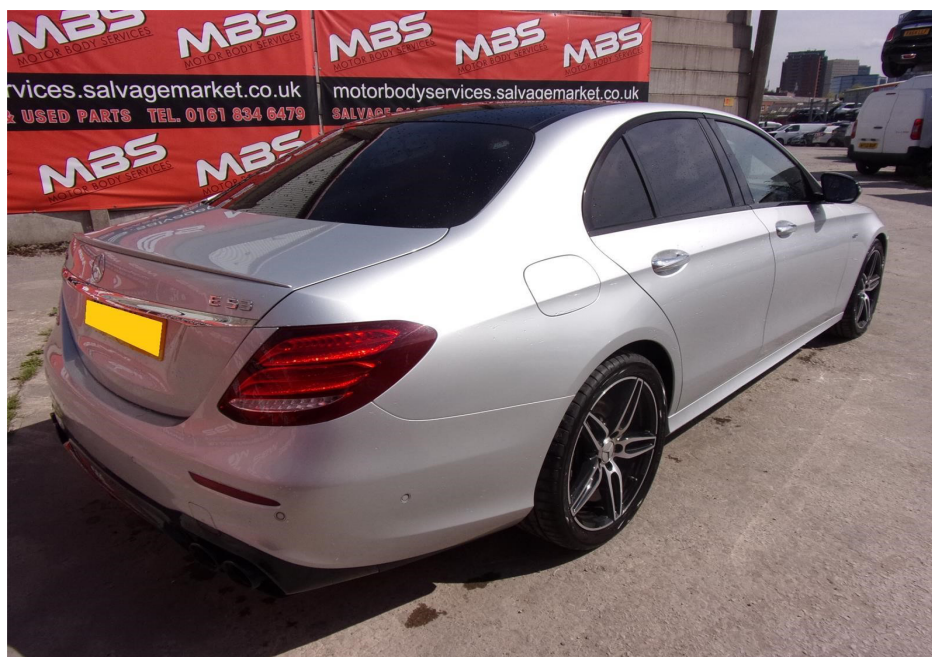
**Photo 4** shows the rear right body of the Motor Car (photograph provided to me). Apart for the front left portion, there was no physical damage observed to other areas of the Motor Car.

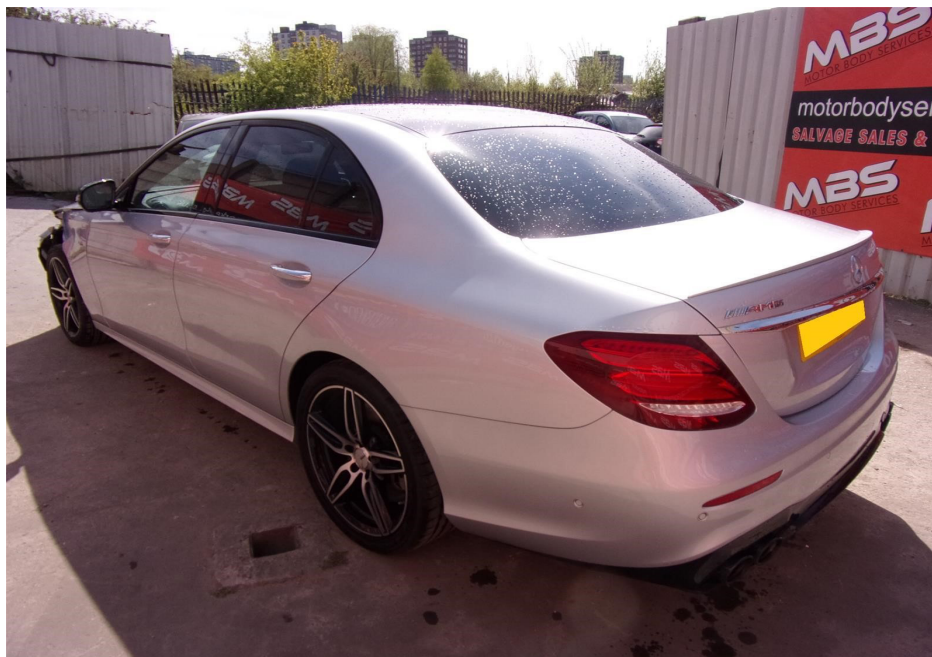
**Photo 5** shows the rear left body of the Motor Car (photograph provided to me). Apart for the front left portion, there was no physical damage observed to other areas of the Motor Car.

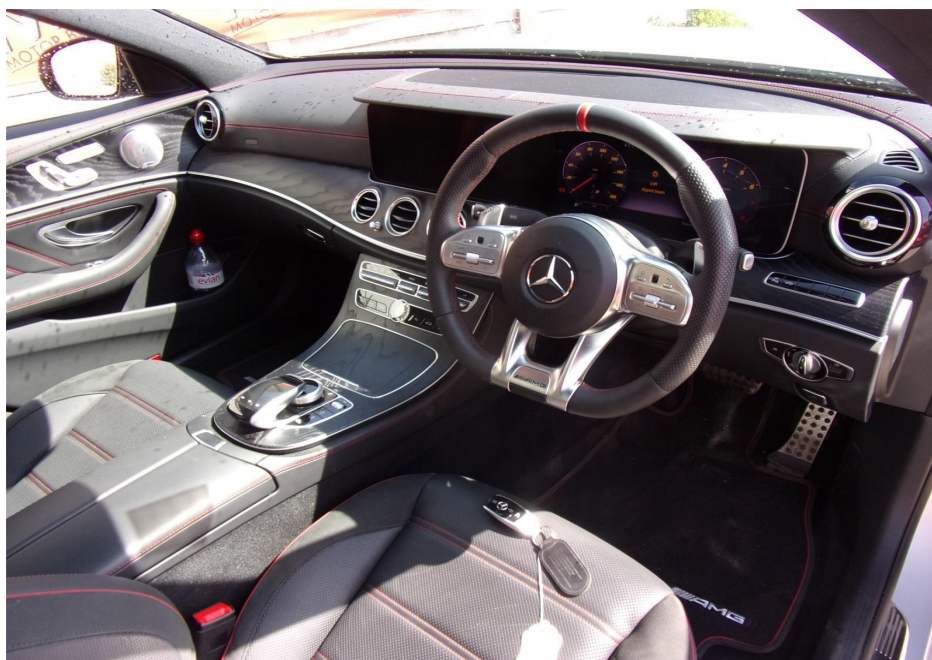
**Photo 6** shows the interior compartment of the Motor Car (photograph provided to me). The various parts and components within the interior compartment were all intact and unaffected. The airbag(s) was not deployed as seen from the photographs that were provided to me.

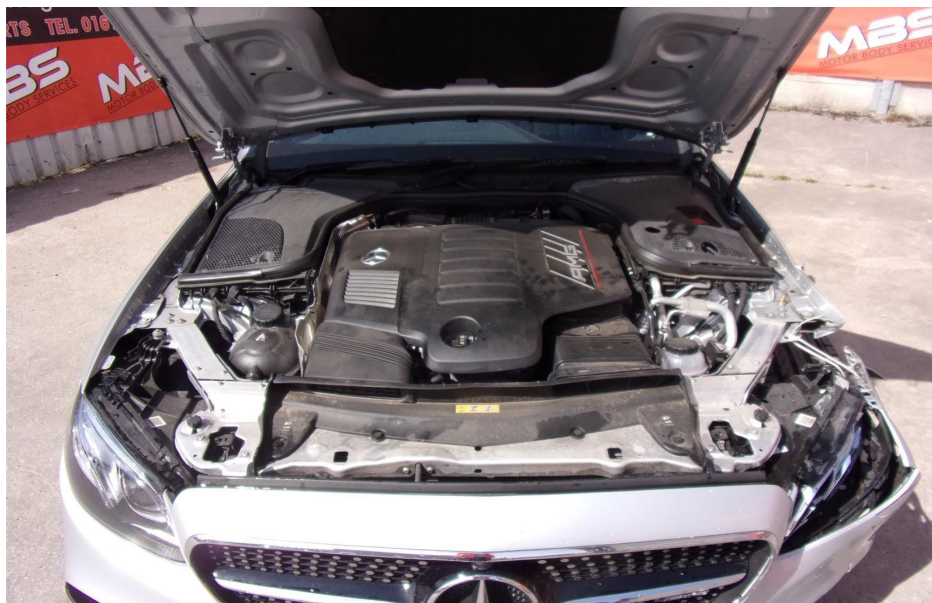
**Photo 7** shows the engine compartment of the Motor Car (photograph provided to me). The various parts and components within the engine compartment were all intact and unaffected.

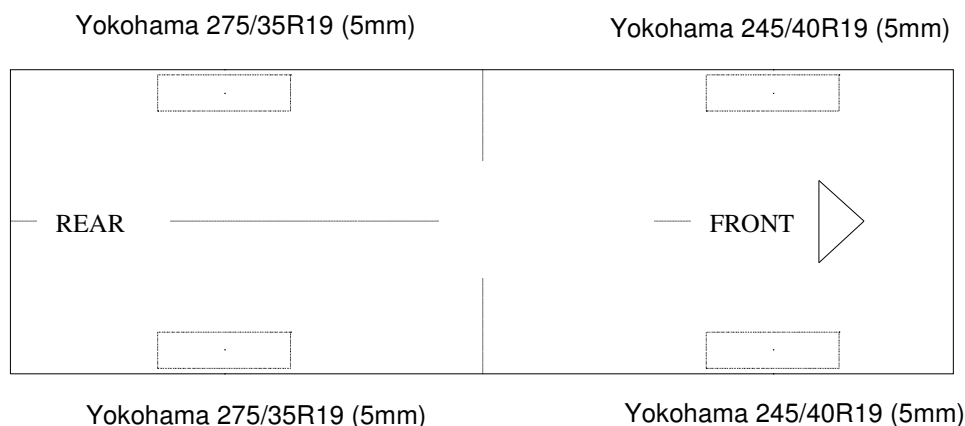
8. It was fitted with 19inch sport wheel rims that were wrapped with tyres that were observed to be of serviceable condition. The tyres were also sufficiently inflated for vehicular operation. The tyre brand, tyre size and approximate remaining tread depth of the 4 tyres of the Motor Car were recorded as follows: -

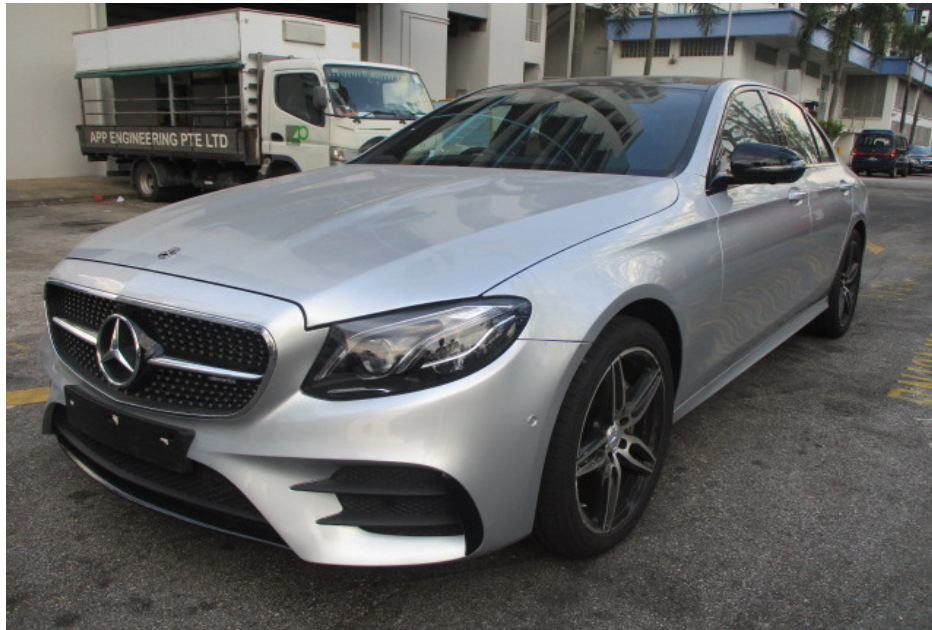
22. The body parts at the front left portion of the Motor Car were visually examined and it was noted that the repair/restoration works carried out to the damaged area of the Motor Car (refer to photograph 1 & 2 above) were reasonably adequate and in order.

**Photo 8** shows a general view of the front left body of the Motor Car at the time of my inspection. The Motor Car was observed to be in a relatively good general condition with no loose exterior fittings observed. The body parts at the front left portion of the Motor Car were visually examined and it was observed that the repair/restoration works carried out to the damaged area of the Motor Car (refer to photograph 1 & 2 above) were reasonably adequate and in order.

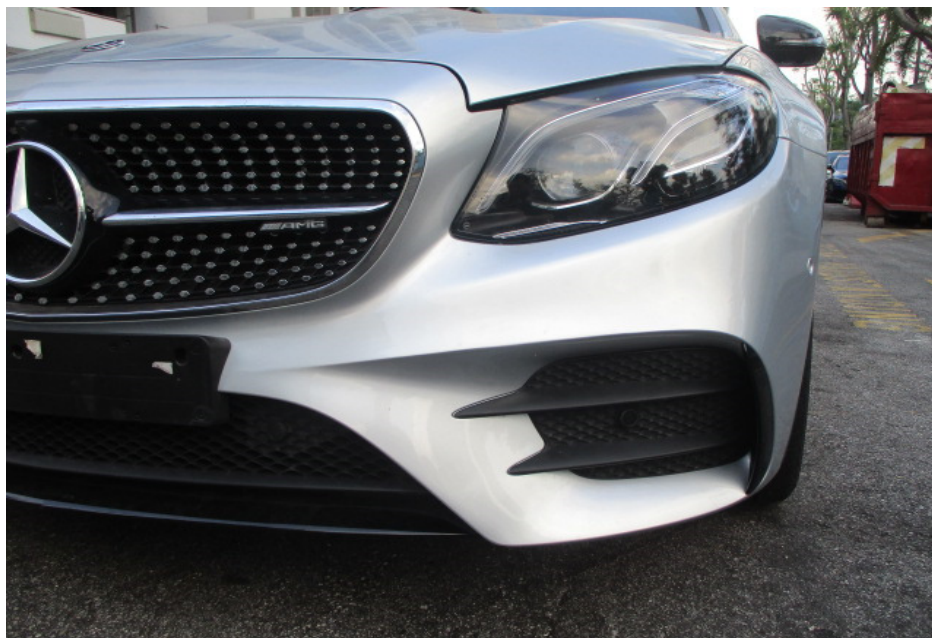
**Photo 9** shows a closer view of the Motor Car's front bumper, front bumper left lower grille, front bumper centre lower grille, radiator grille and front left headlamp at the time of my inspection. The body parts at the front left portion of the Motor Car were visually examined and it was observed that the repair/restoration works carried out to the damaged area of the Motor Car (refer to photograph 1 & 2 above) were reasonably adequate and in order.

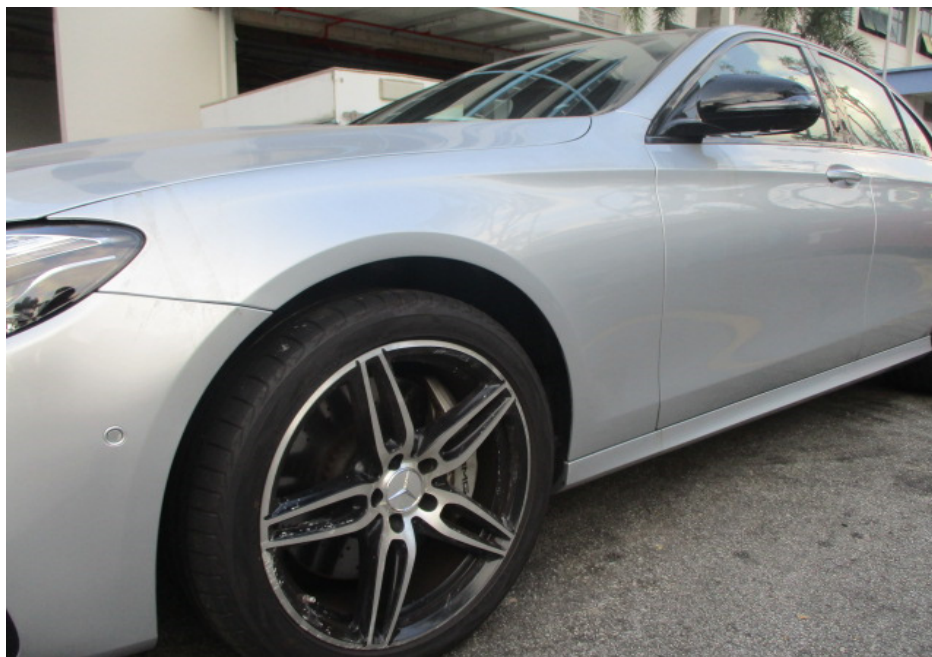
**Photo 10** shows a closer view of the Motor Car's front bumper, front bumper left sensor, front left fender, front left wheel rim and front bonnet at the time of my inspection. The body parts at the front left portion of the Motor Car were visually examined and it was observed that the repair/restoration works carried out to the damaged area of the Motor Car (refer to photograph 1 & 2 above) were reasonably adequate and in order.

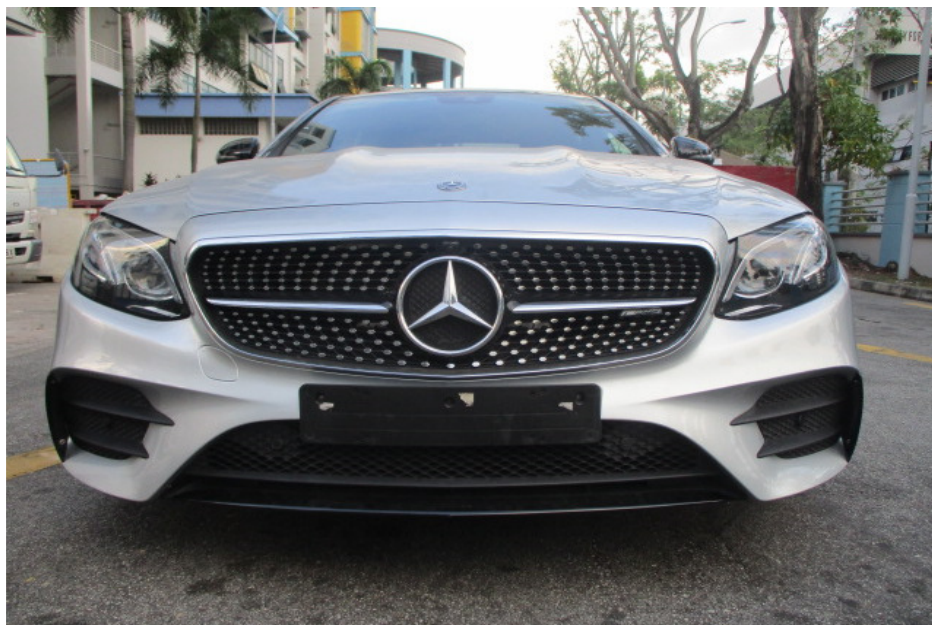
**Photo 11** shows a general view of the frontal body of the Motor Car at the time of my inspection. The Motor Car was observed to be in a relatively good general condition with no loose exterior fittings observed. The body parts at the front left portion of the Motor Car were visually examined and it was observed that the repair/restoration works carried out to the damaged area of the Motor Car (refer to photograph 1 & 2 above) were reasonably adequate and in order.

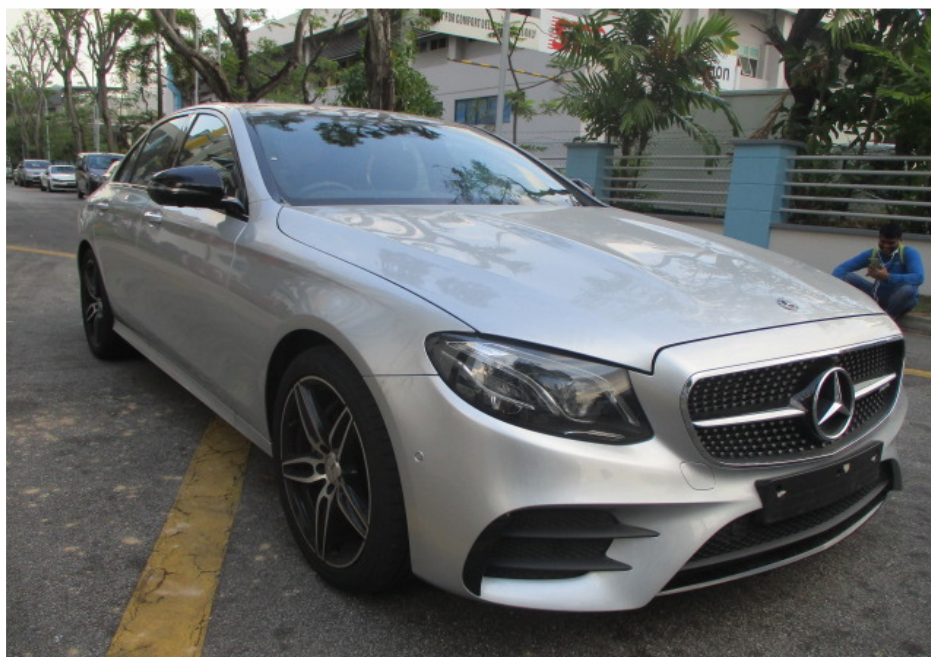
**Photo 12** shows a general view of the front right body of the Motor Car at the time of my inspection. The Motor Car was observed to be in a relatively good general condition with no loose exterior fittings observed. The body parts at the front left portion of the Motor Car were visually examined and it was observed that the repair/restoration works carried out to the damaged area of the Motor Car (refer to photograph 1 & 2 above) were reasonably adequate and in order.

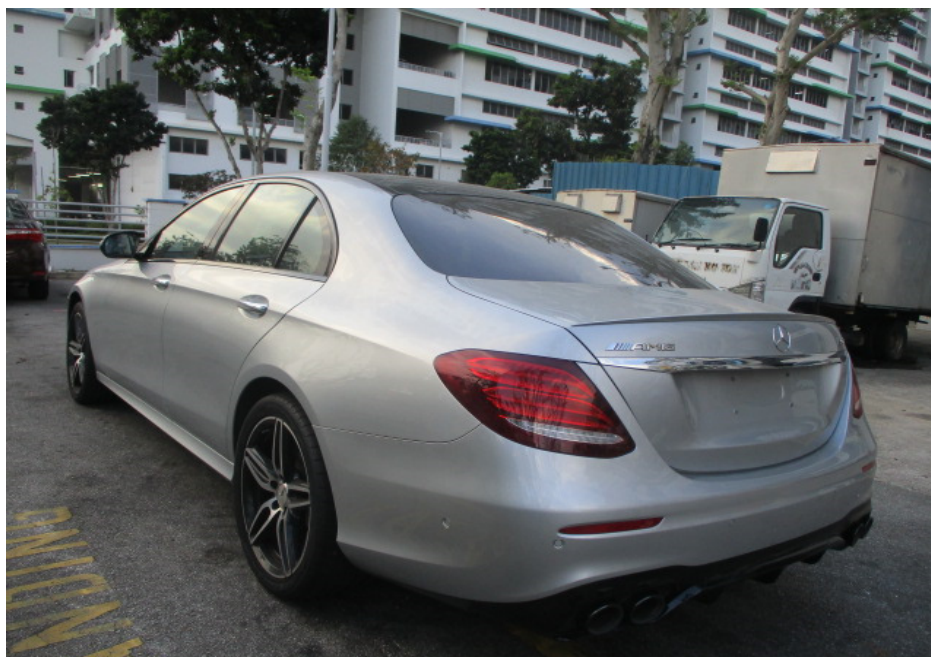
**Photo 13** shows a general view of the rear left body of the Motor Car at the time of my inspection. The Motor Car was observed to be in a relatively good general condition with no loose exterior fittings observed. The mileage of the Motor Car recorded at the time of my inspection was 29,434km.

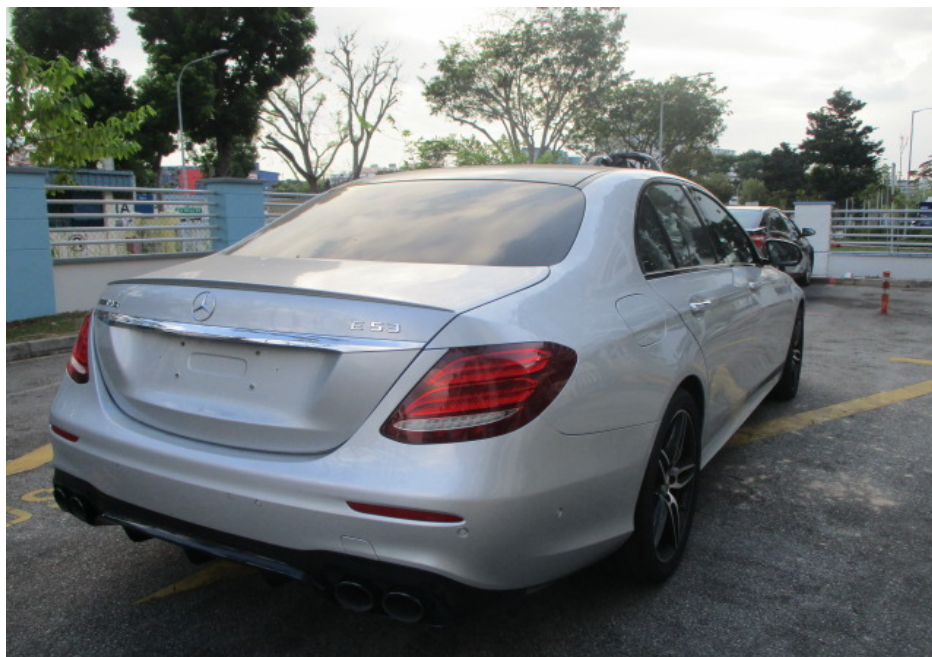
**Photo 14** shows a general view of the rear right body of the Motor Car at the time of my inspection. The Motor Car was observed to be in a relatively good general condition with no loose exterior fittings observed. The mileage of the Motor Car recorded at the time of my inspection was 29,434km.

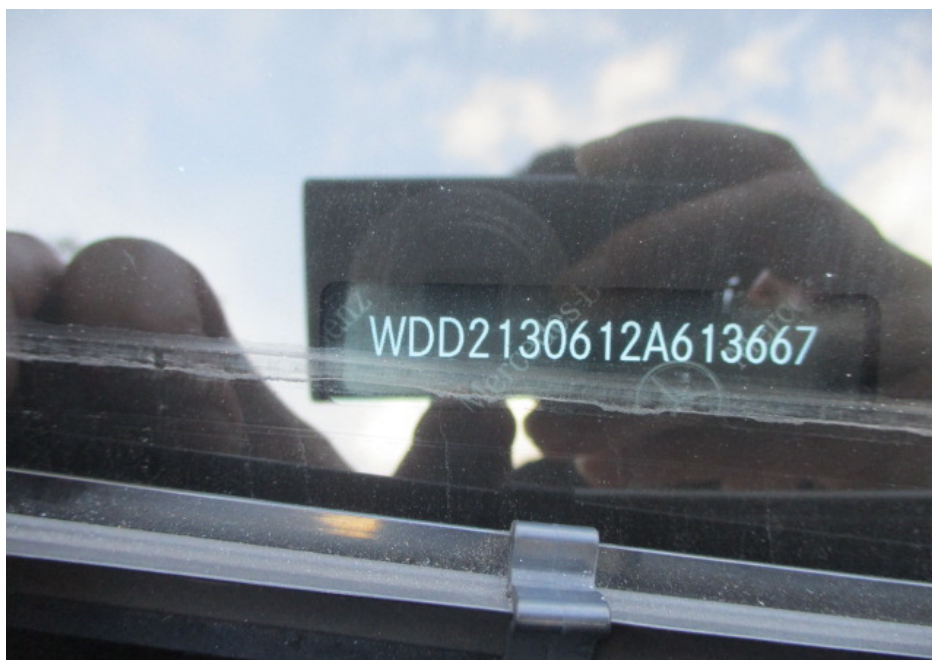
**Photo 15** shows the chassis number of the Motor Car. The chassis number recorded was WDD2130612A613667.

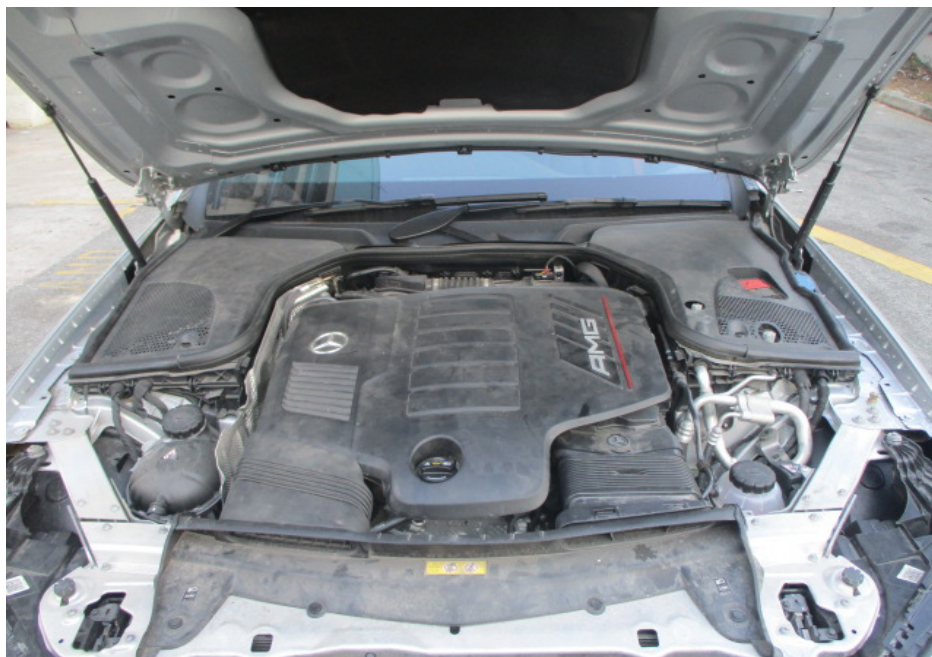
14. My examination of the engine compartment of the Motor Car revealed that the various parts and components inside the engine compartment were all intact and properly fitted. The engine oil, brake fluid and engine coolant were all found to be of sufficient level for operating purposes. Visually, there was also no contamination found to these fluids.
15. My checks on the underside of the Motor Car revealed no sign(s) or indication(s) of fluid leakage and/or fluid stain(s). The engine block and automatic transmission assembly were both secured properly. All undercarriage components of the Motor Car were also observed to be intact and secured in an appropriate manner.

**Photo 16** shows a general view of the engine compartment of the Motor Car at the time of my inspection. The various parts and components inside the engine compartment were all observed to be intact and properly fitted. There was also no sign(s) or indication(s) of fluid leak and/or fluid stain found inside the engine compartment.

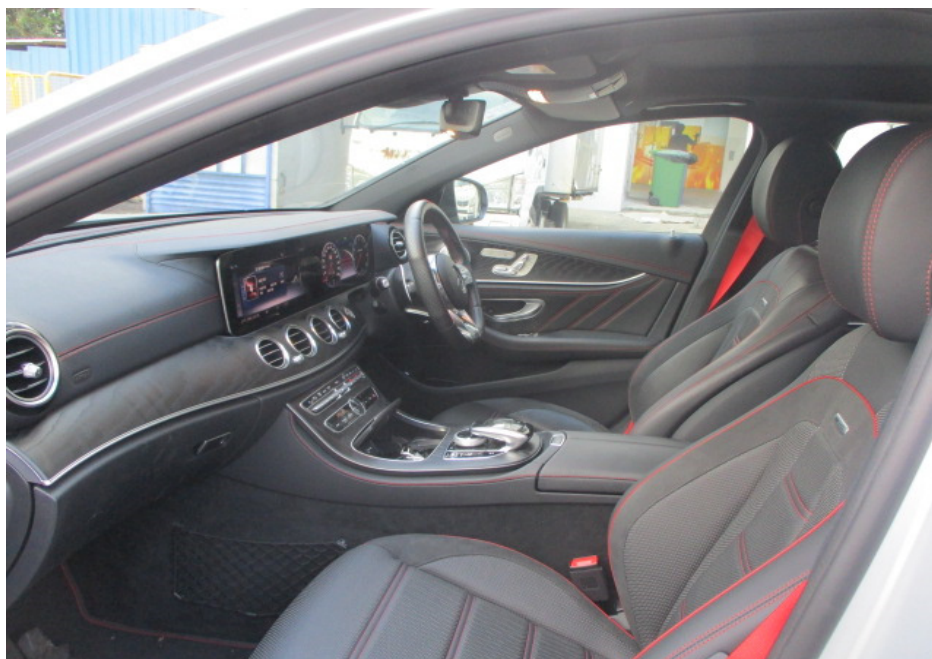
**Photo 17** shows the interior compartment of the Motor Car at the time of my inspection. The various parts and components, trims, carpet, and upholstery inside the interior compartment were all observed to be intact and properly fitted.

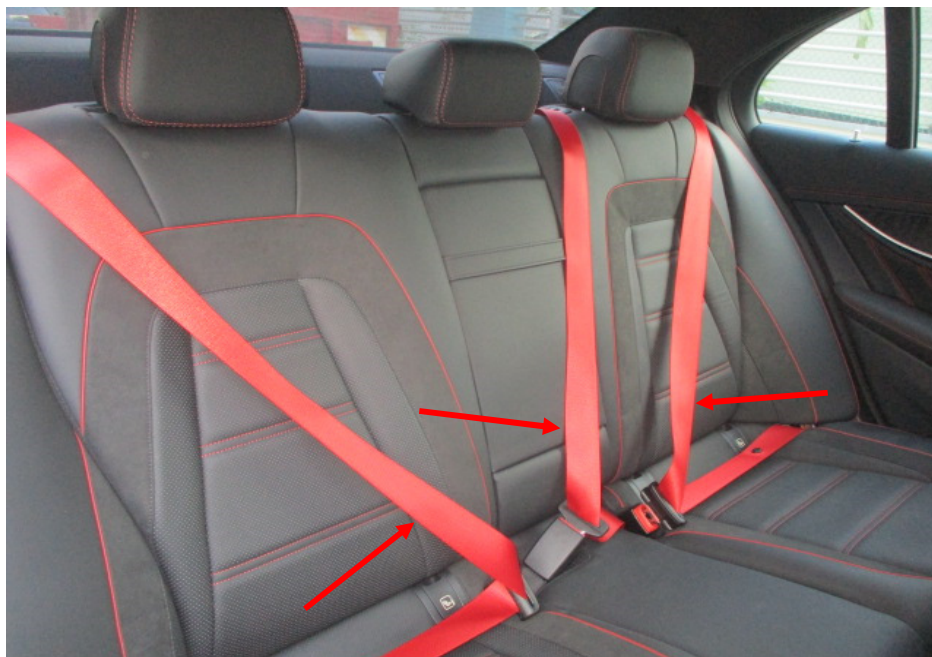
12. The seats of the Motor Car were found to be secured to the floorboard of the Motor Car via seat rails bolted onto the floorboard. Retractable seat belt reels and pre-tensioners were fitted on all seats of the Motor Car. The seat belts were tested and were able to be fastened securely into the respective pre-tensioners that were fixed to the side of all the seats.

**Photo 18** shows the rear seats of the Motor Car. All the seats of the Motor Car were secured via seat rails to the floorboard. They were also fitted with a retractable seat belt reel and a pre-tensioner. The seat belts (arrowed) were tested and were able to be fastened into the respective pre-tensions that were fitted on the side of each individual seat.

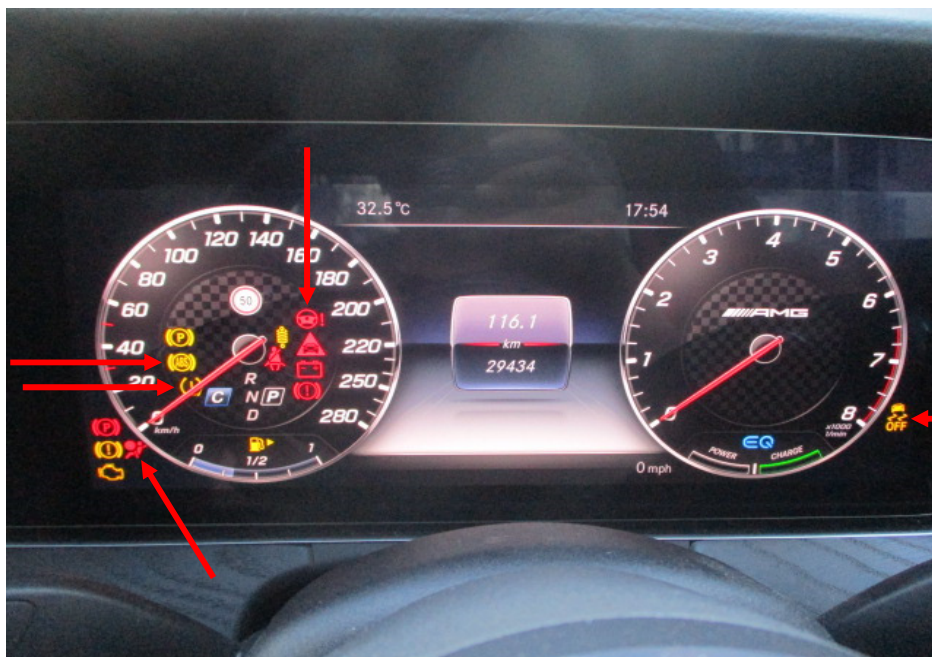
**Photo 19** shows the warning lights for the various electronic safety features appearing on the instrument panel of the Motor Car during its self-test when the engine is cranked, in particular the ABS, SRS, EPS, TPM and TCS lights (arrowed).

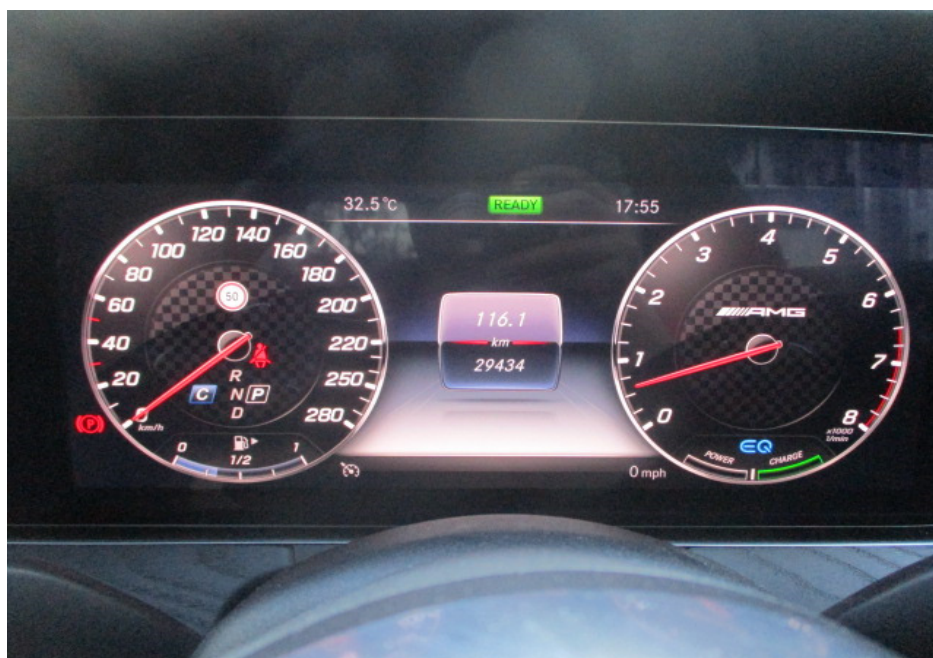
13. The Motor Car's automatic self-test of the functionality of its various electronic safety features like the Anti-Lock Brake System (ABS), Supplemental Restraint System (SRS), Electric Power Steering (EPS), Tyre Pressure Monitor (TPM) and Traction Control System (TCS) during cranking of the engine had indicated that these electronic systems were in working condition. This was determined from the respective warning lights disappearing from the instrument panel after the self-test.

**Photo 20** shows the respective warning lights no longer illuminated, indicating that there is no fault detected to the ABS, SRS, EPS, TPM and TCS systems of the Motor Car during the self-test. These electronic systems were hence in working condition at the time of my inspection.

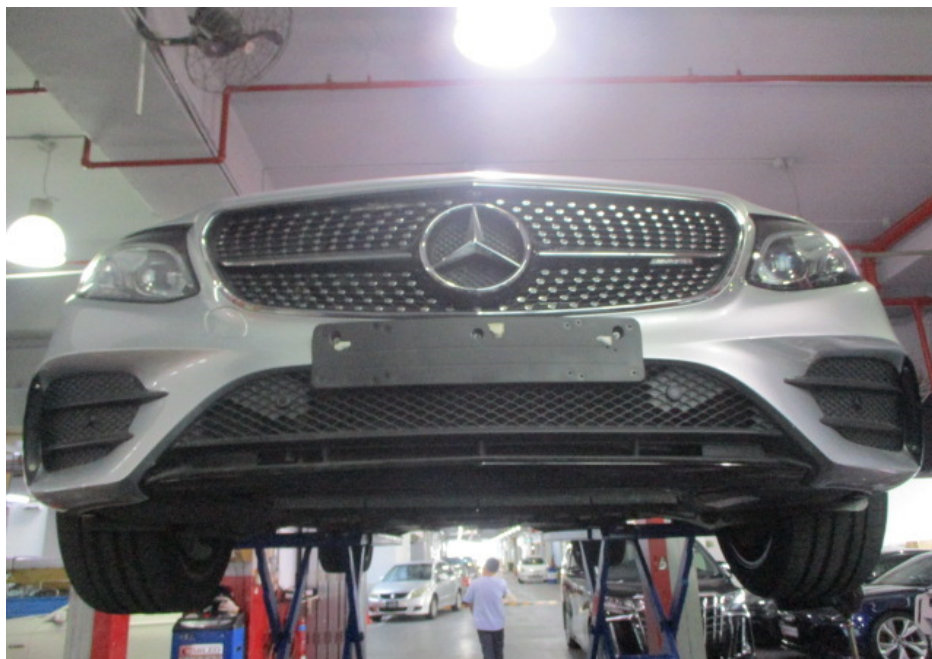
**Photo 21** shows the Motor Car hoisted up for checks on its undercarriage. There was no sign(s) or indication(s) of fluid leakage and/or fluid stain(s) on the underside of the Motor Car. The undercarriage components of the Motor Car were also all observed to be intact and secured in an appropriate manner.

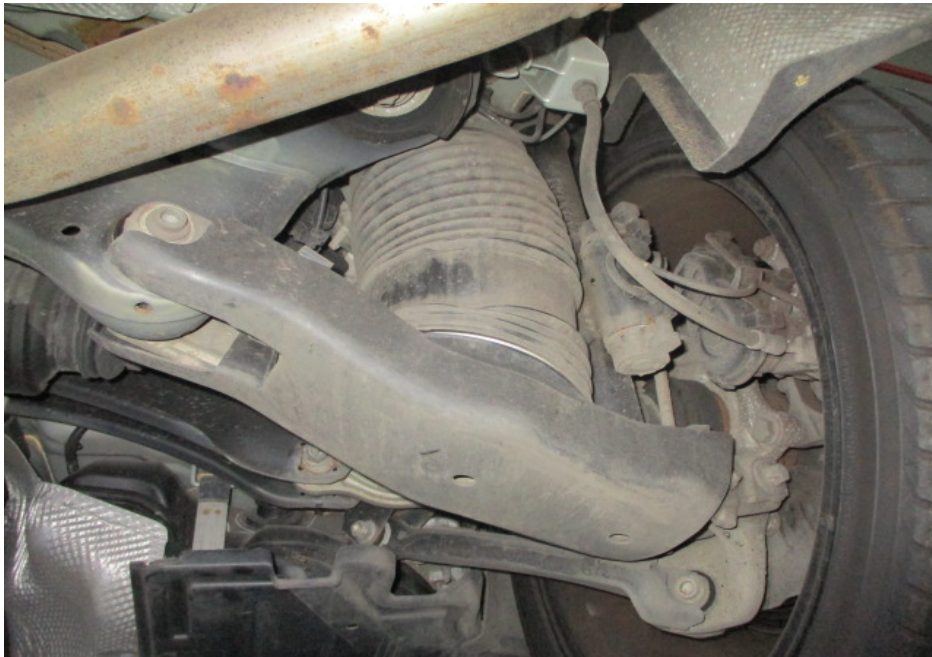
**Photo 22** shows a general view of the control arms and linkages at the rear right wheel of the Motor Car. I did not observe any fluid leak and/or fluid stain on the underside of the Motor Car. All of the Motor Car's undercarriage components were observed to be intact and secured in an appropriate manner.

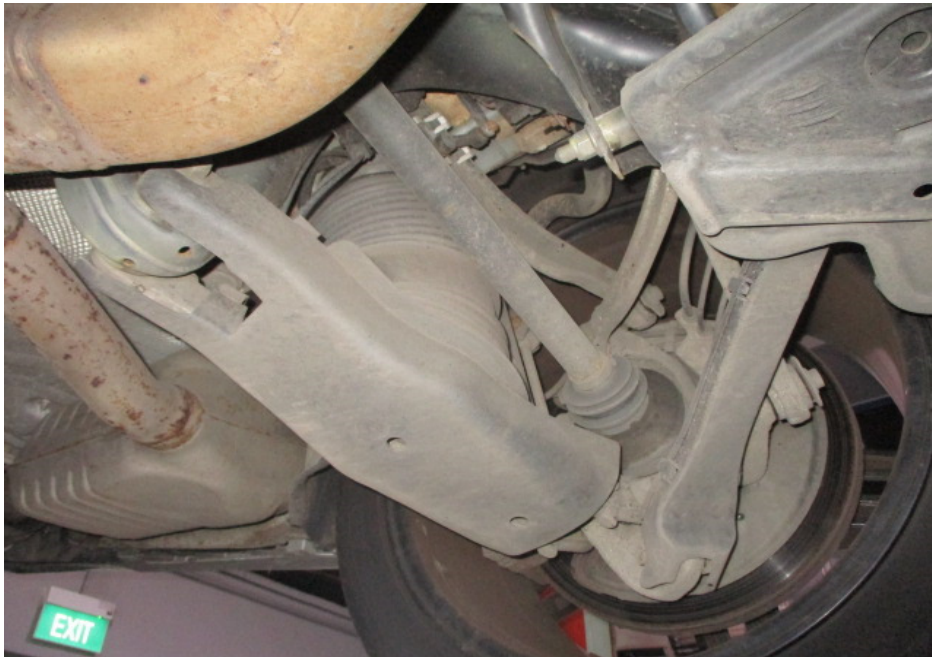
**Photo 23** shows a general view of the control arms and linkages at the rear left wheel of the Motor Car. I did not observe any fluid leak and/or fluid stain on the underside of the Motor Car. All of the Motor Car's undercarriage components were observed to be intact and secured in an appropriate manner.

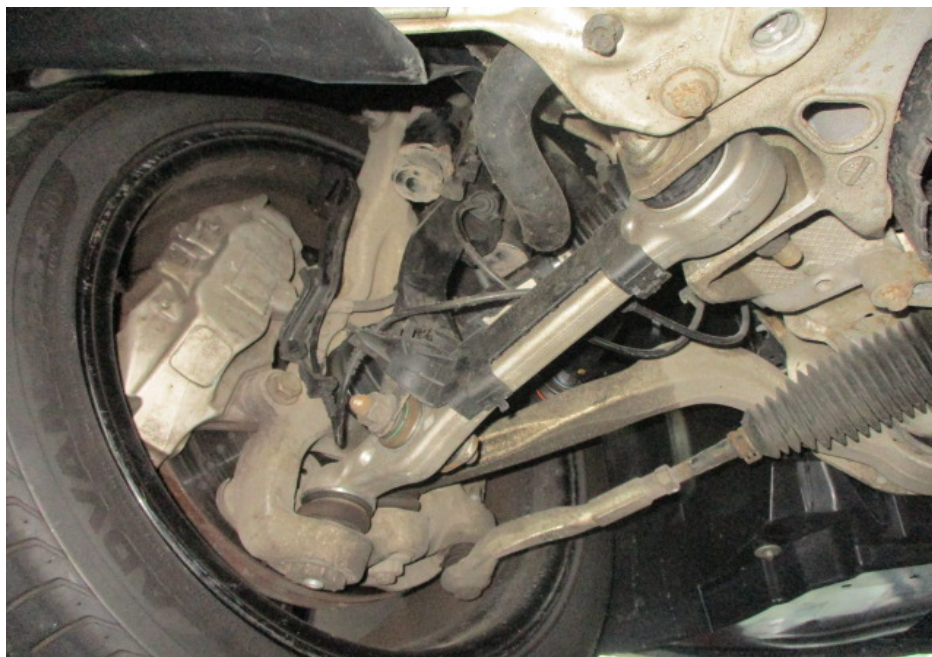
**Photo 24** shows the various undercarriage components at the front left wheel of the Motor Car. The mechanical components, control arms and linkages were all found to be intact and secured in an appropriate manner.

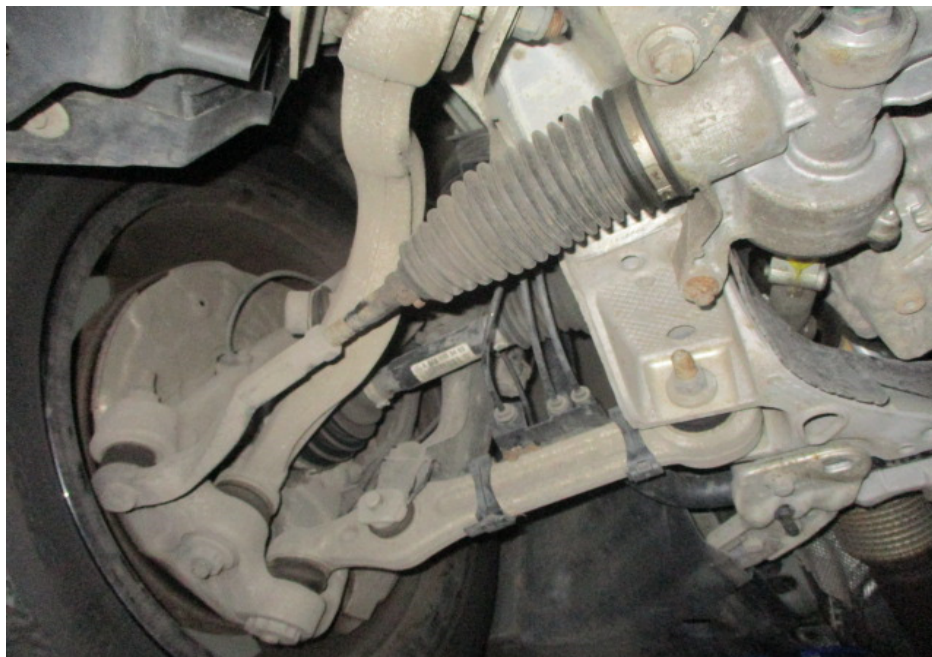
**Photo 25** shows the various undercarriage components at the front right wheel of the Motor Car. The mechanical components, control arms and linkages were all found to be intact and secured in an appropriate manner. I also did not observe any fluid leak and/or fluid stain on the underside of the Motor Car.

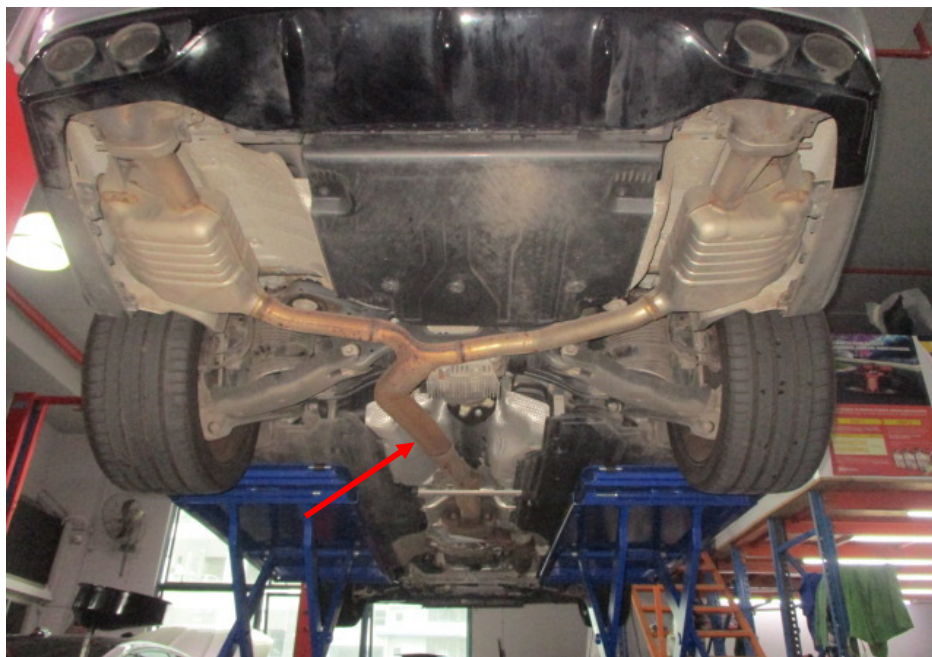
**Photo 26** shows the rear section of the Motor Car's exhaust system. My examination of the Motor Car's exhaust system revealed no sign(s) or indication(s) of any cut or weld marks along its exhaust pipes (arrowed), on its rear mufflers, on its centre resonator box and on its catalytic converter.

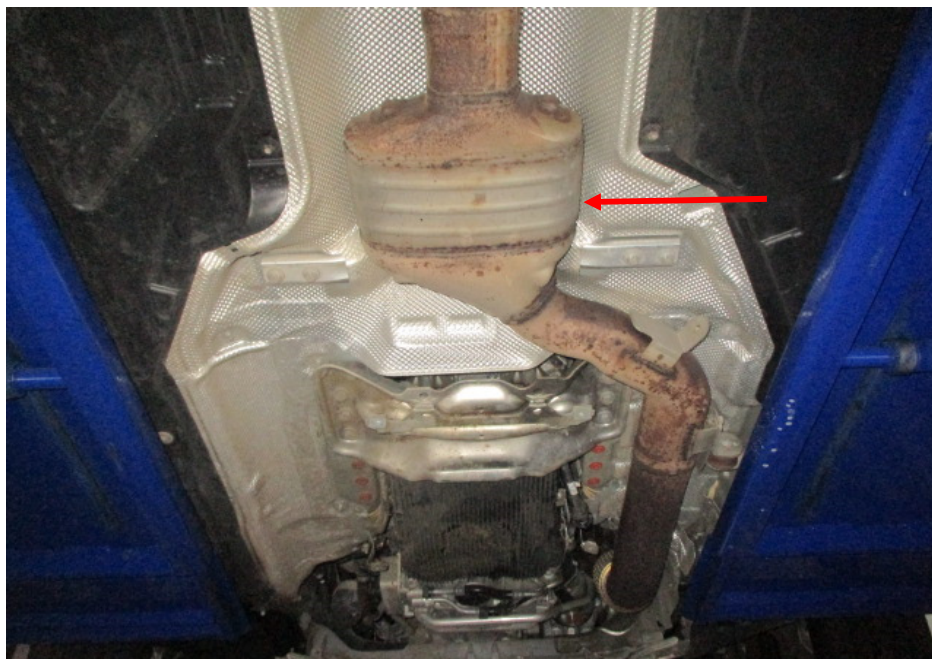
**Photo 27** shows the front section of the Motor Car's exhaust system. My examination of the Motor Car's exhaust system revealed no sign(s) or indication(s) of any cut or weld marks along its exhaust pipes, on its rear mufflers, on its centre resonator box (arrowed) and on its catalytic converter.

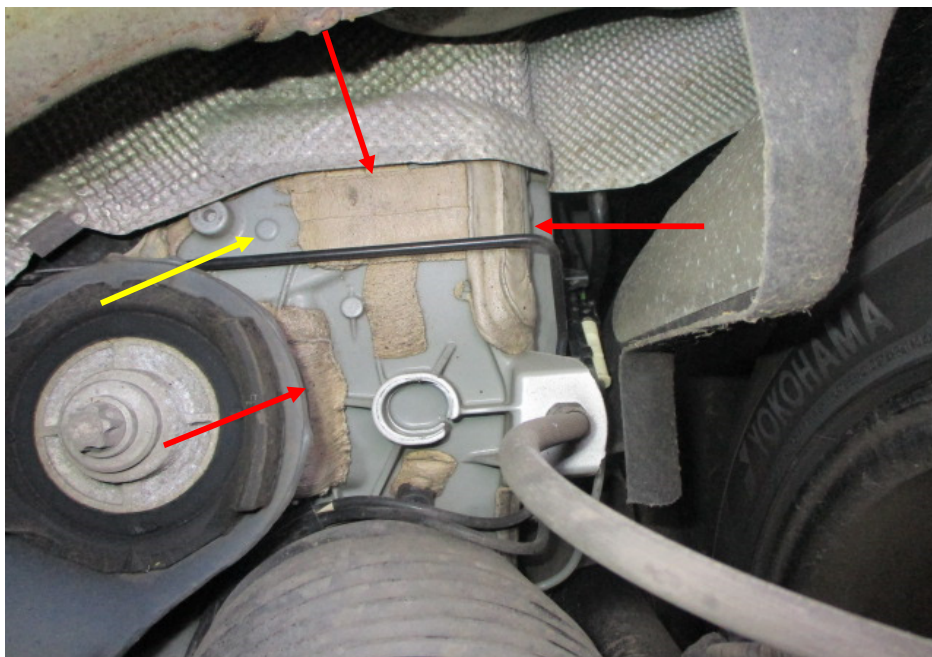
11. Visually, I did not find any weld marks, other than the original spot weld marks, on the chassis/structural body of the Motor Car. The original factory sealant at the joints along the chassis/structural body was also untouched, again indicating that no replacement of the chassis/structural body was carried out; and that the chassis/structural body was originally fitted.

**Photo 28** shows the chassis/structural body at the underside rear right of the Motor Car. I did not find any weld marks other than original spot weld marks (yellow arrow) on the chassis/structural body of the Motor Car. The original factory sealant (red arrow) at the joints along the chassis/structural body was untouched, indicating no work was done on the chassis/structural body of the Motor Car and that the chassis/structural body was originally fitted.

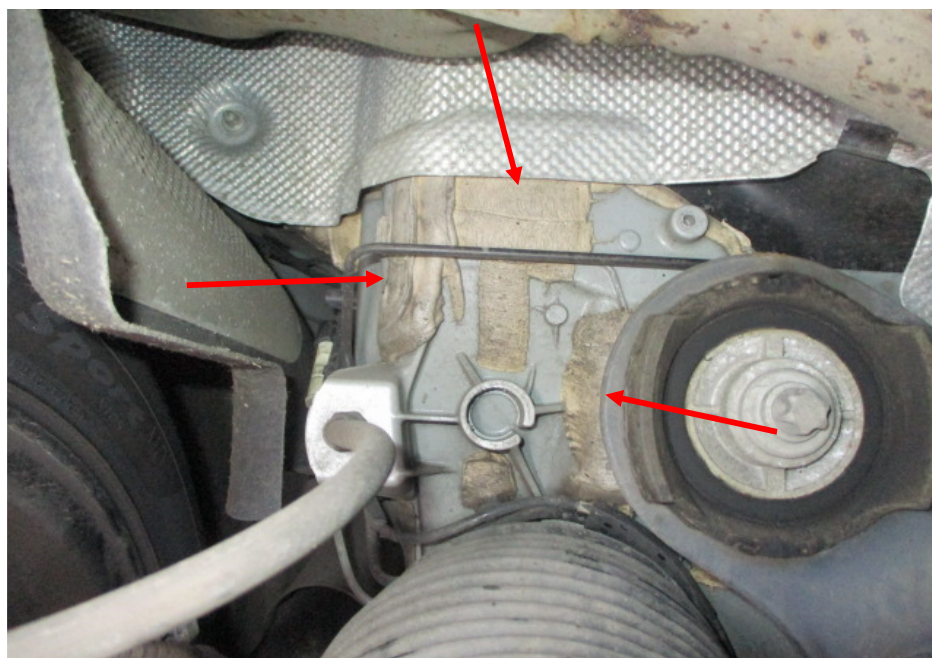
**Photo 29** shows the chassis/structural body at the underside rear left of the Motor Car. The original factory sealant (arrowed) at the joints along the chassis/structural body was observed to be untouched. In general, I had found no work was carried out on the chassis/structural body of the Motor Car. The chassis/structural body of the Motor Car was originally fitted.

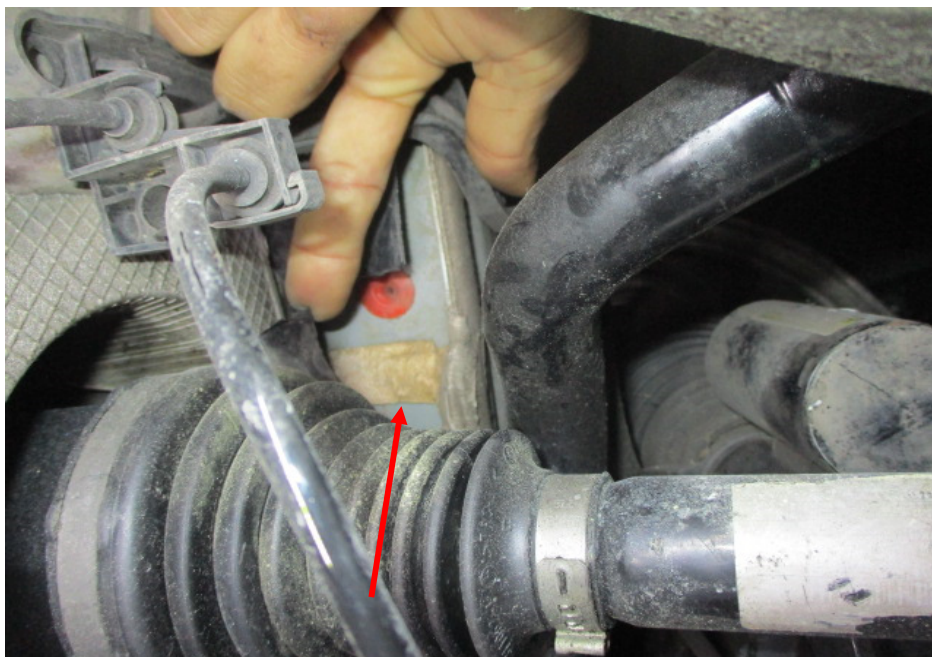
**Photo 30** shows the chassis/structural body at the underside front left of the Motor Car. I did not find any weld marks other than original spot weld marks on the chassis/structural body of the Motor Car. The original factory sealant (arrowed) at the joints along the chassis/structural body was untouched, indicating no work was done on the chassis/structural body of the Motor Car and that the chassis/structural body was originally fitted.

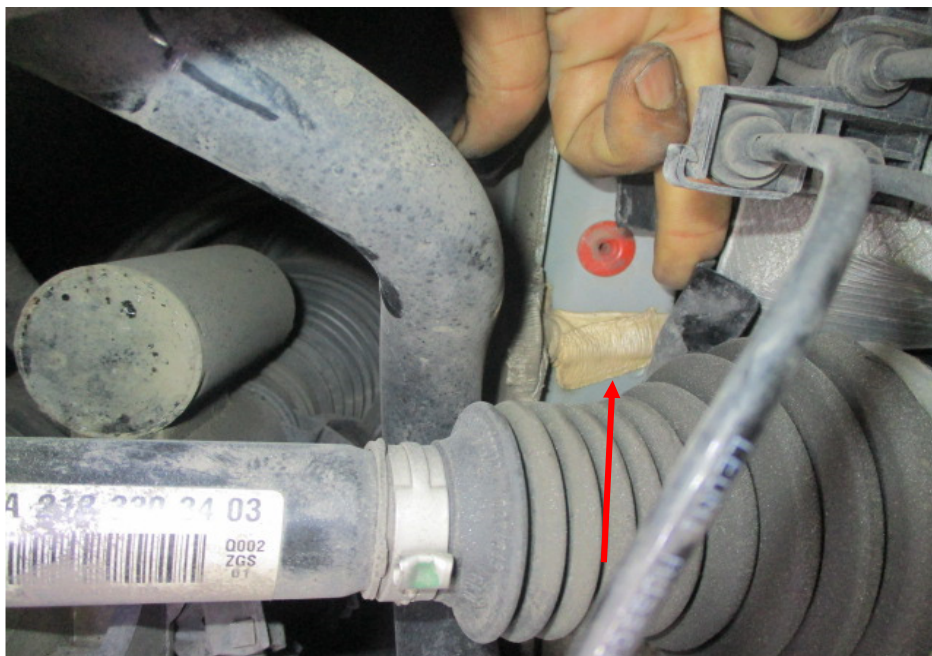
**Photo 31** shows the chassis/structural body at the underside front right of the Motor Car. The original factory sealant (arrowed) at the joints along the chassis/structural body was observed to be untouched. In general, I had found no work was carried out on the chassis/structural body of the Motor Car. The chassis/structural body of the Motor Car was originally fitted.
