Your Ref: Mercedes Benz E53  
(chassis number WDD2130612A613667)  
Our Ref : CI/TP22000938/D

10 February 2022

**Zion Auto Gallery Pte Ltd**  
159 Sin Ming Road #01-04  
Amtech Building  
Singapore 575625

**INSPECTION REPORT OF AN UNREGISTERED MERCEDES BENZ E53  
MOTOR CAR WITH CHASSIS NUMBER WDD2130612A613667**

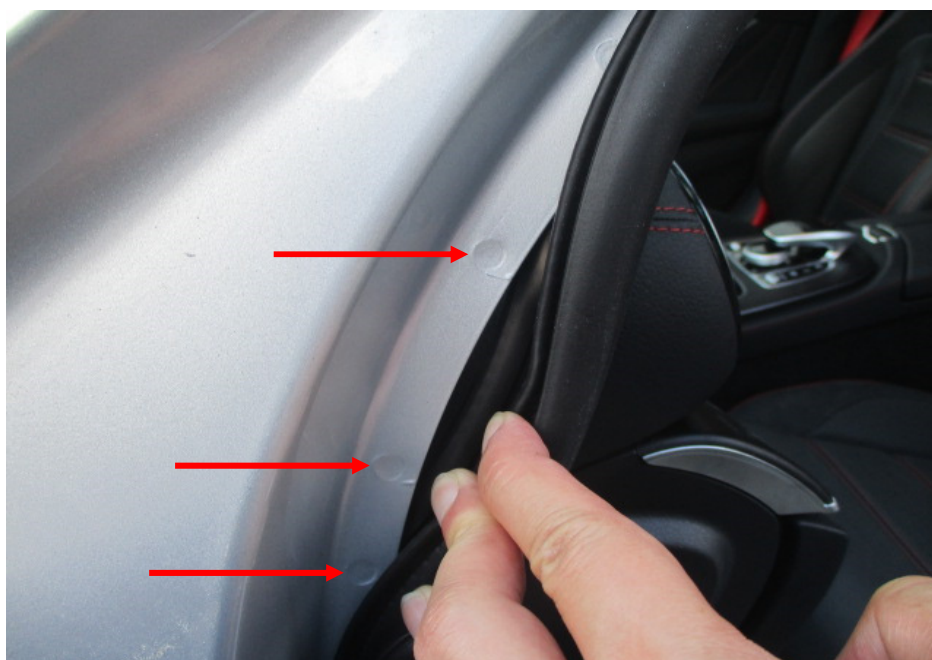
**Photo 32** shows the left side "A" pillar of the Motor Car. I did not find any weld marks other than original spot weld marks (arrowed) on the left side "A" pillar of the Motor Car which, indicates that there was no re-welding works carried out. In general, I had found all the non-detachable body panels of the Motor Car to be originally fitted at the time of my inspection.

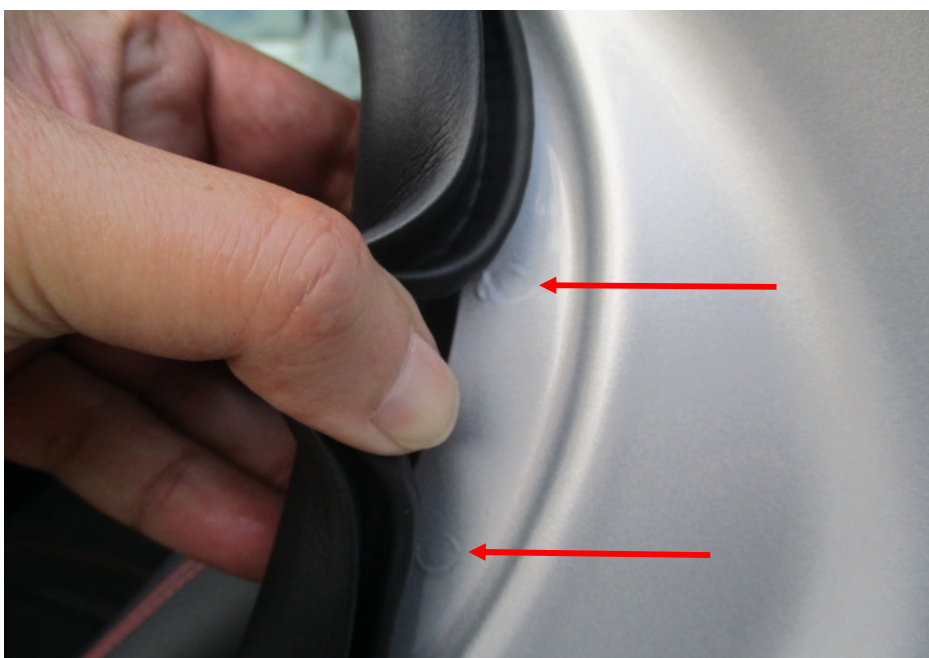
**Photo 33** shows the left side "C" pillar of the Motor Car. I did not find any weld marks other than original spot weld marks (arrowed) on the left side "C" pillar of the Motor Car which, indicates that there was no re-welding works carried out. In general, I had found all the non-detachable body panels of the Motor Car to be originally fitted at the time of my inspection.

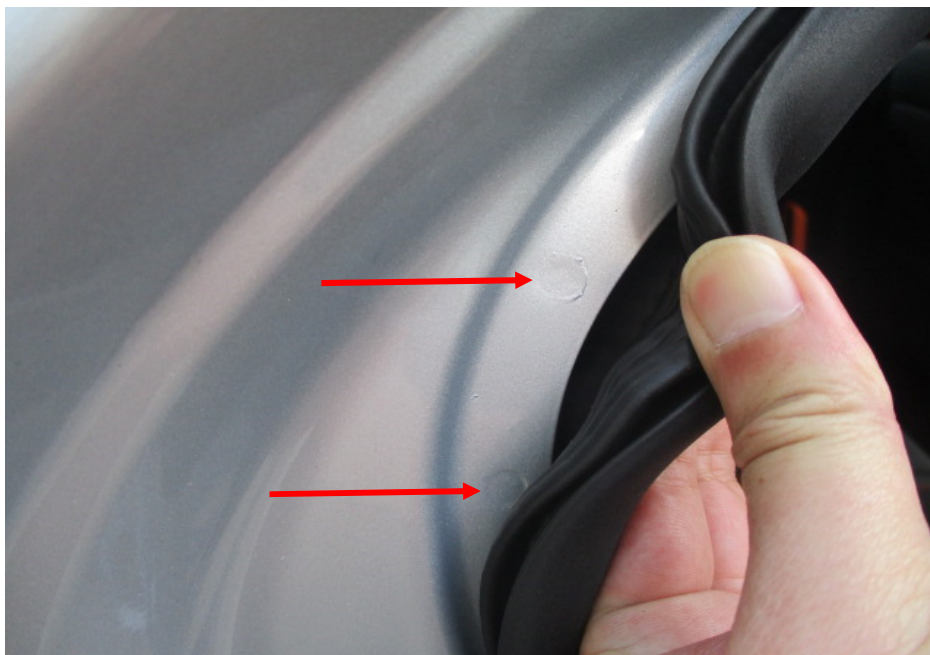
**Photo 34** shows the right side "C" pillar of the Motor Car. I did not find any weld marks other than original spot weld marks (arrowed) on the right side "C" pillar of the Motor Car which, indicates that there was no re-welding works carried out. In general, I had found all the non-detachable body panels of the Motor Car to be originally fitted at the time of my inspection.
