Your Ref: 5803261617SG
Our Ref: CI/AIG22000939/D

04 February 2022

**TECHNICAL INVESTIGATION REPORT OF FIRE INCIDENT INVOLVING THE
INSURED VEHICLE SMX 6877S ON 13 JANUARY 2022**

Vehicle Registration No.	: SMX 6877S
Make / Model	: Mercedes Benz GLB200 Progressive
Chassis No	: W1N2476872W068676
Year of Registration	: 2021 (January)
Mileage	: N.A (wiring affected)

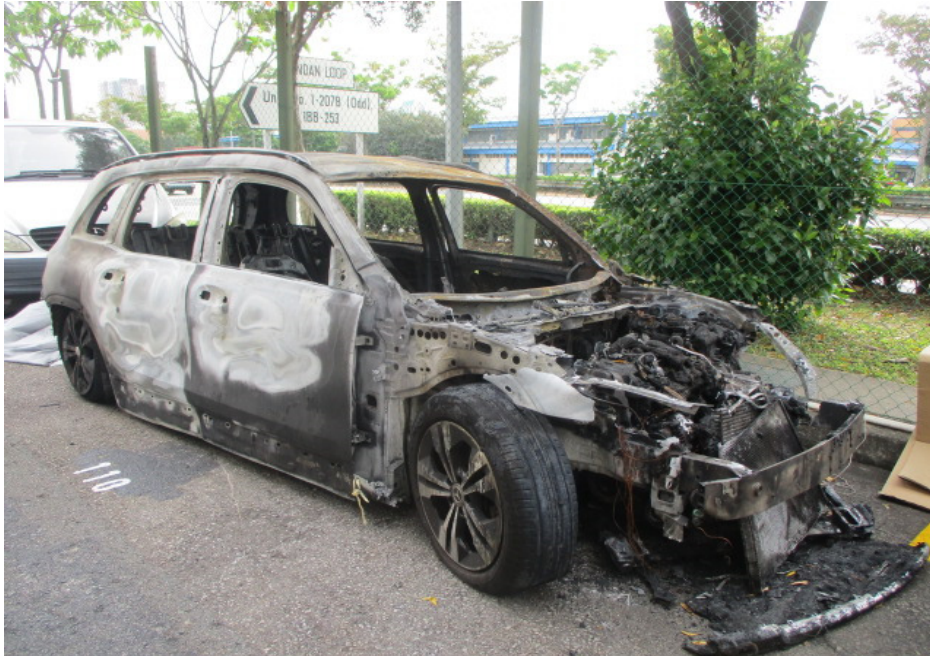
Photo 1 shows a general view of the front right body of the Insured Vehicle at the time of inspection. The Insured Vehicle was observed to have sustained extensive fire damage all around. The body panels at the frontal portion and the undercarriage components at the front underside were all found to have been severely burnt.

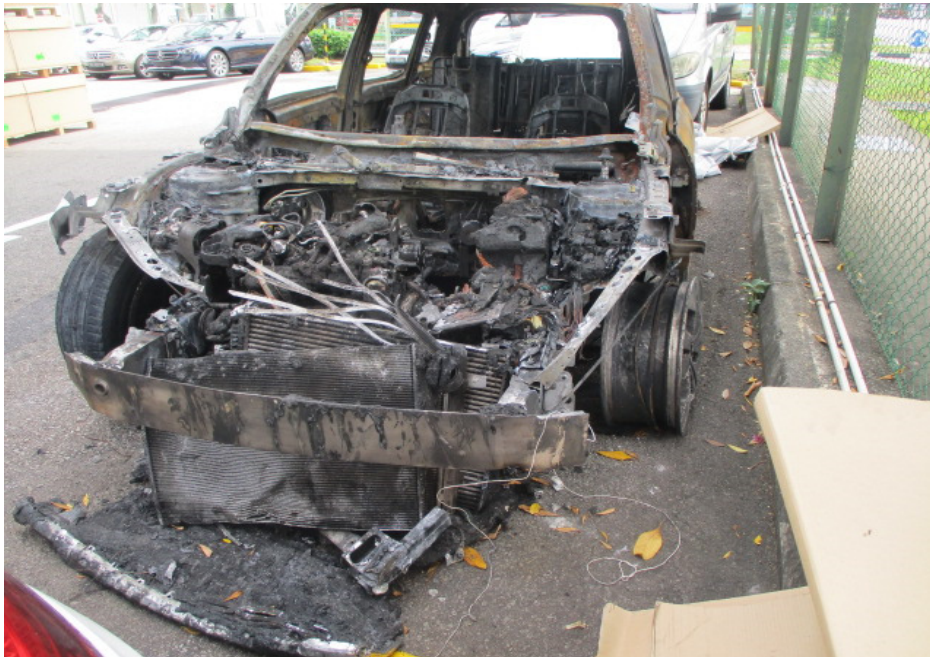
Photo 2 shows a general view of the front left body of the Insured Vehicle at the time of inspection. The Insured Vehicle was observed to have sustained extensive fire damage all around. The body panels at the frontal portion and the undercarriage components at the front underside were all severely burnt.

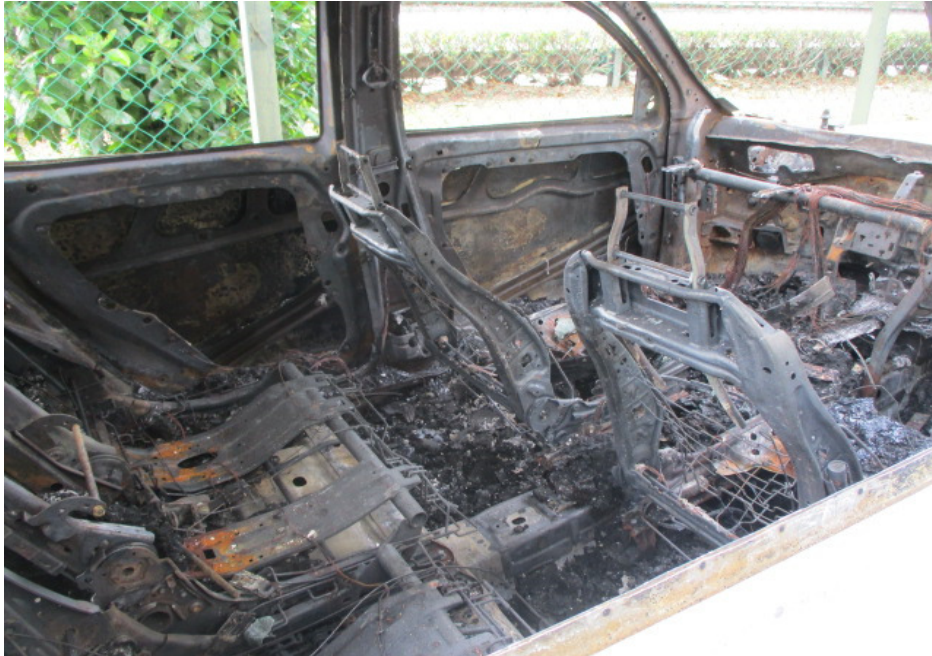
Photo 3 shows the interior compartment of the Insured Vehicle. All the parts inside the interior compartment were found to be extensively burnt. Its front seats, rear seats, roof upholstery, carpet and various trims were all burnt and/or melted as a result of the fire, leaving skeletal remains.

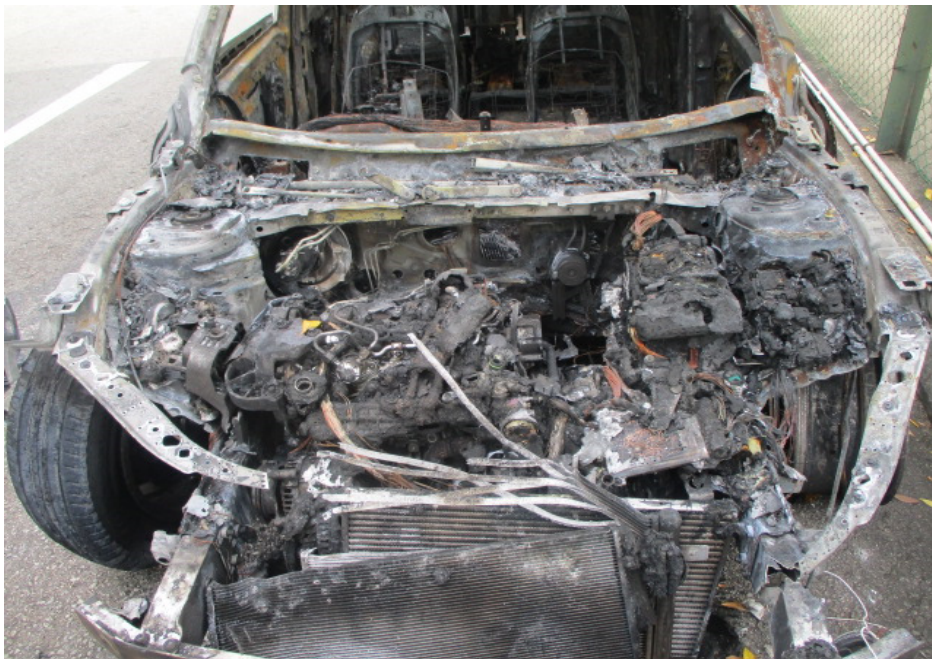
Photo 4 shows a general view of the Insured Vehicle's engine compartment. The various parts and components within the engine compartment of the Insured Vehicle were all extensively affected by the fire. This had included the engine and transmission of the Insured Vehicle.

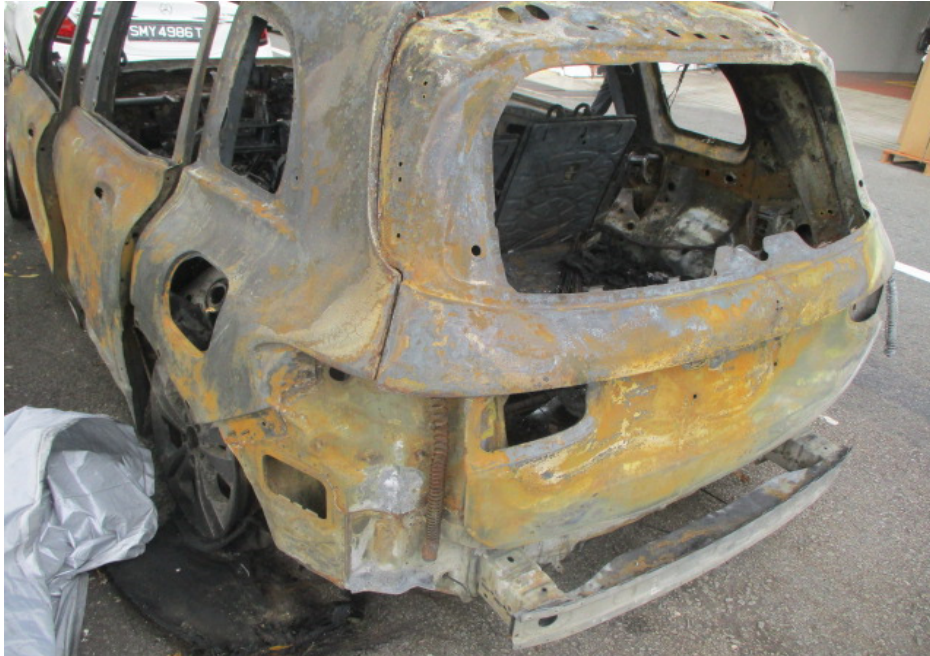
Photo 5 shows the rear left body of the Insured Vehicle. The Insured Vehicle was observed to have sustained extensive fire damage all around. The body panels at the rear portion and the undercarriage components at the rear underside were all severely burnt.

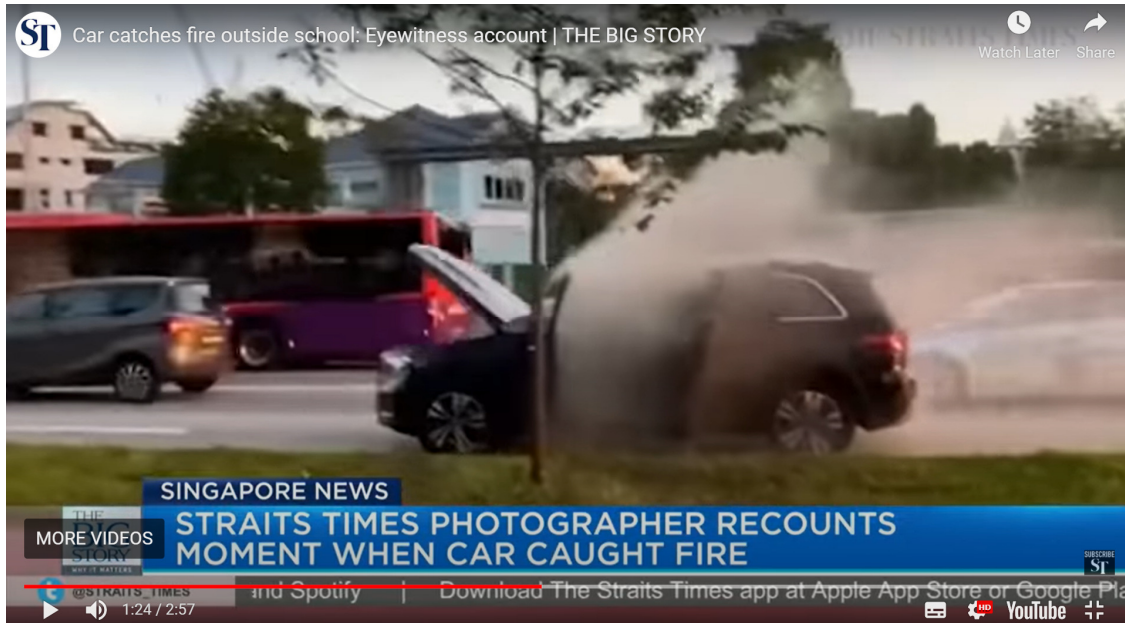
19. Following the aforesaid, the sequence of events that I was able to collectively gather from the available video recordings and photographs appear to suggest that the fire had originated from the interior compartment of the Insured Vehicle. See photo 6 – 9 below.

Photo 6 shows the Insured Vehicle at the incident scene (photograph extracted from public media website). As seen from the photograph, the Insured Vehicle's front bonnet was lifted, front left door and rear left door was in an opened position prior to the fire. Greyish coloured smoke was coming out from the interior compartment of the Insured Vehicle. Notably, no smoke was seen coming out from the engine compartment area of the Insured Vehicle.

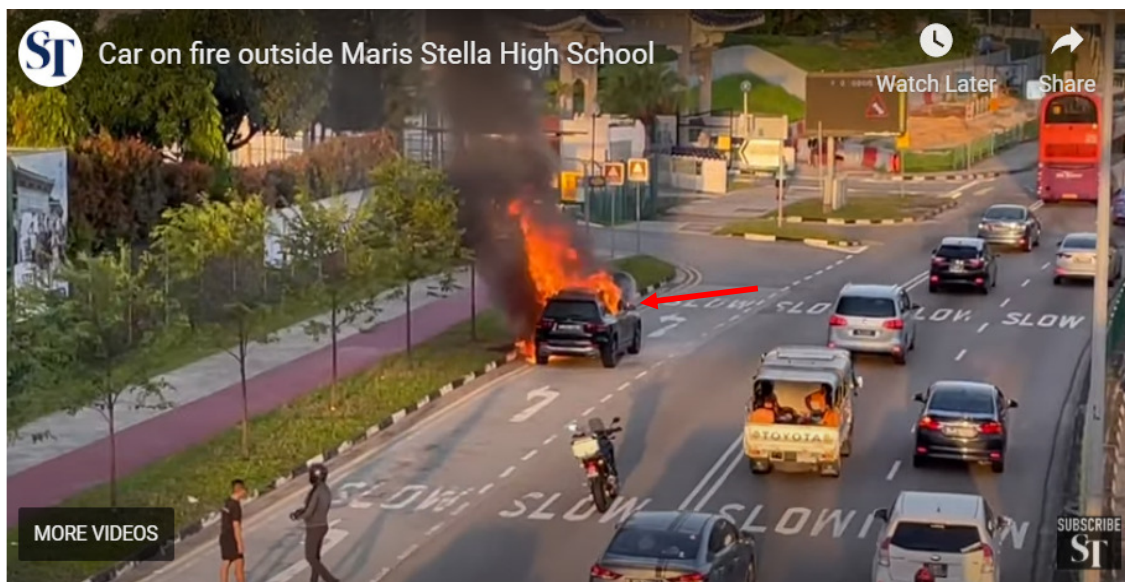
Photo 7 shows the Insured Vehicle at the incident scene (photograph extracted from public media website). The fire that had eventually engulfed the Insured Vehicle can be first seen coming out from the interior compartment of the Insured Vehicle before spreading to the rear portion and engine compartment of the Insured Vehicle. Notably, no fire was seen from the engine compartment area (red arrow) of the Insured Vehicle at the initial stage of the fire. The rear portion can also be clearly seen to be unaffected at the initial stage of the fire. The collective information gathered would suggest to me that the fire had originated from the interior compartment of the Insured Vehicle.

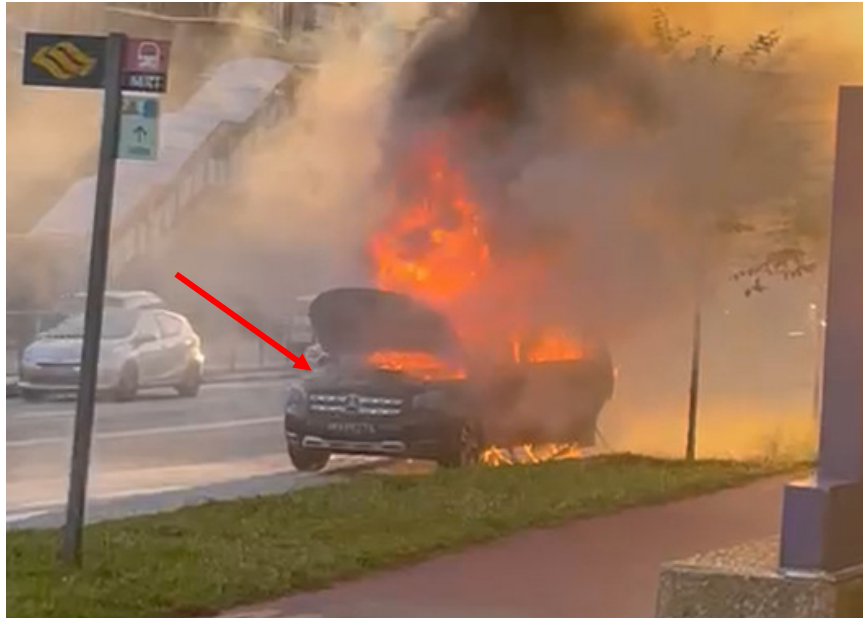
Photo 8 shows the Insured Vehicle at the incident scene (screenshot extracted from the video recording provided by Madam Quek). No fire was seen from the engine compartment area (red arrow) of the Insured Vehicle at the initial stage of the fire. In fact, the frontal portion of the Insured Vehicle was seen to be unaffected even after the fire started spreading.

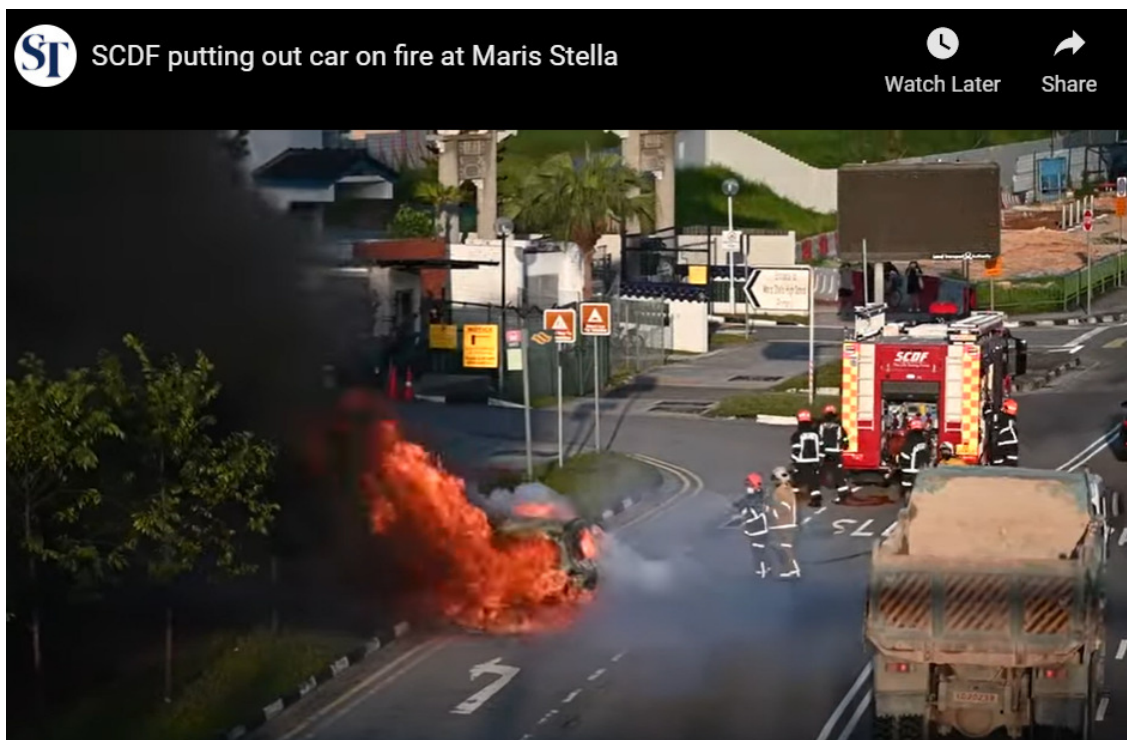
Photo 9 shows the Insured Vehicle at the incident scene (photograph extracted from public media website). The fire that had first originated from the interior compartment of the Insured Vehicle eventually engulfed the Insured Vehicle.

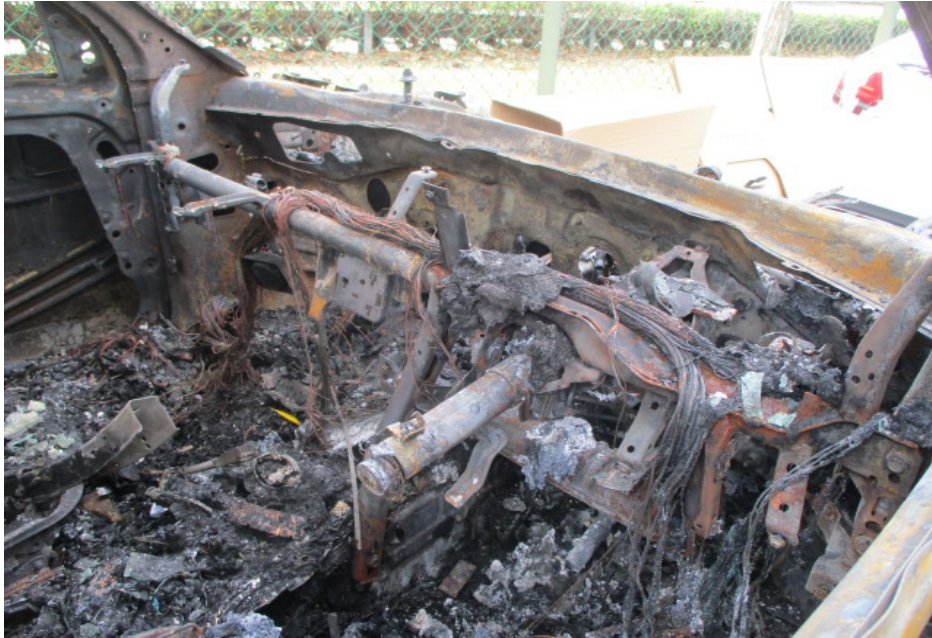
21. In this aspect, the main cause of fire originating from the interior compartment of a vehicle is typically fire of electrical nature (electrical fault) whereby wirings within the interior compartment had experienced an abnormality of electrical current along its circuitry path. Madam Quek had stated that she smelt rubber burning smell and saw white smoke coming out from the aircon vents of the Insured Vehicle. This would suggest that the wirings behind the front dashboard of the Insured Vehicle had possibly experienced an abnormal spike in electrical current. This created excessive heat and/or continuous electrical arcing along the stretch of wirings leading to the melting of wire insulations. A fire then ignited when the surrounding air becomes energised by the exposed electrical arcing.

22. For this case, the wirings behind the front dashboard of the Insured Vehicle were all completely burned to its bare copper state. Because of this, I was not able to determine the electrical fault had occurred along which wiring(s). Refer to photograph 10 & 11 below.

Photo 10 shows the front dashboard area of the Insured Vehicle at the time of my inspection. The fire to the Insured Vehicle was likely to be of electrical nature (electrical fault) originating from one or more of the wirings located behind the front dashboard of the Insured Vehicle. However, given that the wirings behind the front dashboard were all completely burned to its bare copper state, I was not able to determine the electrical fault had occurred along which wiring(s).

25. For this case, I am of the view that the fire had originated within the interior compartment of the Insured Vehicle. The cause of fire was of electrical in nature. The wirings behind the front dashboard of the Insured Vehicle had likely experienced an abnormality of electrical current, which led to the fire.

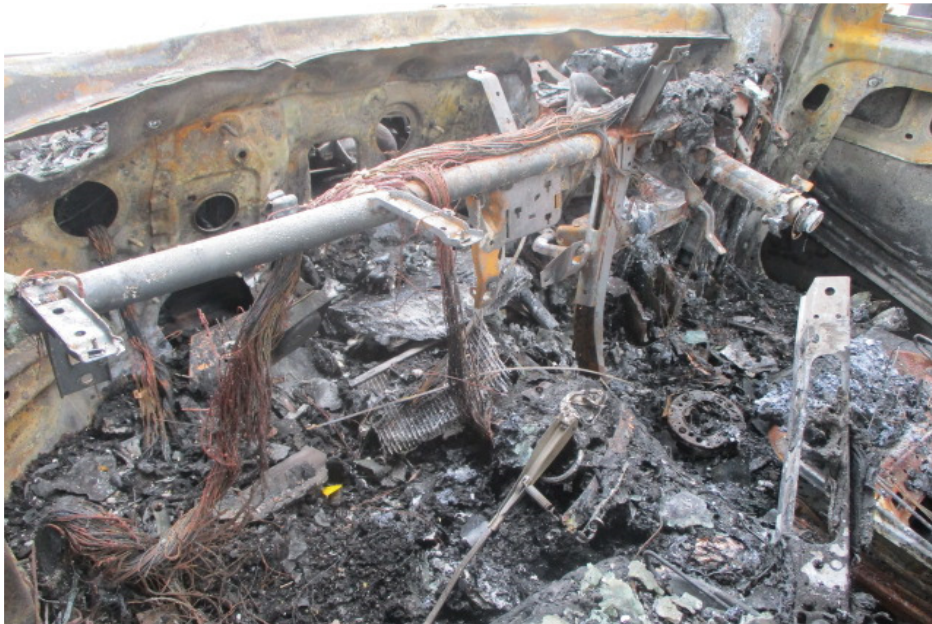
Photo 11 shows another view of the front dashboard area of the Insured Vehicle at the time of my inspection. The wirings behind the front dashboard of the Insured Vehicle were all completely burned to its bare copper state. Because of this, I was not able to determine the electrical fault had occurred along which wiring(s).
