**SURVEY OF VEHICLE NO. SKT 9114K**

## AUTOMOBILE ASSESSMENT REPORT

**Assessment of Vehicle No** : **SKT 9114K**  
**Date of Accident** : **23-December-2017**  
**Date of Inspection** : **27-December-2017**  
**Address of Inspection** : **2 Kaki Bukit Ave 2 #01-17 S'417921**

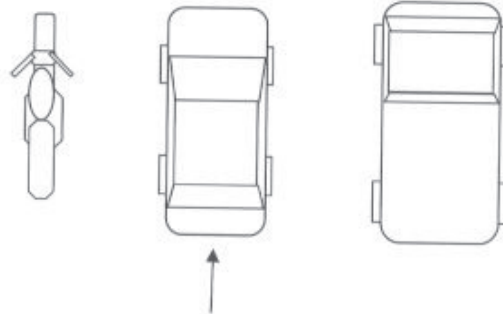
At the time of inspection, this vehicle sustained damages to the **Rear** portion. Please see attached scheduled for details.
