Your Ref : SNM22D200710/C02  
Our Ref : CS/CTI22001018/P

**AUTOMOBILE TECHNICAL INVESTIGATION REPORT OF ACCIDENT  
INVOLVING SLP 1327A AND YP 5020D ON 16 January 2022**

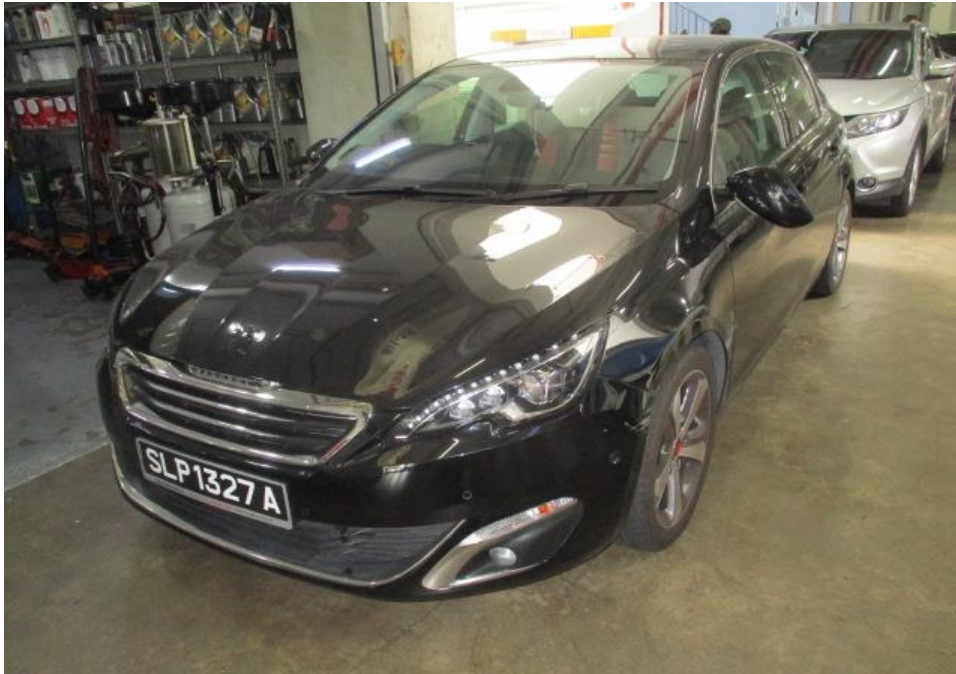
**Photo 1** shows the general view of the front left portion of Car at the time of inspection. The front left side bumper and front left fender and its left rear view mirror had been damaged on the Car. It was also noted that there were scratched marks and paint transfer marks on the front bumper left portion, front left fender, front left wheel rim and tyre as well as its left rear view mirror was scratched and dislodged off as a result of the incident.

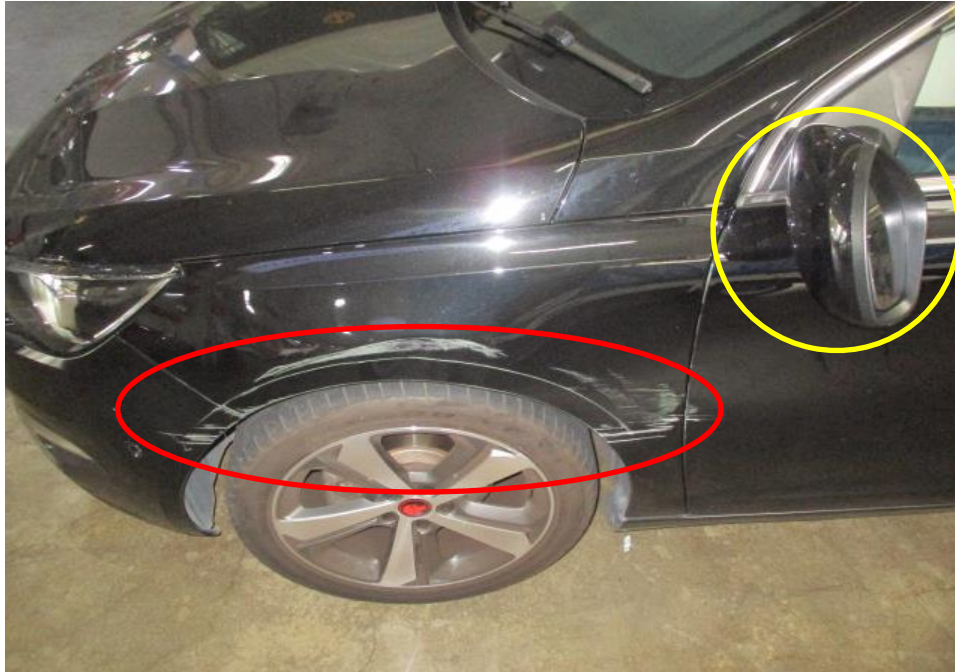
**Photo 2** shows the close up view of the front left portion of Car at the time of inspection. The front bumper left portion, front left fender and front left rear view mirror had been damaged. It was also noted that there were scratched marks and paint transfer marks on the front bumper left portion, front left fender, front left wheel rim and tyre (red circle) as well as its left rear view mirror (yellow circle) was also scratched and dislodged off the Car.

17. We also note that the scratches sustained on the front left portion of the Car appears to be of a slight grey and greenish color which was the same color as the body part at the rear right portion of the Insured Vehicle. This is the body part on the Insured Vehicle that had likely hit and scrape onto the Car which had resulted on the paint transfer marks and scratches on the Car. See photo 2 - 6 above as compared to photo 7 & 8 above.

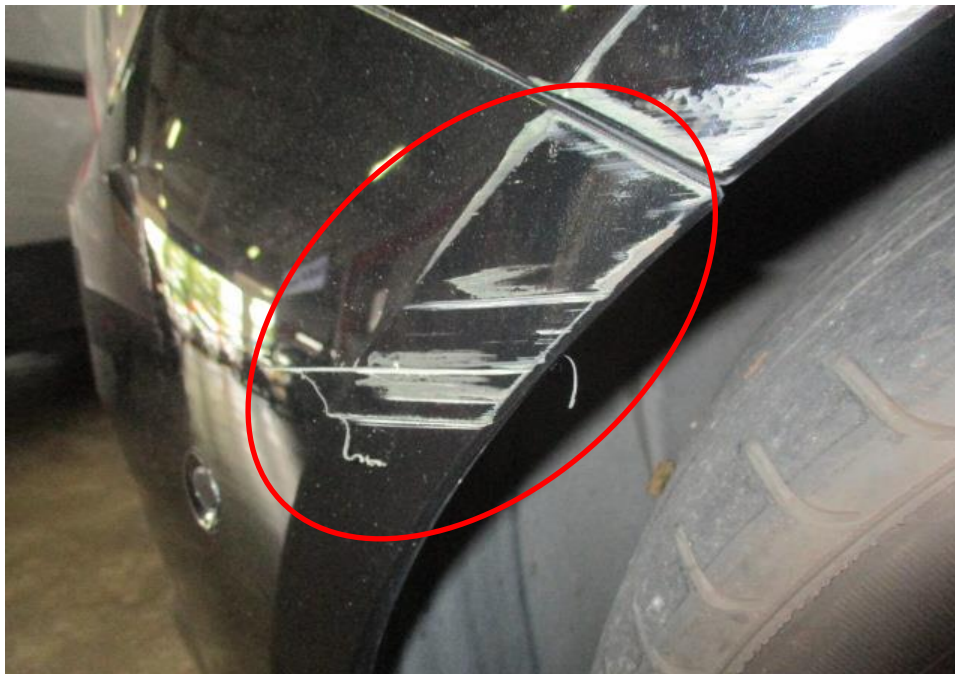
**Photo 3** shows the close up view of the front bumper left portion of Car at the time of inspection. The front bumper left portion had been damaged. It was also noted that there were scratched marks and paint transfer marks (circled) on it.

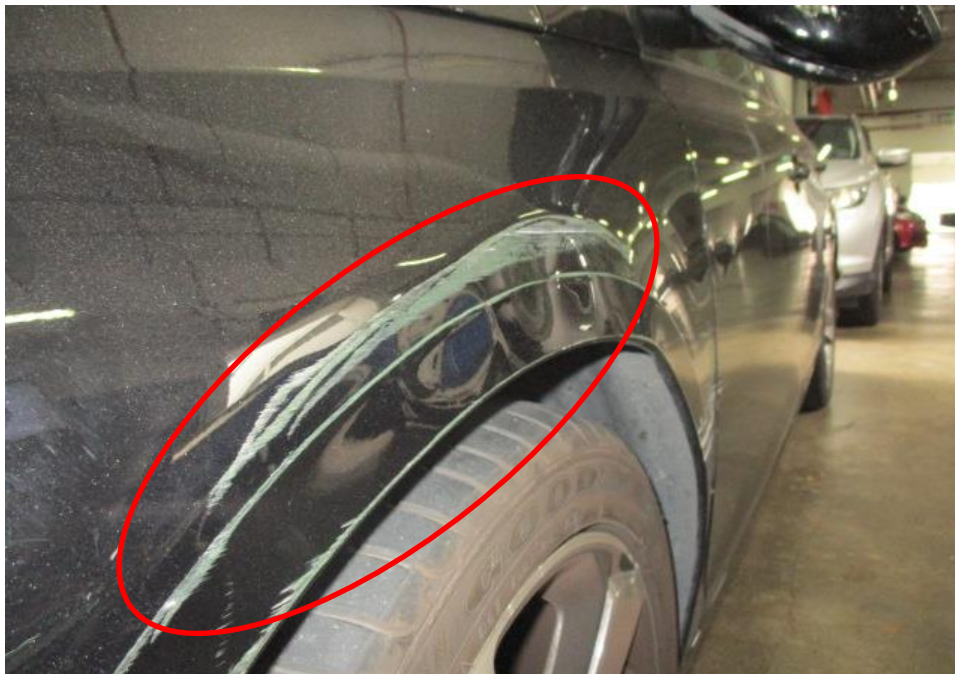
**Photo 4** shows the close up view of the front left fender portion of Car at the time of inspection. The front left bumper portion had been damaged. It was also noted that there were scratched marks and paint transfer marks (circled) on it.

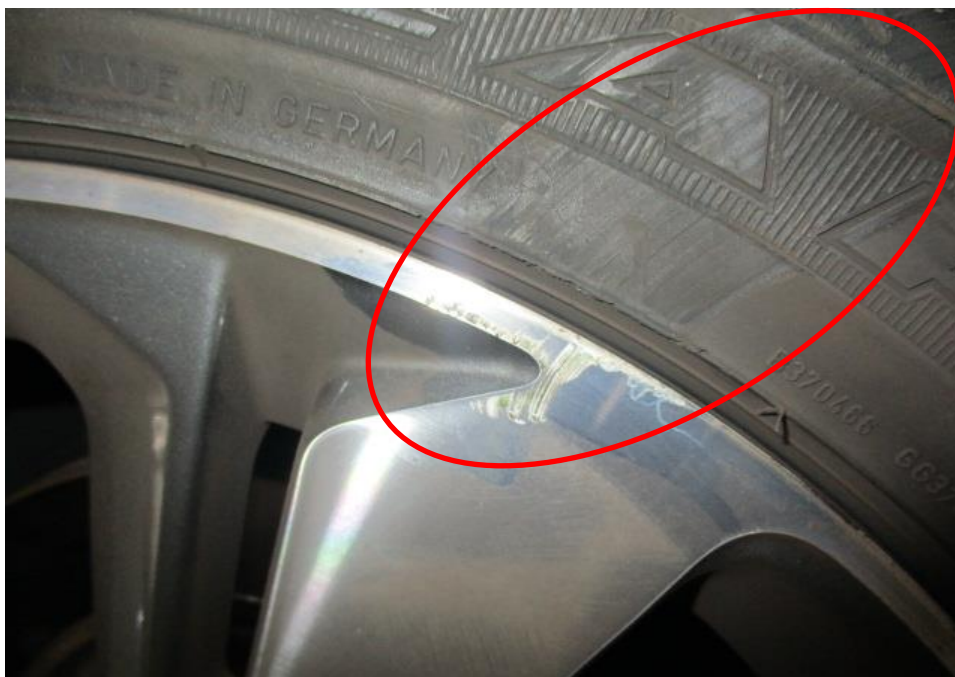
**Photo 5** shows the close up view of the front left wheel rim and tyre of Car at the time of inspection. The front left wheel rim and tyre had sustained damages. It was also noted that there were scratched marks and paint transfer marks (circled) on it.

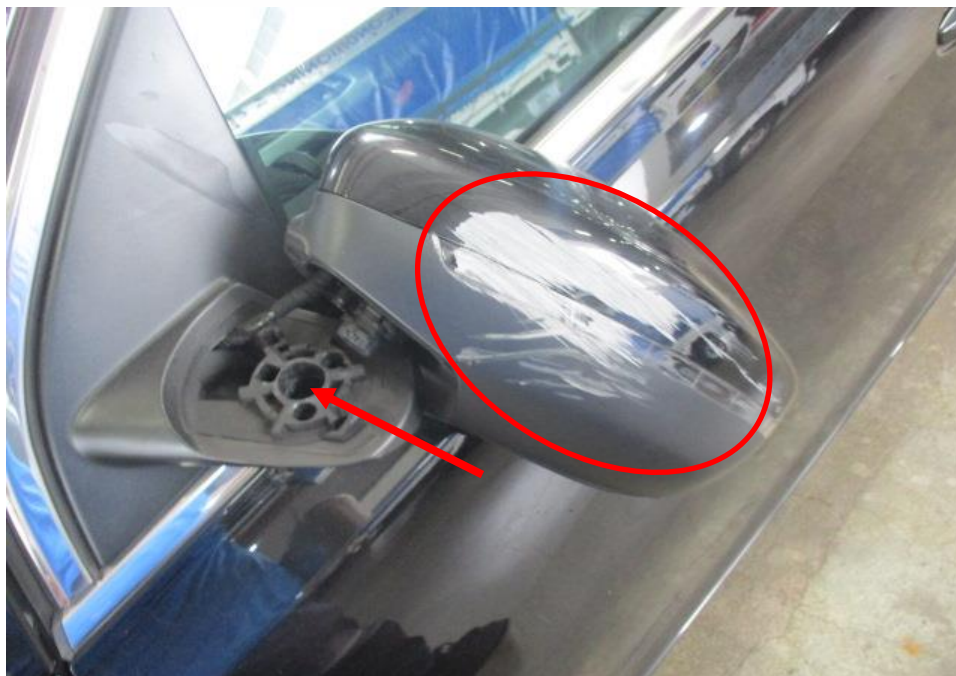
**Photo 6** shows the close up view of the front left rear view mirror of Car at the time of inspection. The front left rear view mirror had been damaged. It was also noted that there were scratched marks and paint transfer marks (circled) and it was dislodged off (arrowed).

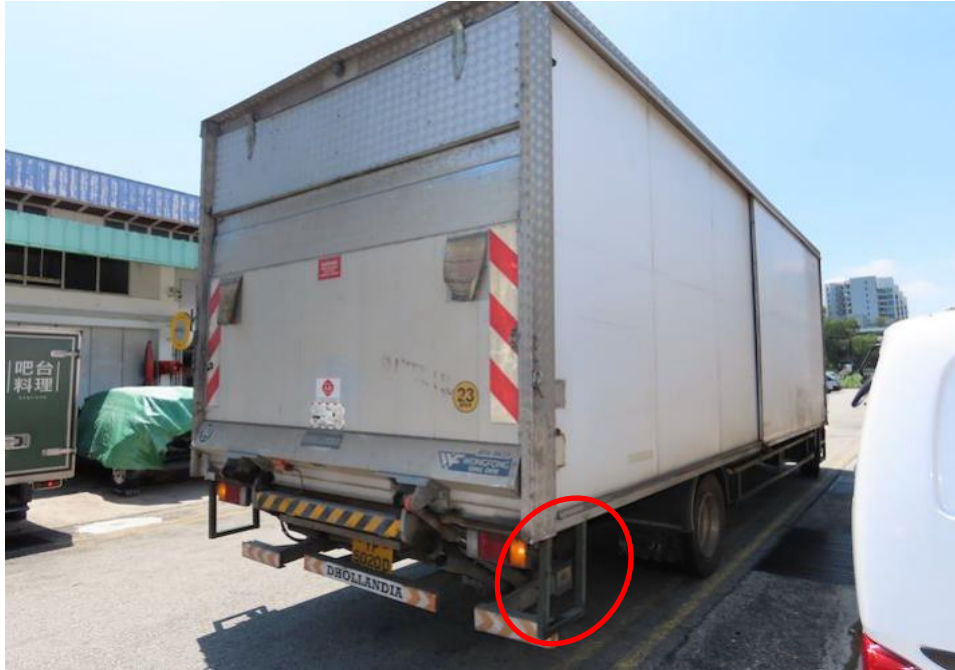
**Photo 7** shows the general view of the right-side rear portion of Insured Vehicle at the time of inspection. We are of the opinion that the possible point of contact of Insured Vehicle would be at its right side rear portion (circled) since Insured Vehicle was on the left side and in front of the Car and drove into the Car from the left side at the mentioned point of collision.

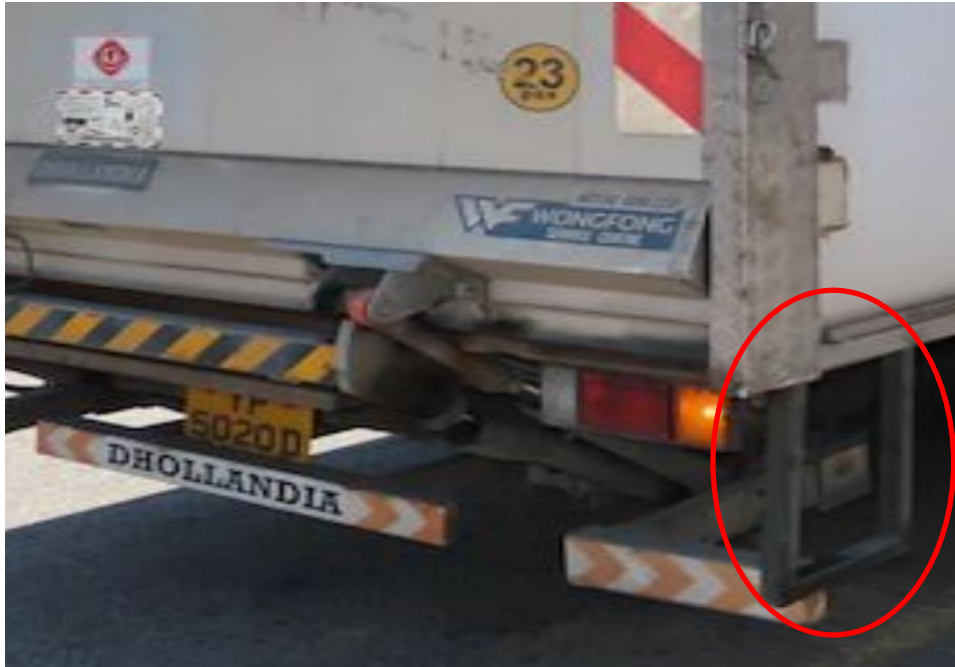
**Photo 8** shows the close up view of the right side rear portion of Insured Vehicle at the time of inspection. We are of the opinion that the possible point of contact of Insured Vehicle would be at its right side rear portion (circled) since Insured Vehicle was on the left side and in front of the Car and drove into the Car from the left side at the mentioned point of collision.

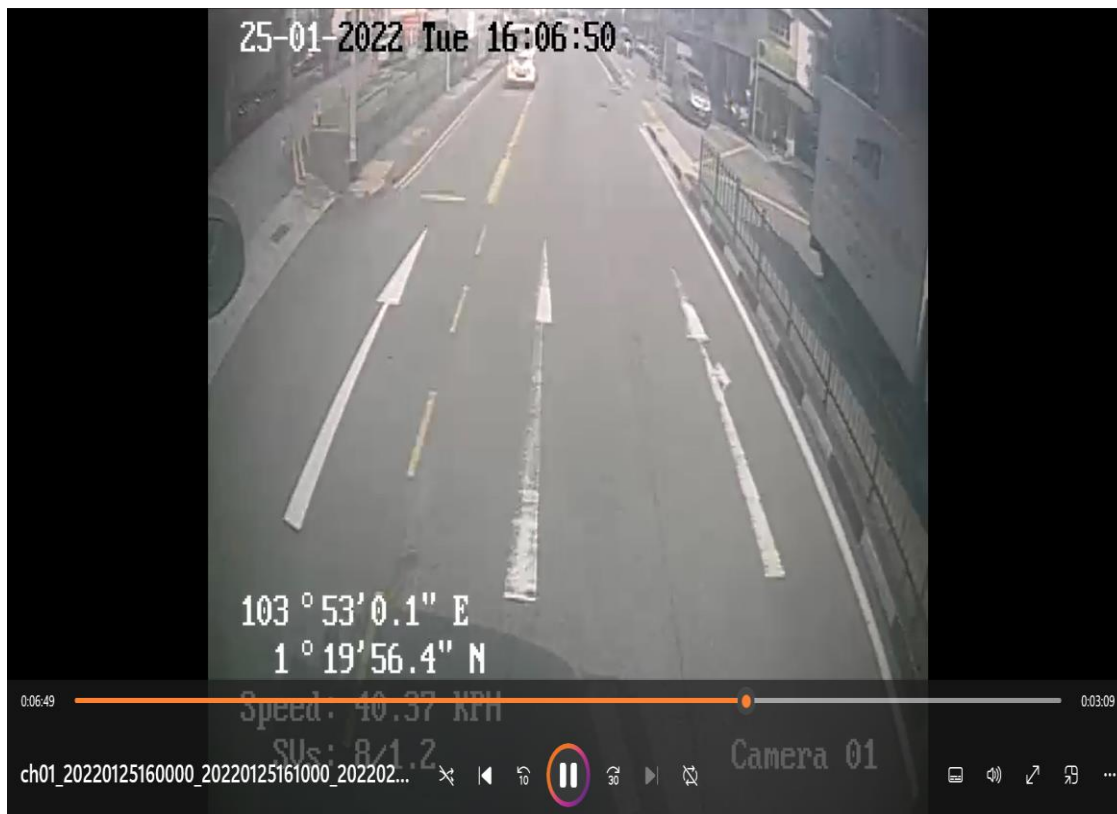
**Screenshot 1** shows at the 1606hrs 50 second mark of the video recording, we had noted that Insured Vehicle was travelling on lane 2 out of 3 lanes along Macpherson Road.

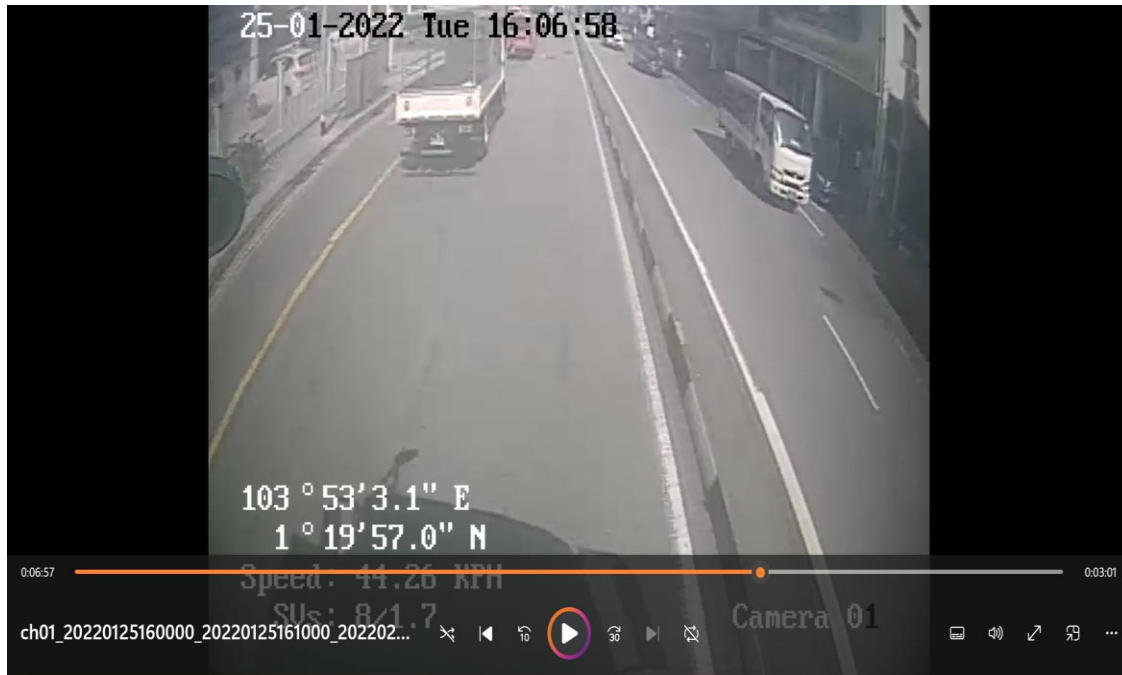
**Screenshot 2** shows at the 1606hrs 58 second mark of the video recording, we had noted that Insured Vehicle had did a lane change from lane 2 into lane 1.

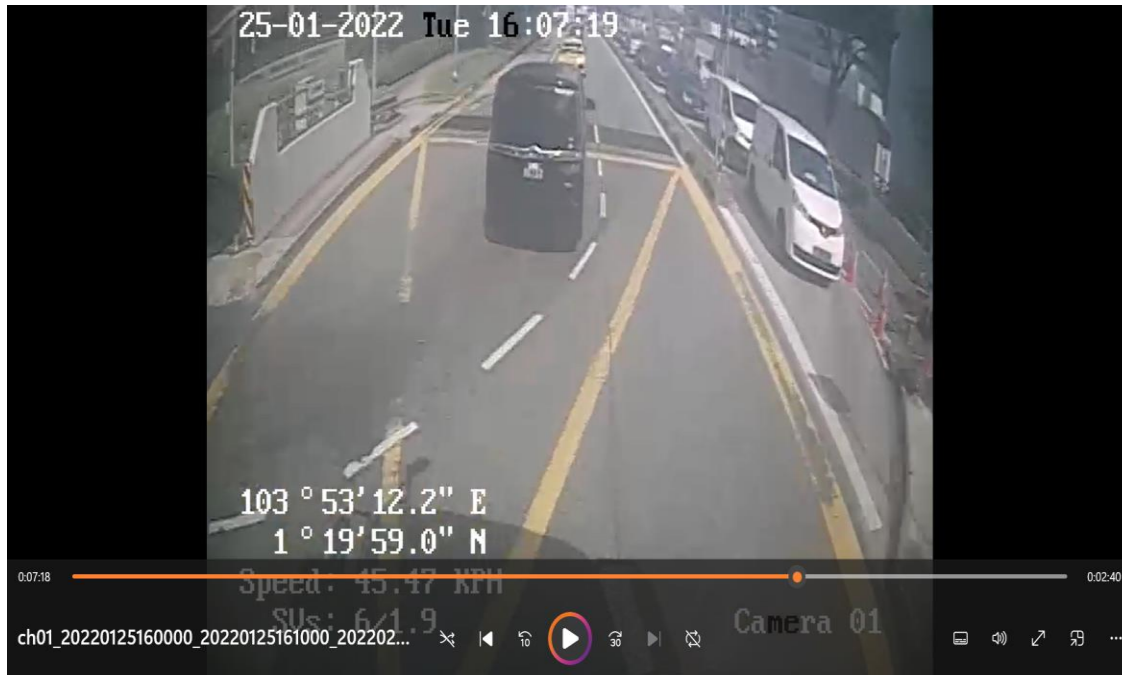
**Screenshot 3** shows at the 1607hrs 19 second mark of the video recording, we had noted that Insured Vehicle had did a lane change from lane 1 into lane 2.

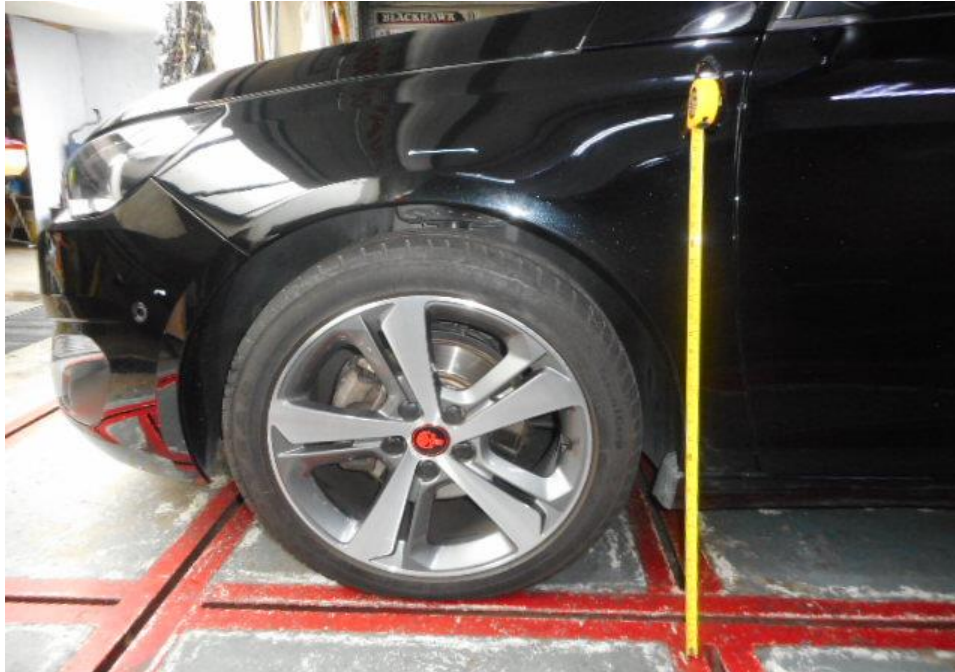
**Photo 9** shows a general view of the height measurement being conducted on the front left portion of Car. The front bumper left portion to the front left fender where the scratched marks is was measured to be from 53cm to 73cm above ground level.

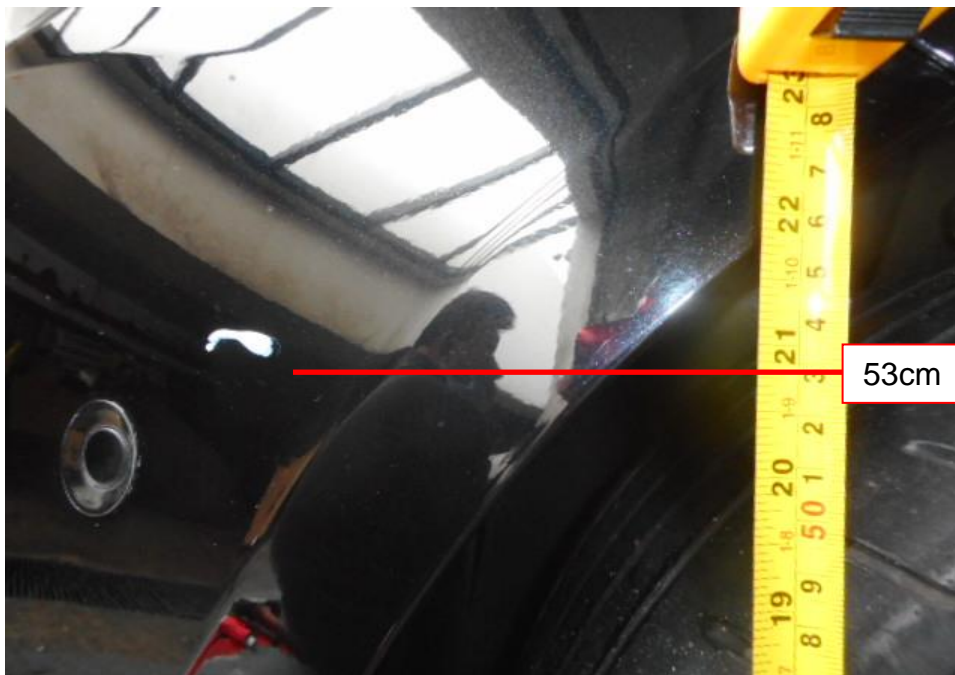
**Photo 10** shows the close up view of the height measurement being conducted on the front portion of Insured Vehicle. The front bumper left portion to the front left fender where the scratched marks is was measured to be from 53cm to 73cm above ground level.

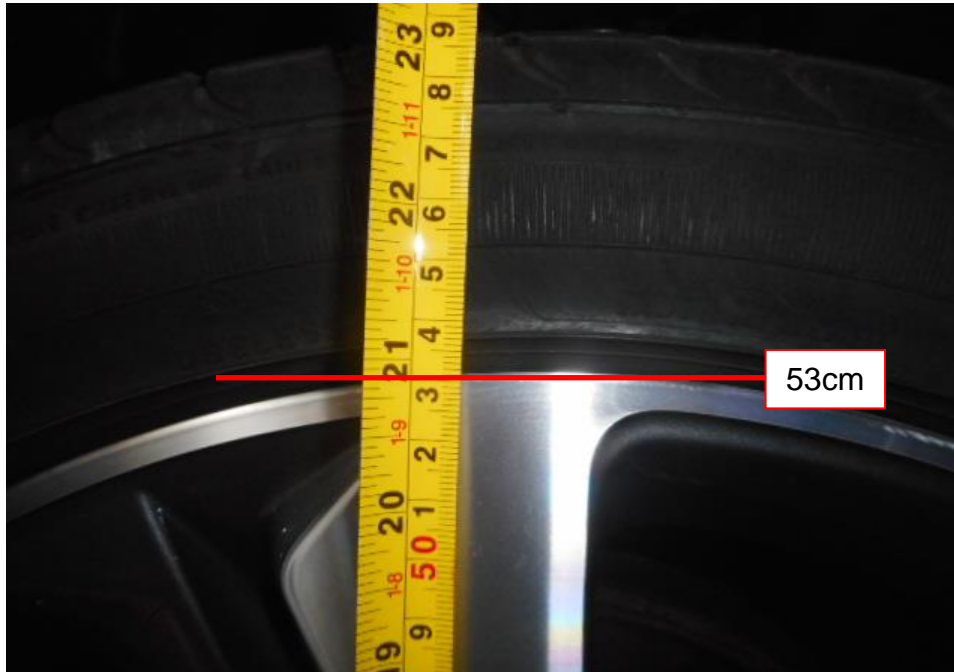
**Photo 11** shows the close up view of the height measurement being conducted on the front left wheel rim and tyre portion of Insured Vehicle. The front left wheel rim and tyre where the scratched marks is was measured to be from 53cm to 73cm above ground level.

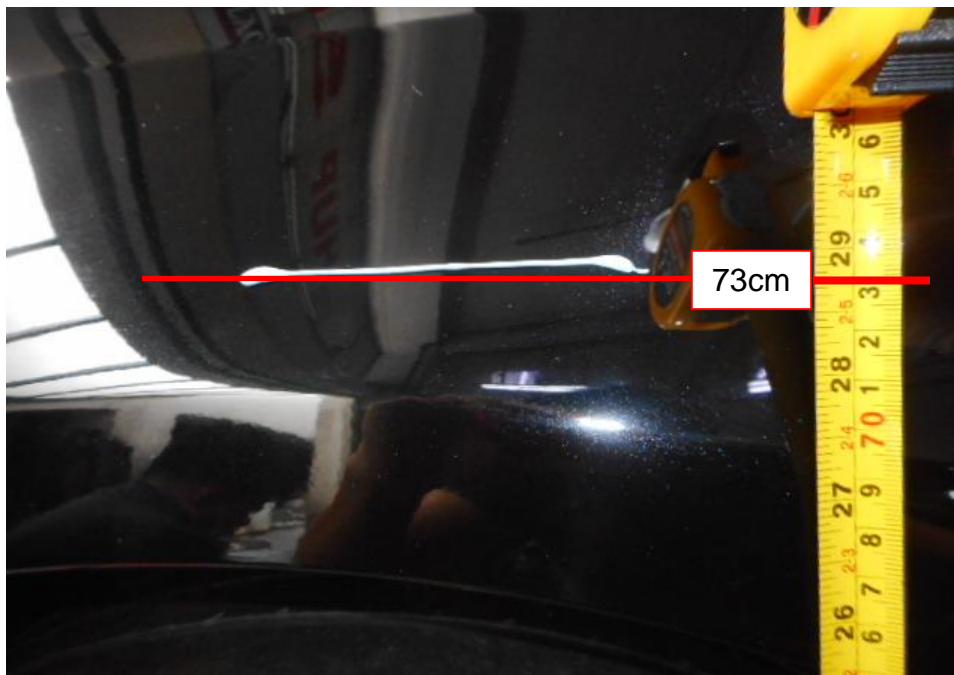
**Photo 12** shows the close up view of the height measurement being conducted on the front portion of Insured Vehicle. The front bumper left portion to the front left fender where the scratched marks is was measured to be from 53cm to 73cm above ground level.

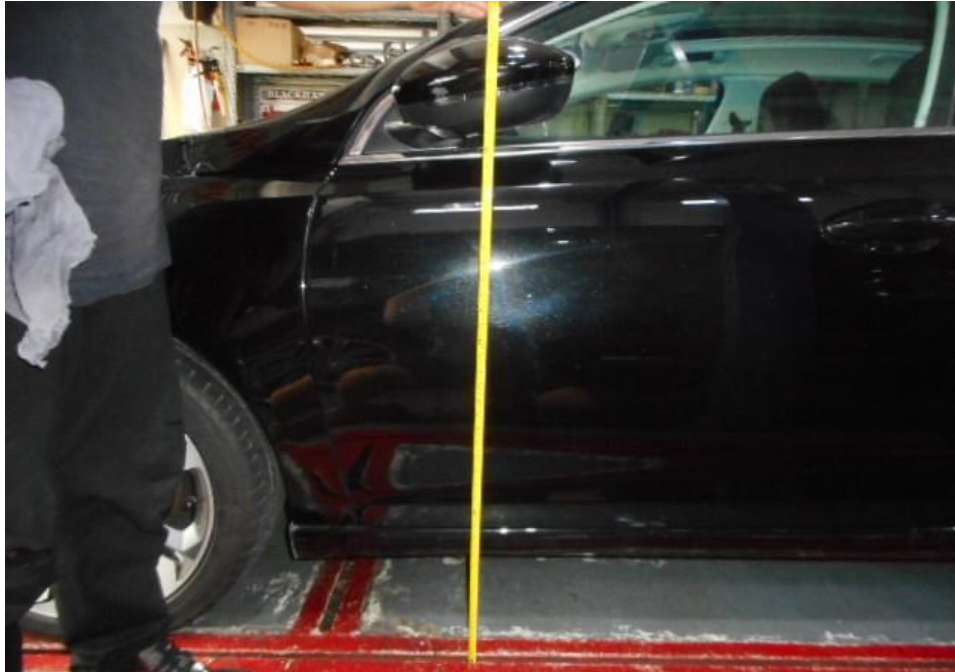
**Photo 13** shows a general view of the height measurement being conducted on the front left portion of Car. The front left rear view mirror where the scratched marks is was measured to be at 99cm to 102cm above ground level.

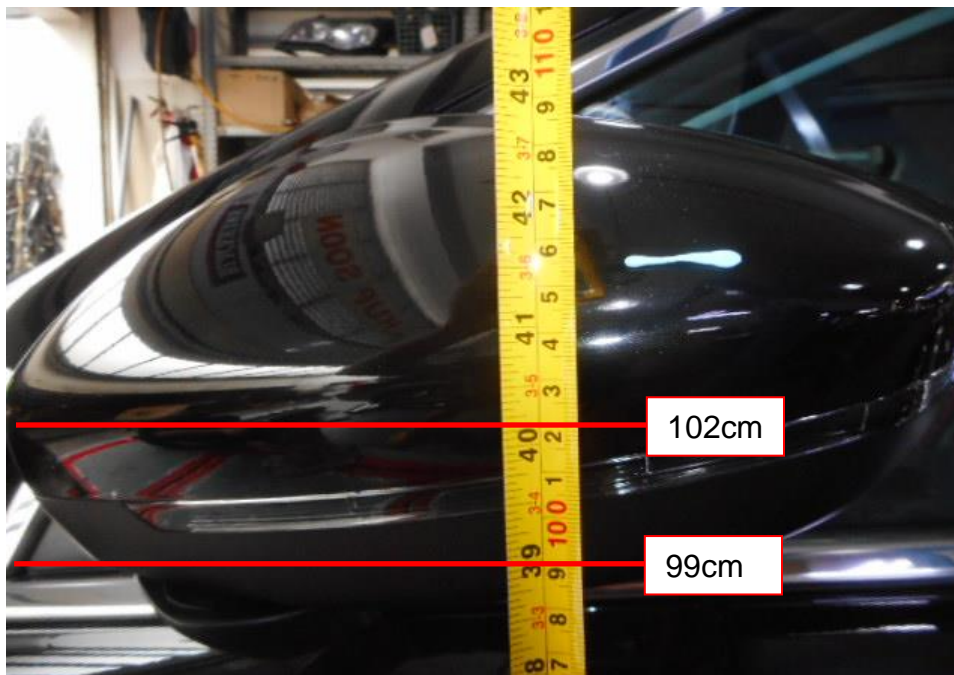
**Photo 14** shows the close up view of the height measurement being conducted on the front left portion of Car. The front left rear view mirror where the scratched marks is was measured to be at 99cm to 102cm above ground level.

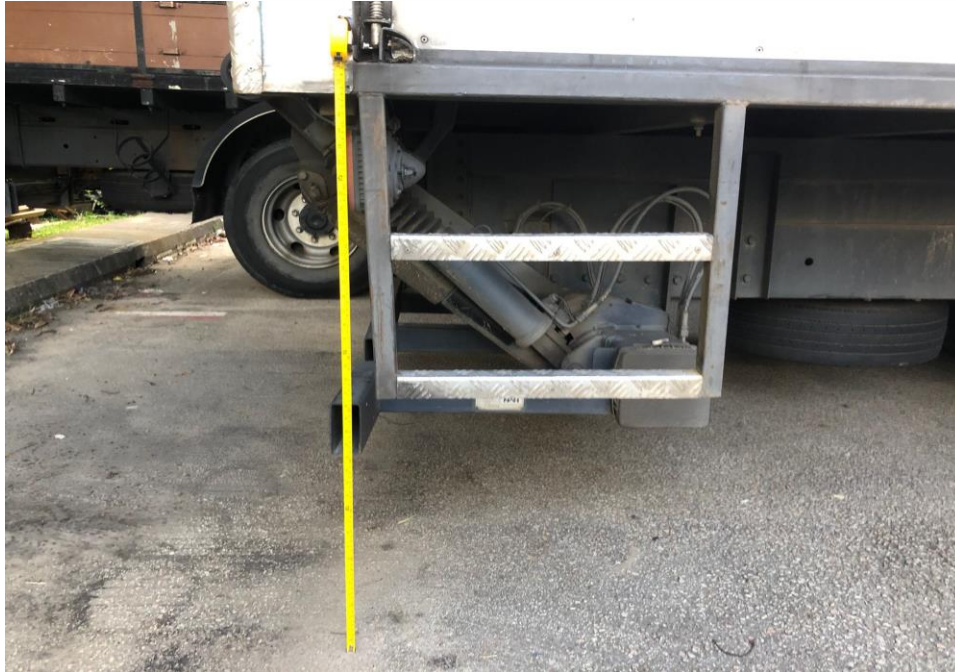
**Photo 15** shows the general view of the height measurement being conducted on the rear right portion of Insured Vehicle. The height above ground level from 53cm to 73cm and 99cm to 102cm is where the possible damages height of the Car compared to the Insured Vehicle.

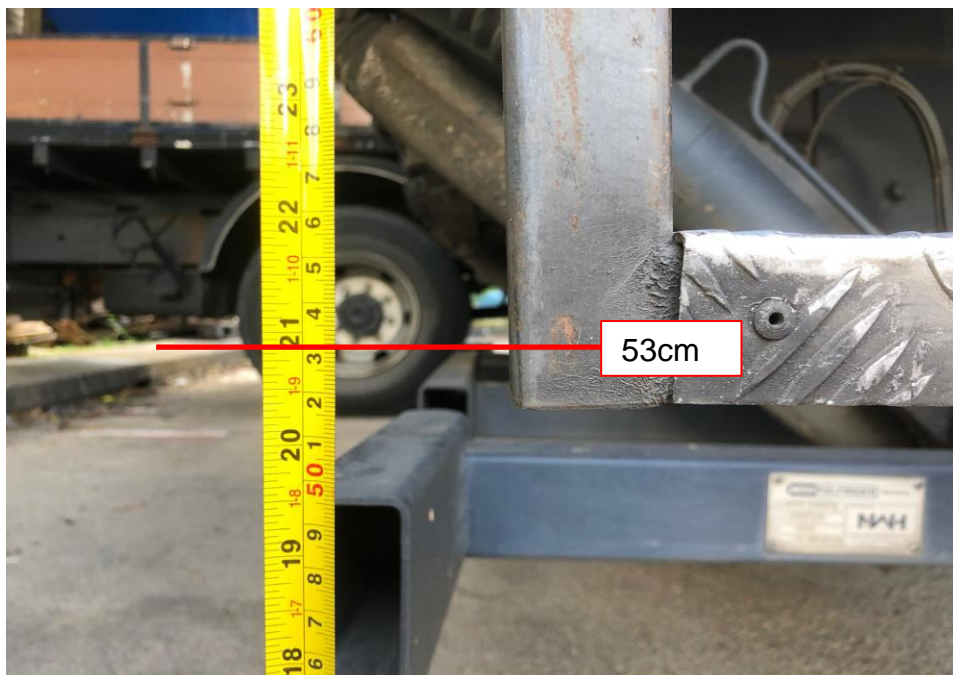
**Photo 16** shows the close up view of the height measurement being conducted on the rear right portion of Insured Vehicle. The height above ground level of where the scratched marks damage that were found from the front bumper left portion, the front left wheel rim and tyre and the front left fender of the Car was between 53cm to 73cm as compared to the rear right portion of the Insured Vehicle.

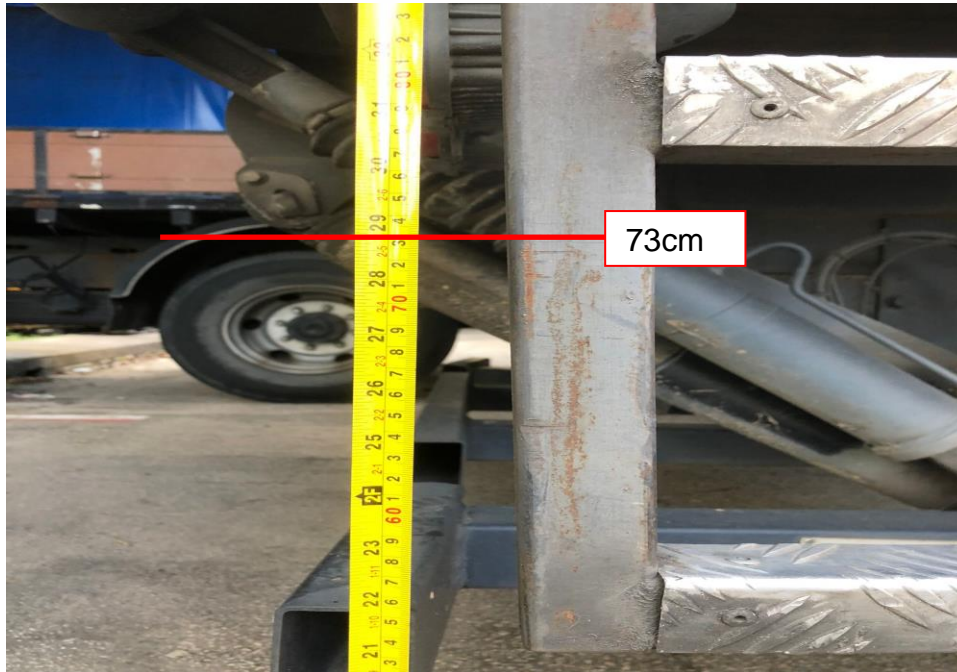
**Photo 17** shows the close up view of the height measurement being conducted on the rear right portion of Insured Vehicle. The height above ground level of where the scratched marks damage that were found from the front bumper left portion, the front left wheel rim and tyre and the front left fender of the Car was between 53cm to 73cm as compared to the rear right portion of the Insured Vehicle.

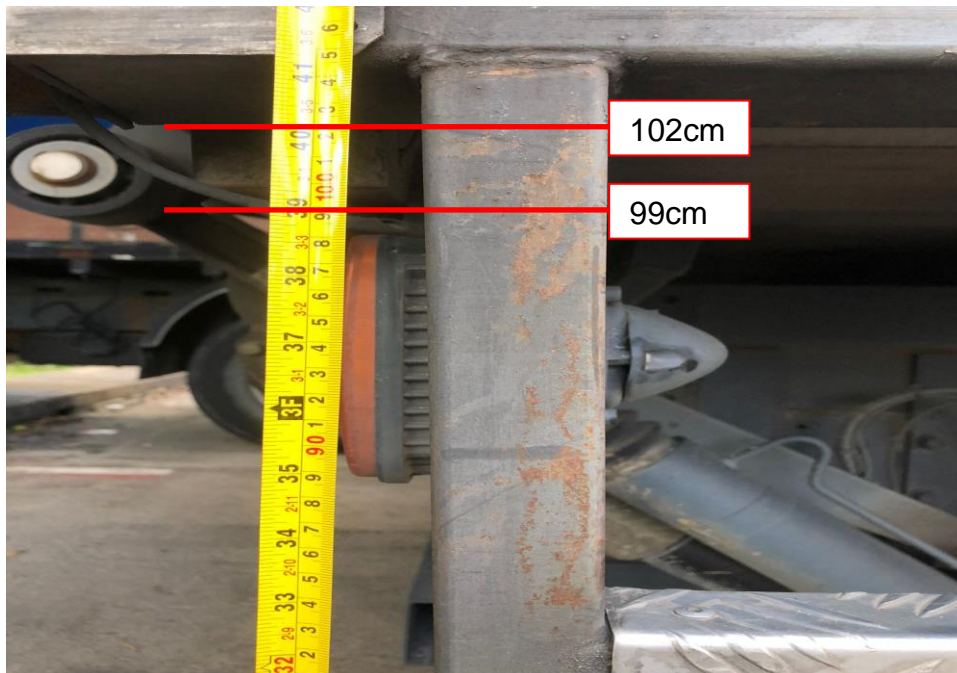
**Photo 18** shows the close up view of the height measurement being conducted on the rear right portion of Insured Vehicle. The height above ground level of where the scratched marks damage that were found from the front left rear view mirror of the Car was between 99cm to 102cm as compared to the rear right portion of the Insured Vehicle.
