Your Ref: 4192902740SG
Our Ref : CS4/AIG22001055/N

21 February 2022

**TECHNICAL INVESTIGATION REPORT OF FIRE INCIDENT INVOLVING THE
INSURED VEHICLE GBF 9147X ON 27 JANUARY 2022**

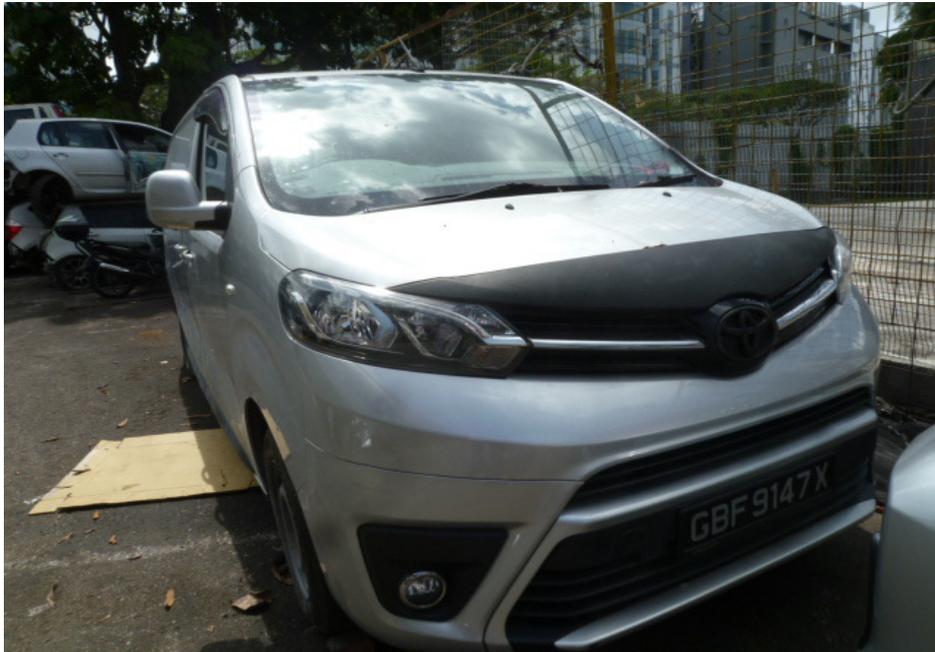
Photo 1 shows the general view of the frontal portion of the Insured Vehicle at the time of our inspection. The fire damage was confined to its interior compartment and undercarriage. The exterior portion of the Insured Vehicle was observed to be relatively unaffected by the fire.

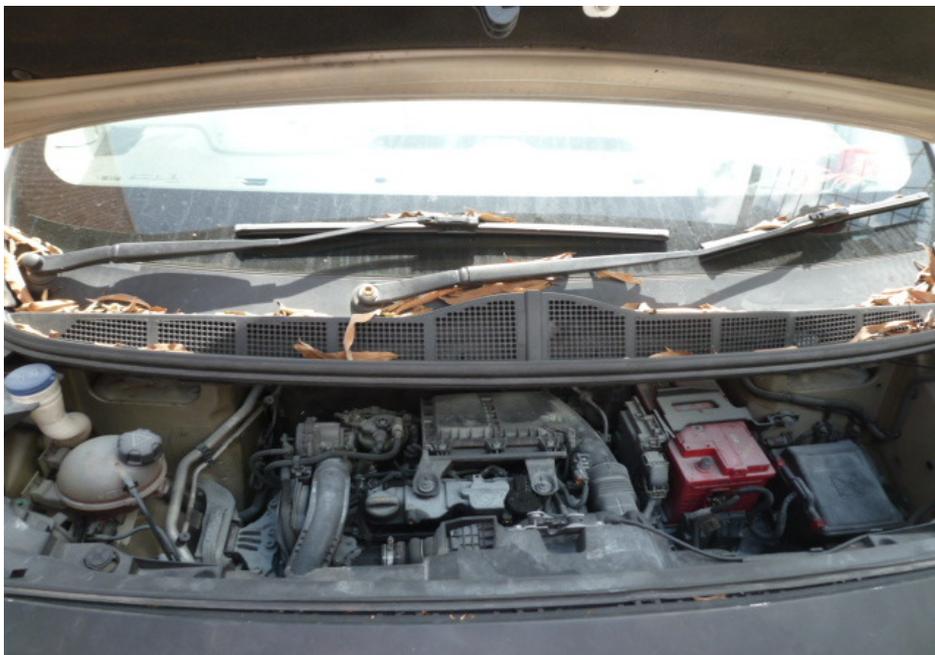
Photo 2 shows the general view of the engine compartment of the Insured Vehicle at the time of our inspection. The fire damage was confined to its interior compartment and undercarriage. The engine compartment of the Insured Vehicle was observed to be relatively unaffected by the fire.

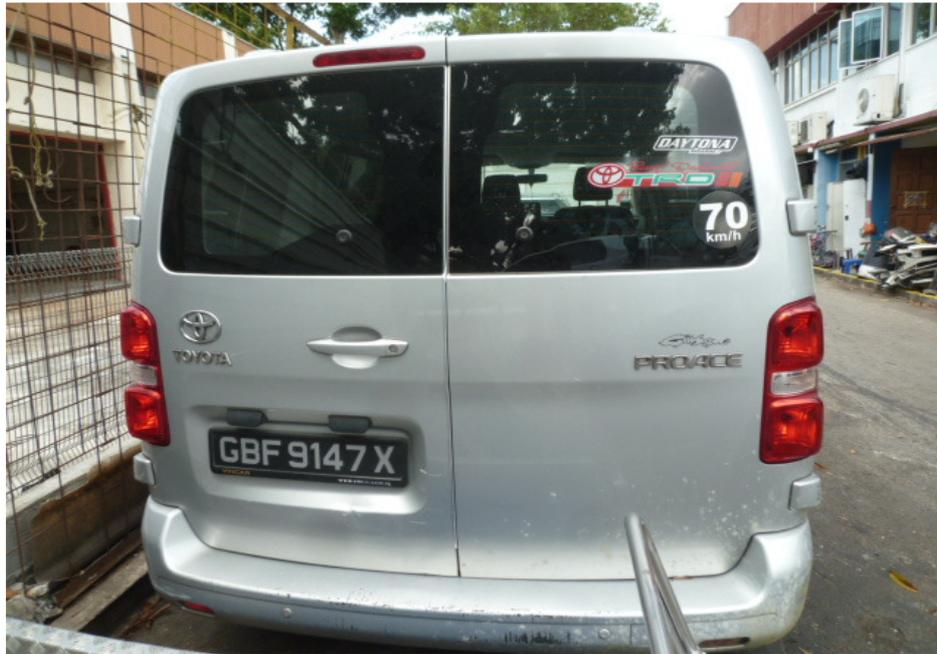
Photo 3 shows the general view of the rear portion of the Insured Vehicle at the time of our inspection. The fire damage was confined to its interior compartment and undercarriage. The exterior portion of the Insured Vehicle was observed to be relatively unaffected by the fire.

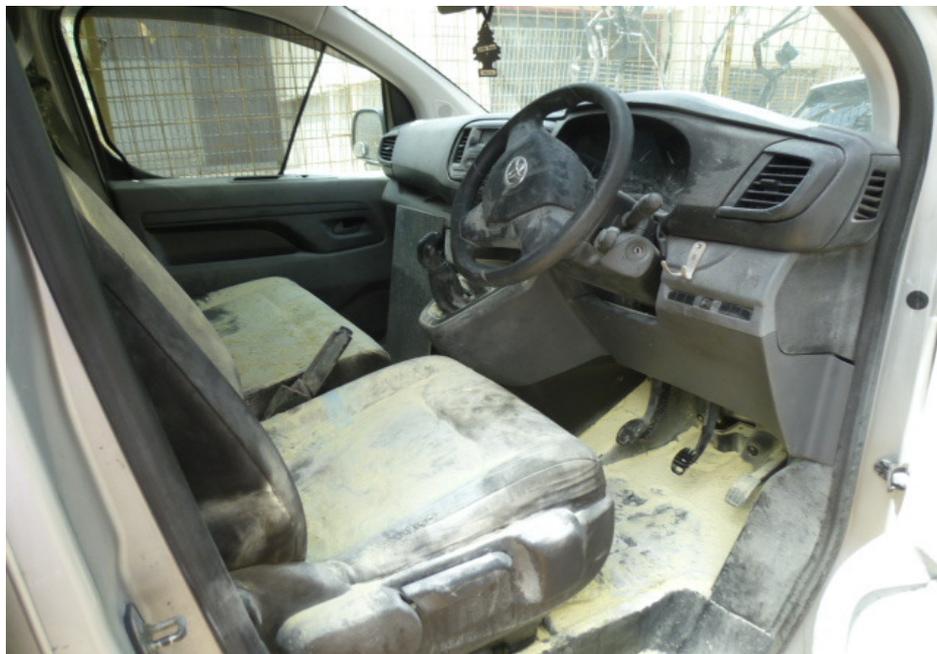
Photo 4 shows the interior compartment of the Insured Vehicle, which was observed to be relatively unaffected by the fire with the exception of the seats.

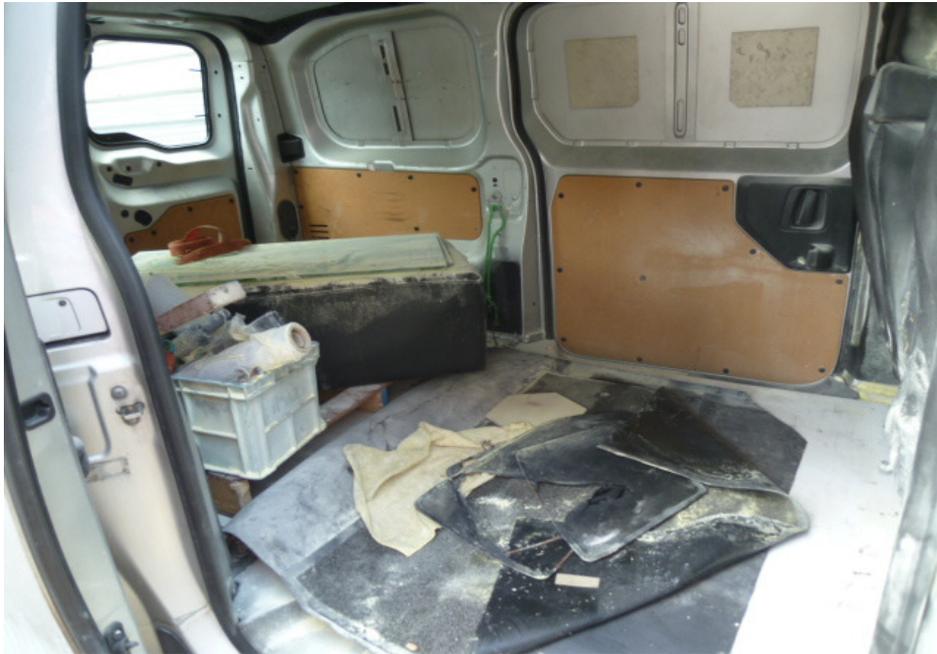
Photo 5 shows the rear cabin of the Insured Vehicle, which was observed to be relatively unaffected by the fire, with the exception of the seats.

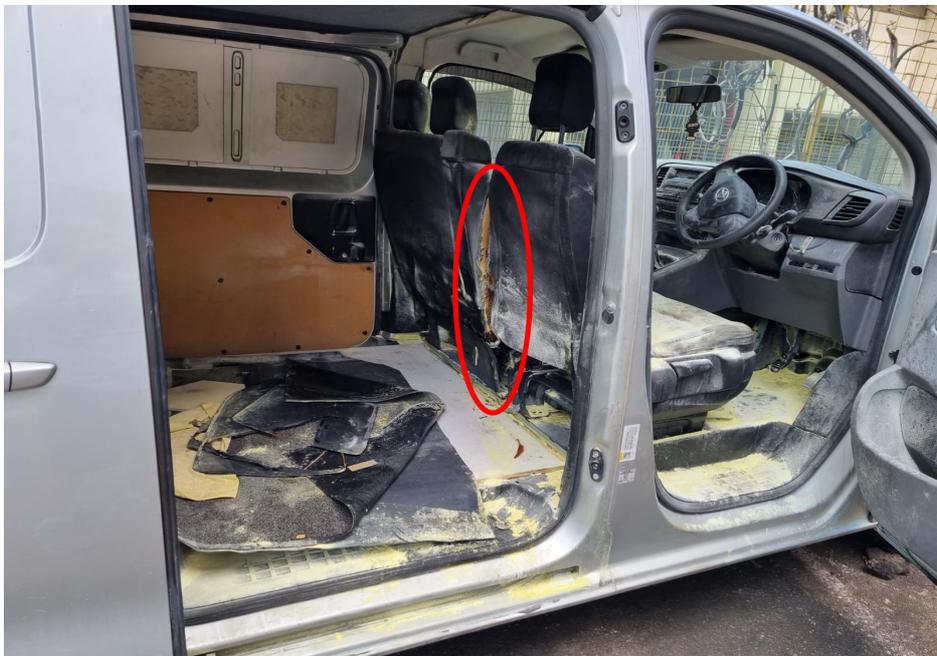
Photo 6 shows the seats of the Insured Vehicle which were observed to be partially burnt and/or melted as a result of the fire (circled).

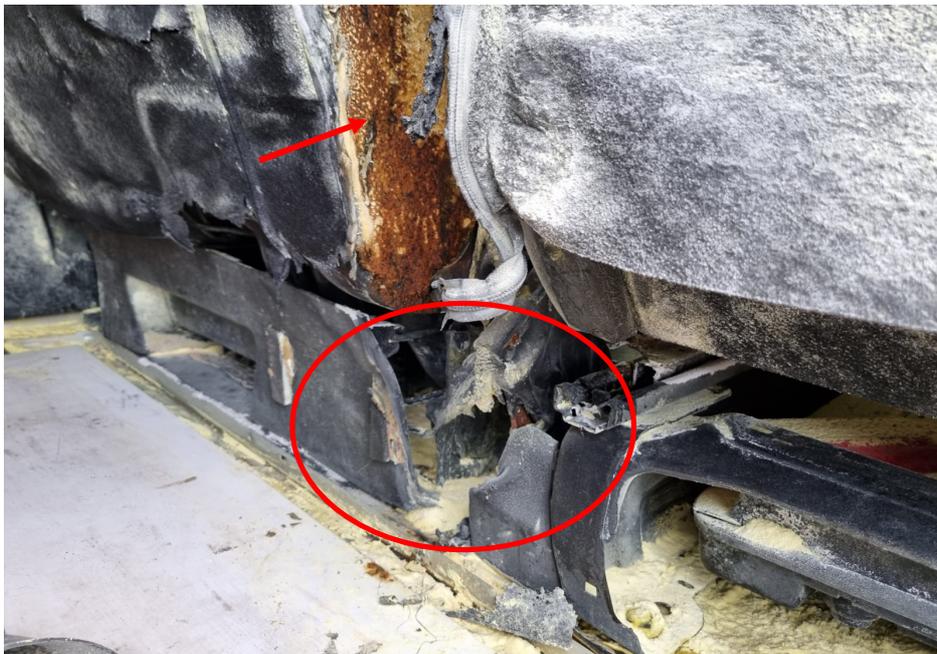
8. Basing on the circumstances of the fires' origin at the material time of incident as well as examining the area where the extent of fire damage was most severe, we can determine that the fire had likely started from the undercarriage of the Insured Vehicle. This can be observed from the burnt seats and insulating material near the seats of the Insured Vehicle. See photo 7 below.

Photo 7 shows a close up view of the burnt seats (arrowed) and insulating material near the seats (circled) which appears to indicate that the fire may have originated from the undercarriage of the Insured Vehicle.

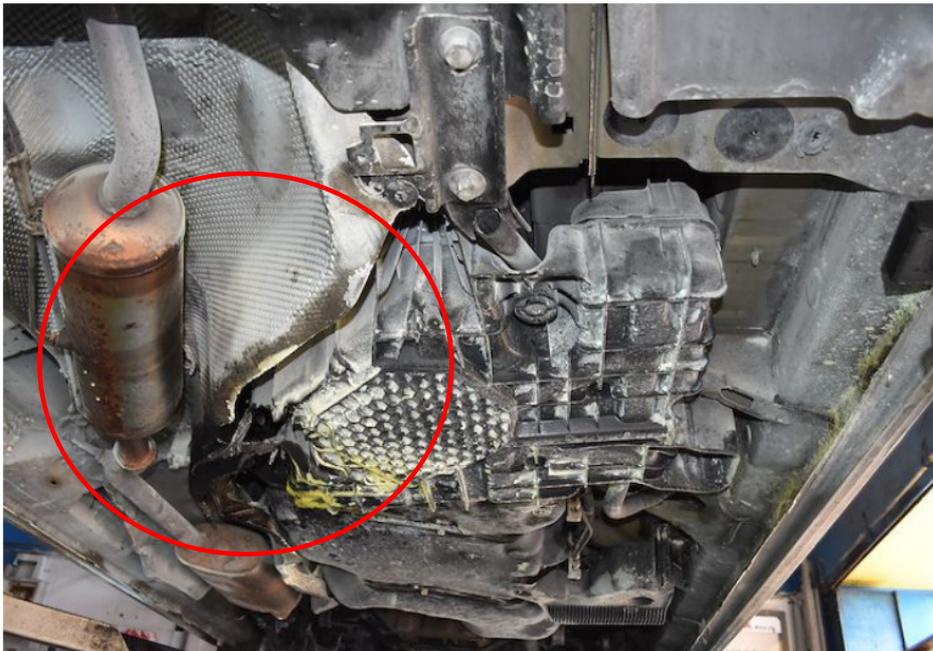
9. For this particular case, the DPF warning light was displayed on the dashboard of the Insured Vehicle before the incident occurred. To determine the cause of fire, the Insured Vehicle was hoisted for us to have a thorough look of the undercarriage. The fire appears to have originated from the engine oil pan cover of the Insured Vehicle. This can be determined from fire extinguisher residue found on the engine oil pan cover, partially burnt and/or melted parts of the engine oil pan cover, DPF and DPF heat shield as well as burnt wirings. Upon closer examination of the engine oil pan cover, which was where the fire to the Insured Vehicle had likely started, we had found faint traces of greenish residue on several stretches of burnt wirings. The presence of greenish residue indicates internal heating of copper wires, a sign of an electrical short circuit occurring. The greenish residue is normally left behind from oxidation as a result of chemical reaction involving the copper wires. This physical evidence would then appear to suggest that the cause of fire to the Insured Vehicle could have possibly been due to electrical in nature. See photos 8 - 12 below.

Photo 8 shows the Insured Vehicle hoisted for us to have a thorough look of the undercarriage. For this particular case, the fire appears to have originated from the engine oil pan cover of the Insured Vehicle. This can be determined from fire extinguisher residue found on the engine oil pan cover, partially burnt and/or melted parts of the engine oil pan cover, DPF and DPF heat shield as well as burnt wirings (circled).

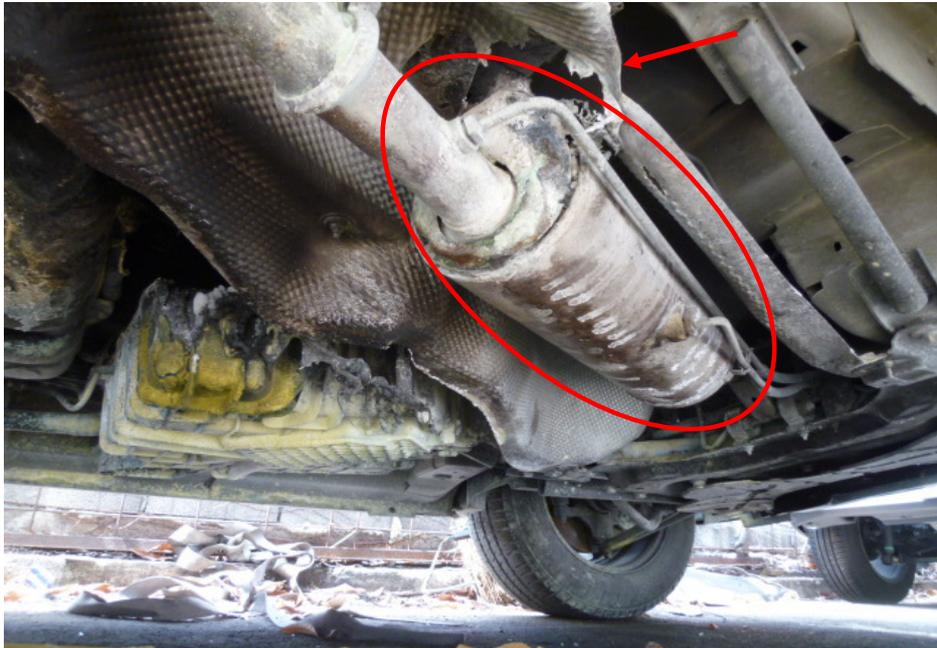
Photo 9 shows a closer view of the partially burnt and/or melted parts of the DPF (circled) and DPF heat shield (arrowed).

22. The fire being due to electrical in nature was most likely a result of the surrounding heat accumulated from increased exhaust temperature caused by a clogged DPF.

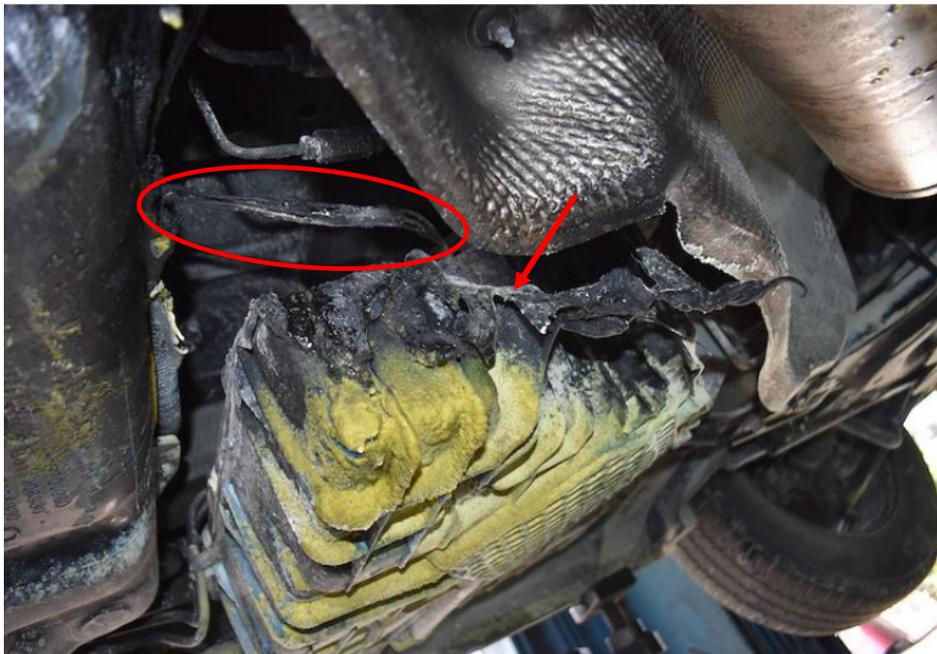
Photo 10 shows a closer view of the partially burnt and/or melted parts of the engine oil pan cover (arrowed) as well as burnt wirings (circled).

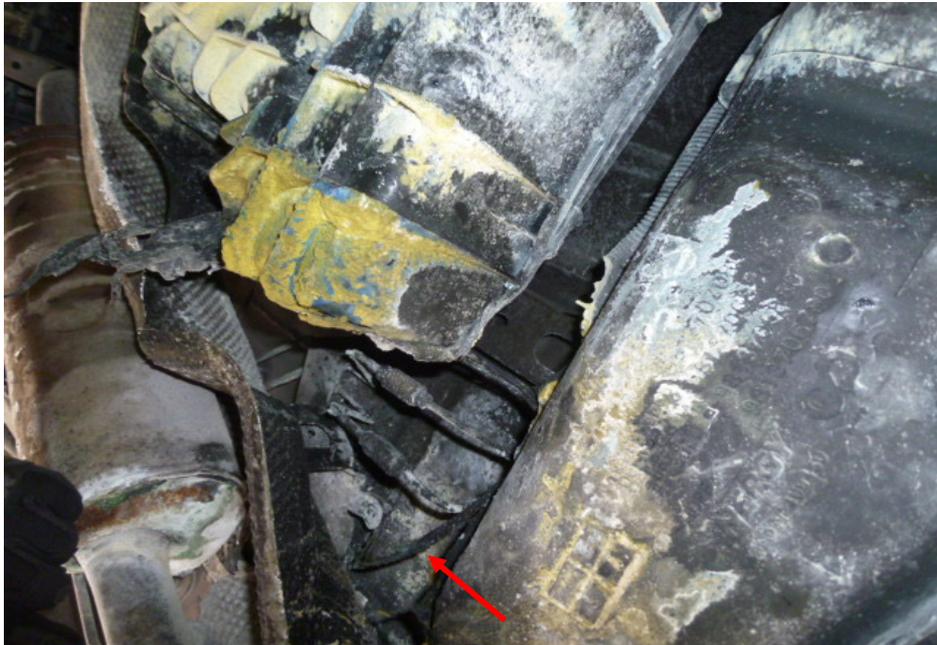
Photo 11 shows upon closer examination of the engine oil pan cover, which was where the fire to the Insured Vehicle had likely started, we had found traces of greenish residue on several stretches of burnt wirings (arrowed).

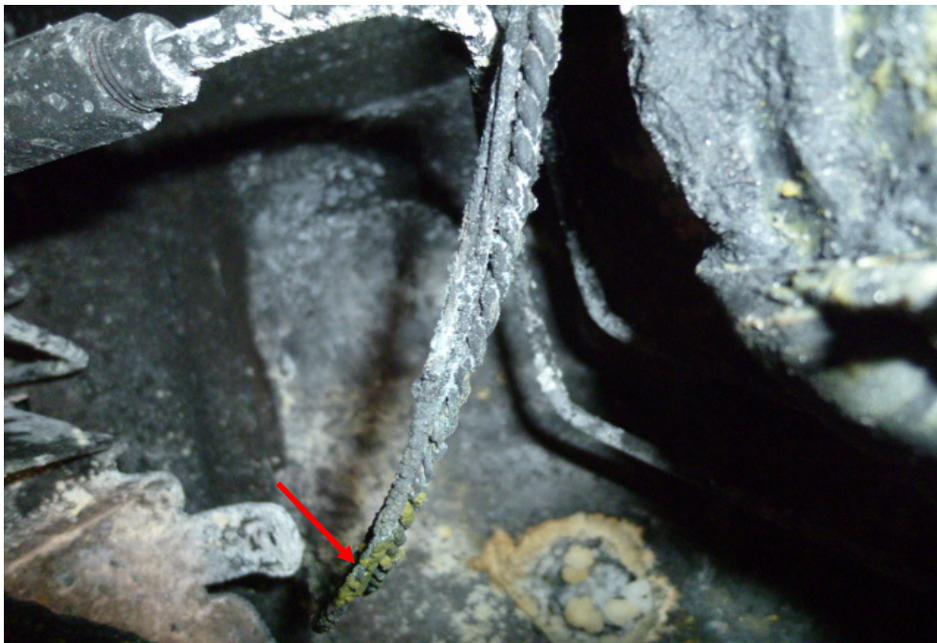
Photo 12 shows a close up view of faint traces of greenish residue on several stretches of burnt wirings (arrowed). The presence of greenish residue indicates internal heating of copper wires, a sign of an electrical short circuit occurring. The greenish residue is normally left behind from oxidation as a result of chemical reaction involving the copper wires. This physical evidence would then appear to suggest that the cause of fire to the Insured Vehicle could have possibly been due to electrical in nature.

21. The possibility of the fire being due to electrical in nature would then seem more likely given that engine overheating and external factors would both seem unlikely. The fire being due to electrical nature is also supported by the greenish residue that was found on the wirings from the undercarriage of the Insured Vehicle, which was earlier discussed in paragraph 9 above.

24. Having investigated and technically analysed the damages of burnt nature to the Insured Vehicle, we are of the view that the cause of fire to the Insured Vehicle was of electrical in nature. For this particular case, the fire had originated from the wirings leading from the oil pan cover of the Insured Vehicle. The wirings were original factory fitted wirings of the Insured Vehicle. The fire was most likely a result of the surrounding heat accumulated from increased exhaust temperature caused by a clogged DPF.
25. We did not find any evidence which had suggested that the cause of fire to the Insured Vehicle was due to poor maintenance and/or recurring electrical problem.
26. There were no modification(s) or additional electronic and/or electrical component(s) fitted on the Insured Vehicle at the time of our inspection of the Insured Vehicle.
