PRE-REPAIR SURVEY REPORT

Assign Date:	14/08/2020	Survey Date:	14/08/2020	Adjustment Date:	03/03/2021
Accident Date:	12/08/2020	TP Policy No:	NA	Our Ref:	AVS2020-24190/ID
Place of Survey:	Hiap Lek Automobile Trading 160 Sin Ming Drive #05-17 Sin Ming AutoCity Singapore 575722			Your Ref:	MT/1099793-002
				Claim Type:	Third Party
				Claimant:	Tan Shen Ching (Chen Xianjun)

Veh. No:	SLH5812G	Make/Model:	Honda Vezel
Colour:	White	Engine No:	NA
Engine Capacity:	NA	Chassis No:	RU31218255
Odometer:	93240	Reg. Date:	10/11/2016

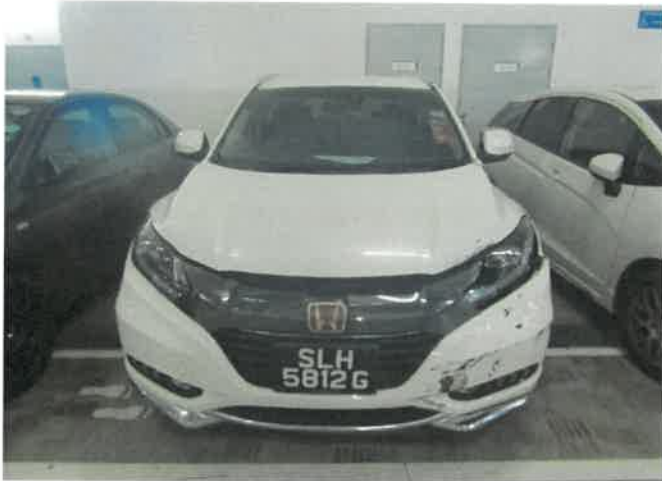
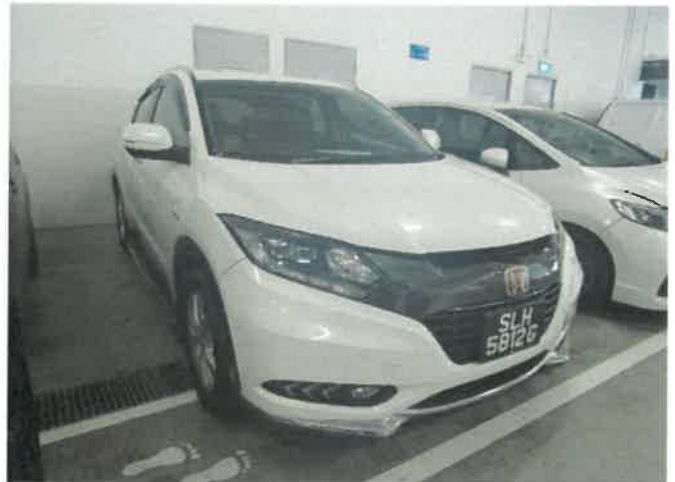
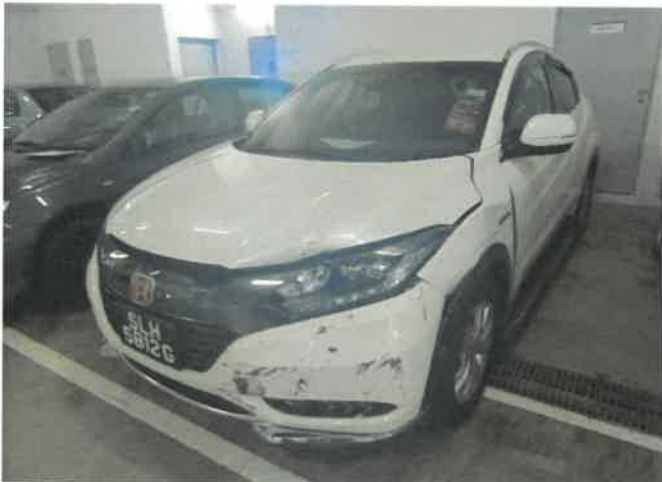
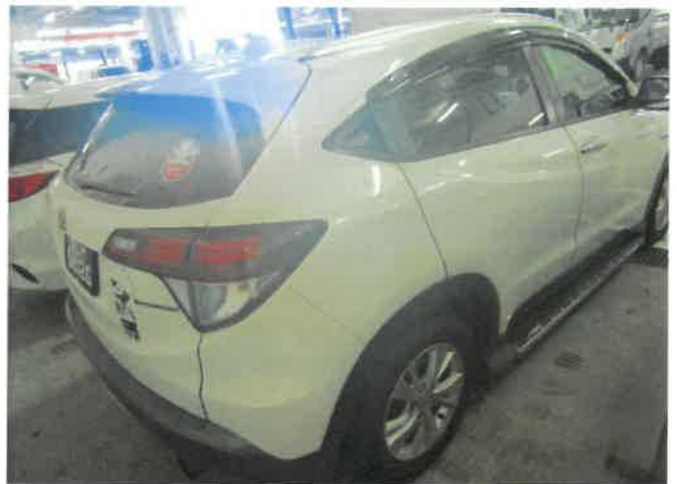
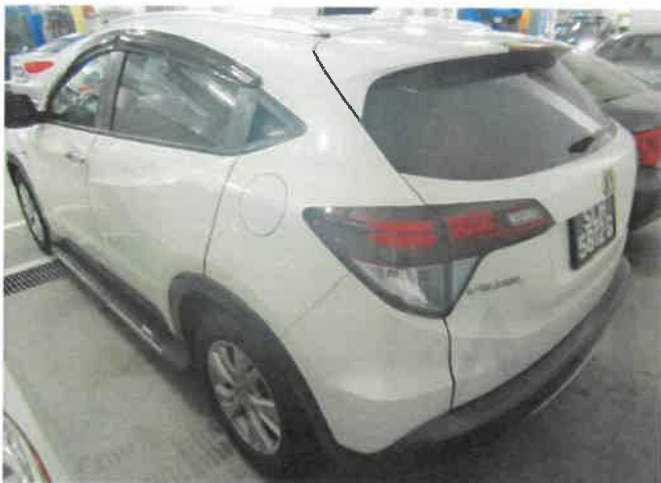
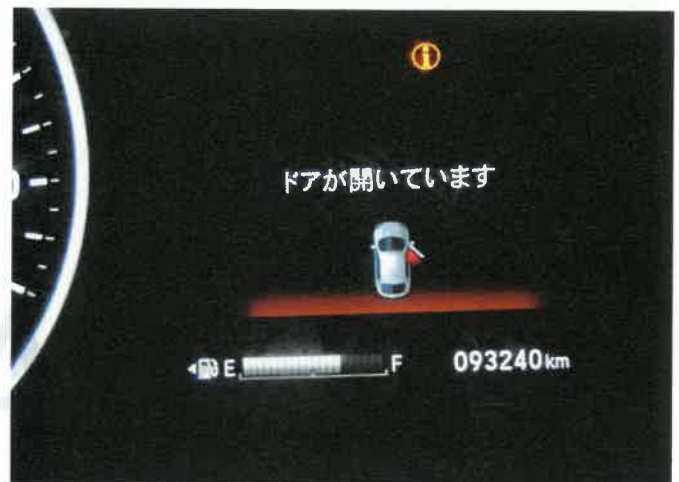
Pre-repair survey - 14/08/2020

The vehicle sustained damage on the front left portion.

Our recommended amount for the cost of contract lumpsum repair is S\$6,500.00 with approximately six (6) working days to complete. However, no finalisation was agreed with the repairer.
