Your Ref: HLBAISCL2022-00002SL  
Our Ref : CS4/AIS22001211/N

18 February 2022

**Allianz Insurance Singapore Pte. Ltd.**

**TECHNICAL INVESTIGATION REPORT OF FIRE INCIDENT INVOLVING THE  
INSURED VEHICLE PA 9341L ON 7 FEBRUARY 2022**

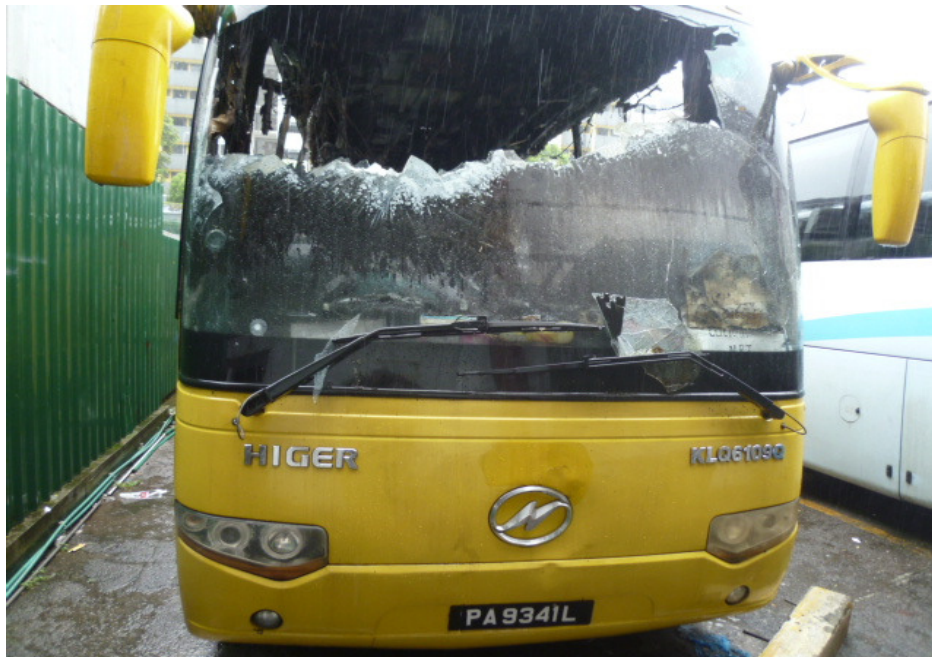
**Photo 1** shows the general view of the frontal portion of the Insured Vehicle at the time of our inspection. The frontal portion of the Insured Vehicle was significantly affected by the fire.

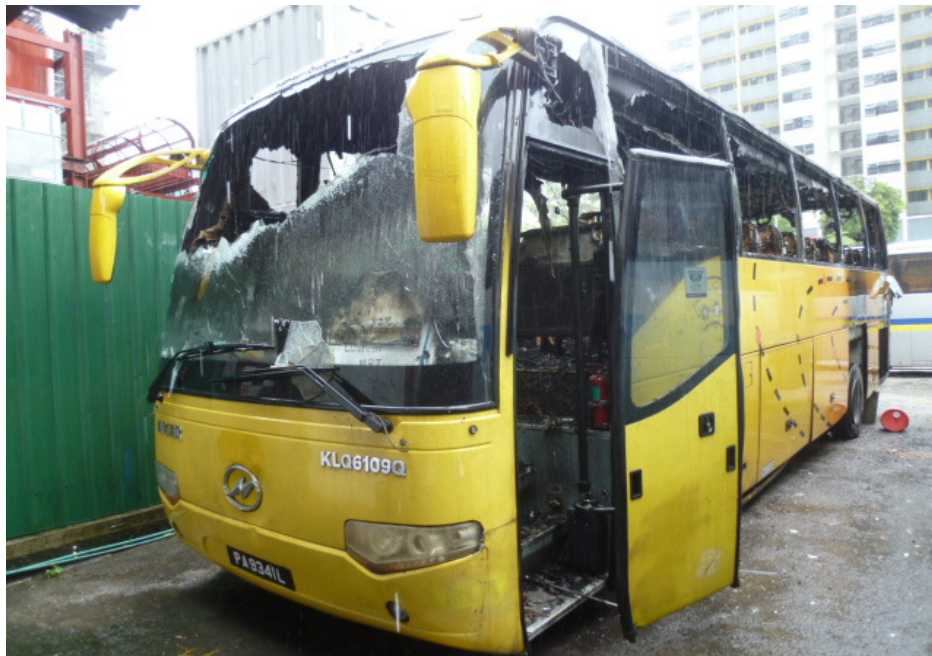
**Photo 2** shows the general view of the left frontal portion of the Insured Vehicle at the time of our inspection. The exterior body of the Insured Vehicle had sustained fire damage at the top portion as well as rear portion. Affected parts had included the side mirrors, roof, windows, rear panels, both windscreens and engine panel, amongst others.

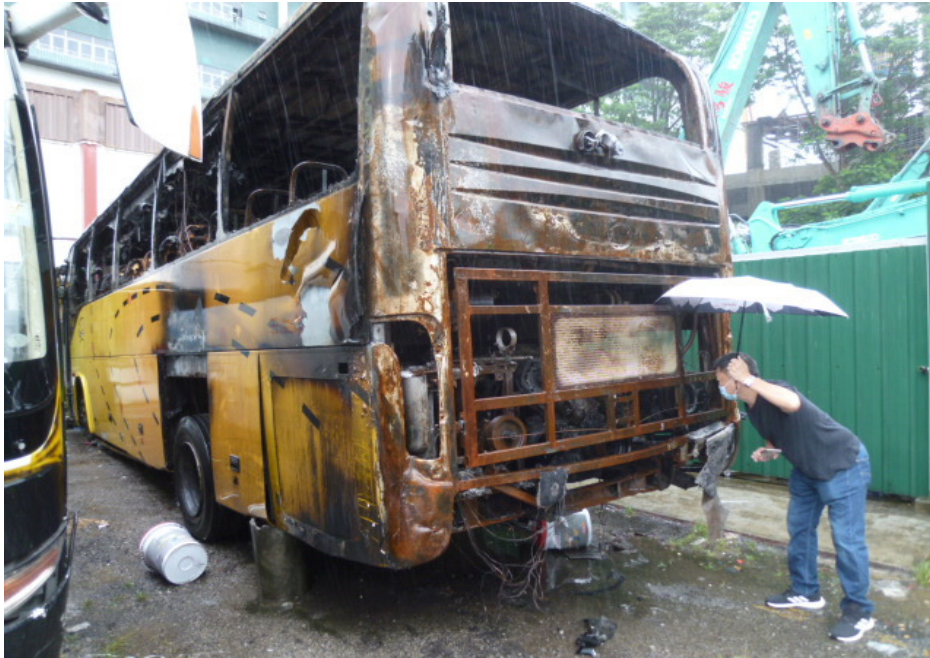
**Photo 3** shows a closer view of the rear portion of the Insured Vehicle at the time of our inspection together with principal consultant Mr Lau. The fire damage was observed to be more severe at its rear portion.

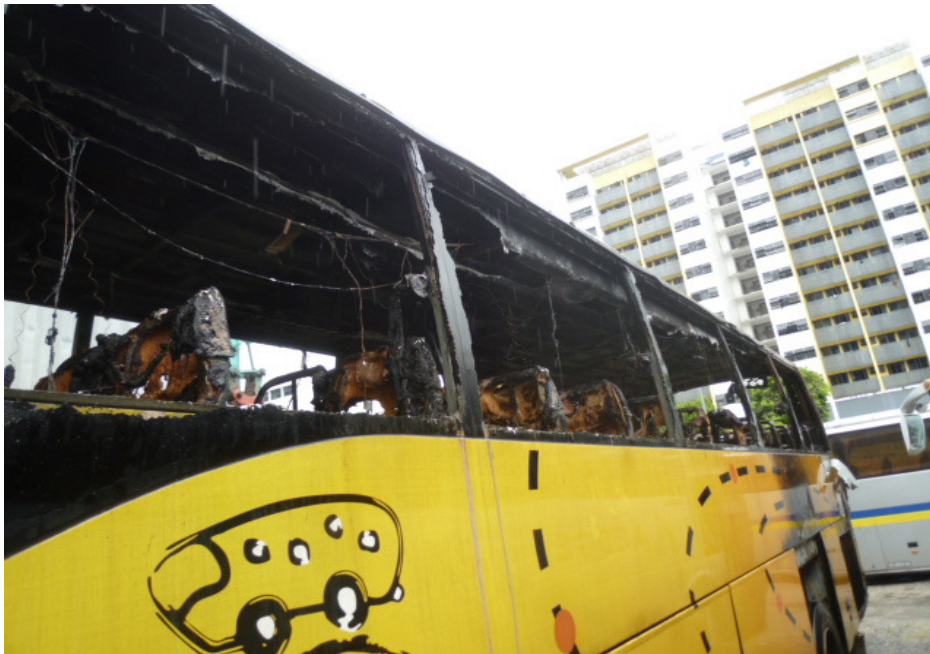
**Photo 4** shows the general view of the top portion of the Insured Vehicle at the time of our inspection. The roof of the Insured Vehicle had sustained serious fire damage.

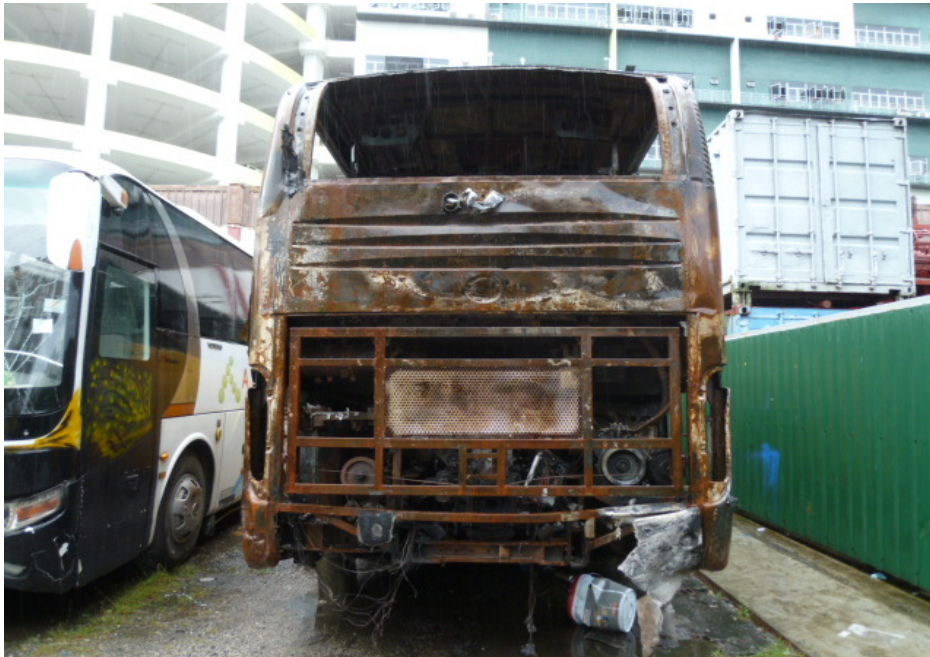
**Photo 5** shows the general view of the rear portion of the Insured Vehicle at the time of our inspection. The Insured Vehicle had sustained severe fire damage at the rear portion.

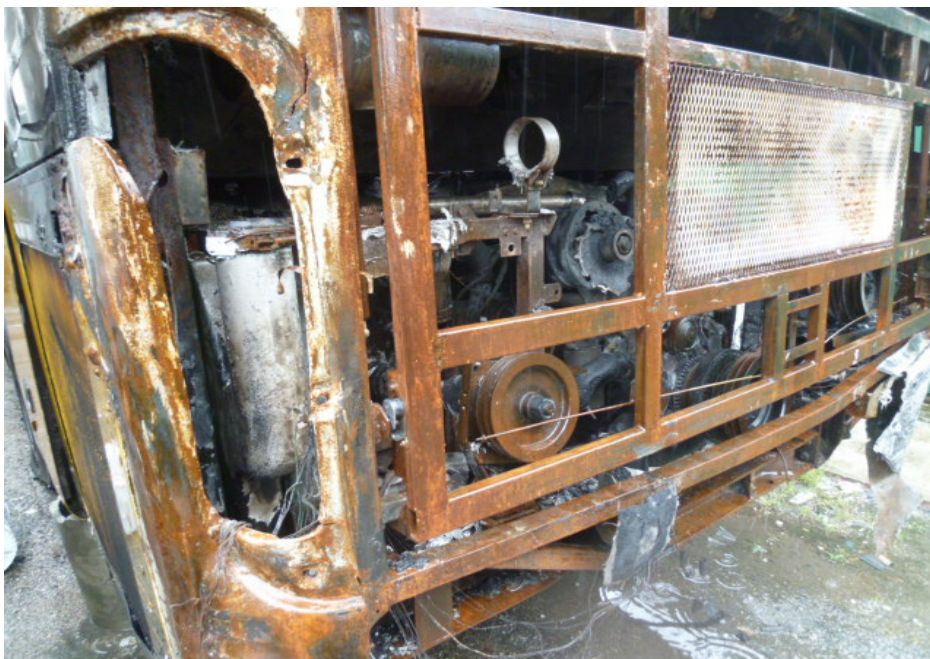
**Photo 6** shows a general view of the engine compartment of the Insured Vehicle at the time of our inspection. The engine compartment of the Insured Vehicle was severely affected by the fire. Most of the parts inside the engine compartment were found to be completely burnt and/or melted as a result of the fire.

7. For this particular case, the fire appears to have originated within the engine compartment of the Insured Vehicle, somewhere around the rear right portion of the engine compartment. This can be determined from the nature of the fire damage which was more extensive at the rear right portion. Basing on the circumstances of the fires' origin at the material time of incident as well as examining the area where the extent of fire damage was most severe, we can determine that the fire had likely started from the rear right portion of the engine compartment of the Insured Vehicle.

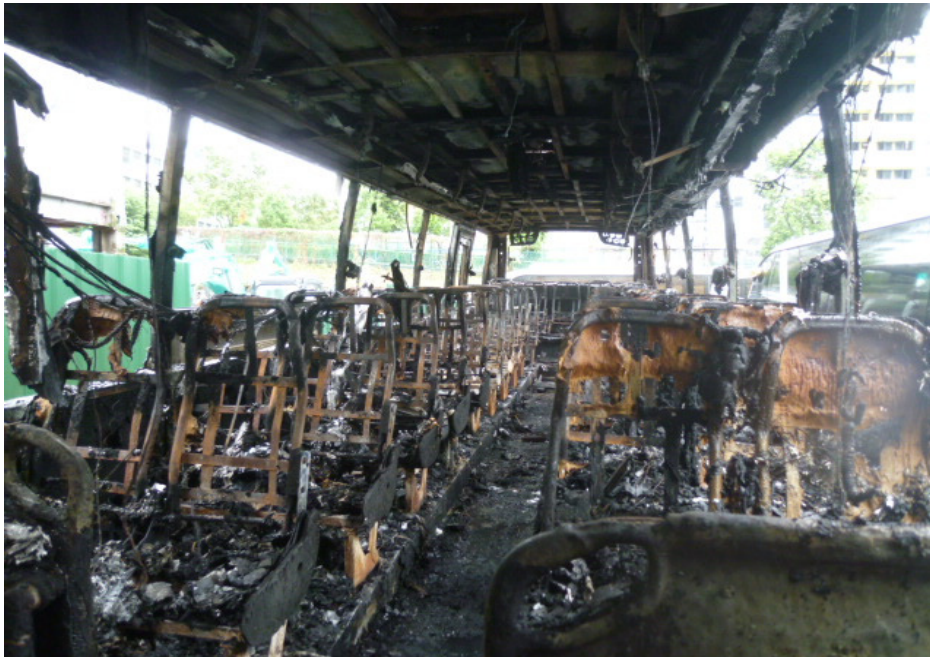
**Photo 7** shows the interior cabin of the Insured Vehicle at the time of inspection. The interior rear cabin was completely burnt.

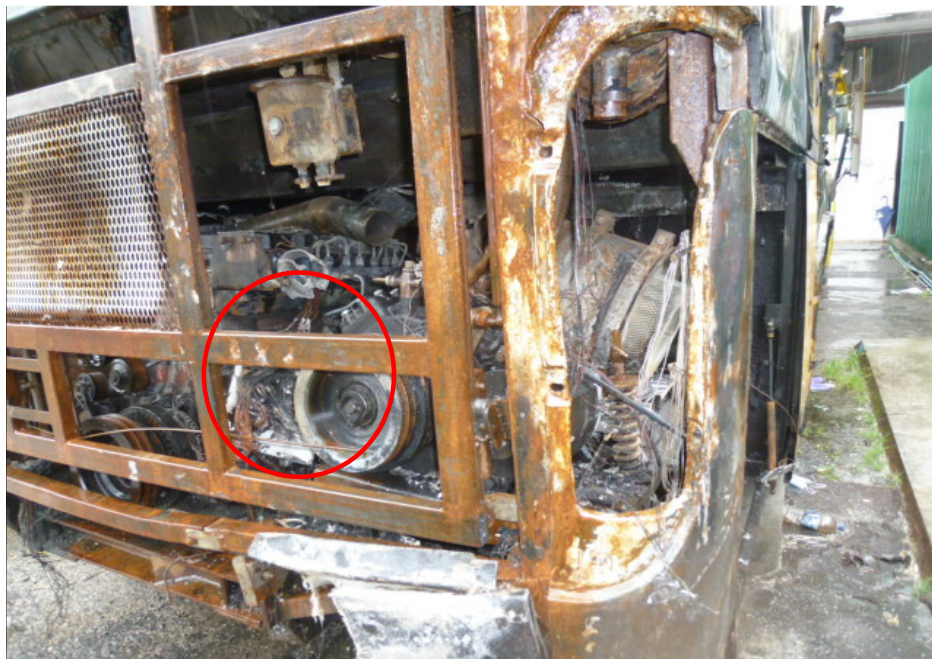
8. Upon closer examination of the area where the fire to the Insured Vehicle had likely started, we had found faint traces of greenish residue on several stretches of original factory fitted wirings leading from the Engine Control Module (ECM) of the Insured Vehicle. The presence of greenish residue indicates internal heating of copper wires, a sign of an electrical short circuit occurring. The greenish residue is normally left behind from oxidation as a result of chemical reaction involving the copper wires. This physical evidence would then appear to suggest that the cause of fire to the Insured Vehicle could have possibly been due to electrical in nature. See photos 8 - 10 below.

**Photo 8** shows a closer view of the rear right portion of the burnt engine compartment of the Insured Vehicle. Upon closer examination, we had found faint traces of greenish residue on several burnt stretches of original factory fitted wirings leading from the Engine Control Module (ECM) of the Insured Vehicle (circled).

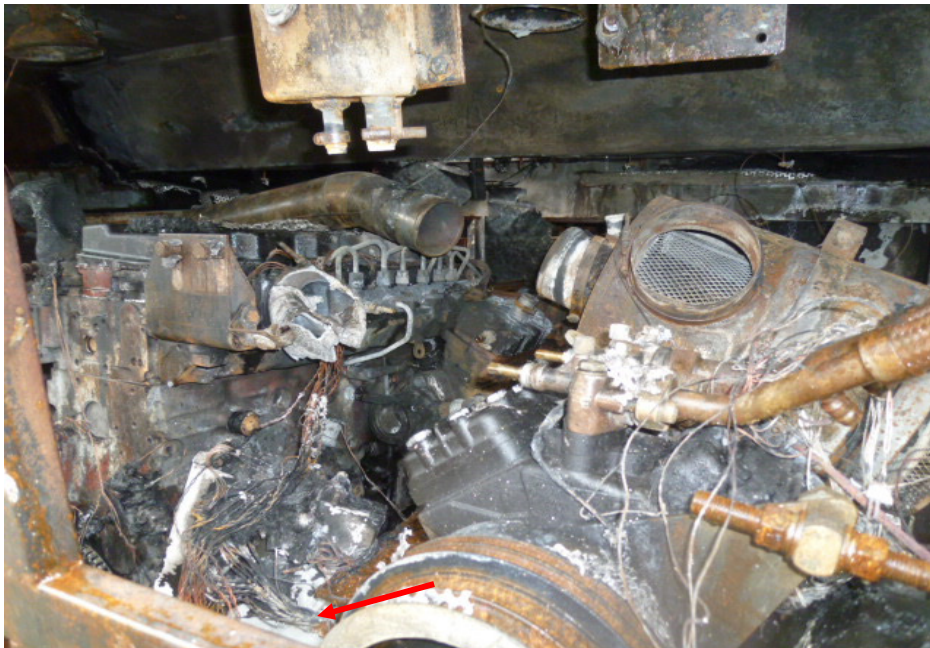
**Photo 9** shows a closer view of the faint traces of greenish residue found on several burnt stretches of original factory fitted wirings leading from the ECM (arrowed) of the Insured Vehicle. The presence of such greenish residue indicates internal heating of copper wires, a sign of an electrical short circuit occurring. The greenish residue is normally left behind from oxidation as a result of chemical reaction involving the copper wires.

24. The possibility of the fire being due to electrical in nature would then seem more likely given that engine overheating and external factors would seem unlikely. The fire being due to electrical nature is also supported by the faint traces of greenish residue that were found on several burnt stretches of original factory fitted wirings around the rear right portion of the engine compartment of the Insured Vehicle, which was earlier discussed in paragraph 8 above.

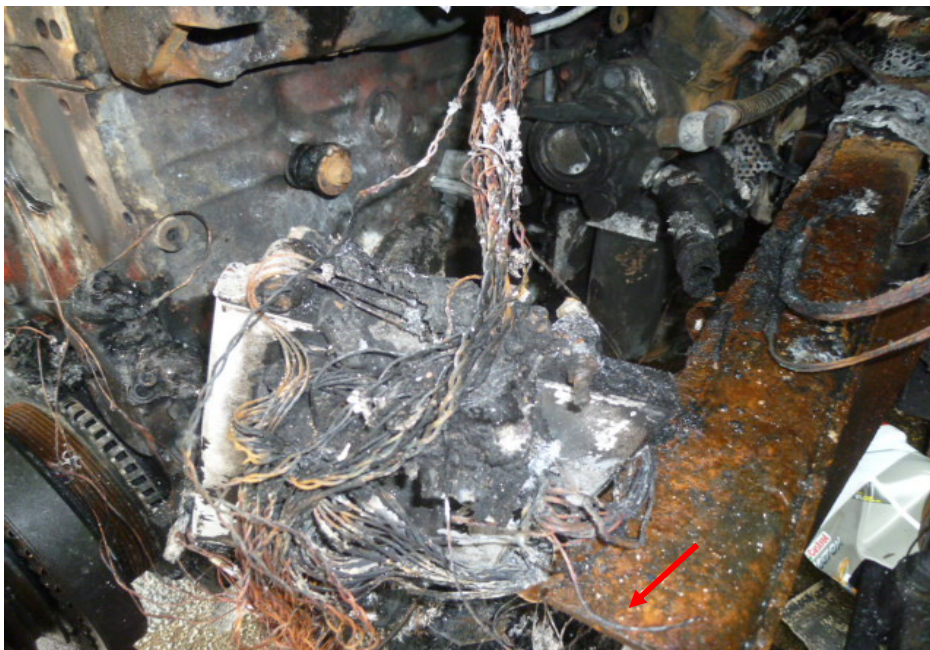
**Photo 10** shows a close up view of the faint traces of greenish residue that was found on several burnt stretches of original factory fitted wirings leading from the ECM (arrowed) of the Insured Vehicle. This seems to suggest the occurrence of an electrical short circuit.

26. Having investigated and technically analysed the damages of burnt nature to the Insured Vehicle, we are of the view that the cause of fire to the Insured Vehicle was of electrical in nature. For this particular case, the fire had originated along the original factory fitted wirings leading from the ECM, around the rear right portion of the engine compartment of the Insured Vehicle.
27. We did not find any evidence which had suggested that the cause of fire to the Insured Vehicle was due to poor maintenance and/or recurring electrical problem.
28. Our investigations had also revealed that at the time of writing this report, there is no manufacturer recall of electrical nature to similar make and model vehicle as the Insured Vehicle that may pose a fire risk.

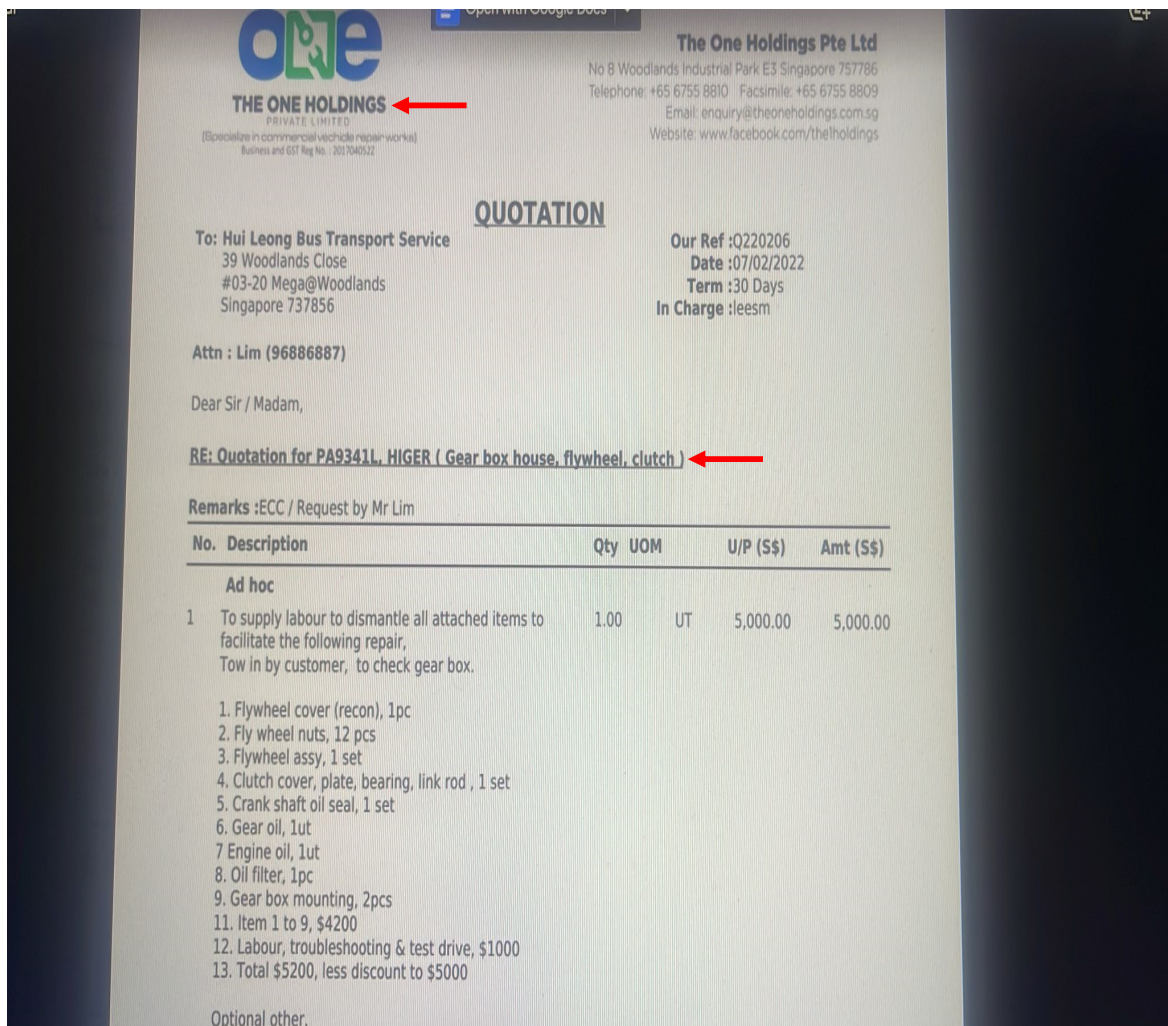
**Invoice 1** shows the last servicing done on the Insured Vehicle at The One (red arrows). The servicing package included changing of engine oil, oil filter and gear oil. The flywheel assembly, flywheel cover, flywheel nuts, gear box engine mounting, clutch cover, clutch plate, clutch bearing, clutch link rod and crank shaft oil seal were also replaced.

21. Based on the vehicle service record invoice provided, we are of the opinion that it is unlikely that the fire could have been caused by poor maintenance of the Insured Vehicle. From our review of the invoice (quotation) provided, the components repaired and replaced were mechanical in nature. None of the parts stated were electrical components.

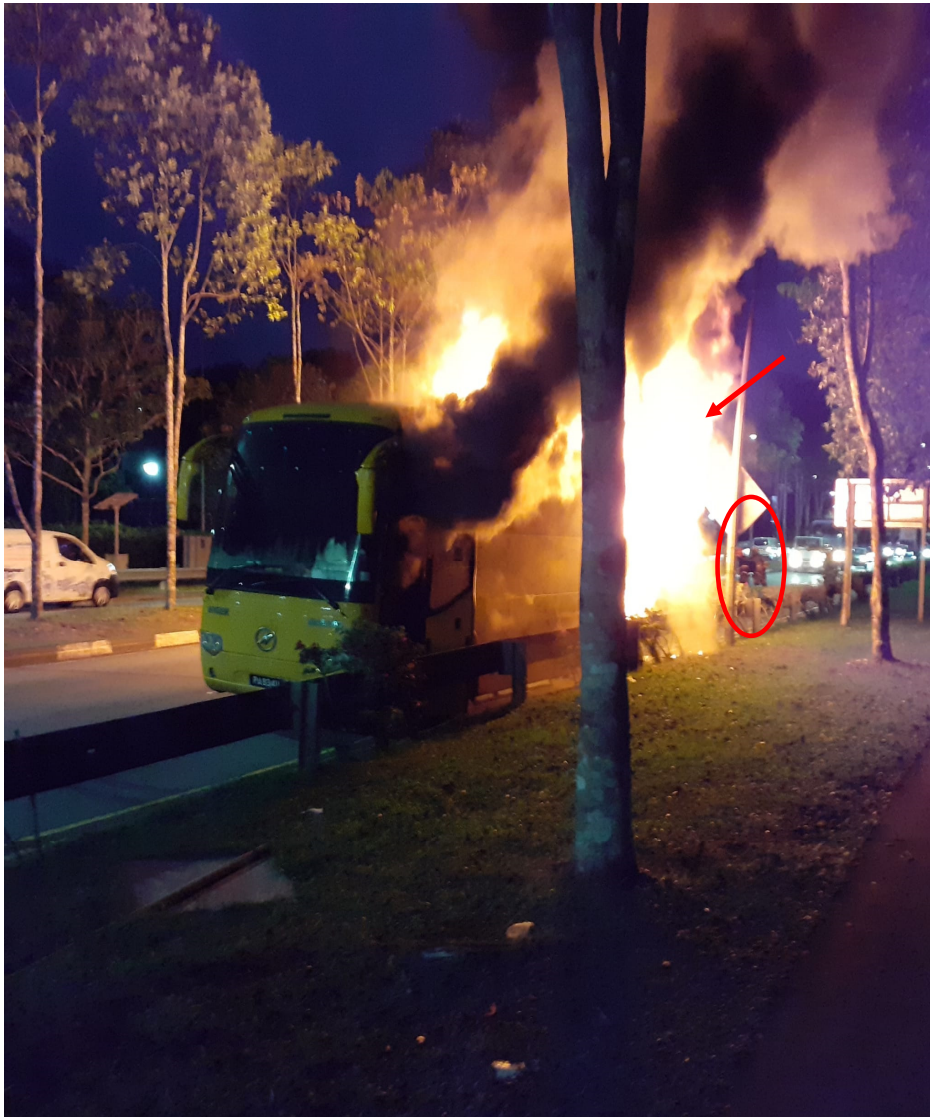
**Photo 11** shows the SCDF having arrived at the incident location and attempting to put out the fire (circled). In general, the information gathered from this photograph had corresponded to Mr Ng's statement, which is the fire had started from the rear portion of the Insured Vehicle (arrowed).

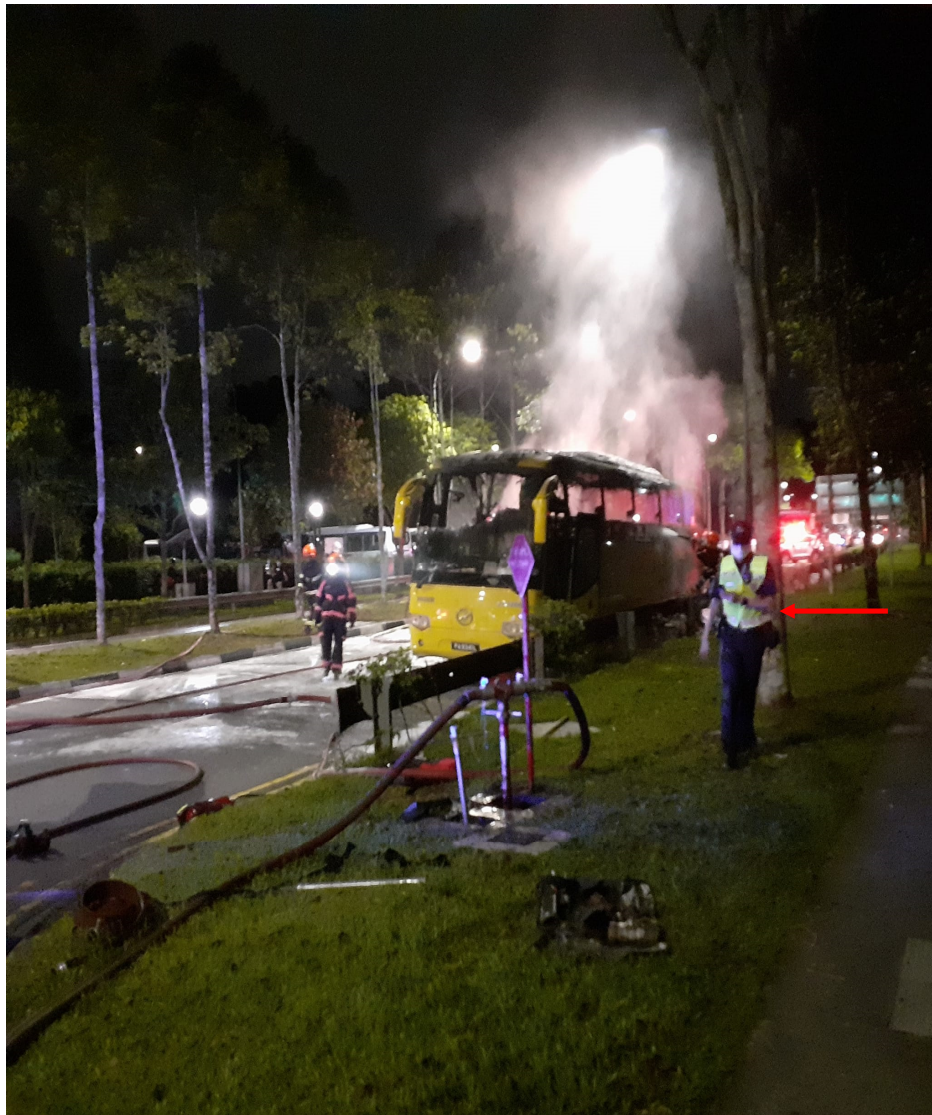
**Photo 12** shows the Insured Vehicle after the fire was extinguished. In general, the information that could be gathered from this photograph had corresponded to Mr Ng's statement, which is the police were also present at the incident location (arrowed).
