Your Ref: G/IP/00336/2022
Our Ref : CI/TPD22001223/P

Fatal Incident Investigation Team

MECHANICAL INSPECTION REPORT OF MOTOR CAR SND 3291U

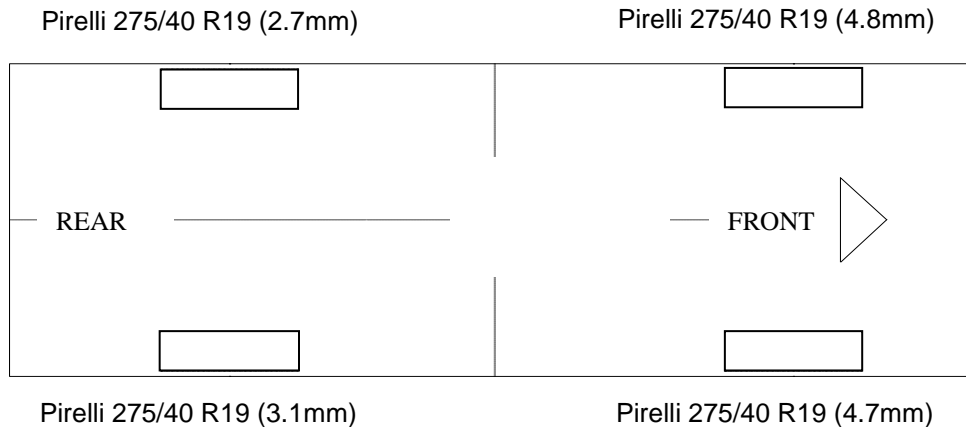
7. The 4 tyres of the Motor Car were observed to be in serviceable condition and sufficiently inflated for vehicular operation. I did not find any tear, cut or burst mark(s) on the outer and the inner sidewalls as well as across the tread of the 4 tyres. The tyre brand, tyre size and remaining tread depth of the 4 tyres of the Motor Car were recorded as follows:-

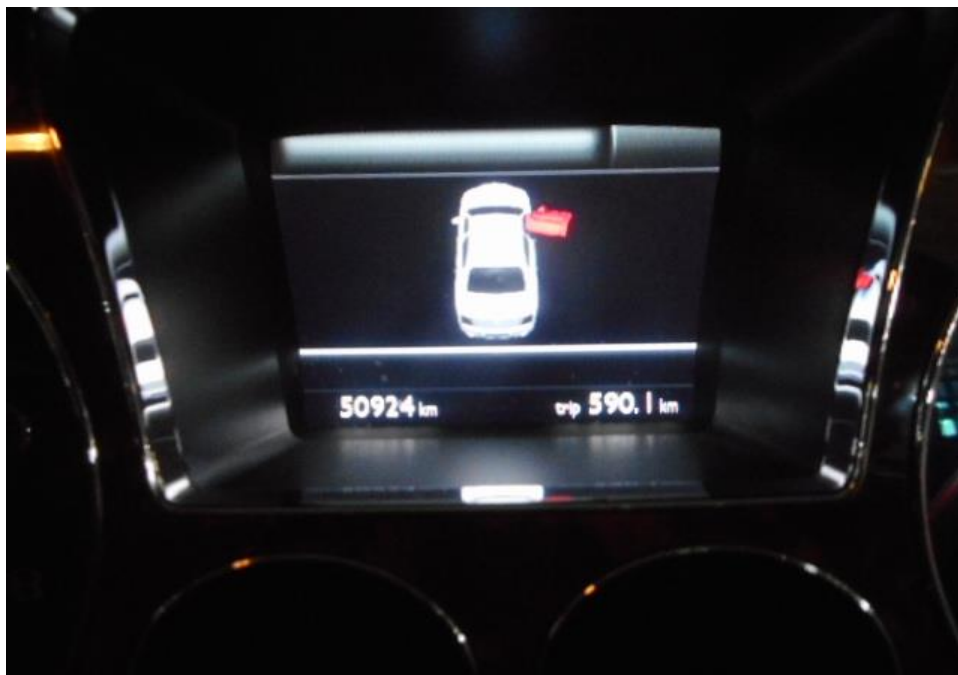
Photo 1 shows a general view of the instrument cluster of the Motor Car at the time of my inspection. The mileage of the Motor Car was 50,924km

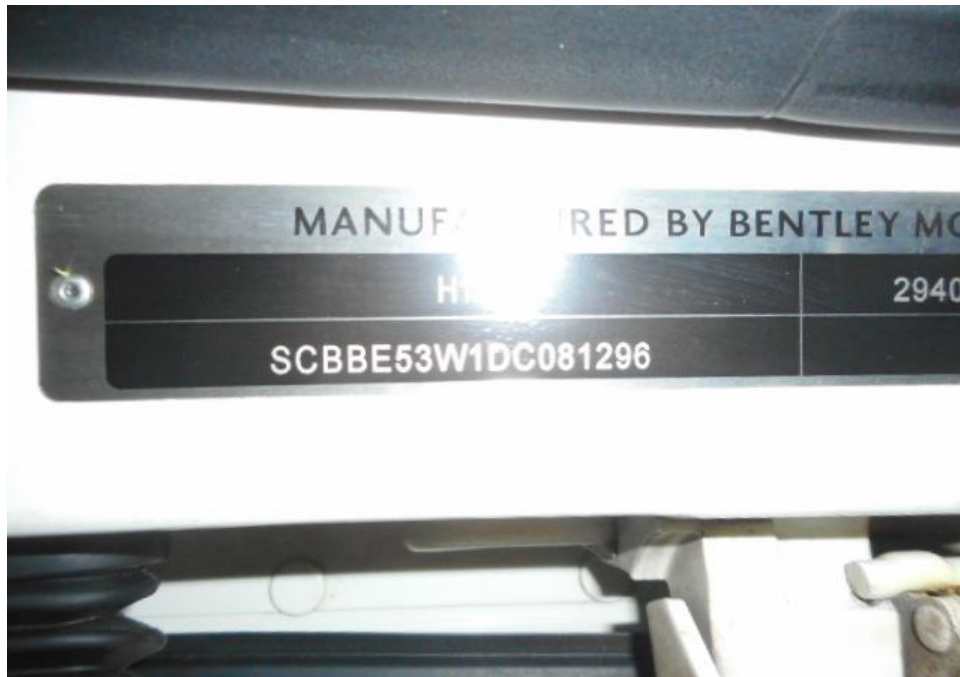
Photo 2 shows a general view of the chassis plate of the Motor Car at the time of my inspection. The chassis number of the Motor Car SCBBE53W1DC081296.

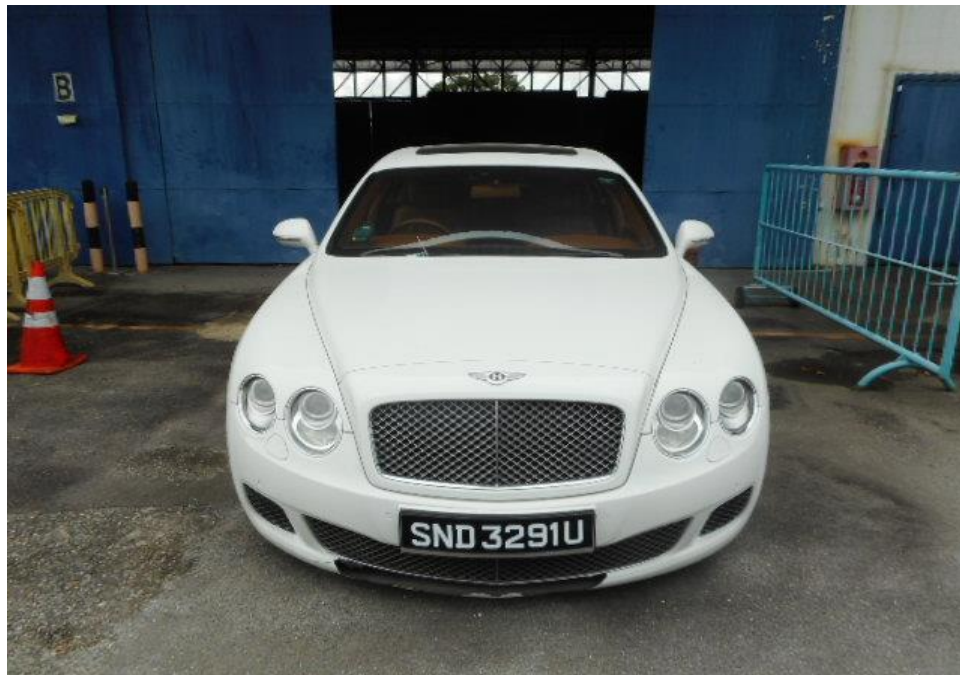
Photo 3 shows a general view of the Motor Car at the time of my inspection. The Motor Car was observed to be intact and unaffected by the incident.

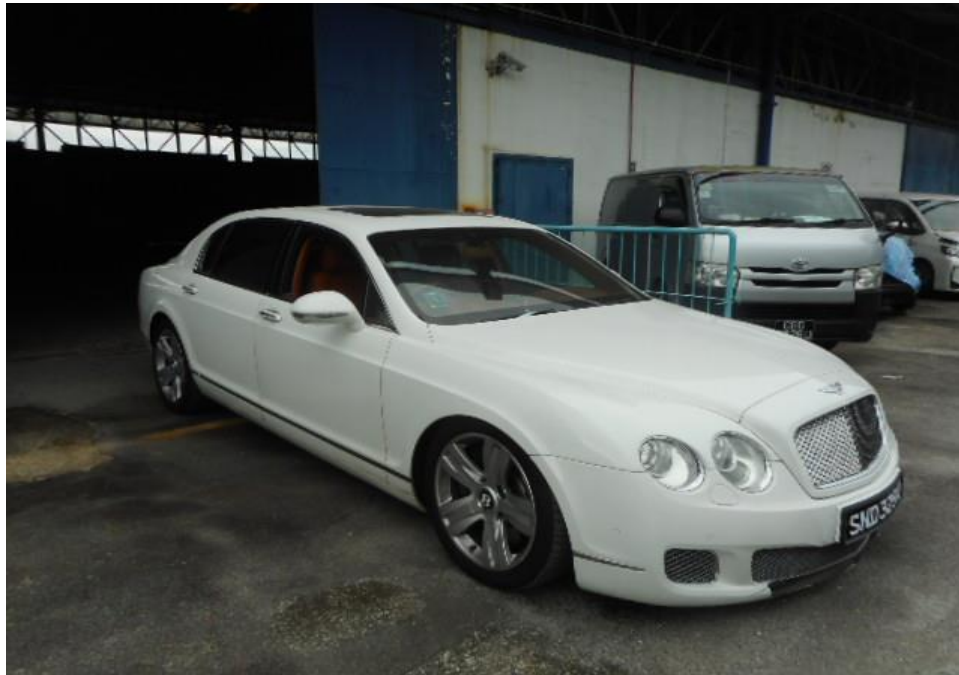
Photo 4 shows a general view of the right body of the Motor Car at the time of my inspection. The Motor Car was observed to be intact and unaffected by the incident.

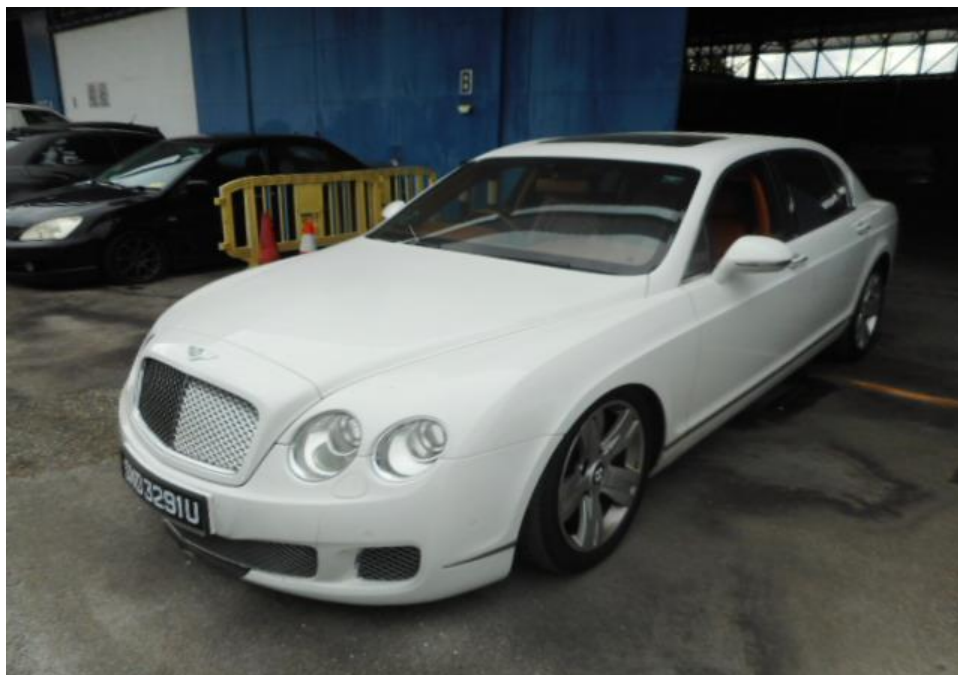
Photo 5 shows a general view of the left body of the Motor Car at the time of my inspection. The Motor Car was observed to be intact and unaffected by the incident.

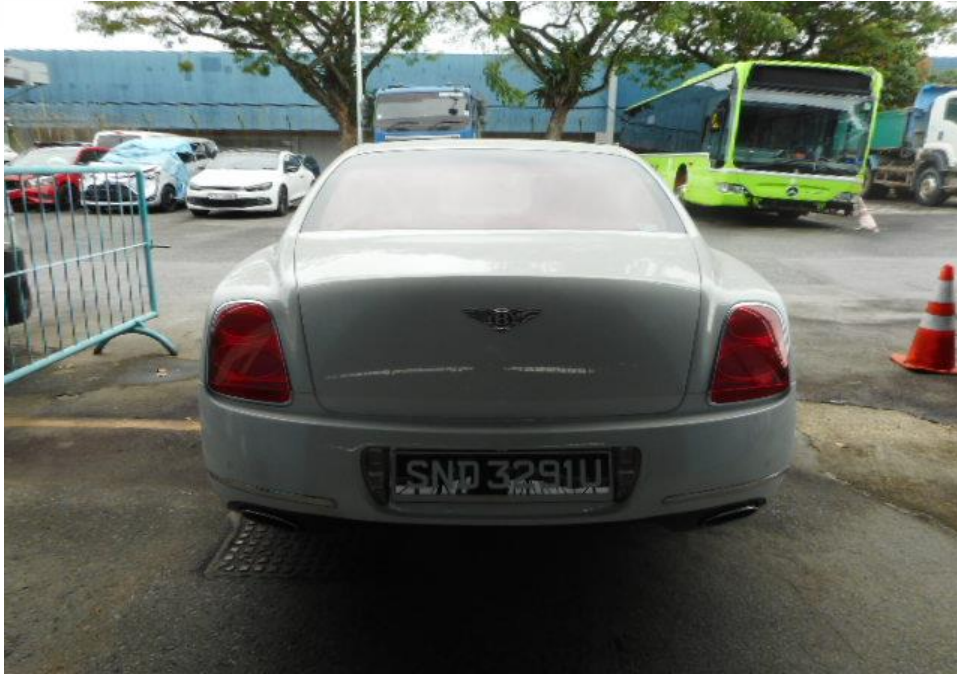
Photo 6 shows a general view of the rear body of the Motor Car at the time of my inspection. The Motor Car was observed to be intact and unaffected by the incident.

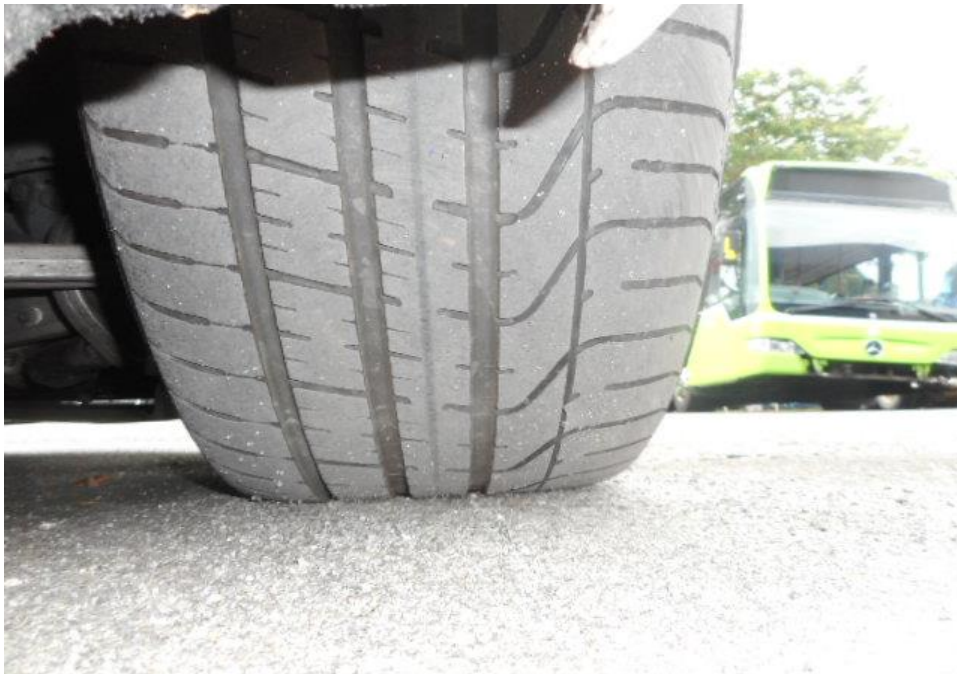
Photo 7 shows the condition of the front right tyre of the Motor Car, which was observed to be in serviceable condition with remaining tread depth of approximately 4.7mm. The tyre, which was wrapped around standard alloy wheel rim, was also observed to be sufficiently inflated for vehicular operation. There was no tear, cut or burst mark(s) on the outer and the inner sidewalls as well as across the tread of the 4 tyres that were fitted on the Motor Car.

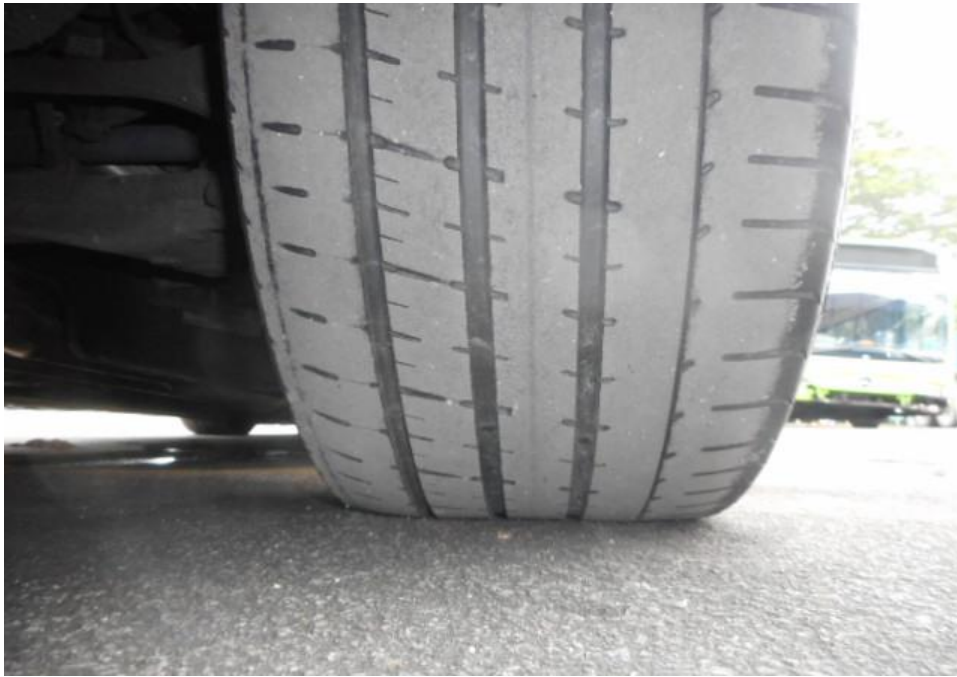
Photo 8 shows the condition of the rear right tyre of the Motor Car, which was observed to be in serviceable condition with remaining tread depth of approximately 3.1mm. The tyre, which was wrapped around standard alloy wheel rim, was also observed to be sufficiently inflated for vehicular operation.

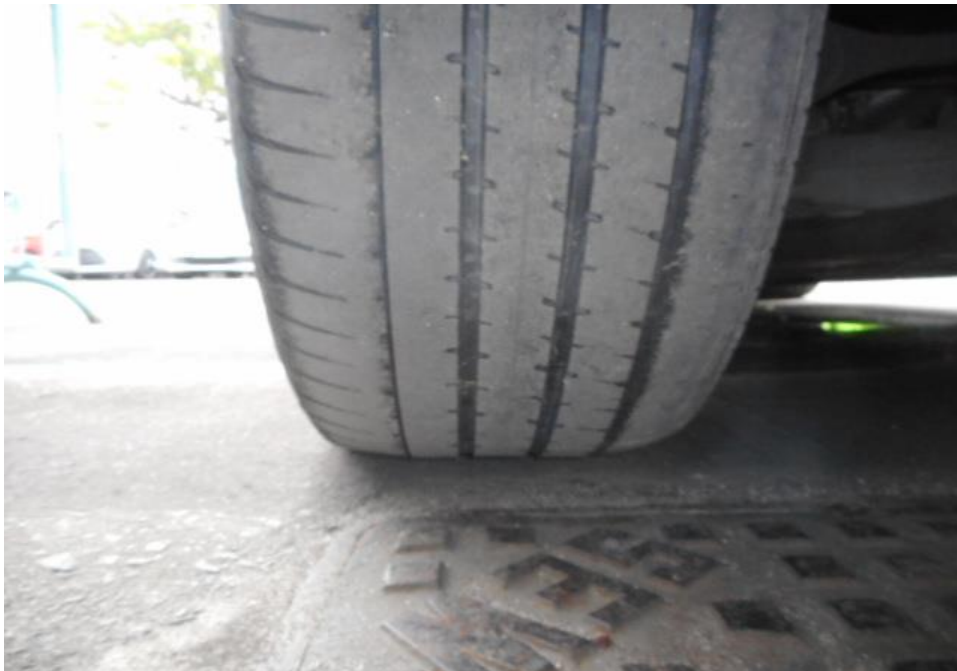
Photo 9 shows the condition of the rear left tyres of the Motor Car, which was observed to be in serviceable condition with remaining tread depth of approximately 2.7mm. The tyres, which were wrapped around standard alloy wheel rim, were also observed to be sufficiently inflated for vehicular operation. There was also no damage found on all 4 alloy wheel rims of the Motor Car.

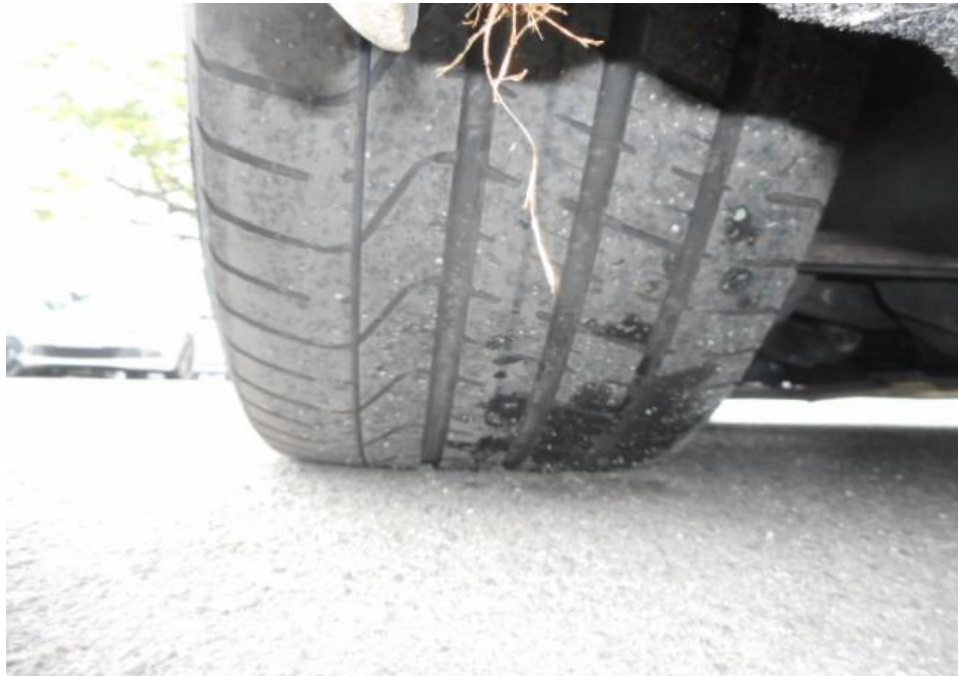
Photo 10 shows the condition of the rear right tyres of the Motor Car, which were observed to be in serviceable condition with remaining, tread depth of approximately 4.8mm. There was also no tear, cut or burst mark(s) on the outer and the inner sidewalls as well as across the tread of the 4 tyres that were fitted on the Motor Car.

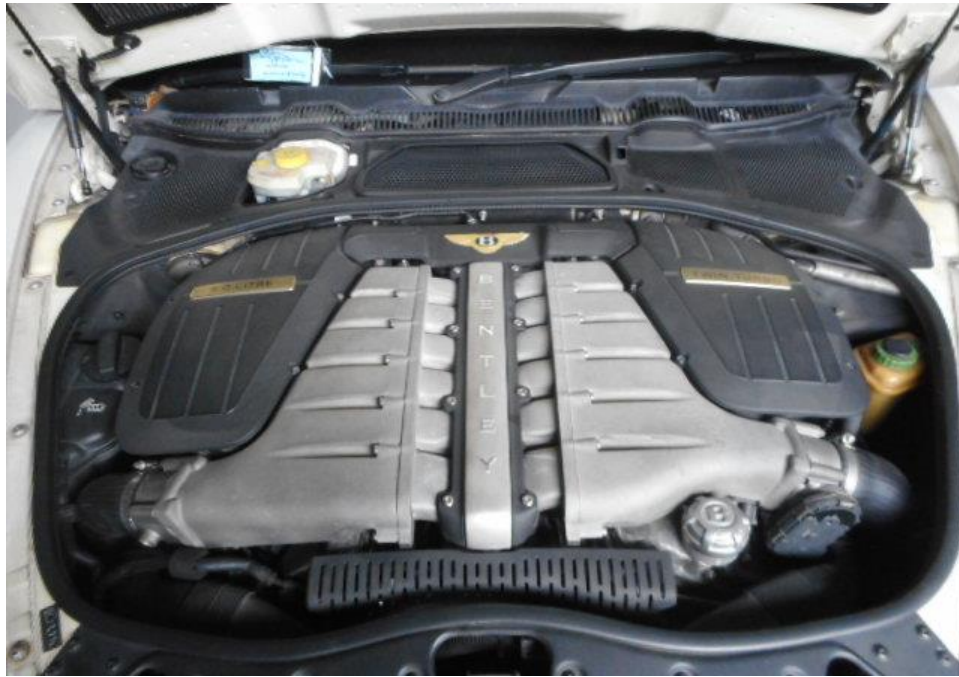
Photo 11 shows a general view of the Motor Car's engine compartment, which was accessed by lifting the front cabin of the Motor Car. The various parts and components inside the engine compartment were unaffected by the incident. There was also no sign(s) or indication(s) of fresh fluid leakage and/or fluid stain within the engine compartment

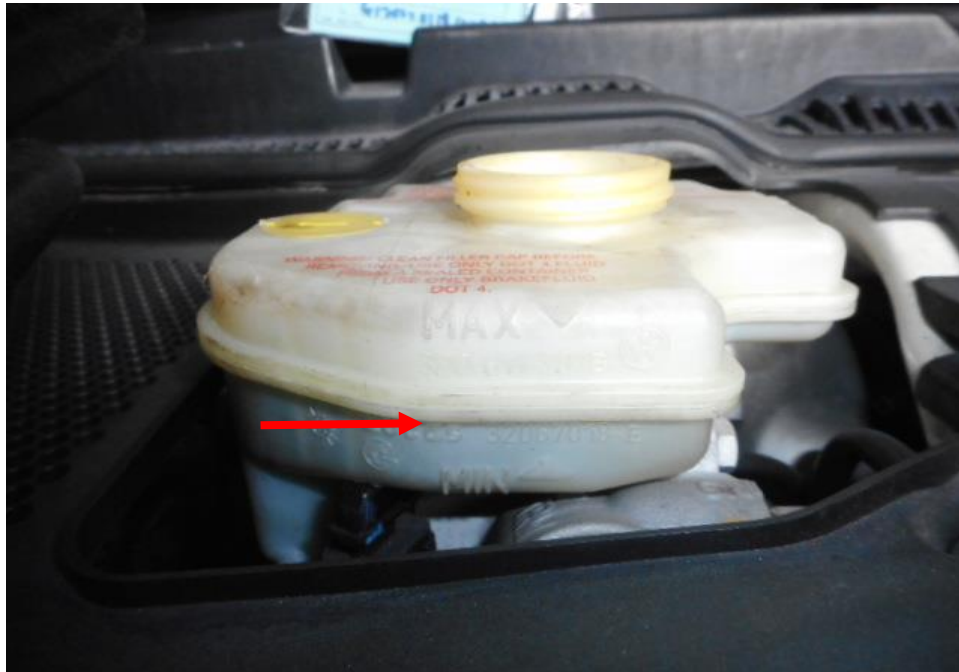
Photo 12 shows the brake fluid reservoir of the Motor Car at the time of my inspection. The brake fluid was observed to be of sufficient level (arrowed) and without any visible contamination.

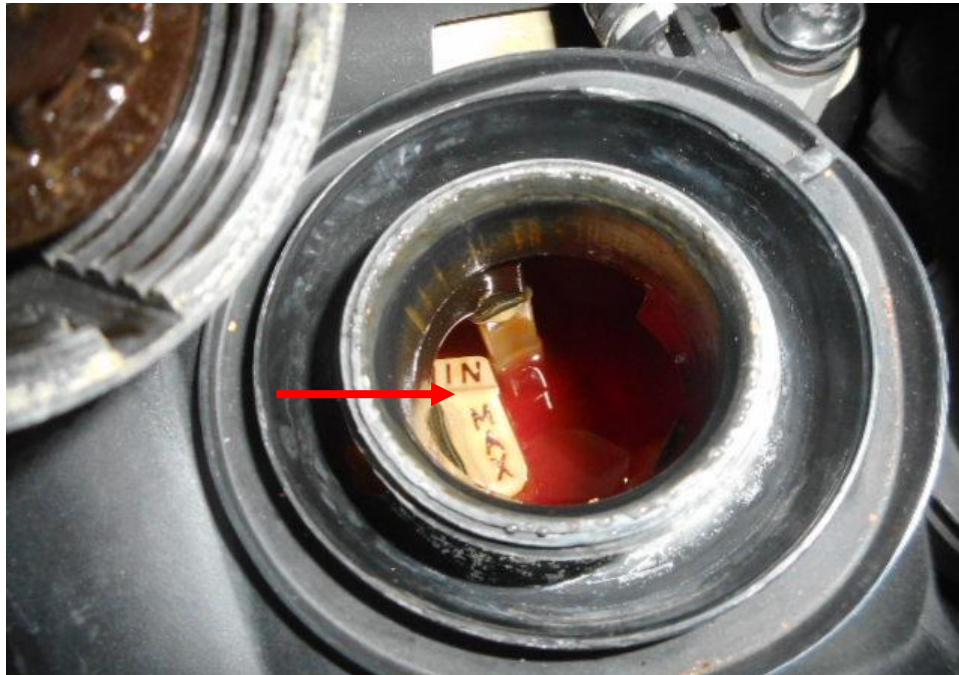
Photo 13 shows the engine coolant reservoir of the Motor Car at the time of my inspection. The engine coolant was observed to be of sufficient level (arrowed) and without any visible contamination.

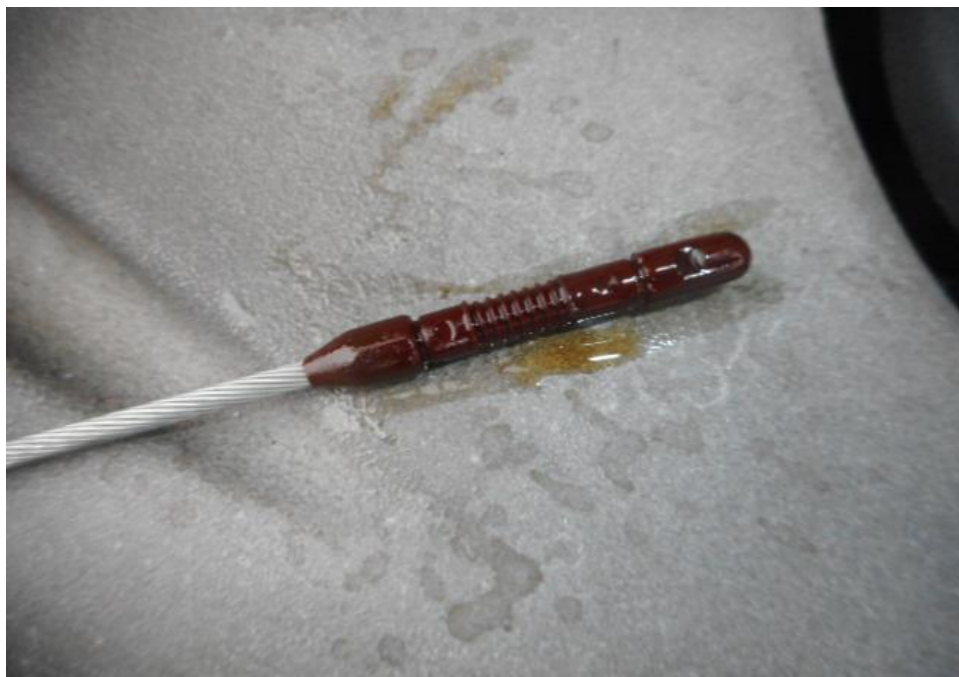
Photo 14 shows the engine oil dip stick of the Motor Car at the time of my inspection. The engine oil was observed to be of sufficient level and without any visible contamination.

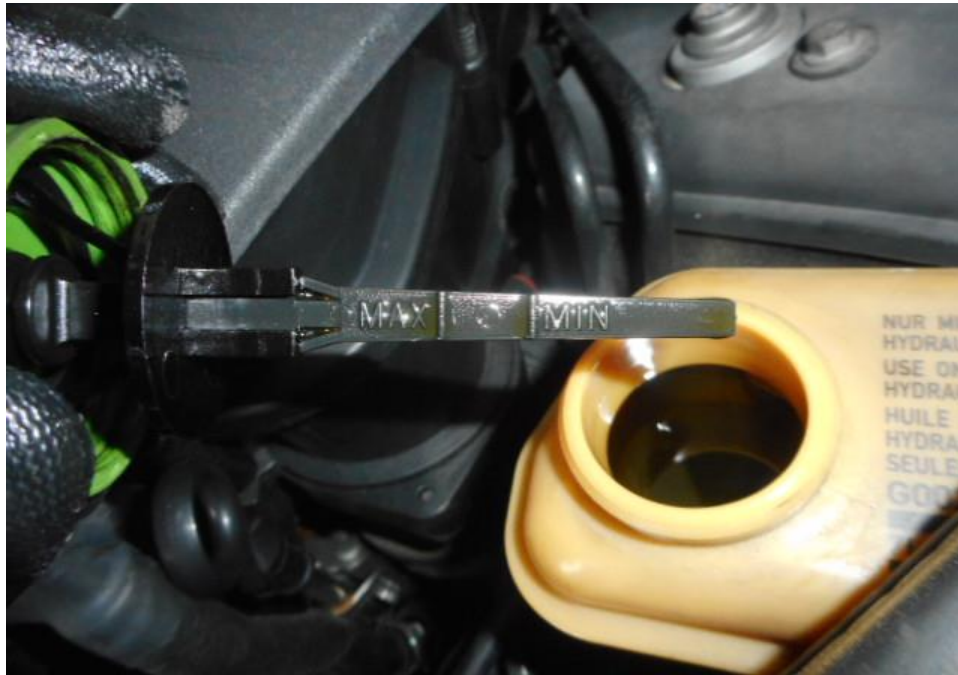
Photo 15 shows the power steering fluid dip stick of the Motor Car at the time of my inspection. The engine oil was observed to be of sufficient level and without any visible contamination.

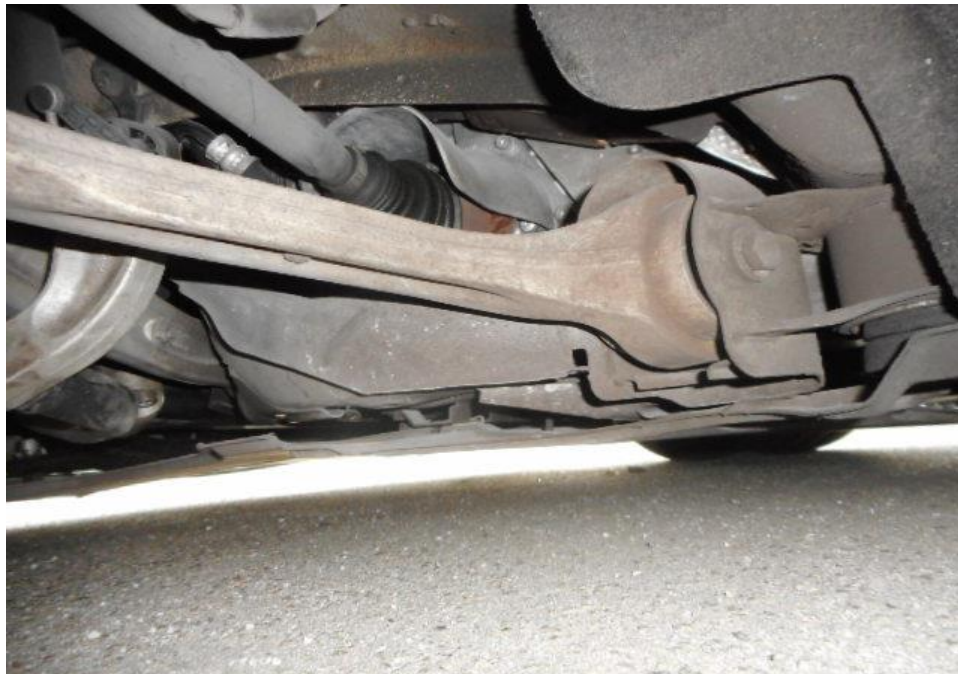
Photo 16 shows the undercarriage of the Motor Car, at the area where the engine housing and transmission housing are located. I did not find any sign(s) or indication(s) of fluid leak and/or fluid stain(s) on the underside of the Motor Car.

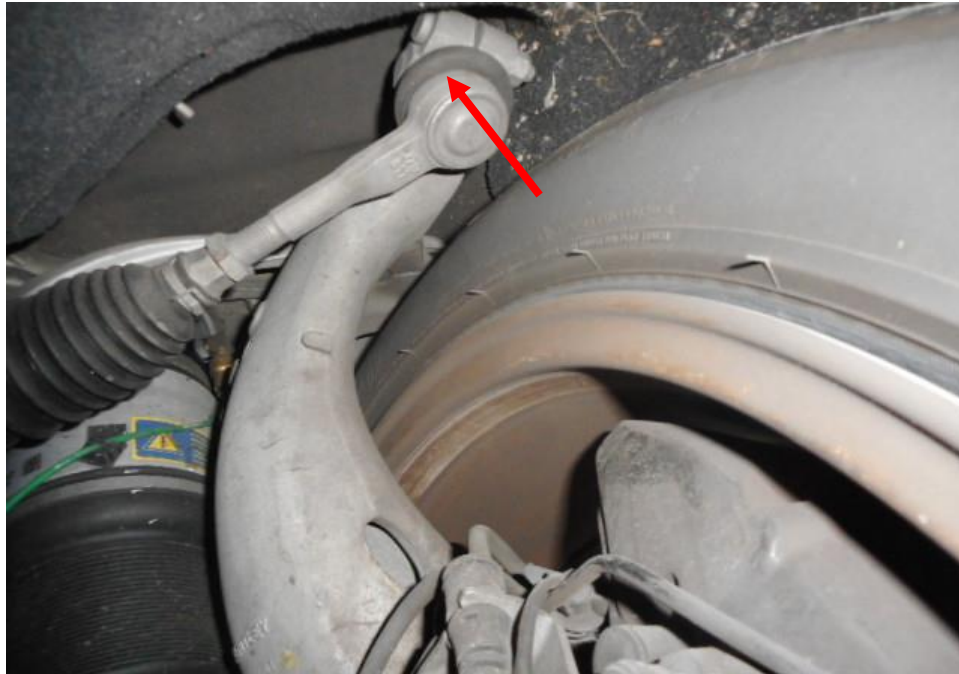
Photo 17 shows the various undercarriage components at the front right wheel of the Motor Car, in particular the steering tie rod end (arrowed). The various steering components were all found to be intact, suggesting that the steering system of the Motor Car was likely to be in serviceable condition at the material time of incident. There was also no sign of fluid stain(s) observed on the various undercarriage components.

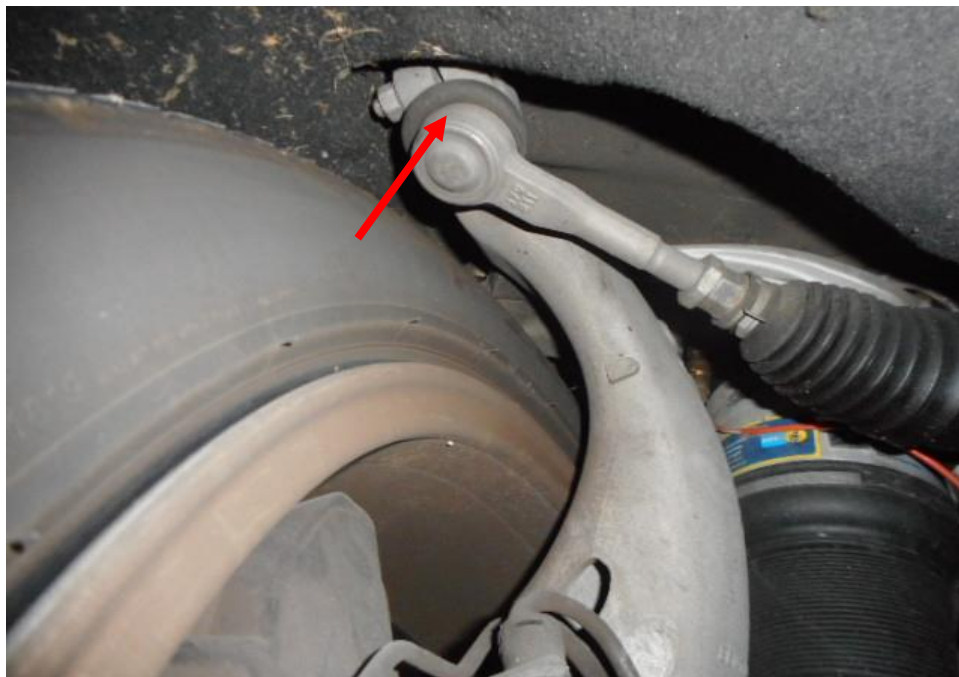
Photo 18 shows the various undercarriage components at the front left wheel of the Motor Car, in particular the steering tie rod end (arrowed). The various Undercarriage components of the Motor Car were all found to be intact without any visible damage. There was also no sign of fluid stain(s) observed on the various undercarriage components.

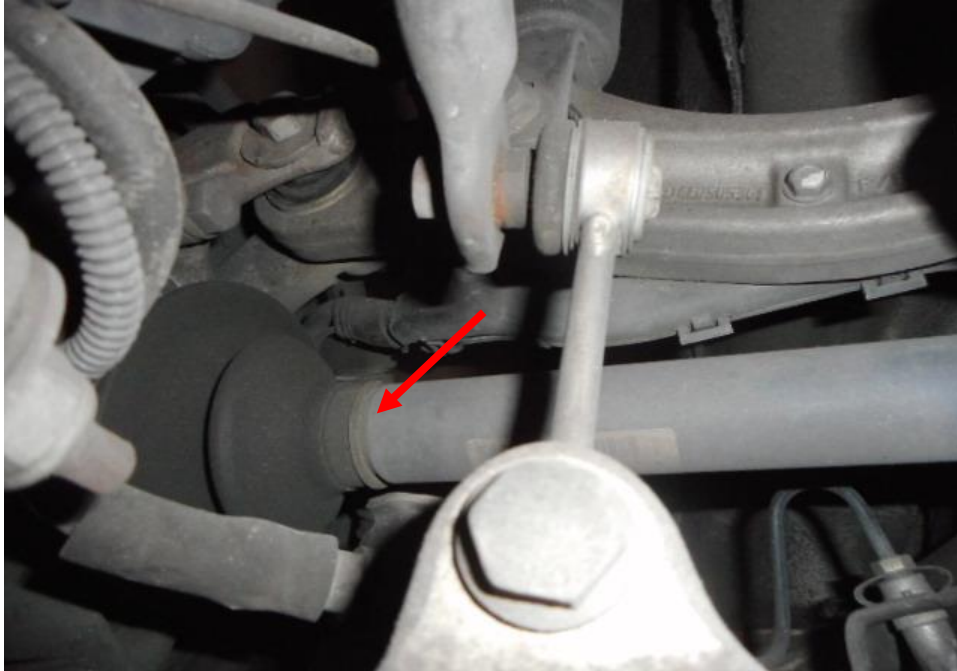
Photo 19 shows the various undercarriage components at the rear left wheel of the Motor Car, in particular the drive shaft (arrowed). The various steering components were all found to be intact, suggesting that the steering system of the Motor Car was likely to be in serviceable condition at the material time of incident. There was also no sign of fluid stain(s) observed on the various undercarriage components.

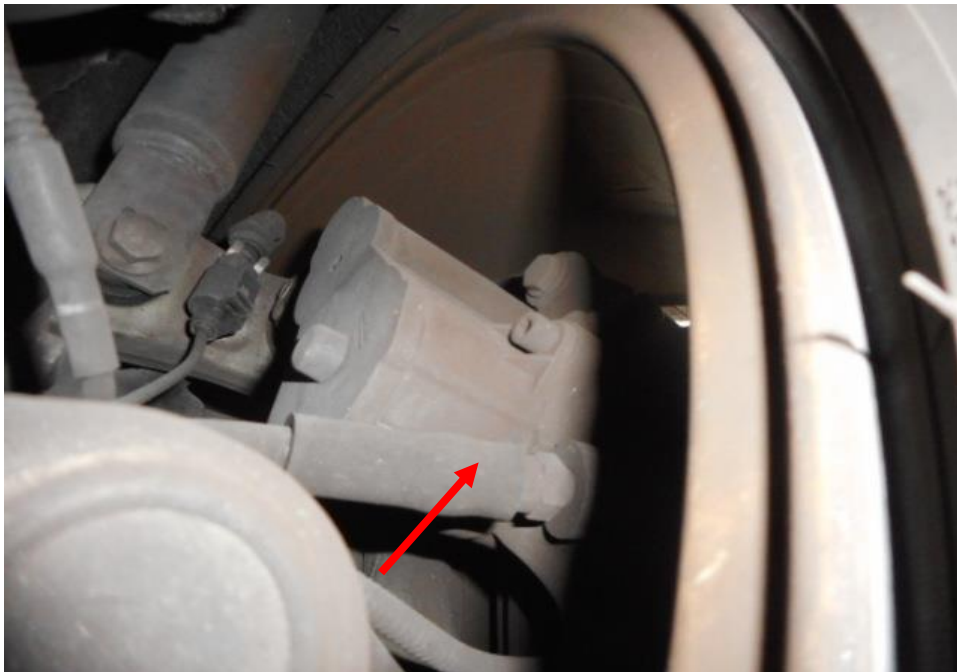
Photo 20 shows the brake pipe (arrowed) at the rear right wheel of the Motor Car. I did not observe any leakage of brake fluid at the time of my inspection of the Motor Car. My static tests of the Motor Car's braking system, along with my visual examination of the various mechanical components in the braking system, had indicated that there was no internal leakage of pressure/vacuum. Hence the braking system of the Motor Car was likely to be in serviceable condition at the material time of incident.

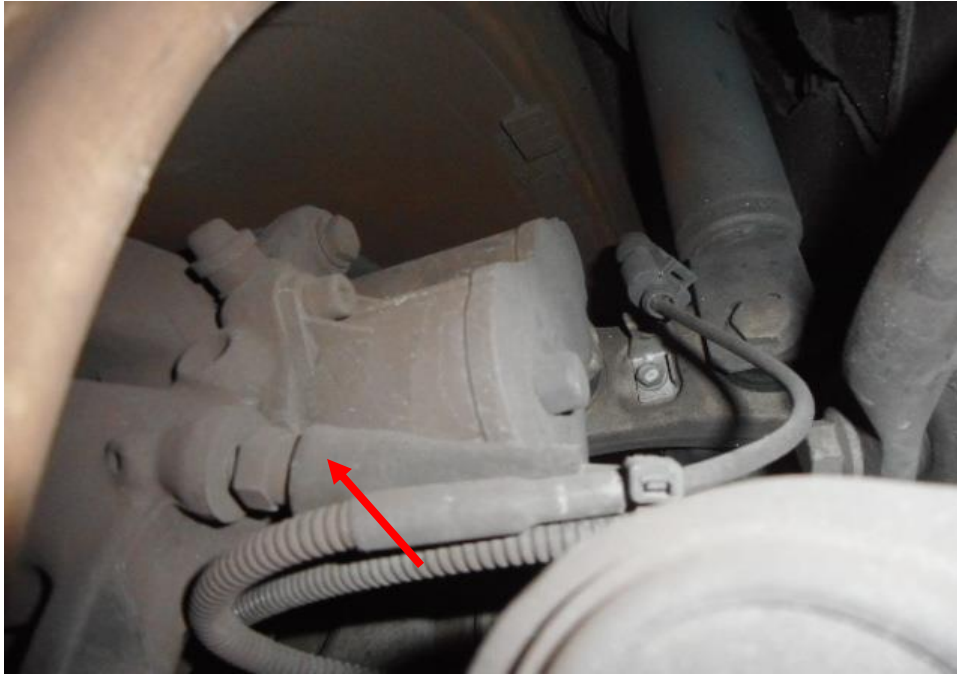
Photo 21 shows the brake pipe (arrowed) at the rear left wheel of the Motor Car. I did not observe any leakage of brake fluid at the time of my inspection of the Motor Car. My static tests of the Motor Car's braking system, along with my visual examination of the various mechanical components in the braking system had indicated that there was no internal leakage of pressure/vacuum. Hence the braking system of the Motor Car was likely to be in serviceable condition at the material time of incident.

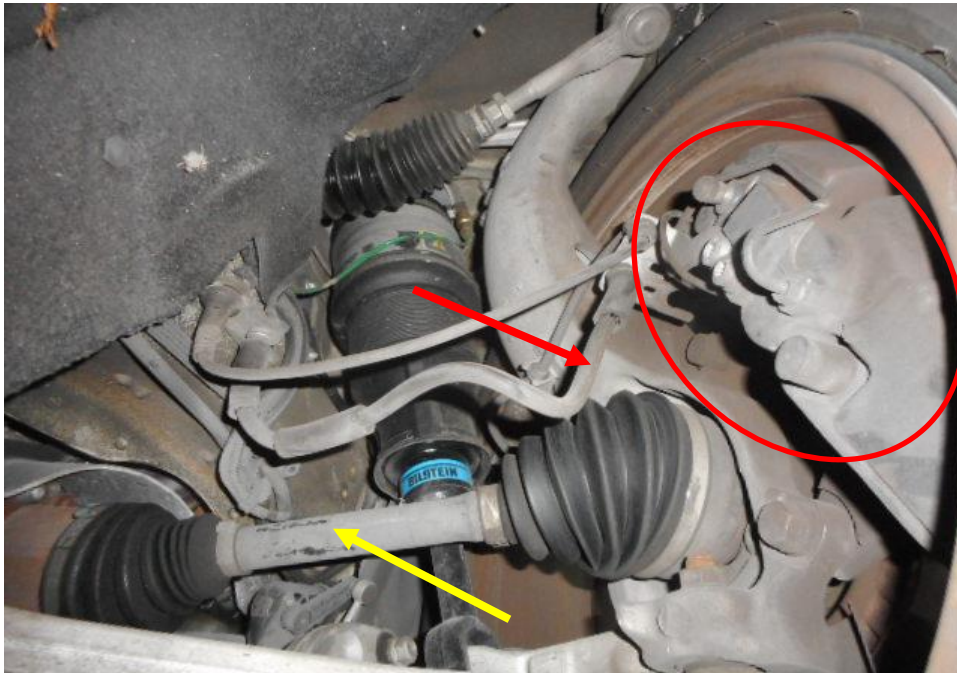
Photo 22 shows the brake hose/pipe (red arrow) at the front right wheel of the Motor Car. No leakage of brake fluid was observed. Visual examination of the various components of the braking system like the brake caliper (circled), brake booster, brake pedal and its front right driveshaft (yellow arrow) etc had revealed all to be intact and without visible damage at the time of incident. There was also no sign of fluid stain(s) observed on the various undercarriage components.

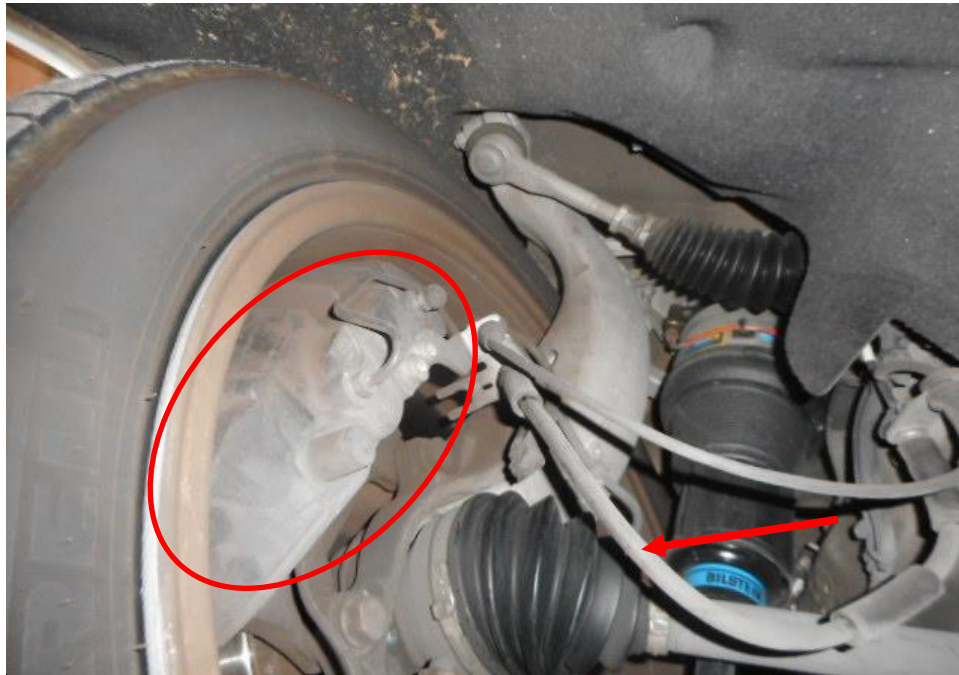
Photo 23 shows the brake hose/pipe (arrowed) at the front left wheel of the Motor Car. No leakage of brake fluid was observed. Visual examination of the various components of the braking system like the brake caliper (circled), brake booster, brake pedal etc had revealed all to be intact and without visible damage at the time of incident. There was also no sign of fluid stain(s) observed on the various undercarriage components.

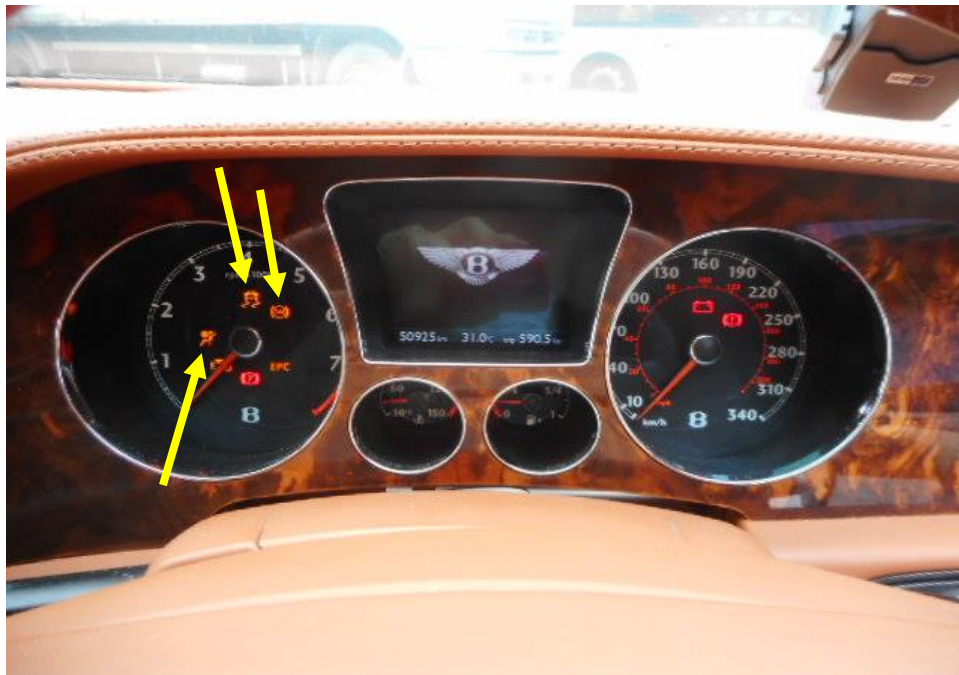
Photo 25 shows the warning light for Anti-Lock Brake System (ABS), Traction Control System (TCS), and Supplemental Restraint System (SRS) appearing on the instrument panel of the Motor Car during the self-test of its various electronic operating systems when its engine was cranked.

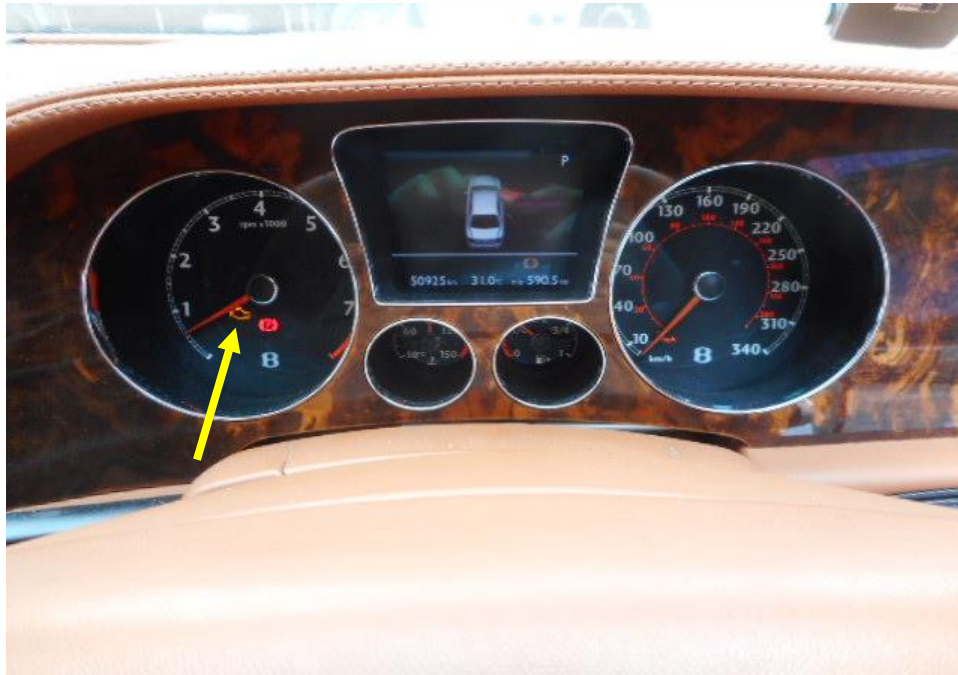
Photo 26 shows only the engine check light (arrowed) remained illuminated due to the insufficient air in the air suspension as a result of a period of storage in the vehicle pound resulting in the body of the Motor Car being lowered than normal, triggering the check light. However, there were no other warning lights illuminated on the instrument panel of the Motor Car after the engine was cranked. This would suggest that there was no abnormality to the various electronic operating systems of the Motor Car, like the ABS, TCS and SRS.

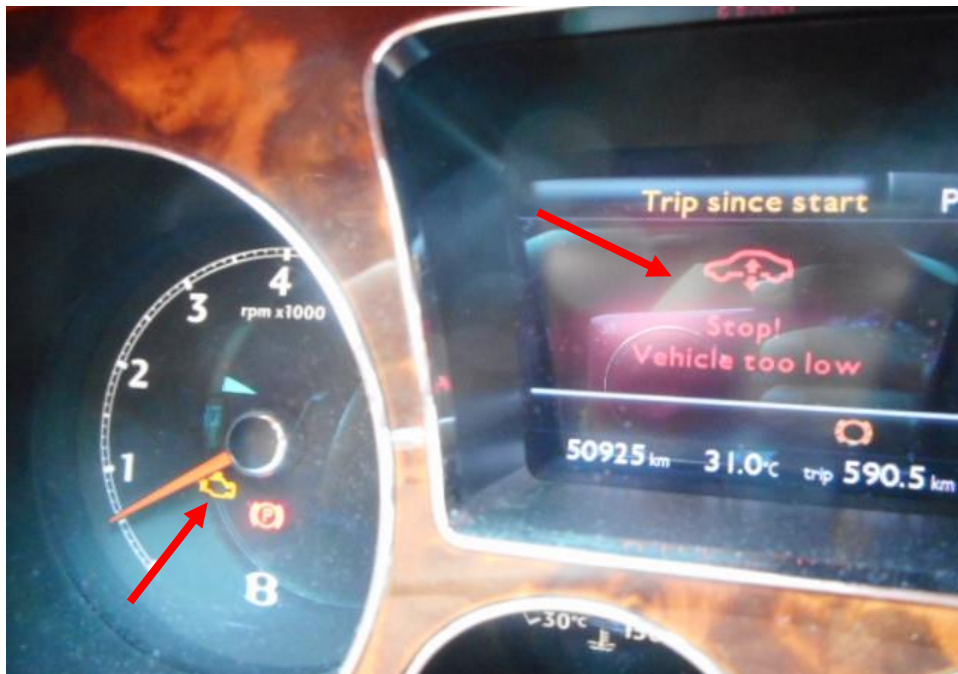
Photo 27 shows only the engine check light (arrowed) remained illuminated due to the insufficient air in the air suspension as a result of a period of storage in the vehicle pound resulting in the body of the Motor Car being lowered than normal, triggering the check light.

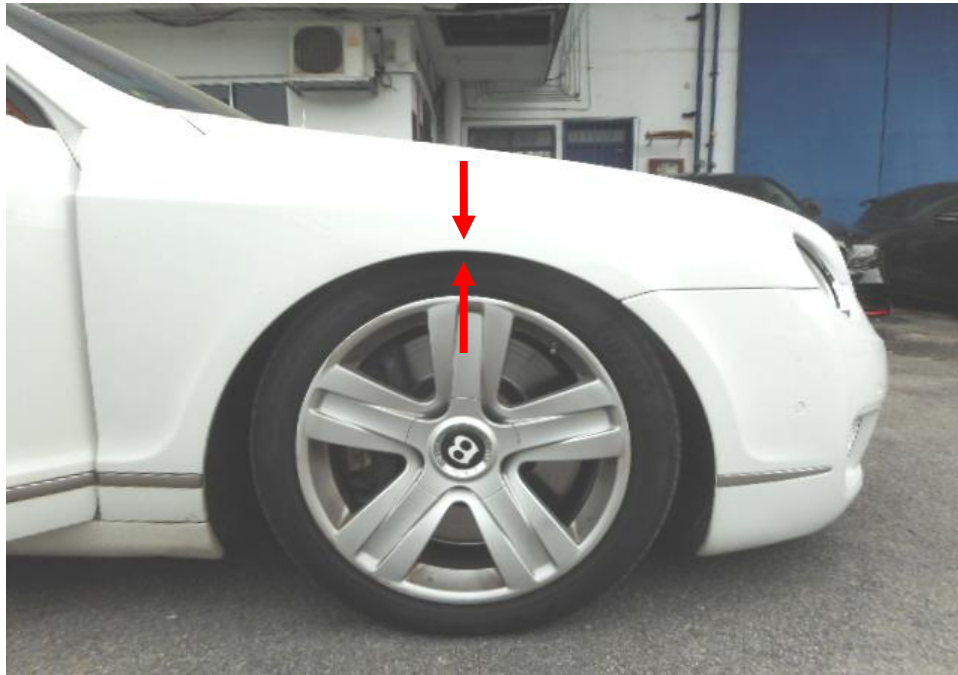
Photo 28 shows the front right wheel of the Motor Car. The vehicle body was observed to be lowered than normal (arrowed) due to the insufficient air in the air suspension as a result of a period of storage in the vehicle pound.
