Your Ref: MTS2022D0000625
Our Ref : CI/III22001252/P

**TECHNICAL INVESTIGATION REPORT OF WARRANTY CLAIM INVOLVING
THE INSURED VEHICLE SDK 1212T ON 9th February 2022**

Vehicle Registration No.	: SDK 1212T
Make / Model	: MERCEDES BENZ S500L
Chassis No	: W1K2231632A015015
Year of Registration	: JUNE 2021
Mileage	: 12,303KM

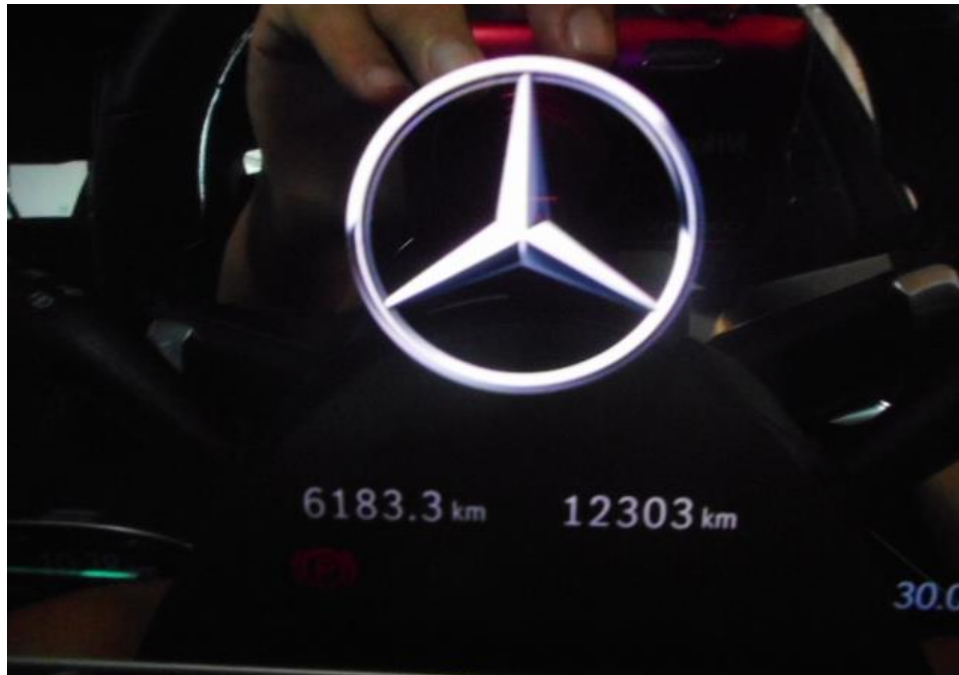
Photo 1 shows the mileage of the Insured Vehicle recorded at the time inspection at 12,303KM

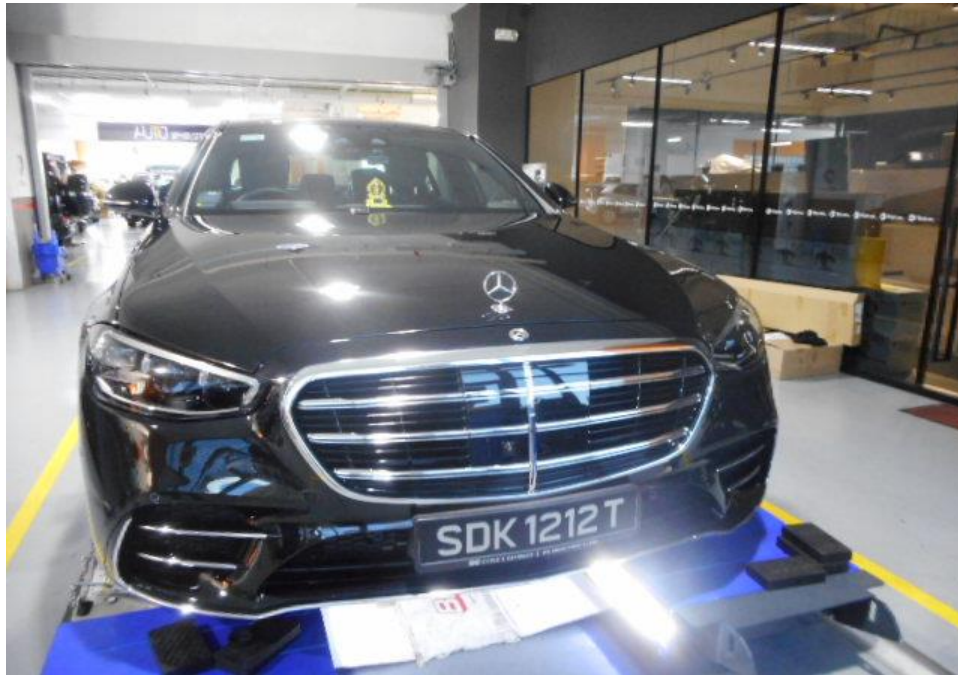
Photo 2 shows the general view of the front portion of the Insured Vehicle at the time of our inspection. The Insured Vehicle is observed to be unaffected by any signs of accident.

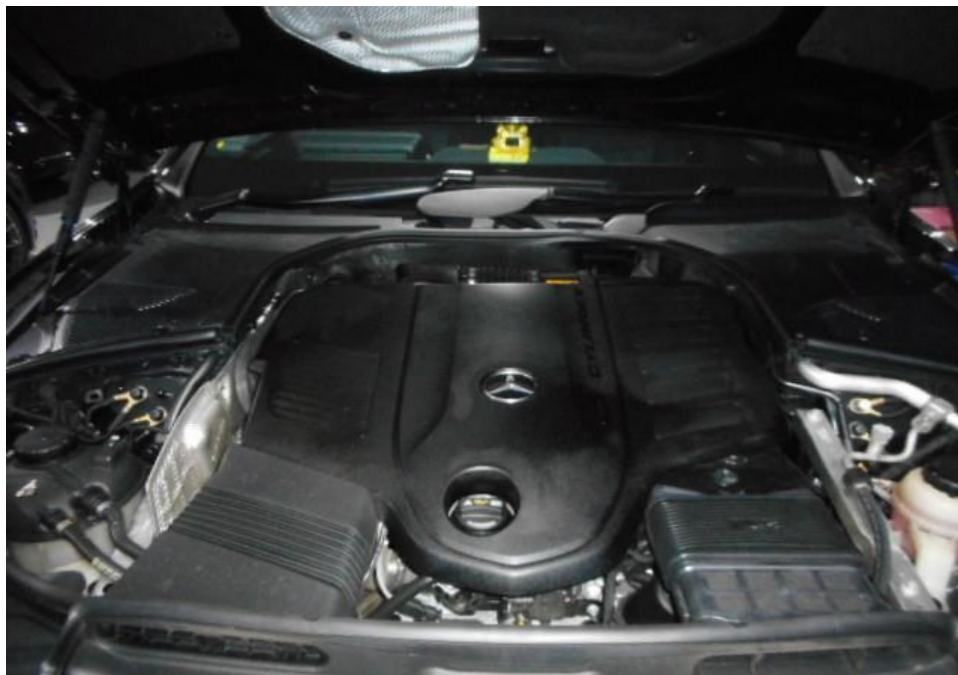
Photo 3 shows the general view of the engine portion of the Insured Vehicle at the time of our inspection. The engine compartment is observed to be unaffected by any signs of accident.

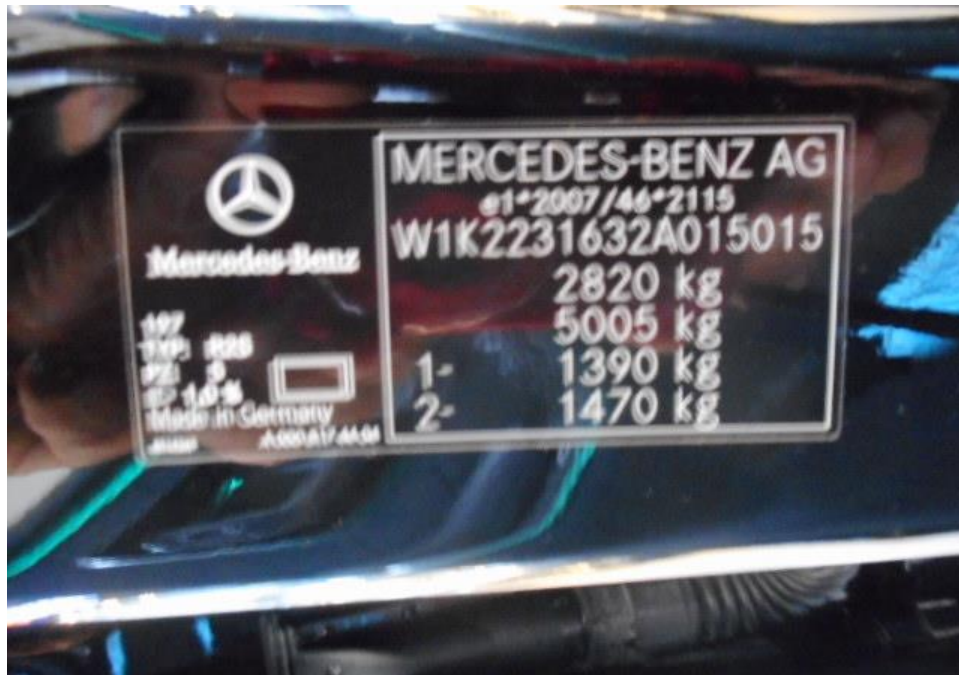
Photo 4 shows the chassis number of the Insured Vehicle at the time of our inspection.

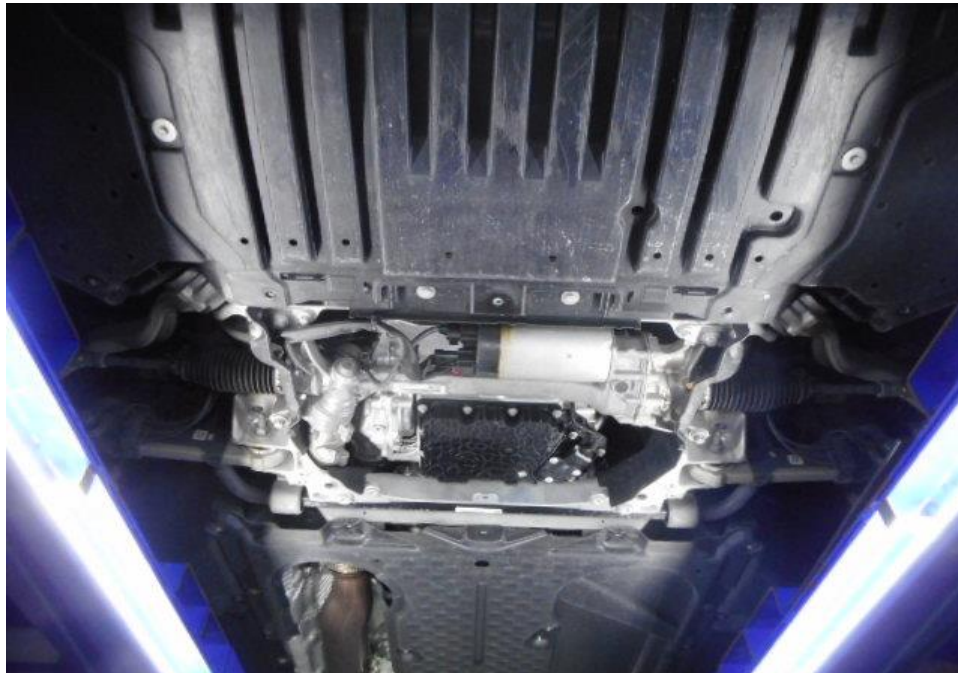
Photo 5 shows the general view of the engine underside portion of the Insured Vehicle at the time of our inspection. The engine underside compartment is observed to be unaffected and by any signs of accident.

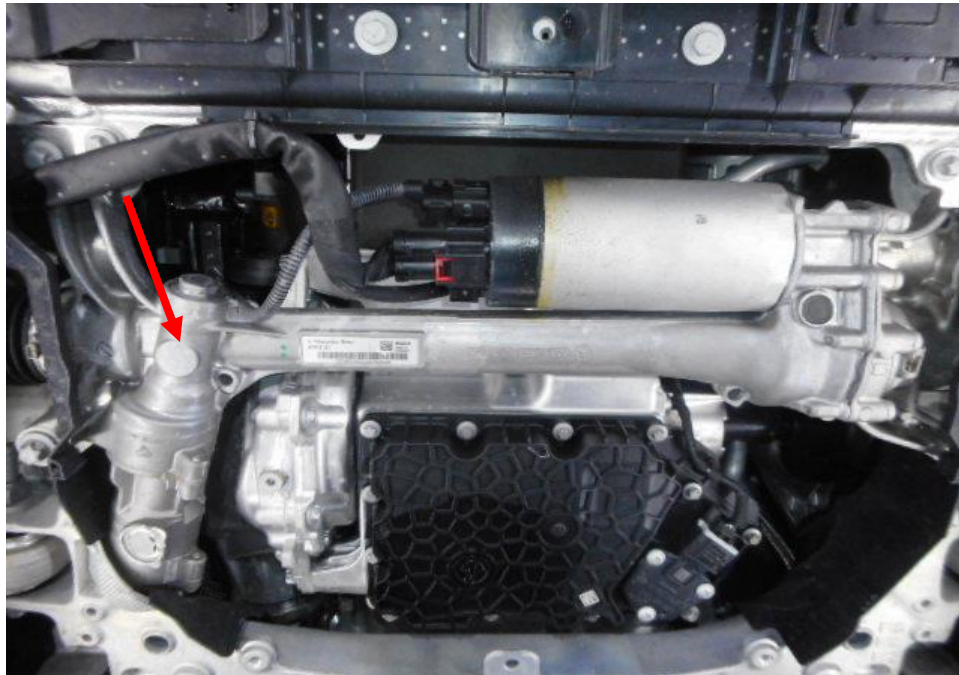
Photo 6 shows the close up view of the power steering portion of the Insured Vehicle at the time of our inspection. The Electronic Power Steering unit and its steering rack and pinion component is observed to be unaffected and by any signs of accident.

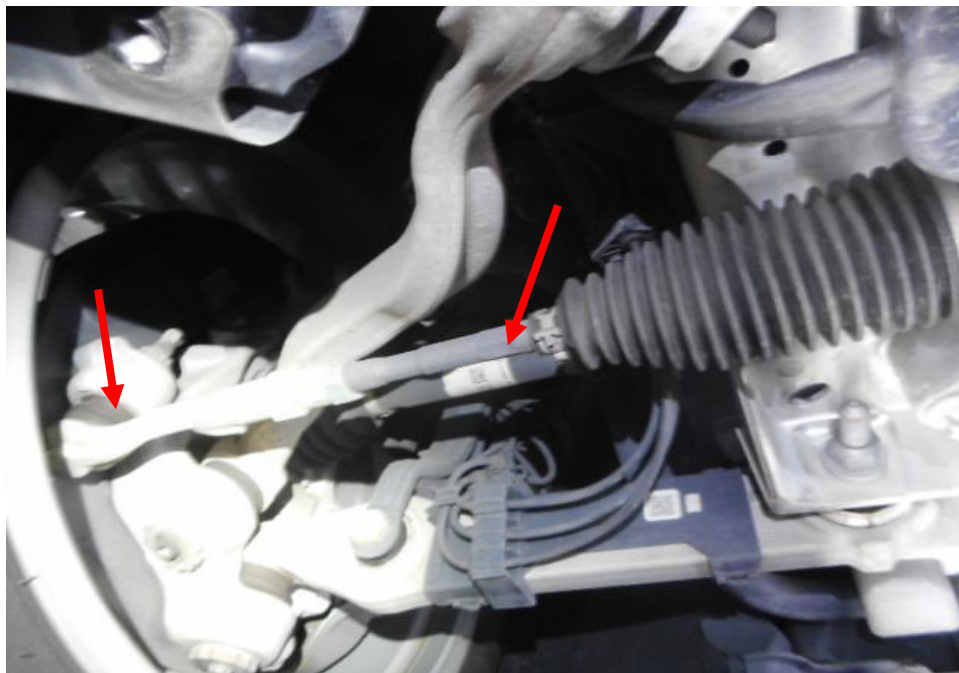
Photo 7 shows the close up view of the front left wheel of the Insured Vehicle at the time of our inspection. The steering tie rod (arrowed) is observed to be unaffected and by any signs of accident.

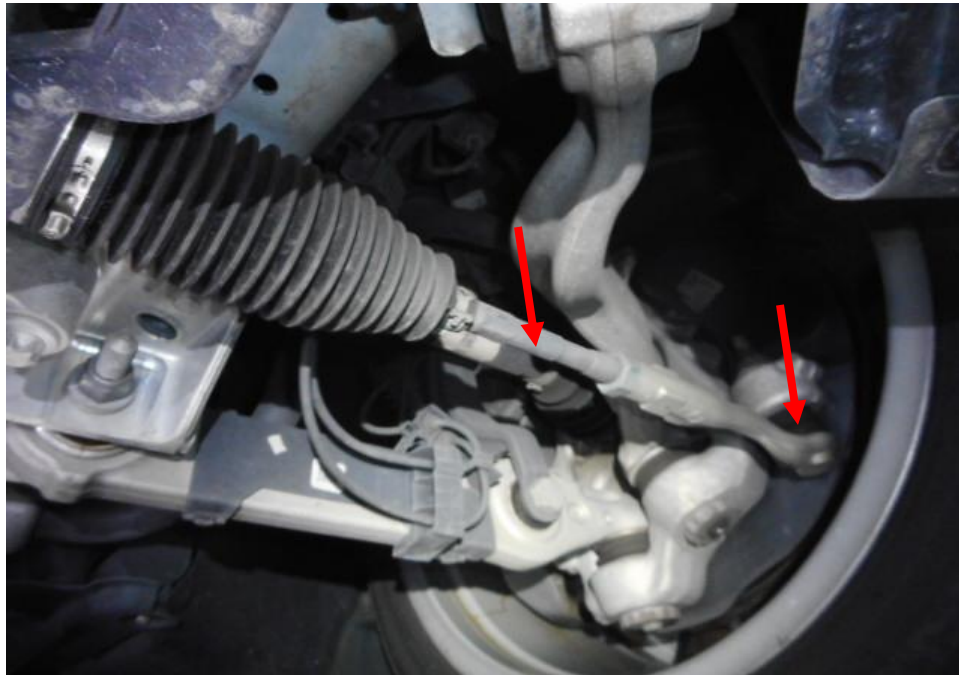
Photo 8 shows the close up view of the front right wheel of the Insured Vehicle at the time of our inspection. The steering tie rod (arrowed) is observed to be unaffected and by any signs of accident.

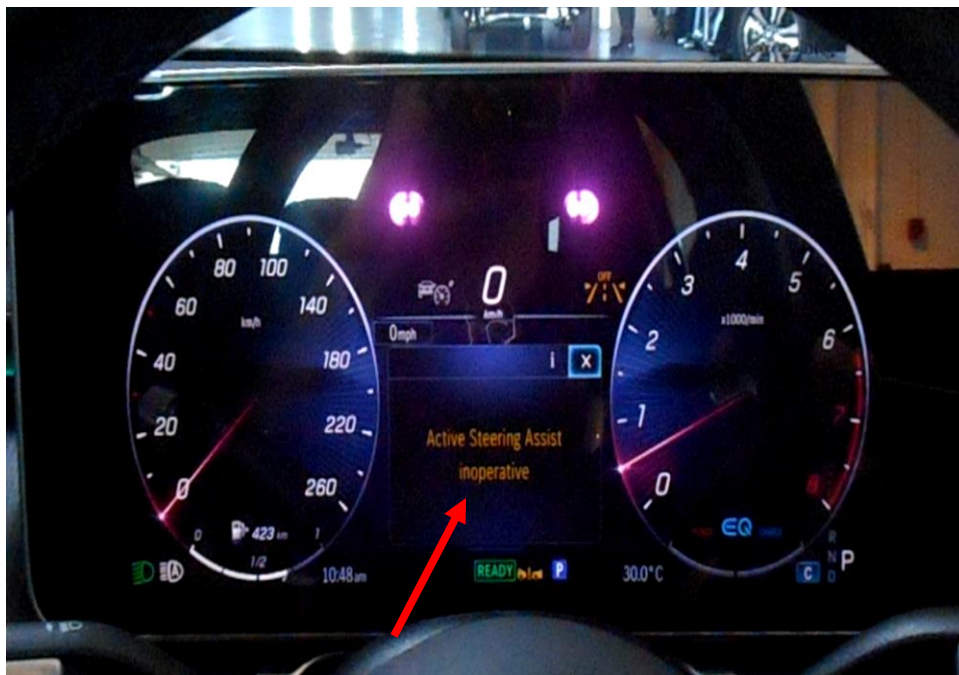
5. The complaint on the Insured Vehicle was noted be an error and warning message light regarding the electronic Advanced Driver Assistance Systems (ADAS) for the steering rack and pinion system. There is a recommendation by the workshop to replace the steering rack and pinion assembly. The vehicle was observed to be unaffected by any signs of accident.

Photo 9 shows the conducted ECU diagnosis of the Insured Vehicle at the time of our inspection. There was an electronic error (arrowed) on the Electronic Power Steering of the Insured Vehicle.

8. We did not find any evidence which had suggested that the cause of abnormalities to the Insured Vehicle was due to poor maintenance and/or recurring problem.
9. The recommendation to replace the Power steering rack and pinion assembly at \$6,498.55 is justifiable as all the relevant checks has been conducted.
