Your Ref: M2200693
Our Ref: CS4/TMI22001265/D

04 March 2022

TECHNICAL INVESTIGATION REPORT OF FIRE INCIDENT INVOLVING THE INSURED VEHICLE SCG 3021Y ON 07 FEBRUARY 2022

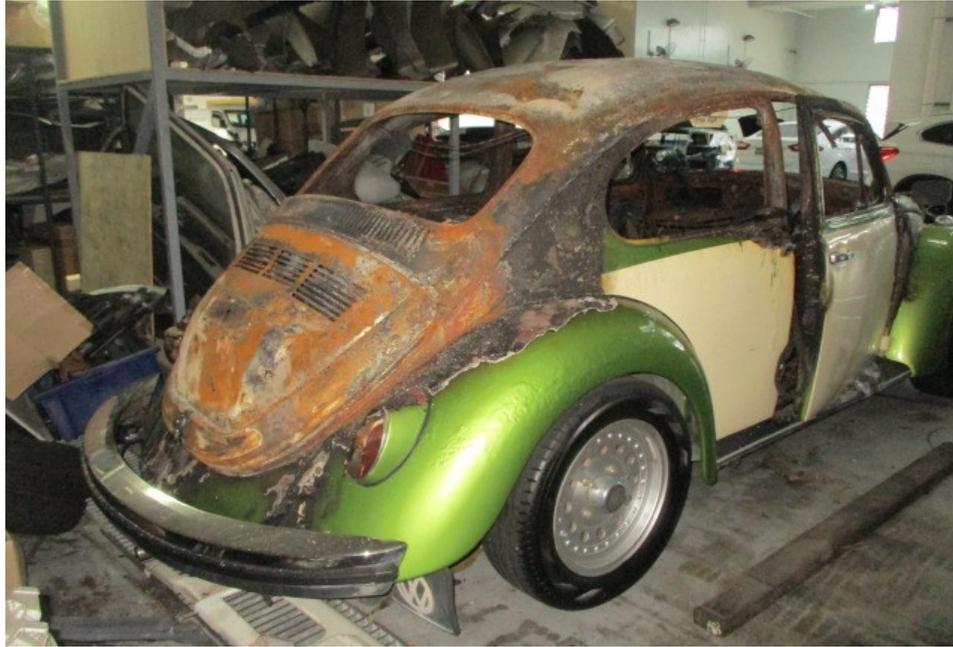
Photo 1 shows a general view of the rear right body of the Insured Vehicle at the time of my inspection. The Insured Vehicle was observed to have sustained extensive fire damage that was confined to its rear portion, engine compartment and interior compartment. The exterior body panels at the rear portion were observed to have been severely burnt.

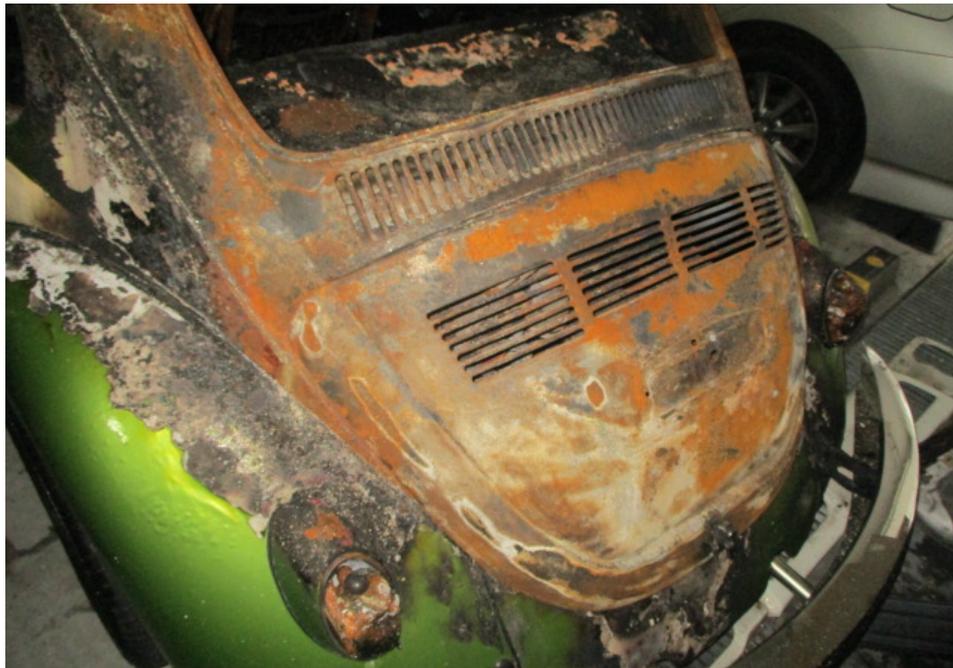
Photo 2 shows a general view of the rear left body of the Insured Vehicle at the time of my inspection. The Insured Vehicle was observed to have sustained extensive fire damage that was confined to its rear portion, engine compartment and interior compartment. The exterior body panels at the rear portion were observed to have been severely burnt.

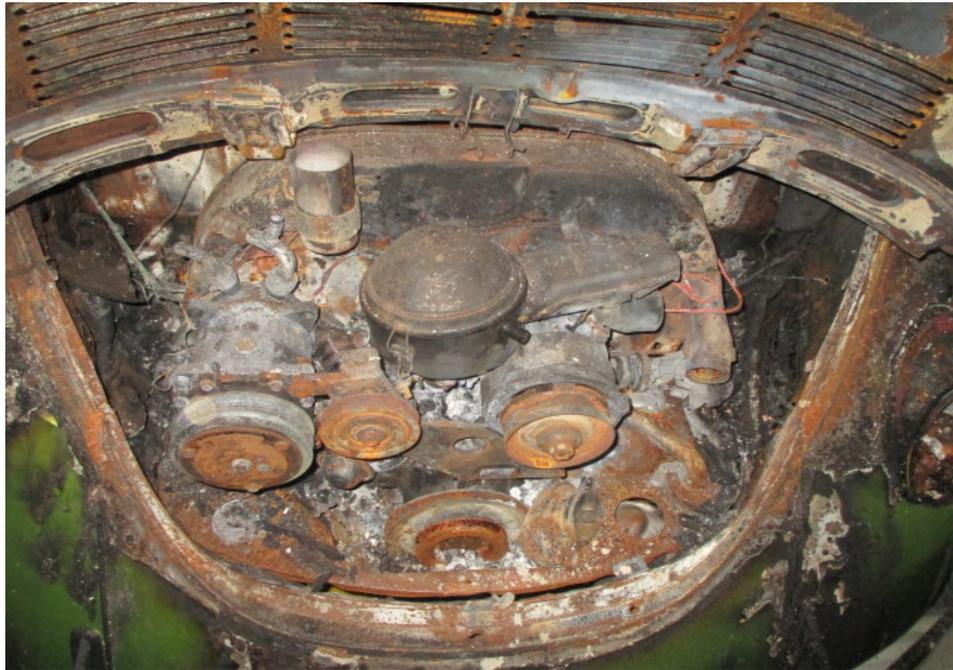
Photo 3 shows a general view of the Insured Vehicle's engine compartment, which was located at the rear portion of the Insured Vehicle. The various parts and components within the engine compartment of the Insured Vehicle were all extensively affected by the fire. This had included the engine and transmission of the Insured Vehicle.

20. At the time of my inspection, I had noted that the engine compartment was located at the rear portion of the Insured Vehicle. Parts and components inside the engine compartment were all completely burnt, leaving charred skeletal remains (refer to photograph 3 above). This would indicate to me that the engine compartment was exposed to prolonged high heat intensity, which suggests that the causation of the fire was within the engine compartment, at the rear portion of the Insured Vehicle. This also follows Mr Loh's description that he first saw smoke coming out of the air vents at the rear portion. The engine compartment is located directly below these air vents. See photo 10 below.

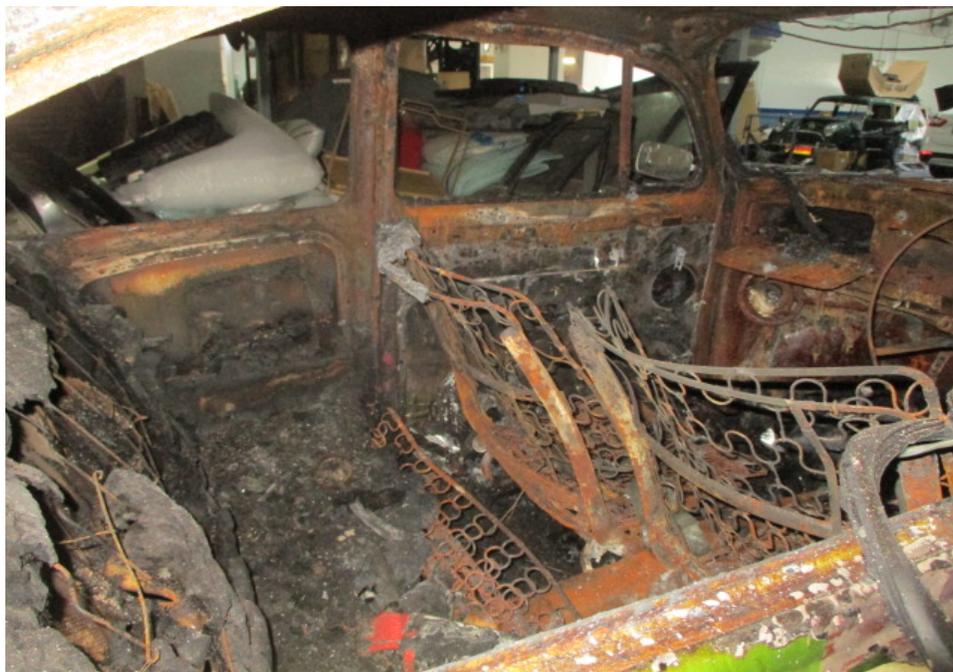
Photo 4 shows a general view of the Insured Vehicle's interior compartment. The various parts and components within the interior compartment of the Insured Vehicle were completely burnt, leaving charred skeletal remains

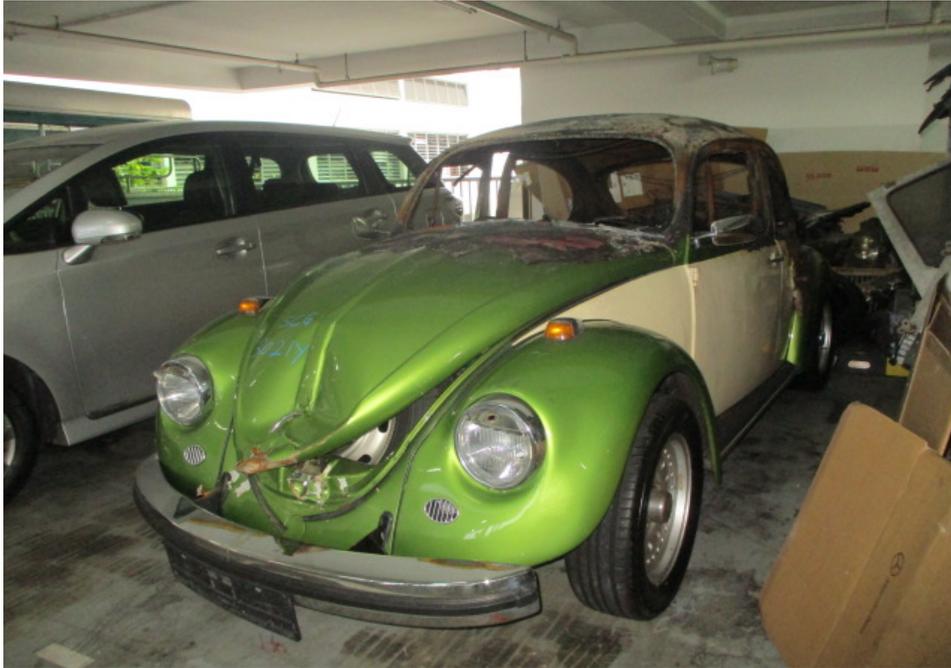
Photo 5 shows the front left body of the Insured Vehicle. The frontal portion of the Insured Vehicle was observed to be relatively unaffected by the fire. The front bonnet was observed to be dented, likely to be force opened by SCDF officers.

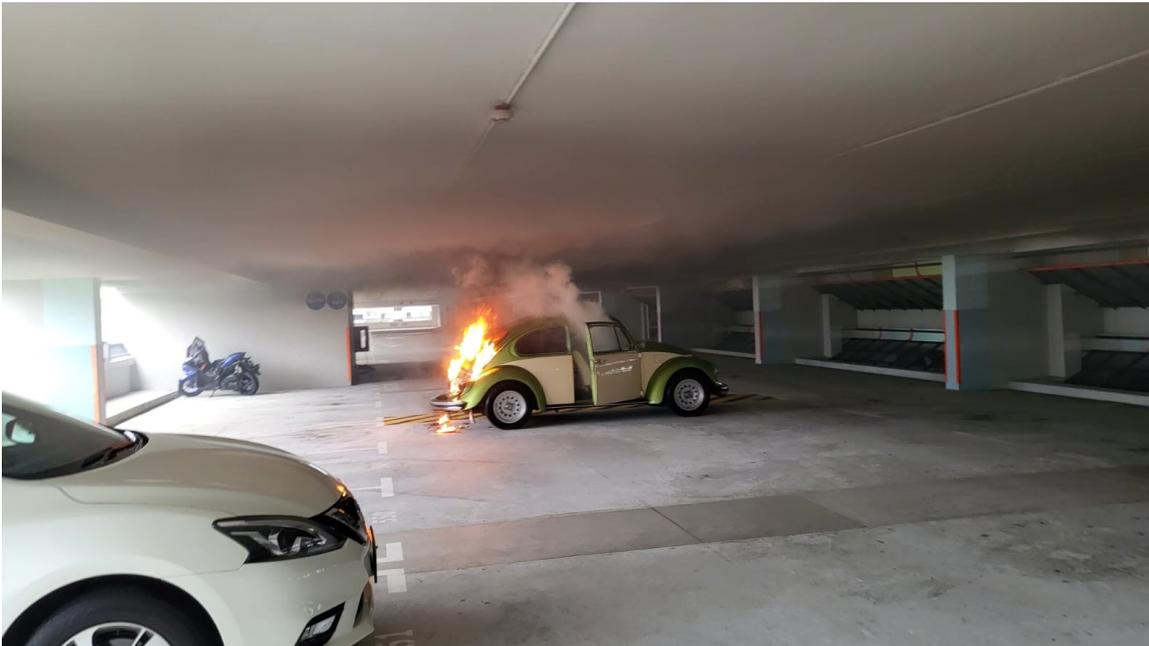
Photo 6 shows the Insured Vehicle at the incident scene (photograph provided by Mr Loh). As seen from the photograph, the Insured Vehicle's was stationary across the driveway of the multi-story carpark with fire at its rear portion. Smoke was also seen coming out from its interior compartment.

19. For this case, the photographs taken by Mr Loh at the incident scene can be relied on to establish where the fire to the Insured Vehicle had occurred. As seen in photograph 6 above, fire was only at the rear portion of the Insured Vehicle at a time when other areas of the Insured Vehicle were still relatively unaffected. Hence, the fire can be established to have originated at the rear portion of the Insured Vehicle before spreading into its interior compartment.

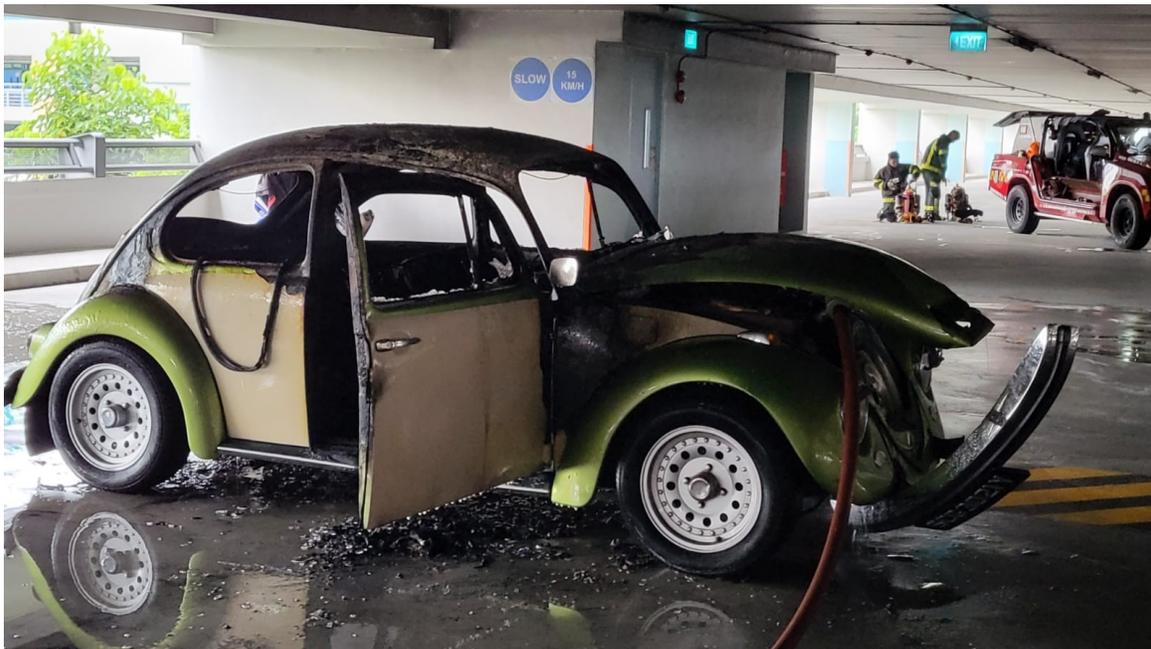
Photo 7 shows a closer view of the Insured Vehicle after the fire was extinguished by SCDF officers (photograph provided by Mr Loh).

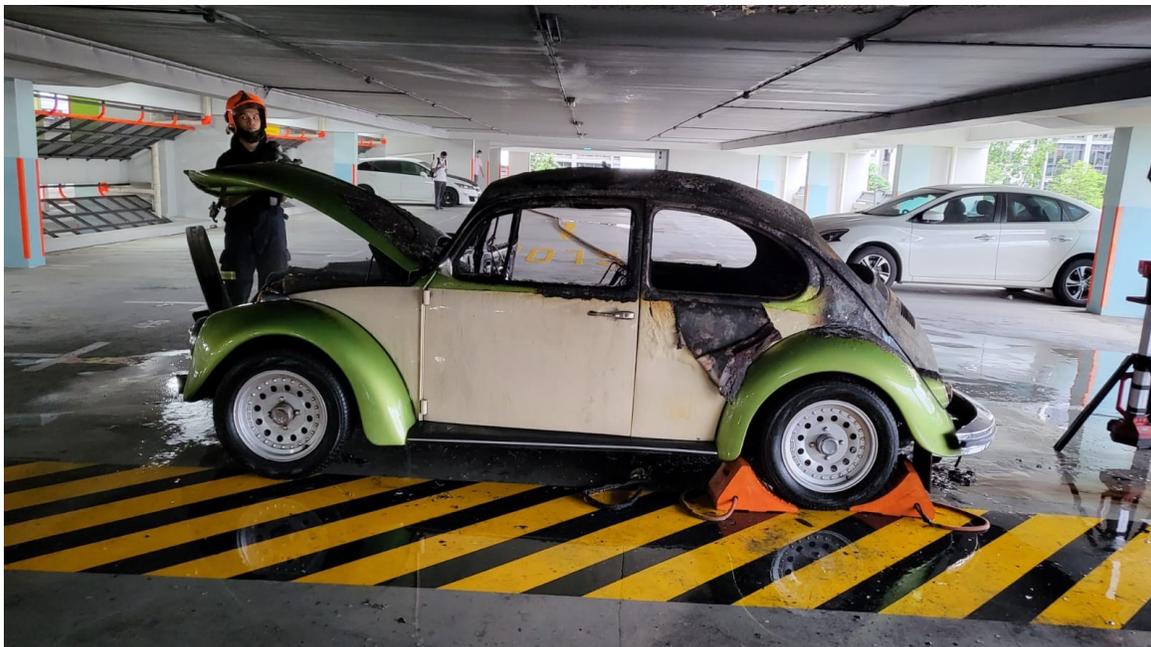
Photo 8 shows a closer view of the Insured Vehicle after the fire was extinguished by SCDF officers (photograph provided by Mr Loh).

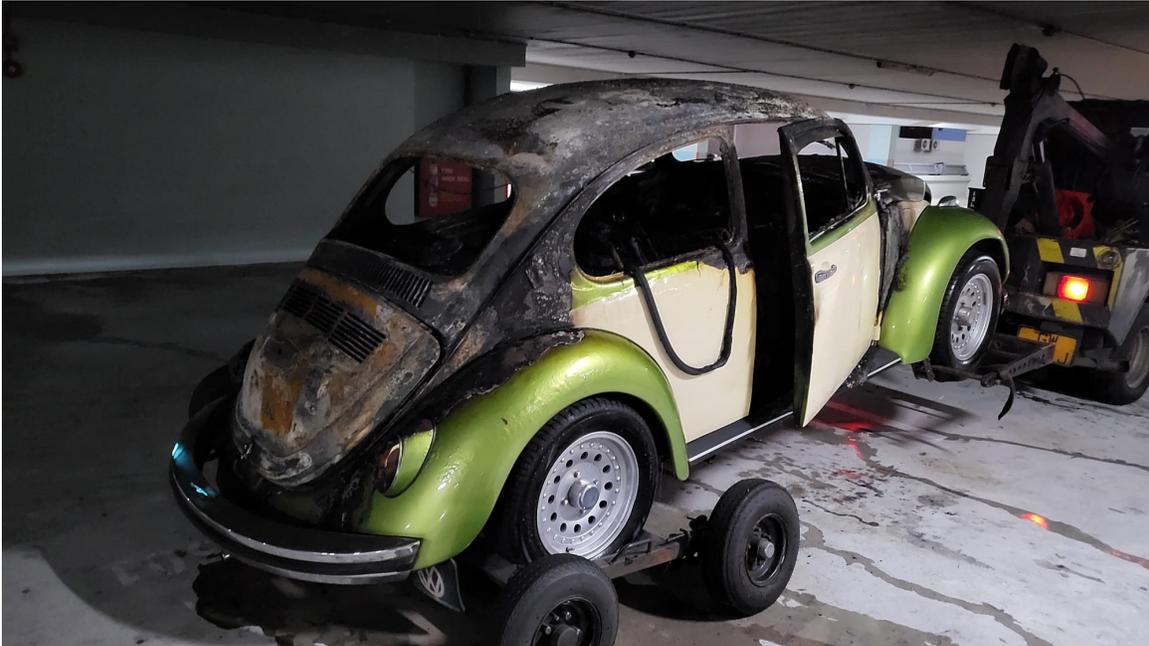
Photo 9 shows the Insured Vehicle being towed to the authorized workshop after the fire was extinguished (photograph provided by Mr Loh).

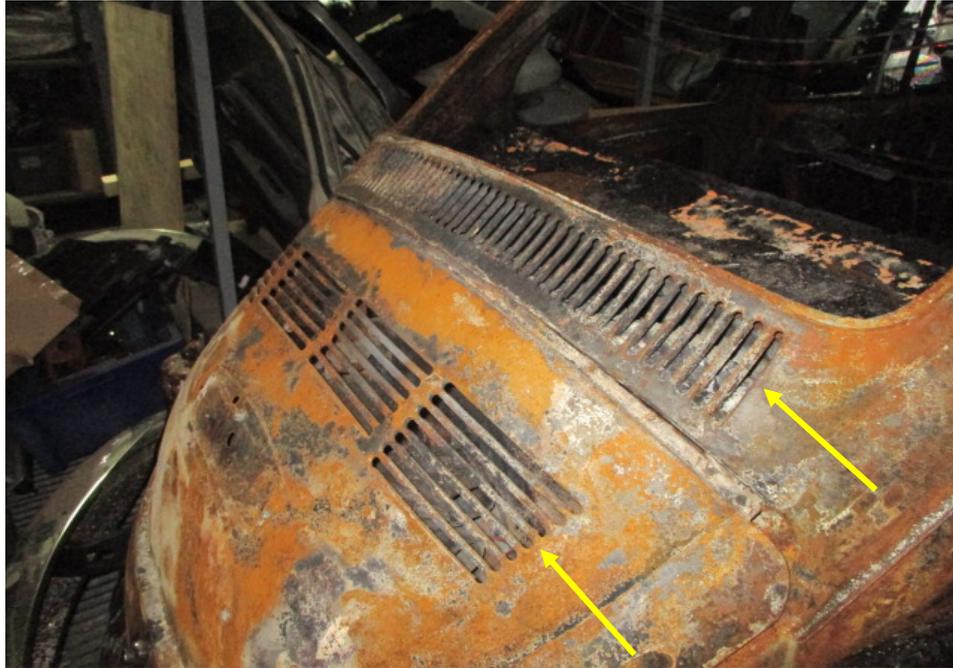
Photo 10 shows the rear portion of the Insured Vehicle. Mr Loh had first saw smoke coming out from the 2 air vents (arrowed) at the rear portion of the Insured Vehicle. The engine compartment is located directly below both air vents. Following the characteristic that heat (hot air) rises upwards, the causation of the fire was determined to be from within the engine compartment.

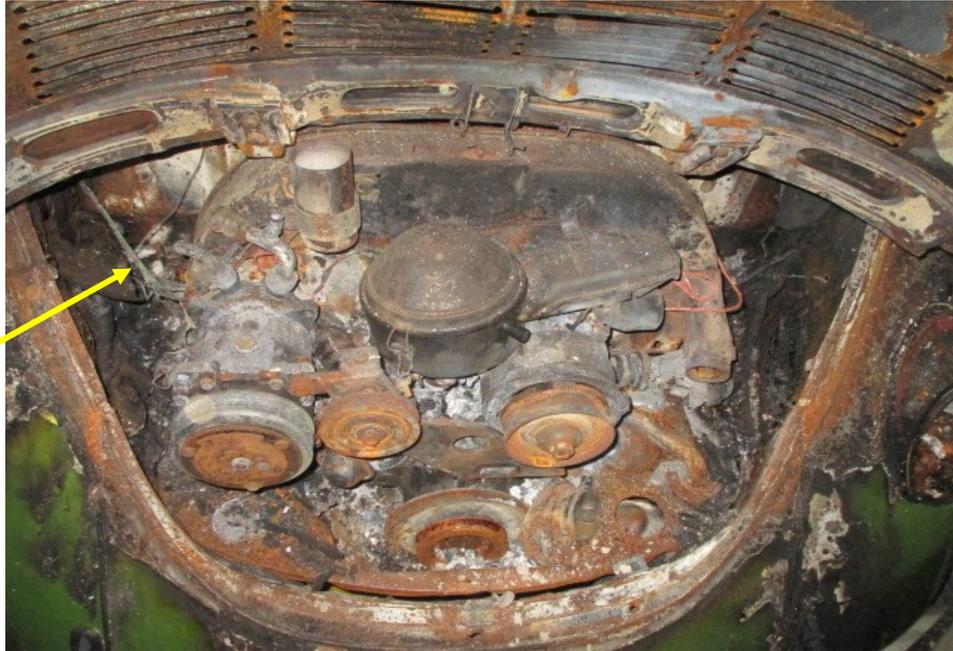
21. Upon closer examination of the Insured Vehicle's engine compartment, I had found traces of greenish residue on several stretches of burnt wirings around the rear left area of the engine compartment. The presence of greenish residue indicates internal heating of copper wires, a sign of an electrical short circuit occurring. The greenish residue is normally left behind from oxidation as a result of chemical reaction involving the copper wires. This physical evidence would then appear to suggest that the cause of fire to the Insured Vehicle was possibly due to electrical in nature. See photos 11 - 14 below.

Photo 11 shows the engine compartment of the Insured Vehicle at the time of my inspection. For this case, the causation of the fire was determined to be from within the engine compartment of the Insured Vehicle. Upon my closer examination, I had found traces of greenish residue on several stretches of burnt wirings (arrowed) at the rear left area of the engine compartment. The presence of greenish residue suggests that the fire was possibly due to electrical in nature.

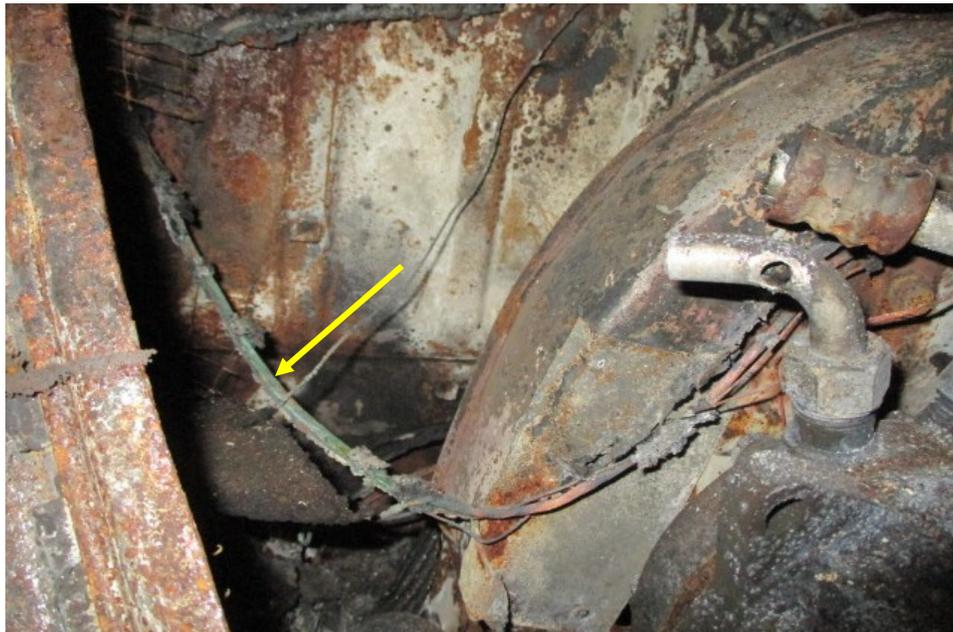
Photo 12 shows a closer view of the burnt wirings (arrowed) with greenish residue. The presence of greenish residue indicates internal heating of copper wires, a sign of an electrical short circuit occurring. The greenish residue is normally left behind from oxidation as a result of chemical reaction involving the copper wires.

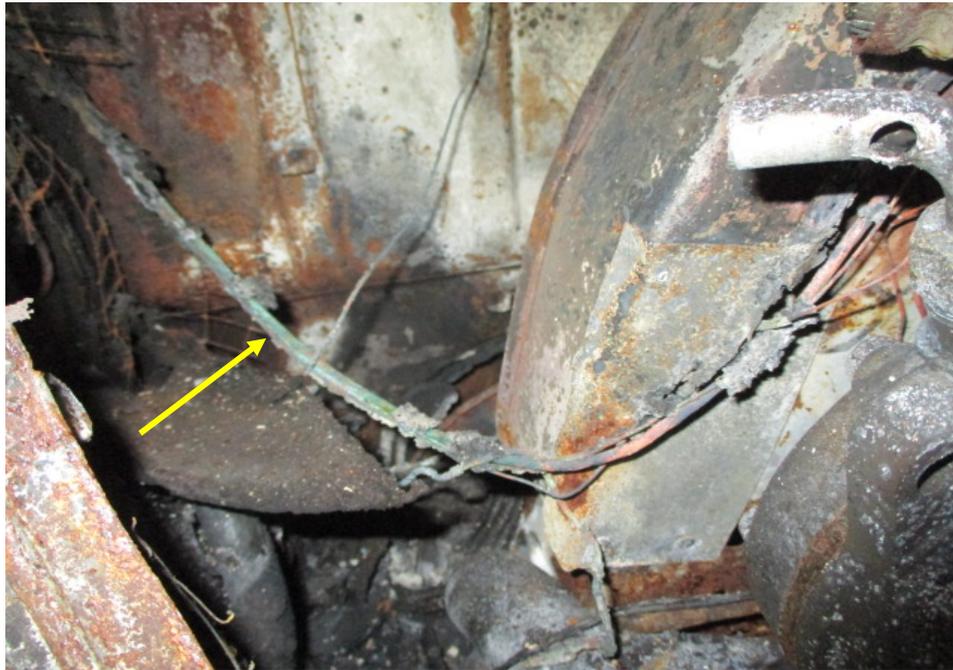
Photo 13 shows another view of the burnt wirings (arrowed) with greenish residue. The presence of greenish residue indicates internal heating of copper wires and is normally left behind from oxidation as a result of chemical reaction involving the copper wires. This physical evidence would then appear to suggest that the cause of fire to the Insured Vehicle was possibly due to electrical in nature.

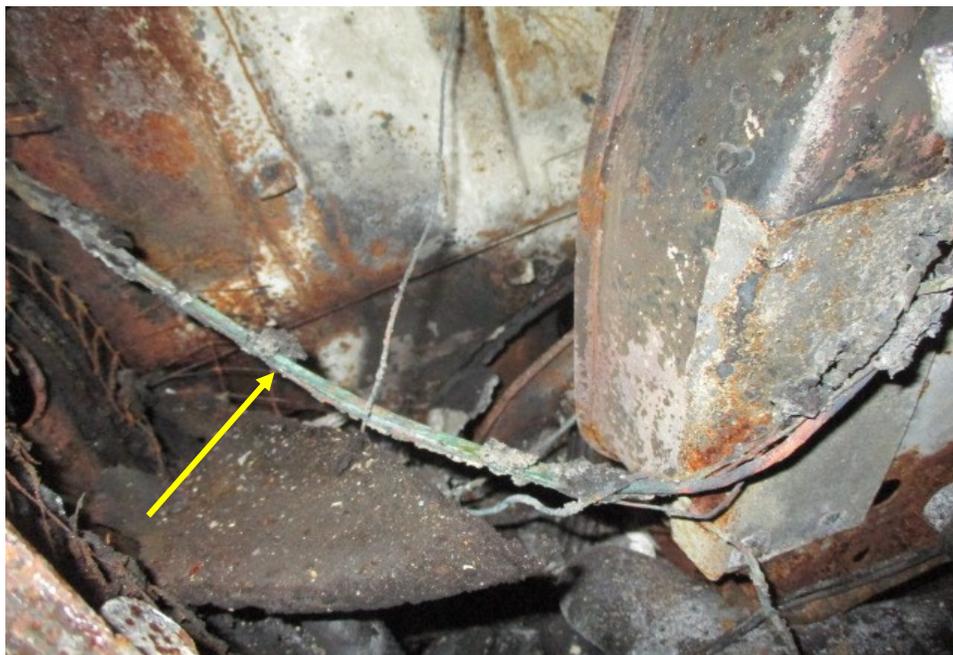
Photo 14 shows a close-up view of the burnt wirings (arrowed) with greenish residue. The presence of greenish residue suggests to me that the cause of fire to the Insured Vehicle was possibly due to electrical in nature. The wirings had likely experienced an abnormality of electrical current, which led to the fire.

23. For this case, I am of the view that the fire had originated within the engine compartment, at the rear portion of the Insured Vehicle. The cause of fire was of electrical in nature. The wirings at the rear left area of the Insured Vehicle's engine compartment had likely experienced an abnormality of electrical current, which led to the fire.
