**PRELIMINARY INVESTIGATION  
FOR THE FORKLIFT INCIDENT  
WITH CIVILIAN VEHICLE  
ON 06 JAN 22 AT  
PASIR LABA AMMUNITION  
DEPOT (PLAD)**

**Prepared By: ME4 Low Zhi Chyim**  
**Appointment: Depot Comd PLAD, GSAB**  
**Contact Number: [REDACTED]**  
**Date: 06 Jan 22**

**PRELIMINARY INVESTIGATION ON THE CIRCUMSTANCES  
LEADING TO THE FORKLIFT INCIDENT WITH CIVILIAN VEHICLE  
ON 06 JAN 22 AT PASIR LABA AMMUNITION DEPOT (PLAD)**

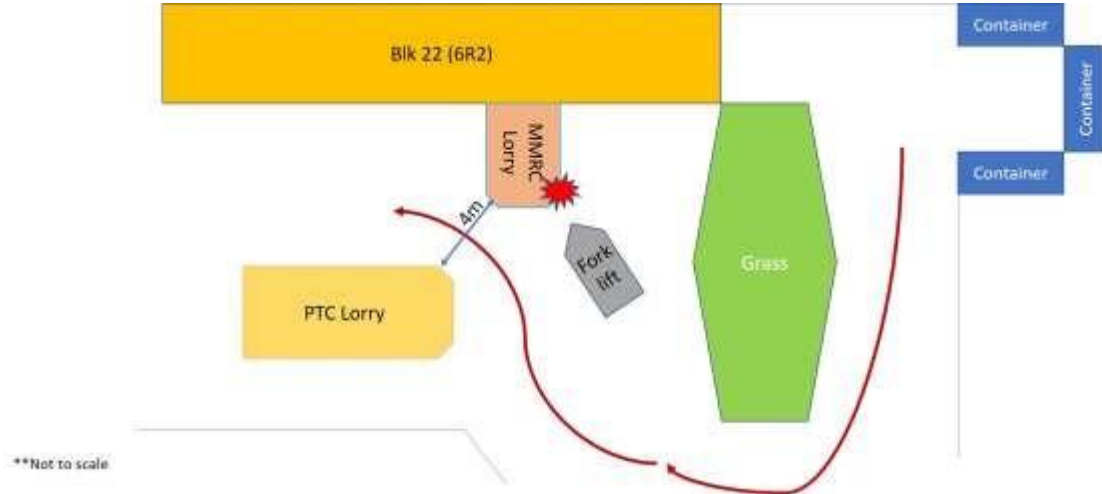
Figure 1. Sketch Diagram of Forklift Incident at Block 22 (6R2) of PLAD

8. **Parking Position of PTC Lorry (see Figure 1) as Possible Contributing Factor**. As the PTC lorry was parked just 4m perpendicular to the MMRC lorry, it created a "limited driving space" for ME1 JASON KOH to drive through so as to place pallet #3 (P3) onto the left-hand side of PTC lorry (see **Figure 2**). Such hazard would have been eliminated should the PTC lorry had parked further apart from the MMRC lorry. That would create more working space for safe Forklift manoeuvring to perform such loading and unloading tasks.

9. **Demarcate Clear Parking Lots for Commercial Vehicles to Load General Stores**. Presently in PLAD, demarcated parking lots (i.e. "Yellow boxes" parking lots) at block 22 (6R2) were catered primarily only for military vehicles such as OUV and 5-Ton vehicles to load and unload live ammunition. As such, it is recommended that additional Parking Lots meant for commercial lorries to load and unload general stores be drawn-up; so as to design-out hazards due to limited working space for forklift manoeuvring.

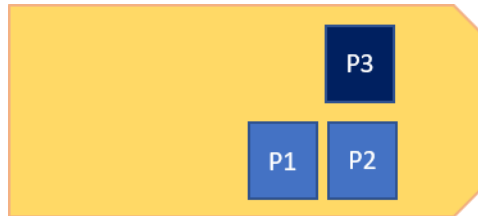
Figure 2. Placement Position of Pallet #3 (P3) on PTC Lorry

4. On **06 1240H Jan 22**, as ME1 JASON KOH was manoeuvring the forklift to load pallet #3 (P3) of RAI ammunition boxes for placement onto the PTC lorry, he misjudged the turning radius as he was approaching the PTC lorry. As a result, the Forklift operated by ME1 JASON KOH knocked into a **Multi Mission Range Complex (MMRC) lorry's (GBJ 8874R) left passenger side door** which was parked stationary and perpendicular to block 22 as shown in **Figure 1**. ME1 JASON KOH had to manoeuvre to Left Hand Side (LHS) of the PTC to distribute the P3 load evenly as shown in **Figure 2**. The PTC lorry was positioned in an 'L' - shape with about 4m distance to the MMRC lorry. The dented area was caused by the wooden pallet. See **Figure 3** for pictures of dent damage to the MMRC lorry left-hand side passenger side door.

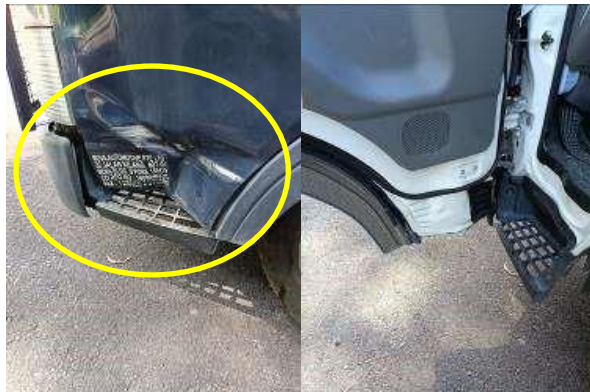
Figure 3. Dent Damage of MMRC's Lorry Left-Hand Side Passenger Side Door

7. **Judgemental Error made by Forklift Operator**. Based on the initial facts and findings, the likely primary cause of this incident was due to ME1 JASON KOH's **judgemental error** where he **misjudged the turning radius during his manoeuvring approach to the PTC lorry**; so as to load pallet #3 (P3) of empty RAI ammunition box on the Left-hand side of PTC lorry. Prior to this incident, ME1 JASON KOH had sufficient rest and did not undertake DOS or Duty Team duties the day before 06 Jan 22. Hence, human fatigue was ruled out as one of the causal factor.

At 06 1240H Jan 22, on my third pallet I went to the container which was at extreme right side of block 22 to take the RAI boxes of M2 boxes. Upon going into the issue bay I accidentally knock onto the MMRC vehicle as I misjudge the turning radius and hit the passenger side of the vehicle. Where it was dented at the bottom left passenger door of the vehicle.
