INVESTIGATION REPORT:

Our Ref : CS6/AIS22001282/N
Policy No : SP2000580304-01
Insured : SND 5858Y
Date of Incident : 3 February 2022
Location : Whitley Road towards PIE (TUAS)

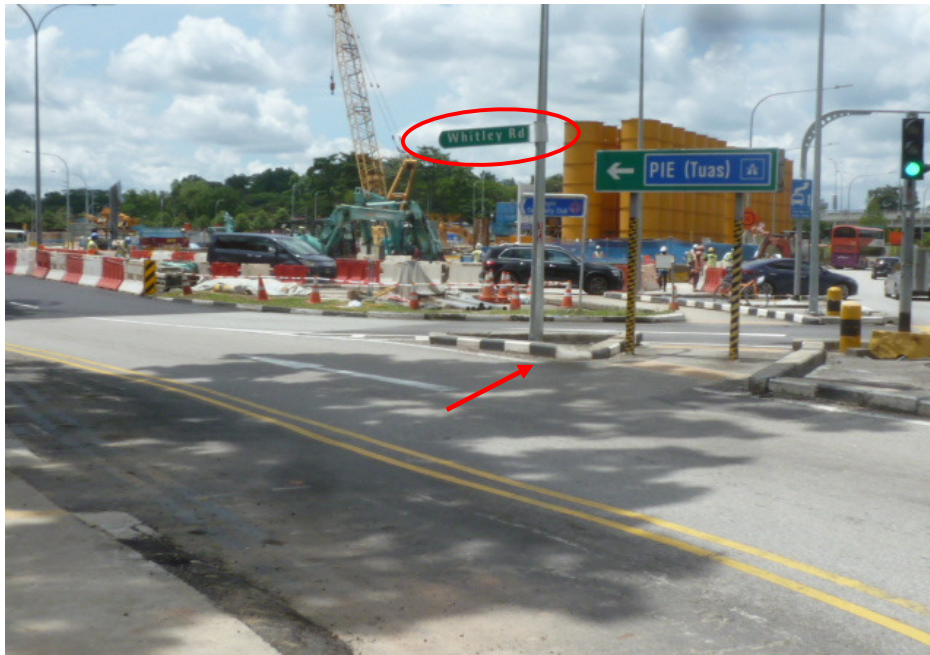
Photo 1 shows the location where the incident had occurred, along the left bend (arrowed) towards Whitley Road (circled). We noticed that the vicinity was not monitored by CCTV camera(s).

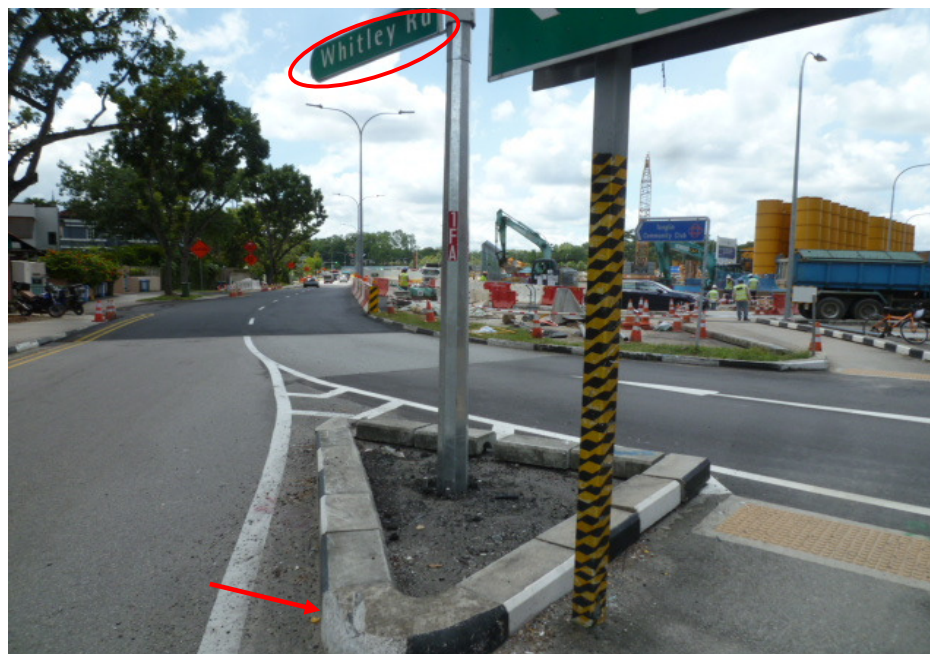
Photo 2 shows a closer view of the location where the incident had occurred, along the left bend (arrowed) towards Whitley Road (circled). We noticed that the vicinity was not monitored by CCTV camera(s).

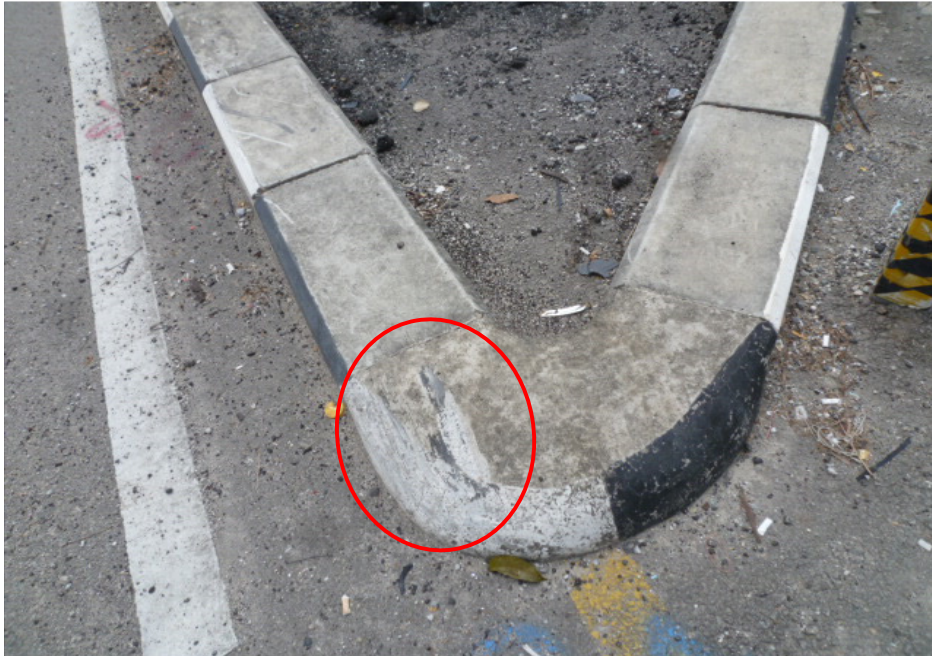
Photo 3 shows the graze marks and tyre marks found on the kerb which Ms Pek had mounted (circled).

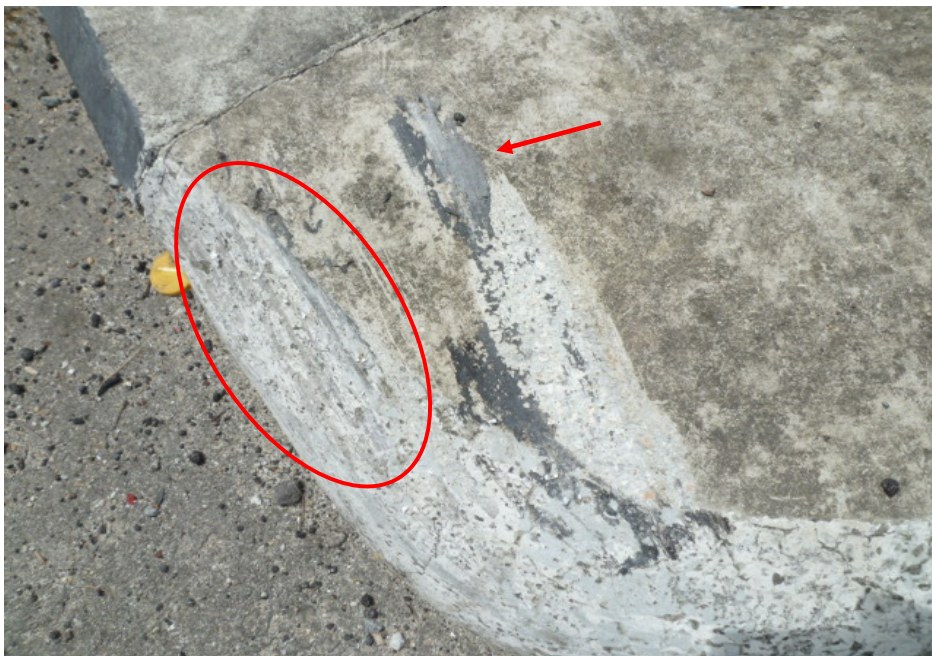
Photo 4 shows a close up view of the graze marks (circled) and tyre marks (arrowed) found on the kerb which Ms Pek had mounted.

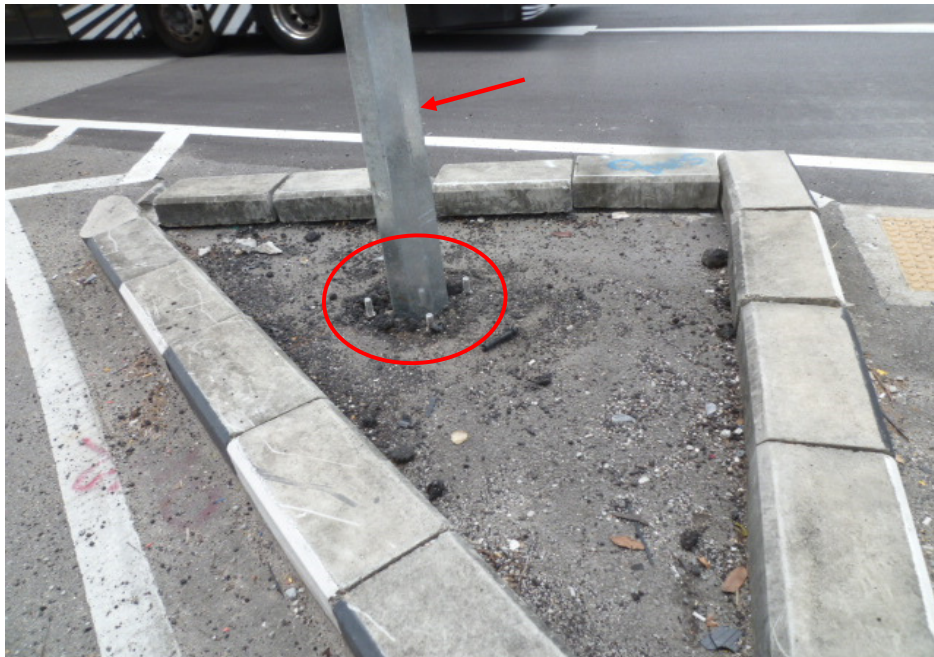
Photo 5 shows the lamp post (arrowed) which Ms Pek had collided into. We observed that the base of the lamp post had been replaced. The bolts surrounding the base of the lamp post and the re-laid tar are indications that it had been recently replaced (circled).

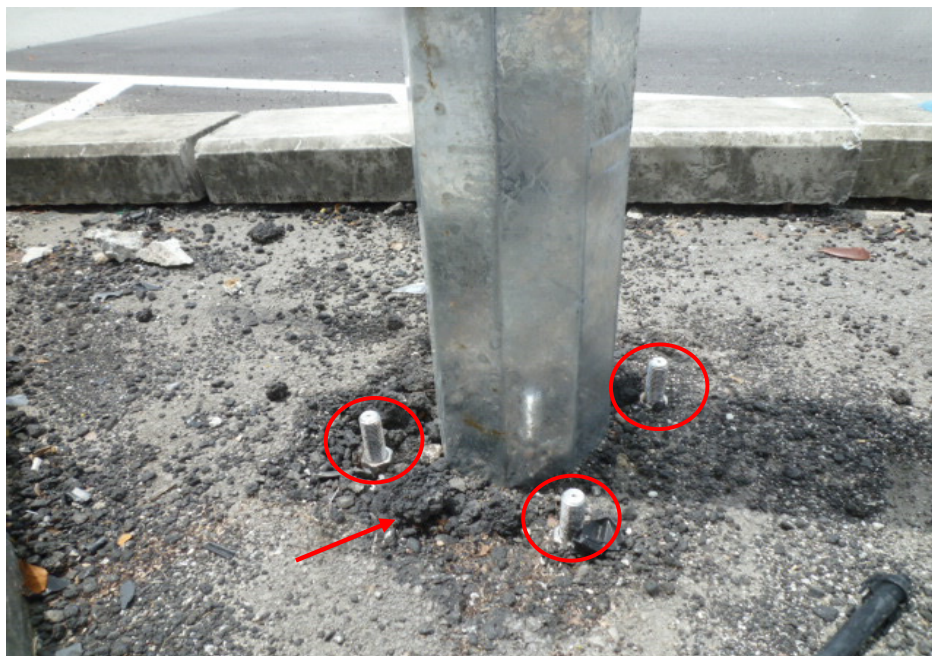
Photo 6 shows a close up view of the bolts surrounding the base (circled) and the re-laid tar (arrowed) at the bottom of the lamp post which are indications that the base of the lamp post had been recently replaced.

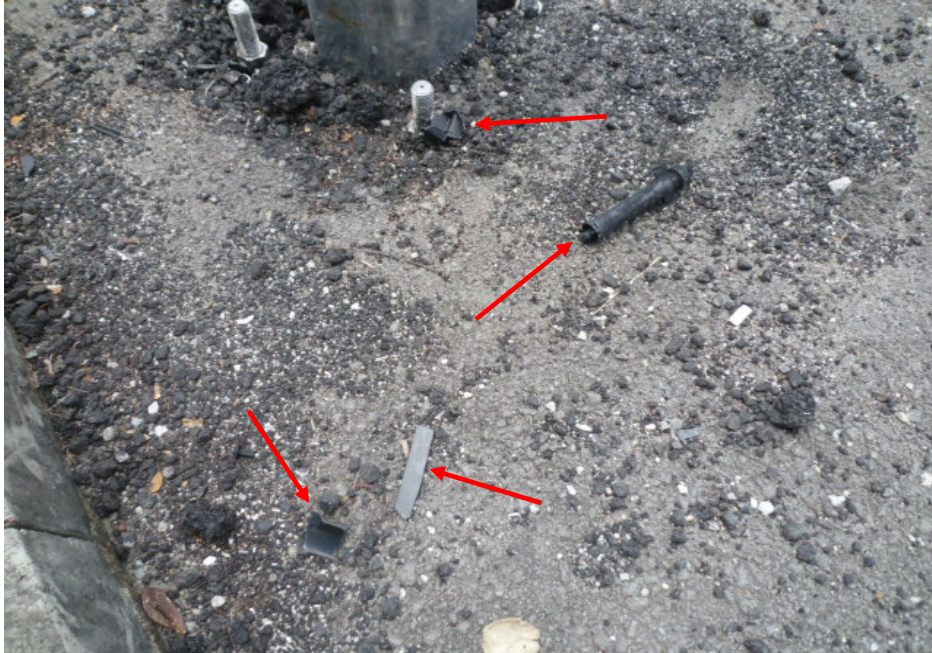
Photo 7 shows the broken plastic parts and vehicular debris of the Insured Vehicle (arrowed) that were found on the ground surrounding the lamp post.

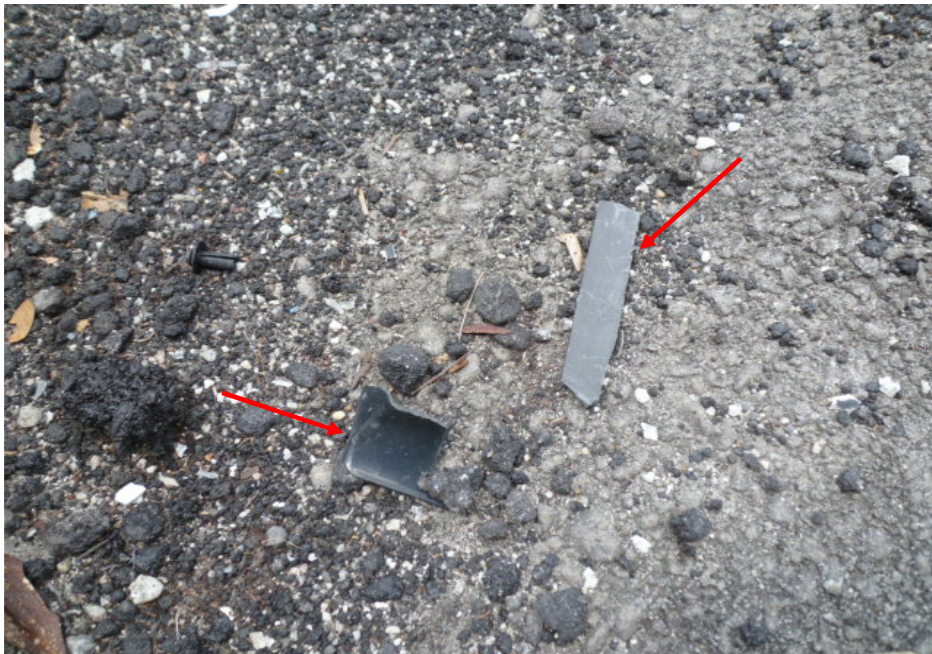
Photo 8 shows a close up view of the broken plastic parts and vehicular debris of the Insured Vehicle (arrowed) that were found on the ground surrounding the lamp post.

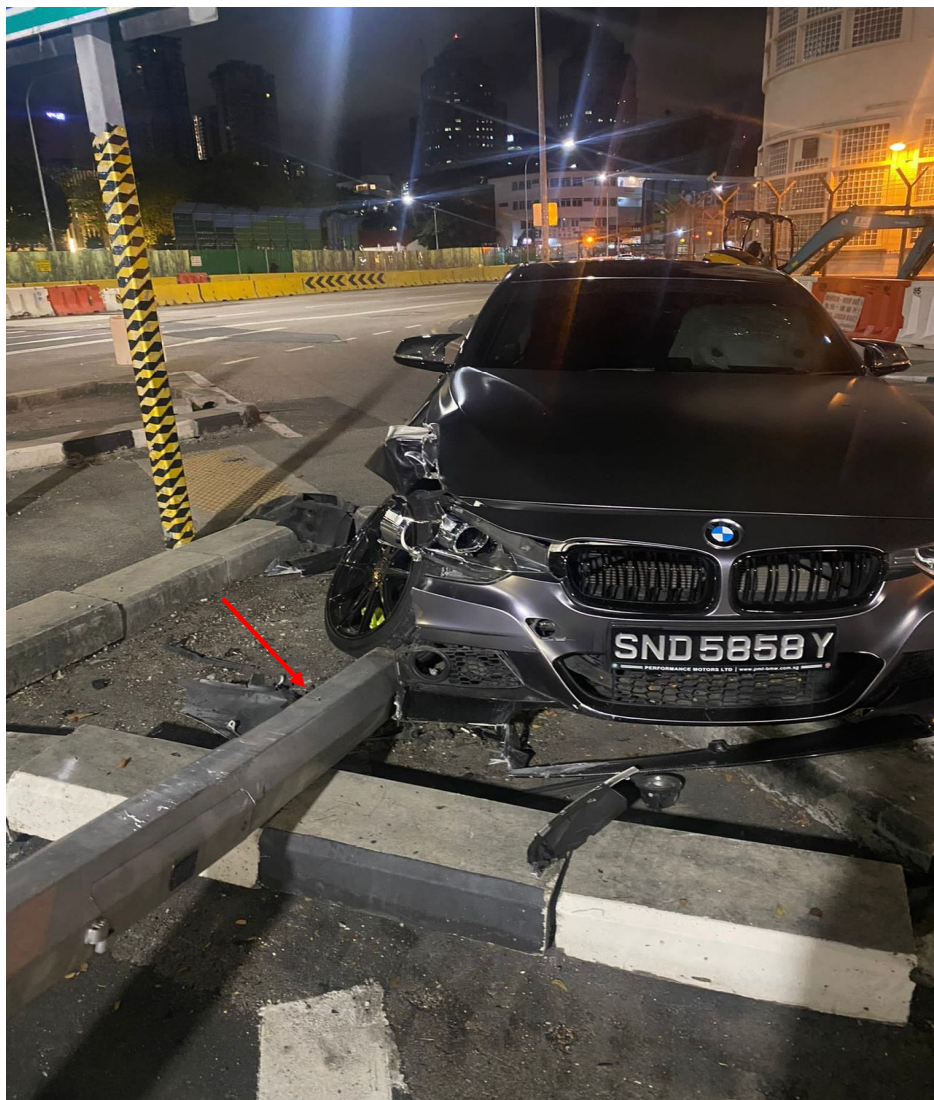
Photo 9 shows the Insured Vehicle at its respective final rest position at the incident scene before it was towed away. It seems to correlate with Ms Pek's account of the incident. The incident had occurred along the left bend. Ms Pek had mounted the kerb and collided into a lamp post (arrowed).

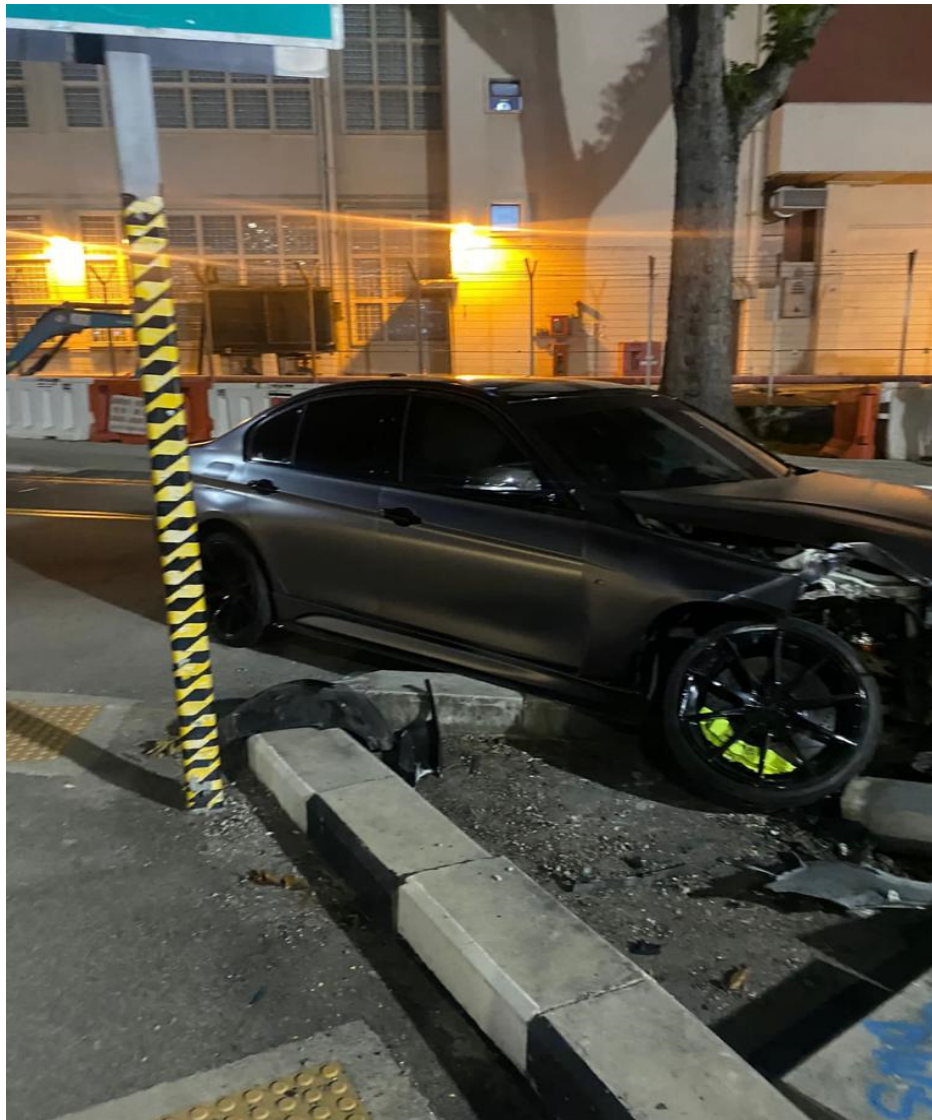
Photo 10 shows the Insured Vehicle at its respective final rest position at the incident scene before it was towed away. It seems to correlate with Ms Pek's account of the incident.

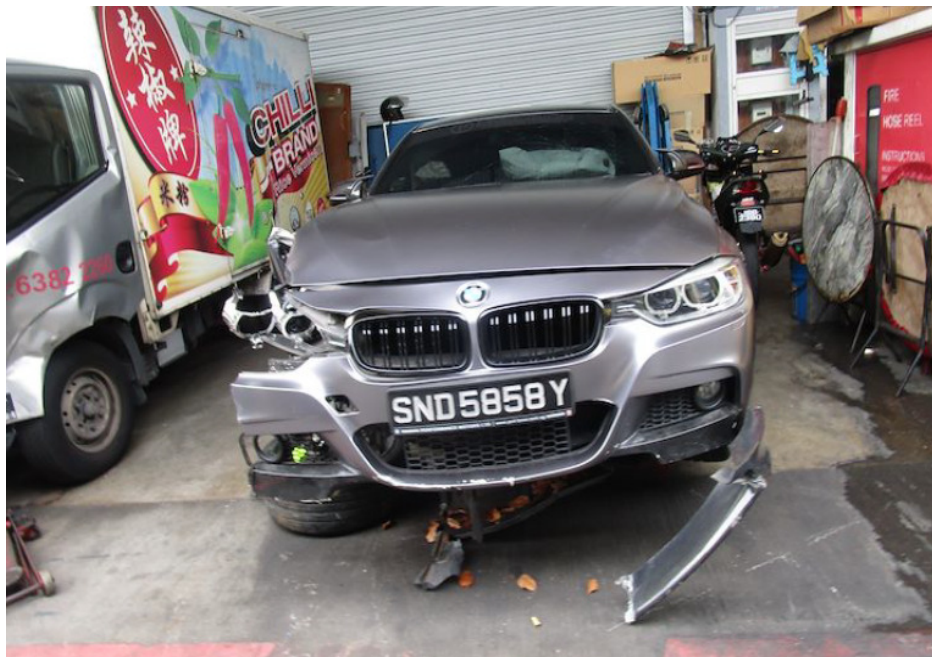
20. Our physical inspection of the Insured Vehicle at SME revealed that the Insured Vehicle had sustained significant damages to its frontal portion, particularly to its front bonnet, front bumper, front right fender and right headlamp. There were remains of the driver and front passenger airbags in the interior compartment of the Insured Vehicle which corroborates with Mr Pek's statement that the airbags were deployed post- incident. See photos 11 - 13 below.

Photo 11 shows the general frontal view of the Insured Vehicle during the physical inspection at SME. The Insured Vehicle had sustained significant damages to its frontal portion and right body.

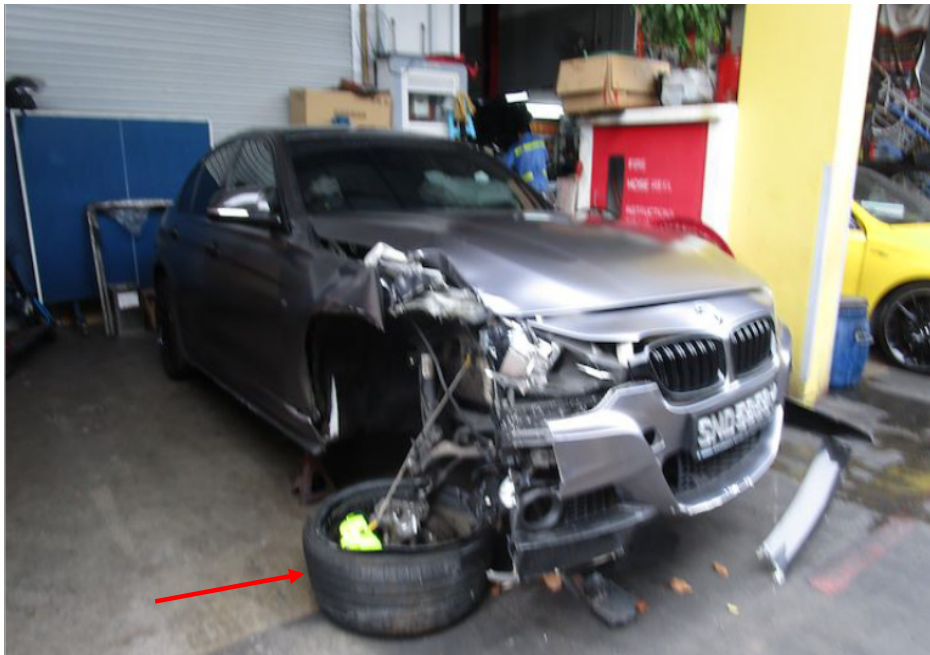
Photo 12 shows the right frontal portion of the Insured Vehicle during the physical inspection at SME. The Insured Vehicle had sustained significant damages to its frontal portion and right body, particularly to its front bonnet, front bumper, front right fender, right headlamp, right front rim and tyre as a result of the incident. Upon closer inspection, we observed the detached right front wheel rim of the Insured Vehicle (arrowed) which corroborated with Ms Pek's statement.

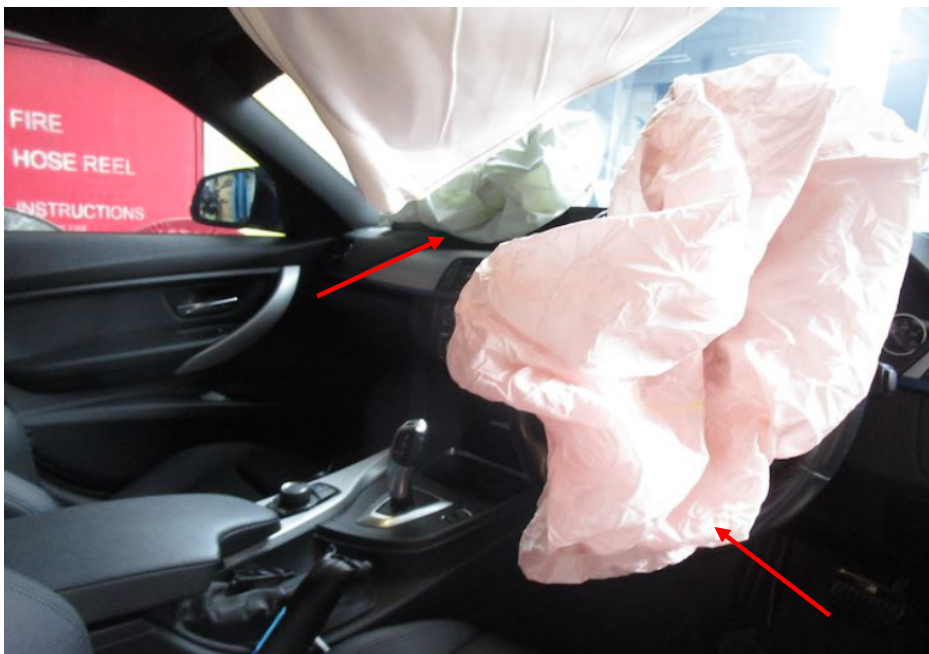
Photo 13 shows the remains of the driver and front passenger airbags of the Insured Vehicle (arrowed) which corroborates with Ms Pek's statement that the airbags were deployed post- incident.
