Your Ref: BMW M4 Coupe  
(chassis number WBS32AZ060CG62207)  
Our Ref : CI/TP22001317/D

11 February 2022

**INSPECTION REPORT OF AN UNREGISTERED BMW M4 COUPE MOTOR CAR WITH CHASSIS NUMBER WBS32AZ060CG62207**

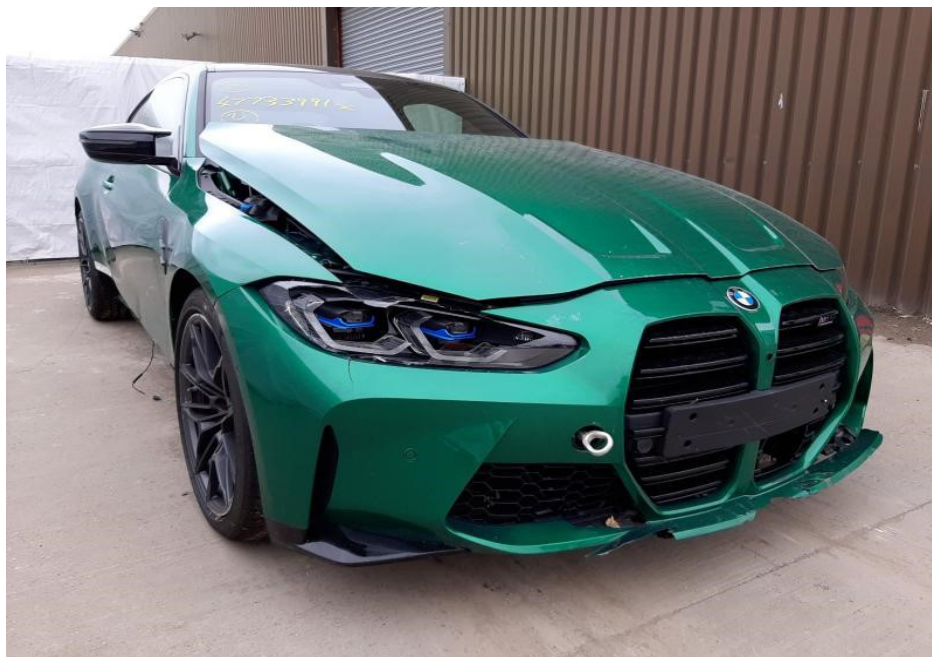
**Photo 1** shows the front right body of the Motor Car (photograph provided to me). The photographs provided to me had showed damage to the frontal portion and front underside of the Motor Car. The front bumper, front bonnet and front right headlamp were amongst the body parts that were observed to have been damaged.

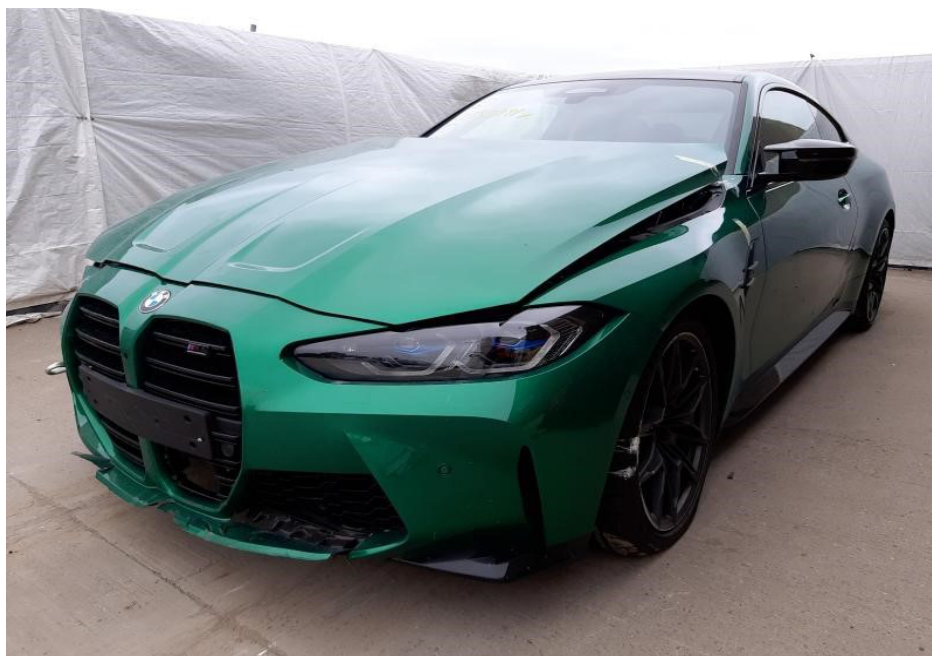
**Photo 2** shows the front left body of the Motor Car (photograph provided to me). The photographs provided to me had showed damage to the frontal portion and front underside of the Motor Car. The front bumper, front bumper left lower grille and front bonnet were amongst the body parts that were observed to have been damaged.

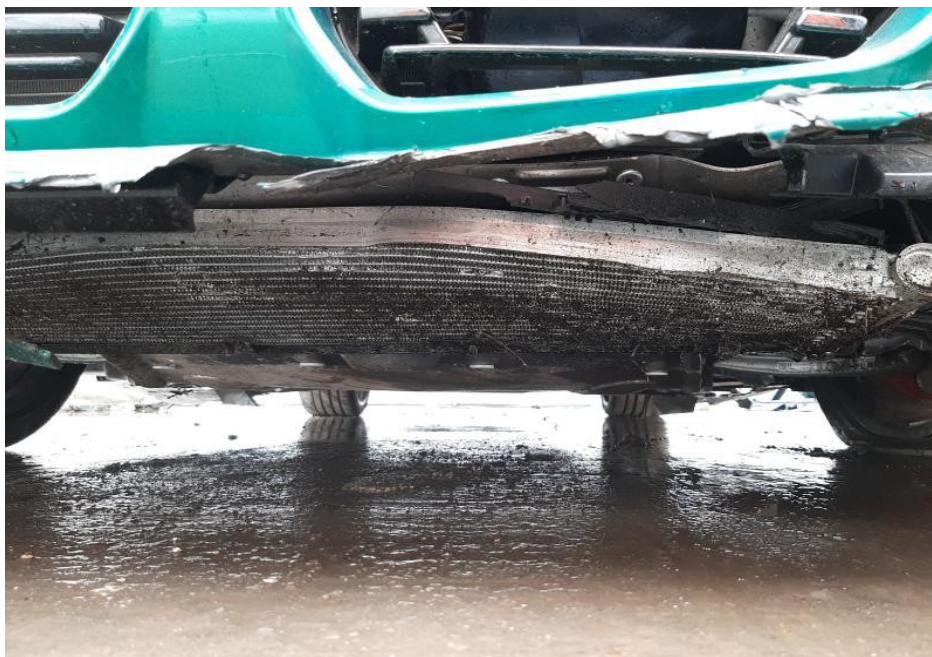
**Photo 3** shows the front underside of the Motor Car (photograph provided to me). The front bumper, front under cover and oil cooler were amongst the body parts at the front underside of the Motor Car that were observed to have been damaged.

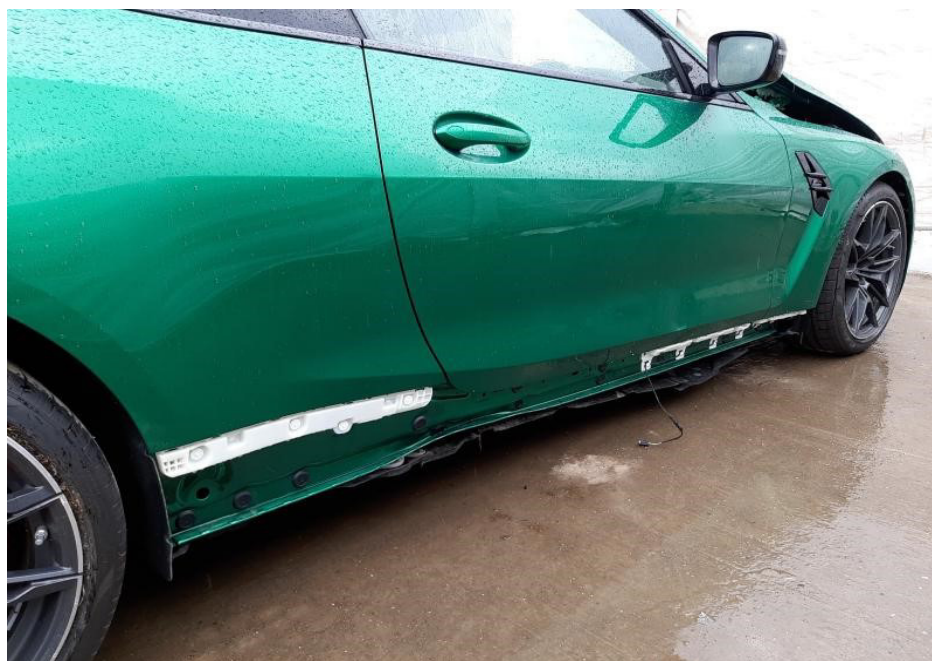
**Photo 4** shows the right side body of the Motor Car (photograph provided to me). Apart for the damage to the frontal portion and front underside of the Motor Car, I had also observed that the Motor Car's right side lower skirting was dislodged/damaged/missing.

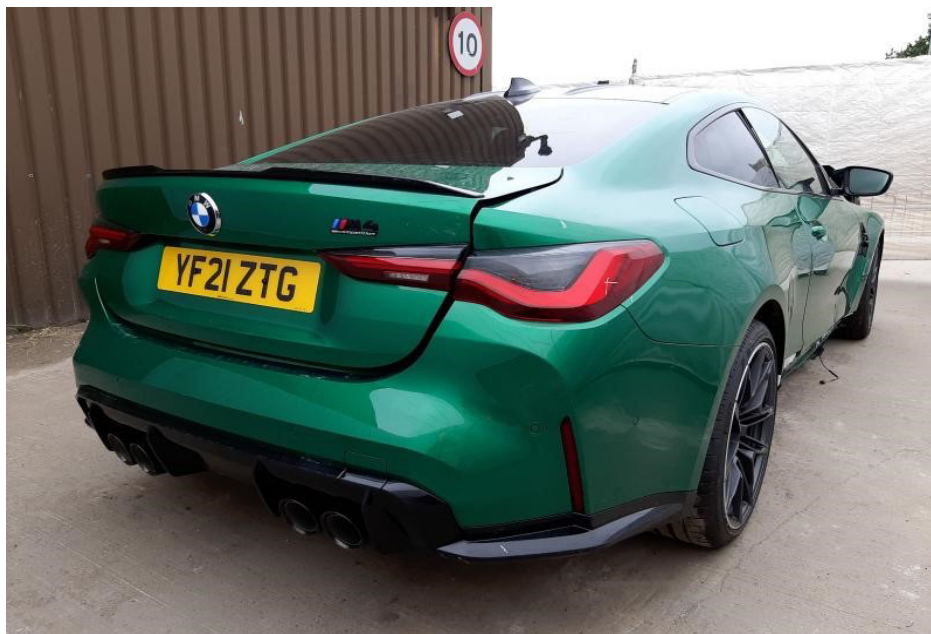
**Photo 5** shows the rear right body of the Motor Car (photograph provided to me). No physical damage was observed to the rear portion of the Motor Car.

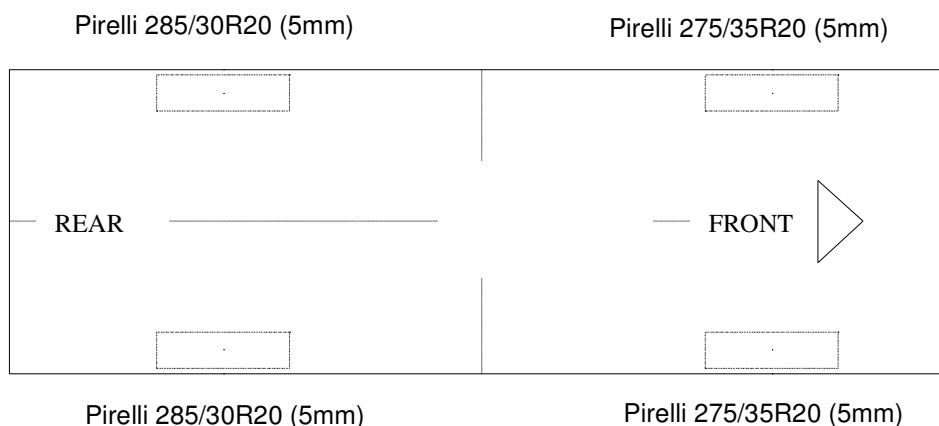
8. It was fitted with 20inch sport wheel rims that were wrapped with tyres that were observed to be of serviceable condition. The tyres were also sufficiently inflated for vehicular operation. The tyre brand, tyre size and approximate remaining tread depth of the 4 tyres of the Motor Car were recorded as follows: -

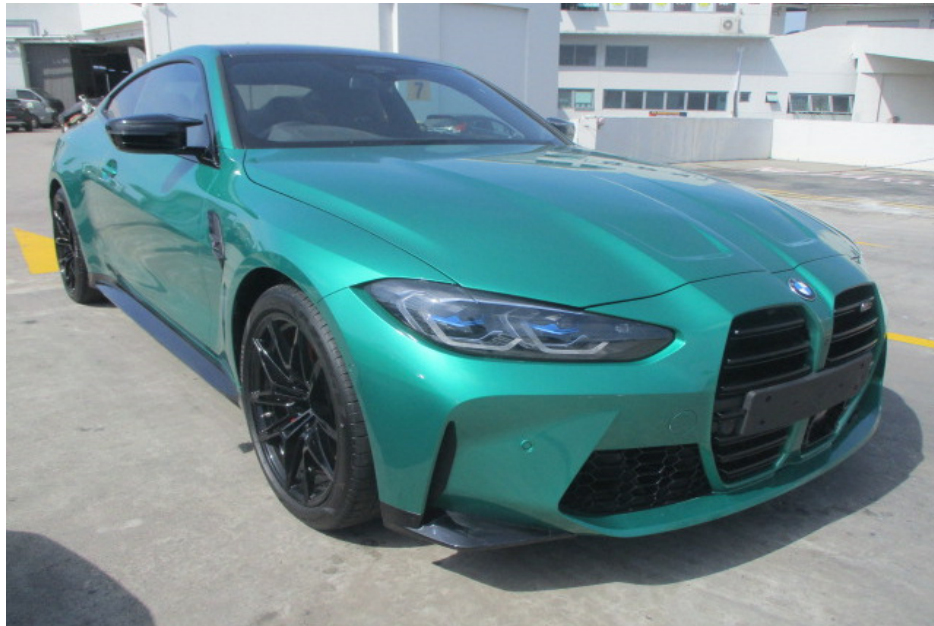
**Photo 6** shows a general view of the front right body of the Motor Car at the time of my inspection. The Motor Car was observed to be in a relatively good general condition with no loose exterior fittings observed. The body parts at the frontal portion and front underside of the Motor Car were visually examined and it was observed that the repair/restoration works carried out to the damaged area of the Motor Car (refer to photograph 1 - 3 above) were reasonably adequate and in order.

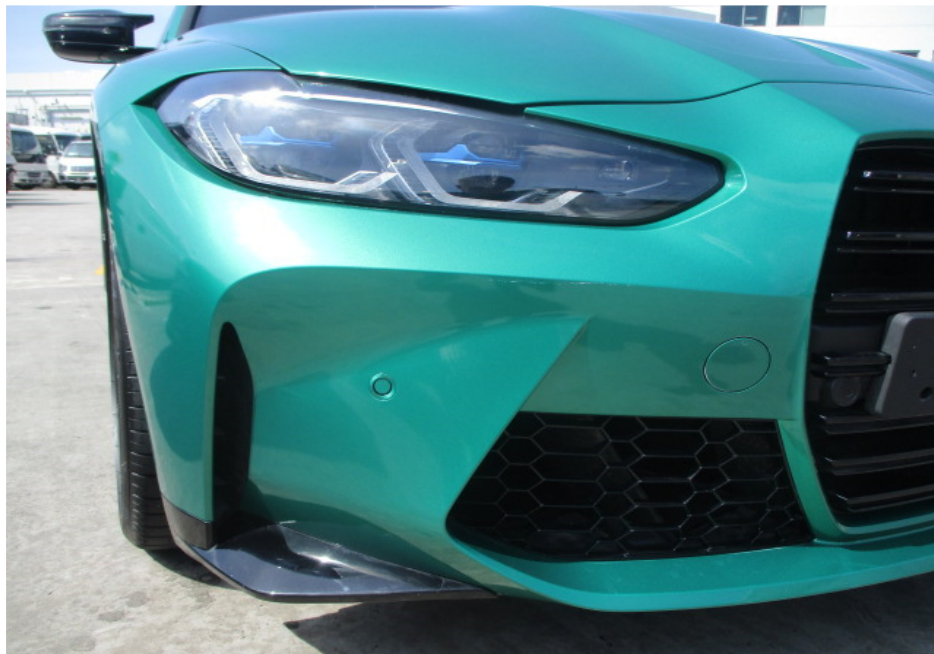
**Photo 7** shows a closer view of the Motor Car's front bumper, front bumper right lower grille and front right headlamp. The body parts at the frontal portion and front underside of the Motor Car were visually examined and it was observed that the repair/restoration works carried out to the damaged area of the Motor Car (refer to photograph 1 - 3 above) were reasonably adequate and in order.

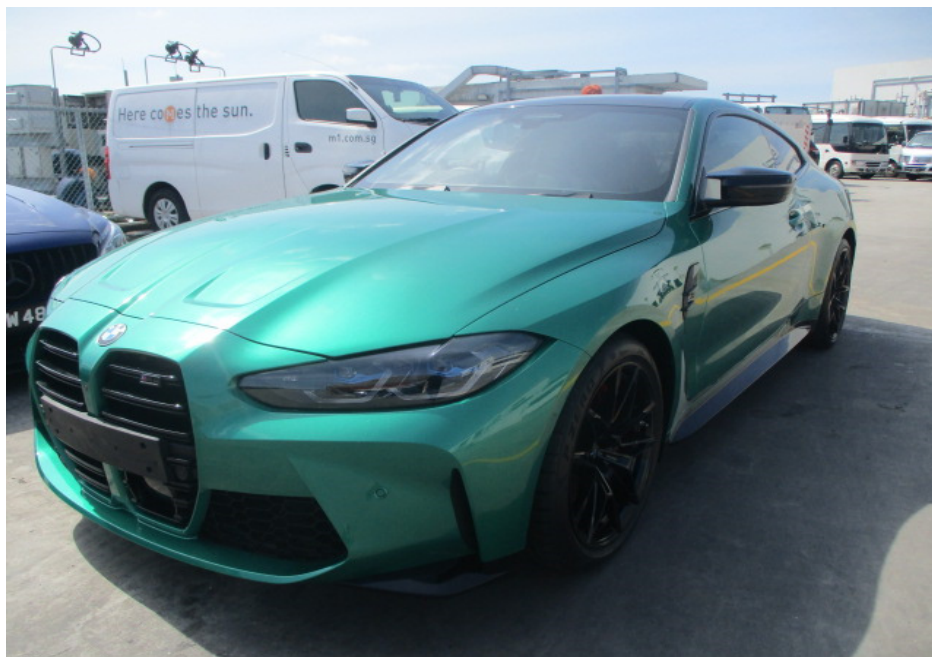
**Photo 8** shows a general view of the front left body of the Motor Car at the time of my inspection. The Motor Car was observed to be in a relatively good general condition with no loose exterior fittings observed. The body parts at the frontal portion and front underside of the Motor Car were visually examined and it was observed that the repair/restoration works carried out to the damaged area of the Motor Car (refer to photograph 1 - 3 above) were reasonably adequate and in order.

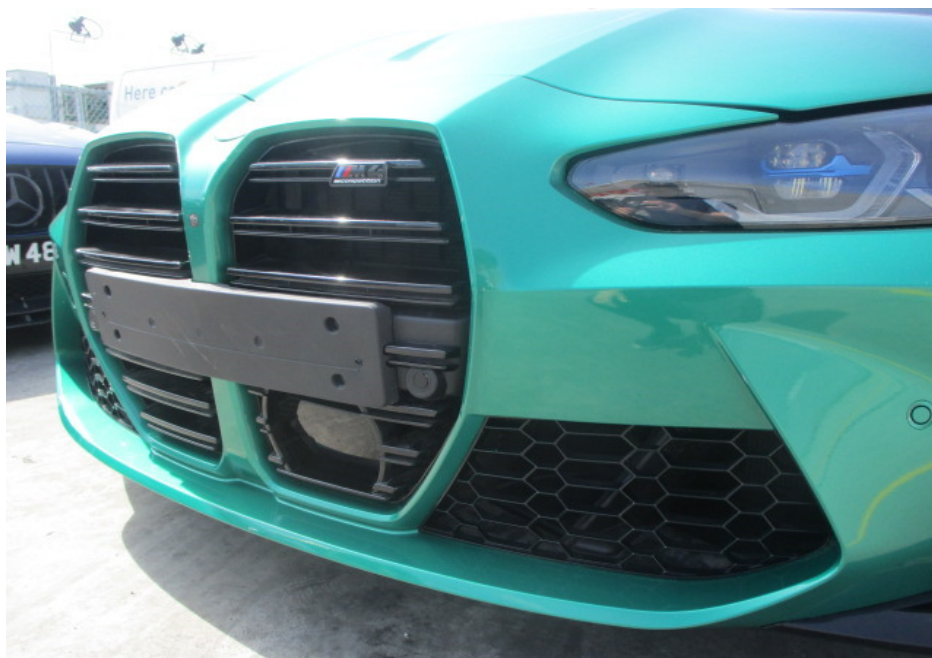
**Photo 9** shows a closer view of the Motor Car's front bumper, front bumper left lower grille, radiator grilles and front radar. The body parts at the frontal portion and front underside of the Motor Car were visually examined and it was observed that the repair/restoration works carried out to the damaged area of the Motor Car (refer to photograph 1 - 3 above) were reasonably adequate and in order.

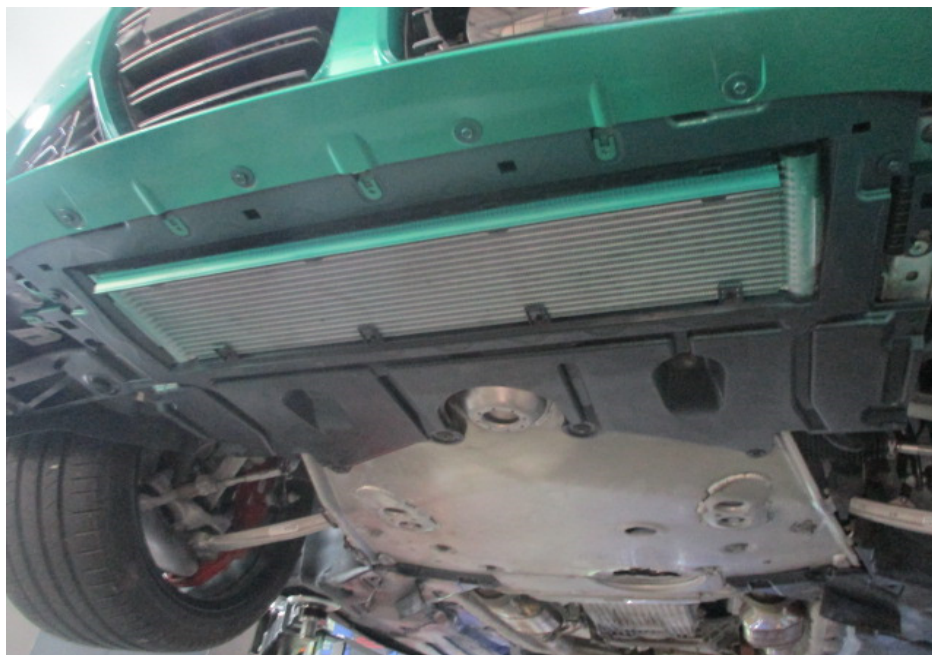
**Photo 10** shows a general view of the Motor Car's front underside at the time of my inspection. The body parts at the frontal portion and front underside of the Motor Car were visually examined and it was observed that the repair/restoration works carried out to the damaged area of the Motor Car (refer to photograph 1 - 3 above) were reasonably adequate and in order.

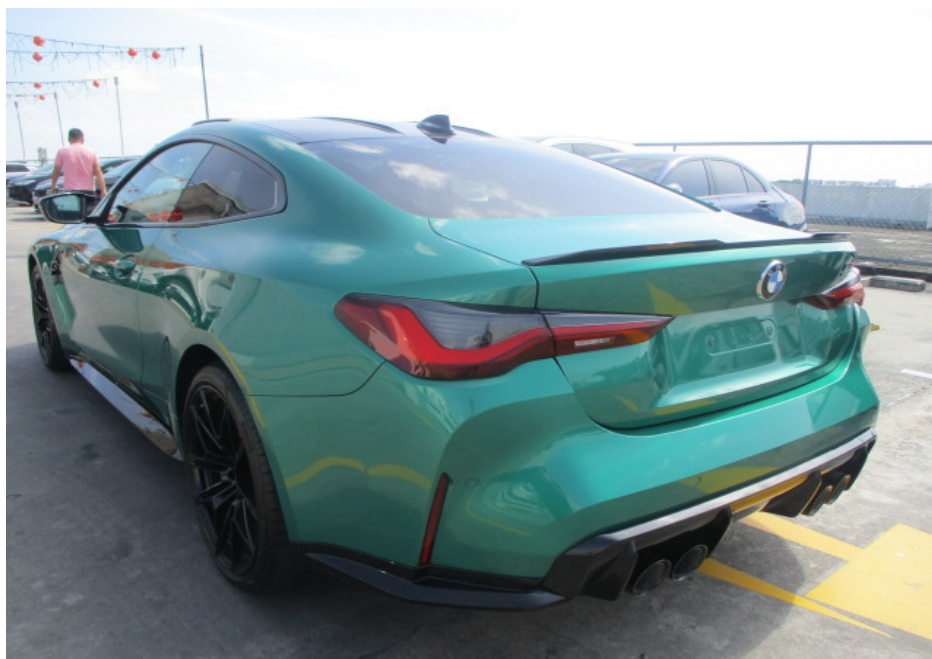
**Photo 11** shows a general view of the rear left body of the Motor Car at the time of my inspection. The Motor Car was observed to be in a relatively good general condition with no loose exterior fittings observed. The mileage of the Motor Car recorded at the time of my inspection was 882km.

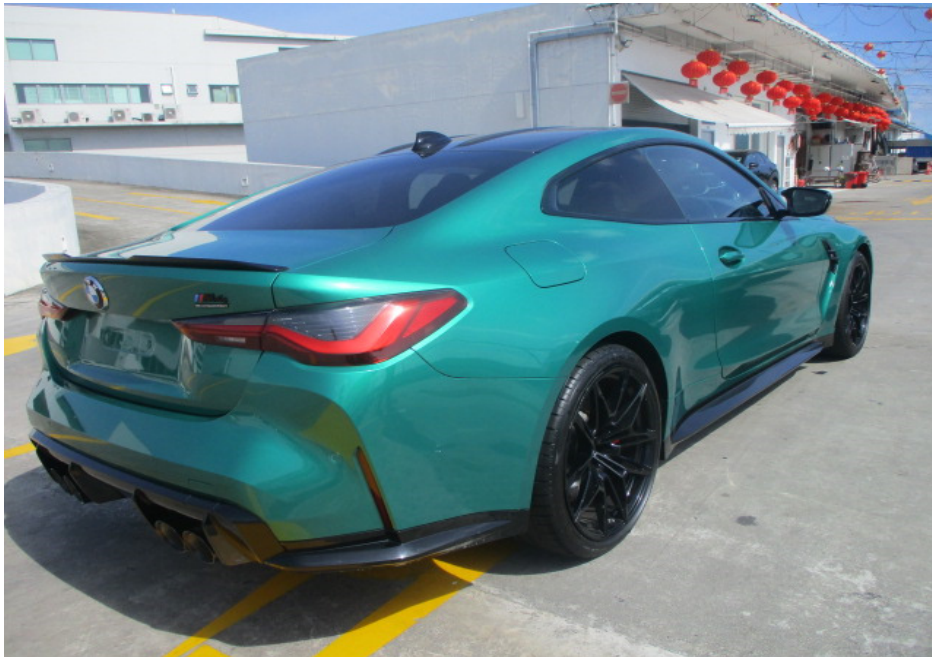
**Photo 12** shows a general view of the rear right body of the Motor Car at the time of my inspection. The Motor Car was observed to be in a relatively good general condition with no loose exterior fittings observed. The mileage of the Motor Car recorded at the time of my inspection was 882km.

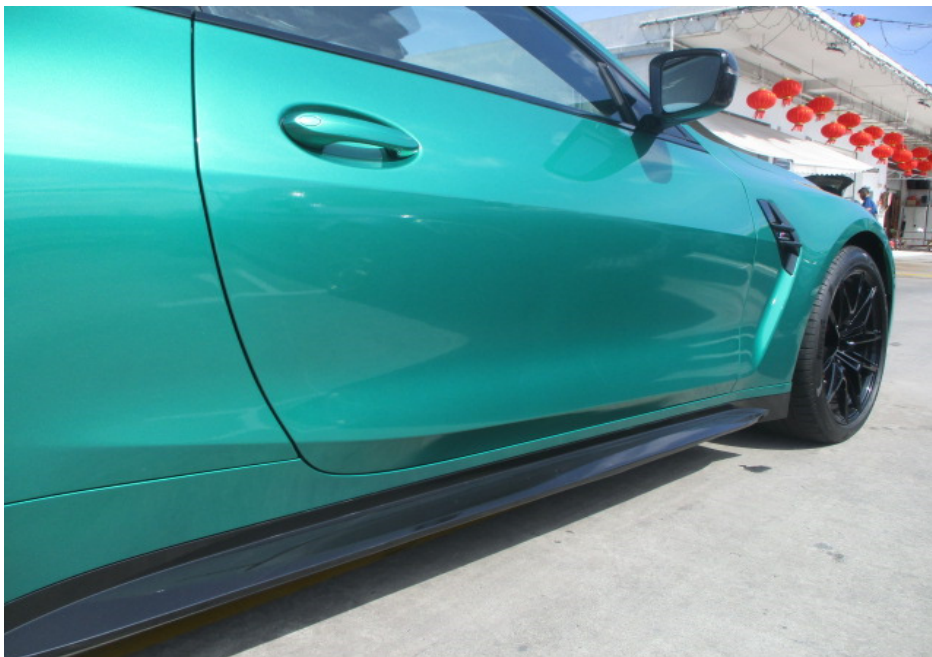
**Photo 13** shows a closer view of the Motor Car's front right door and right side lower skirting. The body parts at the right side of the Motor Car were visually examined and it was observed that the repair/restoration works carried out to the damaged area of the Motor Car (refer to photograph 4 above) were reasonably adequate and in order.

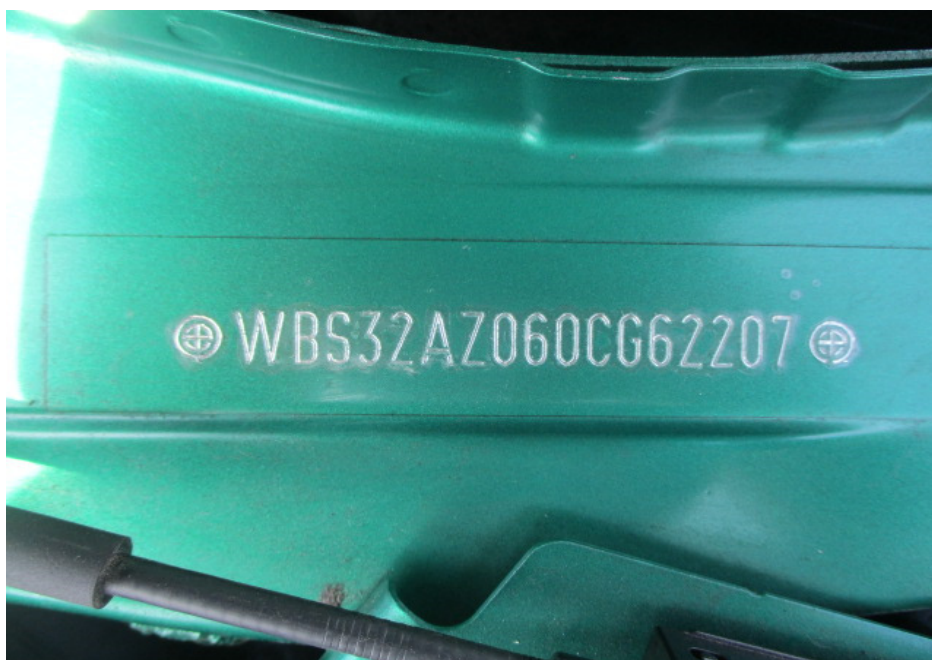
**Photo 14** shows the chassis number of the Motor Car. The chassis number recorded was WBS32AZ060CG62207.

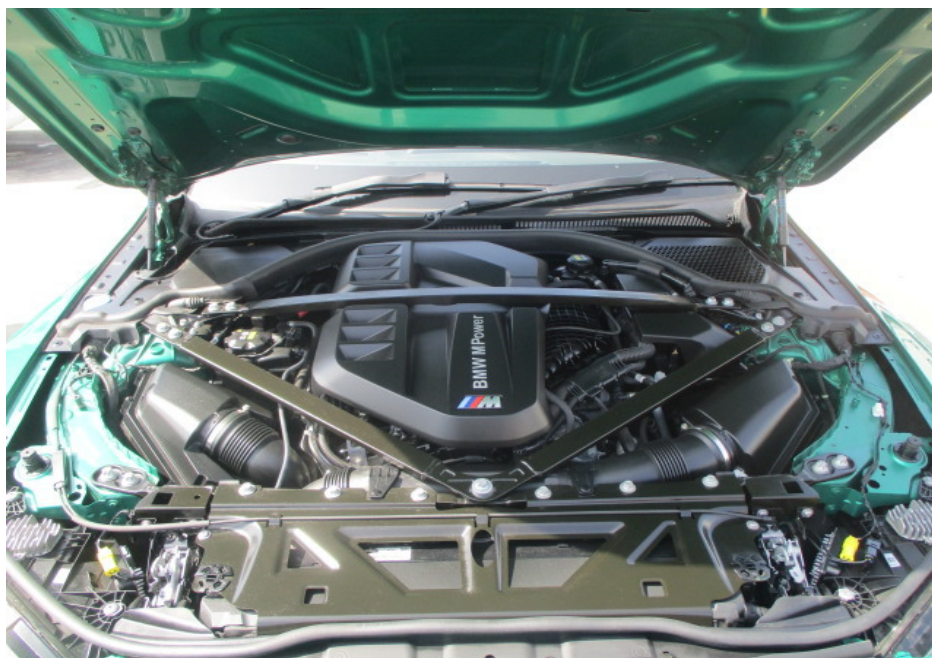
**Photo 15** shows a general view of the engine compartment of the Motor Car at the time of my inspection. The various parts and components inside the engine compartment were all observed to be intact and properly fitted. There was also no sign(s) or indication(s) of fluid leak and/or fluid stain found inside the engine compartment.

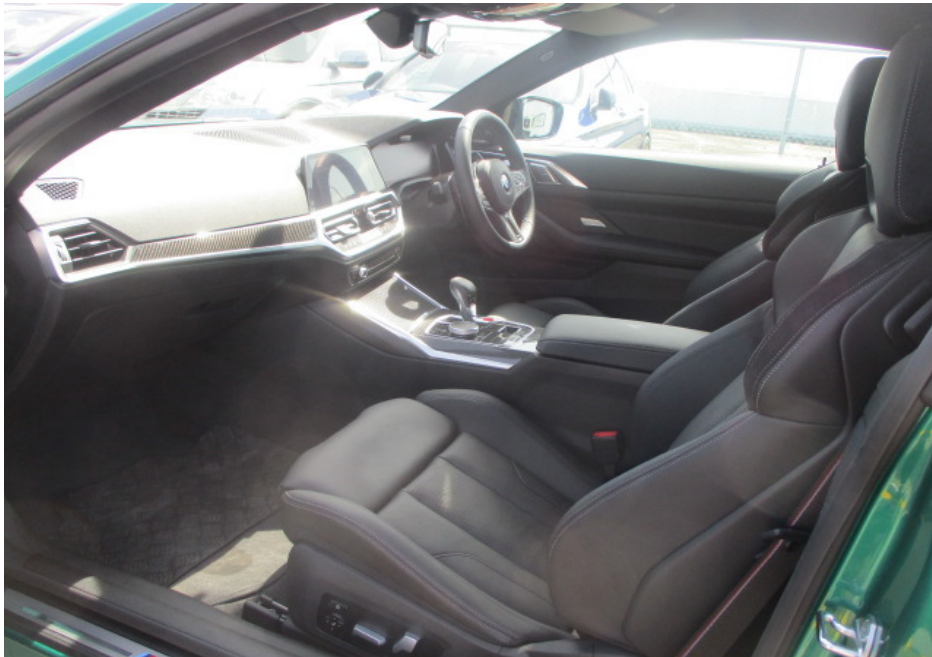
**Photo 16** shows the interior compartment of the Motor Car at the time of my inspection. The various parts and components, trims, carpet, and upholstery inside the interior compartment were all observed to be intact and properly fitted.

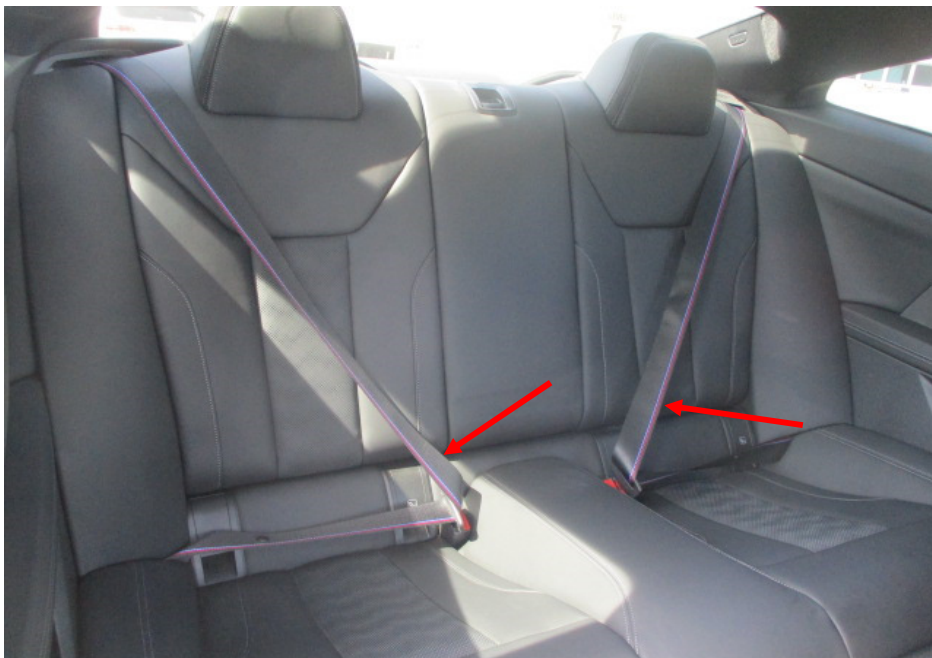
**Photo 17** shows the rear seats of the Motor Car. All the seats of the Motor Car were secured via seat rails to the floorboard. They were also fitted with a retractable seat belt reel and a pre-tensioner. The seat belts (arrowed) were tested and were able to be fastened into the respective pre-tensions that were fitted on the side of each individual seat.

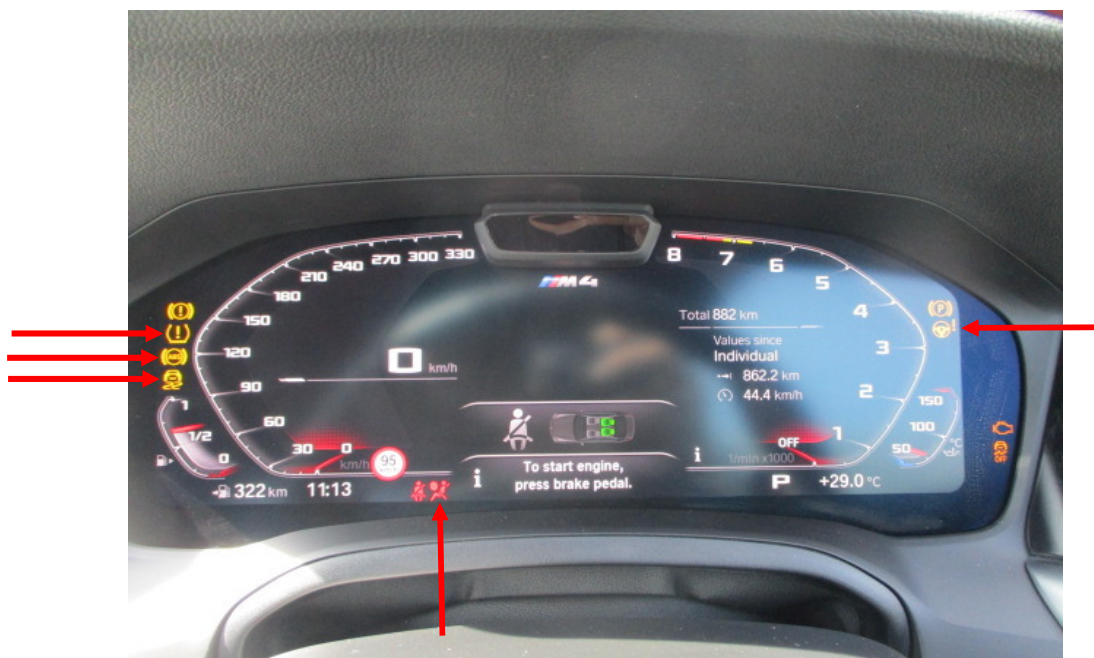
**Photo 18** shows the warning lights for the various electronic safety features appearing on the instrument panel of the Motor Car during its self-test when the engine is cranked, in particular the ABS, SRS, IAS, TPM and DSC lights (arrowed).

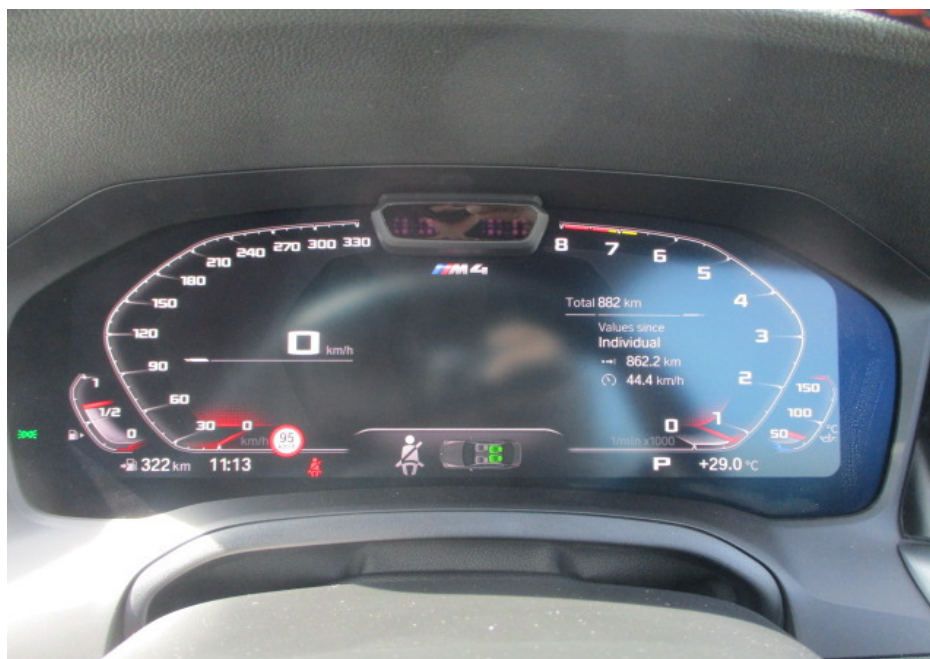
**Photo 19** shows the respective warning lights no longer illuminated, indicating that there is no fault detected to the ABS, SRS, IAS, TPM and DSC systems of the Motor Car during the self-test. These electronic systems were hence in working condition at the time of my inspection.

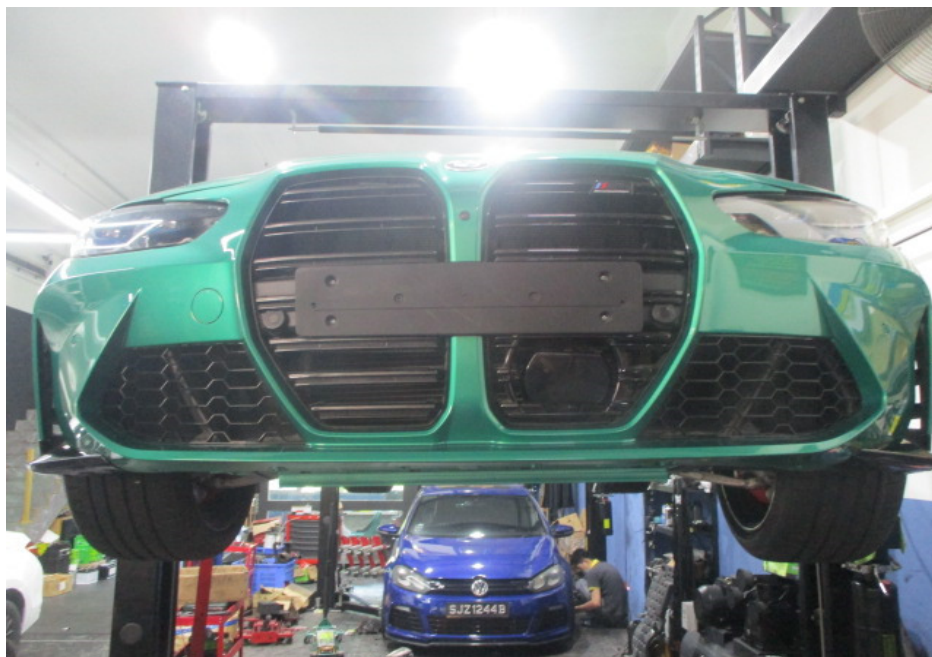
**Photo 20** shows the Motor Car hoisted up for checks on its undercarriage. There was no sign(s) or indication(s) of fluid leakage and/or fluid stain(s) on the underside of the Motor Car. The undercarriage components of the Motor Car were also all observed to be intact and secured in an appropriate manner.

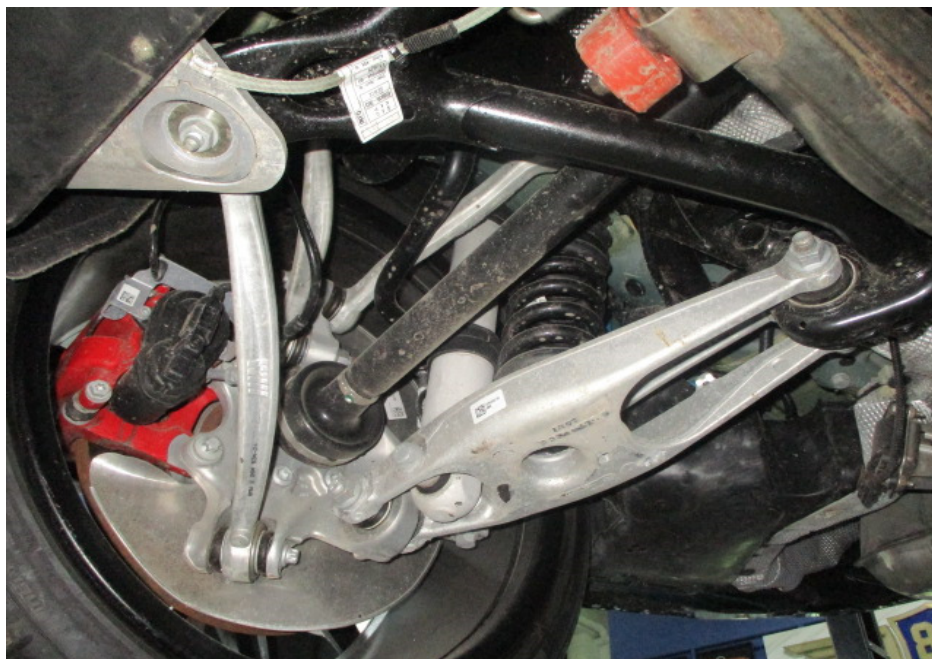
**Photo 21** shows a general view of the control arms and linkages at the rear right wheel of the Motor Car. I did not observe any fluid leak and/or fluid stain on the underside of the Motor Car. All of the Motor Car's undercarriage components were observed to be intact and secured in an appropriate manner.

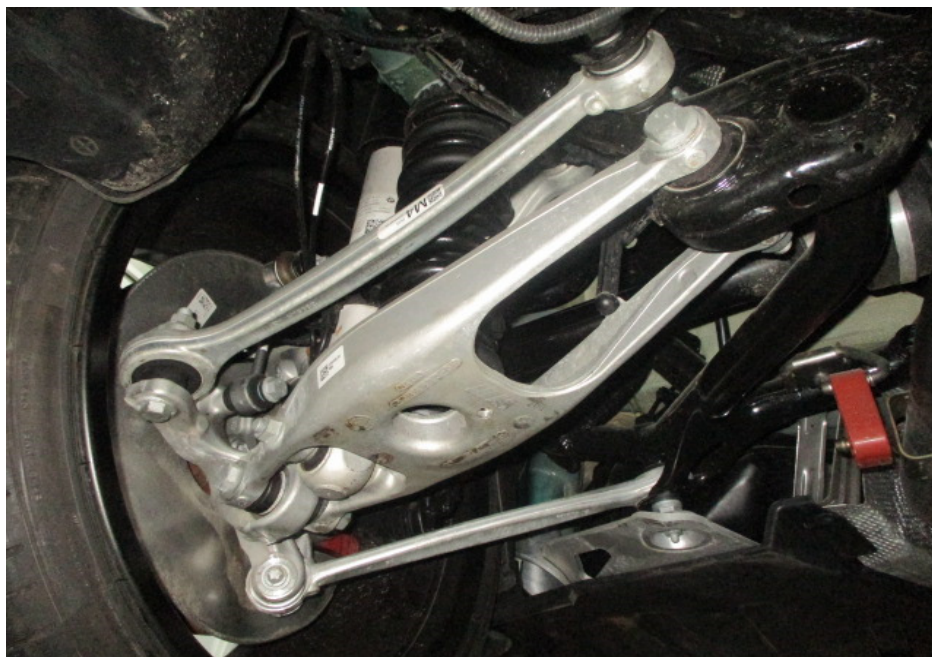
**Photo 22** shows a general view of the control arms and linkages at the rear left wheel of the Motor Car. I did not observe any fluid leak and/or fluid stain on the underside of the Motor Car. All of the Motor Car's undercarriage components were observed to be intact and secured in an appropriate manner.

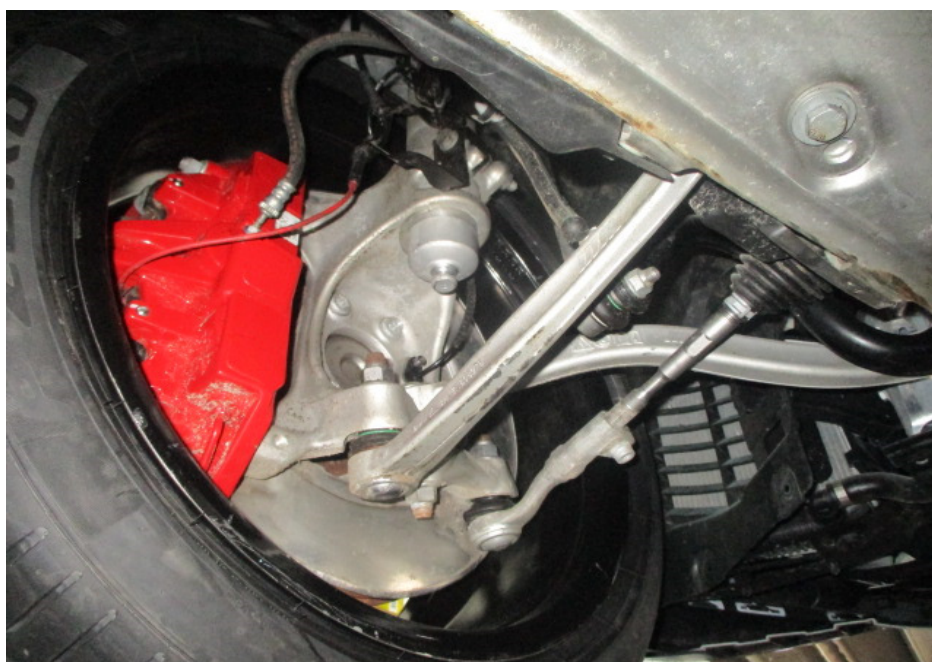
**Photo 23** shows the various undercarriage components at the front left wheel of the Motor Car. The mechanical components, control arms and linkages were all found to be intact and secured in an appropriate manner.

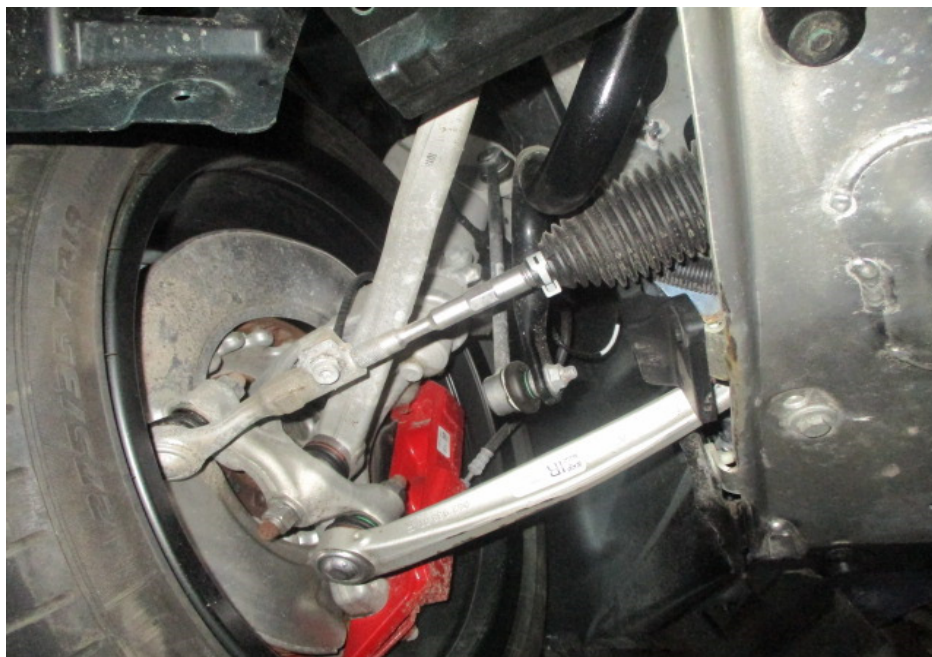
**Photo 24** shows the various undercarriage components at the front right wheel of the Motor Car. The mechanical components, control arms and linkages were all found to be intact and secured in an appropriate manner. I also did not observe any fluid leak and/or fluid stain on the underside of the Motor Car.

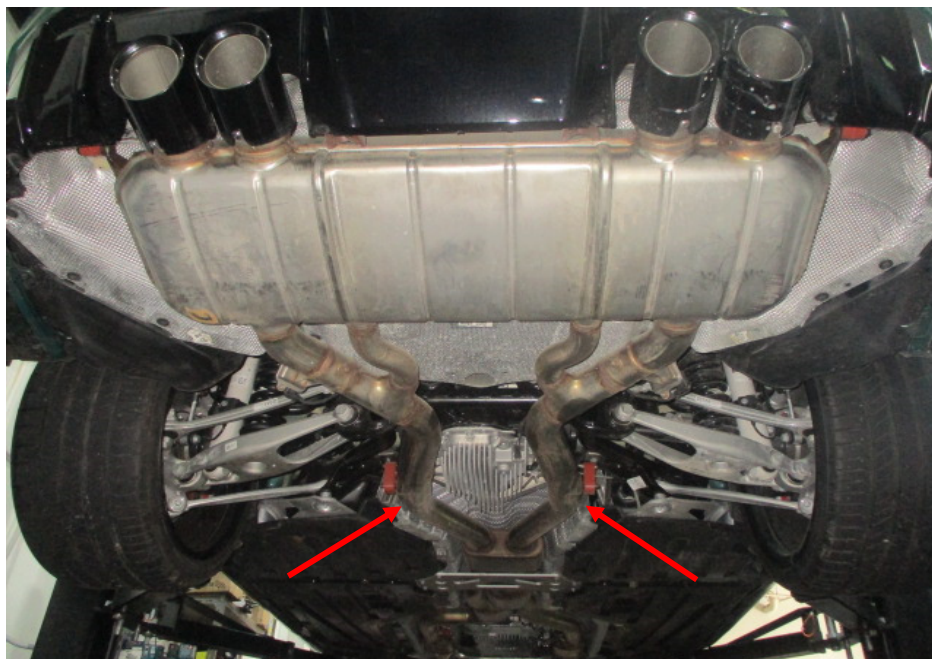
**Photo 25** shows the rear section of the Motor Car's exhaust system. My examination of the Motor Car's exhaust system revealed no sign(s) or indication(s) of any cut or weld marks along its exhaust pipes (arrowed), on its rear muffler, on its centre resonator boxes and on its catalytic converters.

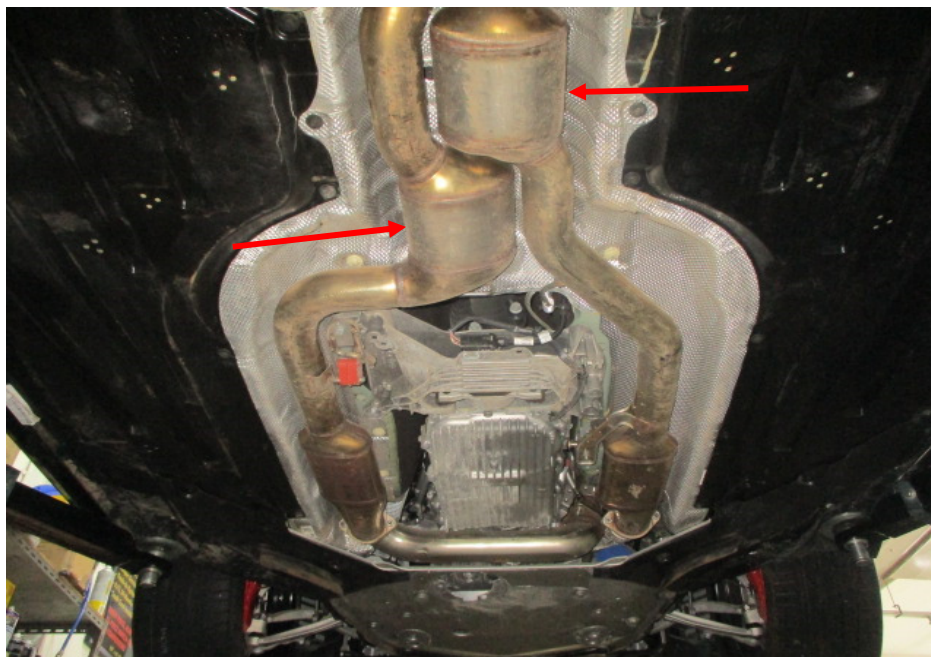
**Photo 26** shows the front section of the Motor Car's exhaust system. My examination of the Motor Car's exhaust system revealed no sign(s) or indication(s) of any cut or weld marks along its exhaust pipes, on its rear muffler, on its centre resonator boxes (arrowed) and on its catalytic converters.

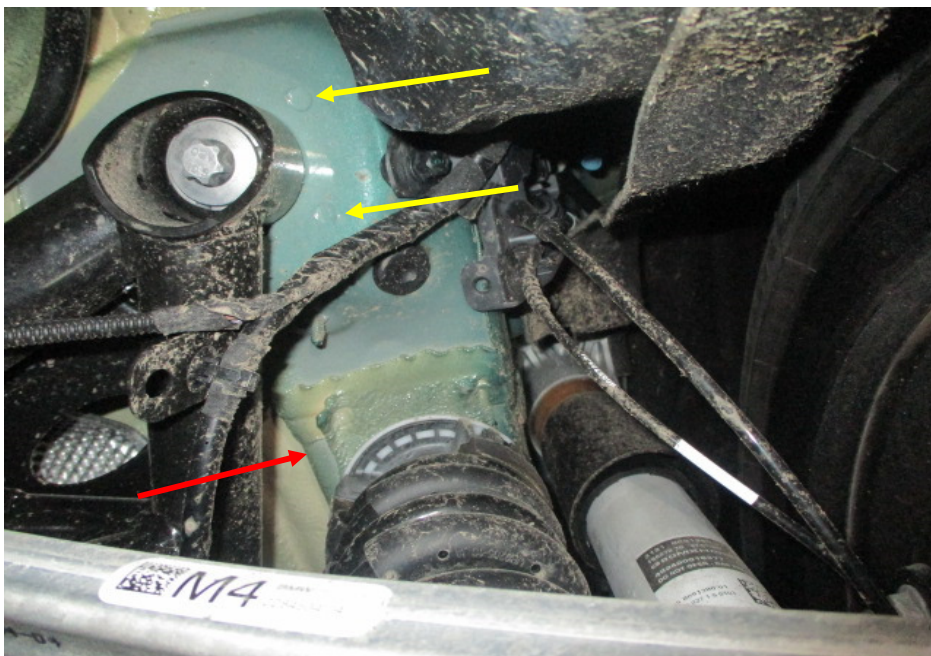
**Photo 27** shows the chassis/structural body at the underside rear right of the Motor Car. I did not find any weld marks other than original spot weld marks (yellow arrow) on the chassis/structural body of the Motor Car. The original factory sealant (red arrow) at the joints along the chassis/structural body was untouched, indicating no work was done on the chassis/structural body of the Motor Car and that the chassis/structural body was originally fitted.

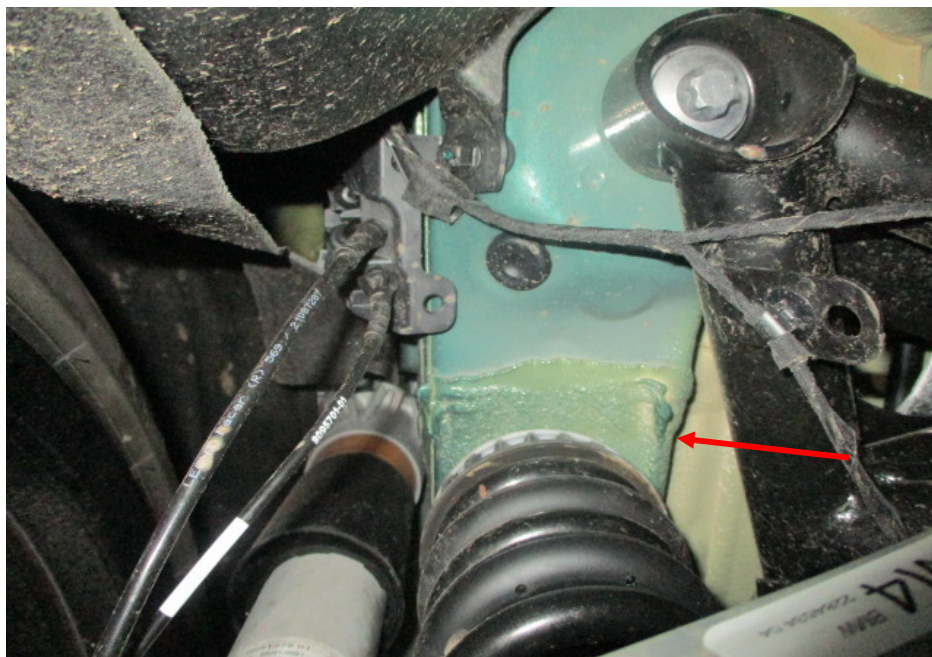
**Photo 28** shows the chassis/structural body at the underside rear left of the Motor Car. The original factory sealant (arrowed) at the joints along the chassis/structural body was observed to be untouched. In general, I had found no work was carried out on the chassis/structural body of the Motor Car. The chassis/structural body of the Motor Car was originally fitted.

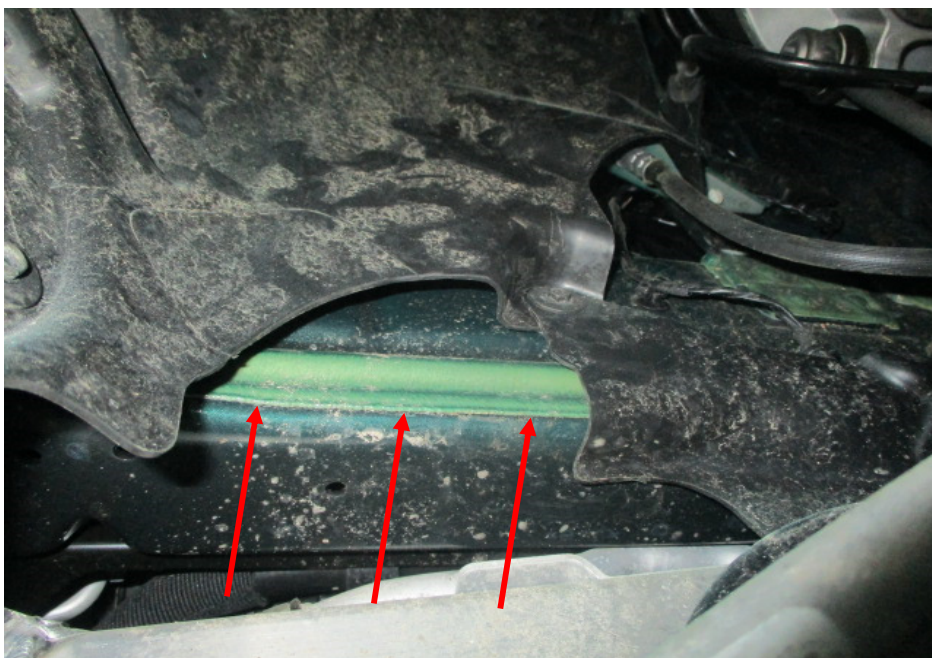
**Photo 29** shows the chassis/structural body at the underside front left of the Motor Car. I did not find any weld marks other than original spot weld marks on the chassis/structural body of the Motor Car. The original factory sealant (arrowed) at the joints along the chassis/structural body was untouched, indicating no work was done on the chassis/structural body of the Motor Car and that the chassis/structural body was originally fitted.

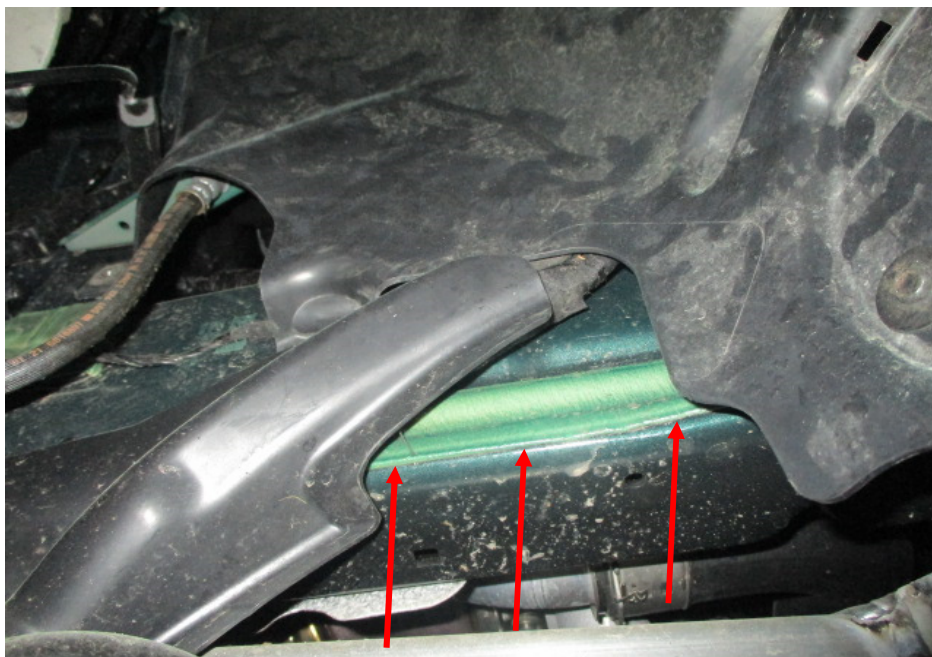
**Photo 30** shows the chassis/structural body at the underside front right of the Motor Car. The original factory sealant (arrowed) at the joints along the chassis/structural body was observed to be untouched. In general, I had found no work was carried out on the chassis/structural body of the Motor Car. The chassis/structural body of the Motor Car was originally fitted.

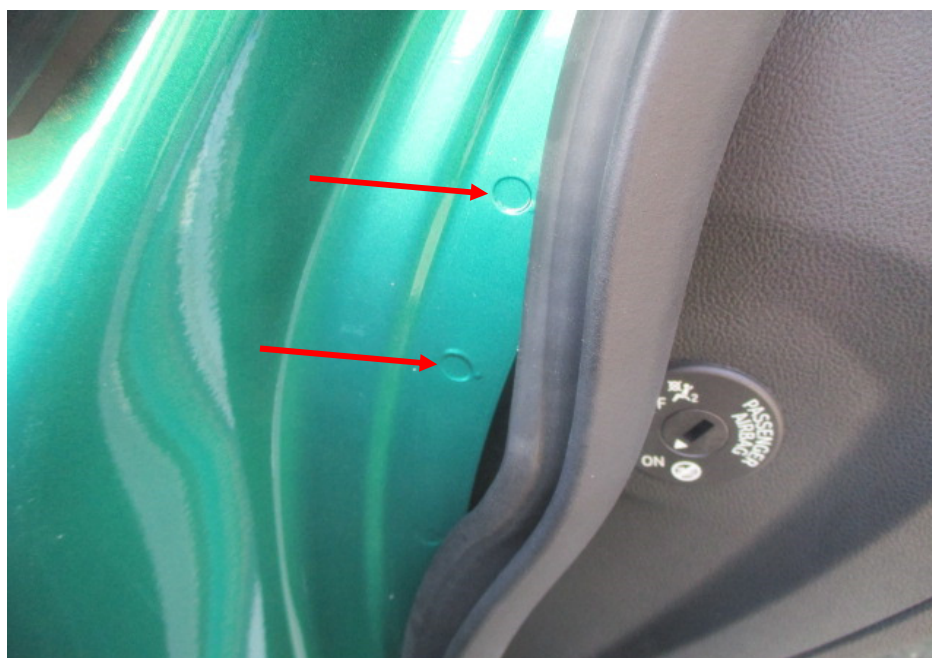
**Photo 31** shows the left side "A" pillar of the Motor Car. I did not find any weld marks other than original spot weld marks (arrowed) on the left side "A" pillar of the Motor Car which, indicates that there was no re-welding works carried out. In general, I had found all the non-detachable body panels of the Motor Car to be originally fitted at the time of my inspection.
