Your Ref: BMW M4 Coupe  
(chassis number WBS32AZ060CG62207)  
Our Ref : CI/TP22001317/D

11 February 2022

**INSPECTION REPORT OF AN UNREGISTERED BMW M4 COUPE MOTOR CAR WITH CHASSIS NUMBER WBS32AZ060CG62207**

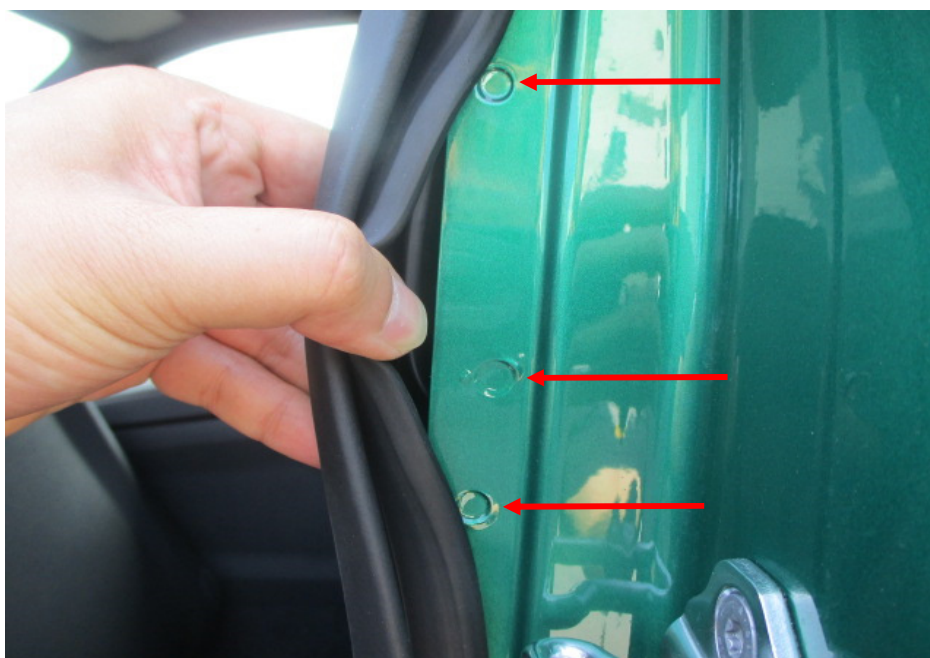
**Photo 32** shows the left side rear body panel of the Motor Car. I did not find any weld marks other than original spot weld marks (arrowed) on the left side rear body panel of the Motor Car which, indicates that there was no re-welding works carried out. In general, I had found all the non-detachable body panels of the Motor Car to be originally fitted at the time of my inspection.

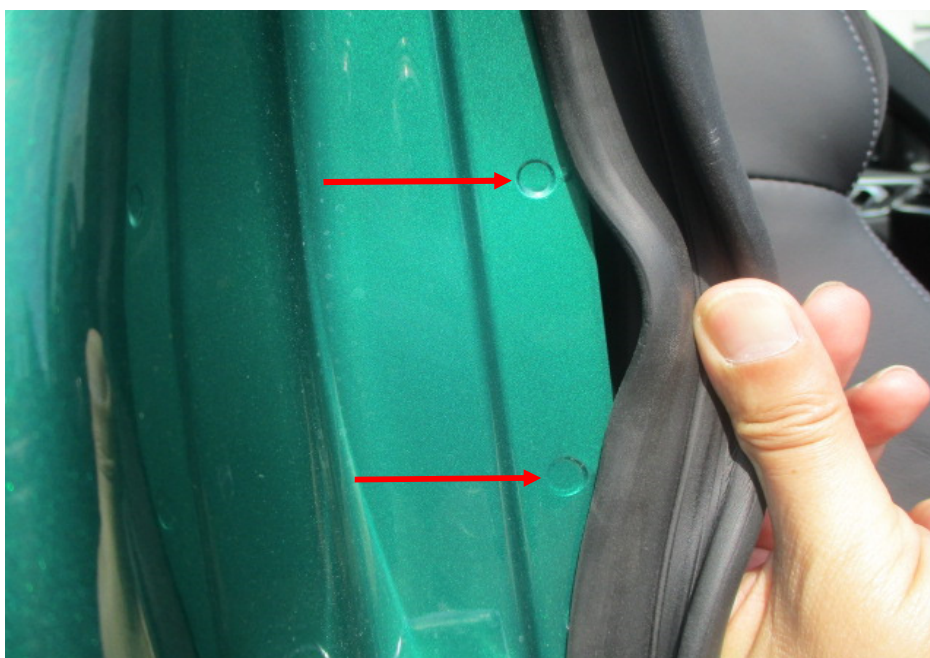
**Photo 33** shows the right side rear body panel of the Motor Car. I did not find any weld marks other than original spot weld marks (arrowed) on the right side rear body panel of the Motor Car which, indicates that there was no re-welding works carried out. In general, I had found all the non-detachable body panels of the Motor Car to be originally fitted at the time of my inspection.

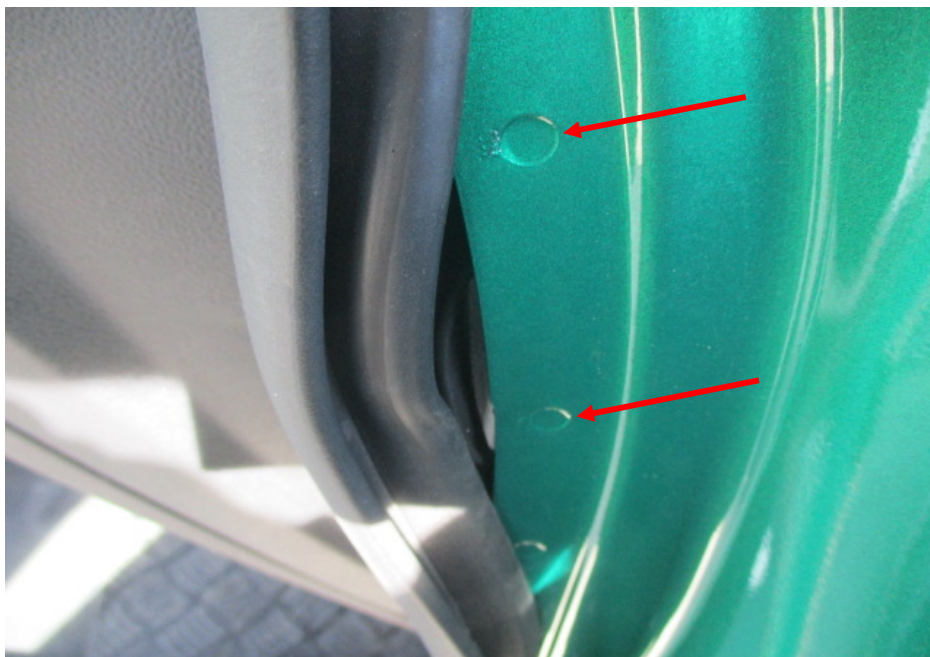
**Photo 34** shows the right side "A" pillar of the Motor Car. I did not find any weld marks other than original spot weld marks (arrowed) on the right side "A" pillar of the Motor Car which, indicates that there was no re-welding works carried out. In general, I had found all the non-detachable body panels of the Motor Car to be originally fitted at the time of my inspection.
