Your Ref: Audi TT Coupe
(chassis number TRUZZZFV0L1007491)
Our Ref : CI/TP22001324/D

14 February 2022

INSPECTION REPORT OF AN UNREGISTERED AUDI TT COUPE MOTOR CAR WITH CHASSIS NUMBER TRUZZZFV0L1007491

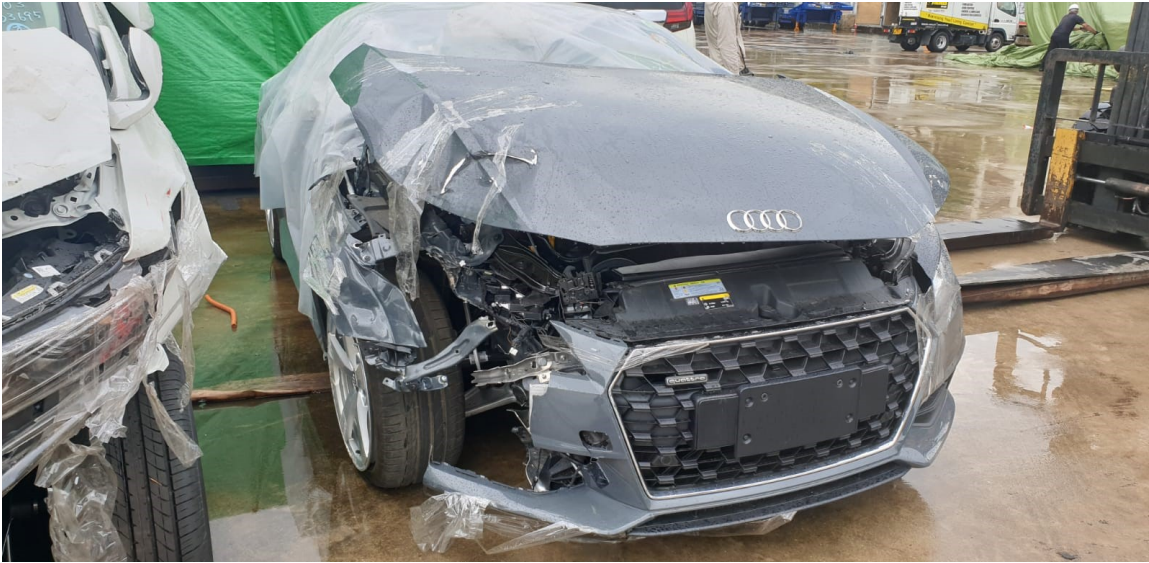
3. The photographs provided to me had showed damage to the front right portion of the Motor Car. Body parts damaged include the front bumper, front bumper tow hook cover, front bumper reinforcement, front bumper sponge, front bumper right lower grille, front right headlamp, front right headlamp panel, front right fender, front right fender inner shield, front right fender top inner panel, front bonnet, front bonnet hinges, front support panel and front support panel top centre garnish amongst others.

4. No physical damage was observed to other areas of the Motor Car apart for its front right portion.
5. The photographs provided were unclear whether the Motor Car's airbag(s) was deployed or not. However, given the extent of damage to the front right portion of the Motor Car, it may be possible that the driver's airbag and/or the front left passenger airbag was deployed. See photo 1 – 4 below.

Photo 1 shows the front right body of the Motor Car (photograph provided to me). The photographs provided to me had showed damage to the front right portion of the Motor Car. The front bumper, front bumper tow hook cover, front bumper reinforcement, front bumper sponge, front bumper right lower grille, front right headlamp, front right headlamp panel, front right fender, front right fender inner shield, front right fender top inner panel, front bonnet, front bonnet hinges, front support panel and front support panel top centre garnish were amongst the body parts that were observed to have been damaged. The photographs provided were unclear whether the Motor Car's airbag(s) was deployed or not. However, given the extent of damage to the front right portion of the Motor Car, it may be possible that the driver's airbag and/or the front left passenger airbag was deployed.

24. The body parts at the front right portion of the Motor Car were visually examined and it was noted that the repair/restoration works carried out to the damaged area of the Motor Car (refer to photograph 1 above) were reasonably adequate and in order.

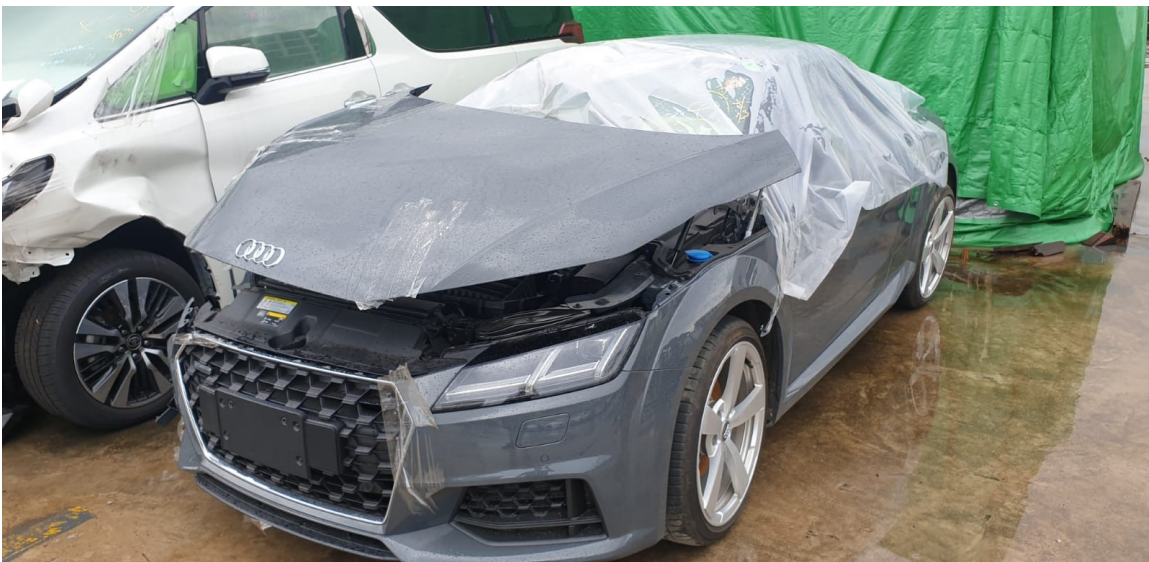
Photo 2 shows the front left body of the Motor Car (photograph provided to me). The front left portion of the Motor Car was observed to be relatively unaffected and without any physical damage.

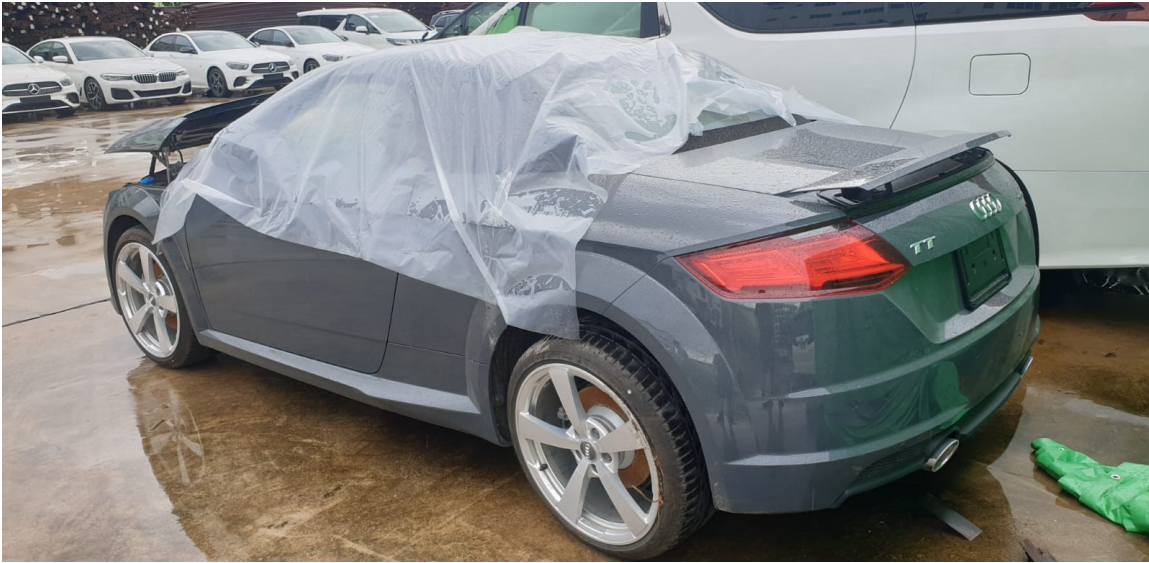
Photo 3 shows the rear left body of the Motor Car (photograph provided to me). The rear left portion of the Motor Car was observed to be relatively unaffected and without any physical damage.

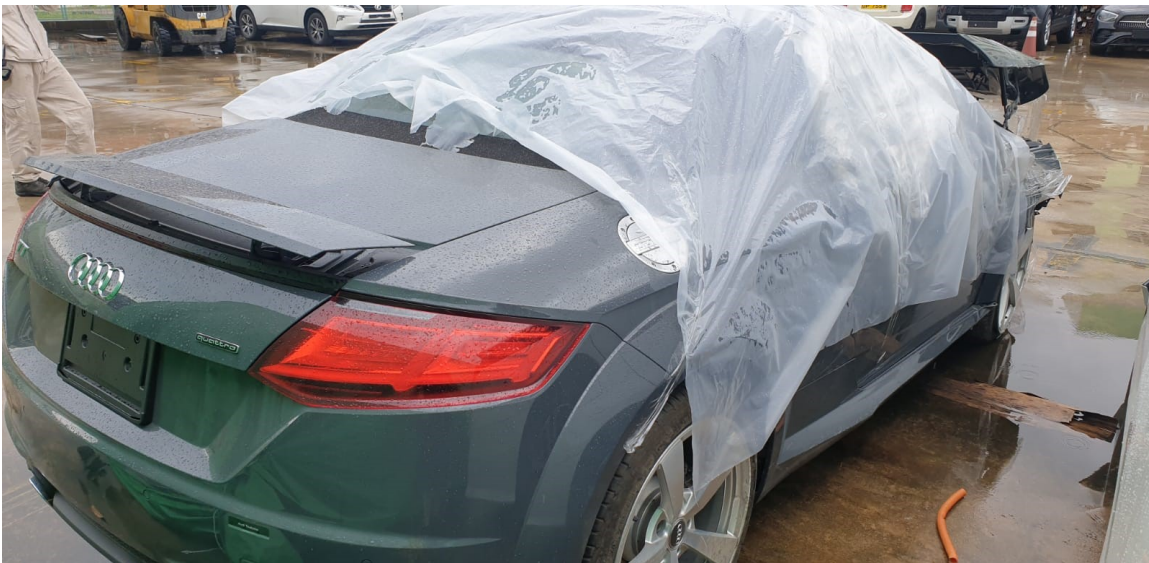
Photo 4 shows the rear right body of the Motor Car (photograph provided to me). The rear right portion of the Motor Car was observed to be relatively unaffected and without any physical damage.

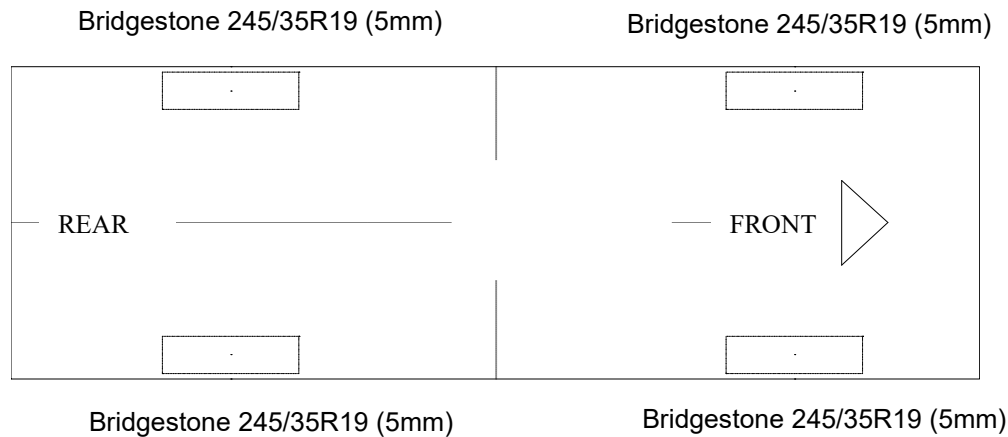
10. It was fitted with 19inch sport wheel rims that were wrapped with tyres that were observed to be of serviceable condition. The tyres were also sufficiently inflated for vehicular operation. The tyre brand, tyre size and approximate remaining tread depth of the 4 tyres of the Motor Car were recorded as follows: -

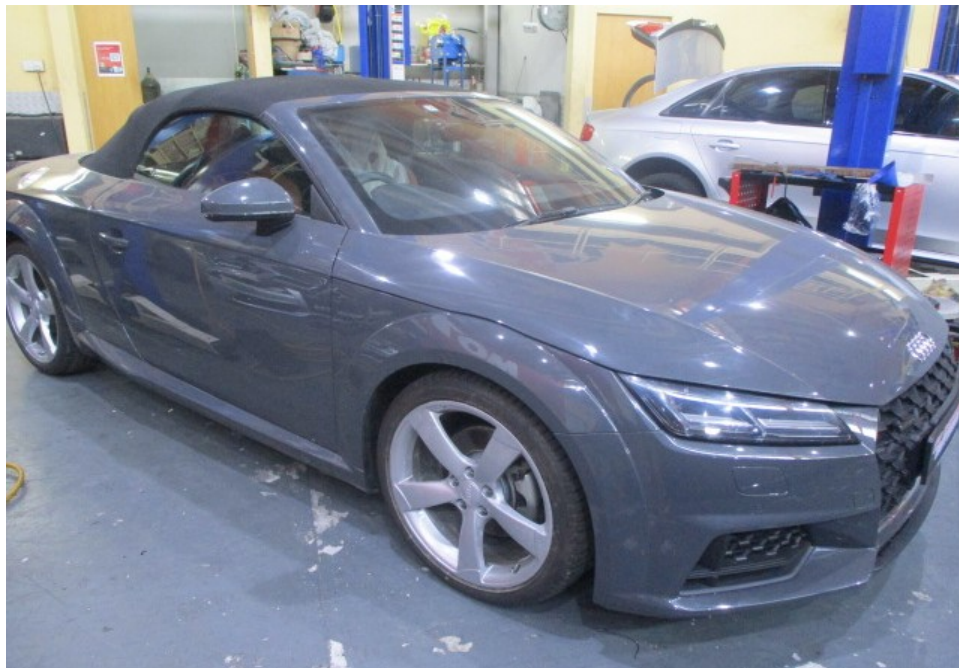
Photo 5 shows a general view of the front right body of the Motor Car at the time of my inspection. The Motor Car was observed to be in a relatively good general condition with no loose exterior fittings observed. The body parts at the front right portion of the Motor Car were visually examined and it was observed that the repair/restoration works carried out to the damaged area of the Motor Car (refer to photograph 1 above) were reasonably adequate and in order.

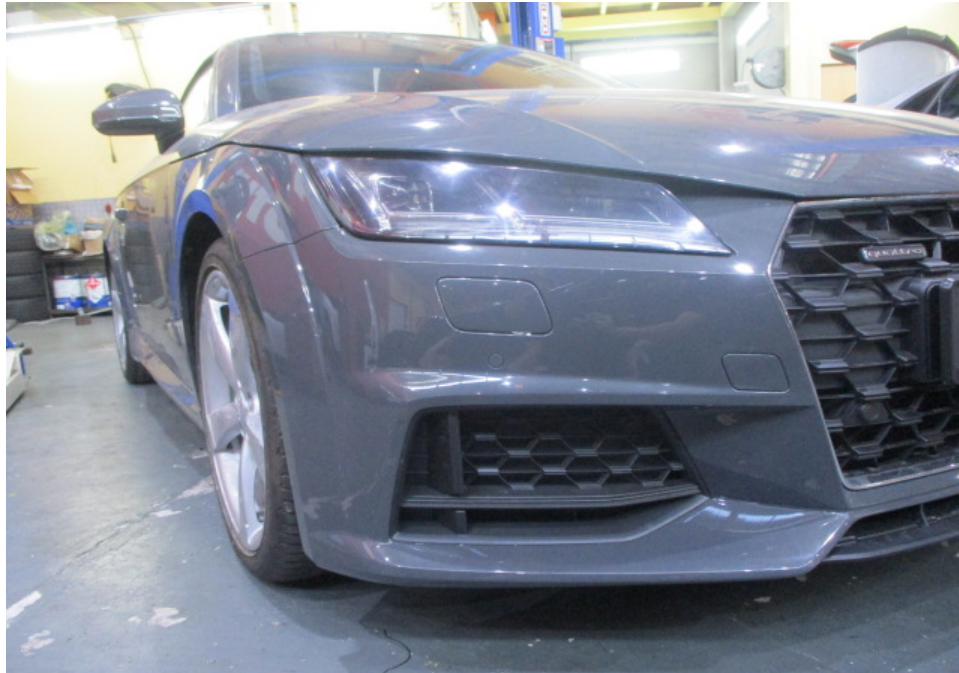
Photo 6 shows a closer view of the Motor Car's front bumper, front bumper right lower grille, front bumper tow hook cover and front right headlamp. The body parts at the front right portion of the Motor Car were visually examined and it was observed that the repair/restoration works carried out to the damaged area of the Motor Car (refer to photograph 1 above) were reasonably adequate and in order.

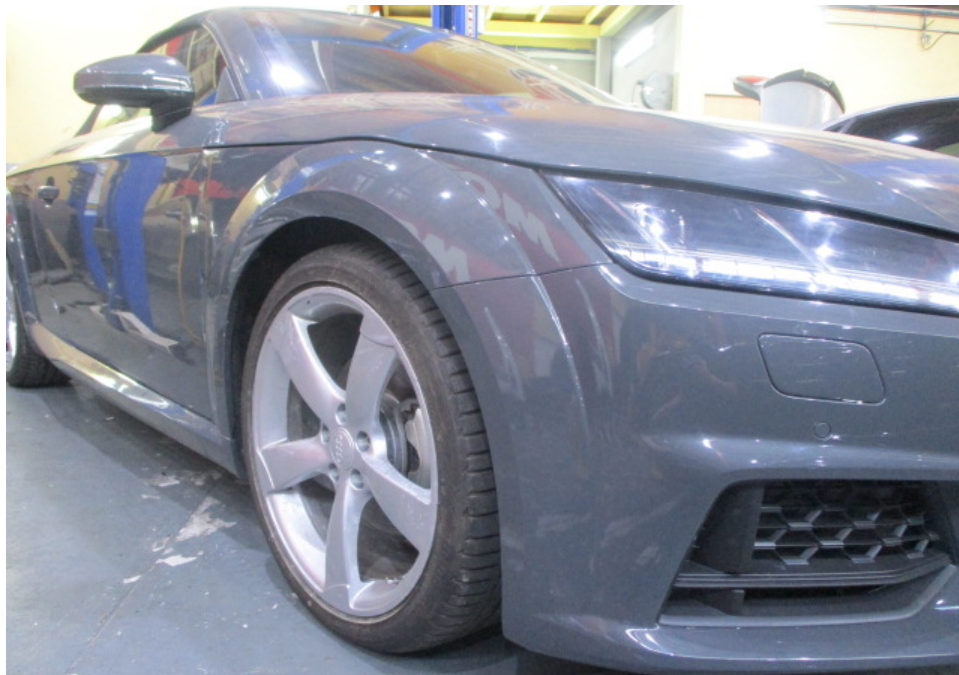
Photo 7 shows a closer view of the Motor Car's front bumper, front right headlamp, front right fender, front right wheel rim and front bonnet. The body parts at the front right portion of the Motor Car were visually examined and it was observed that the repair/restoration works carried out to the damaged area of the Motor Car (refer to photograph 1 above) were reasonably adequate and in order.

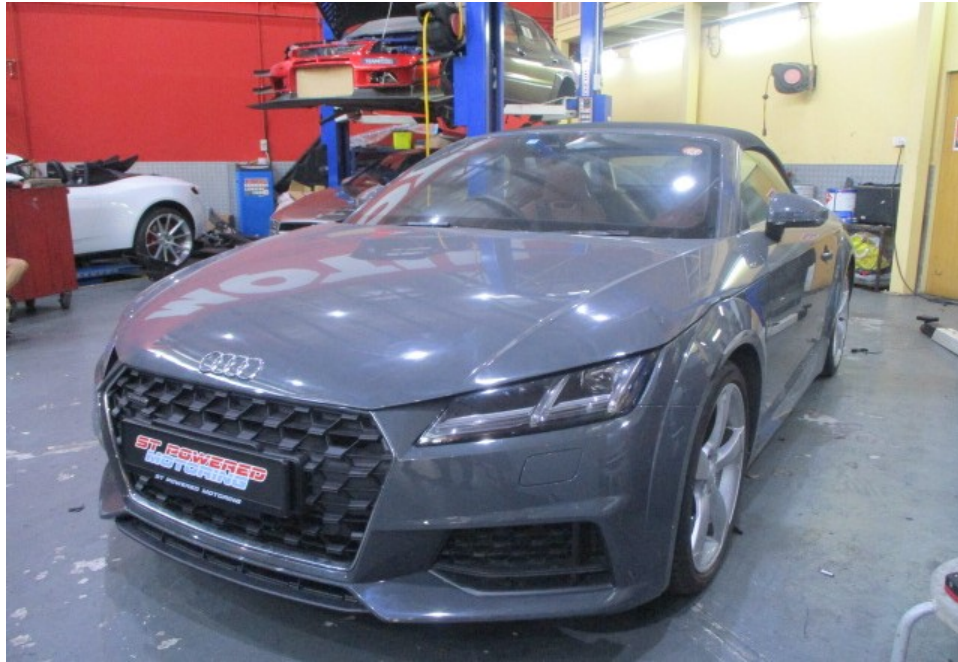
Photo 8 shows a general view of the front left body of the Motor Car at the time of my inspection. The Motor Car was observed to be in a relatively good general condition with no loose exterior fittings observed. The body parts at the front right portion of the Motor Car were visually examined and it was observed that the repair/restoration works carried out to the damaged area of the Motor Car (refer to photograph 1 above) were reasonably adequate and in order.

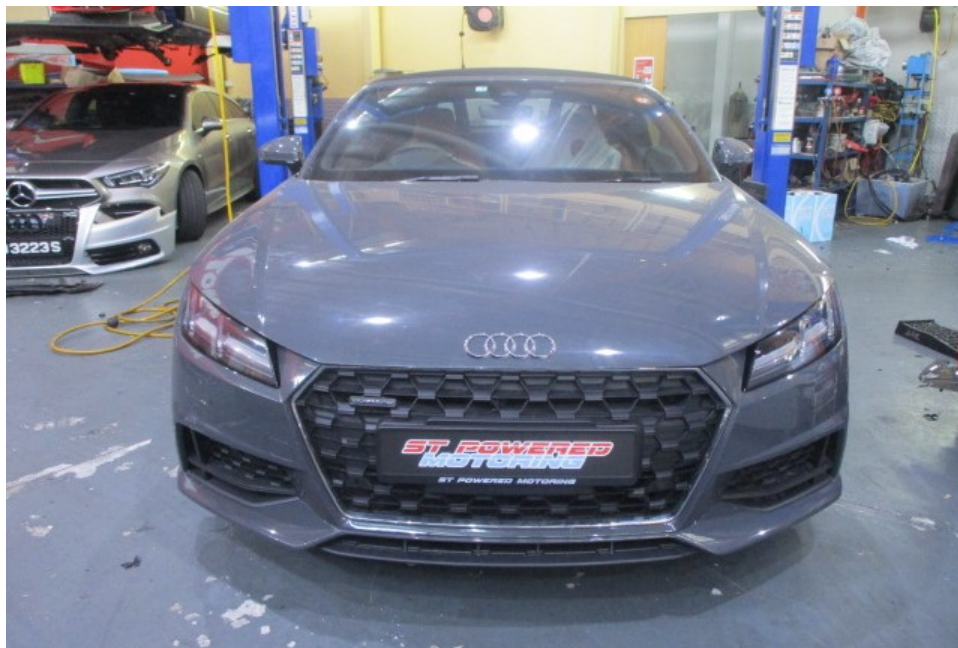
Photo 9 shows a general view of the frontal body of the Motor Car at the time of my inspection. The Motor Car was observed to be in a relatively good general condition with no loose exterior fittings observed. The body parts at the front right portion of the Motor Car were visually examined and it was observed that the repair/restoration works carried out to the damaged area of the Motor Car (refer to photograph 1 above) were reasonably adequate and in order.

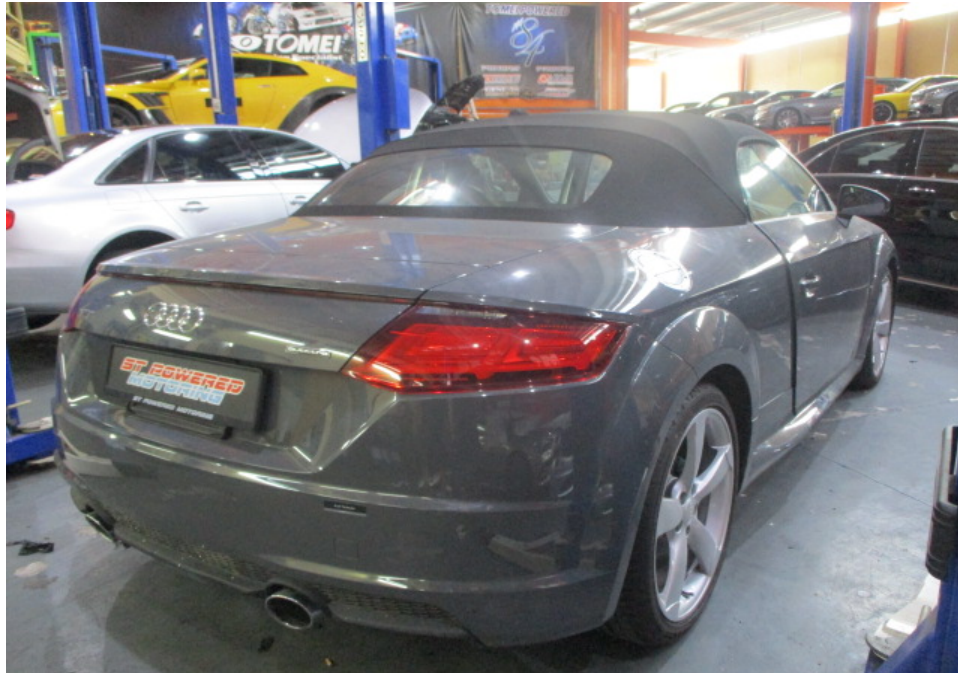
Photo 10 shows a general view of the rear right body of the Motor Car at the time of my inspection. The Motor Car was observed to be in a relatively good general condition with no loose exterior fittings observed. The mileage of the Motor Car recorded at the time of my inspection was 1,738km.

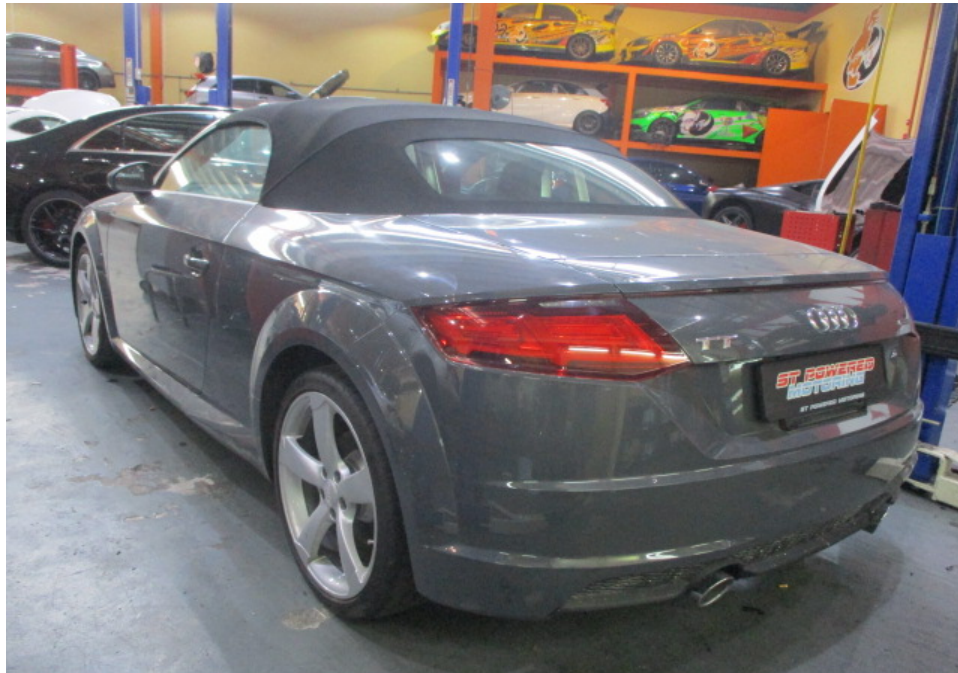
Photo 11 shows a general view of the rear left body of the Motor Car at the time of my inspection. The Motor Car was observed to be in a relatively good general condition with no loose exterior fittings observed. The mileage of the Motor Car recorded at the time of my inspection was 1,738km.

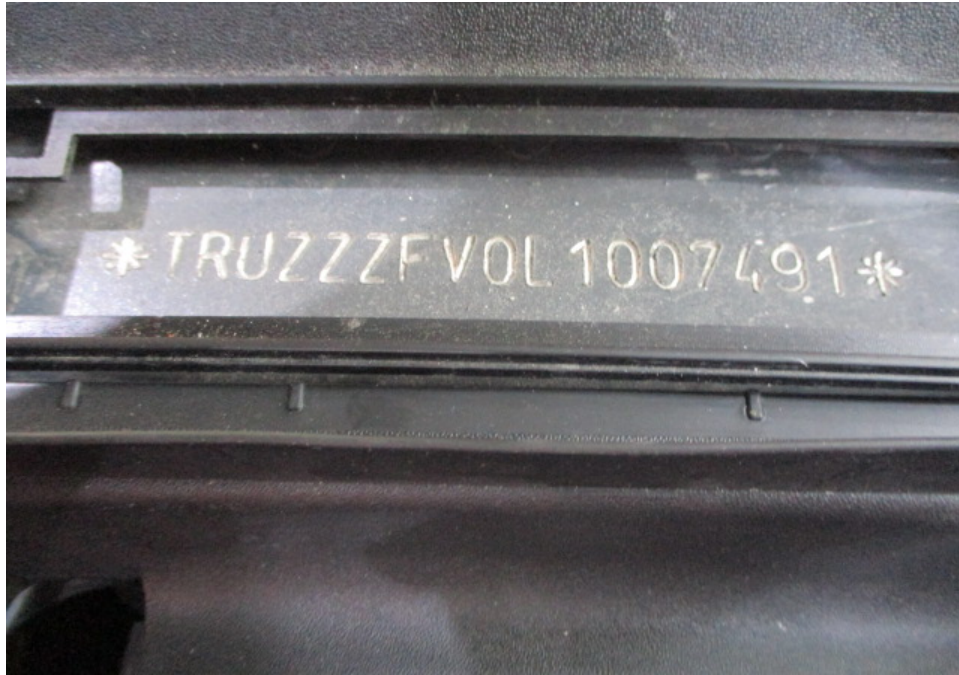
Photo 12 shows the chassis number of the Motor Car. The chassis number recorded was TRUZZZFVOL1007491.

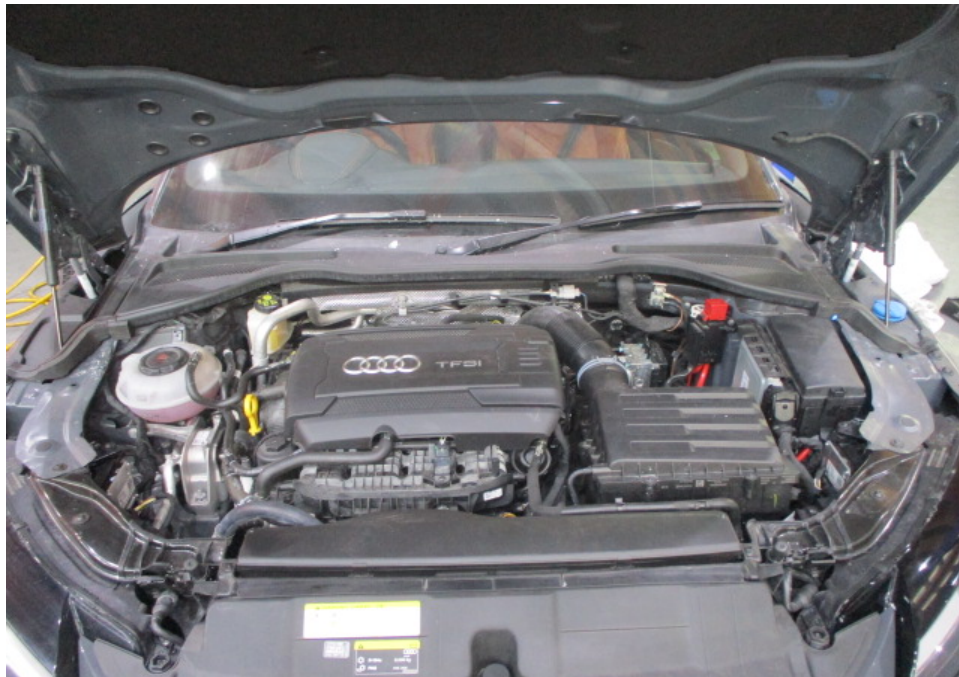
16. My examination of the engine compartment of the Motor Car revealed that the various parts and components inside the engine compartment were all intact and properly fitted. The engine oil, brake fluid and engine coolant were all found to be of sufficient level for operating purposes. Visually, there was also no contamination found to these fluids.

Photo 13 shows a general view of the engine compartment of the Motor Car at the time of my inspection. The various parts and components inside the engine compartment were all observed to be intact and properly fitted. There was also no sign(s) or indication(s) of fluid leak and/or fluid stain found inside the engine compartment. The repair/restoration works carried out to the various parts within the engine compartment like the front right headlamp panel, front right fender top inner panel, front support panel centre garnish and front support panel amongst others, were reasonably adequate and in order.

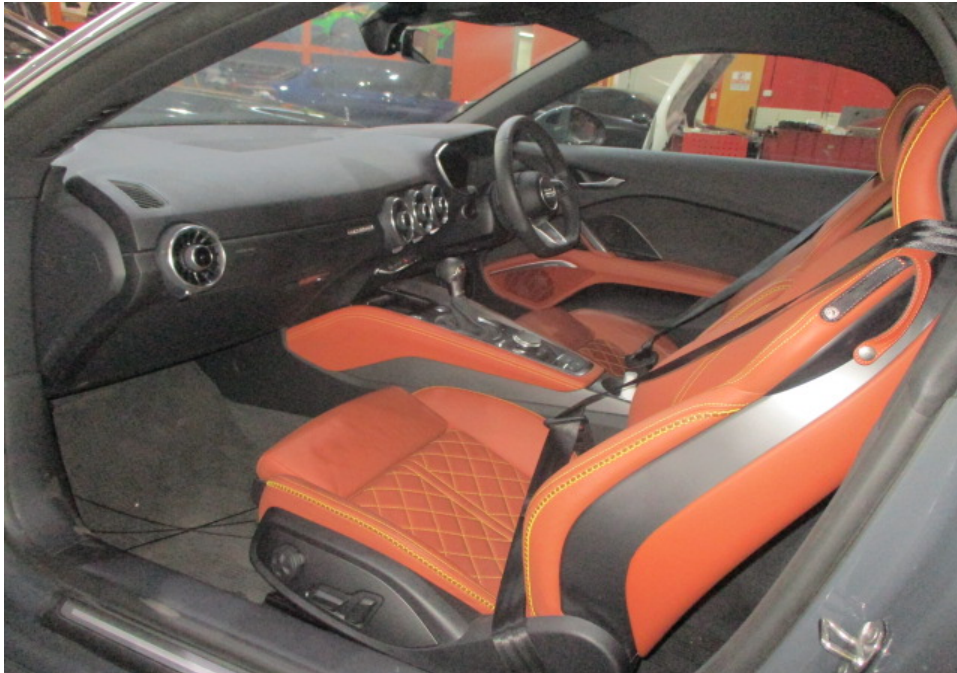
Photo 14 shows the interior compartment of the Motor Car at the time of my inspection. The various parts and components, trims, carpet, and upholstery inside the interior compartment were all observed to be intact and properly fitted.

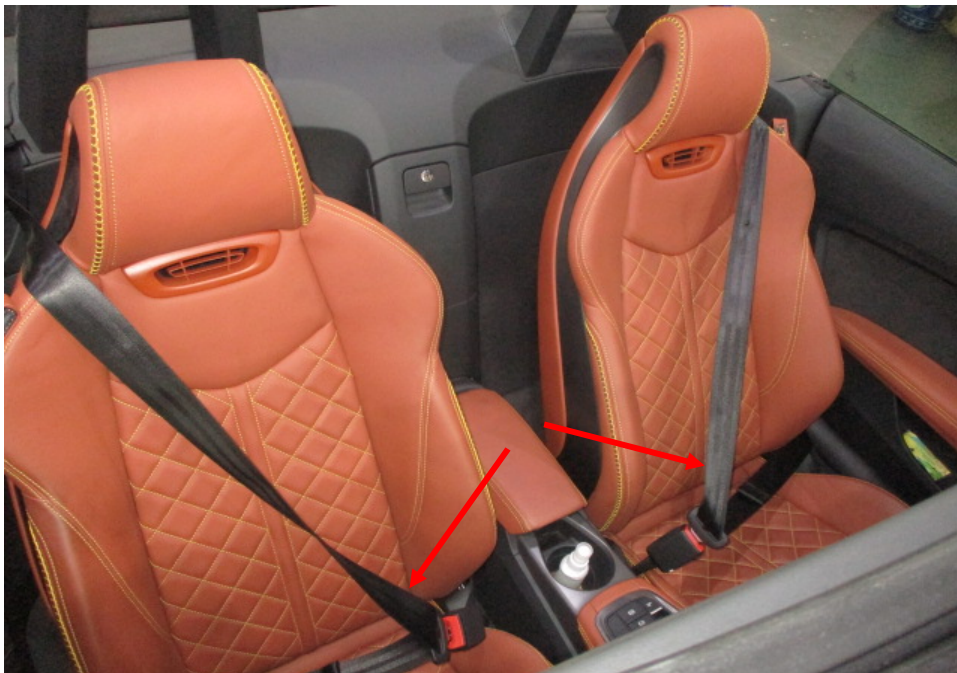
14. The seats of the Motor Car were found to be secured to the floorboard of the Motor Car via seat rails bolted onto the floorboard. Retractable seat belt reels and pre-tensioners were fitted on all seats of the Motor Car. The seat belts were tested and were able to be fastened securely into the respective pre-tensioners that were fixed to the side of all the seats.

Photo 15 shows the seats of the Motor Car. All the seats of the Motor Car were secured via seat rails to the floorboard. They were also fitted with a retractable seat belt reel and a pre-tensioner. The seat belts (arrowed) were tested and were able to be fastened into the respective pre-tensions that were fitted on the side of each individual seat.

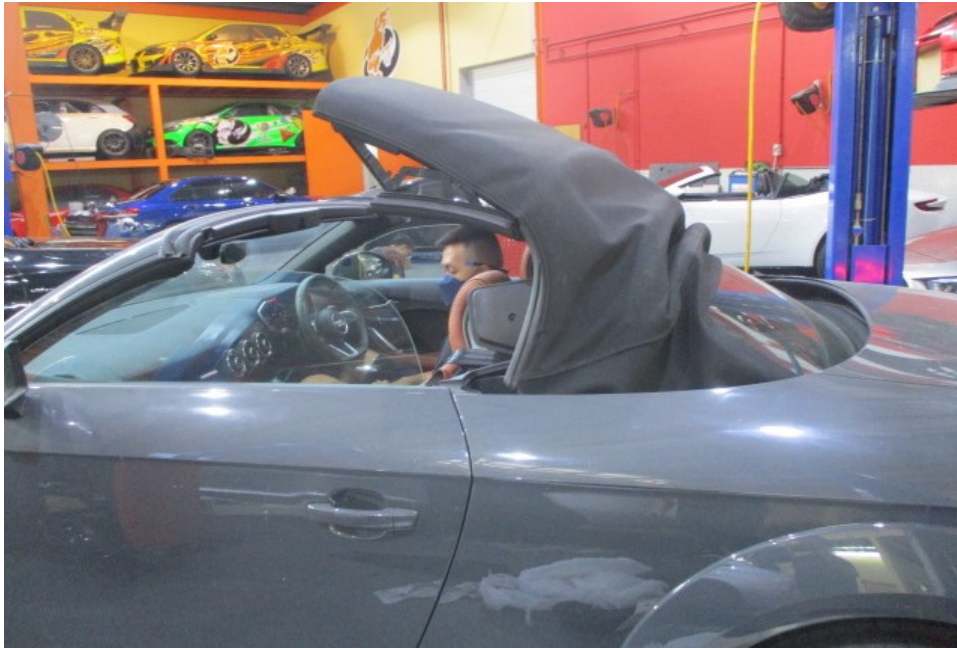
8. The Motor Car was observed to be in a relatively good general condition with no loose exterior fittings observed.
9. Its soft top roof was tested and found to be operating normally. The soft top roof was able to fold and unfold without any difficulty. It was also observed that during the folding and unfolding process, the soft top roof did not extend laterally beyond the Motor Car's body. As a safety feature, the soft top roof could only open and close when the Motor Car was in a stationary position.

Photo 16 shows the Motor Car's soft top roof being tested. It was observed that as a safety feature, the soft top roof could only open and close when the Motor Car was in a stationary position. When opened, the soft top roof is completely folded into the rear compartment with no parts protruding out of the Motor Car's body. The soft top roof was also found adequately secured to the "A" pillar after closing.

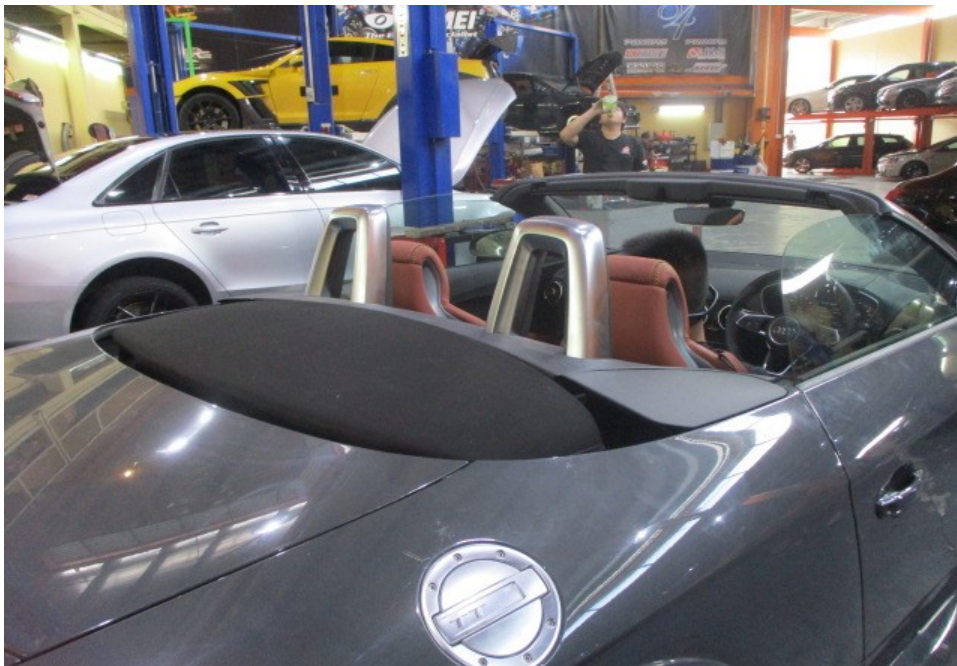
Photo 17 shows the Motor Car with its soft top roof completely folded. It was observed that as a safety feature, the soft top roof could only open and close when the Motor Car was in a stationary position. When opened, the soft top roof is completely folded into the rear compartment with no parts protruding out of the Motor Car's body. The soft top roof was also found adequately secured to the "A" pillar after closing.

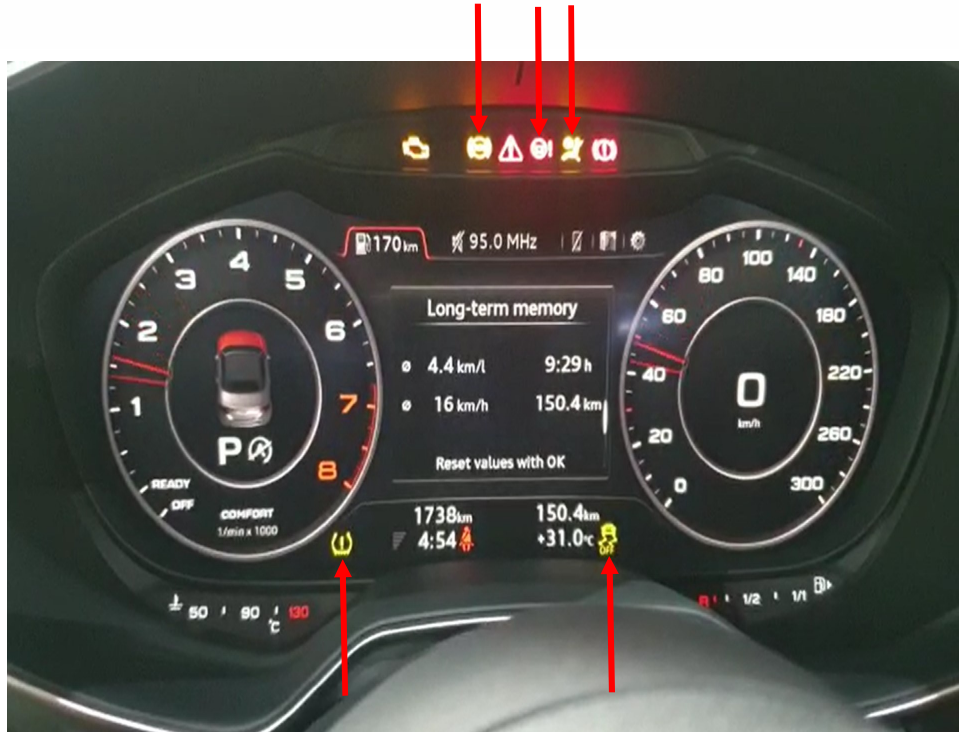
Photo 18 shows the warning lights for the various electronic safety features appearing on the instrument panel of the Motor Car during its self-test when the engine is cranked, in particular ABS, SRS, EPS, TPM and ESC lights (arrowed).

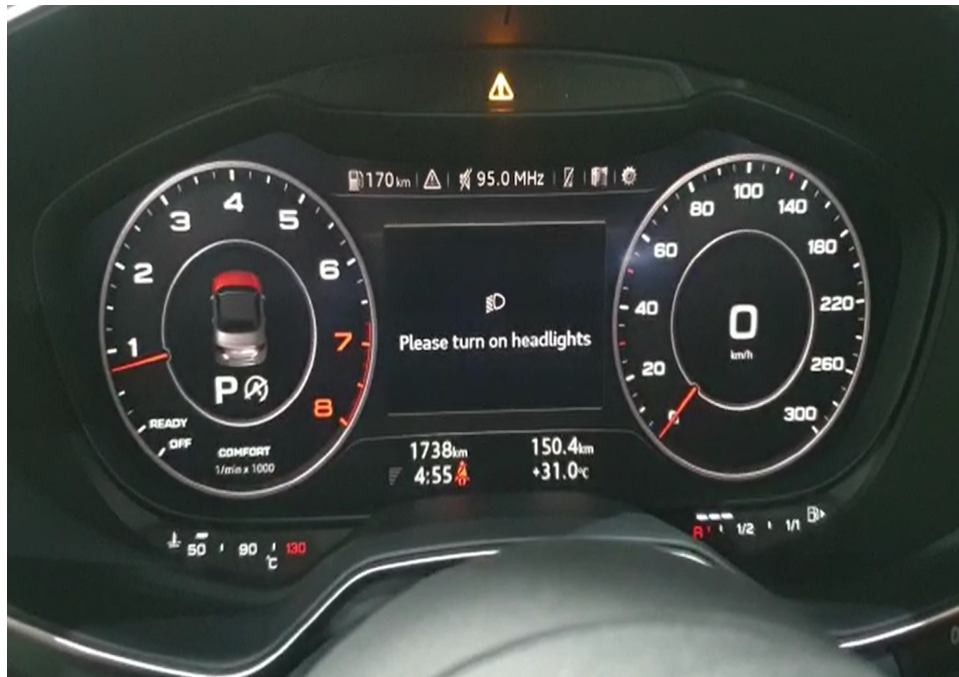
15. The Motor Car's automatic self-test of the functionality of its various electronic safety features like the Anti-Lock Brake System (ABS), Supplemental Restraint System (SRS), Electronic Power Steering (EPS), Tyre Pressure Monitor (TPM) and Electronic Stability Control (ESC) during cranking of the engine had indicated that these electronic systems were in working condition. This was determined from the respective warning lights disappearing from the instrument panel after the self-test.

Photo 19 shows the respective warning lights no longer illuminated, indicating that there is no fault detected to ABS, SRS, EPS, TPM and ESC systems of the Motor Car during the self-test. These electronic systems were hence in working condition at the time of my inspection.

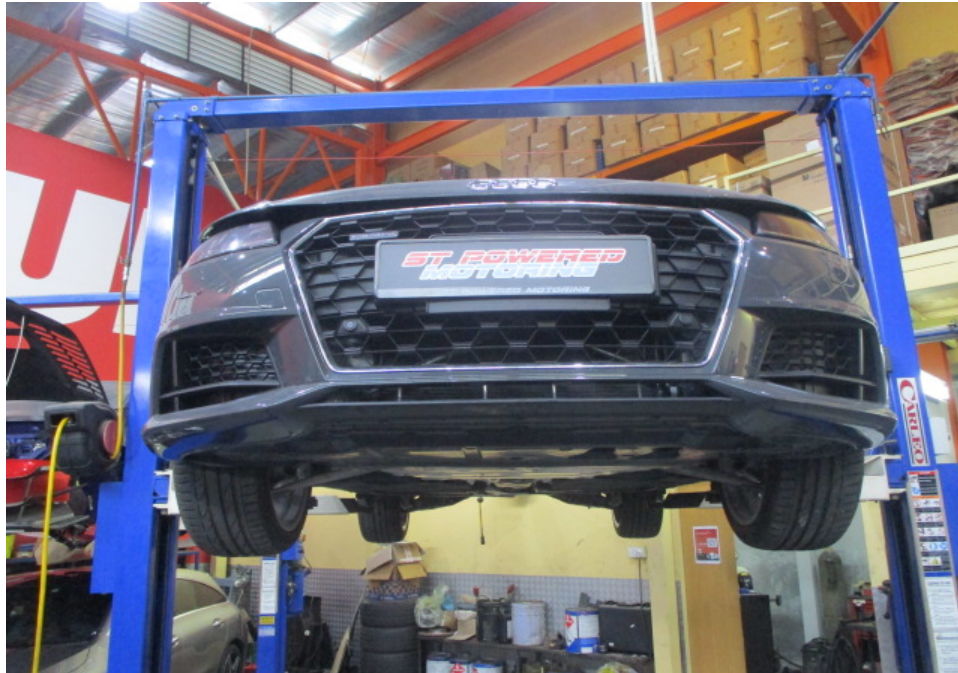
17. My checks on the underside of the Motor Car revealed no sign(s) or indication(s) of fluid leakage and/or fluid stain(s). The engine block and automatic transmission assembly were both secured properly. All undercarriage components of the Motor Car were also observed to be intact and secured in an appropriate manner.

Photo 20 shows the Motor Car hoisted up for checks on its undercarriage. There was no sign(s) or indication(s) of fluid leakage and/or fluid stain(s) on the underside of the Motor Car. The undercarriage components of the Motor Car were also all observed to be intact and secured in an appropriate manner.

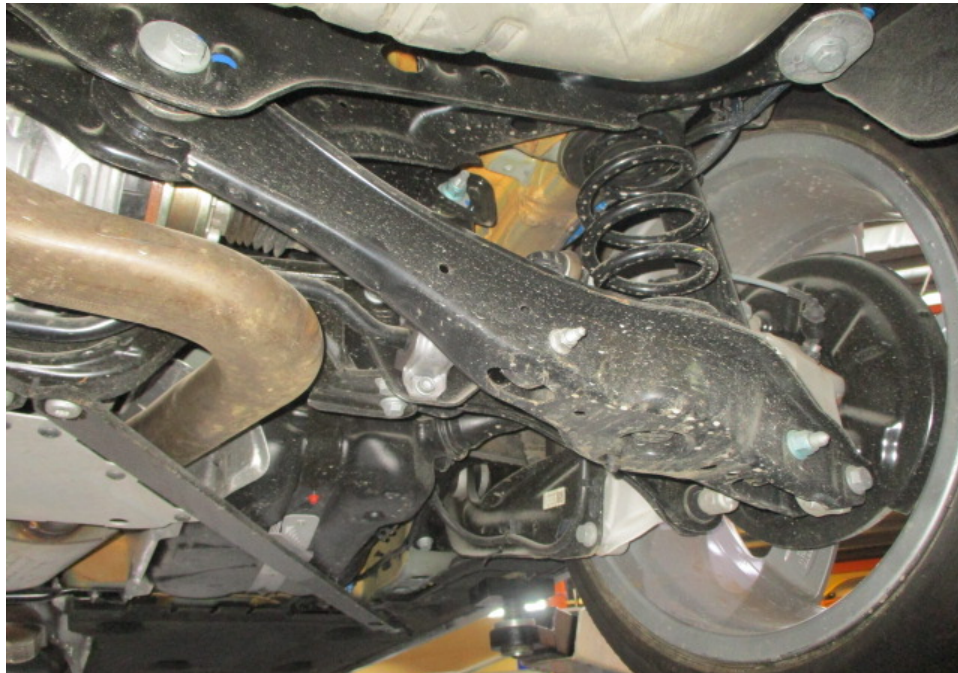
Photo 21 shows a general view of the control arms and linkages at the rear right wheel of the Motor Car. I did not observe any fluid leak and/or fluid stain on the underside of the Motor Car. All of the Motor Car's undercarriage components were observed to be intact and secured in an appropriate manner.

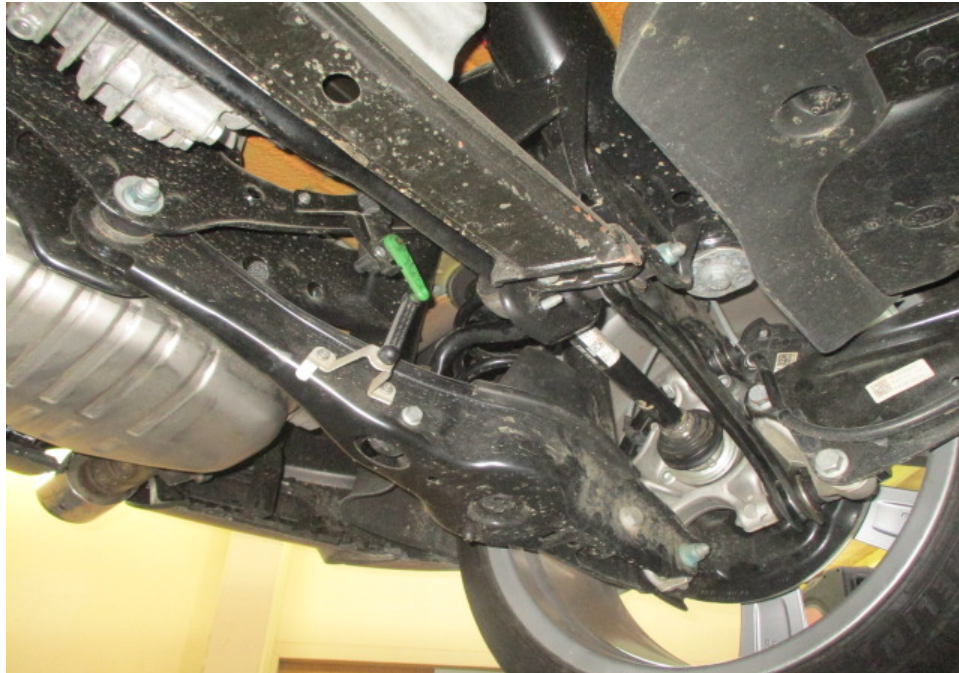
Photo 22 shows a general view of the control arms and linkages at the rear left wheel of the Motor Car. I did not observe any fluid leak and/or fluid stain on the underside of the Motor Car. All of the Motor Car's undercarriage components were observed to be intact and secured in an appropriate manner.

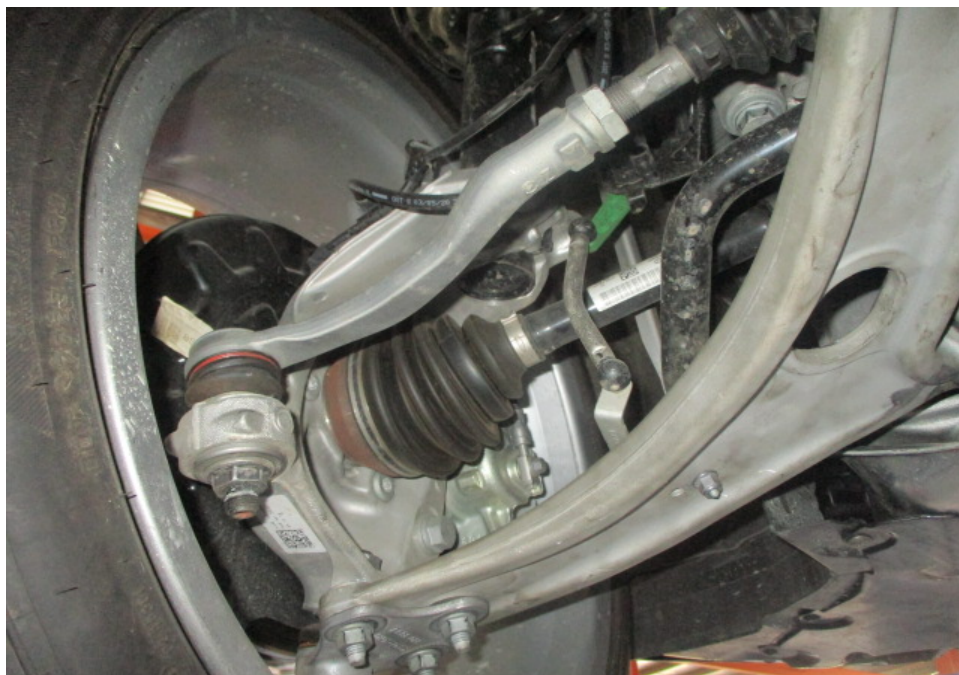
Photo 23 shows the various undercarriage components at the front left wheel of the Motor Car. The mechanical components, control arms and linkages were all found to be intact and secured in an appropriate manner.

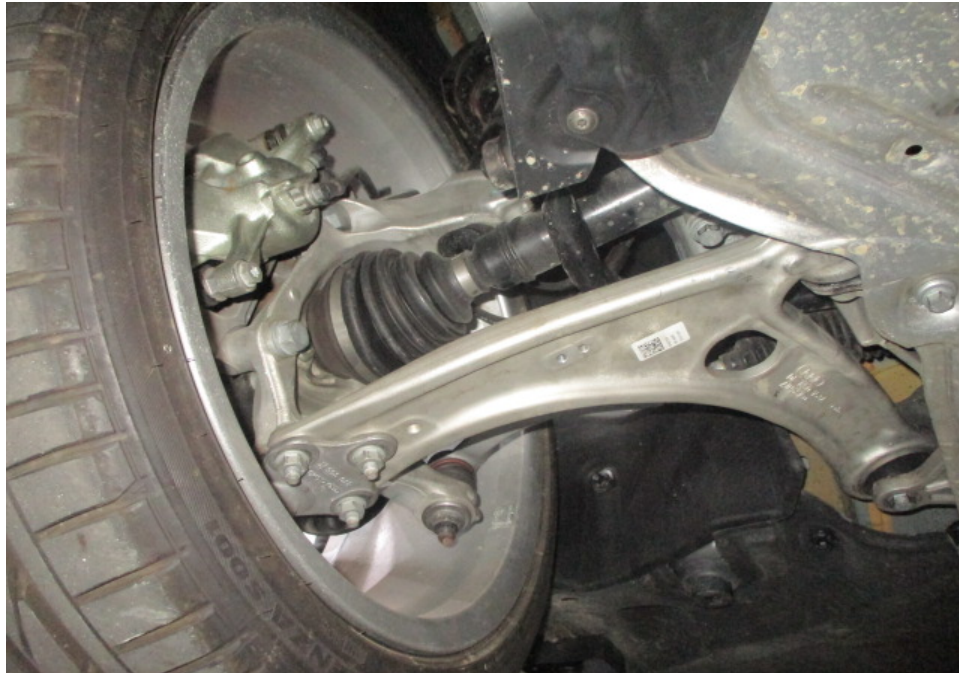
Photo 24 shows the various undercarriage components at the front right wheel of the Motor Car. The mechanical components, control arms and linkages were all found to be intact and secured in an appropriate manner. I also did not observe any fluid leak and/or fluid stain on the underside of the Motor Car.

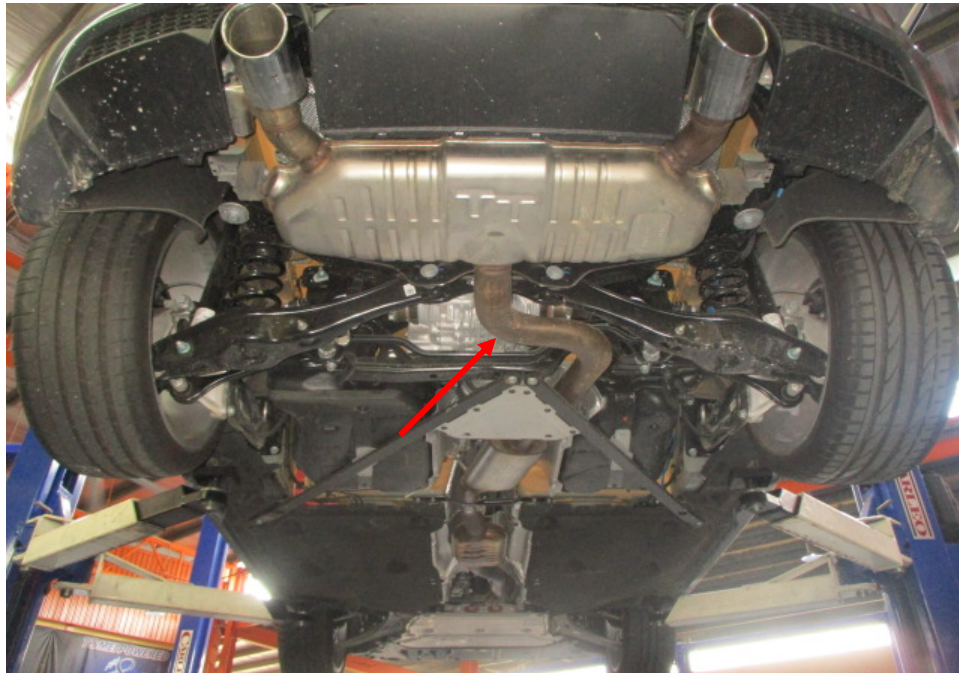
Photo 25 shows the rear section of the Motor Car's exhaust system. My examination of the Motor Car's exhaust system revealed no sign(s) or indication(s) of any cut or weld marks along its exhaust pipes (arrowed), on its rear muffler, on its centre resonator boxes and on its catalytic converter.

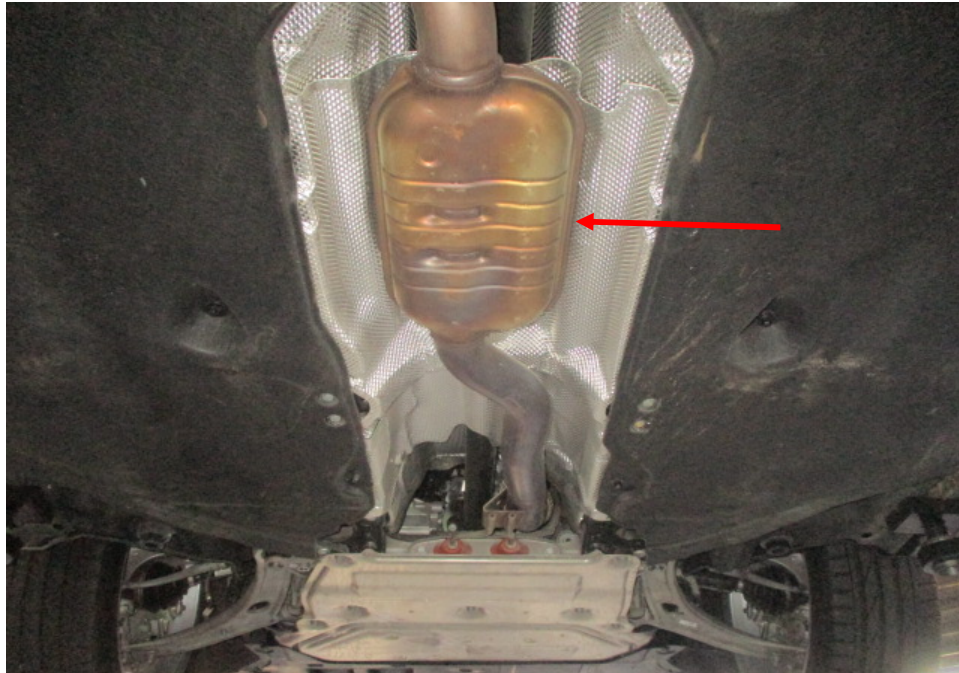
Photo 26 shows the front section of the Motor Car's exhaust system. My examination of the Motor Car's exhaust system revealed no sign(s) or indication(s) of any cut or weld marks along its exhaust pipes, on its rear muffler, on its centre resonator boxes (arrowed) and on its catalytic converter.

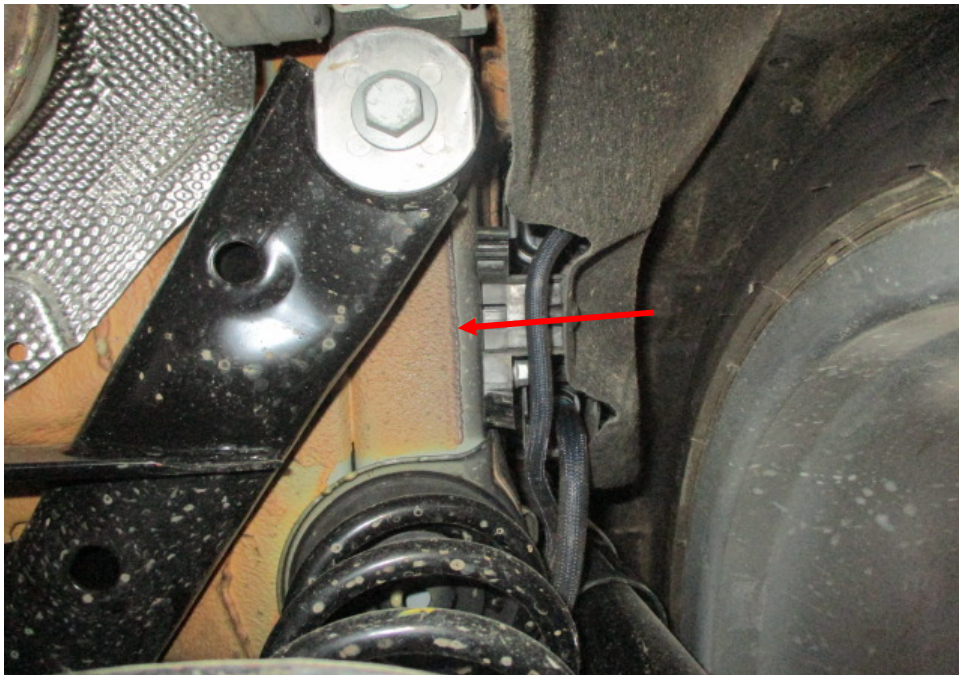
13. Visually, I did not find any weld marks, other than the original spot weld marks, on the chassis/structural body of the Motor Car. The original factory sealant at the joints along the chassis/structural body was also untouched, again indicating that no replacement of the chassis/structural body was carried out; and that the chassis/structural body was originally fitted.

Photo 27 shows the chassis/structural body at the underside rear right of the Motor Car. I did not find any weld marks other than original spot weld marks on the chassis/structural body of the Motor Car. The original factory sealant (arrowed) at the joints along the chassis/structural body was untouched, indicating no work was done on the chassis/structural body of the Motor Car and that the chassis/structural body was originally fitted.

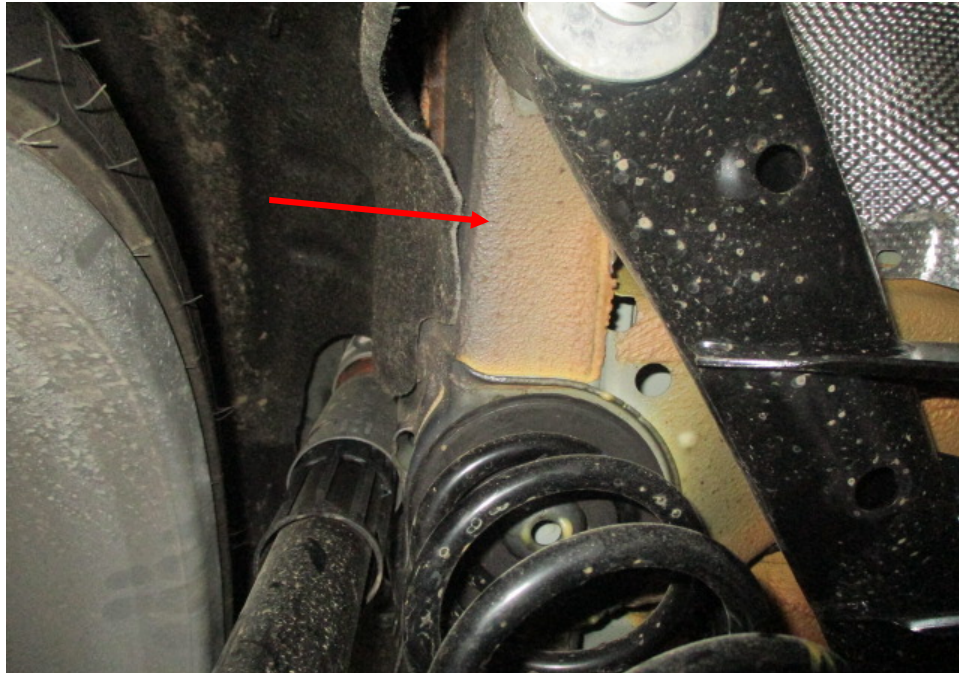
Photo 28 shows the chassis/structural body at the underside rear left of the Motor Car. The original factory sealant (arrowed) at the joints along the chassis/structural body was observed to be untouched. In general, I had found no work was carried out on the chassis/structural body of the Motor Car. The chassis/structural body of the Motor Car was originally fitted.
