Your Ref: Audi TT Coupe
(chassis number TRUZZZFV0L1007491)
Our Ref : CI/TP22001324/D

14 February 2022

INSPECTION REPORT OF AN UNREGISTERED AUDI TT COUPE MOTOR CAR WITH CHASSIS NUMBER TRUZZZFV0L1007491

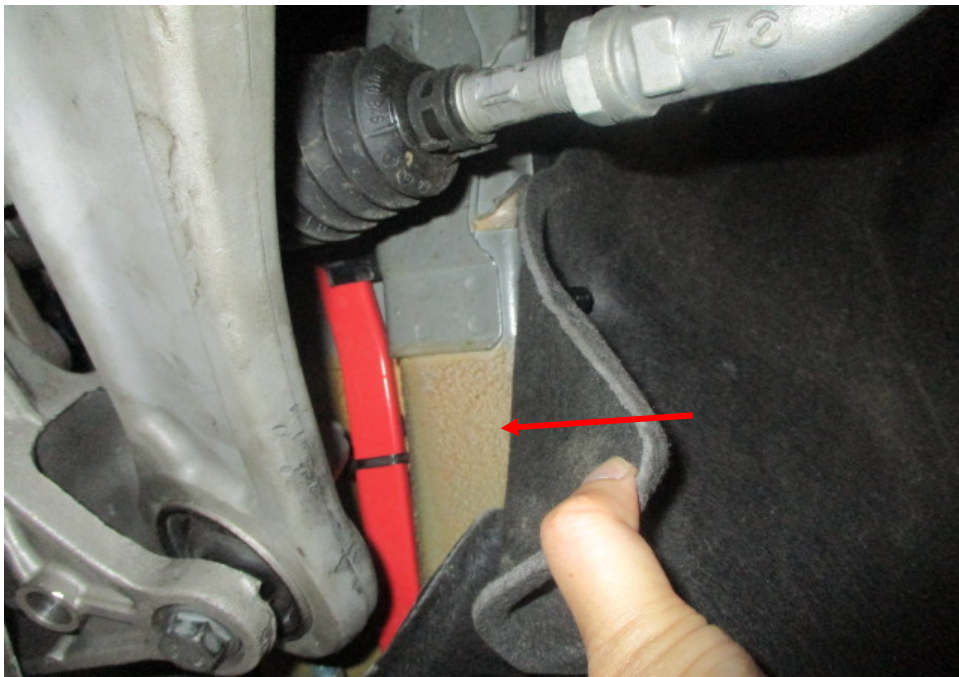
Photo 29 shows the chassis/structural body at the underside front left of the Motor Car. I did not find any weld marks other than original spot weld marks on the chassis/structural body of the Motor Car. The original factory sealant (arrowed) at the joints along the chassis/structural body was untouched, indicating no work was done on the chassis/structural body of the Motor Car and that the chassis/structural body was originally fitted.

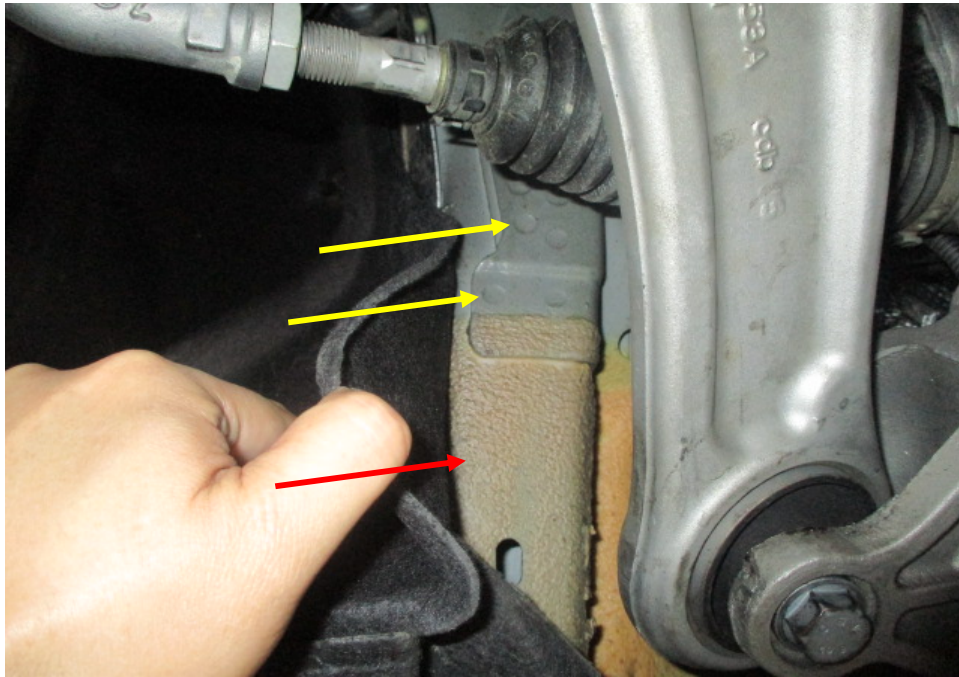
Photo 30 shows the chassis/structural body at the underside front right of the Motor Car. I did not find any weld marks other than original spot weld marks (yellow arrow) on the chassis/structural body of the Motor Car. The original factory sealant (red arrow) at the joints along the chassis/structural body was untouched, indicating no work was done on the chassis/structural body of the Motor Car and that the chassis/structural body was originally fitted.
