Your Ref: BMW Z4 Coupe
(chassis number WBAHF12000WW41759)
Our Ref : CI/TP22001325/D

INSPECTION REPORT OF AN UNREGISTERED BMW Z4 COUPE MOTOR CAR WITH CHASSIS NUMBER WBAHF12000WW41759

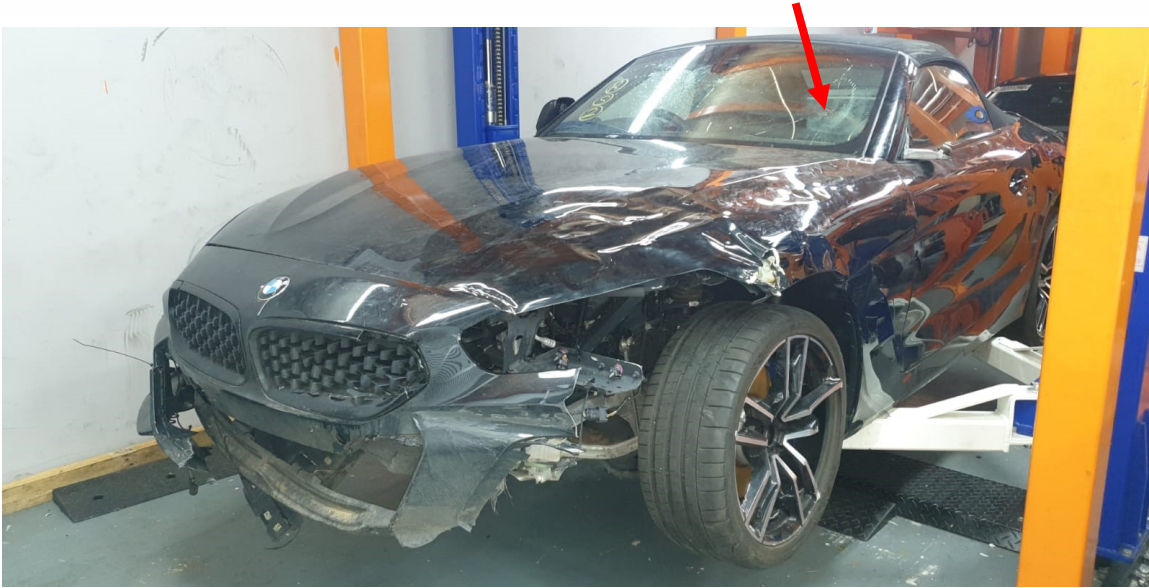
3. The photographs provided to me had showed damage to the front left portion of the Motor Car. Body parts damaged include the front bumper, front bumper left lower grille, front bumper centre lower grille, front bumper sensors, front bumper reinforcement, front bumper sponge, front left radiator grille, front left headlamp, front left fender, front left fender inner shield, front left wheel rim, left wing mirror, front under cover, front bonnet and front windscreen amongst others. The rear left taillamp was also observed to be cracked.

4. The photographs provided also appear to indicate damage to undercarriage parts at the front left wheel of the Motor Car. The front left lower arm, front left knuckle arm, front left shock absorber and front left steering tie rod amongst others are undercarriage parts that may possibly be damaged.

5. The front left passenger airbag of the Motor Car was deployed as seen from the photographs that were provided to me. See photo 1 – 4 below.

Photo 1 shows the front left body of the Motor Car (photograph provided to me). The photographs provided to me had showed damage to the front left portion of the Motor Car. The front bumper, front bumper left lower grille, front bumper centre lower grille, front bumper sensors, front bumper reinforcement, front bumper sponge, front left radiator grille, front left headlamp, front left fender, front left fender inner shield, front left wheel rim, left wing mirror, front under cover, front bonnet and front windscreen were amongst the body parts that were observed to have been damaged. The front left passenger airbag (arrowed) of the Motor Car was deployed as seen from the photographs that were provided to me. The undercarriage parts at the Motor Car's front left wheel appears to be also damaged. The front left lower arm, front left knuckle arm, front left shock absorber and front left steering tie rod amongst others are undercarriage parts that may possibly be damaged

24. The body parts at the front left portion and undercarriage parts at the front left wheel of the Motor Car were visually examined and it was noted that the repair/restoration works carried out to the damaged area of the Motor Car (refer to photograph 1 above) were reasonably adequate and in order.

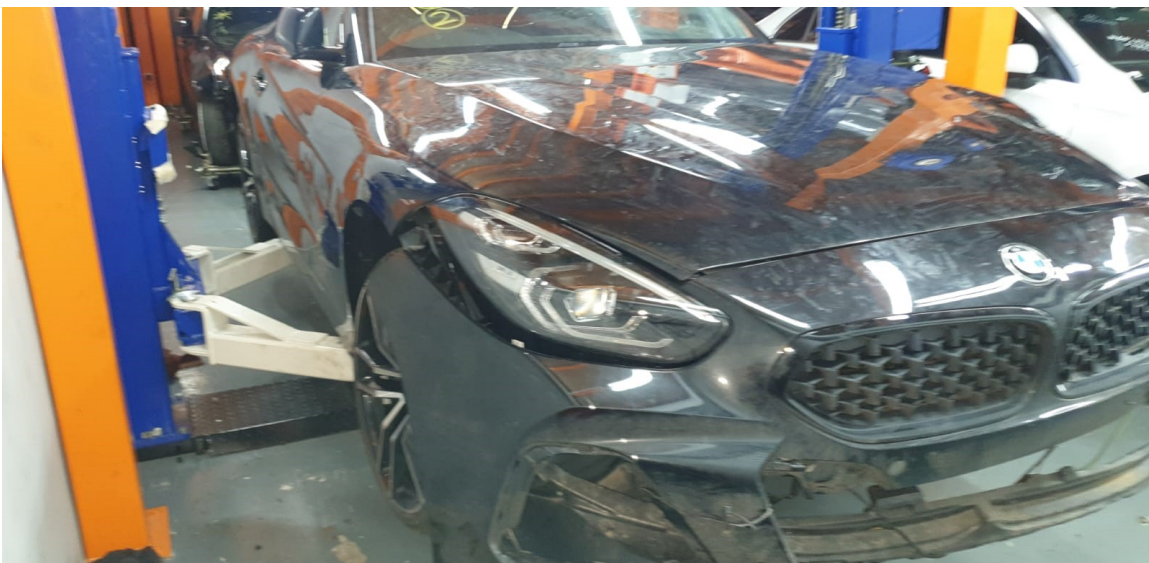
Photo 2 shows the front right body of the Motor Car (photograph provided to me). The front right portion of the Motor Car was observed to be relatively unaffected and without any physical damage.

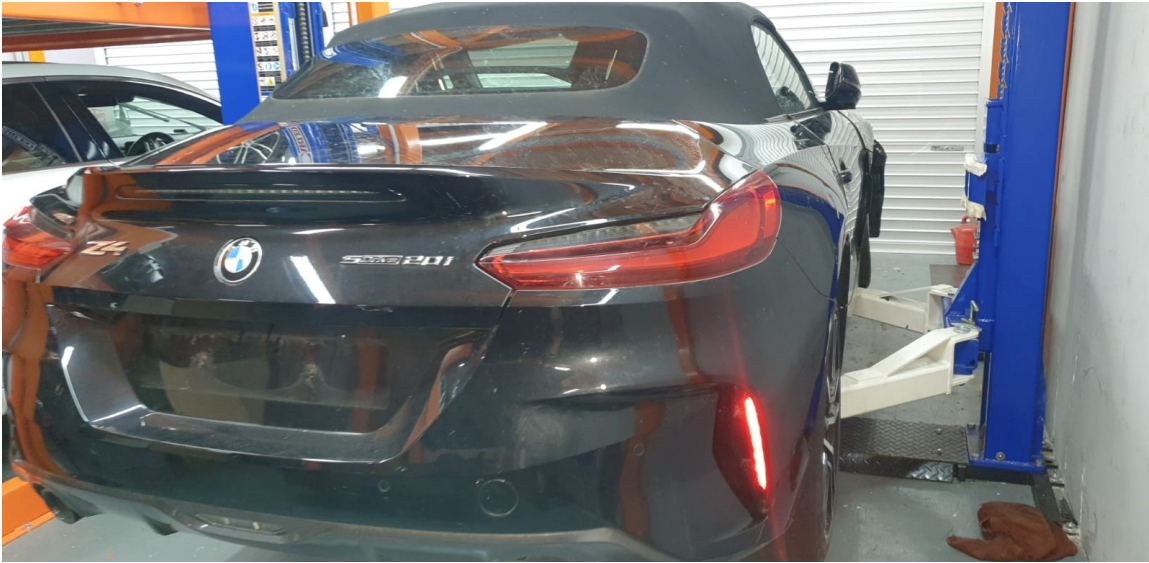
Photo 3 shows the rear right body of the Motor Car (photograph provided to me). The rear right portion of the Motor Car was observed to be relatively unaffected and without any physical damage.

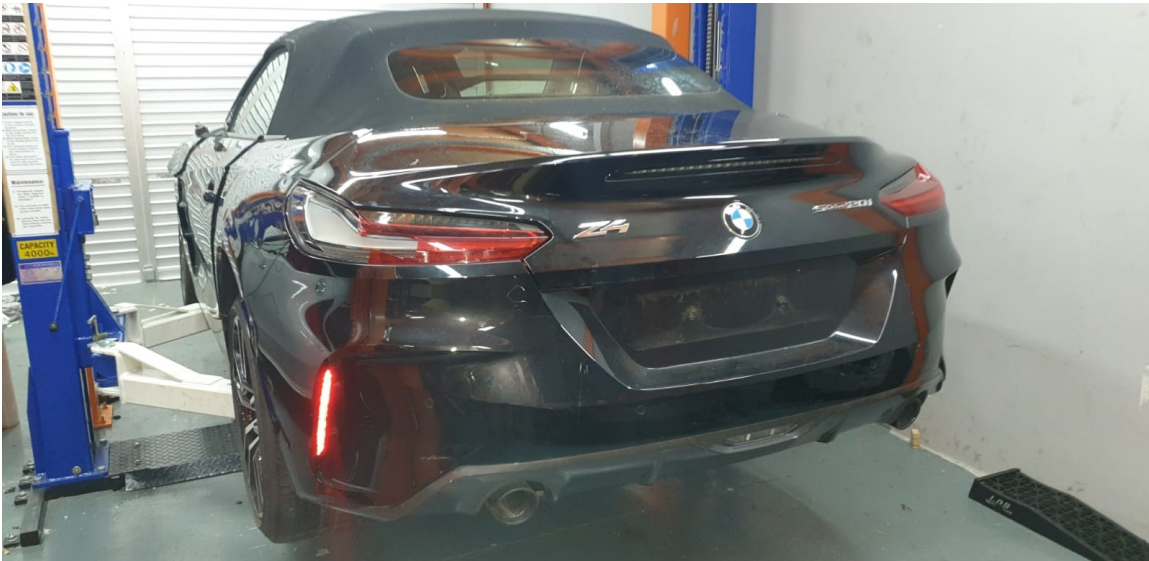
Photo 4 shows the rear left body of the Motor Car (photograph provided to me). The rear left portion of the Motor Car was observed to be relatively unaffected and without any physical damage except for the rear left taillamp, which was observed to be cracked.

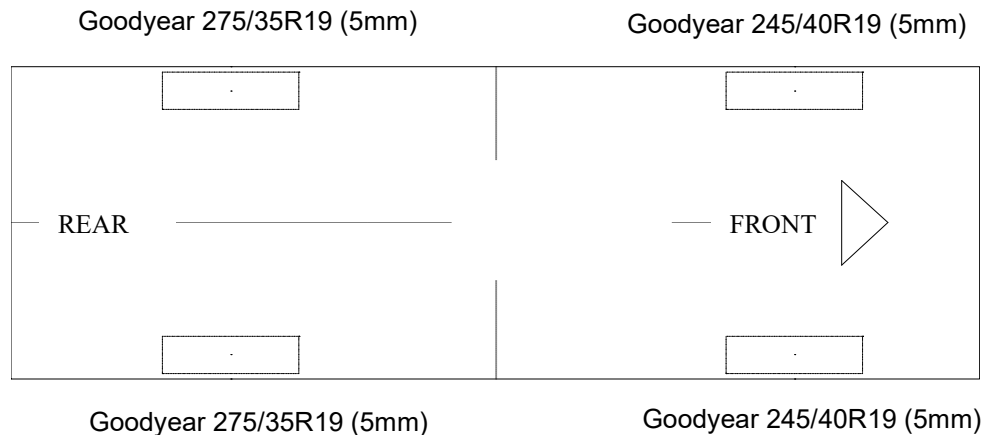
10. It was fitted with 19inch sport wheel rims that were wrapped with tyres that were observed to be of serviceable condition. The tyres were also sufficiently inflated for vehicular operation. The tyre brand, tyre size and approximate remaining tread depth of the 4 tyres of the Motor Car were recorded as follows: -

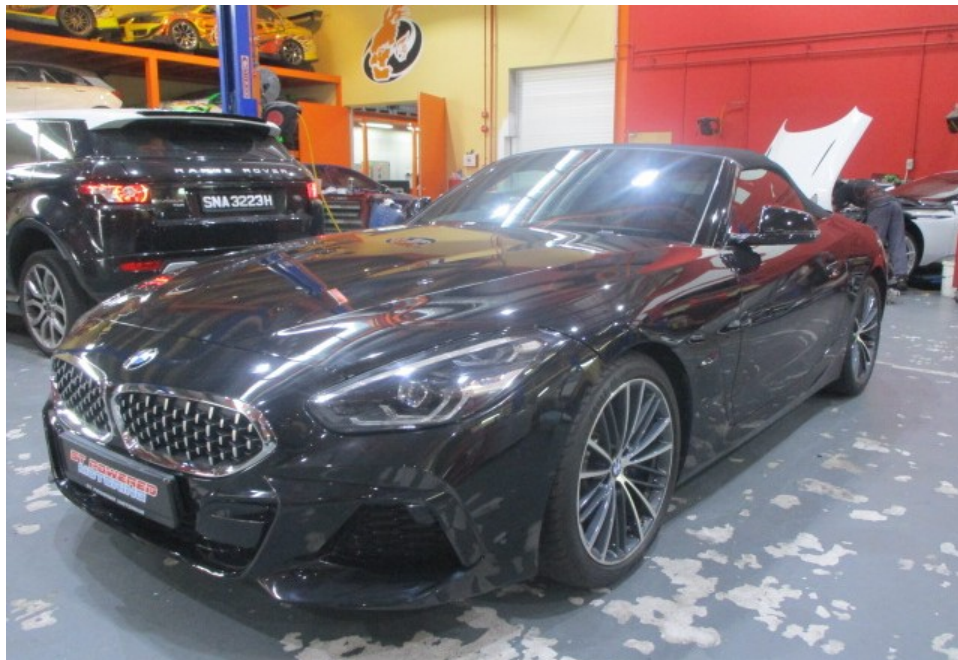
Photo 5 shows a general view of the front left body of the Motor Car at the time of my inspection. The Motor Car was observed to be in a relatively good general condition with no loose exterior fittings observed. The body parts at the front left portion of the Motor Car were visually examined and it was observed that the repair/restoration works carried out to the damaged area of the Motor Car (refer to photograph 1 above) were reasonably adequate and in order.

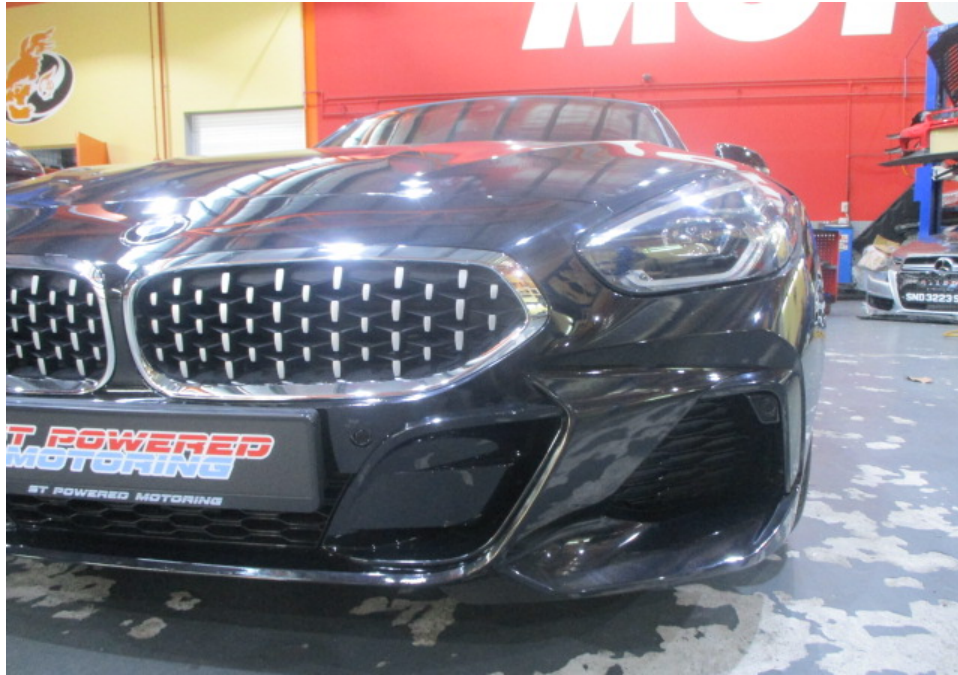
Photo 6 shows a closer view of the Motor Car's front bumper, front bumper centre lower grille, front bumper left lower grille, radiator grilles and front left headlamp. The body parts at the front left portion of the Motor Car were visually examined and it was observed that the repair/restoration works carried out to the damaged area of the Motor Car (refer to photograph 1 above) were reasonably adequate and in order.

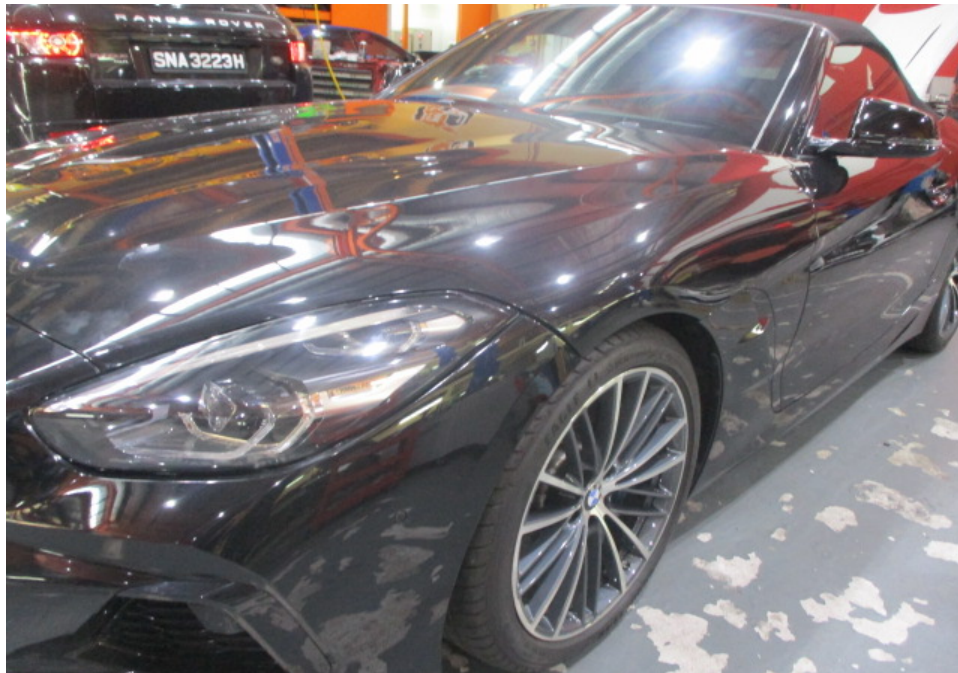
Photo 7 shows a closer view of the Motor Car's front left headlamp, front left fender, front left wheel rim, front bonnet and left wing mirror. The body parts at the front left portion of the Motor Car were visually examined and it was observed that the repair/restoration works carried out to the damaged area of the Motor Car (refer to photograph 1 above) were reasonably adequate and in order.

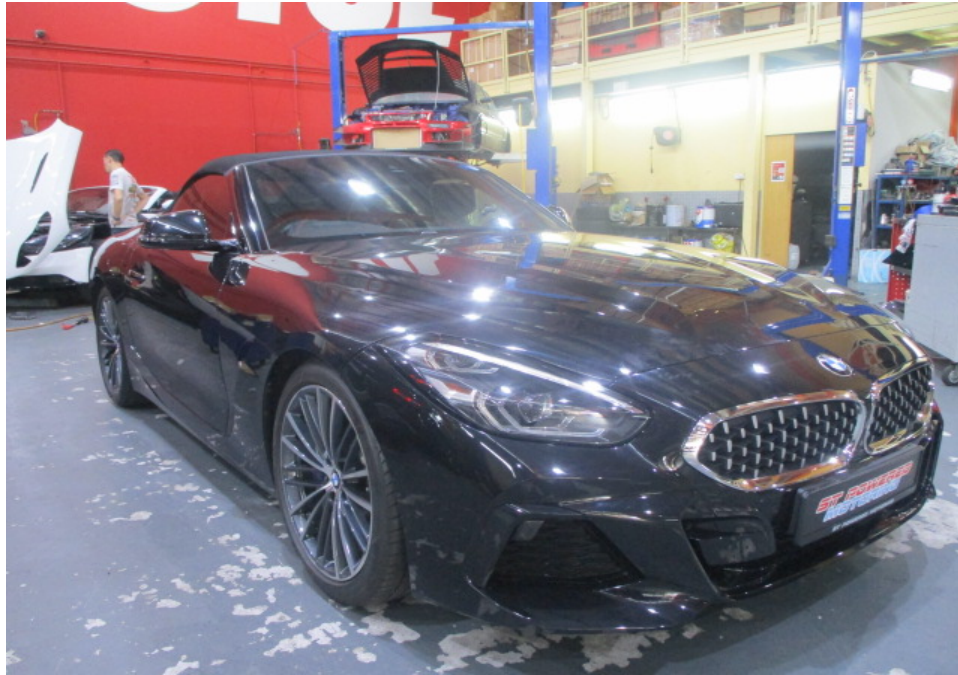
Photo 8 shows a general view of the front right body of the Motor Car at the time of my inspection. The Motor Car was observed to be in a relatively good general condition with no loose exterior fittings observed. The body parts at the front left portion of the Motor Car were visually examined and it was observed that the repair/restoration works carried out to the damaged area of the Motor Car (refer to photograph 1 above) were reasonably adequate and in order.

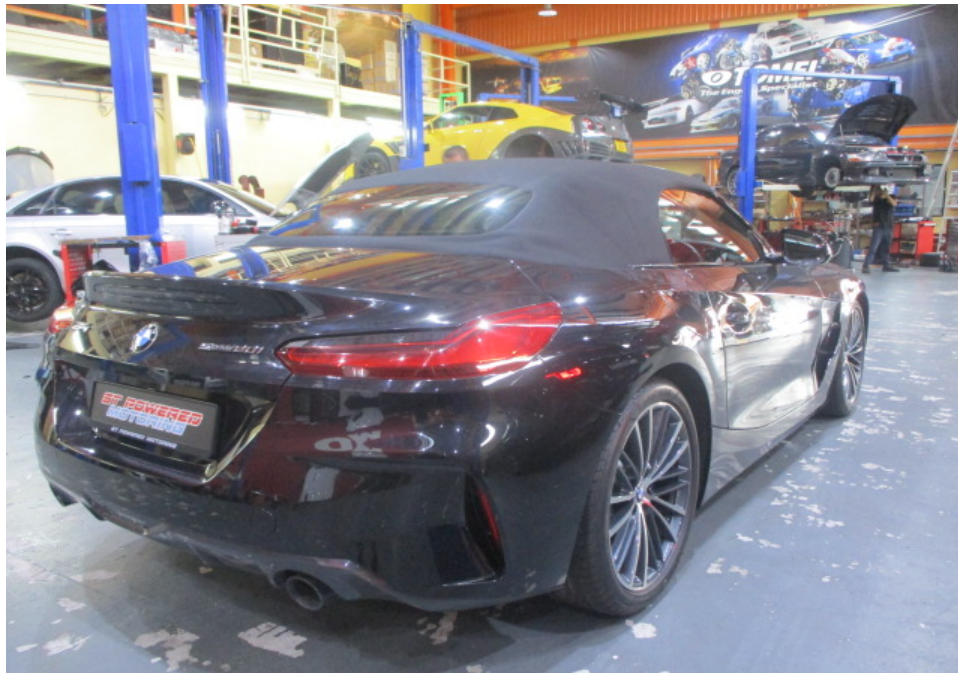
Photo 9 shows a general view of the rear right body of the Motor Car at the time of my inspection. The Motor Car was observed to be in a relatively good general condition with no loose exterior fittings observed. The mileage of the Motor Car recorded at the time of my inspection was **2,245km**.

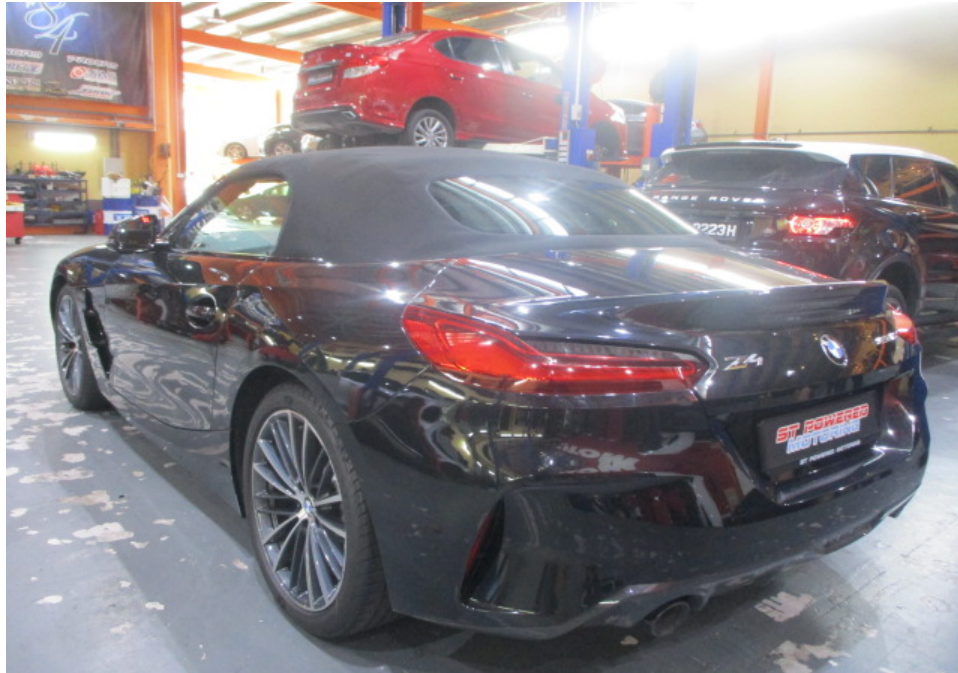
Photo 10 shows a general view of the rear left body of the Motor Car at the time of my inspection. The Motor Car was observed to be in a relatively good general condition with no loose exterior fittings observed. The mileage of the Motor Car recorded at the time of my inspection was **2,245km**. The damaged rear left taillamp (refer to photograph 4 above) was observed to be replaced.

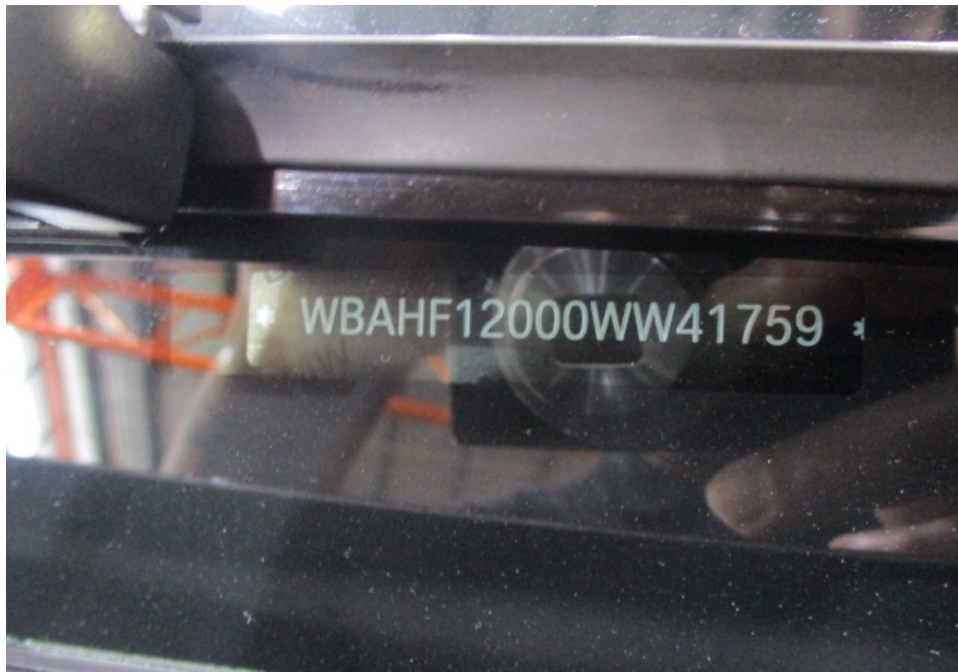
Photo 11 shows the chassis number of the Motor Car. The chassis number recorded was WBAHF12000WW41759.

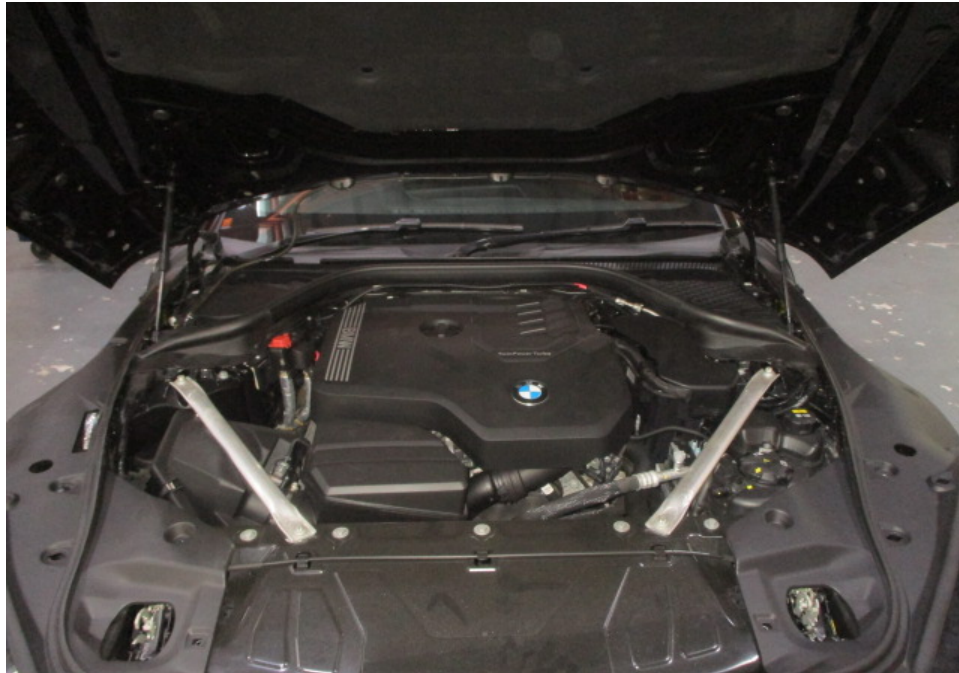
Photo 12 shows a general view of the engine compartment of the Motor Car at the time of my inspection. The various parts and components inside the engine compartment were all observed to be intact and properly fitted. There was also no sign(s) or indication(s) of fluid leak and/or fluid stain found inside the engine compartment.

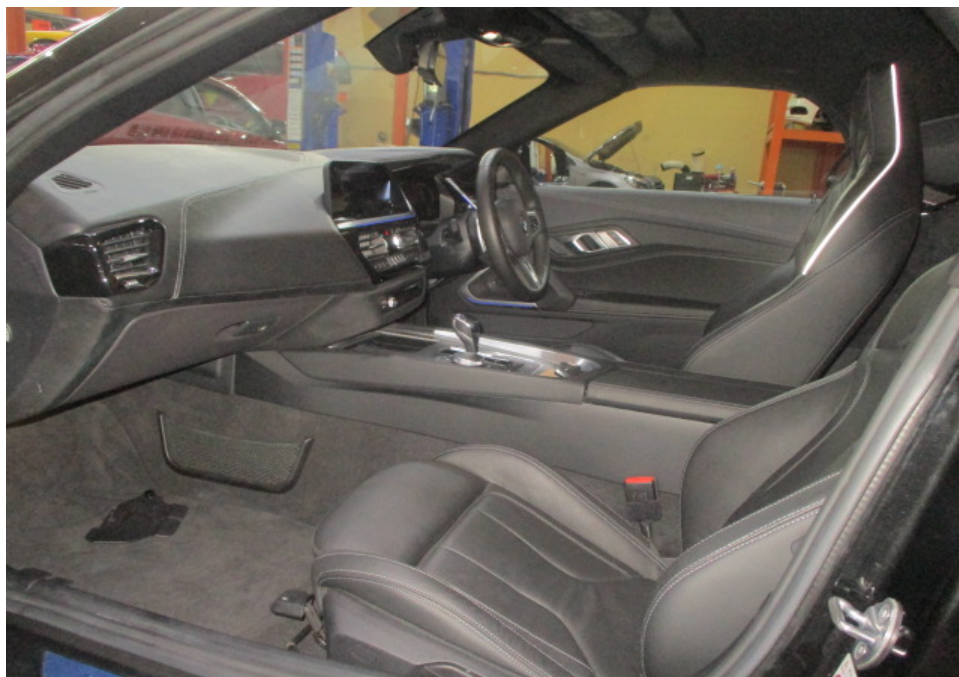
Photo 13 shows the interior compartment of the Motor Car at the time of my inspection. The various parts and components, trims, carpet, and upholstery inside the interior compartment were all observed to be intact and properly fitted.

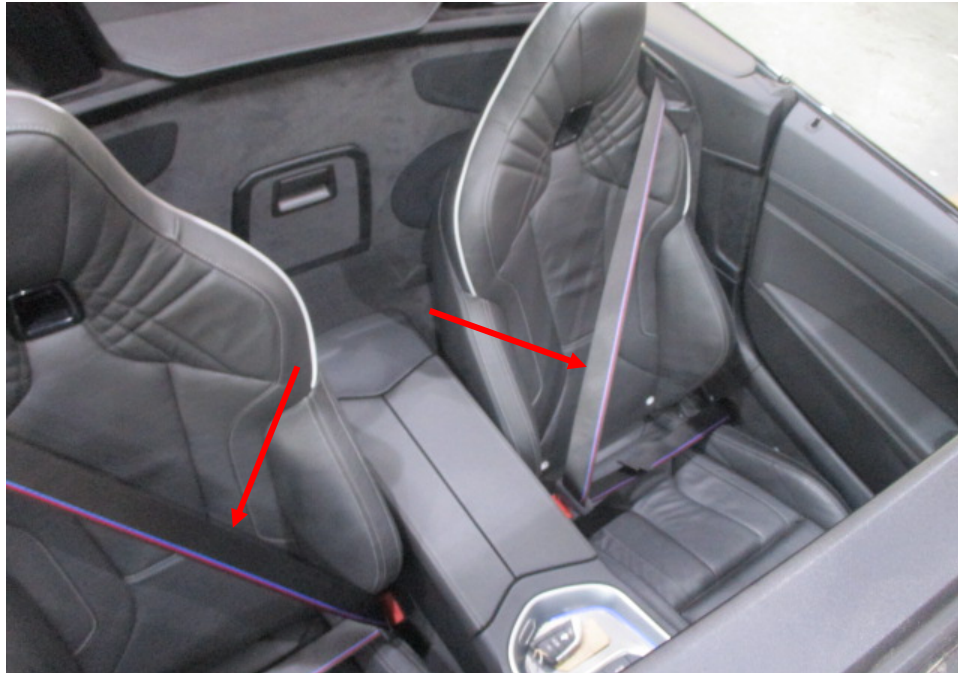
Photo 14 shows the seats of the Motor Car. All the seats of the Motor Car were secured via seat rails to the floorboard. They were also fitted with a retractable seat belt reel and a pre-tensioner. The seat belts (arrowed) were tested and were able to be fastened into the respective pre-tensions that were fitted on the side of each individual seat.

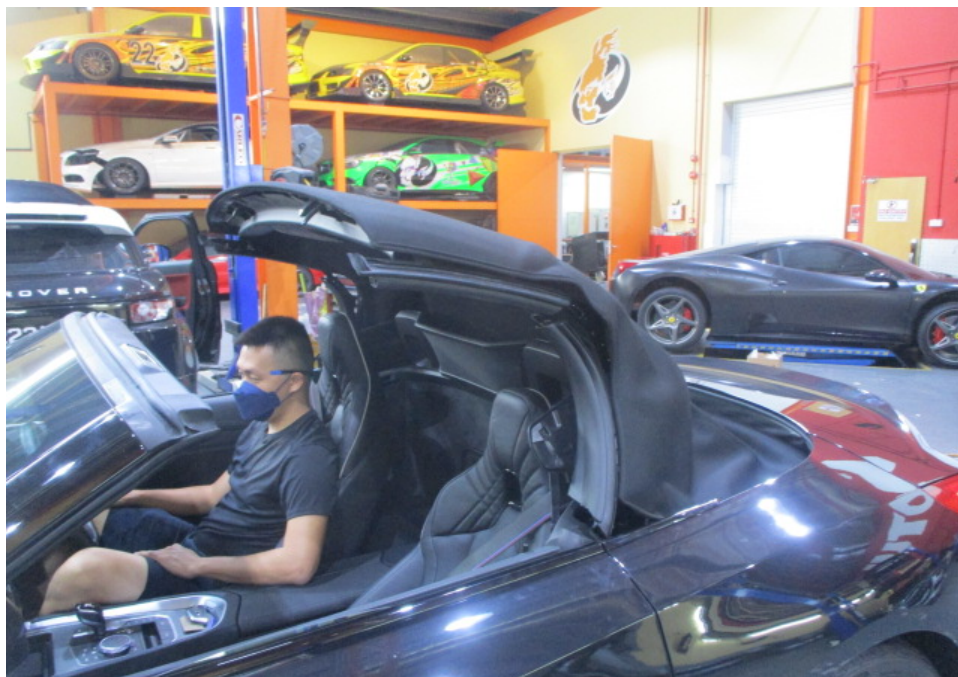
Photo 15 shows the Motor Car's soft top roof being tested. It was observed that as a safety feature, the soft top roof could only open and close when the Motor Car was in a stationary position. When opened, the soft top roof is completely folded into the rear compartment with no parts protruding out of the Motor Car's body. The soft top roof was also found adequately secured to the "A" pillar after closing.

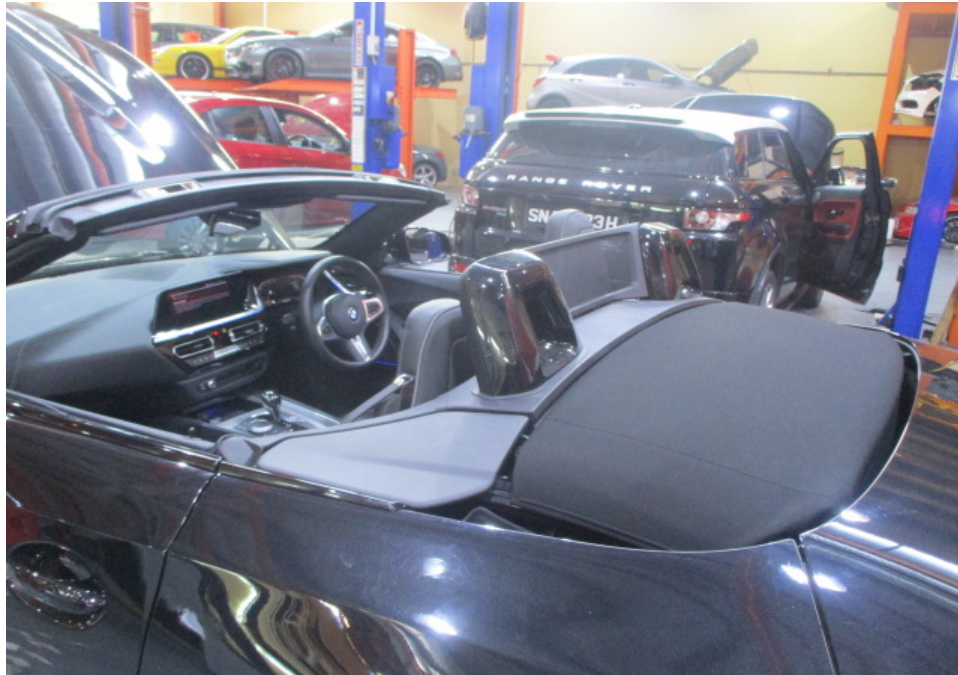
Photo 16 shows the Motor Car with its soft top roof completely folded. It was observed that as a safety feature, the soft top roof could only open and close when the Motor Car was in a stationary position. When opened, the soft top roof is completely folded into the rear compartment with no parts protruding out of the Motor Car's body. The soft top roof was also found adequately secured to the "A" pillar after closing.

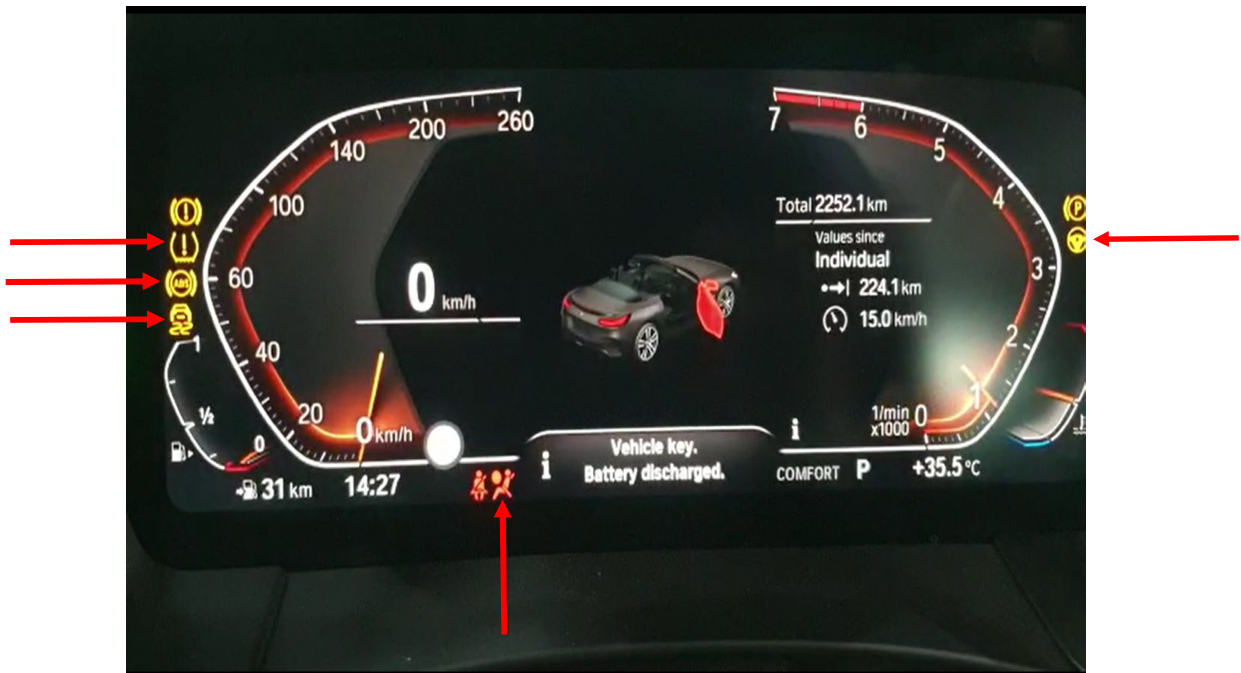
Photo 17 shows the warning lights for the various electronic safety features appearing on the instrument panel of the Motor Car during its self-test when the engine is cranked, in particular ABS, SRS, IAS, TPM and DSC lights (arrowed).

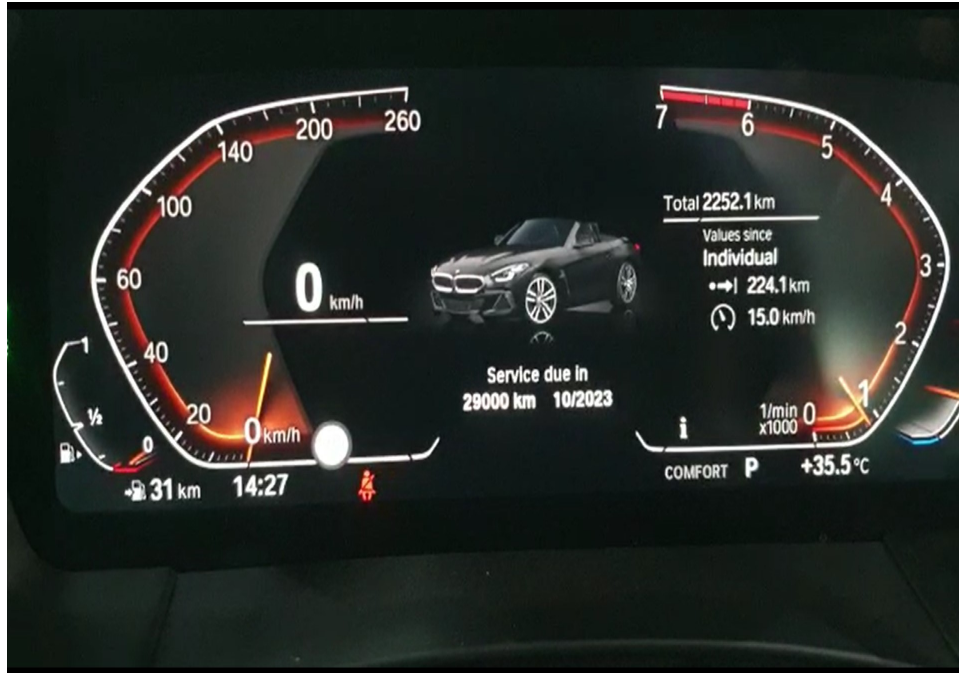
Photo 18 shows the respective warning lights no longer illuminated, indicating that there is no fault detected to ABS, SRS, IAS, TPM and DSC systems of the Motor Car during the self-test. These electronic systems were hence in working condition at the time of my inspection.

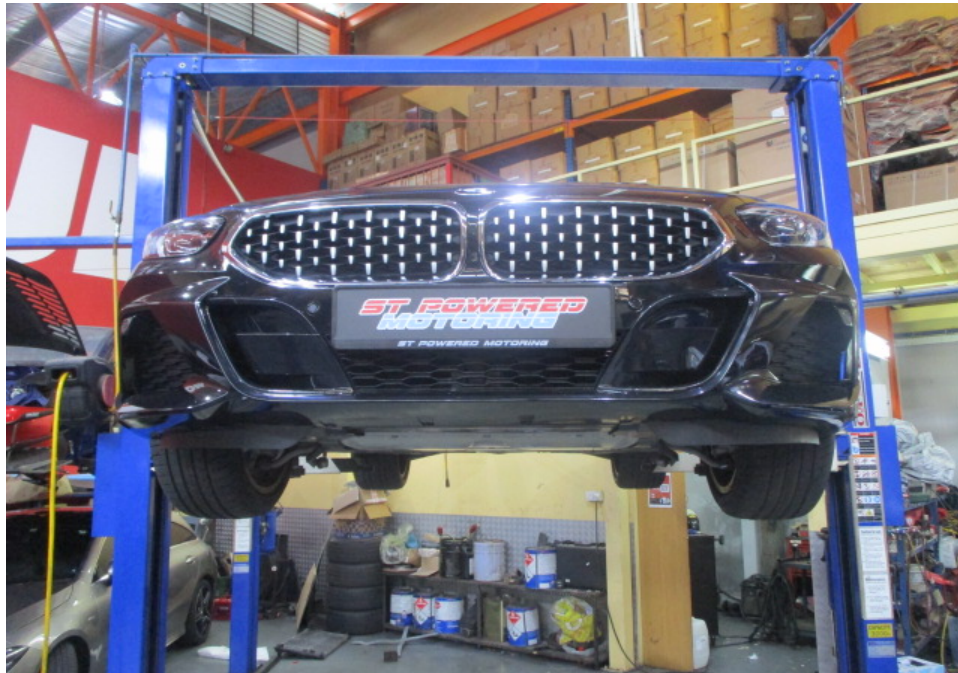
Photo 19 shows the Motor Car hoisted up for checks on its undercarriage. There was no sign(s) or indication(s) of fluid leakage and/or fluid stain(s) on the underside of the Motor Car. The undercarriage components of the Motor Car were also all observed to be intact and secured in an appropriate manner.

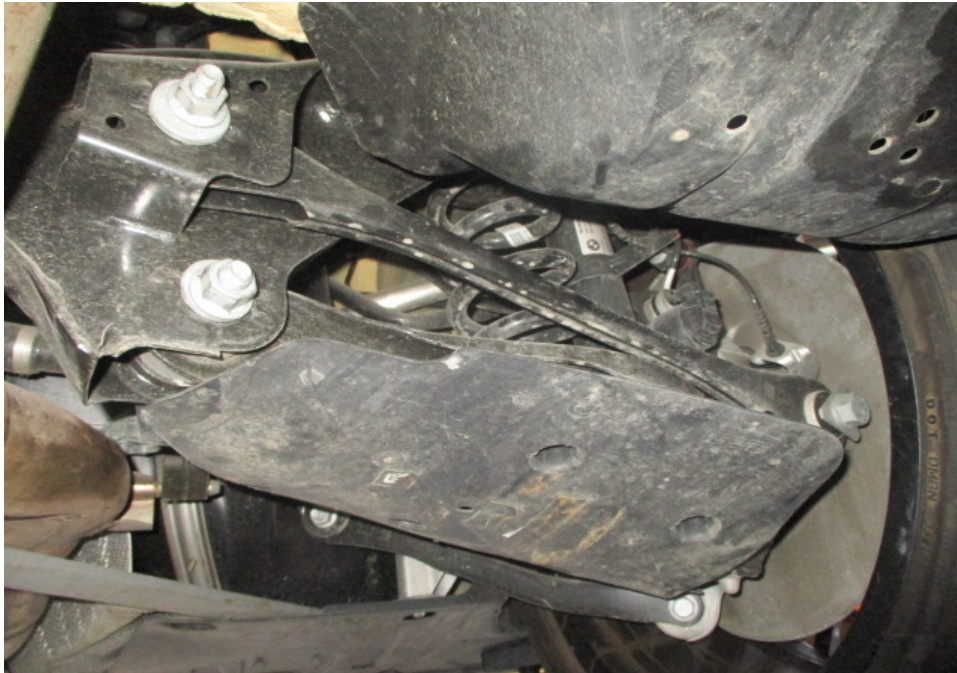
Photo 20 shows a general view of the control arms and linkages at the rear right wheel of the Motor Car. I did not observe any fluid leak and/or fluid stain on the underside of the Motor Car. All of the Motor Car's undercarriage components were observed to be intact and secured in an appropriate manner.

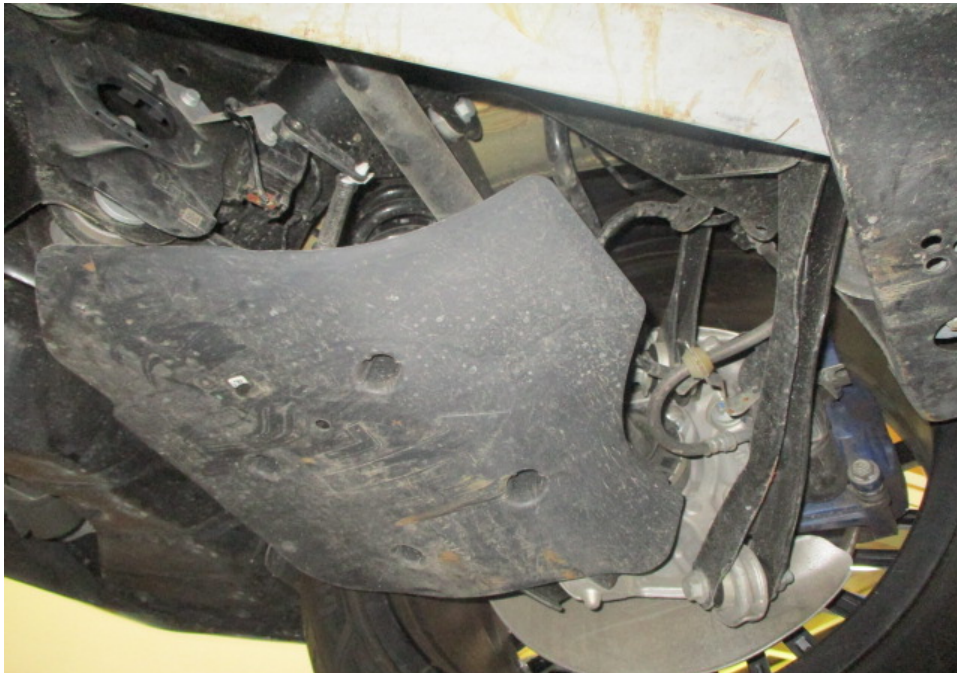
Photo 21 shows a general view of the control arms and linkages at the rear left wheel of the Motor Car. I did not observe any fluid leak and/or fluid stain on the underside of the Motor Car. All of the Motor Car's undercarriage components were observed to be intact and secured in an appropriate manner.

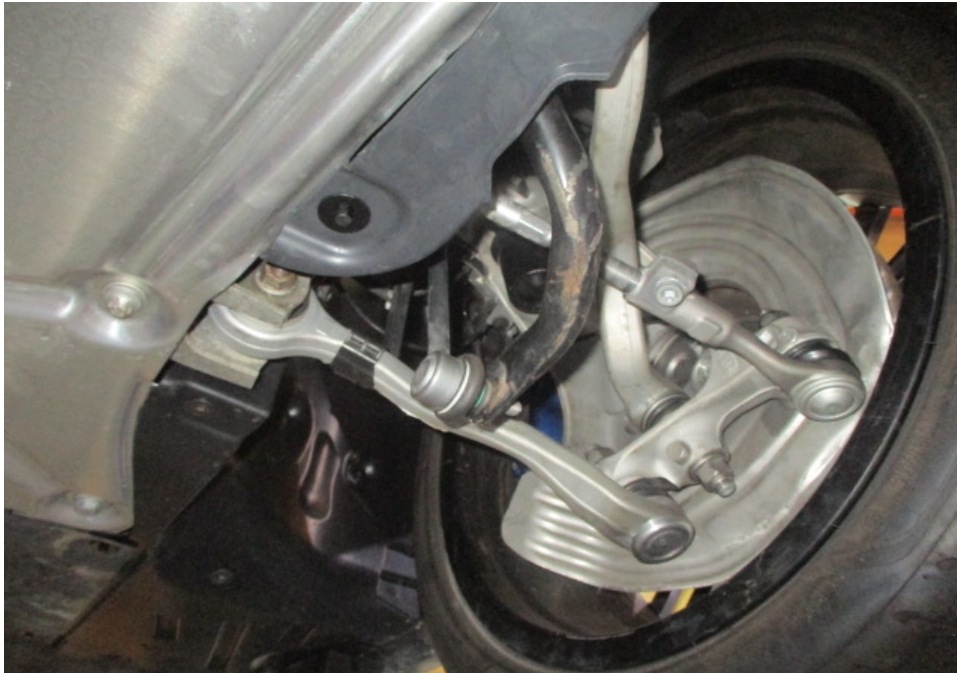
Photo 22 shows the various undercarriage components at the front left wheel of the Motor Car. The mechanical components, control arms and linkages were all found to be intact and secured in an appropriate manner.

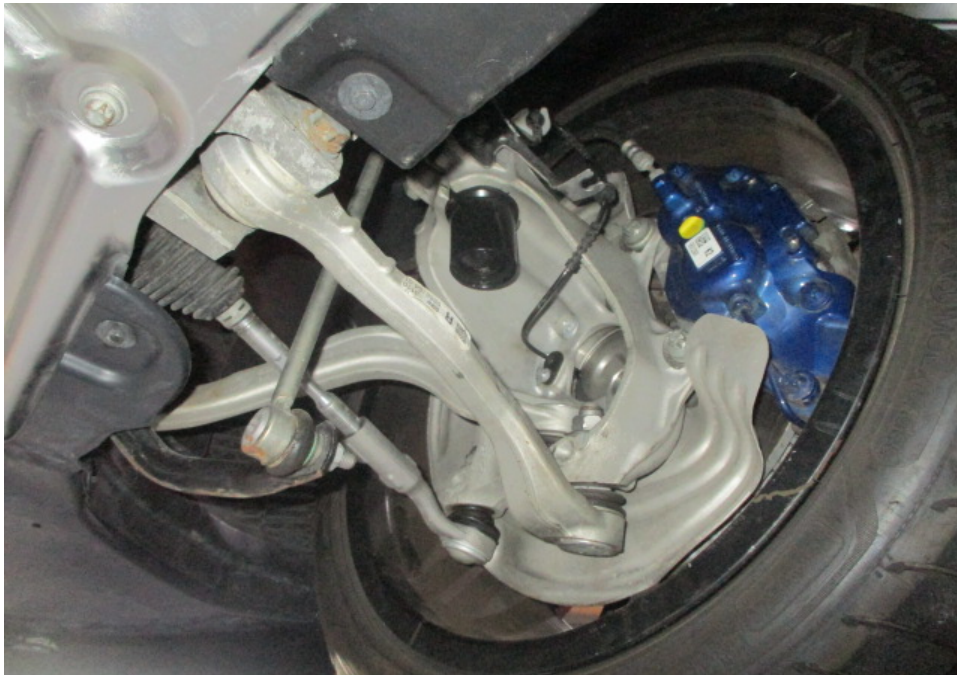
Photo 23 shows the various undercarriage components at the front right wheel of the Motor Car. The mechanical components, control arms and linkages were all found to be intact and secured in an appropriate manner. I also did not observe any fluid leak and/or fluid stain on the underside of the Motor Car.

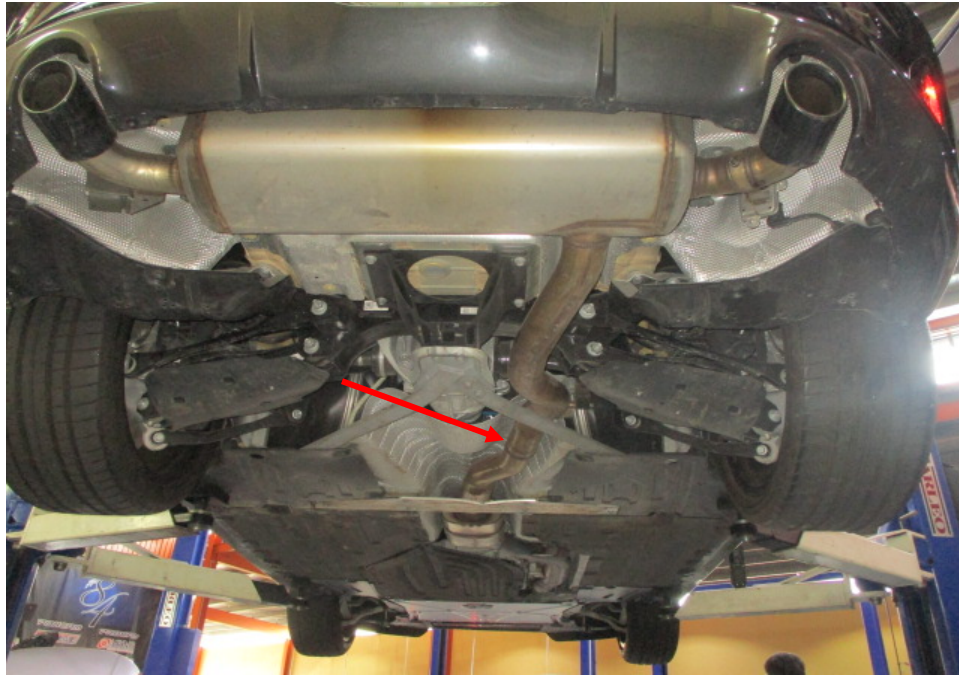
Photo 24 shows the rear section of the Motor Car's exhaust system. My examination of the Motor Car's exhaust system revealed no sign(s) or indication(s) of any cut or weld marks along its exhaust pipes (arrowed), on its rear muffler, on its centre resonator box and on its catalytic converter.

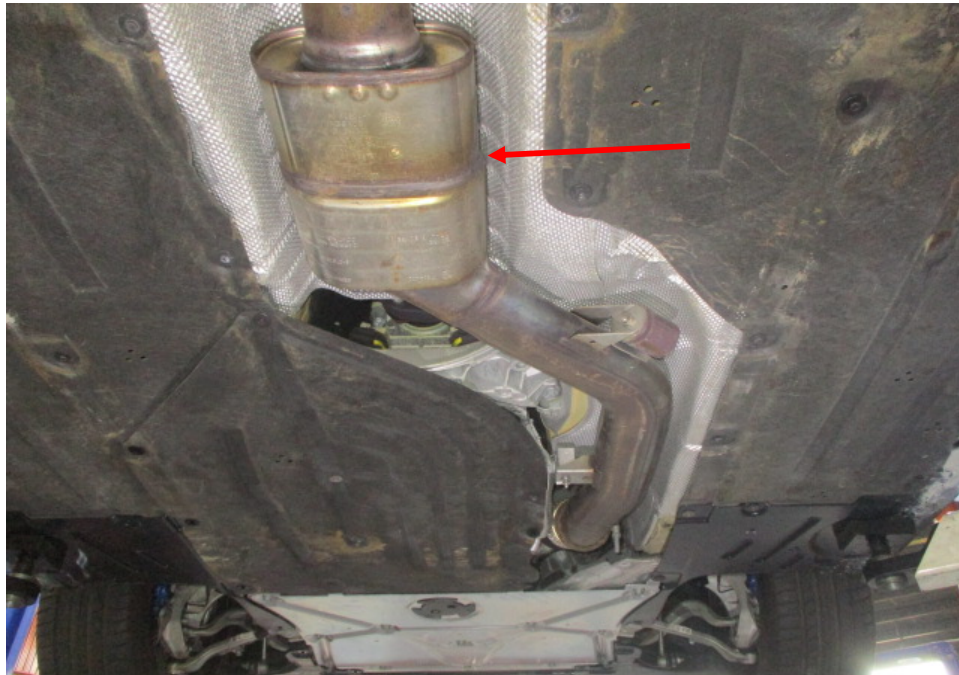
Photo 25 shows the front section of the Motor Car's exhaust system. My examination of the Motor Car's exhaust system revealed no sign(s) or indication(s) of any cut or weld marks along its exhaust pipes, on its rear muffler, on its centre resonator box (arrowed) and on its catalytic converter.

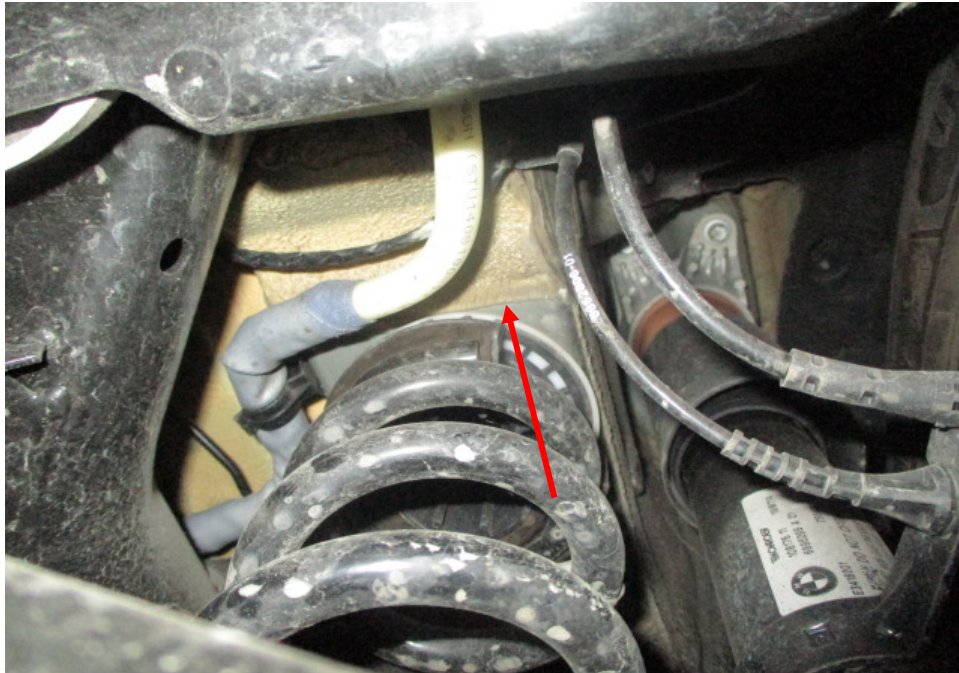
Photo 26 shows the chassis/structural body at the underside rear right of the Motor Car. I did not find any weld marks other than original spot weld marks on the chassis/structural body of the Motor Car. The original factory sealant (arrowed) at the joints along the chassis/structural body was untouched, indicating no work was done on the chassis/structural body of the Motor Car and that the chassis/structural body was originally fitted.

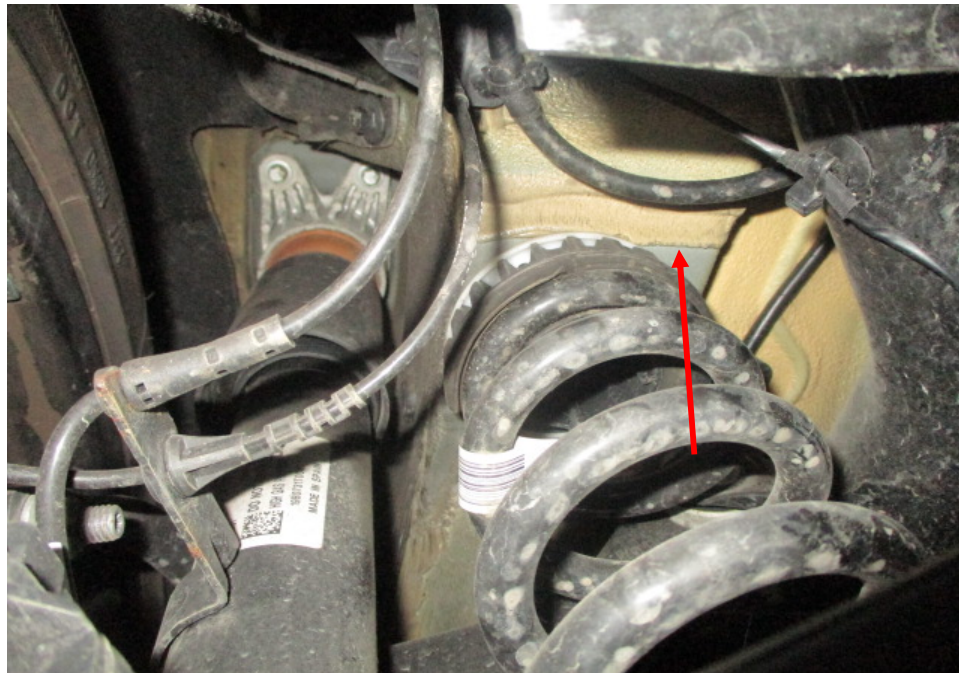
Photo 27 shows the chassis/structural body at the underside rear left of the Motor Car. The original factory sealant (arrowed) at the joints along the chassis/structural body was observed to be untouched. In general, I had found no work was carried out on the chassis/structural body of the Motor Car. The chassis/structural body of the Motor Car was originally fitted.

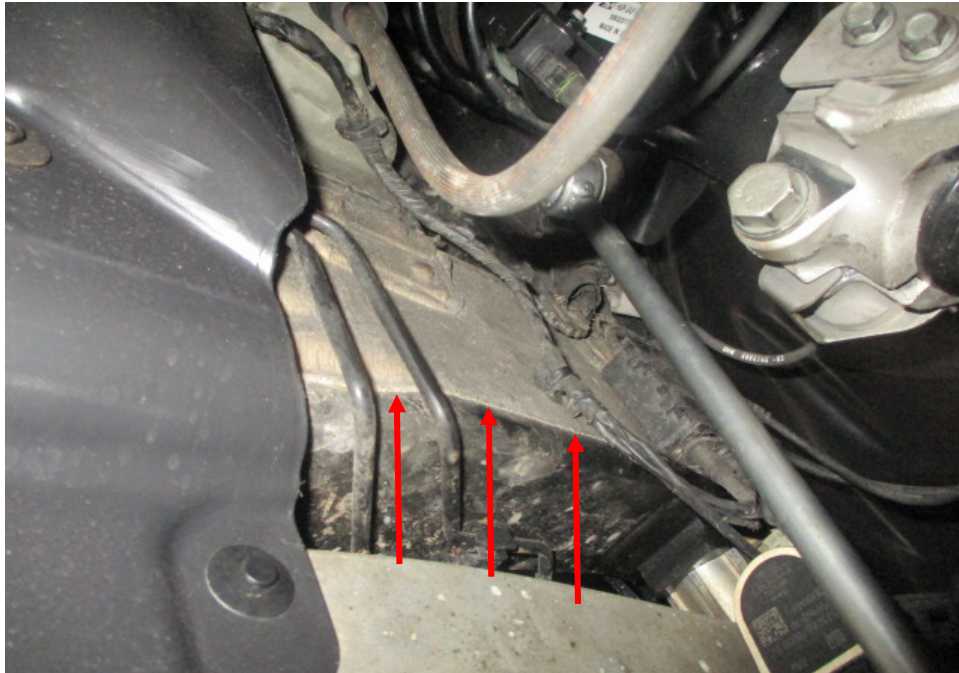
Photo 28 shows the chassis/structural body at the underside front left of the Motor Car. I did not find any weld marks other than original spot weld marks on the chassis/structural body of the Motor Car. The original factory sealant (arrowed) at the joints along the chassis/structural body was untouched, indicating no work was done on the chassis/structural body of the Motor Car and that the chassis/structural body was originally fitted.

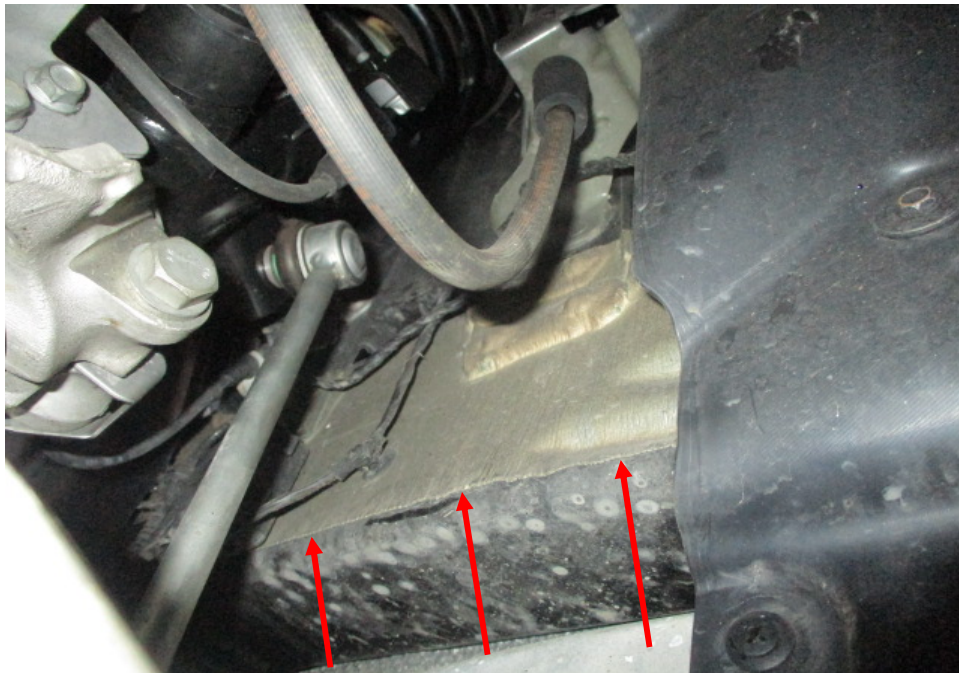
Photo 29 shows the chassis/structural body at the underside front right of the Motor Car. The original factory sealant (arrowed) at the joints along the chassis/structural body was observed to be untouched. In general, I had found no work was carried out on the chassis/structural body of the Motor Car. The chassis/structural body of the Motor Car was originally fitted.
