Your Ref: BMW Z4 Coupe
(chassis number WBAHF12000WW41759)
Our Ref : CI/TP22001325/D

INSPECTION REPORT OF AN UNREGISTERED BMW Z4 COUPE MOTOR CAR WITH CHASSIS NUMBER WBAHF12000WW41759

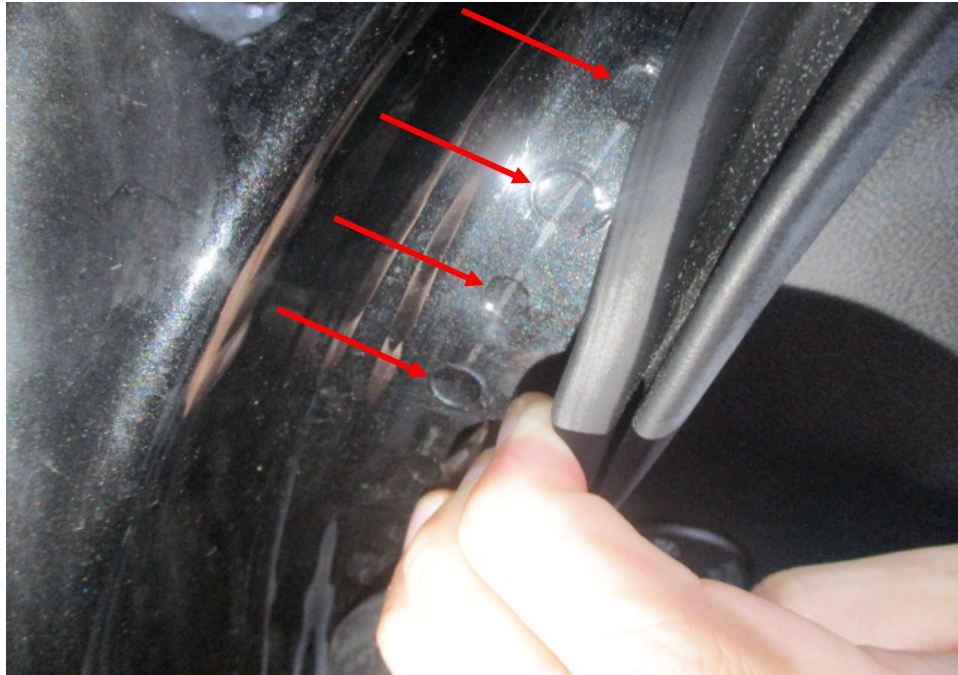
Photo 30 shows the left side "A" pillar of the Motor Car. I did not find any weld marks other than original spot weld marks (arrowed) on the left side "A" pillar of the Motor Car which, indicates that there was no re-welding works carried out. In general, I had found all the non-detachable body panels of the Motor Car to be originally fitted at the time of my inspection.

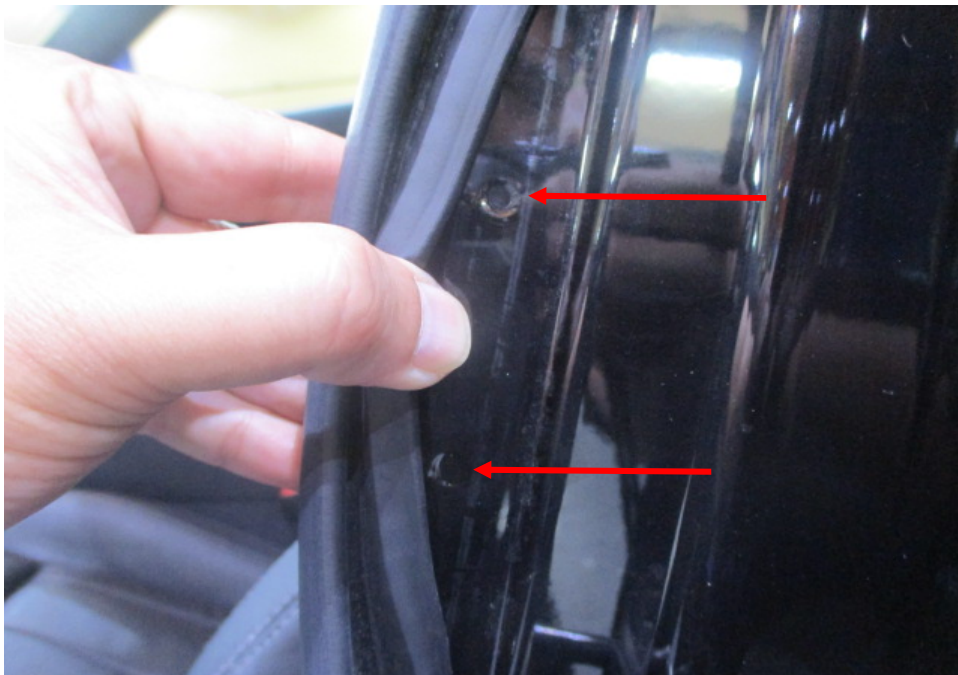
Photo 31 shows the rear left body panel of the Motor Car. I did not find any weld marks other than original spot weld marks (arrowed) on the rear left body panel of the Motor Car, which indicates that there was no re-welding works carried out. In general, I had found all the non-detachable body panels of the Motor Car to be originally fitted at the time of my inspection.

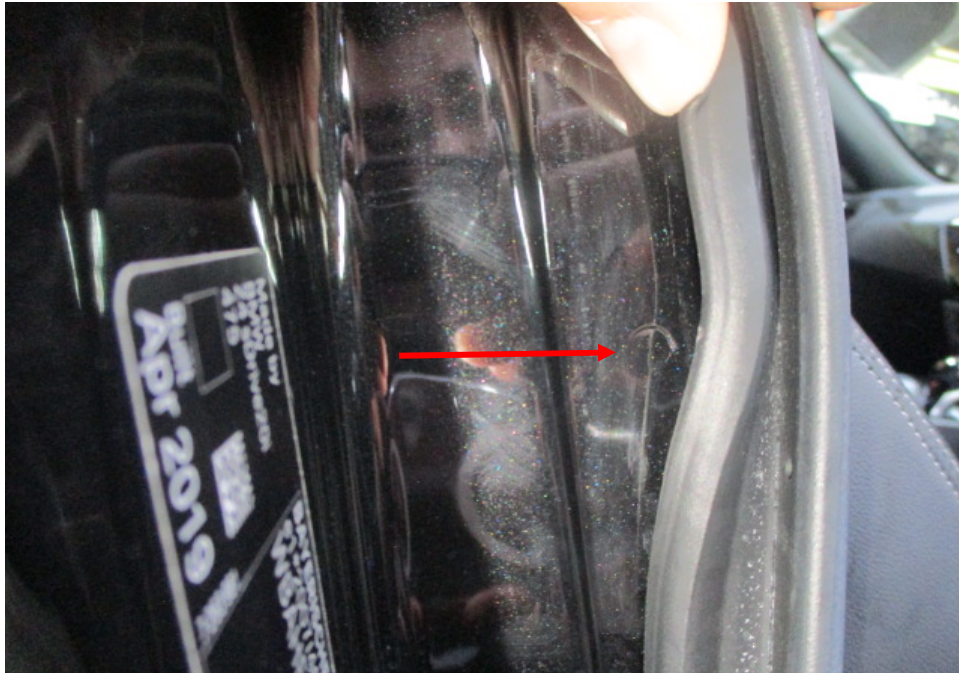
Photo 32 shows the rear right body panel of the Motor Car. I did not find any weld marks other than original spot weld marks (arrowed) on the rear right body panel of the Motor Car, which indicates that there was no re-welding works carried out. In general, I had found all the non-detachable body panels of the Motor Car to be originally fitted at the time of my inspection.
