LKK Auto Consultants Pte Ltd

Affiliated to Federation Internationale Des Experts En Automobile				
INDIA INTERNATIONAL INSURANCE PL		Ref: CS3/GRB22000619/Evf3-1		
64 CECIL STREET		Date: 15/02/2022

AUTOMOBILE INSPECTION REPORT

ADJUSTMENT ON REPAIR COST FOR VEHICLE NO. SLN 4090Y

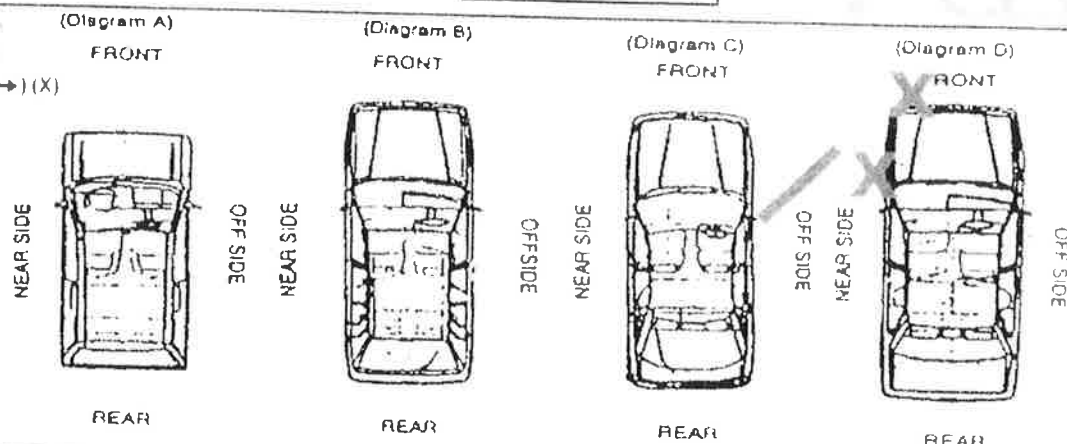
POINT OF IMPACT

The vehicle sustained impact on its N/s Front Portion. (see Diagram D)

Parts damaged were : **The front n/s fender and bumper, bonnet were dented.**

A static inspection was carried out on 22/01/2022 & our report is here with enclosed for your perusal. The Repairs Estimate submitted by M/s ENG HUP AUTO PARTS ACCESSORIES CO as per attached Appraisement Schedule have been revised and scrutinised thoroughly by us & in our opinion, we consider it to be fair and reasonable. The repairer has agreed to effect repairs to the owners satisfaction & to roadworthy condition on an agreed Part - By - Part Repair Basis of \$4,187.36 after deducting the Policy Excess Clause of \$ NA. As instructed, we have not authorised any of the repairs on your behalf.
