**TECHNICAL INVESTIGATION REPORT OF WARRANTY CLAIM INVOLVING  
THE INSURED VEHICLE SMY 2928A ON 10<sup>th</sup> February 2022**

Vehicle Registration No. : SMY 2928A  
Make / Model : MERCEDES BENZ GLC 300 SPORT 4MATIC

Chassis No : W1N253984V261488  
Year of Registration : February 2021  
Mileage : 30,001KM

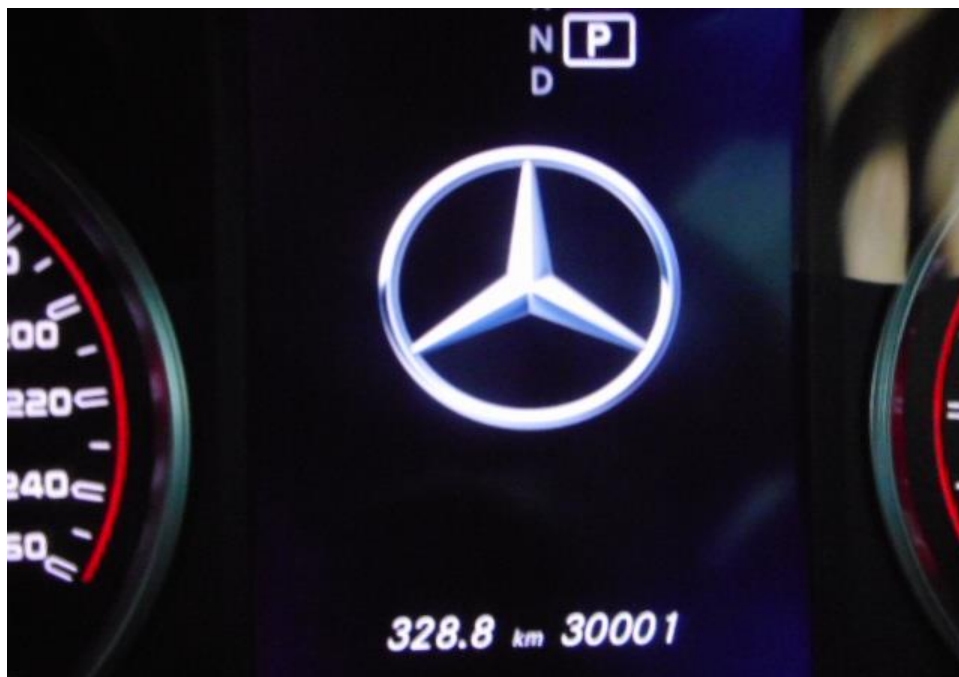
**Photo 1** shows the mileage of the Insured Vehicle recorded at the time inspection at 30,001KM

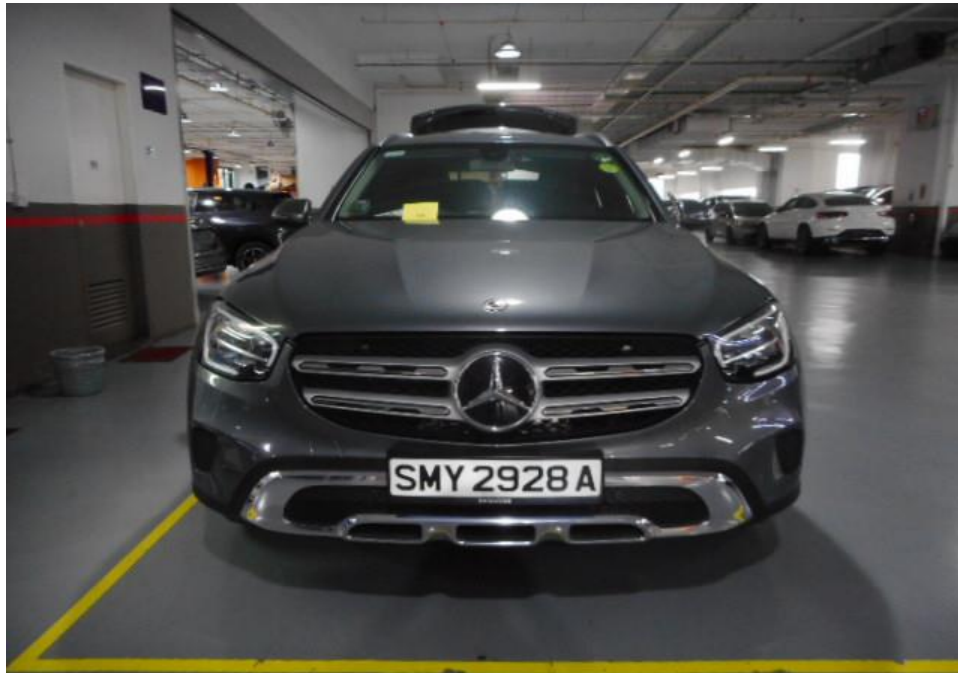
**Photo 2** shows the general view of the front portion of the Insured Vehicle at the time of our inspection. The Insured Vehicle is observed to be unaffected by any signs of accident.

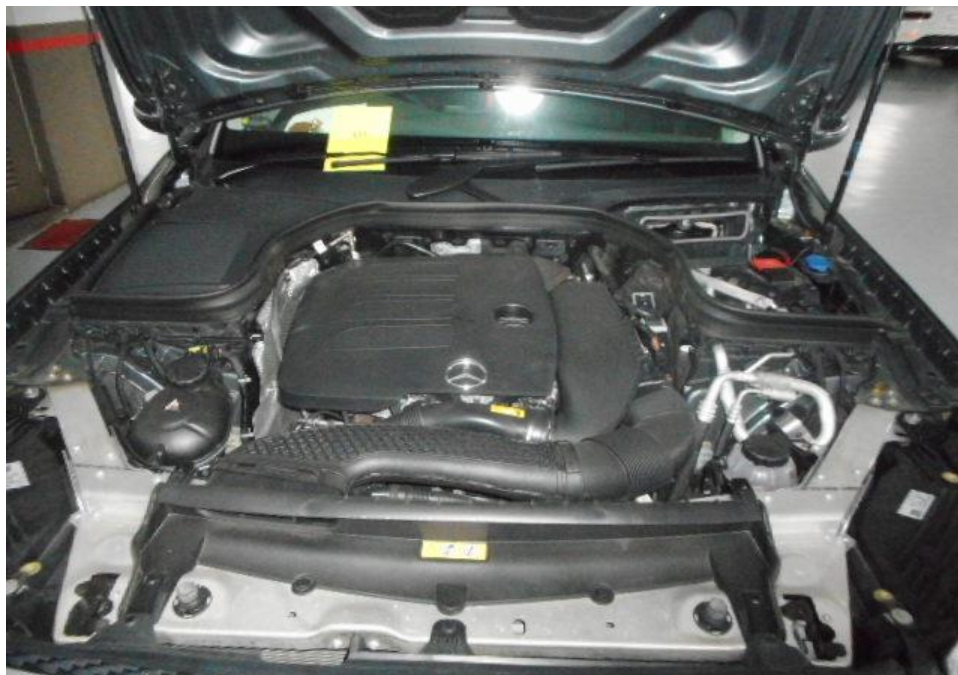
**Photo 3** shows the general view of the engine portion of the Insured Vehicle at the time of our inspection. The engine compartment is observed to be unaffected by any signs of accident.

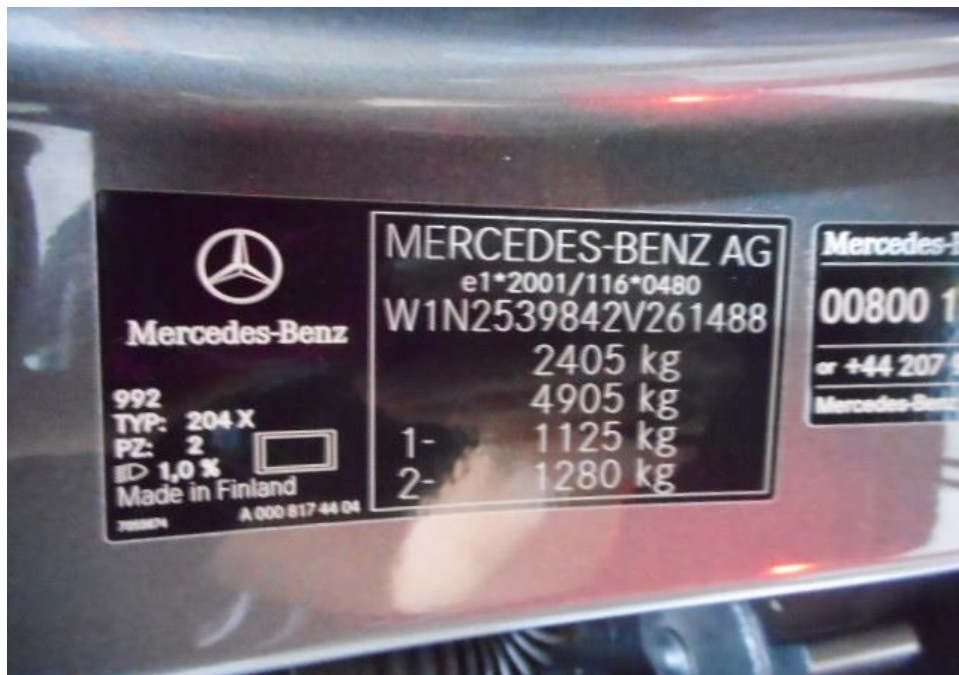
**Photo 4** shows the chassis number of the Insured Vehicle at the time of our inspection.

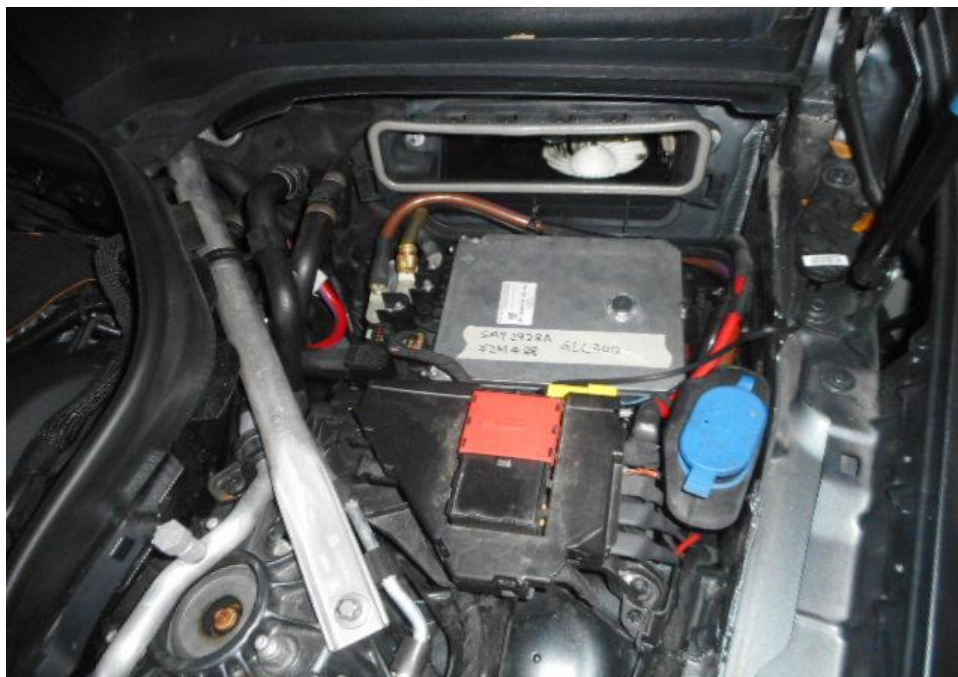
**Photo 5** shows the general view of the 48v battery and its components in the engine compartment portion of the Insured Vehicle at the time of our inspection. The 48v battery and its components is observed to be unaffected and by any signs of accident.

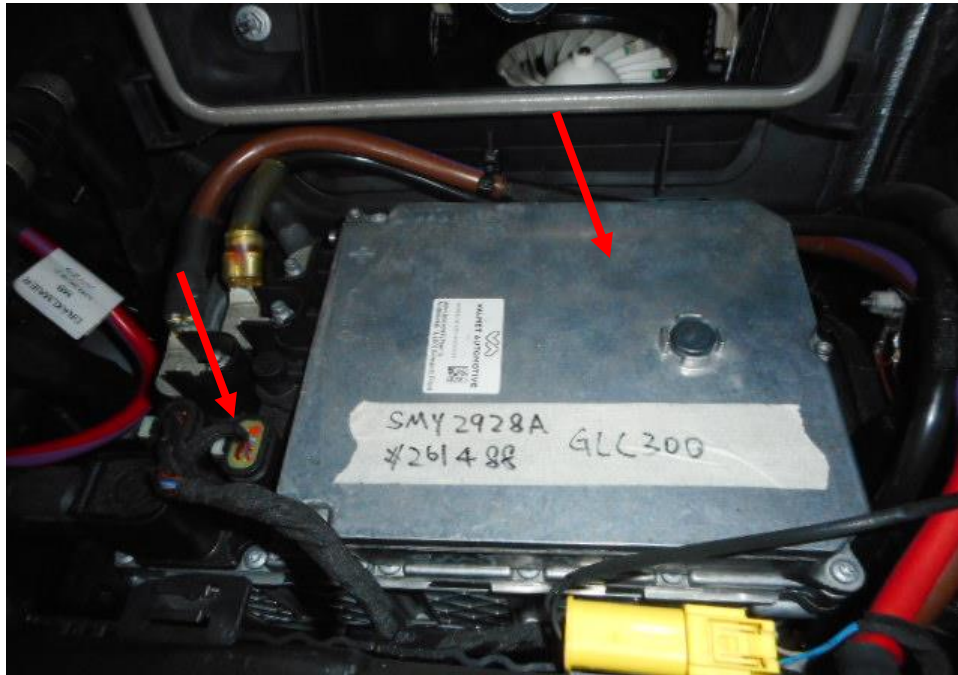
**Photo 6** shows the close up view of the 48v battery and its components (arrowed) in the engine compartment portion of the Insured Vehicle at the time of our inspection. The 48v battery and its components is observed to be unaffected and by any signs of accident.

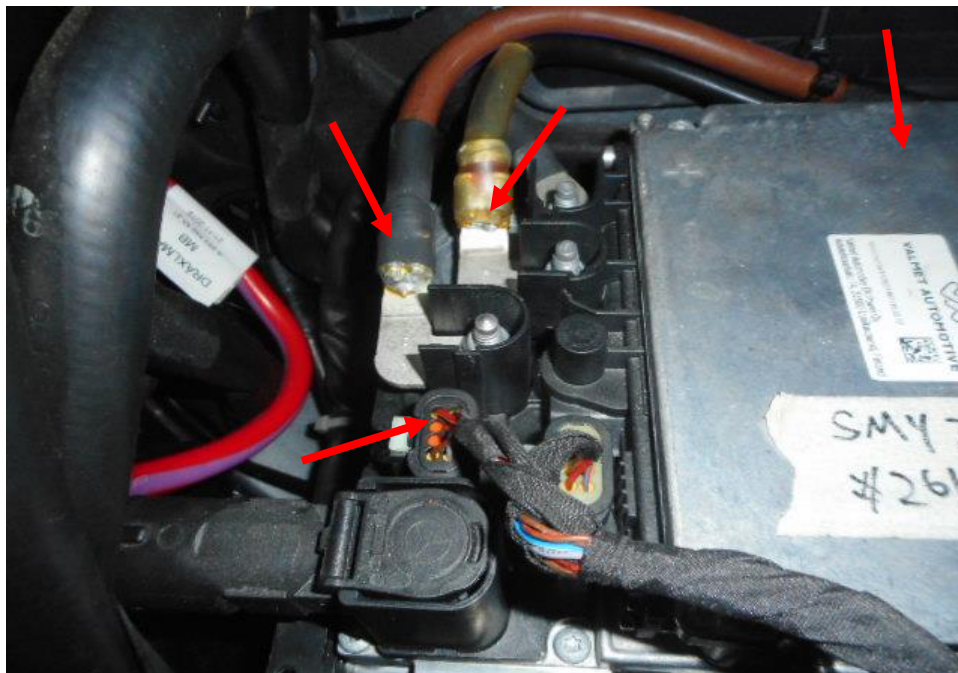
**Photo 7** shows the close up view of the 48v battery and its components (arrowed) in the engine compartment portion of the Insured Vehicle at the time of our inspection. The 48v battery and its components is observed to be unaffected and by any signs of accident.

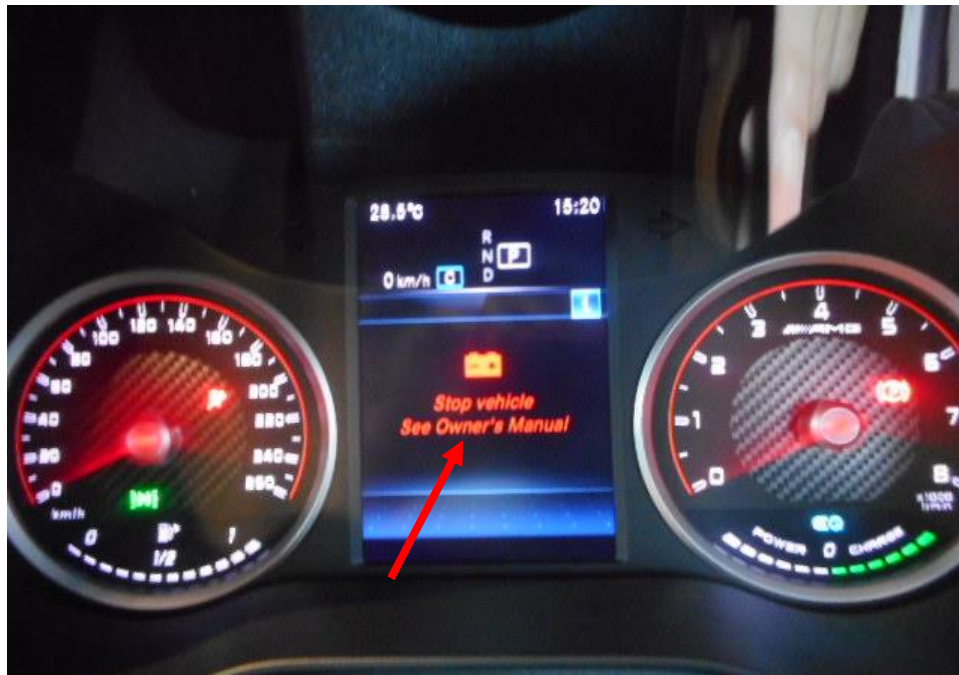
5. The complaint on the Insured Vehicle was noted be an error and warning message light regarding the electronic 48V battery Systems (ISG) for the integrated starter generator system. There is a recommendation by the workshop to replace 48V battery and its electric DC converter unit. The vehicle was observed to be unaffected by any signs of accident.

**Photo 8** shows the conducted ECU diagnosis of the Insured Vehicle at the time of our inspection. There was an electronic error (arrowed) on the 48v battery integrated starter system (ISG) of the Insured Vehicle.

8. We did not find any evidence which had suggested that the cause of abnormalities to the Insured Vehicle was due to poor maintenance and/or recurring problem.
9. The recommendation to replace the 48V battery and DC convertor unit at \$2,819.45 is justifiable as all the relevant checks has been conducted.
