Your Ref: SND 2265C
Our Ref : CI/TP22001617/D

AUTOMOBILE INSPECTION REPORT OF MOTOR CAR SND 2265C

Vehicle Registration No.	: SND 2265C
Make / Model	: Mitsubishi Lancer Evolution Wagon 5A/T
Chassis No	: CT9W0002732
Year of Registration	: 2006 (September)
Mileage	: 91,510km

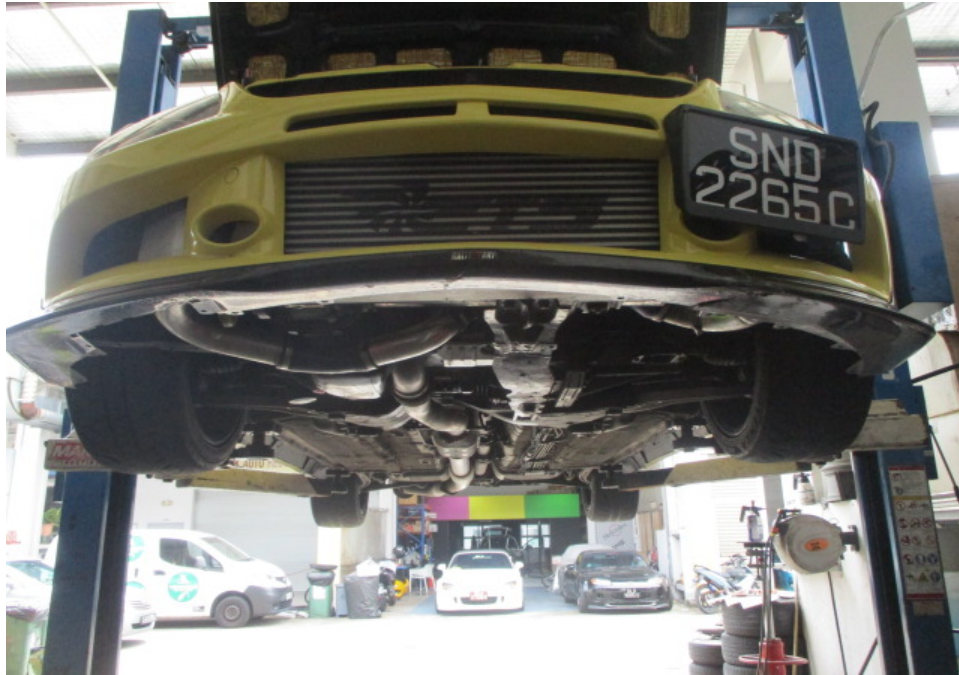
Photo 1 shows the Motor Car hoisted for checks on its undercarriage, in particular to its transmission.

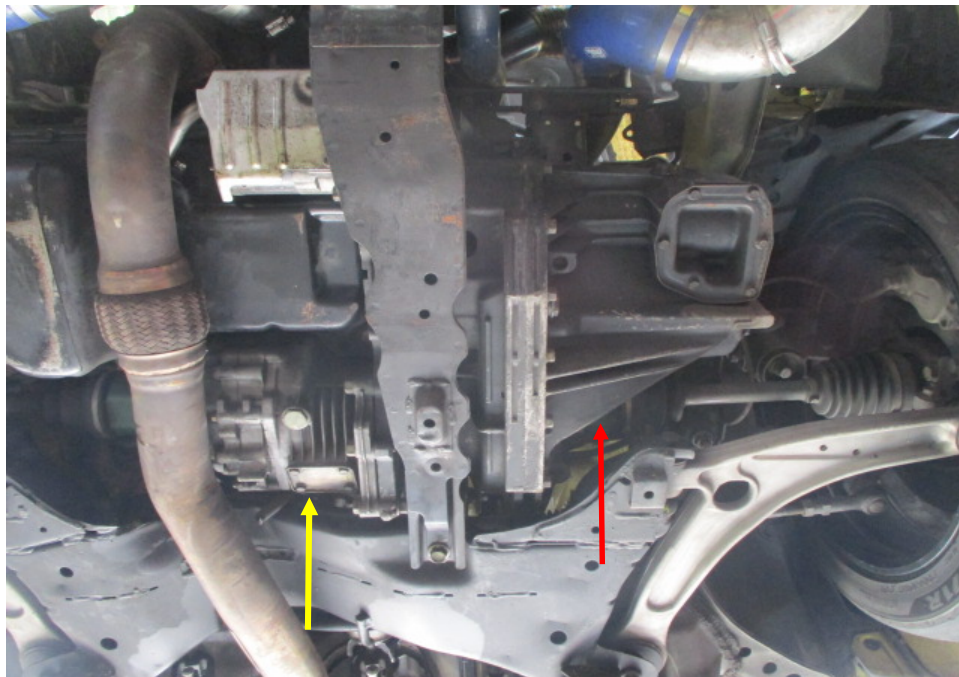
Photo 2 shows a general view of the transmission that was fitted on the Motor Car. The input side of the transmission (red arrow), which houses the main shaft and various gear sets, is bolted to the crankshaft side of the engine block. The gear set in the input side of the transmission connects to the transfer case (yellow arrow), which is the output side of the Motor Car's transmission.

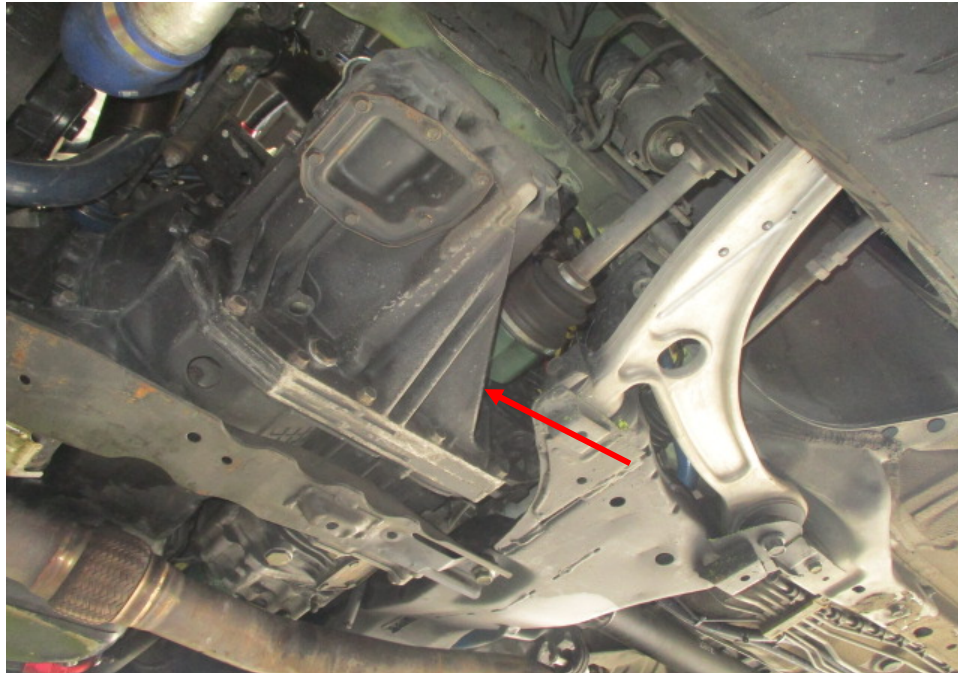
Photo 3 shows another view of the transmission (arrowed) that was fitted on the Motor Car. This was the input side of the transmission, which houses the main shaft and various gear sets. There was no crack and/or hole observed on the transmission housing.

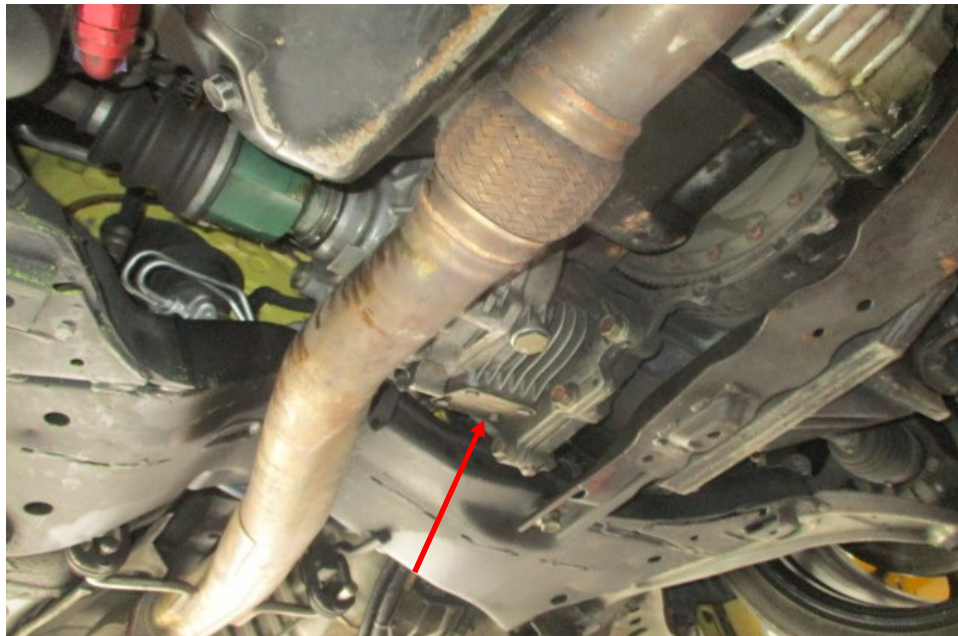
Photo 4 shows the transfer case (arrowed) of the Motor Car. The transfer case is also the output side of the Motor Car's transmission. The gear set in the input side of the transmission connects to this transfer case, which is the second of the 2 main housings of the Motor Car's transmission. Drive to the front wheels of the Motor Car is provided via drive shafts that are extended from this transfer case. The transfer case also connects to the propeller shaft, which leads to the rear differential of the Motor Car, providing the drive to the rear wheels of the Motor Car.

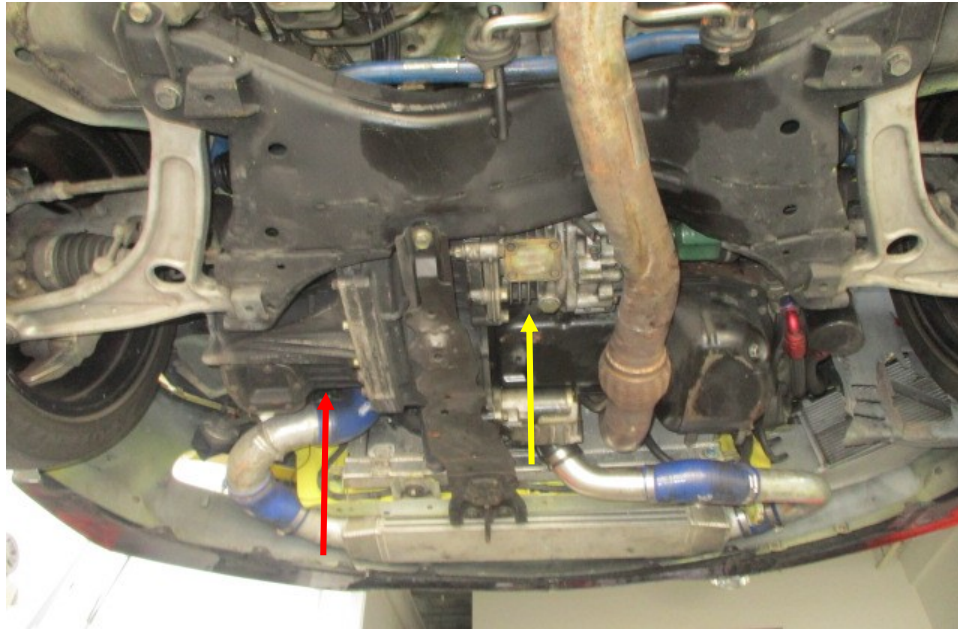
Photo 5 shows the transmission that was fitted on the Motor Car, as viewed from the rear to front. The input side of the transmission (red arrow), which houses the main shaft and various gear sets is bolted to the crankshaft side of the engine block. The gear set in the input side of the transmission connects to the transfer case (yellow arrow), which is the output side of the Motor Car's transmission.

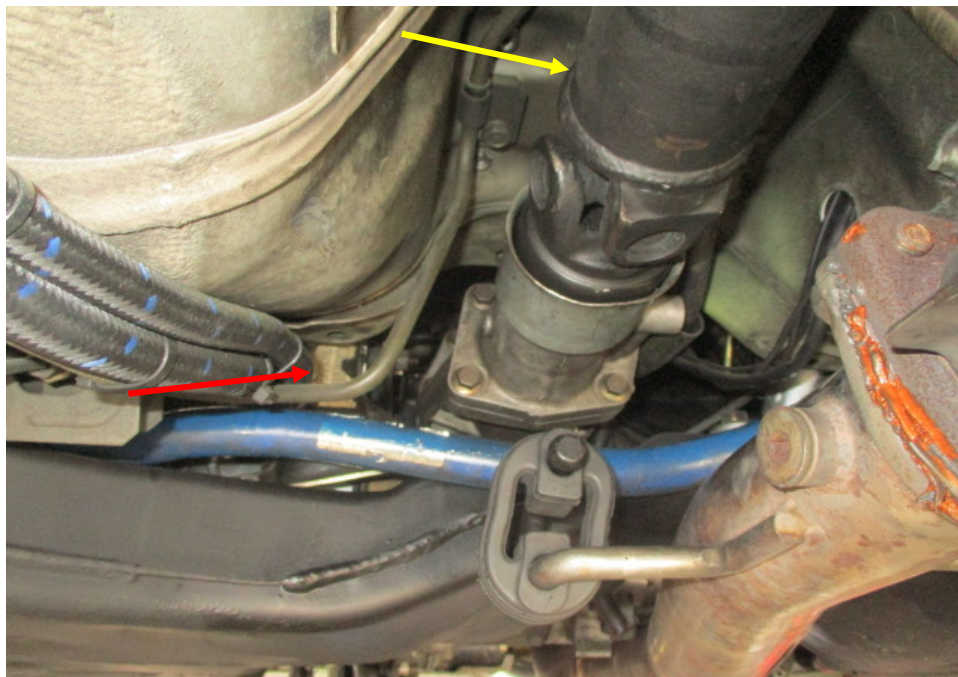
Photo 6 shows the propeller shaft (yellow arrow), which is connected to the transfer case of the Motor Car. This propeller shaft connects to the rear differential of the Motor Car, providing the drive to the rear wheels of the Motor Car. The transmission of the Motor Car is supported by 3 brackets. One at the front, one at the rear (red arrow) and one at the top left of the transmission.

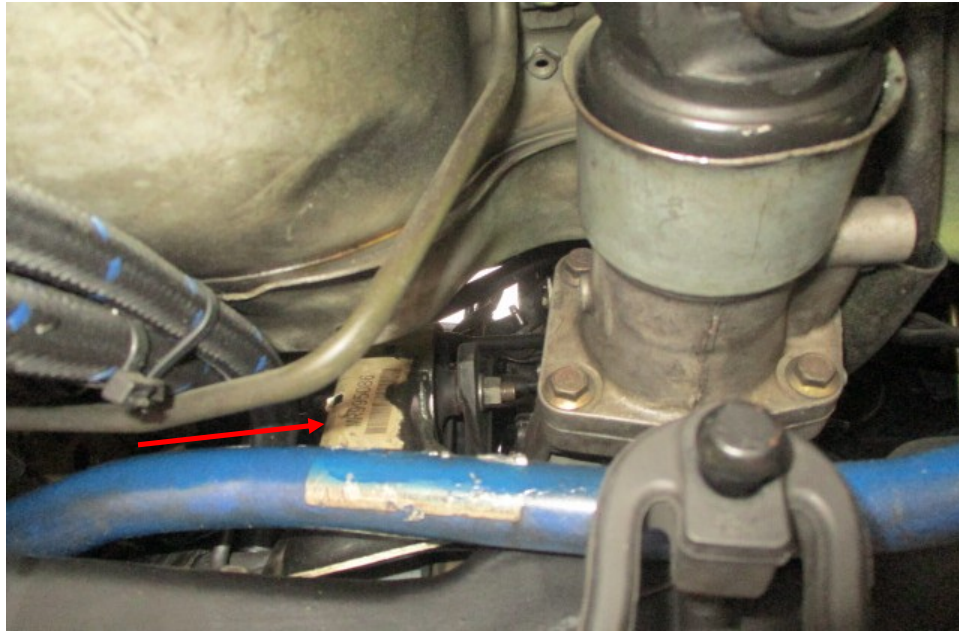
Photo 7 shows the bracket that supports the rear of the Motor Car's transmission. This bracket (arrowed) at the rear of the transmission was observed to be mounted onto the Motor Car's lateral crossmember. The bracket was with rubber bushing, which absorbs any vibrations arising from the rotation of the transmission gears, minimising any stress to the bracket and correspondingly also minimise any stress to the lateral crossmember that this bracket is mounted onto.

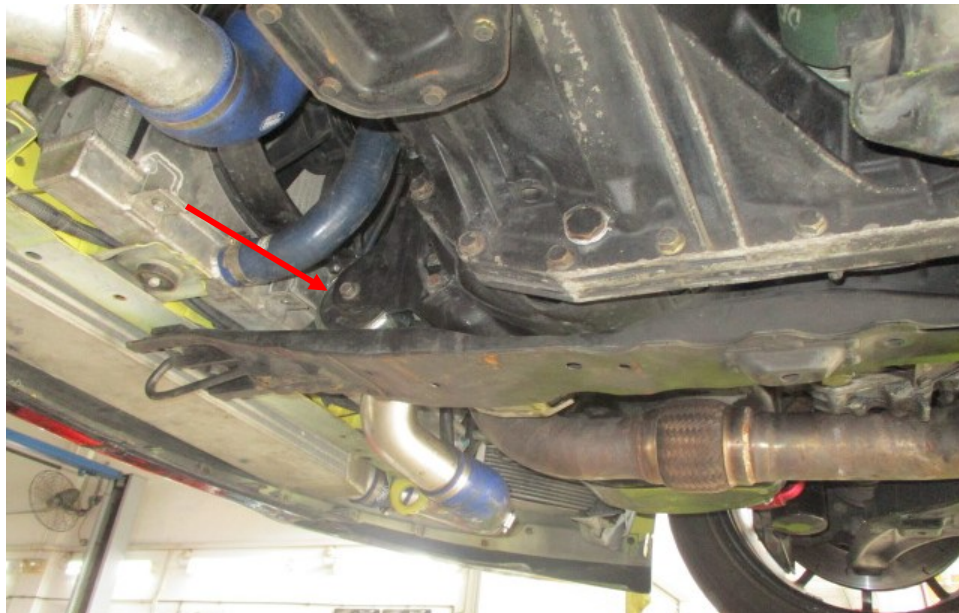
Photo 8 shows the bracket at the front of the Motor Car's transmission, which was observed to be mounted onto the Motor Car's longitudinal crossmember. Similar to the bracket at the rear, this bracket (arrowed) was also with rubber bushing, which absorbs any vibrations arising from the rotation of the transmission gears, minimising any stress to the bracket and correspondingly also minimise any stress to the longitudinal crossmember that this bracket is mounted onto.

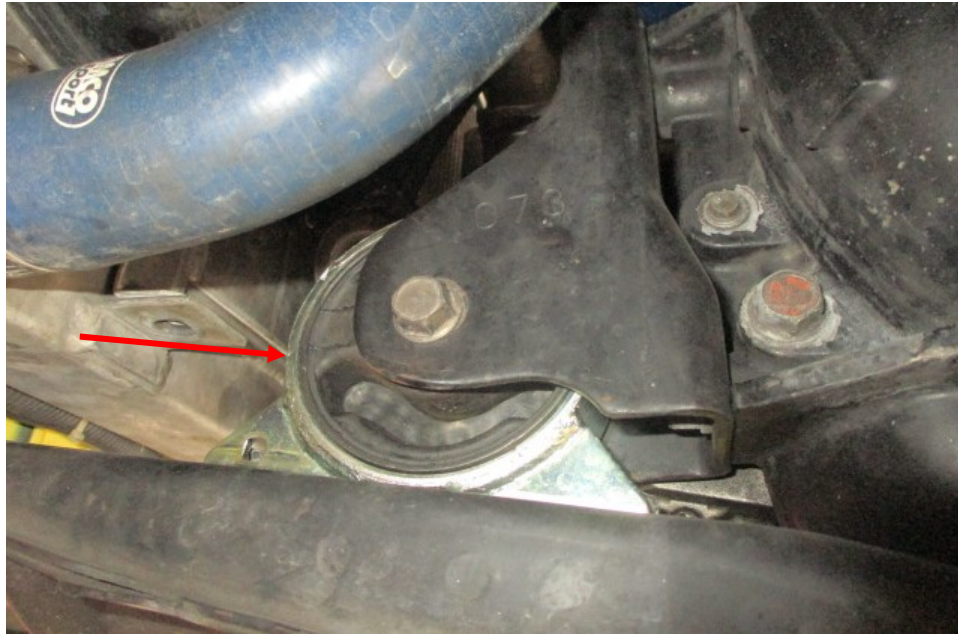
Photo 9 shows a closer view of the bracket supporting the front of the Motor Car's transmission. Similar to the bracket at the rear, this bracket (arrowed) was also with rubber bushing, which absorbs any vibrations arising from the rotation of the transmission gears, minimising any stress to the bracket and correspondingly also minimise any stress to the longitudinal crossmember that this bracket is mounted onto.

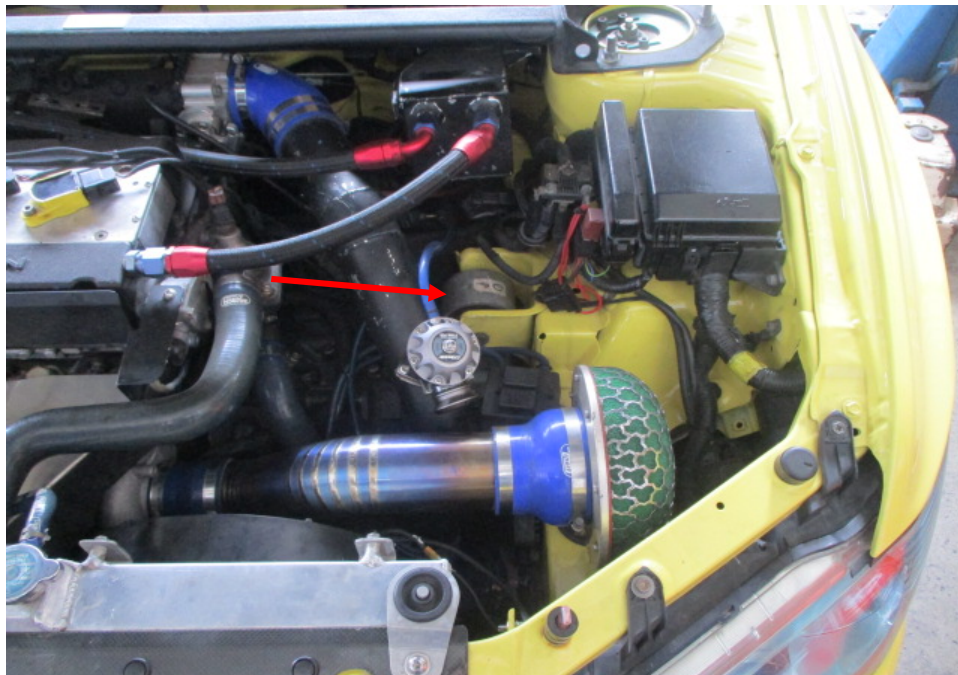
Photo 10 shows the bracket (arrowed) supporting the top left of the Motor Car's transmission. This bracket was found to be mounted onto the left side front chassis, adjacent to the left side front wheel house. The mounting of this bracket is the original mounting point for the this bracket as the welding for the support of this bracket was of original weld.

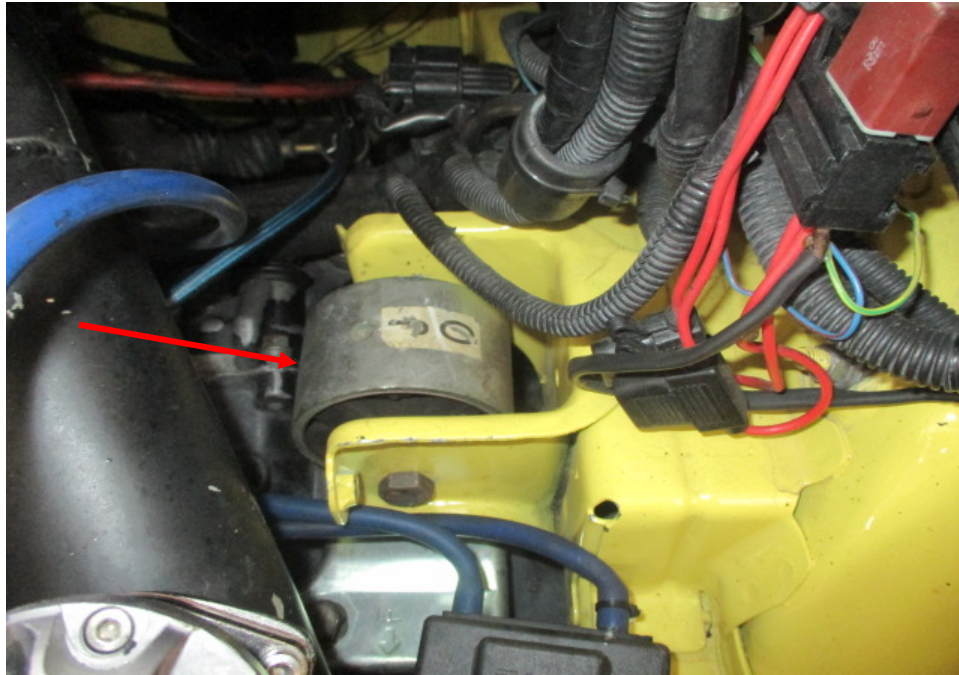
Photo 11 shows a closer view of the bracket (arrowed) supporting the top left of the Motor Car's transmission. This bracket was found to be mounted onto the left side front chassis, adjacent to the left side front wheel house. The mounting of this bracket is the original mounting point for this bracket as the welding for the support of this bracket was of original weld. This bracket was also with rubber bushing, which absorbs any vibrations arising from the rotation of the transmission gears, minimising any stress to the bracket and correspondingly also minimise any stress to the left side front chassis.

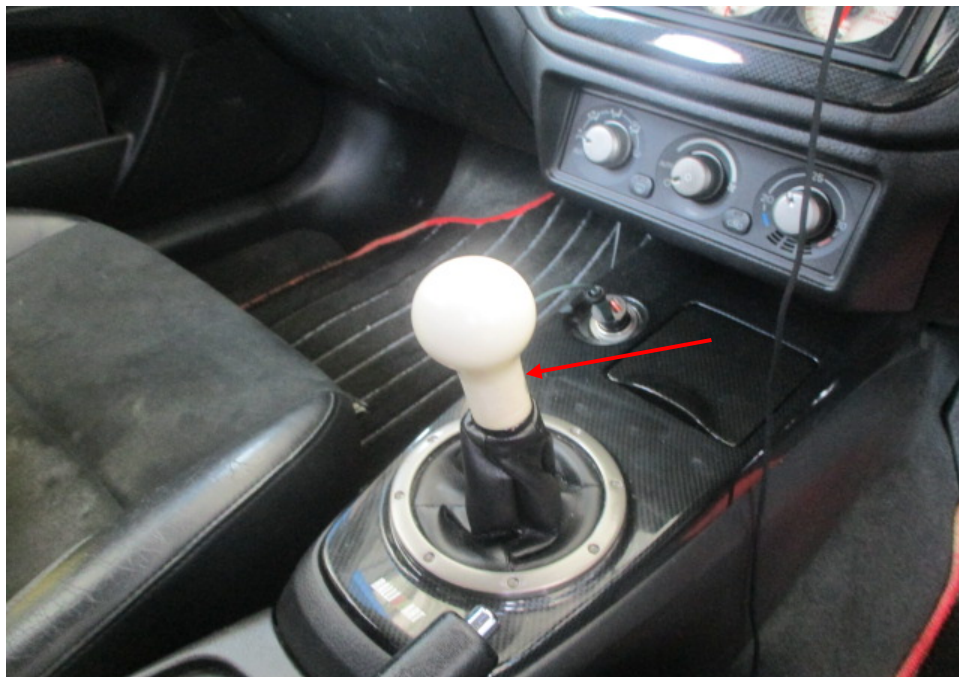
Photo 12 shows the manual gear shifter (arrowed) that was fitted on the Motor Car, for manually selecting the transmission gear to be engaged.

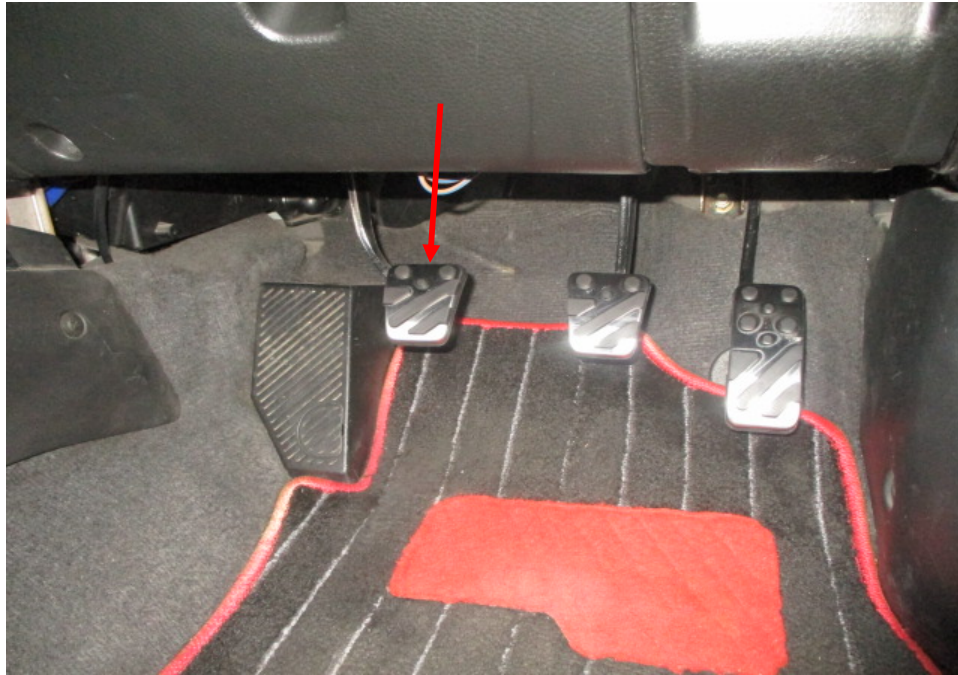
Photo 13 shows the clutch pedal (arrowed) of the Motor Car, for engaging and disengaging the transmission gears.
