Your Ref: Porsche Panamera  
(chassis number WP0ZZZ97ZLL126165)  
Our Ref : CI/TP22001634/D

21 February 2022

**INSPECTION REPORT OF AN UNREGISTERED PORSCHE PANAMERA  
MOTOR CAR WITH CHASSIS NUMBER WP0ZZZ97ZLL126165**

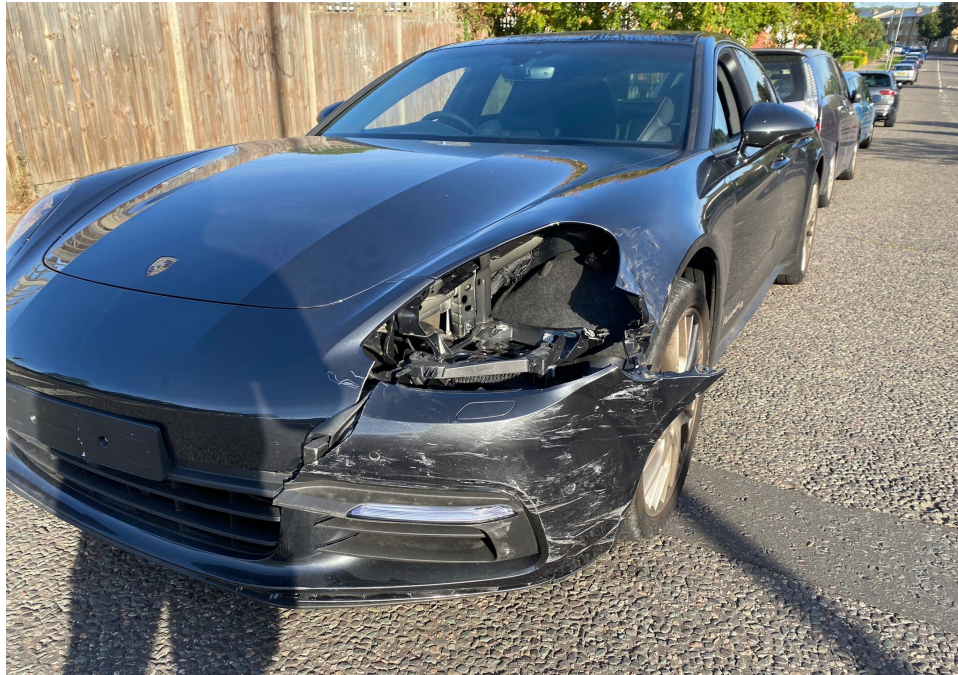
3. The photographs provided to me had showed damage to the front left portion of the Motor Car. Body parts damaged include the front bumper, front bumper lower lip, front bumper centre lower grille, front bumper left lower grille, front bumper left sensors, front left day light, front left headlamp, front left headlamp lower bracket and front left fender amongst others.
4. Apart for the front left portion, there was no physical damage observed to other areas of the Motor Car. The airbag(s) was not deployed as seen from the photographs that were provided to me. See photo 1 – 4 below.

**Photo 1** shows the front left body of the Motor Car (photograph provided to me). The photographs provided to me had showed damage to the front left portion of the Motor Car. The front bumper, front bumper lower lip, front bumper centre lower grille, front bumper left lower grille, front bumper left sensors, front left day light, front left headlamp, front left headlamp lower bracket and front left fender were amongst the body parts that were observed to have been damaged.

22. The body parts at the front left portion of the Motor Car were visually examined and it was noted that the repair/restoration works carried out to the damaged area of the Motor Car (refer to photograph 1 - 3 above) were reasonably adequate and in order.

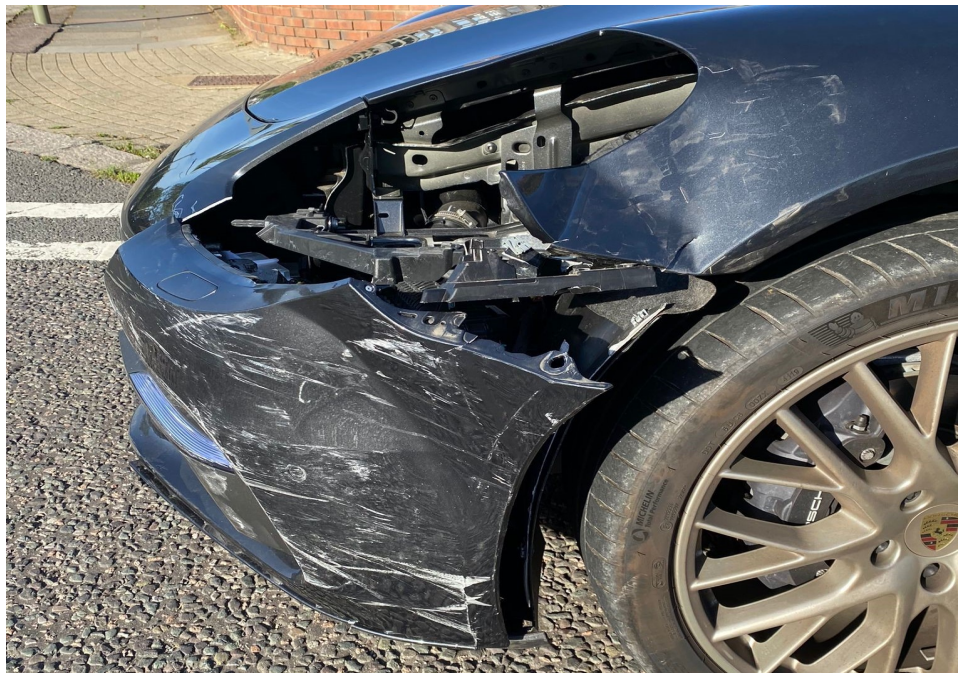
**Photo 2** shows another view of the damage at the front left portion of the Motor Car (photograph provided to me). The front bumper, front bumper left sensors, front left headlamp, front left headlamp bracket and front left fender were amongst the body parts that were observed to have been damaged.

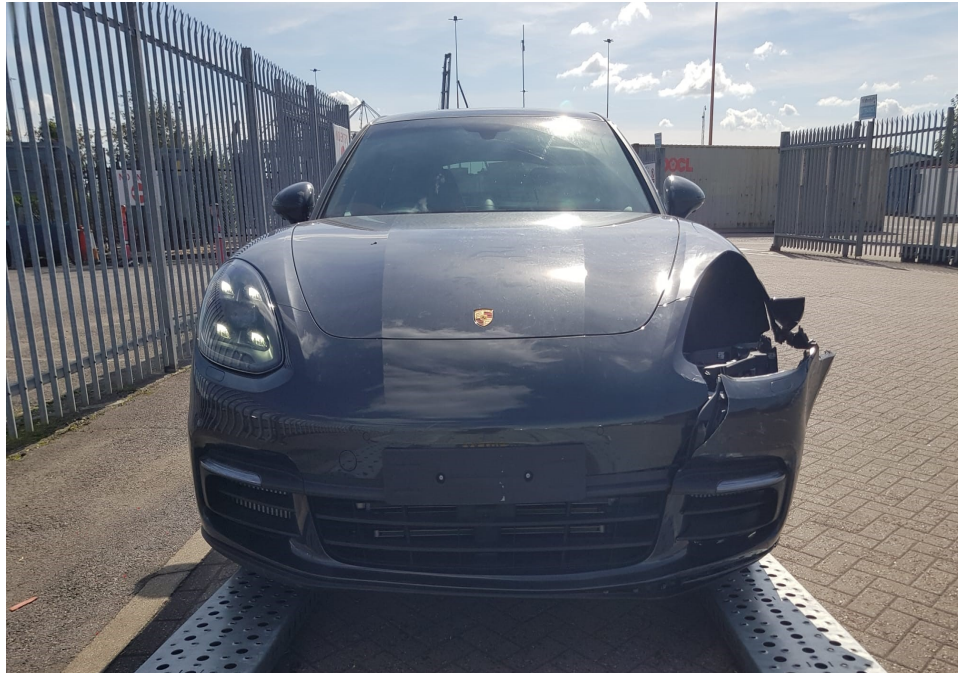
**Photo 3** shows the frontal body of the Motor Car (photograph provided to me). The photographs provided to me had showed damage to the front left portion of the Motor Car. The front bumper, front bumper lower lip, front bumper centre lower grille, front bumper left lower grille, front bumper left sensors, front left day light and front left headlamp were amongst the body parts that were observed to have been damaged.

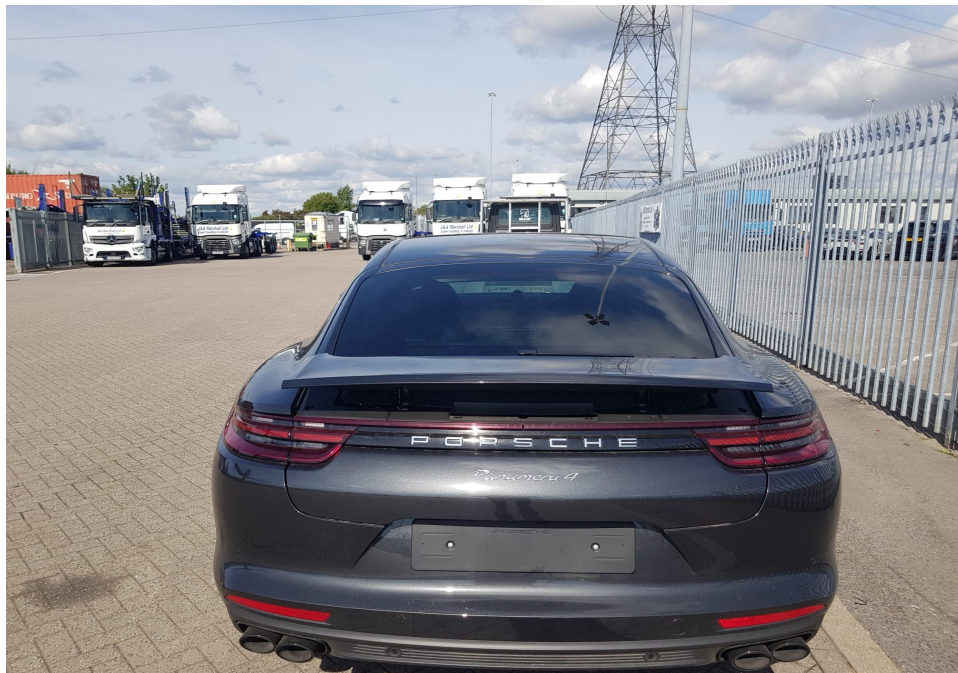
**Photo 4** shows the rear body of the Motor Car (photograph provided to me). Apart for the front left portion, there was no physical damage observed to other areas of the Motor Car. The airbag(s) was not deployed as seen from the photographs that were provided to me.

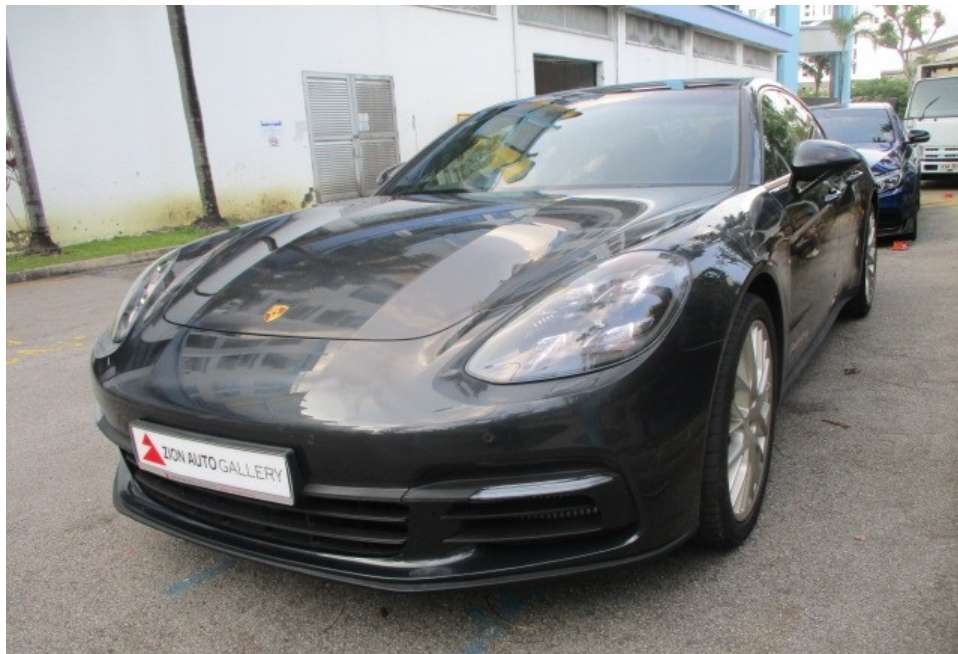
**Photo 5** shows a general view of the front left body of the Motor Car at the time of my inspection. The Motor Car was observed to be in a relatively good general condition with no loose exterior fittings observed. The body parts at the front left portion of the Motor Car were visually examined and it was observed that the repair/restoration works carried out to the damaged area of the Motor Car (refer to photograph 1 – 3 above) were reasonably adequate and in order.

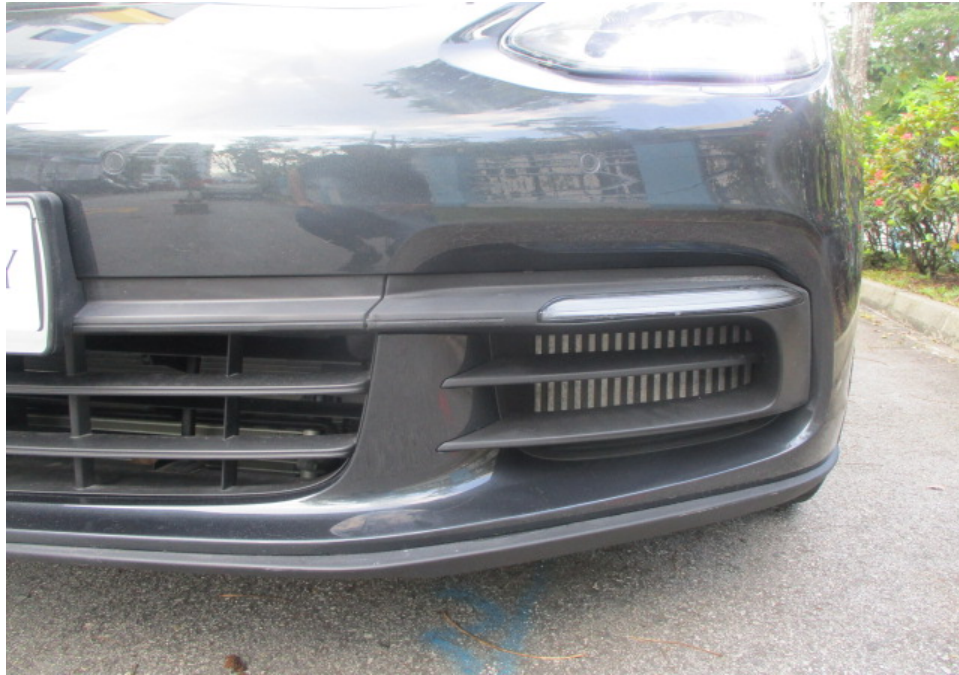
**Photo 6** shows a closer view of the Motor Car's front bumper, front bumper lower lip, front bumper centre lower grille, front bumper left lower grille and front left day light at the time of my inspection. The body parts at the front left portion of the Motor Car were visually examined and it was observed that the repair/restoration works carried out to the damaged area of the Motor Car (refer to photograph 1 – 3 above) were reasonably adequate and in order.

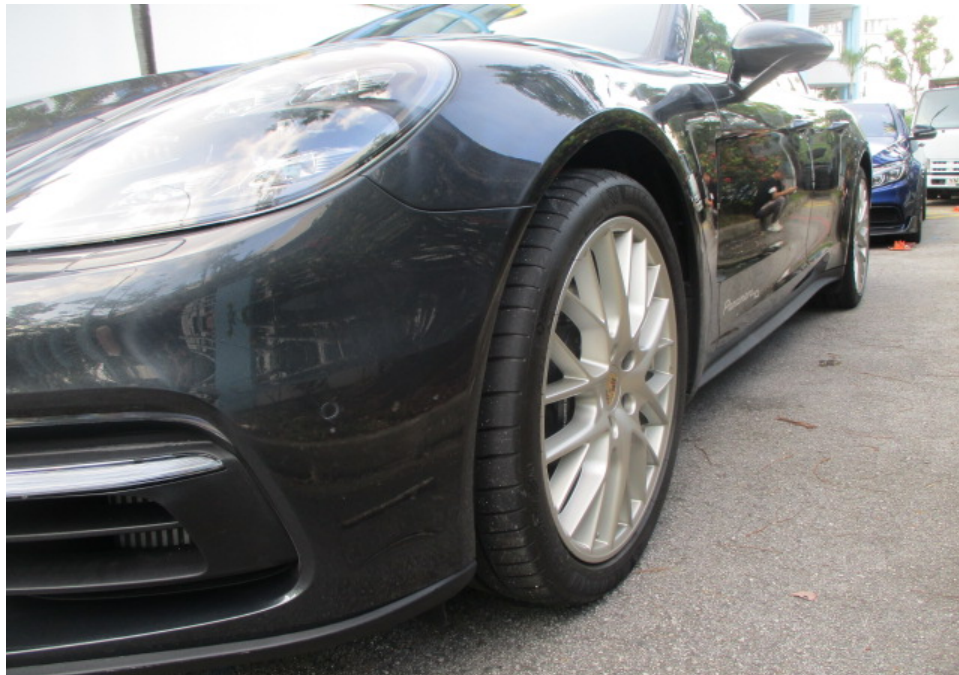
**Photo 7** shows a closer view of the Motor Car's front bumper, front left headlamp and front left fender at the time of my inspection. The body parts at the front left portion of the Motor Car were visually examined and it was observed that the repair/restoration works carried out to the damaged area of the Motor Car (refer to photograph 1 – 3 above) were reasonably adequate and in order.

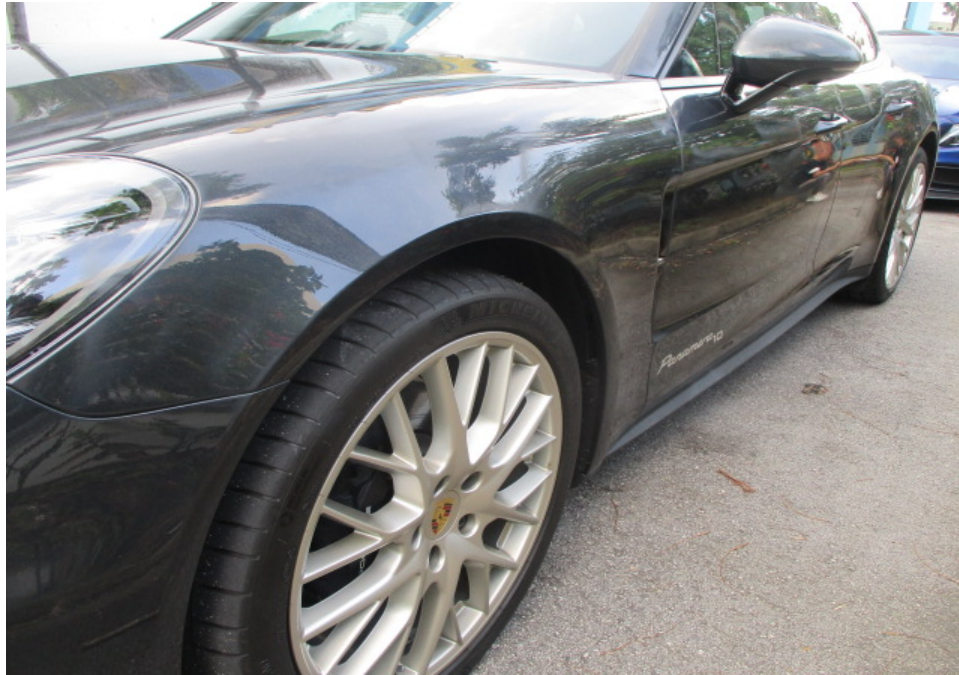
**Photo 8** shows a closer view of the Motor Car's front left fender and front left wheel rim at the time of my inspection. The body parts at the front left portion of the Motor Car were visually examined and it was observed that the repair/restoration works carried out to the damaged area of the Motor Car (refer to photograph 1 – 3 above) were reasonably adequate and in order.

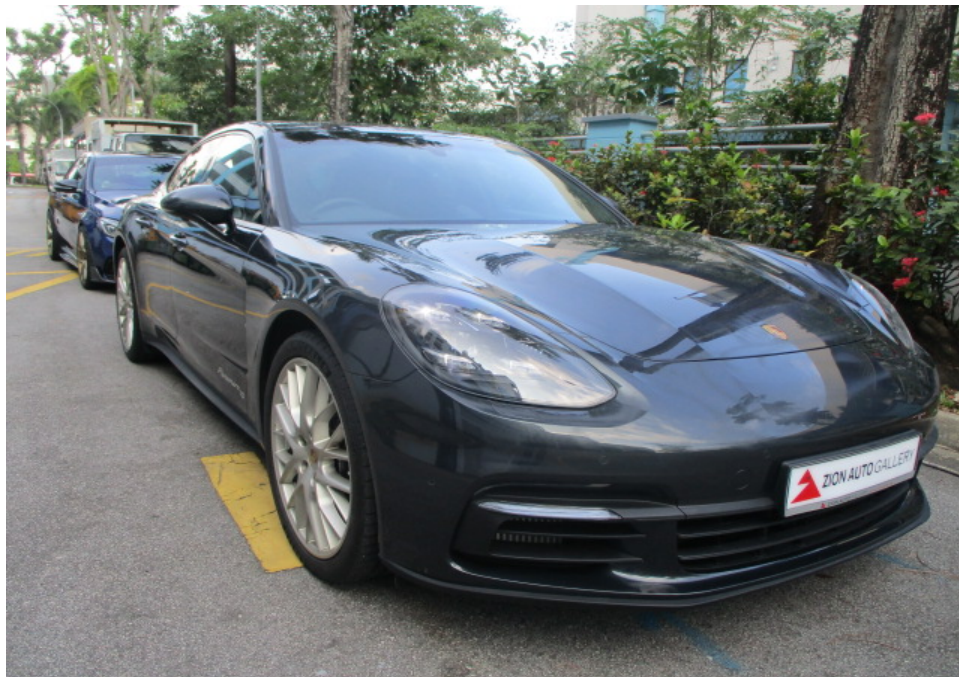
**Photo 9** shows a general view of the front right body of the Motor Car at the time of my inspection. The Motor Car was observed to be in a relatively good general condition with no loose exterior fittings observed. The body parts at the front left portion of the Motor Car were visually examined and it was observed that the repair/restoration works carried out to the damaged area of the Motor Car (refer to photograph 1 – 3 above) were reasonably adequate and in order.

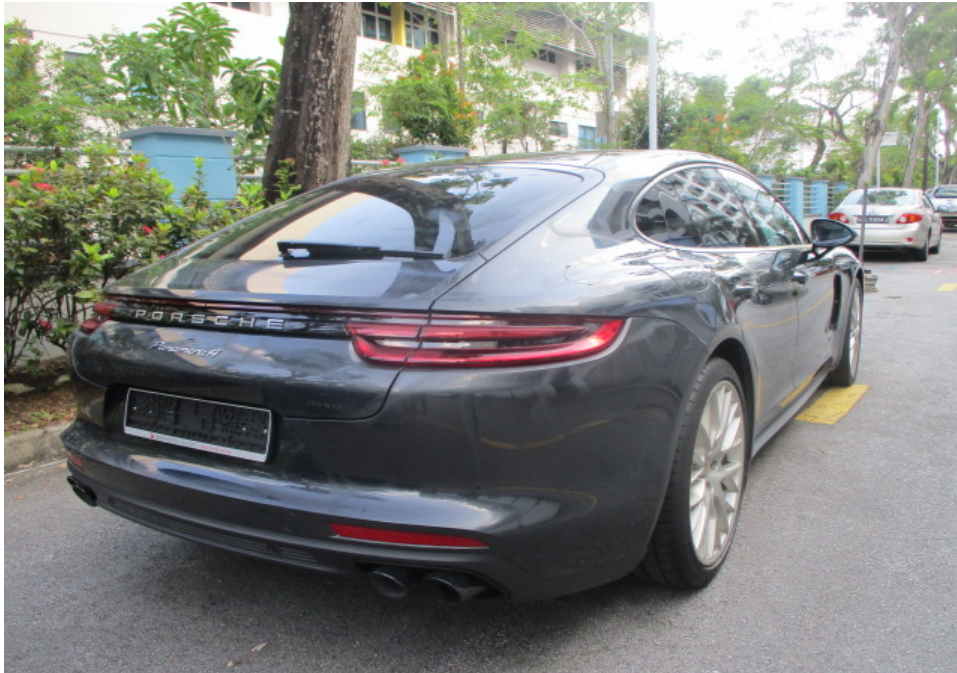
**Photo 10** shows a general view of the rear right body of the Motor Car at the time of my inspection. The Motor Car was observed to be in a relatively good general condition with no loose exterior fittings observed. The mileage of the Motor Car recorded at the time of my inspection was 2,722km.

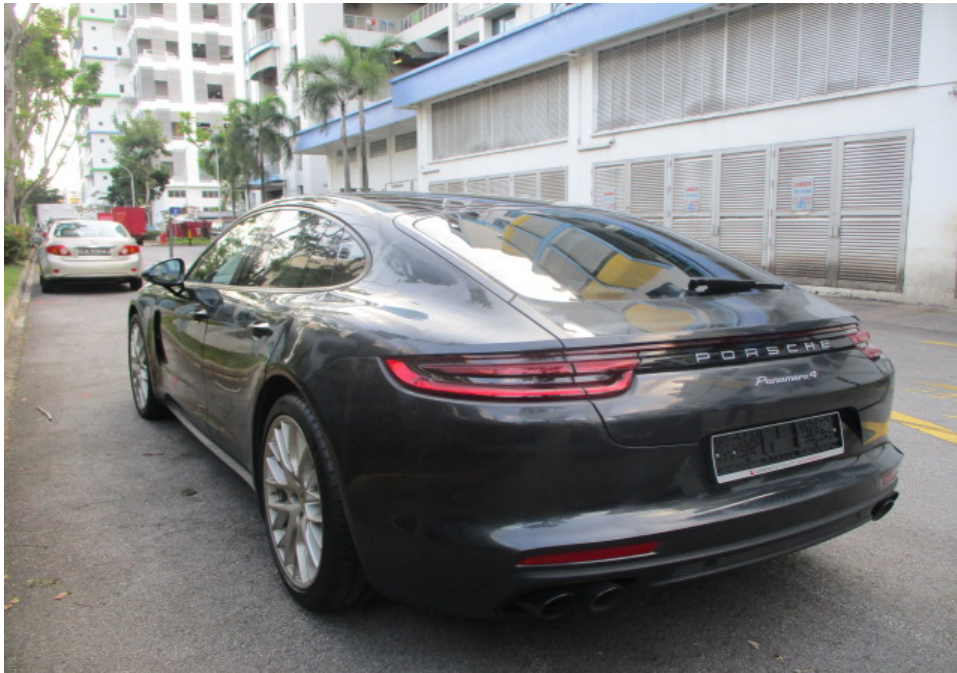
**Photo 11** shows a general view of the rear left body of the Motor Car at the time of my inspection. The Motor Car was observed to be in a relatively good general condition with no loose exterior fittings observed. The mileage of the Motor Car recorded at the time of my inspection was 2,722km.

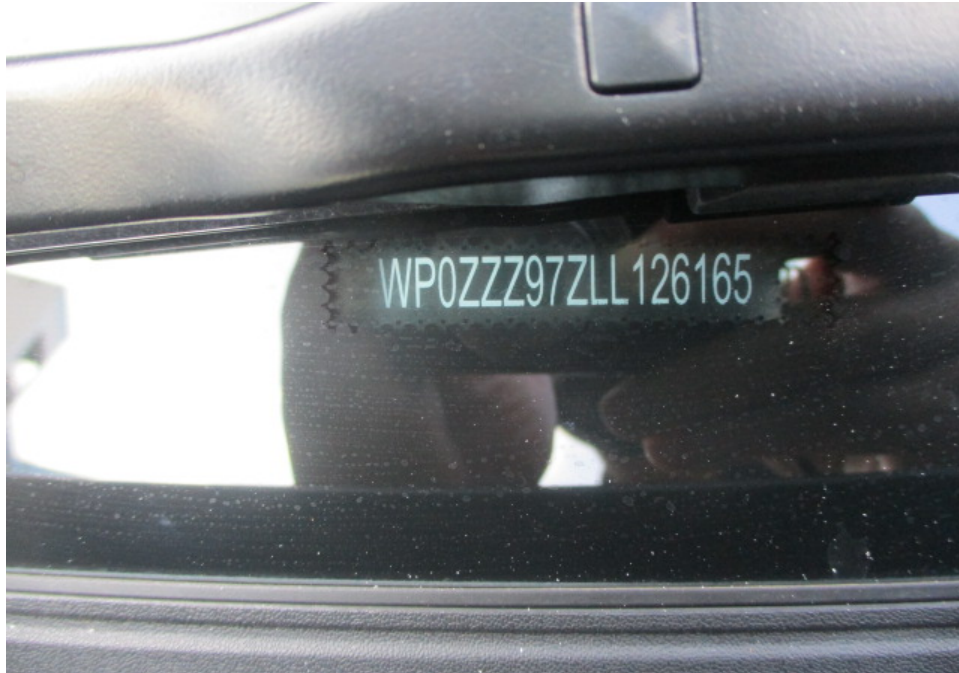
**Photo 12** shows the chassis number of the Motor Car. The chassis number recorded was WP0ZZZ97ZLL126165.

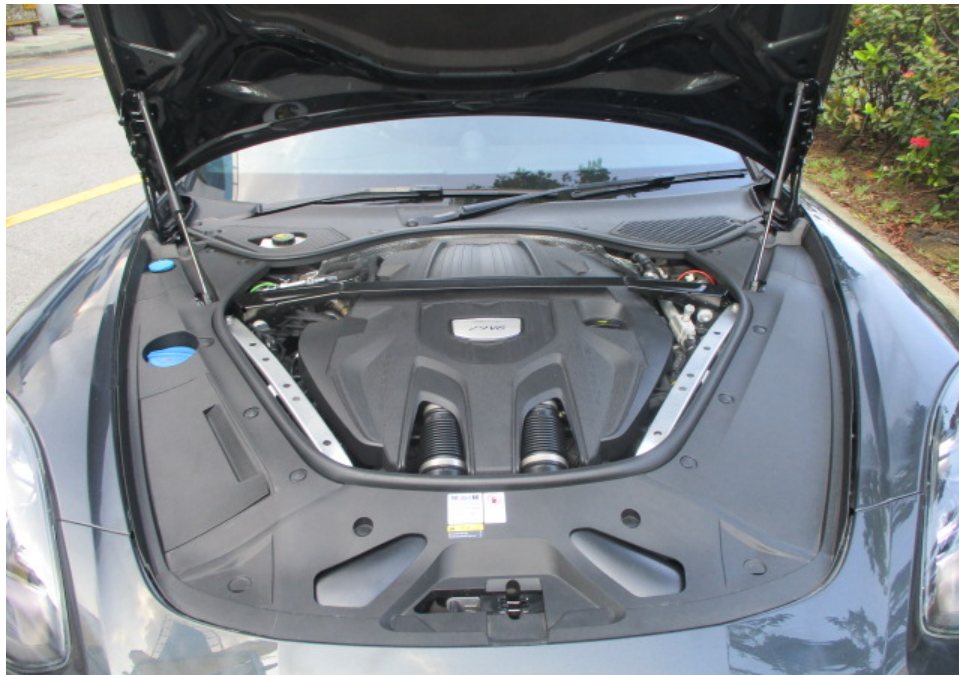
14. My examination of the engine compartment of the Motor Car revealed that the various parts and components inside the engine compartment were all intact and properly fitted. The engine oil, brake fluid and engine coolant were all found to be of sufficient level for operating purposes. Visually, there was also no contamination found to these fluids.

**Photo 13** shows a general view of the engine compartment of the Motor Car at the time of my inspection. The various parts and components inside the engine compartment were all observed to be intact and properly fitted. There was also no sign(s) or indication(s) of fluid leak and/or fluid stain found inside the engine compartment.

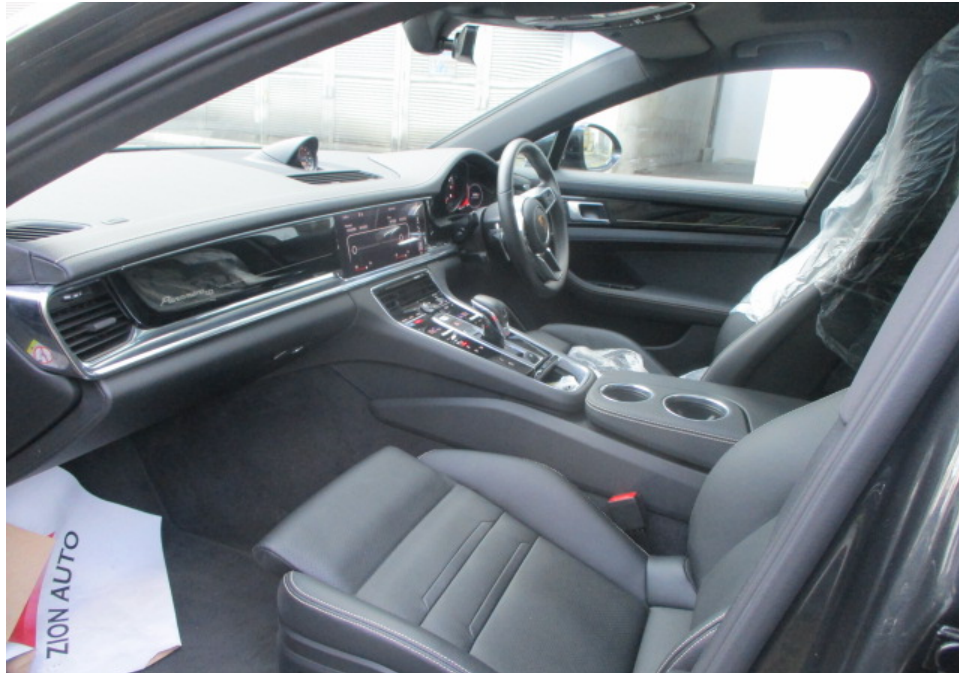
**Photo 14** shows the interior compartment of the Motor Car at the time of my inspection. The various parts and components, trims, carpet, and upholstery inside the interior compartment were all observed to be intact and properly fitted.

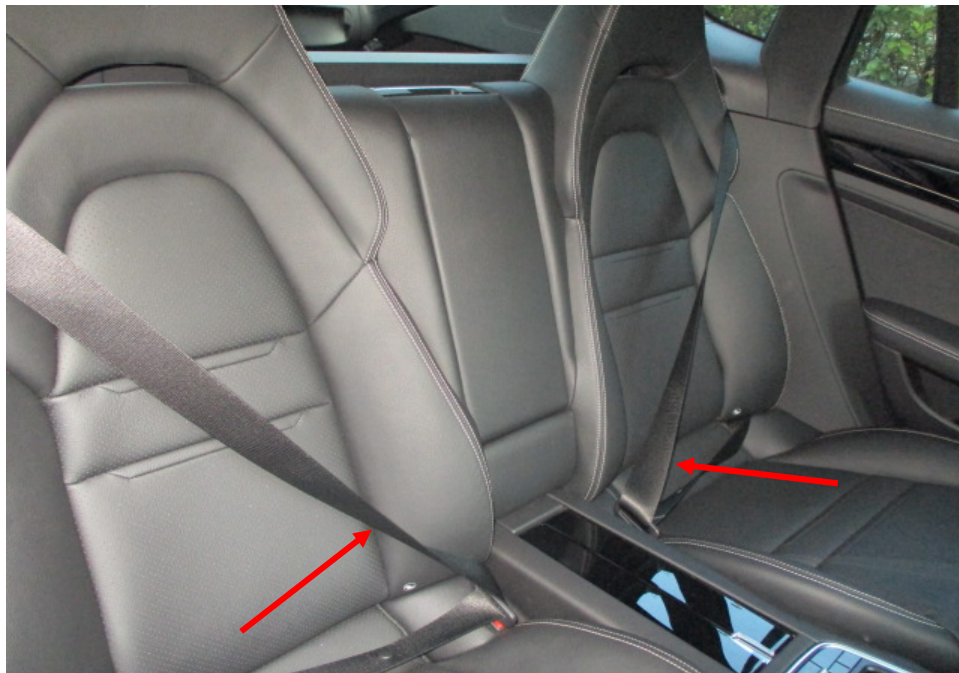
12. The seats of the Motor Car were found to be secured to the floorboard of the Motor Car via seat rails bolted onto the floorboard. Retractable seat belt reels and pre-tensioners were fitted on all seats of the Motor Car. The seat belts were tested and were able to be fastened securely into the respective pre-tensioners that were fixed to the side of all the seats.

**Photo 15** shows the rear seats of the Motor Car. All the seats of the Motor Car were secured via seat rails to the floorboard. They were also fitted with a retractable seat belt reel and a pre-tensioner. The seat belts (arrowed) were tested and were able to be fastened into the respective pre-tensions that were fitted on the side of each individual seat.

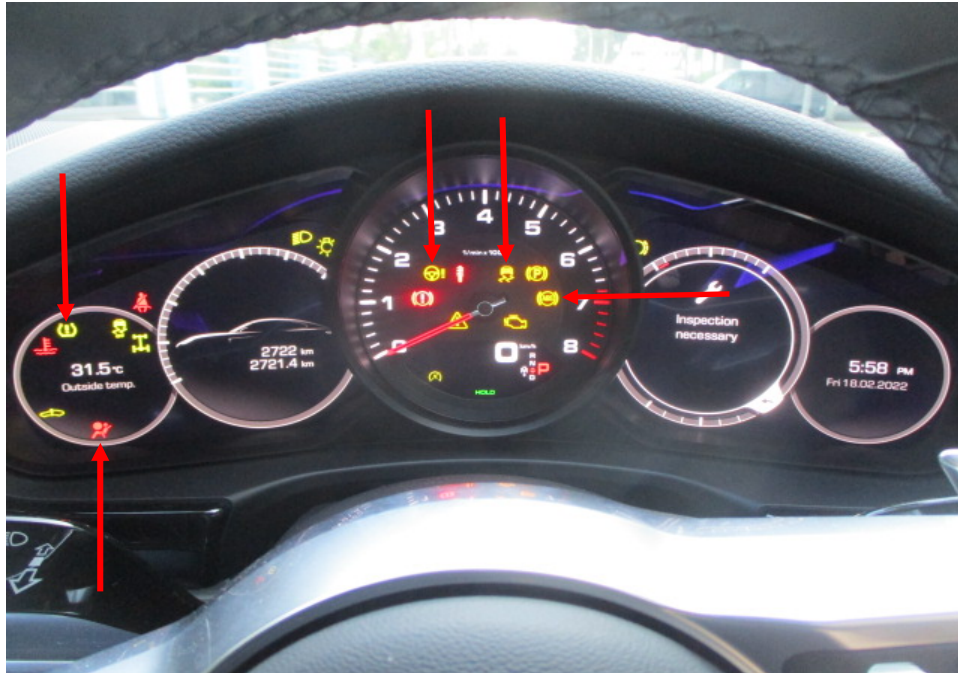
**Photo 16** shows the warning lights for the various electronic safety features appearing on the instrument panel of the Motor Car during its self-test when the engine is cranked, in particular the ABS, SRS, EPS, TPM and TCS lights (arrowed).

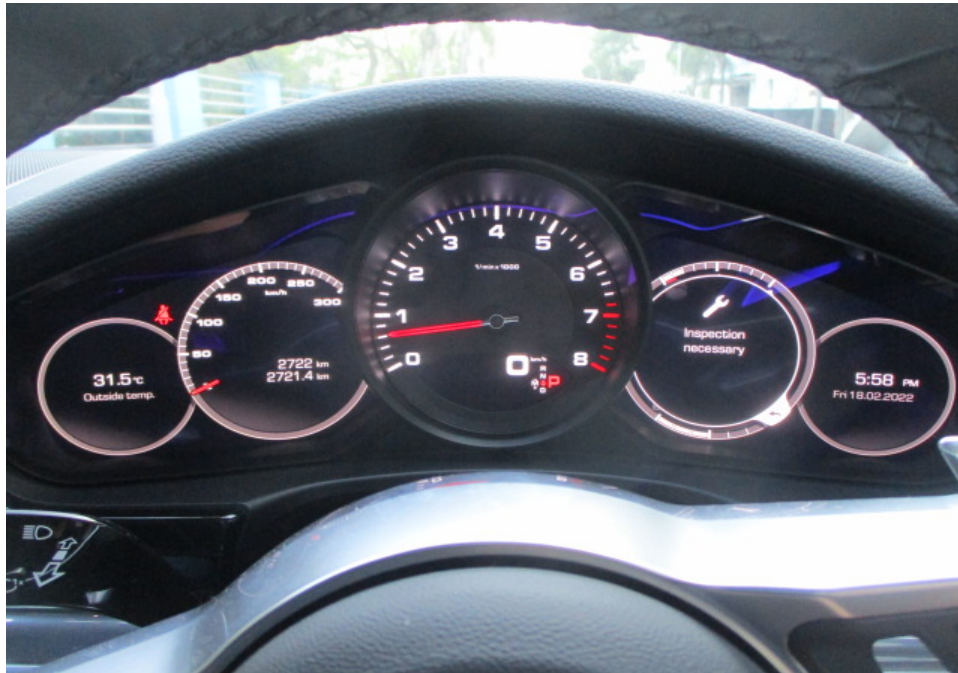
13. The Motor Car's automatic self-test of the functionality of its various electronic safety features like the Anti-Lock Brake System (ABS), Supplemental Restraint System (SRS), Electric Power Steering (EPS), Tyre Pressure Monitor (TPM) and Traction Control System (TCS) during cranking of the engine had indicated that these electronic systems were in working condition. This was determined from the respective warning lights disappearing from the instrument panel after the self-test.

**Photo 17** shows the respective warning lights no longer illuminated, indicating that there is no fault detected to the ABS, SRS, EPS, TPM and TCS systems of the Motor Car during the self-test. These electronic systems were hence in working condition at the time of my inspection.

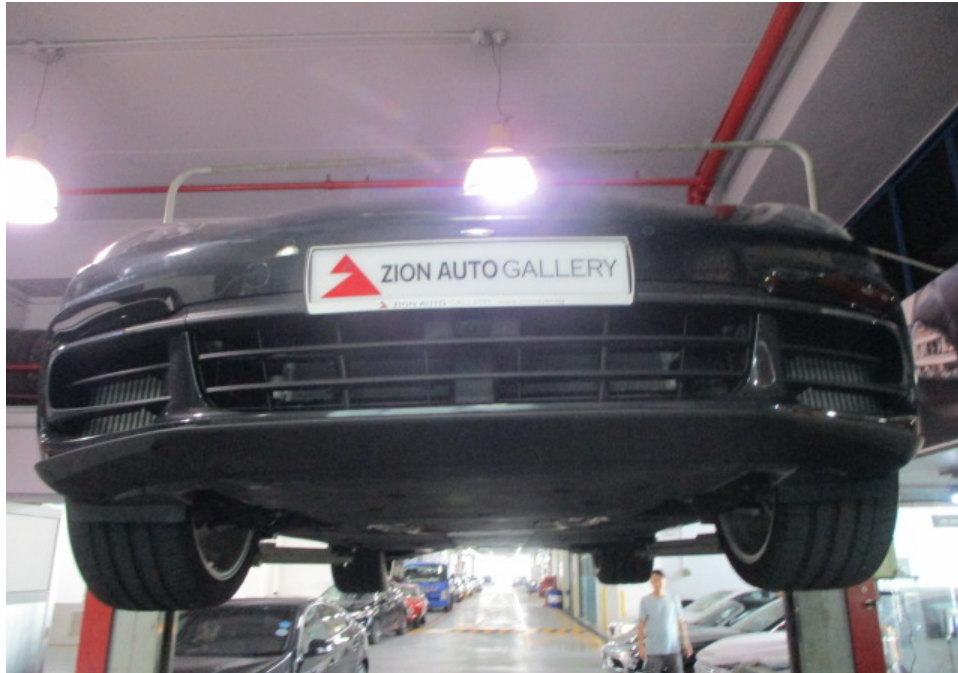
15. My checks on the underside of the Motor Car revealed no sign(s) or indication(s) of fluid leakage and/or fluid stain(s). The engine block and automatic transmission assembly were both secured properly. All undercarriage components of the Motor Car were also observed to be intact and secured in an appropriate manner.

**Photo 18** shows the Motor Car hoisted up for checks on its undercarriage. There was no sign(s) or indication(s) of fluid leakage and/or fluid stain(s) on the underside of the Motor Car. The undercarriage components of the Motor Car were also all observed to be intact and secured in an appropriate manner.

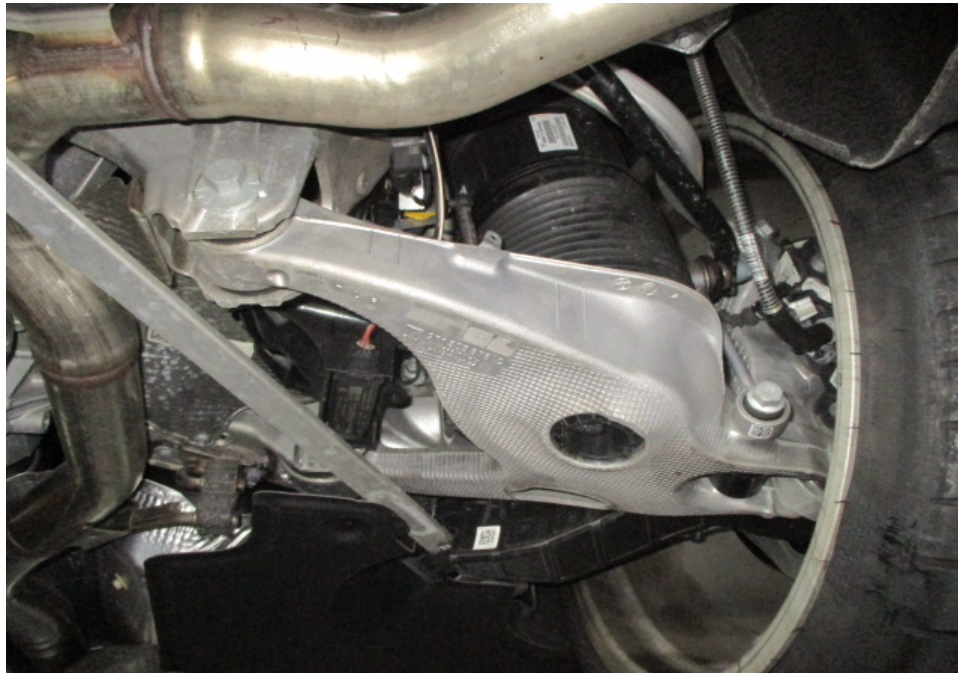
**Photo 19** shows a general view of the control arms and linkages at the rear right wheel of the Motor Car. I did not observe any fluid leak and/or fluid stain on the underside of the Motor Car. All of the Motor Car's undercarriage components were observed to be intact and secured in an appropriate manner.

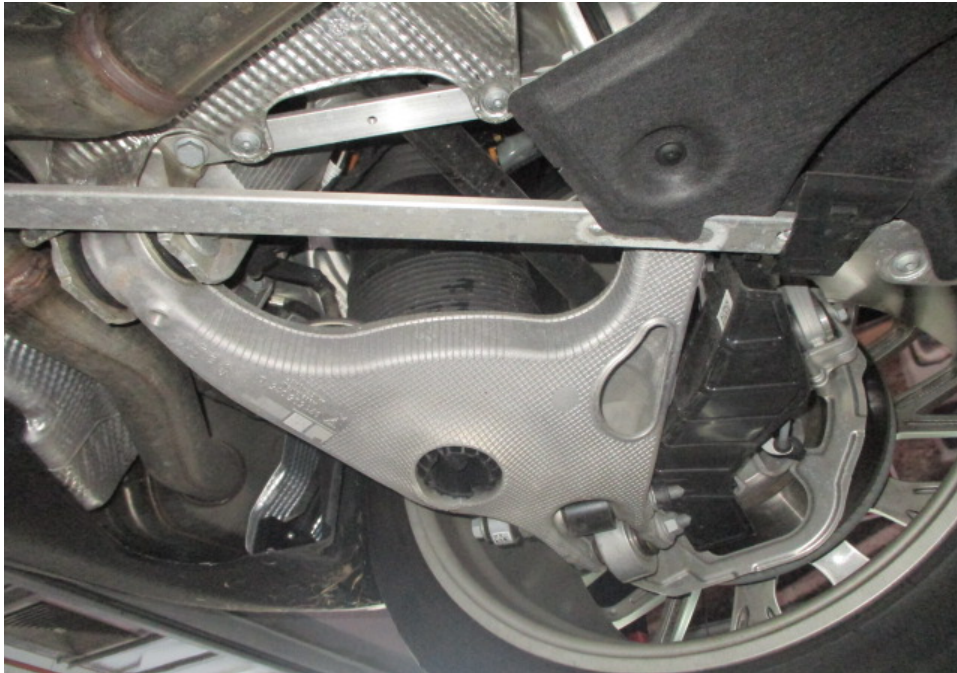
**Photo 20** shows a general view of the control arms and linkages at the rear left wheel of the Motor Car. I did not observe any fluid leak and/or fluid stain on the underside of the Motor Car. All of the Motor Car's undercarriage components were observed to be intact and secured in an appropriate manner.

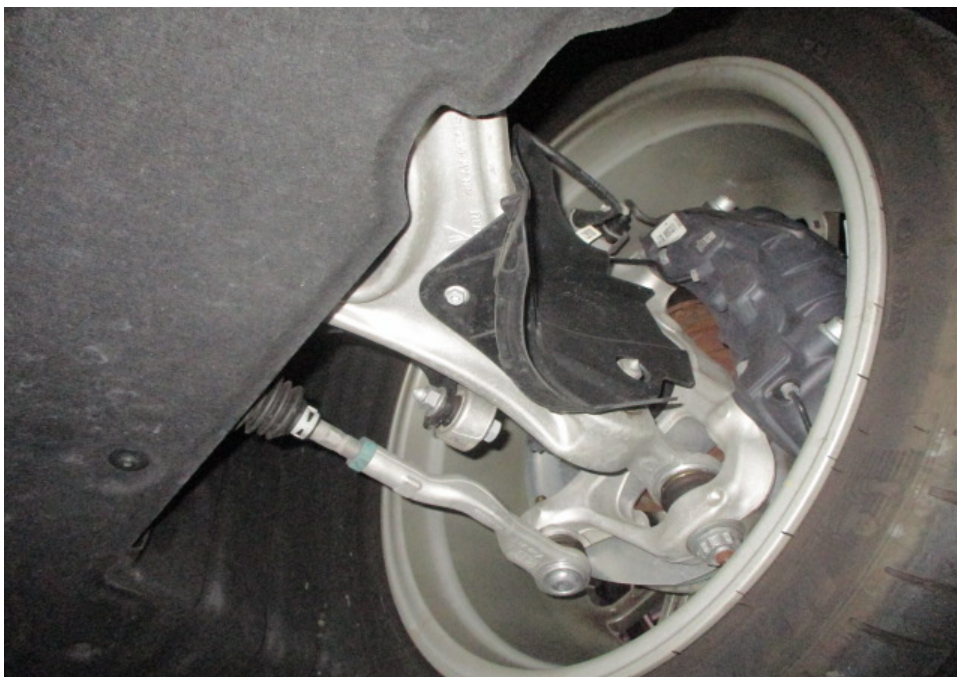
**Photo 21** shows the various undercarriage components at the front left wheel of the Motor Car. The mechanical components, control arms and linkages were all found to be intact and secured in an appropriate manner.

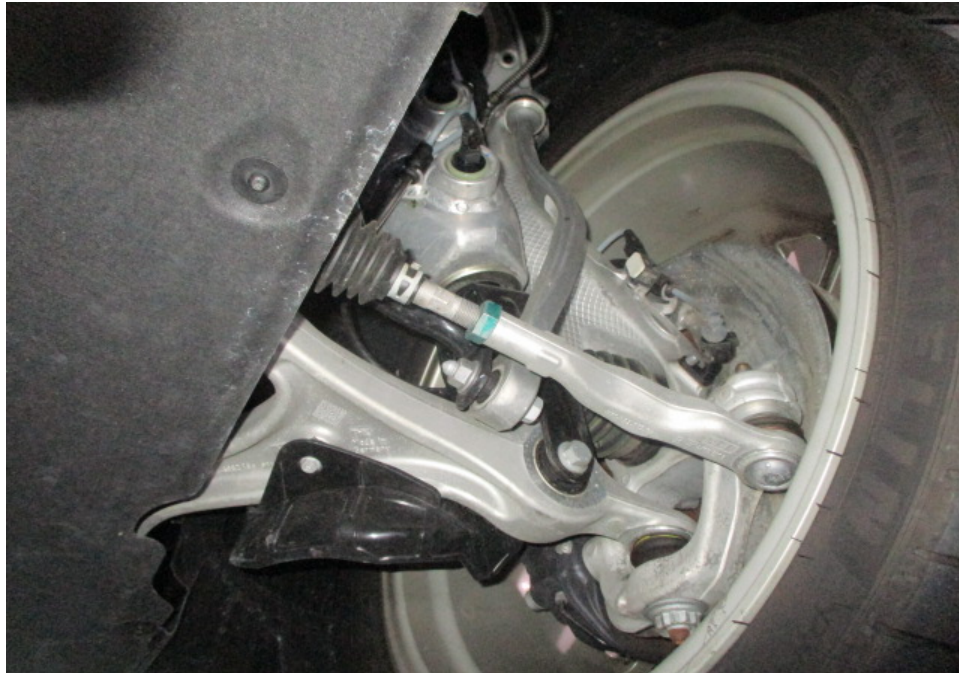
**Photo 22** shows the various undercarriage components at the front right wheel of the Motor Car. The mechanical components, control arms and linkages were all found to be intact and secured in an appropriate manner. I also did not observe any fluid leak and/or fluid stain on the underside of the Motor Car.

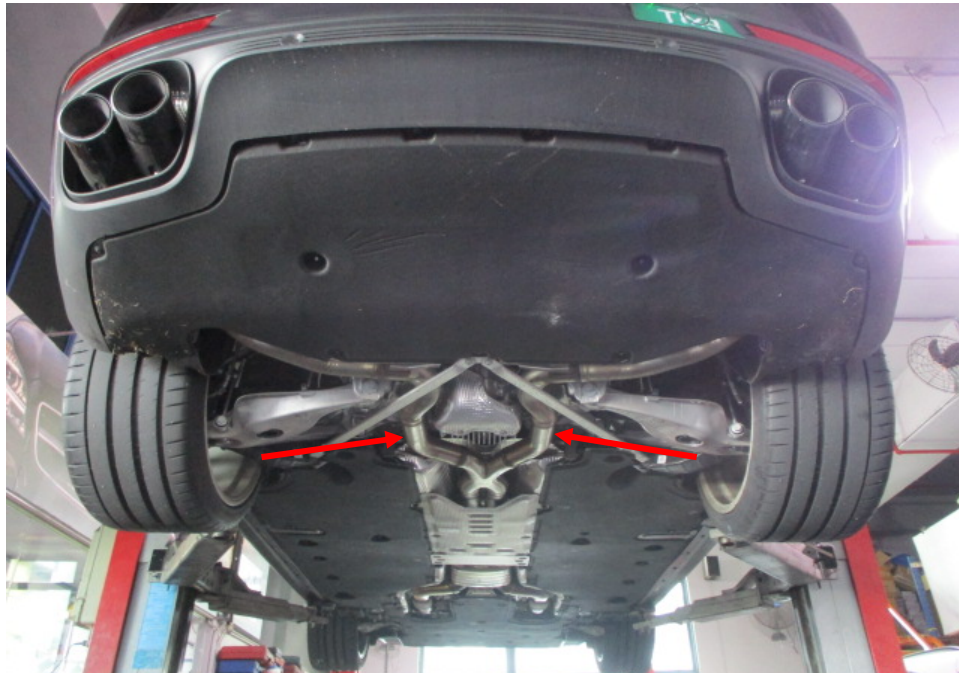
**Photo 23** shows the rear section of the Motor Car's exhaust system. My examination of the Motor Car's exhaust system revealed no sign(s) or indication(s) of any cut or weld marks along its exhaust pipes (arrowed), on its rear mufflers, on its centre resonator box and on its catalytic converters.

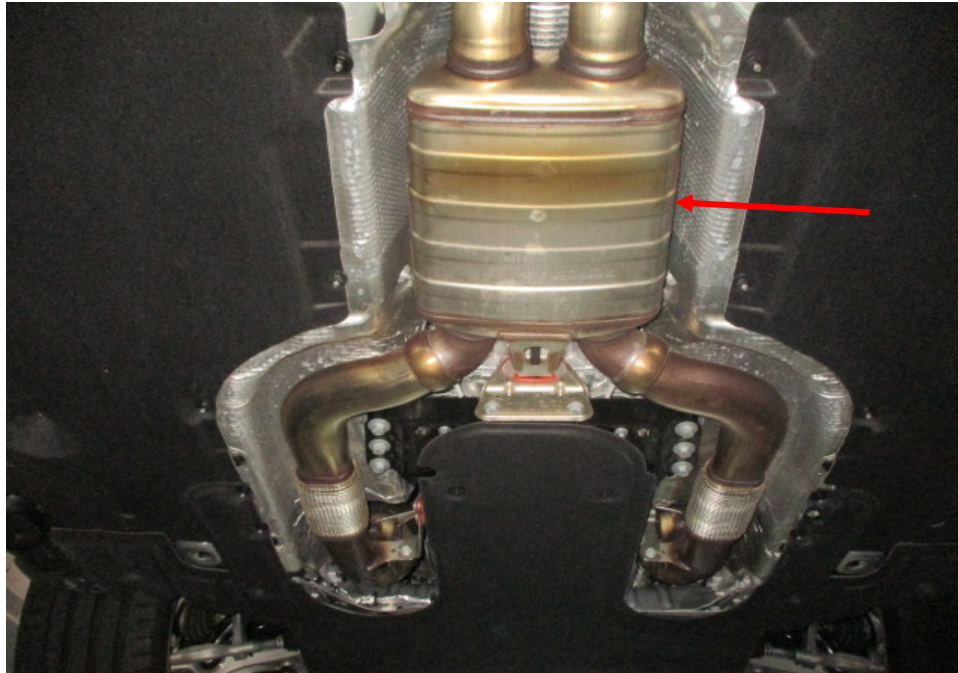
**Photo 24** shows the front section of the Motor Car's exhaust system. My examination of the Motor Car's exhaust system revealed no sign(s) or indication(s) of any cut or weld marks along its exhaust pipes, on its rear mufflers, on its centre resonator box (arrowed) and on its catalytic converters.

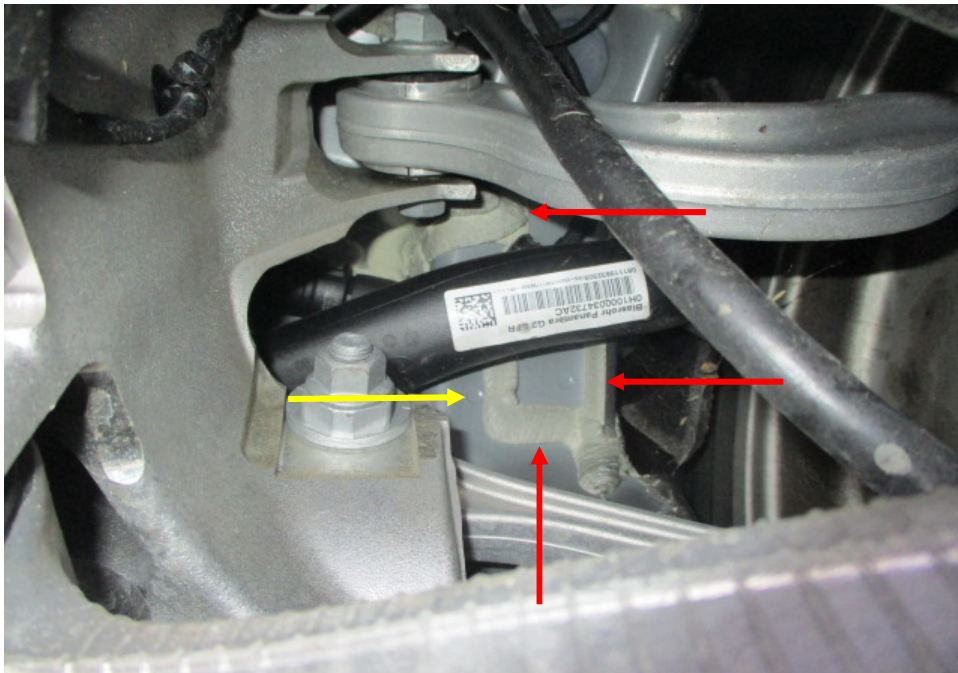
11. Visually, I did not find any weld marks, other than the original spot weld marks, on the chassis/structural body of the Motor Car. The original factory sealant at the joints along the chassis/structural body was also untouched, again indicating that no replacement of the chassis/structural body was carried out; and that the chassis/structural body was originally fitted.

**Photo 25** shows the chassis/structural body at the underside rear right of the Motor Car. I did not find any weld marks other than original spot weld marks (yellow arrow) on the chassis/structural body of the Motor Car. The original factory sealant (red arrow) at the joints along the chassis/structural body was untouched, indicating no work was done on the chassis/structural body of the Motor Car and that the chassis/structural body was originally fitted.

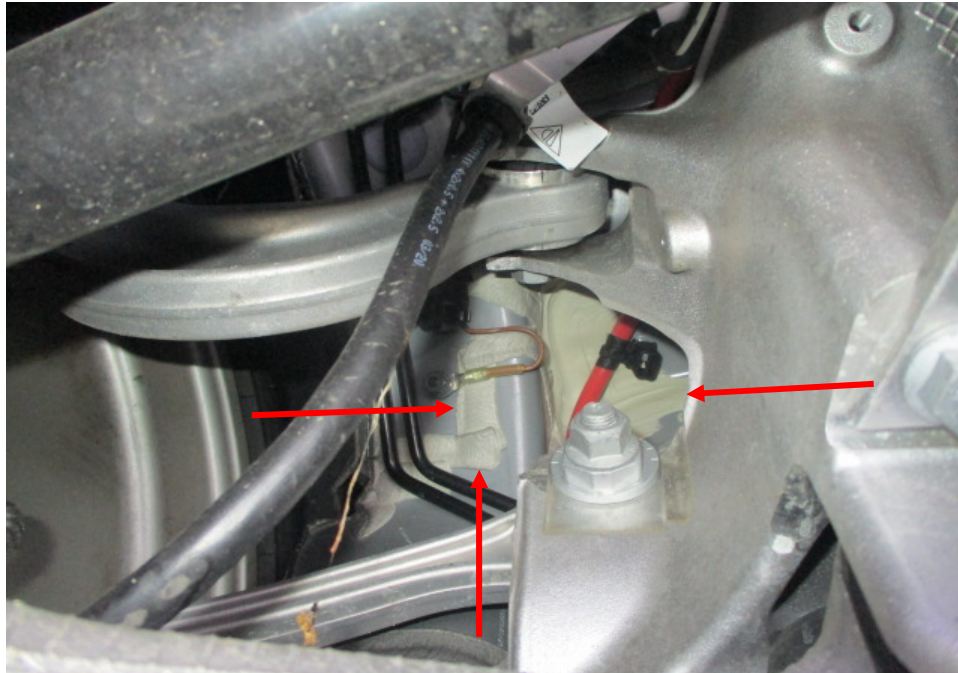
**Photo 26** shows the chassis/structural body at the underside rear left of the Motor Car. The original factory sealant (arrowed) at the joints along the chassis/structural body was observed to be untouched. In general, I had found no work was carried out on the chassis/structural body of the Motor Car. The chassis/structural body of the Motor Car was originally fitted.

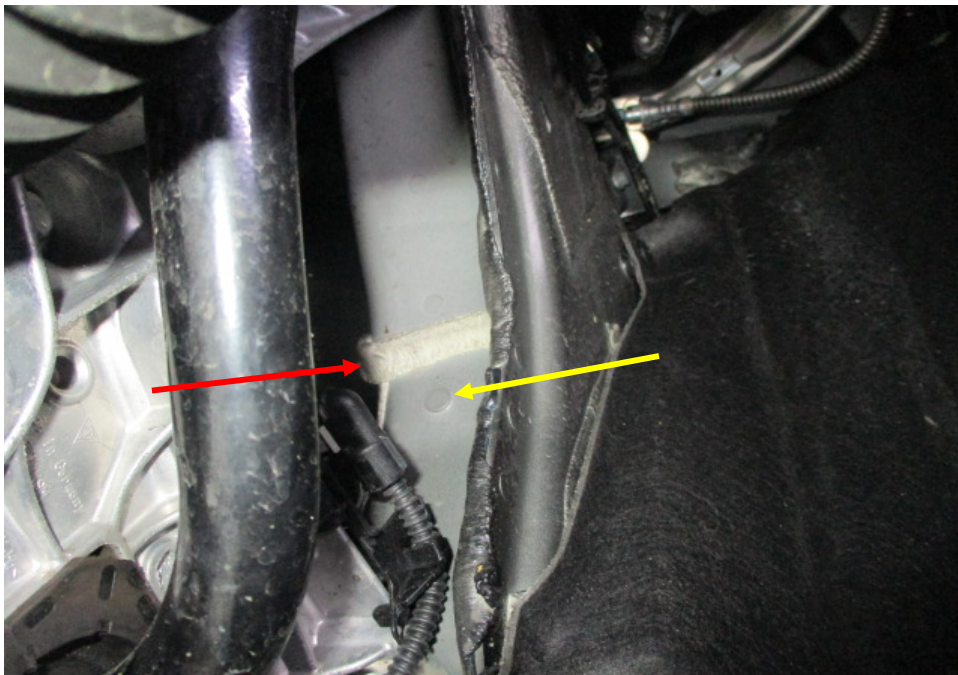
**Photo 27** shows the chassis/structural body at the underside front left of the Motor Car. I did not find any weld marks other than original spot weld marks (yellow arrow) on the chassis/structural body of the Motor Car. The original factory sealant (red arrow) at the joints along the chassis/structural body was untouched, indicating no work was done on the chassis/structural body of the Motor Car and that the chassis/structural body was originally fitted.

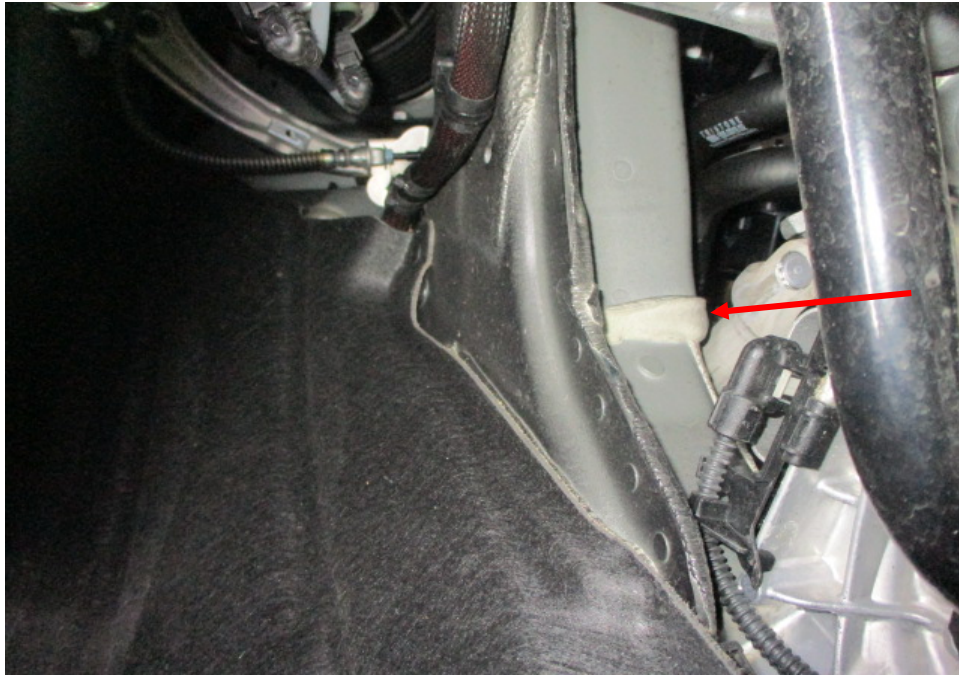
**Photo 28** shows the chassis/structural body at the underside front right of the Motor Car. The original factory sealant (arrowed) at the joints along the chassis/structural body was observed to be untouched. In general, I had found no work was carried out on the chassis/structural body of the Motor Car. The chassis/structural body of the Motor Car was originally fitted.
