Your Ref: Porsche Cayenne  
(chassis number WP1ZZZ9YZMDA01035)  
Our Ref : CI/TP22001635/D

20 February 2022

**INSPECTION REPORT OF AN UNREGISTERED PORSCHE CAYENNE  
MOTOR CAR WITH CHASSIS NUMBER WP1ZZZ9YZMDA01035**

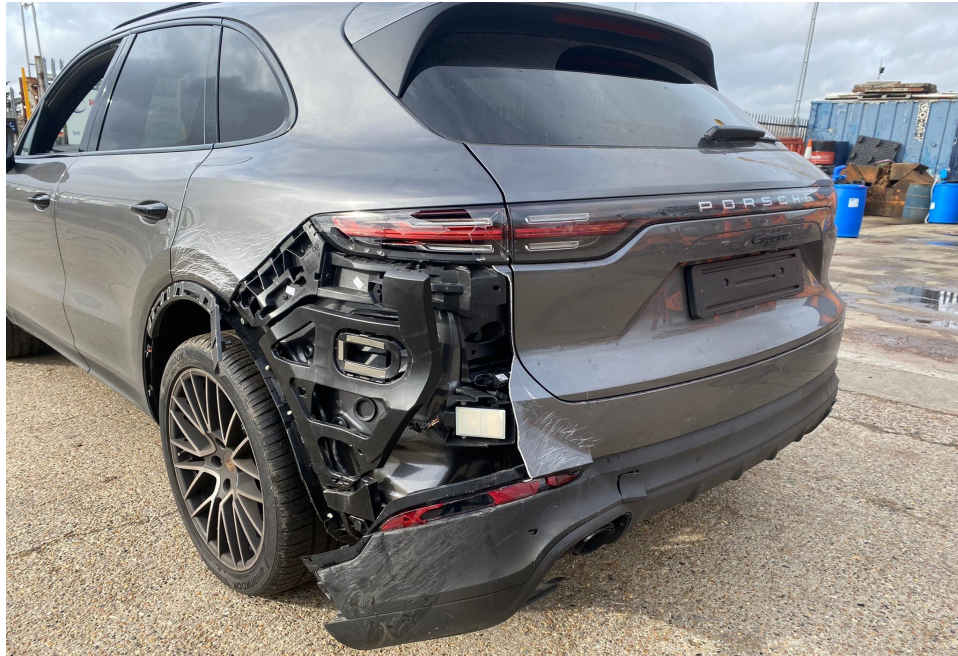
**Photo 1** shows the rear left body of the Motor Car (photograph provided to me). The photographs provided to me had showed damage to the rear left portion of the Motor Car. The rear bumper, rear bumper lower cover, rear bumper lower garnish, rear bumper left sensors, rear bumper left reflector, rear bumper left bracket and rear left taillamp were amongst the body parts that were observed to have been damaged.

22. The body parts at the rear left portion of the Motor Car were visually examined and it was noted that the repair/restoration works carried out to the damaged area of the Motor Car (refer to photograph 1 - 3 above) were reasonably adequate and in order.

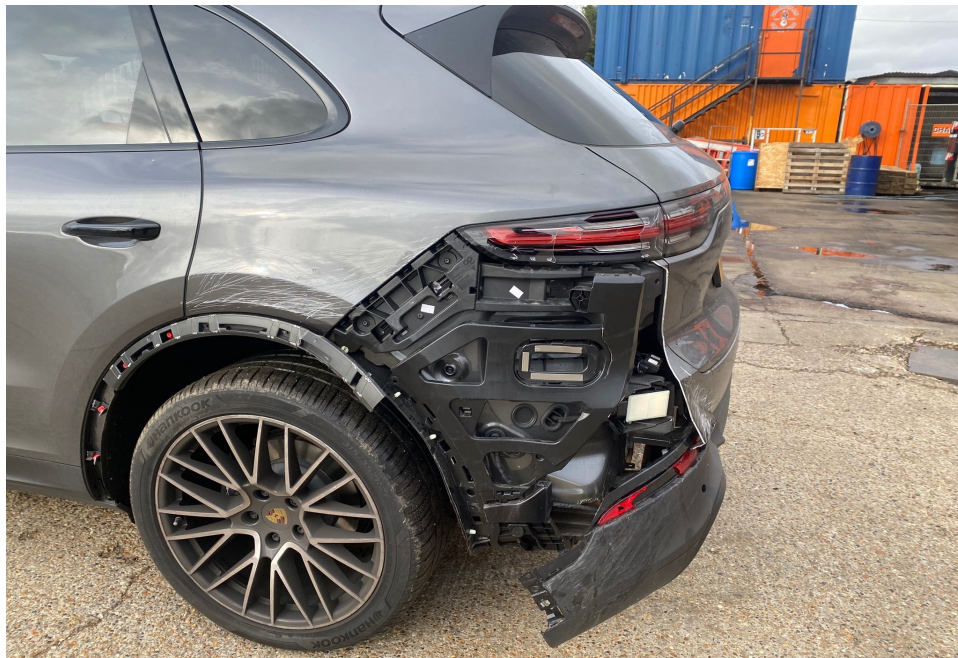
**Photo 2** shows another view of the Motor Car's rear left body (photograph provided to me). The photographs provided to me had showed damage to the rear left portion of the Motor Car. The rear bumper, rear bumper lower cover, rear bumper left bracket, rear left taillamp, rear left fender and rear left fender wheel arc garnish were amongst the body parts that were observed to have been damaged.

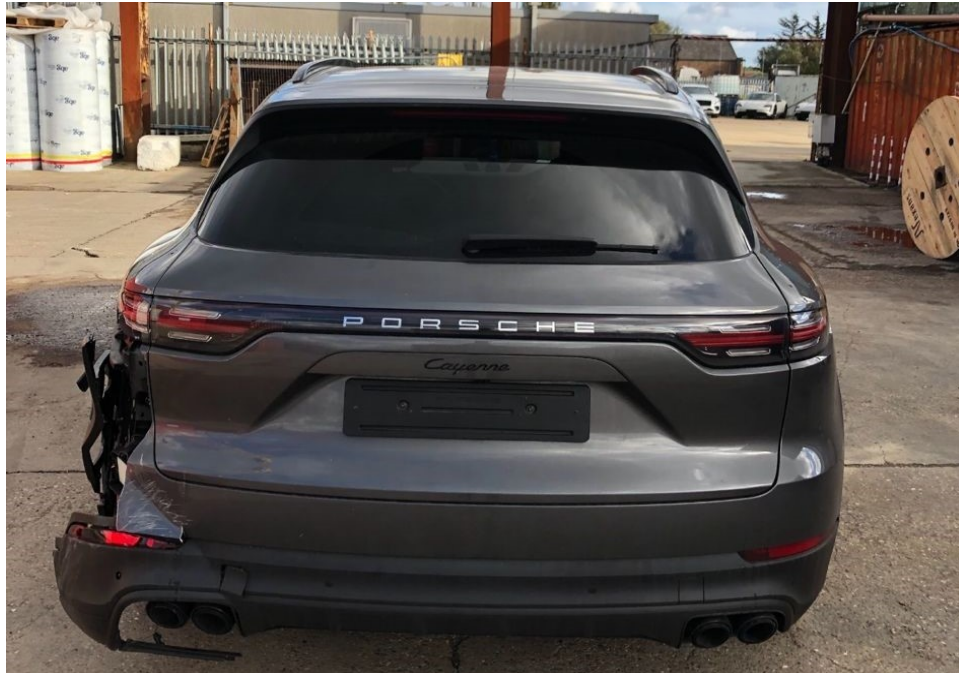
**Photo 3** shows the rear body of the Motor Car (photograph provided to me). The photographs provided to me had showed damage to the rear left portion of the Motor Car. Body parts damaged include rear bumper, rear bumper lower cover, rear bumper lower garnish, rear bumper left sensors and rear bumper left reflector amongst others.

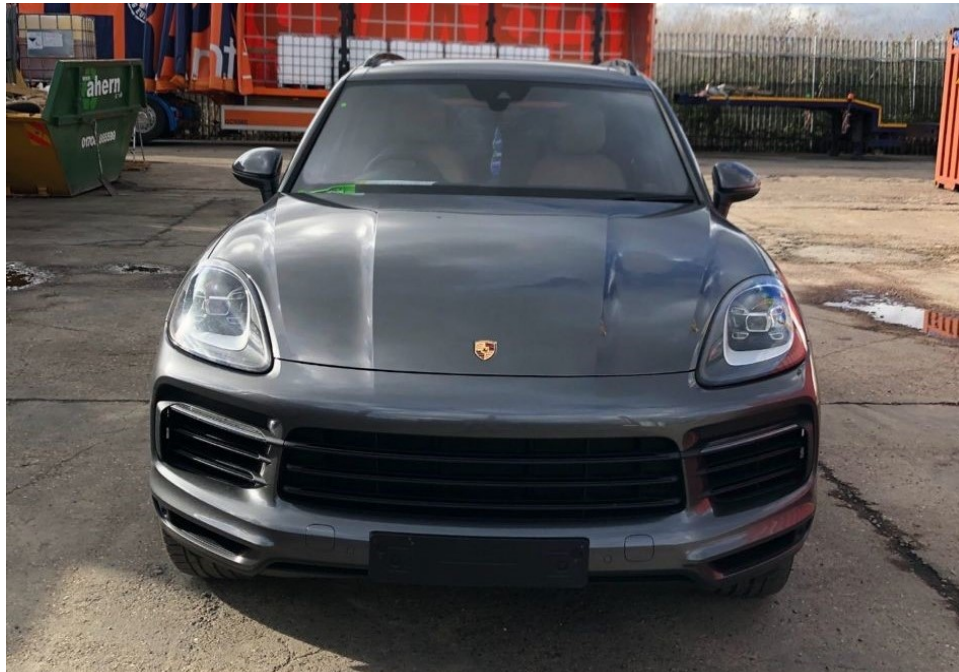
**Photo 4** shows the frontal body of the Motor Car (photograph provided to me). Apart from the rear left portion, there was no physical damage observed to other areas of the Motor Car. The airbag(s) was not deployed as seen from the photographs that were provided to me.

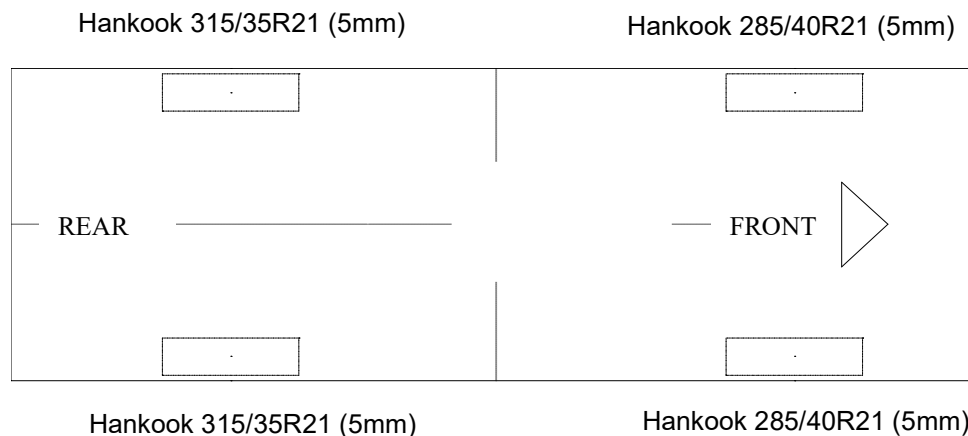
8. It was fitted with 21inch sport wheel rims that were wrapped with tyres that were observed to be of serviceable condition. The tyres were also sufficiently inflated for vehicular operation. The tyre brand, tyre size and approximate remaining tread depth of the 4 tyres of the Motor Car were recorded as follows: -

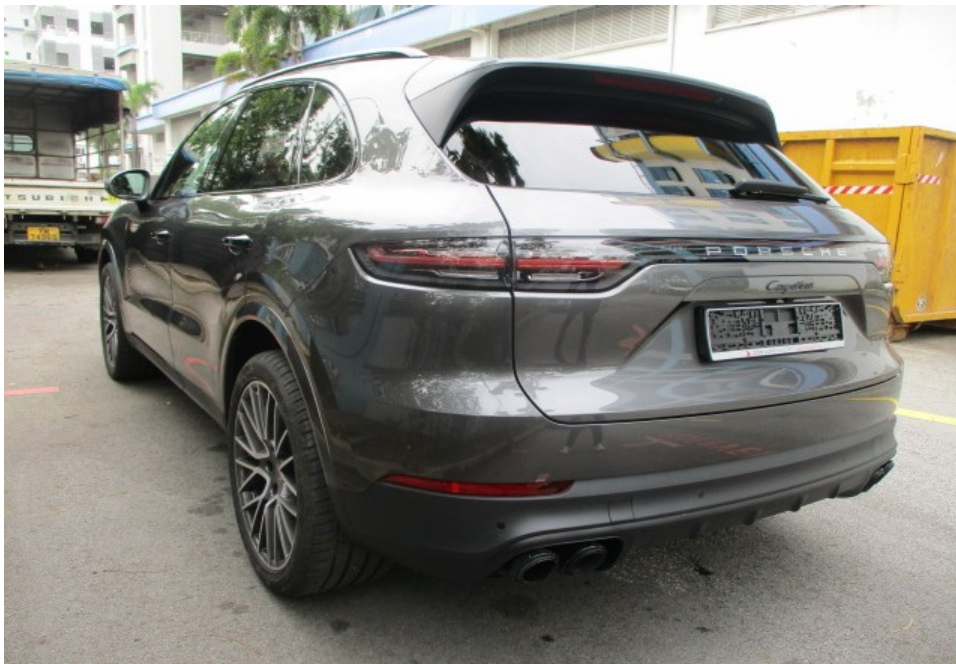
**Photo 5** shows a general view of the rear left body of the Motor Car at the time of my inspection. The Motor Car was observed to be in a relatively good general condition with no loose exterior fittings observed. The body parts at the rear left portion of the Motor Car were visually examined and it was observed that the repair/restoration works carried out to the damaged area of the Motor Car (refer to photograph 1 – 3 above) were reasonably adequate and in order.

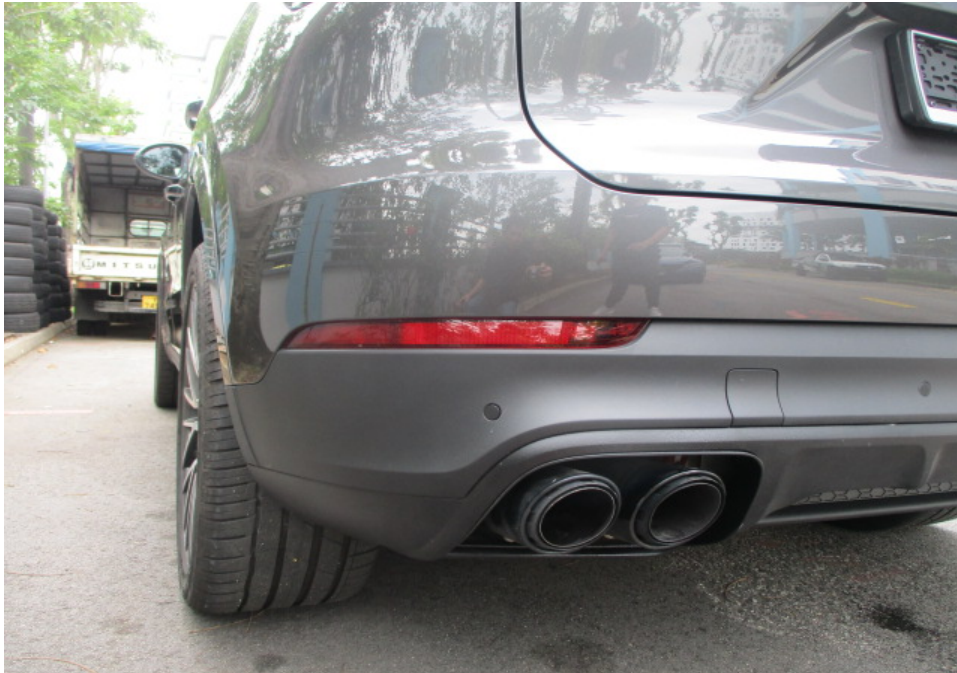
**Photo 6** shows a closer view of the Motor Car's rear bumper, rear bumper lower cover, rear bumper lower garnish, rear bumper left sensors and rear bumper left reflector at the time of my inspection. The body parts at the rear left portion of the Motor Car were visually examined and it was observed that the repair/restoration works carried out to the damaged area of the Motor Car (refer to photograph 1 – 3 above) were reasonably adequate and in order.

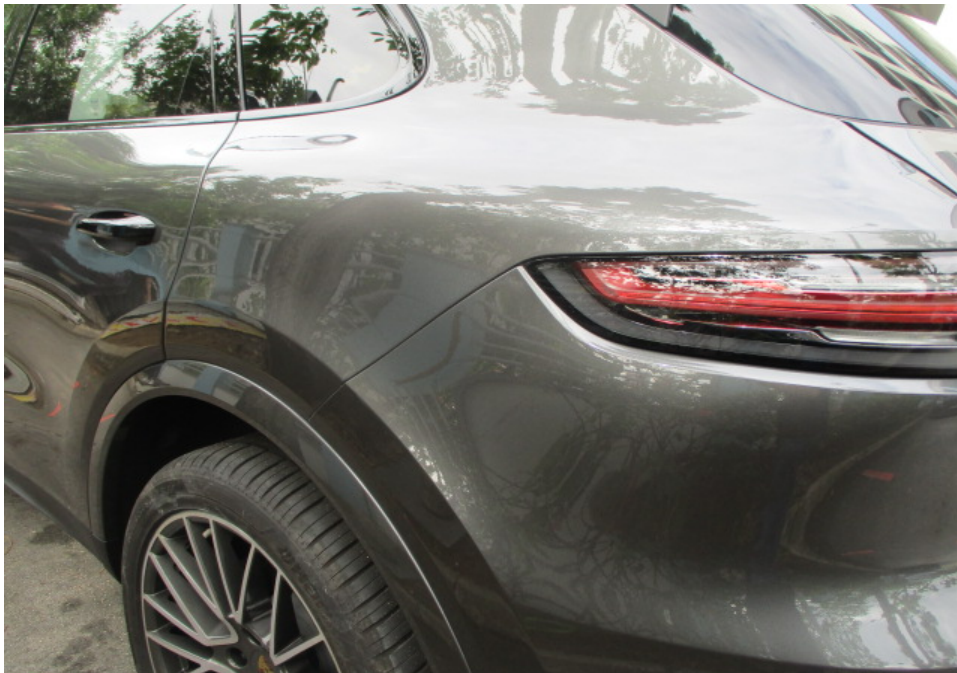
**Photo 7** shows a closer view of the Motor Car's rear bumper, rear left taillamp and rear left fender at the time of my inspection. The body parts at the rear left portion of the Motor Car were visually examined and it was observed that the repair/restoration works carried out to the damaged area of the Motor Car (refer to photograph 1 – 3 above) were reasonably adequate and in order.

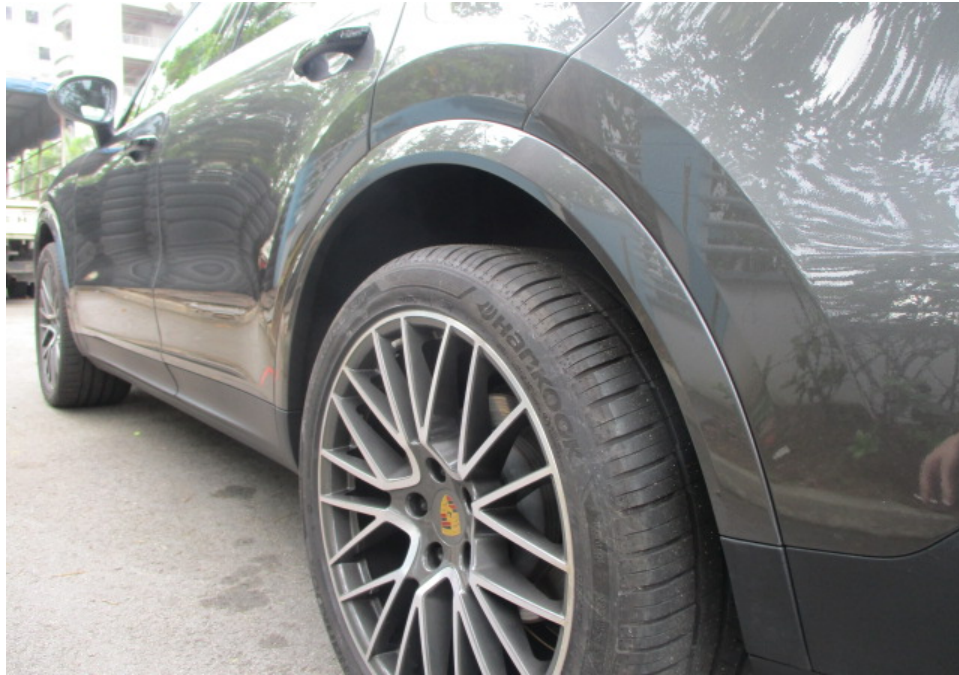
**Photo 8** shows a closer view of the Motor Car's rear left fender, rear left fender wheel arc garnish and rear left wheel rim at the time of my inspection. The body parts at the rear left portion of the Motor Car were visually examined and it was observed that the repair/restoration works carried out to the damaged area of the Motor Car (refer to photograph 1 – 3 above) were reasonably adequate and in order.

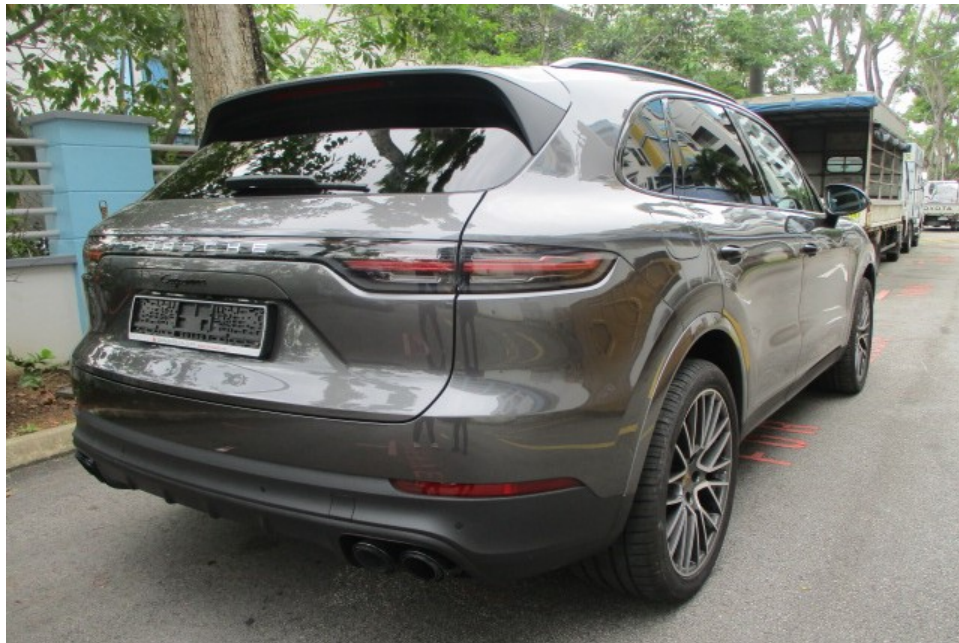
**Photo 9** shows a general view of the rear right body of the Motor Car at the time of my inspection. The Motor Car was observed to be in a relatively good general condition with no loose exterior fittings observed. The body parts at the rear left portion of the Motor Car were visually examined and it was observed that the repair/restoration works carried out to the damaged area of the Motor Car (refer to photograph 1 – 3 above) were reasonably adequate and in order.

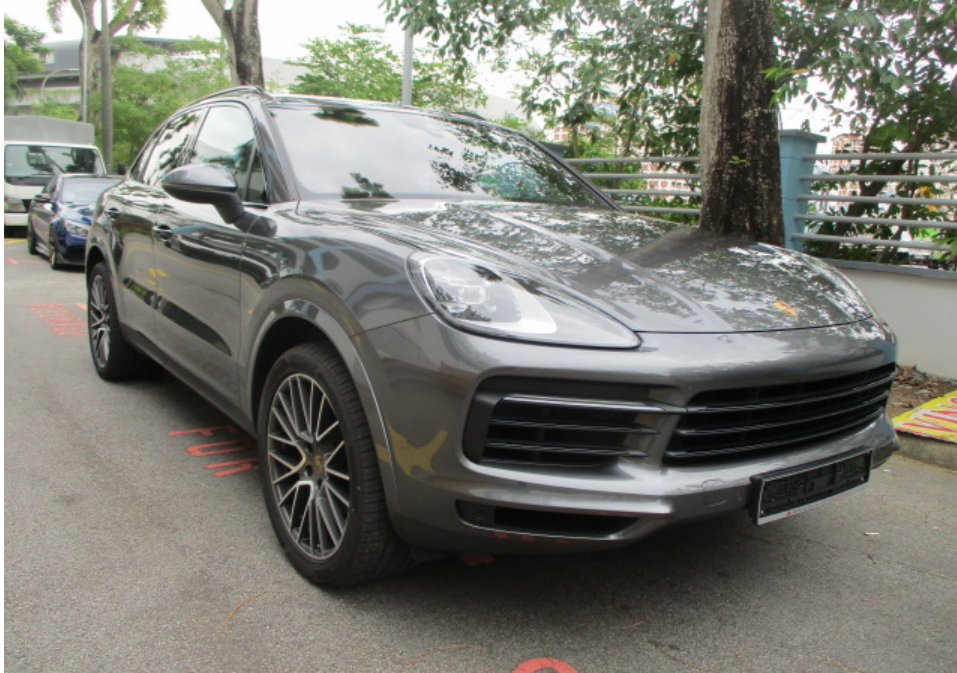
**Photo 10** shows a general view of the front right body of the Motor Car at the time of my inspection. The Motor Car was observed to be in a relatively good general condition with no loose exterior fittings observed. The mileage of the Motor Car recorded at the time of my inspection was 9,942km.

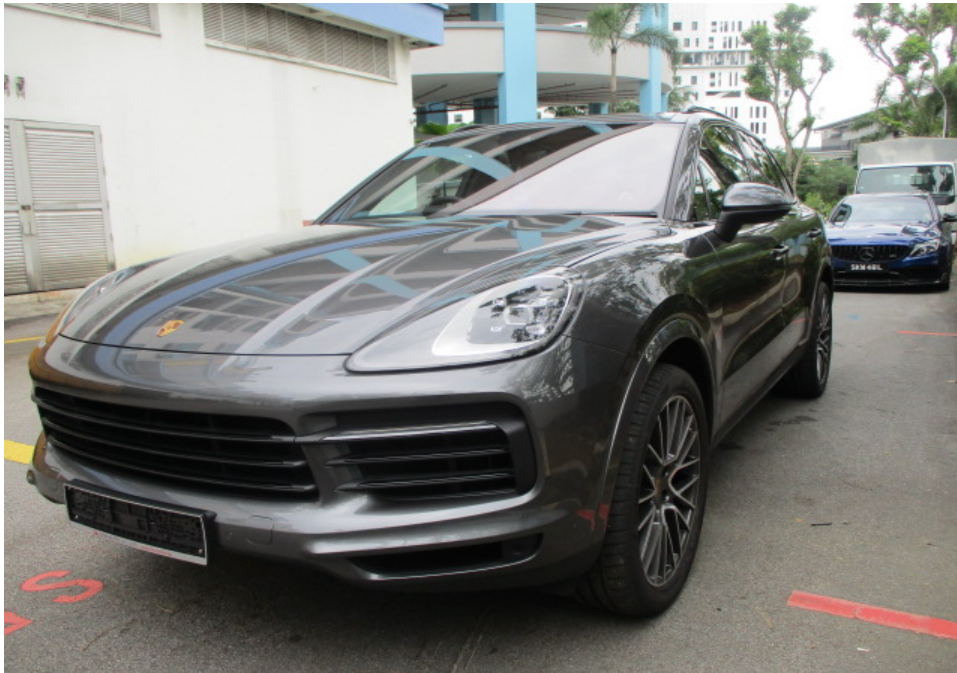
**Photo 11** shows a general view of the front left body of the Motor Car at the time of my inspection. The Motor Car was observed to be in a relatively good general condition with no loose exterior fittings observed. The mileage of the Motor Car recorded at the time of my inspection was 9,942km.

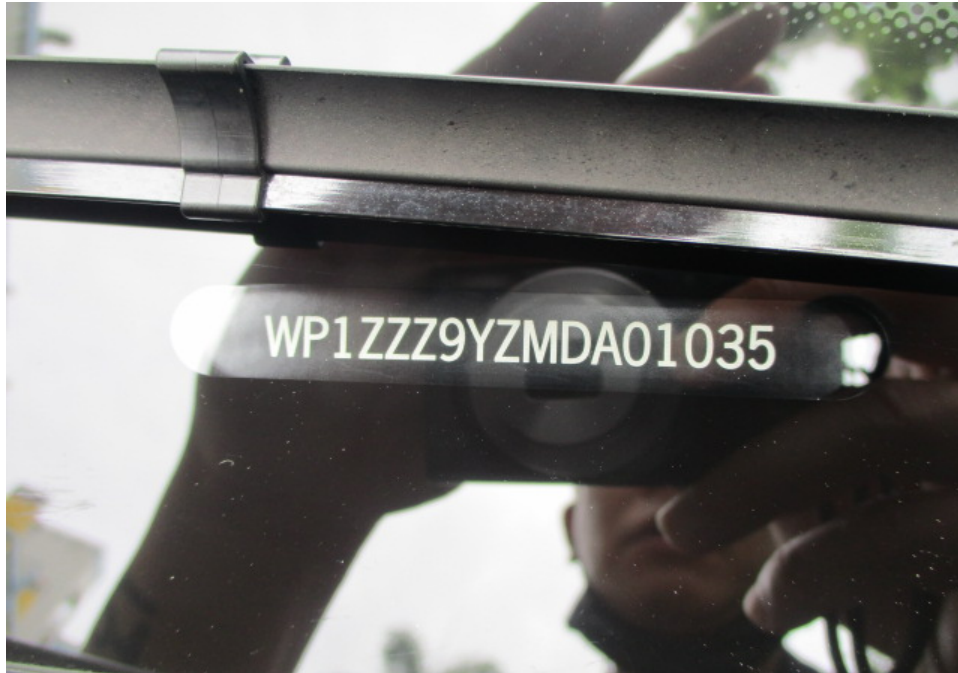
**Photo 12** shows the chassis number of the Motor Car. The chassis number recorded was WP1ZZZ9YZMDA01035.

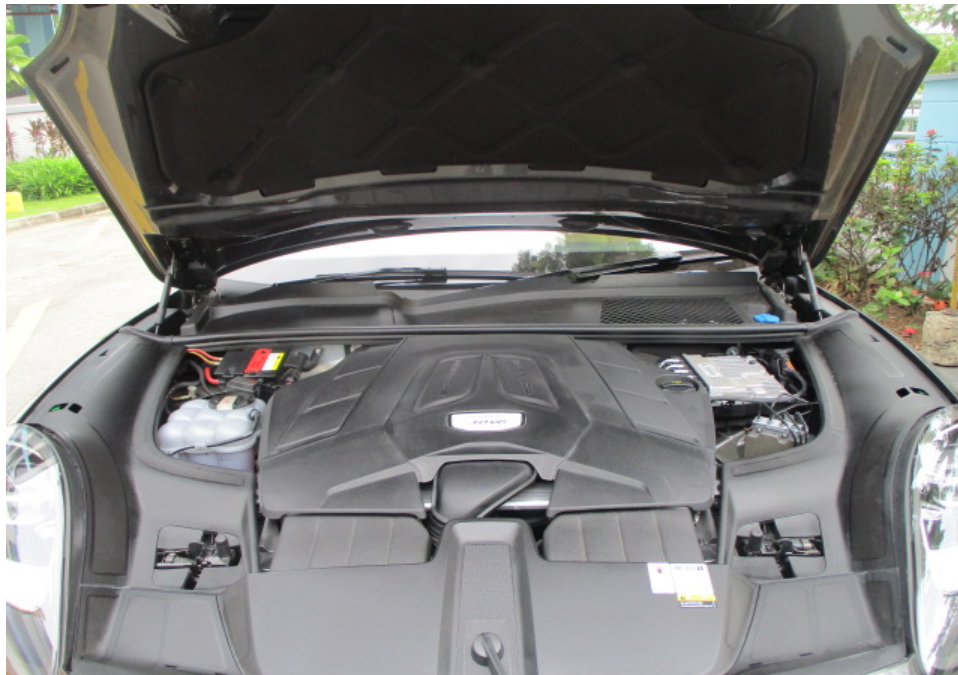
**Photo 13** shows a general view of the engine compartment of the Motor Car at the time of my inspection. The various parts and components inside the engine compartment were all observed to be intact and properly fitted. There was also no sign(s) or indication(s) of fluid leak and/or fluid stain found inside the engine compartment.

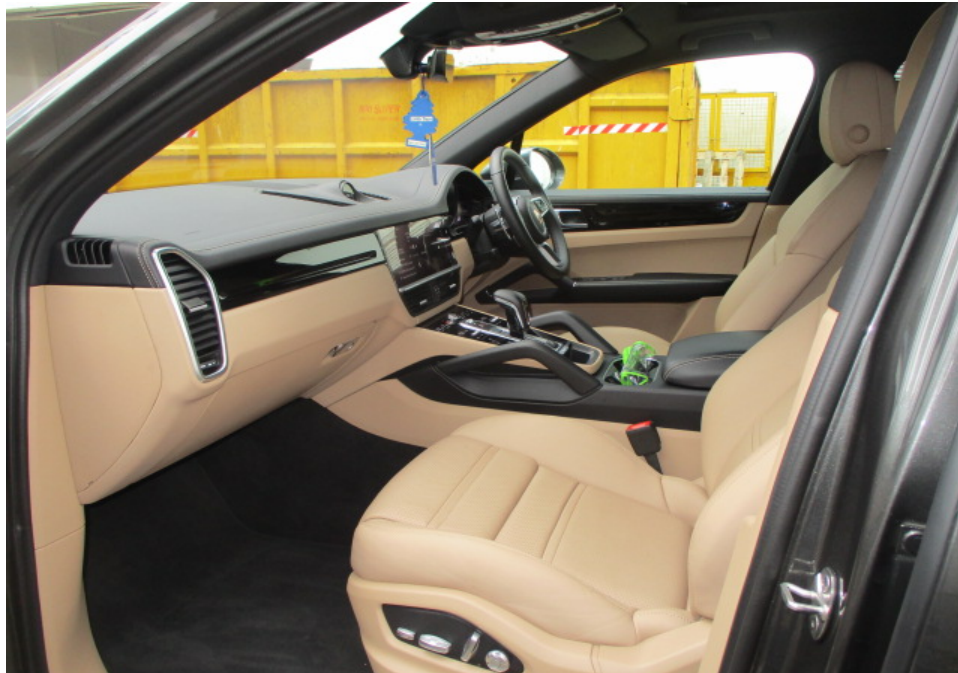
**Photo 14** shows the interior compartment of the Motor Car at the time of my inspection. The various parts and components, trims, carpet, and upholstery inside the interior compartment were all observed to be intact and properly fitted.

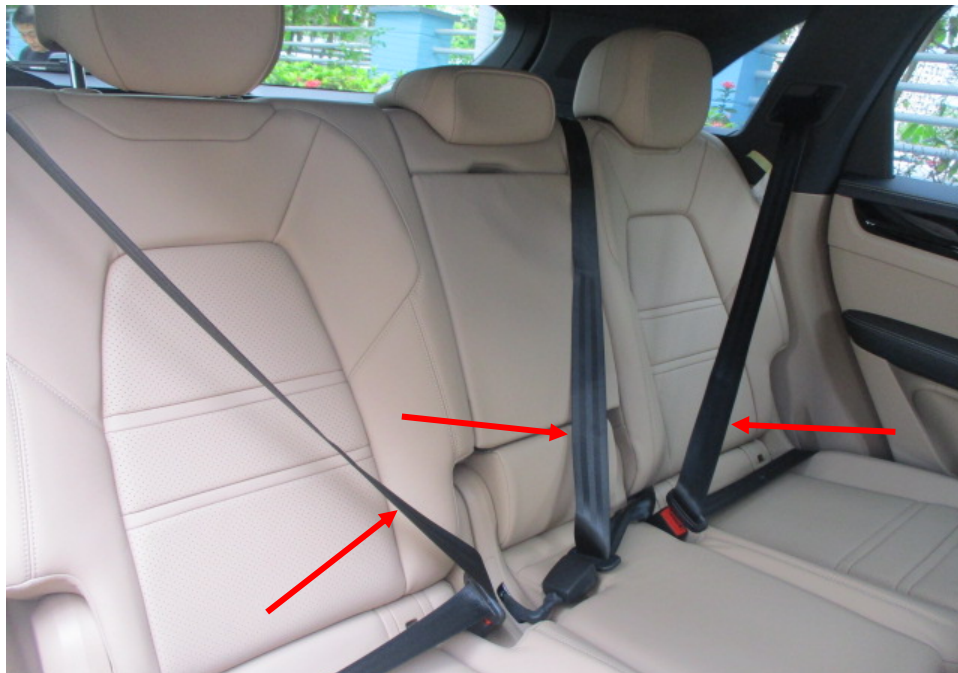
**Photo 15** shows the rear seats of the Motor Car. All the seats of the Motor Car were secured via seat rails to the floorboard. They were also fitted with a retractable seat belt reel and a pre-tensioner. The seat belts (arrowed) were tested and were able to be fastened into the respective pre-tensions that were fitted on the side of each individual seat.

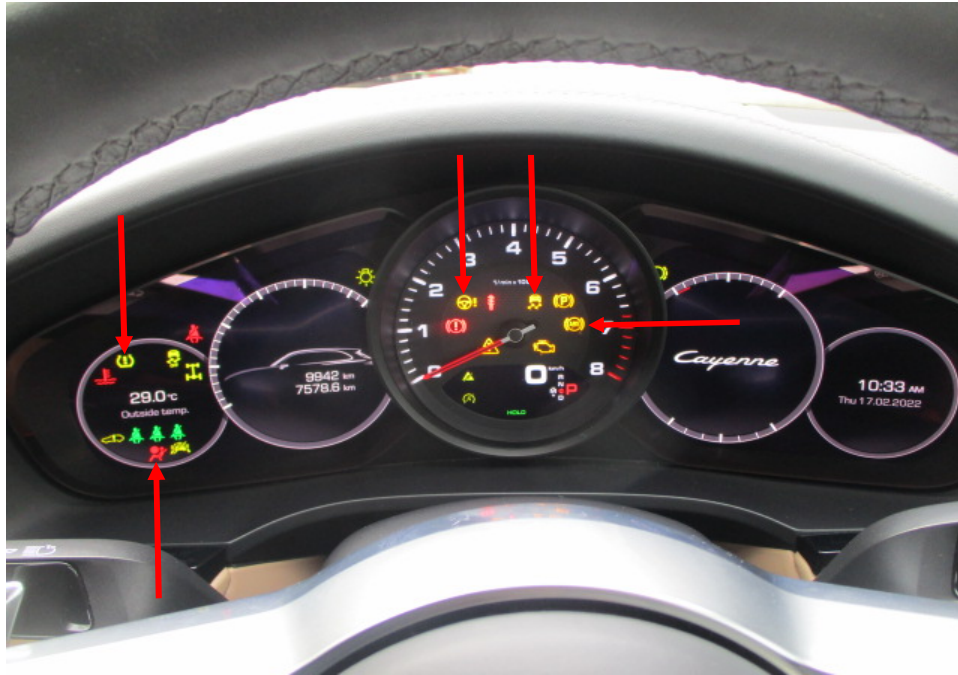
**Photo 16** shows the warning lights for the various electronic safety features appearing on the instrument panel of the Motor Car during its self-test when the engine is cranked, in particular the ABS, SRS, EPS, TPM and TCS lights (arrowed).

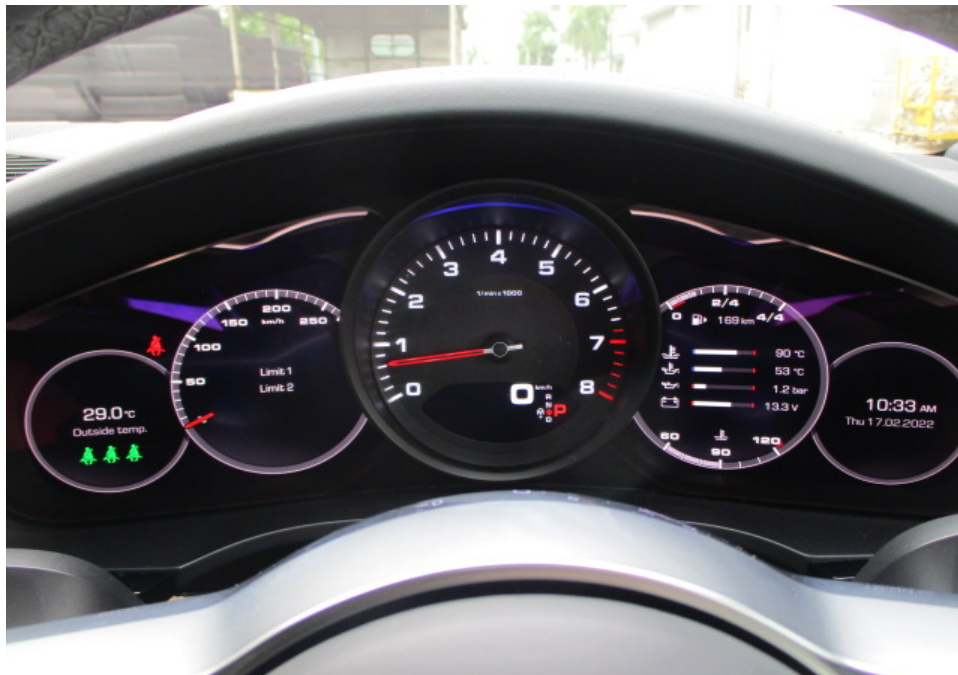
**Photo 17** shows the respective warning lights no longer illuminated, indicating that there is no fault detected to the ABS, SRS, EPS, TPM and TCS systems of the Motor Car during the self-test. These electronic systems were hence in working condition at the time of my inspection.

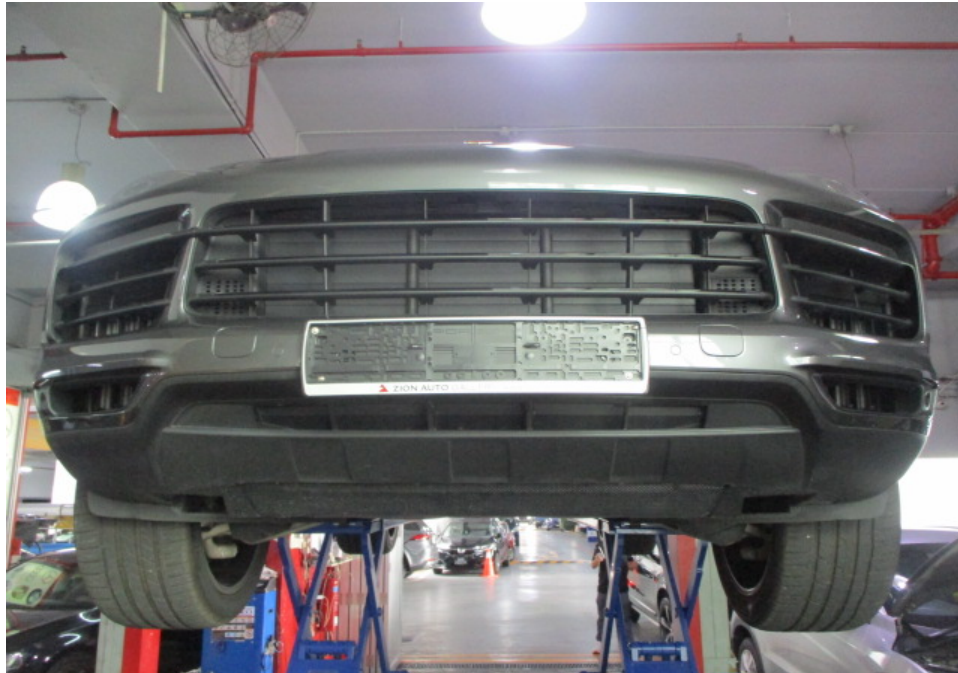
**Photo 18** shows the Motor Car hoisted up for checks on its undercarriage. There was no sign(s) or indication(s) of fluid leakage and/or fluid stain(s) on the underside of the Motor Car. The undercarriage components of the Motor Car were also all observed to be intact and secured in an appropriate manner.

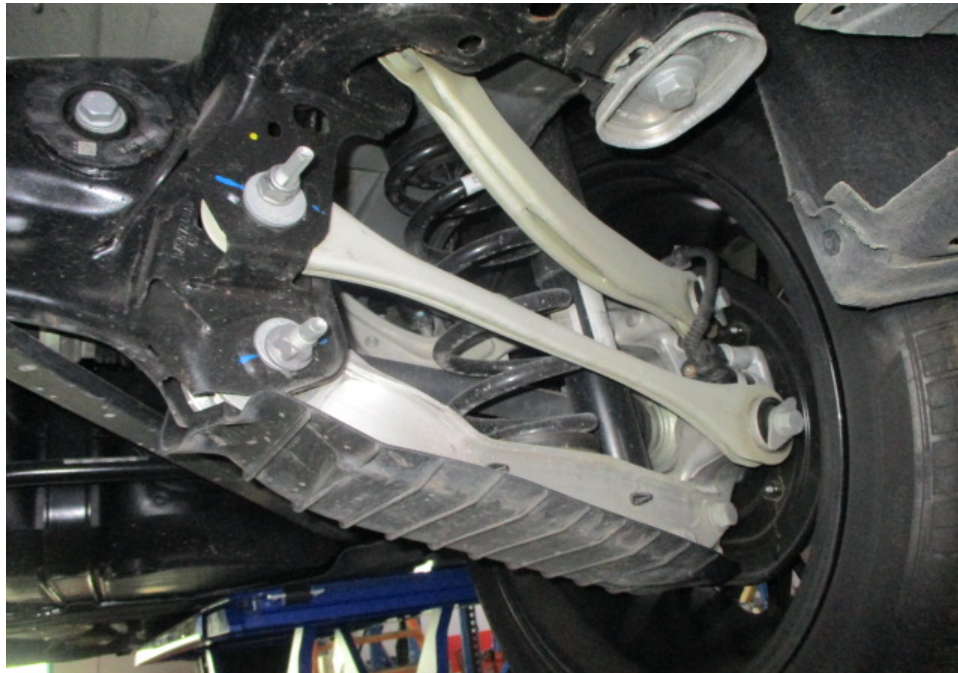
**Photo 19** shows a general view of the control arms and linkages at the rear right wheel of the Motor Car. I did not observe any fluid leak and/or fluid stain on the underside of the Motor Car. All of the Motor Car's undercarriage components were observed to be intact and secured in an appropriate manner.

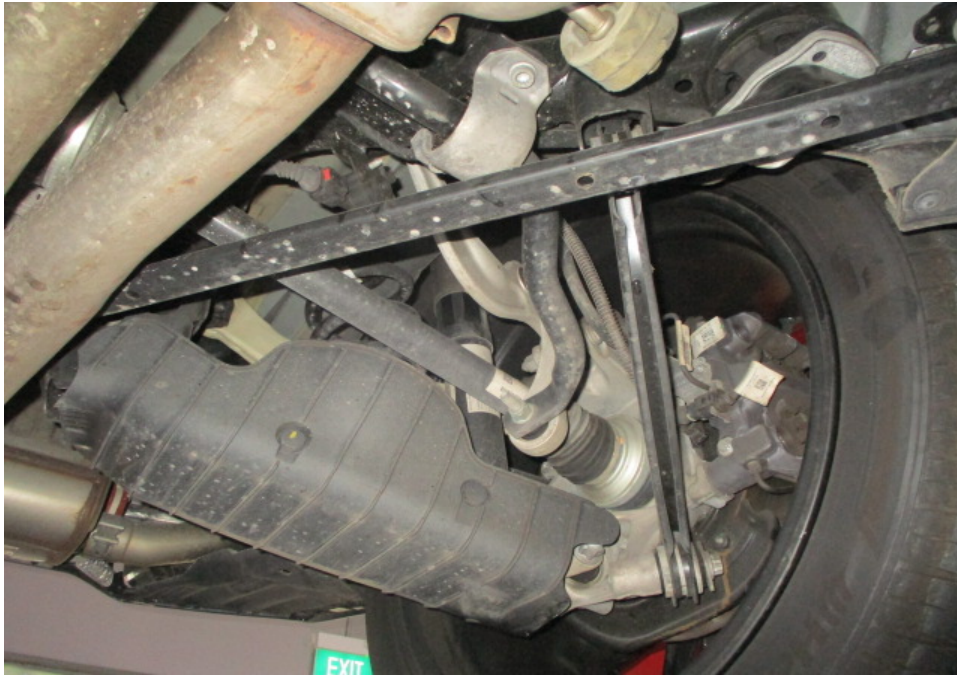
**Photo 20** shows a general view of the control arms and linkages at the rear left wheel of the Motor Car. I did not observe any fluid leak and/or fluid stain on the underside of the Motor Car. All of the Motor Car's undercarriage components were observed to be intact and secured in an appropriate manner.

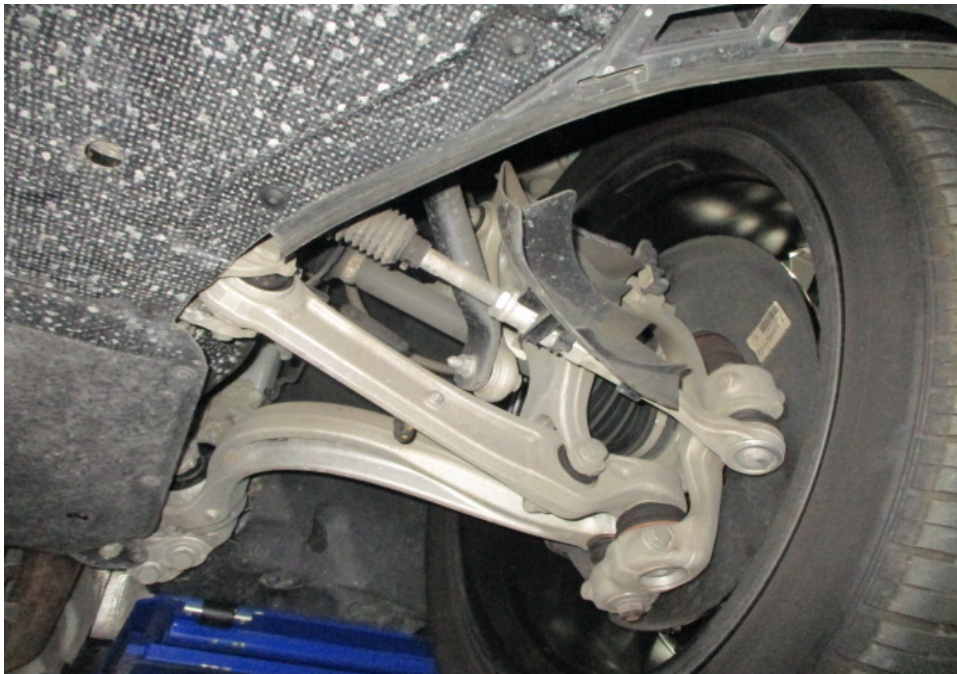
**Photo 21** shows the various undercarriage components at the front left wheel of the Motor Car. The mechanical components, control arms and linkages were all found to be intact and secured in an appropriate manner.

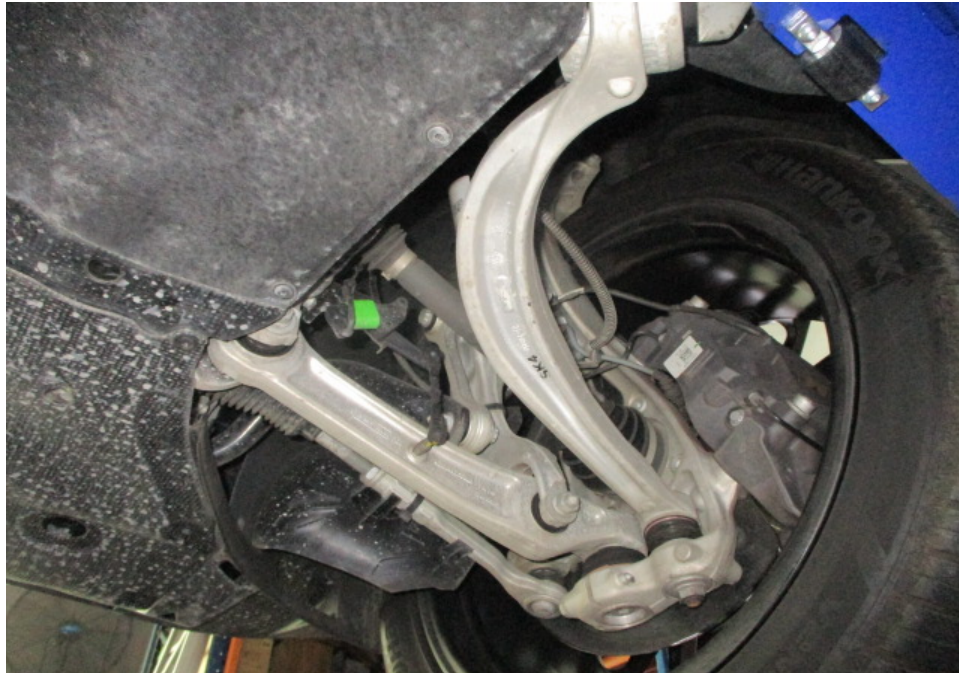
**Photo 22** shows the various undercarriage components at the front right wheel of the Motor Car. The mechanical components, control arms and linkages were all found to be intact and secured in an appropriate manner. I also did not observe any fluid leak and/or fluid stain on the underside of the Motor Car.

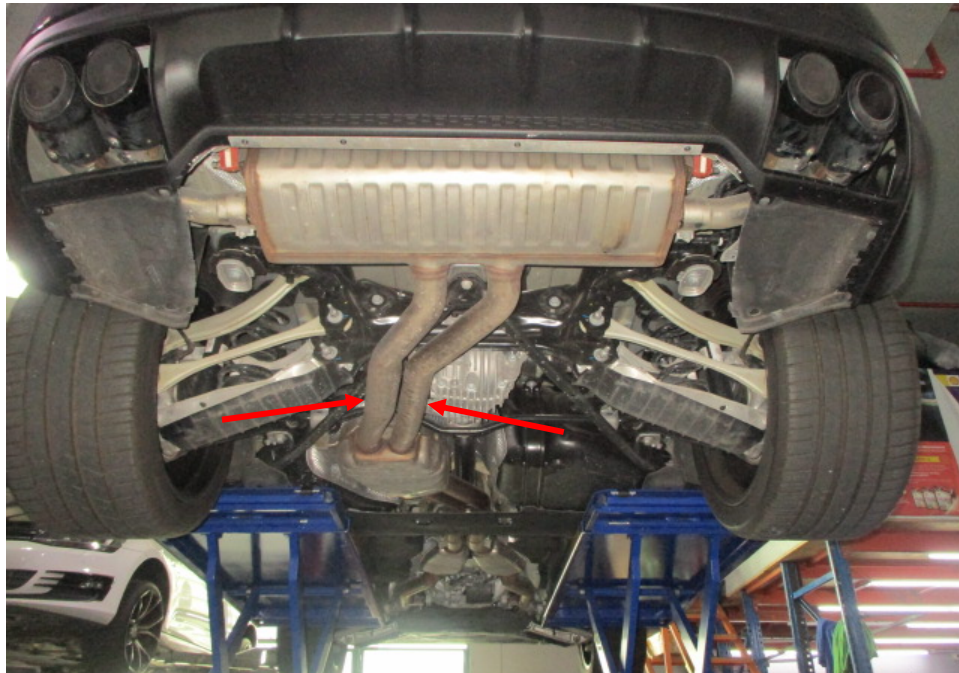
**Photo 23** shows the rear section of the Motor Car's exhaust system. My examination of the Motor Car's exhaust system revealed no sign(s) or indication(s) of any cut or weld marks along its exhaust pipes (arrowed), on its rear muffler, on its centre resonator boxes and on its catalytic converters.

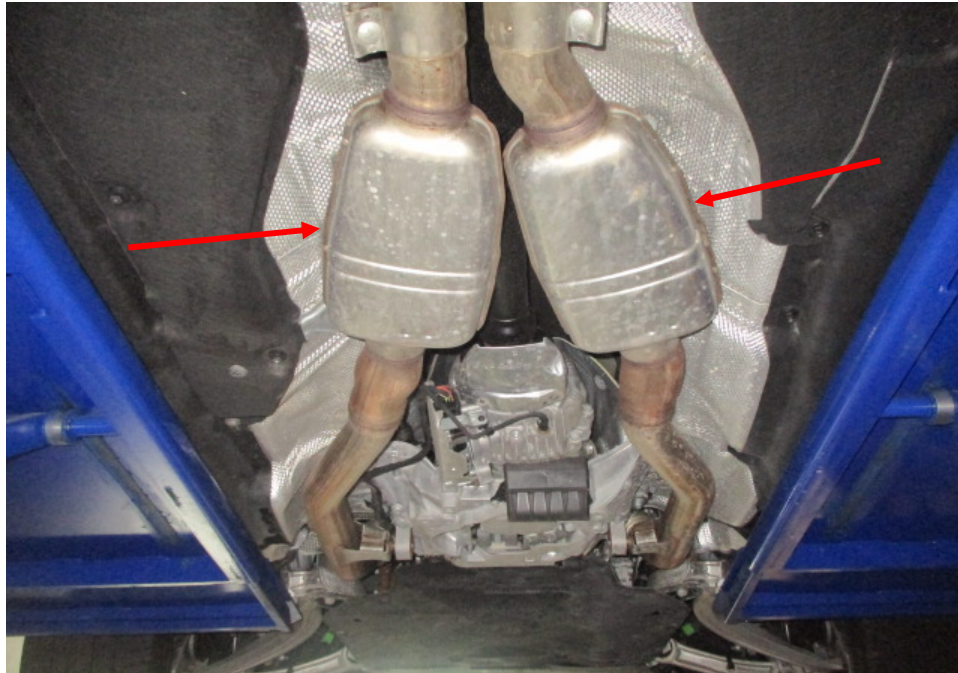
**Photo 24** shows the front section of the Motor Car's exhaust system. My examination of the Motor Car's exhaust system revealed no sign(s) or indication(s) of any cut or weld marks along its exhaust pipes, on its rear muffler, on its centre resonator boxes (arrowed) and on its catalytic converters.

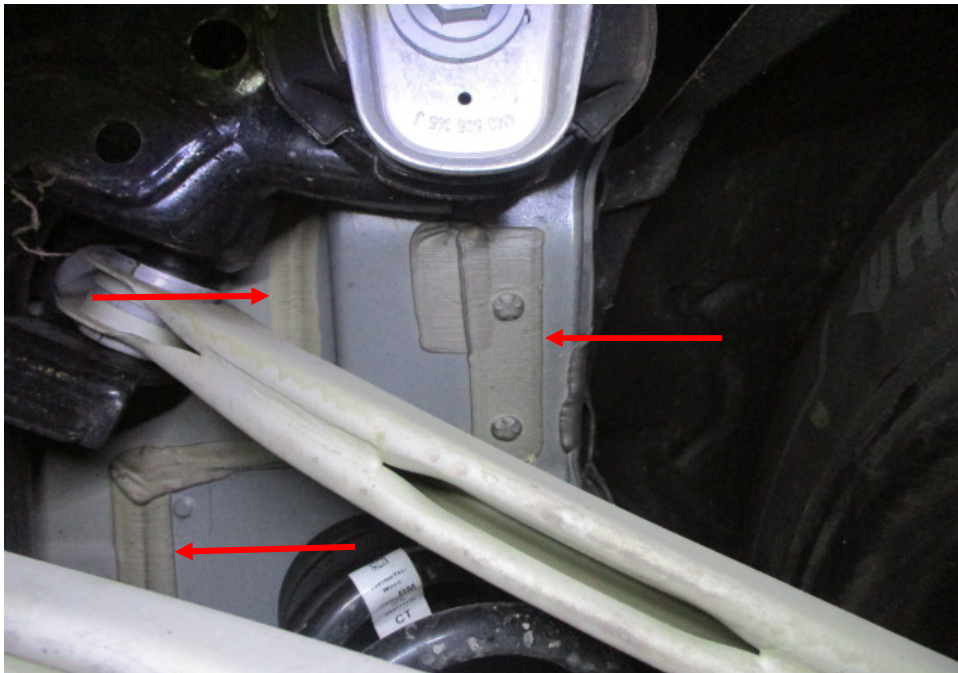
**Photo 25** shows the chassis/structural body at the underside rear right of the Motor Car. I did not find any weld marks other than original spot weld marks on the chassis/structural body of the Motor Car. The original factory sealant (arrowed) at the joints along the chassis/structural body was untouched, indicating no work was done on the chassis/structural body of the Motor Car and that the chassis/structural body was originally fitted.

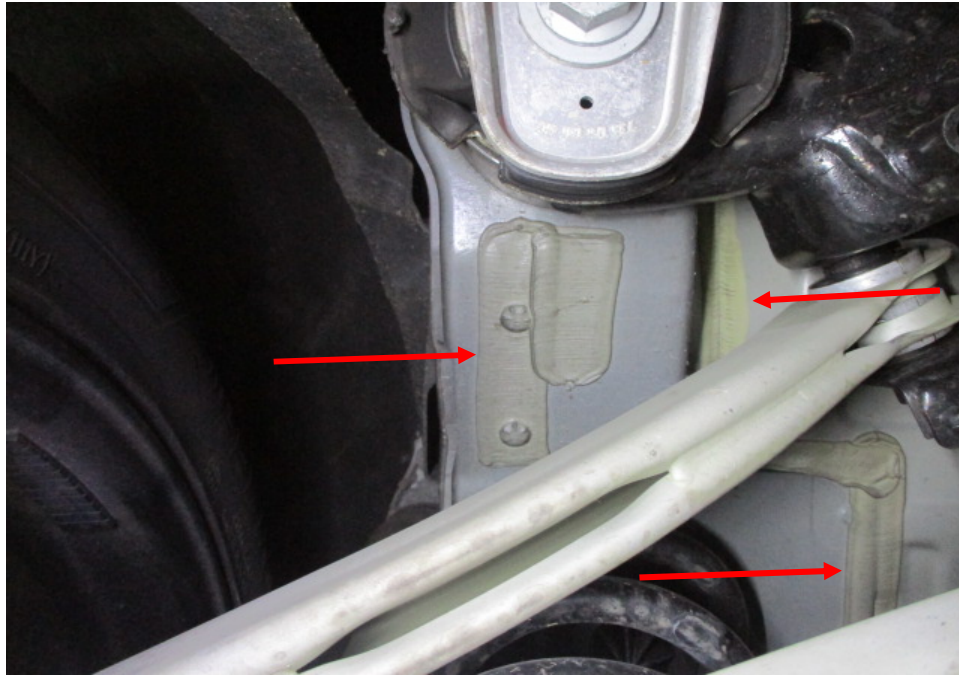
**Photo 26** shows the chassis/structural body at the underside rear left of the Motor Car. The original factory sealant (arrowed) at the joints along the chassis/structural body was observed to be untouched. In general, I had found no work was carried out on the chassis/structural body of the Motor Car. The chassis/structural body of the Motor Car was originally fitted.

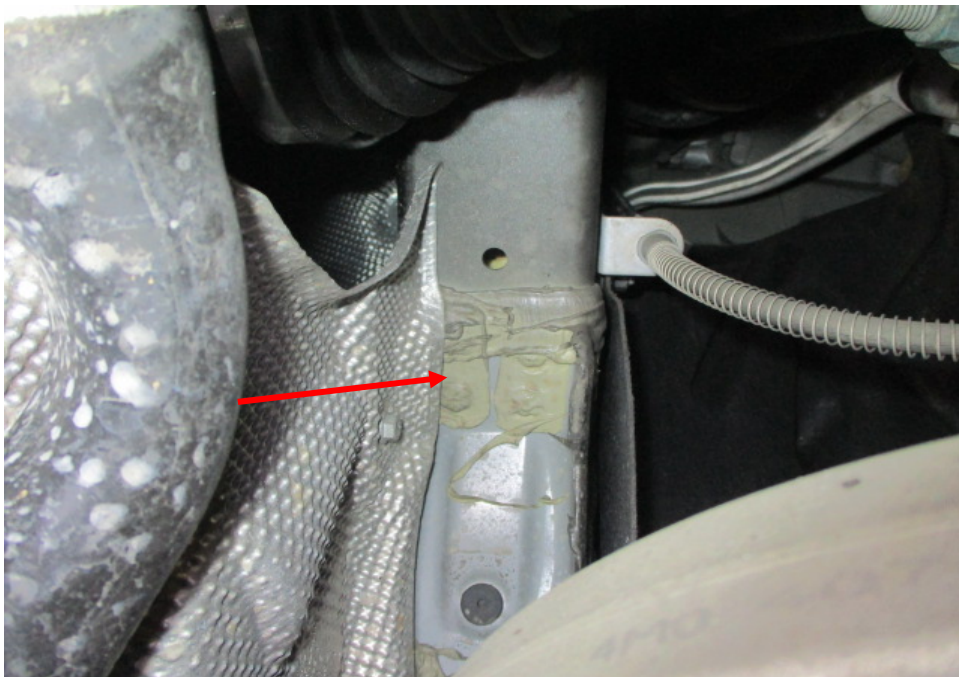
**Photo 27** shows the chassis/structural body at the underside front left of the Motor Car. I did not find any weld marks other than original spot weld marks on the chassis/structural body of the Motor Car. The original factory sealant (arrowed) at the joints along the chassis/structural body was untouched, indicating no work was done on the chassis/structural body of the Motor Car and that the chassis/structural body was originally fitted.

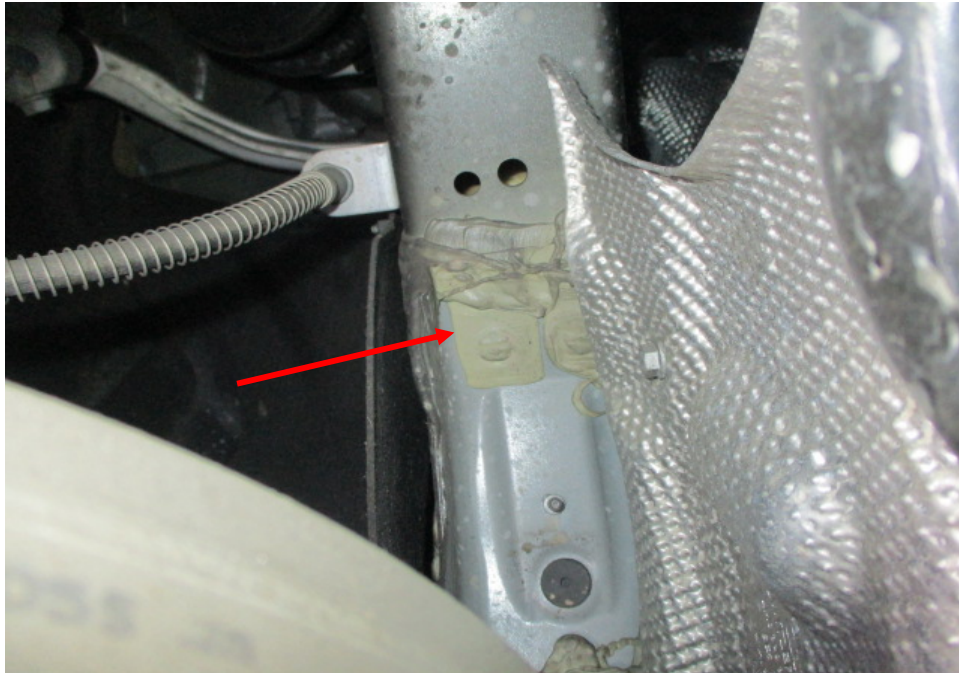
**Photo 28** shows the chassis/structural body at the underside front right of the Motor Car. The original factory sealant (arrowed) at the joints along the chassis/structural body was observed to be untouched. In general, I had found no work was carried out on the chassis/structural body of the Motor Car. The chassis/structural body of the Motor Car was originally fitted.
