LKK Auto Consultants Pte Ltd

Affiliated to Federation Internationale Des Experts En Automobile				
CHINA TAIPING INSURANCE (S) PTE LTD 3 ANSON ROAD #16-00 SPRINGLEAF TOWERSINGAPORE 079909			Ref: CC3/CTI22001643/Tpa3q2 Date: 01/11/2022 Code: CTI

ADJUSTMENT ON REPAIR COST FOR VEHICLE NO. SHB 8043T

PHOTOGRAPHS FOR VEHICLE NO. SHB 8043T

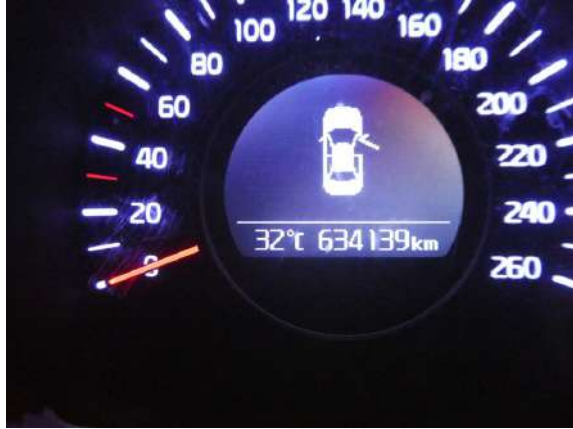
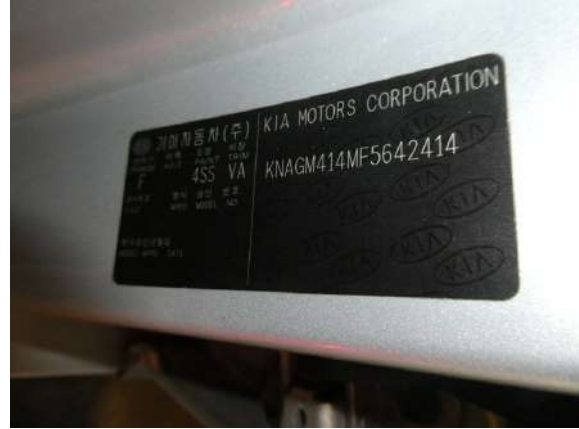
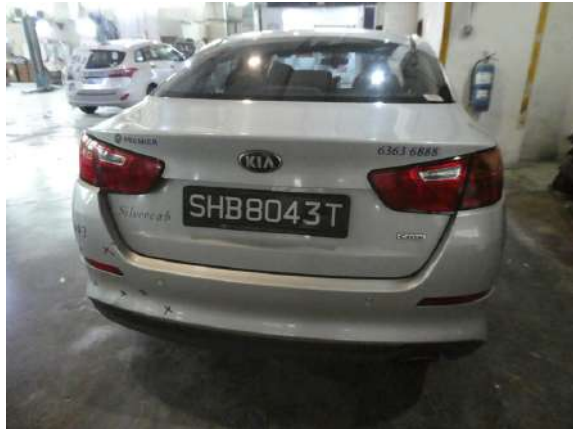
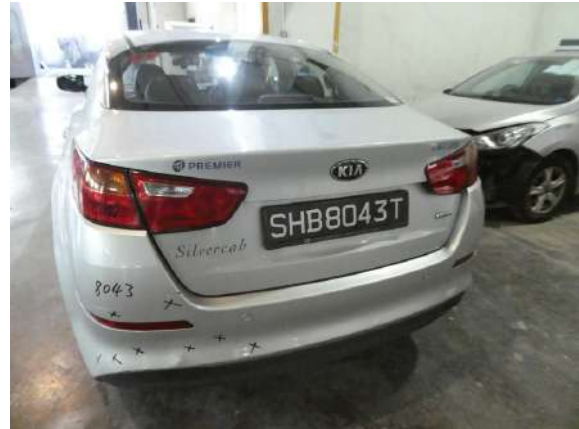
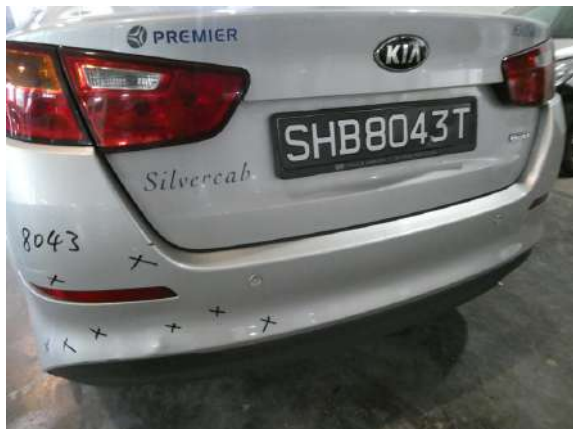
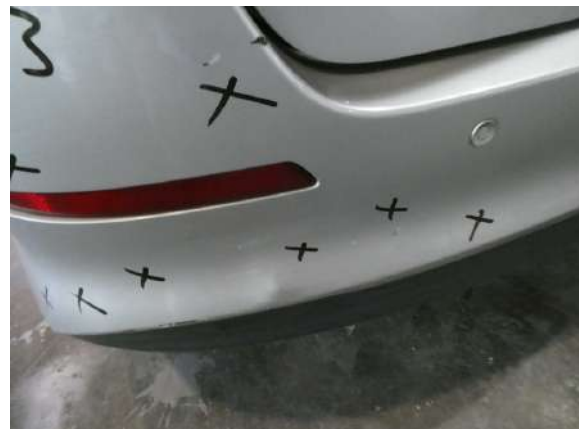
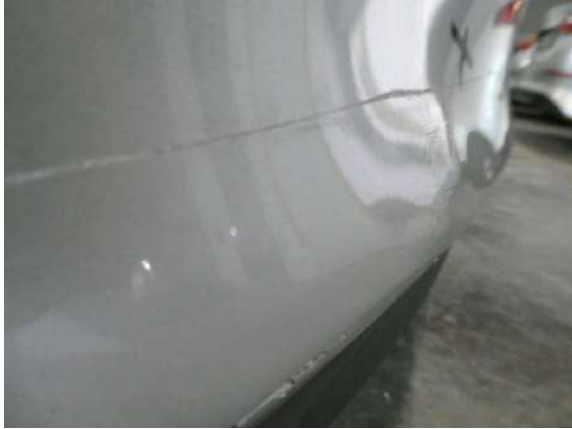
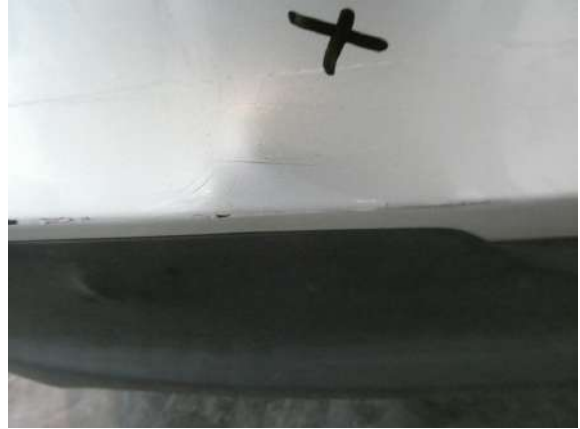
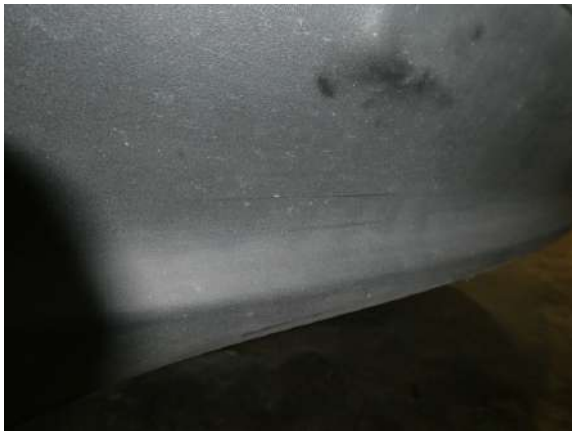
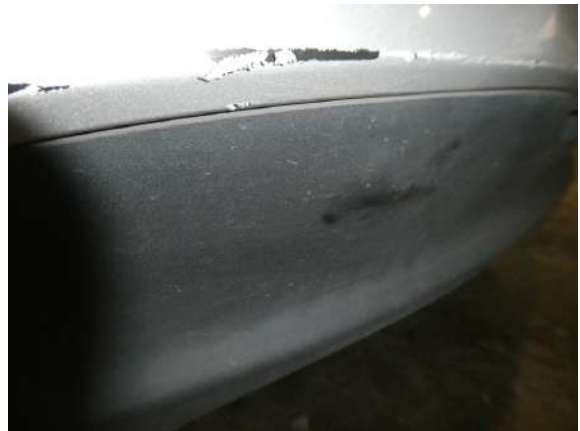
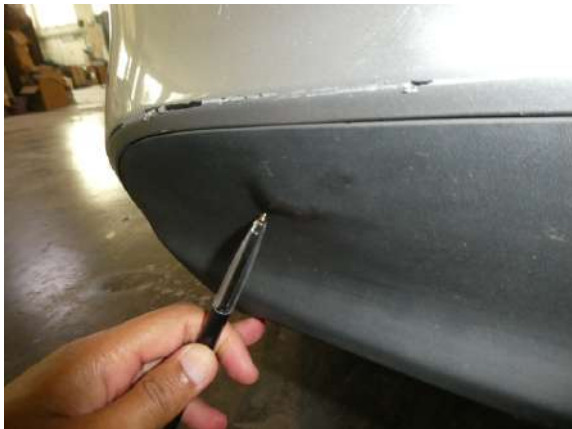
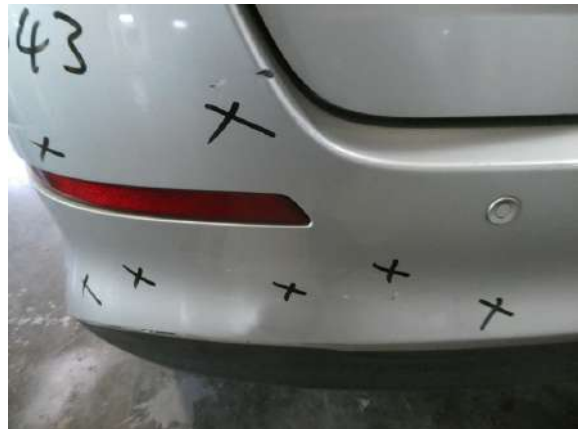
4. Description of Damages				
THE VEHICLE SUSTAINED DAMAGES AT THE REAR PORTION. DAMAGES SEE DETAILS.				
5. General Information				
Accident Date	19/02/2022	Inspection Date	21/02/2022	
Survey held at	PREMIER AUTOMOTIVE SERVICES PTE LTD 23 CHANGI SOUTH AVENUE 2 #01-02 SINGAPORE 486443			
5a. Remarks				
A)THE INSPECTION WAS CONDUCTED ON A"WITHOUT PREJUDICE" BASIS. B)IN ACCORDANCE TO YOUR INSTRUCTIONS, WE HAVE NOT AUTHORISED REPAIRS.				
5b. Estimate Days of Repair				
ESTIMATED NORMAL PERIOD FOR REPAIR:			2 Working Days
