You're Ref: TP/REG/20/2021
Our Ref: CI/TPD22001758/P

Fatal Incident Investigation Team

MECHANICAL INSPECTION REPORT OF MOTOR CAR SGP 6680E

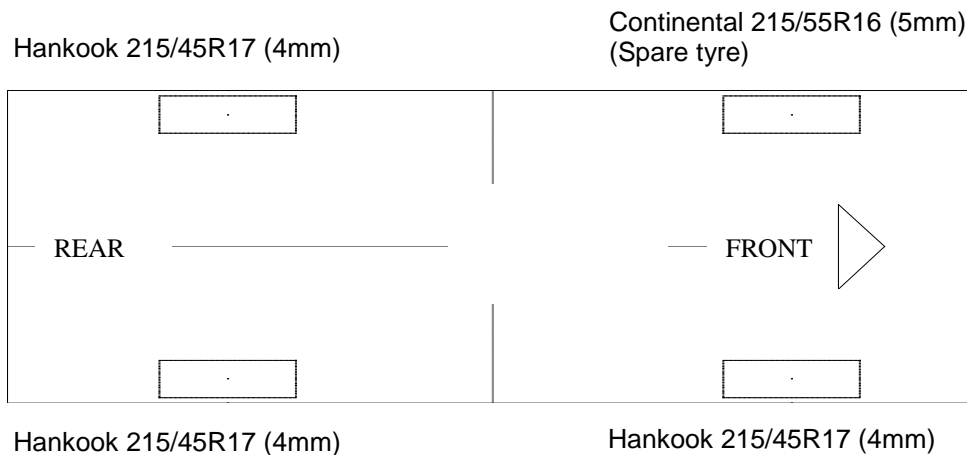
6. The condition of the Motor Car's 4 tyres was observed to be in serviceable condition. I did not find any tear, cut or burst mark(s) on the outer and the inner sidewalls as well as across the tread of the 4 tyres. The 4 tyres were also observed to be sufficiently inflated for vehicular operation. The tyre brand, tyre size and remaining tread depth of the 4 tyres were recorded as follows:-

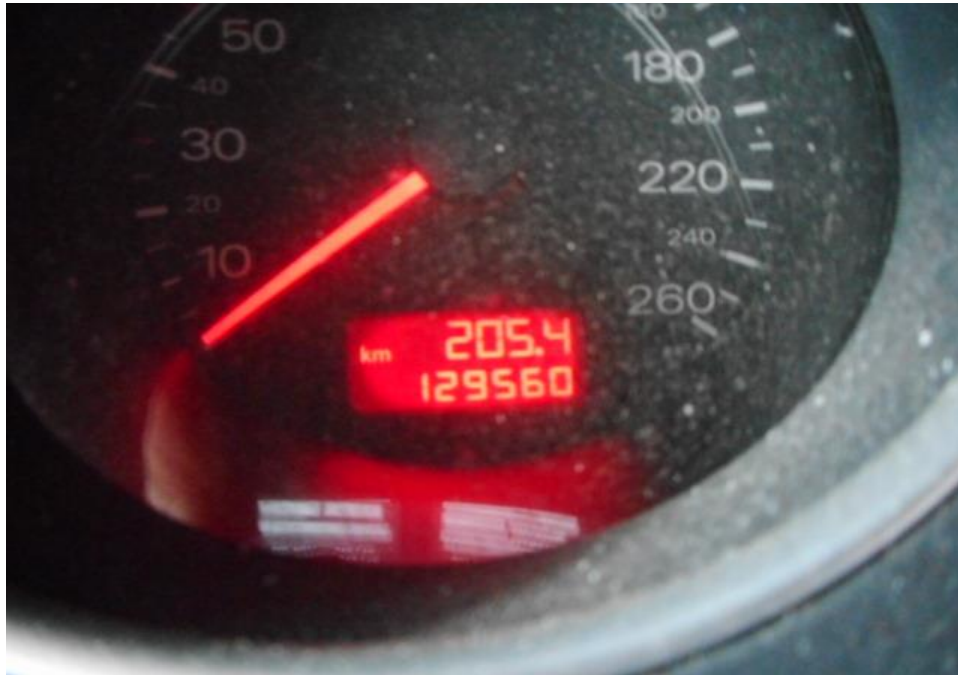
Photo 1 shows the mileage of the Motor Car at the time of my inspection. The mileage observed was 129,560km.

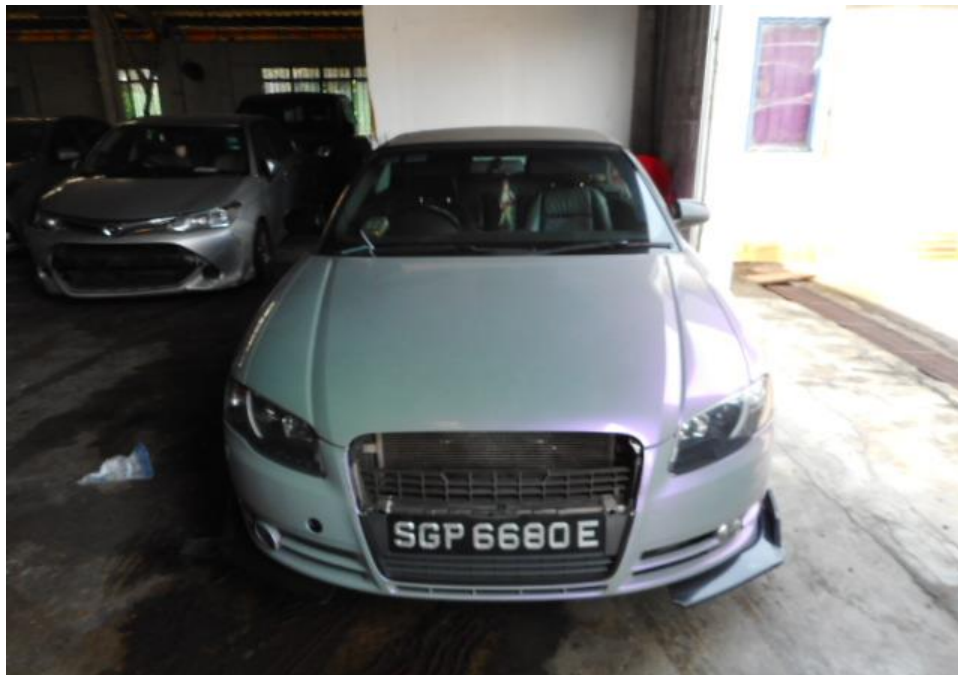
Photo 2 shows a general view of the Motor Car's front body at the time of my inspection. The Motor Car front was observed to be unaffected by the incident.

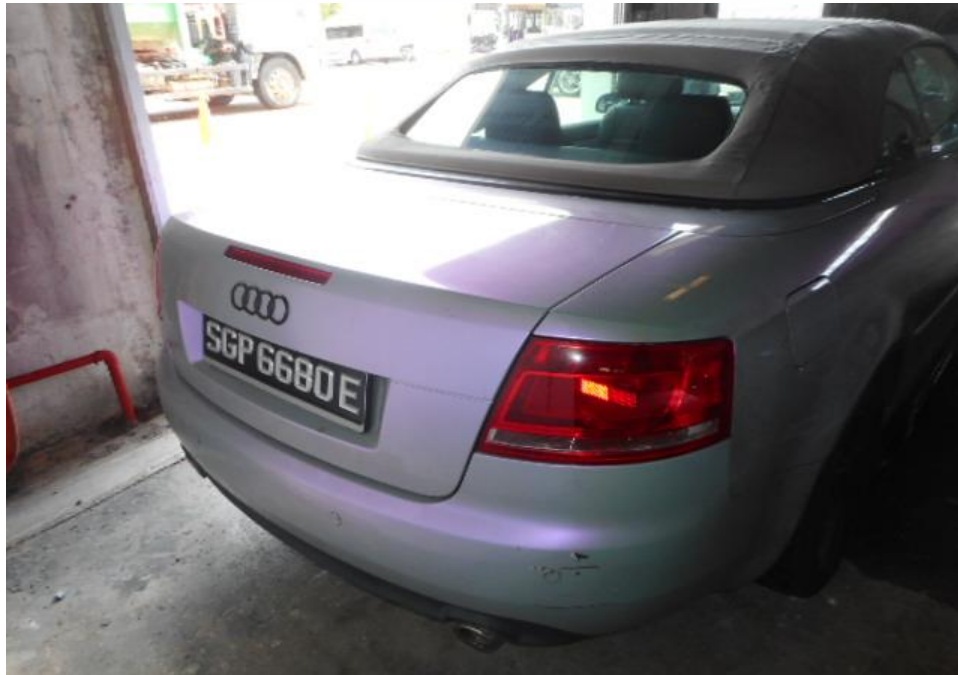
Photo 3 shows the general view of the Motor Car's rear body at the time of my inspection. The Motor Car was observed to have sustained damage at its rear bumper portion. Its rear bumper right portion were amongst were the body parts that were damaged as a result of the incident.

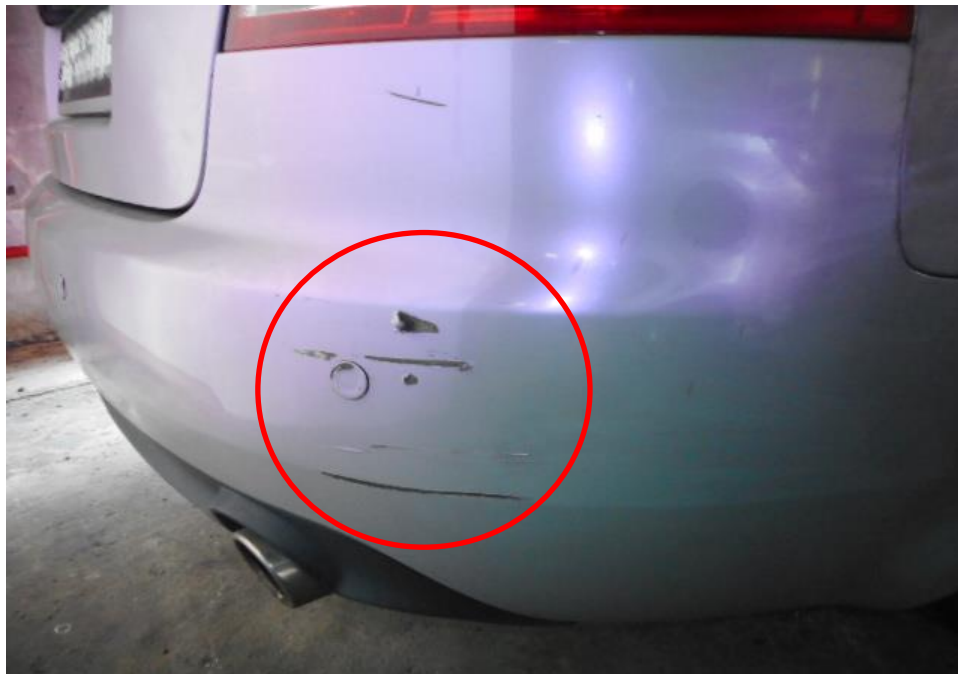
Photo 4 shows a close up view of the Motor Car's rear portion at the time of my inspection. The Motor Car was observed to have sustained damage at its rear bumper portion. Its rear bumper right portion (circled) were the body parts that were damaged as a result of the incident.

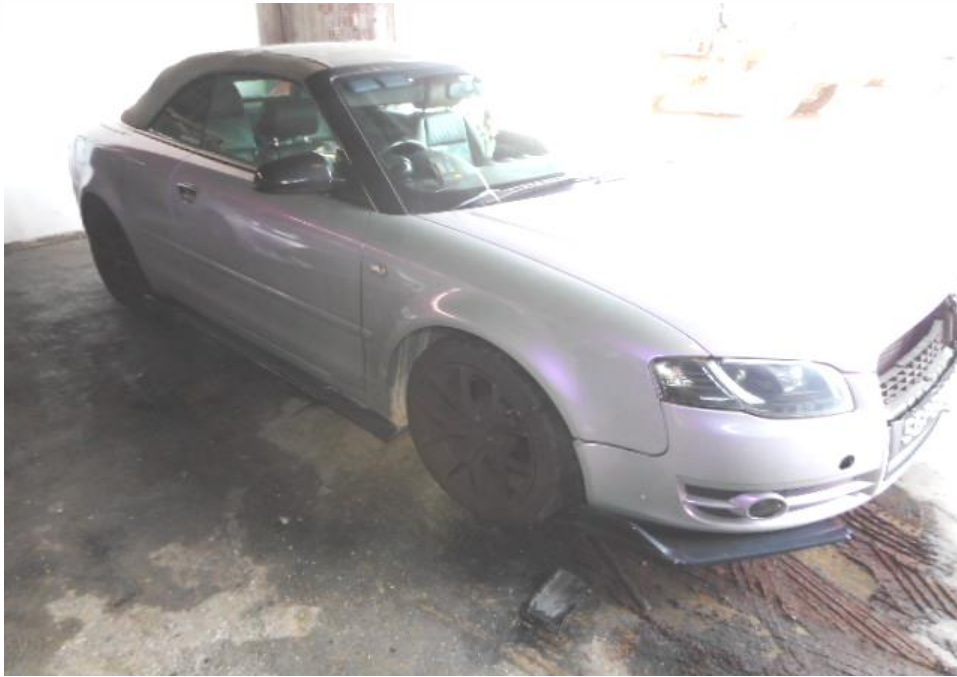
Photo 5 shows a general view of the Motor Car's right body at the time of my inspection. The right portion of the Motor Car was observed to have been unaffected by the incident.

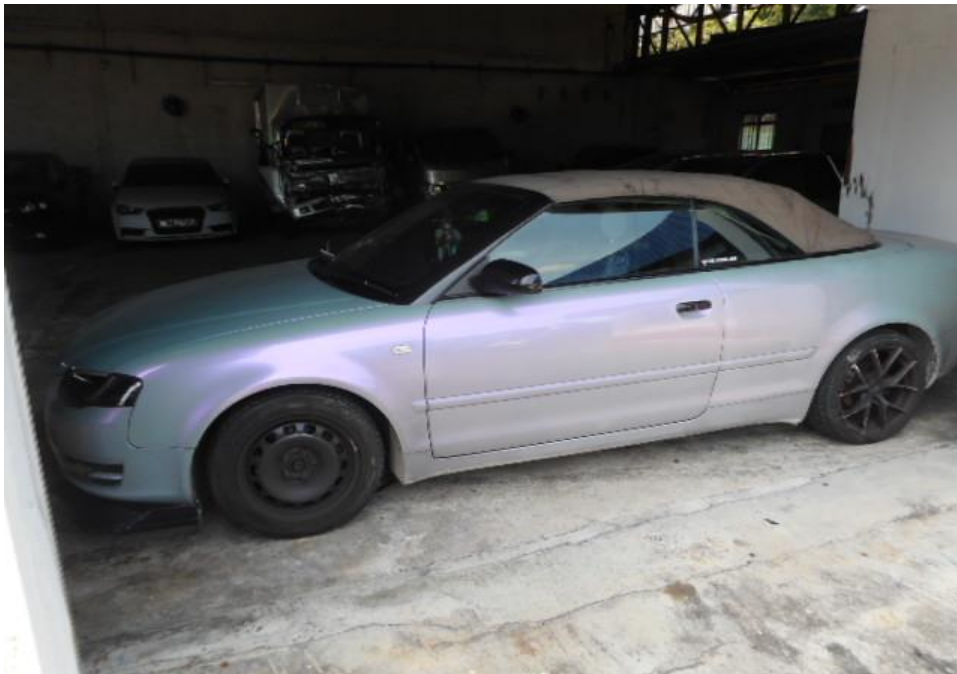
Photo 6 shows a general view of the Motor Car's left body at the time of my inspection. The left portion of the Motor Car was observed to have been unaffected by the incident.

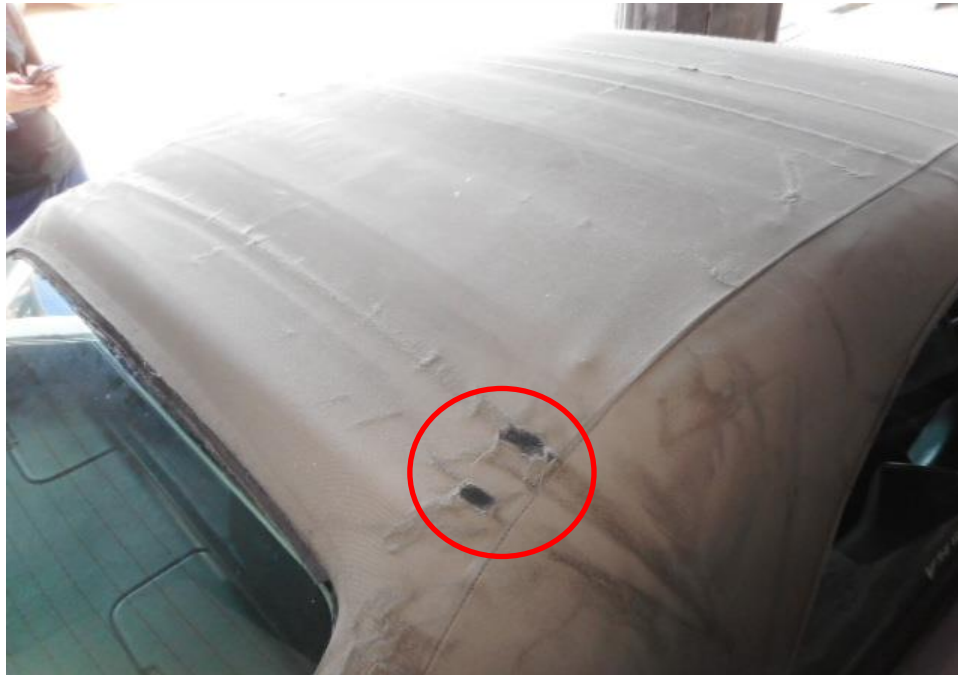
Photo 7 shows a general view of the Motor Car's cloth roof portion at the time of my inspection. There was holes present prior to the incident at the rear right cloth roof portion (circled) of the Motor Car and water intrusion had likely started from these holes flowing down into the interior cabin of the Motor Car.

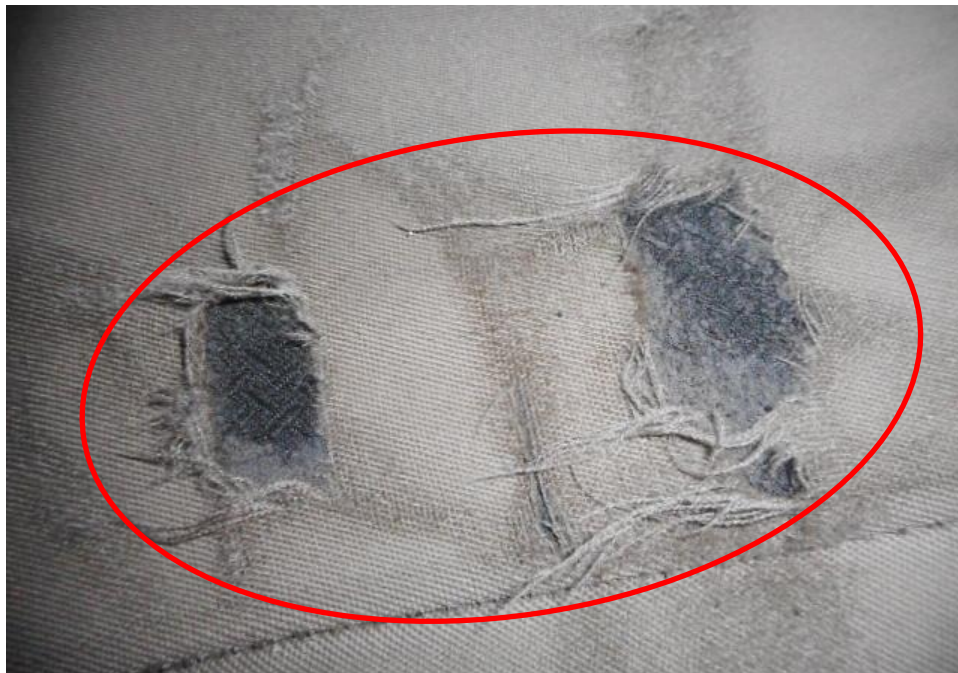
Photo 8 shows a close up view of the Motor Car's cloth roof portion at the time of my inspection. There was holes present prior to the incident at the rear right cloth roof portion (circled) of the Motor Car and water intrusion had likely started from these holes flowing down into the interior cabin of the Motor Car.

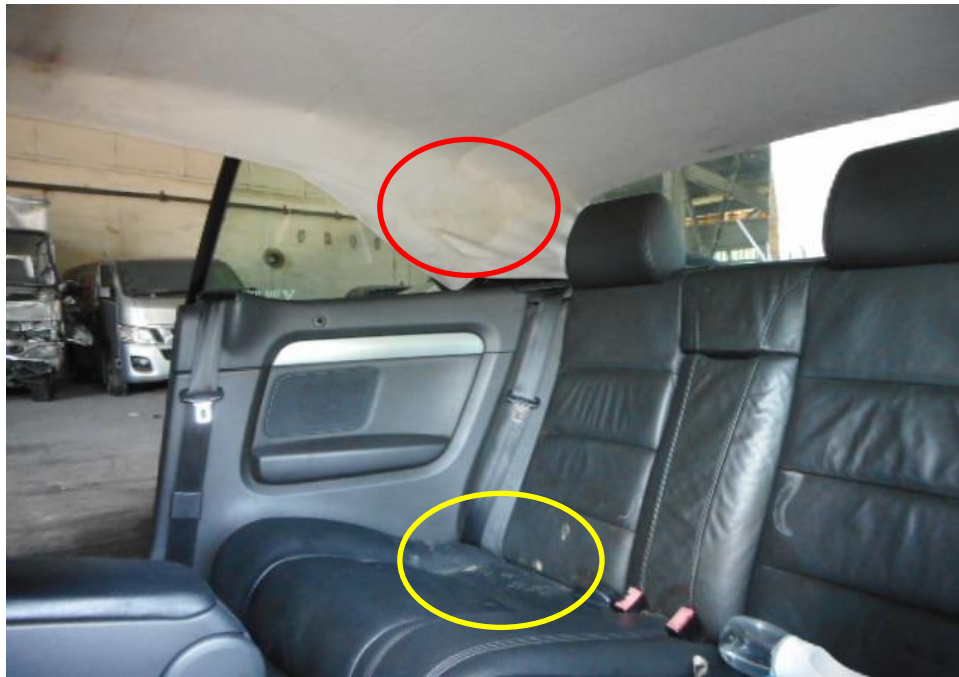
Photo 9 shows a general view of the Motor Car's interior cabin portion at the time of my inspection. Its cloth roof (red circle) and seats (yellow circle) at the rear right portion had suffered water intrusion damages due to water seeping down from the holes on the cloth roof above.

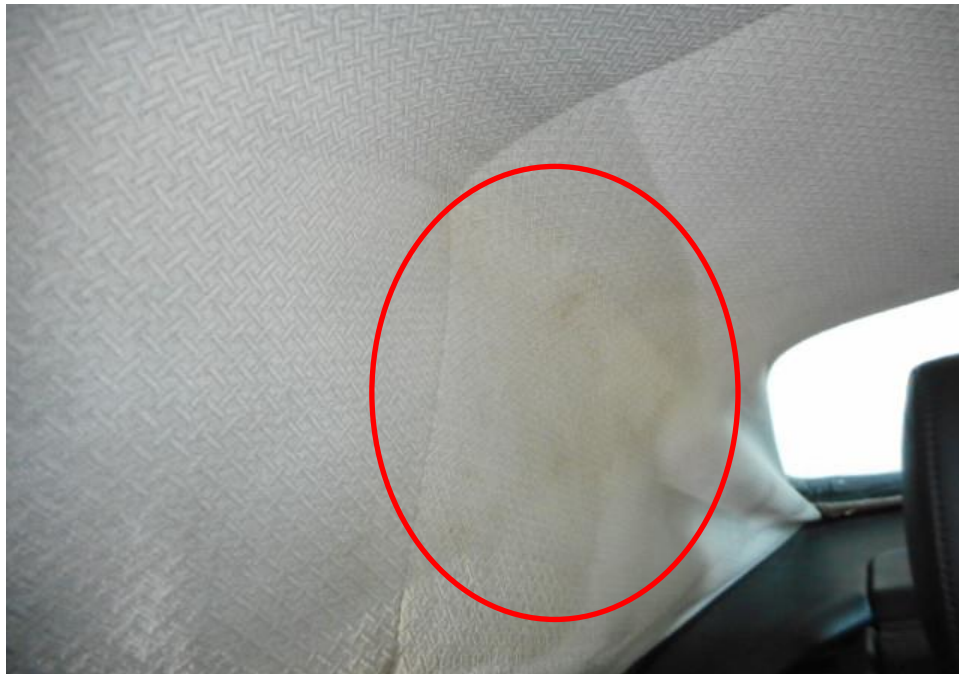
Photo 10 shows a close up view of the Motor Car's interior cabin portion at the time of my inspection. We have observed mouldy stains on its cloth roof (circled) at the rear right portion due to water intrusion from the water seeping down from the holes of the cloth roof above.

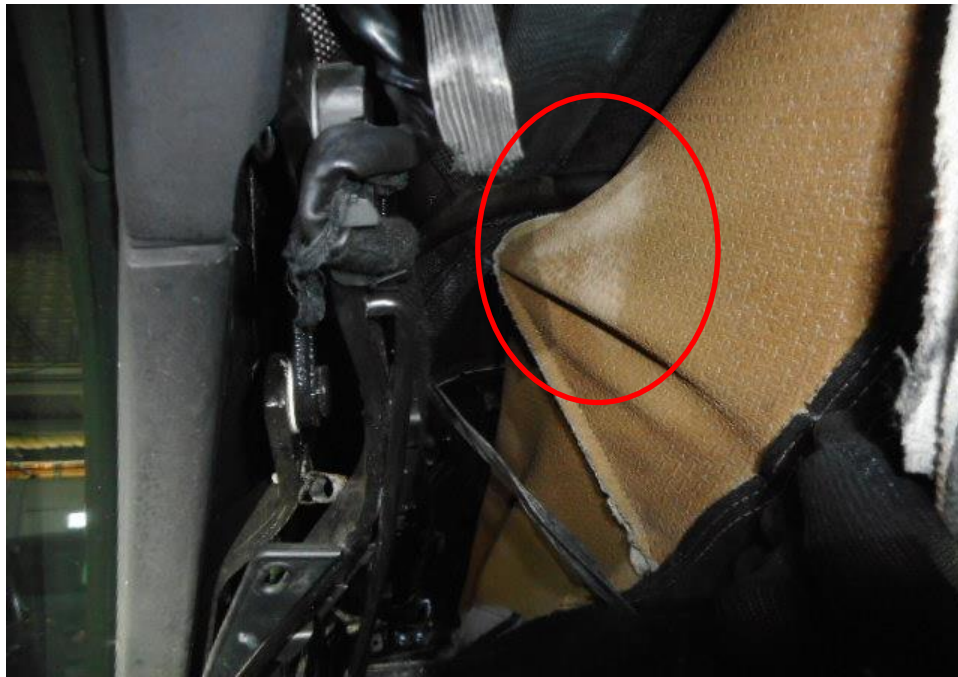
Photo 11 shows a close up view of the Motor Car's interior cabin portion at the time of my inspection. We have observed mouldy stains on inside of the cloth roof (circled) at the rear right portion due to water intrusion from the water seeping down from the holes of the cloth roof above.

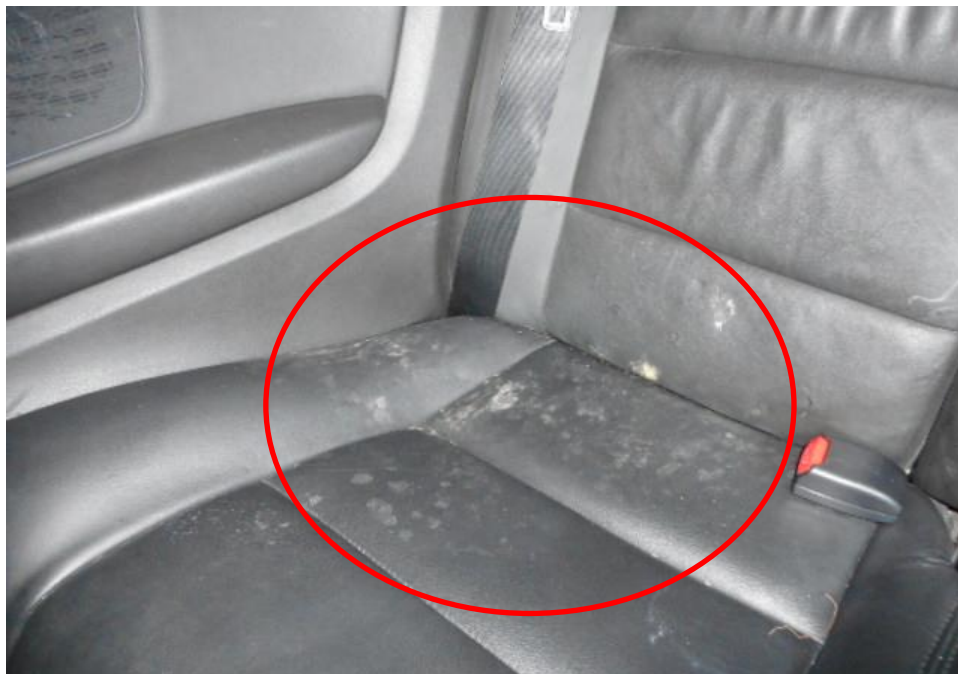
Photo 12 shows a close up view of the Motor Car's interior cabin portion at the time of my inspection. We have observed mouldy stains on the seats (circled) at the rear right portion due to water intrusion from the water seeping down from the holes of the cloth roof above.

22. We are in view that the damages caused by the built up of rust and corrosion on the electrical connectors of the driver's seat mechanism and built up mould and stains to the rear right seats was caused by water intrusion from the holes in the cloth roof of the Motor Car at the time of incident.

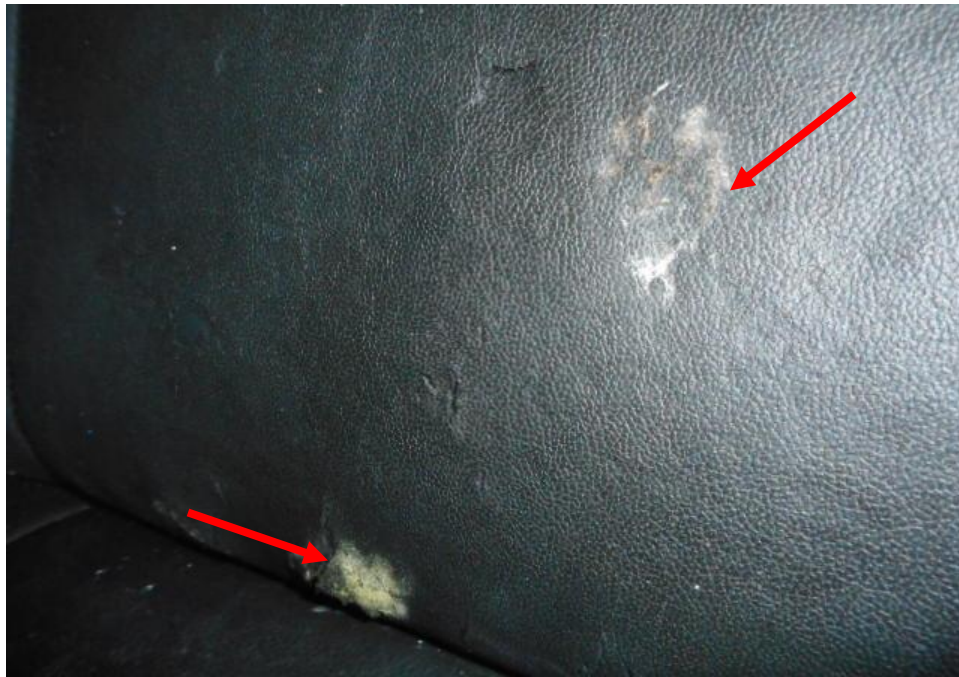
Photo 13 shows a close up view of the Motor Car's interior cabin portion at the time of my inspection. We have observed mouldy stains on the seats (arrowed) at the rear right portion due to water intrusion from the water seeping down from the holes of the cloth roof above.

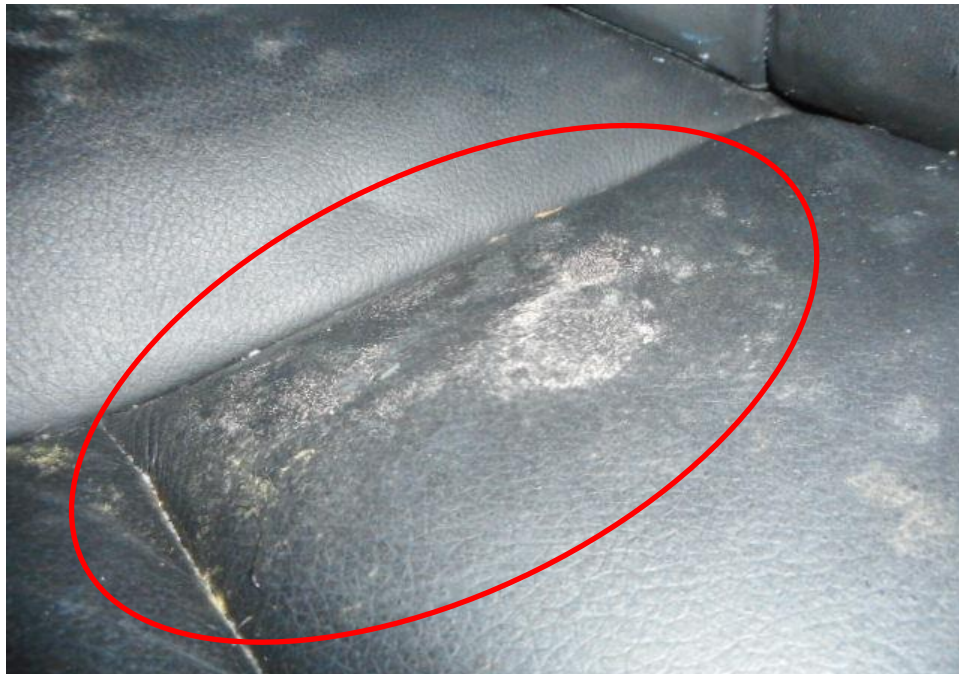
Photo 14 shows a close up view of the Motor Car's interior cabin portion at the time of my inspection. We have observed mouldy stains on the seats (circled) at the rear right portion due to water intrusion from the water seeping down from the holes of the cloth roof above.

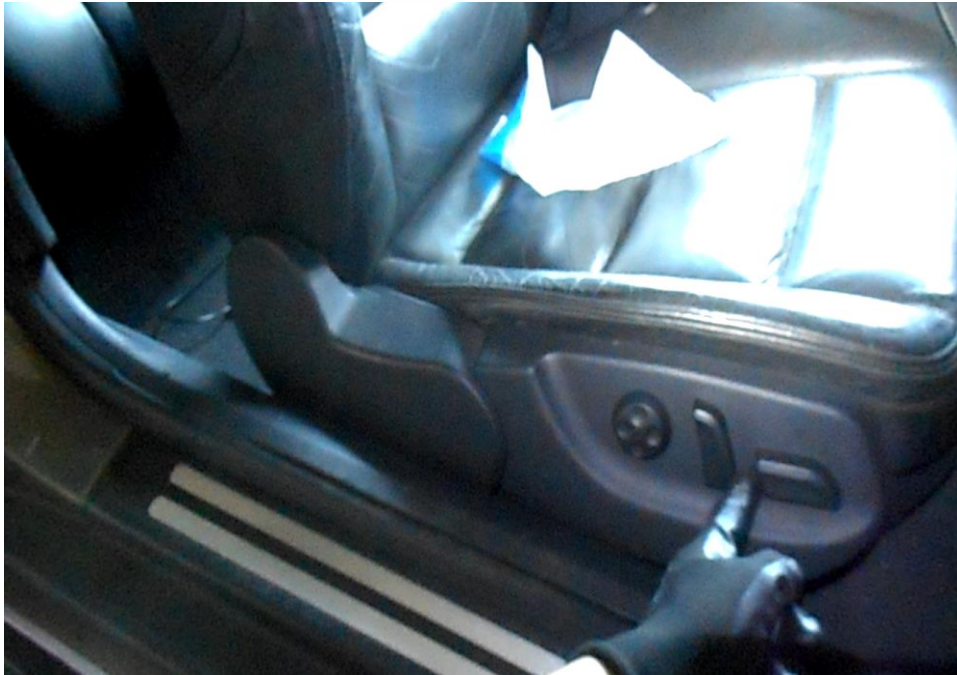
Photo 15 shows a general view of the Motor Car's front driver seat portion at the time of my inspection. We have conduct and test on the seat controls and a check on the electrical connectors of the seat. The seating controls was not responsive to our inputs and our visual checks on the electrical connectors of the seat, we had observed rust due to water corrosion on the pins of the connectors which had been caused by the water intrusion from the cloth roof above.

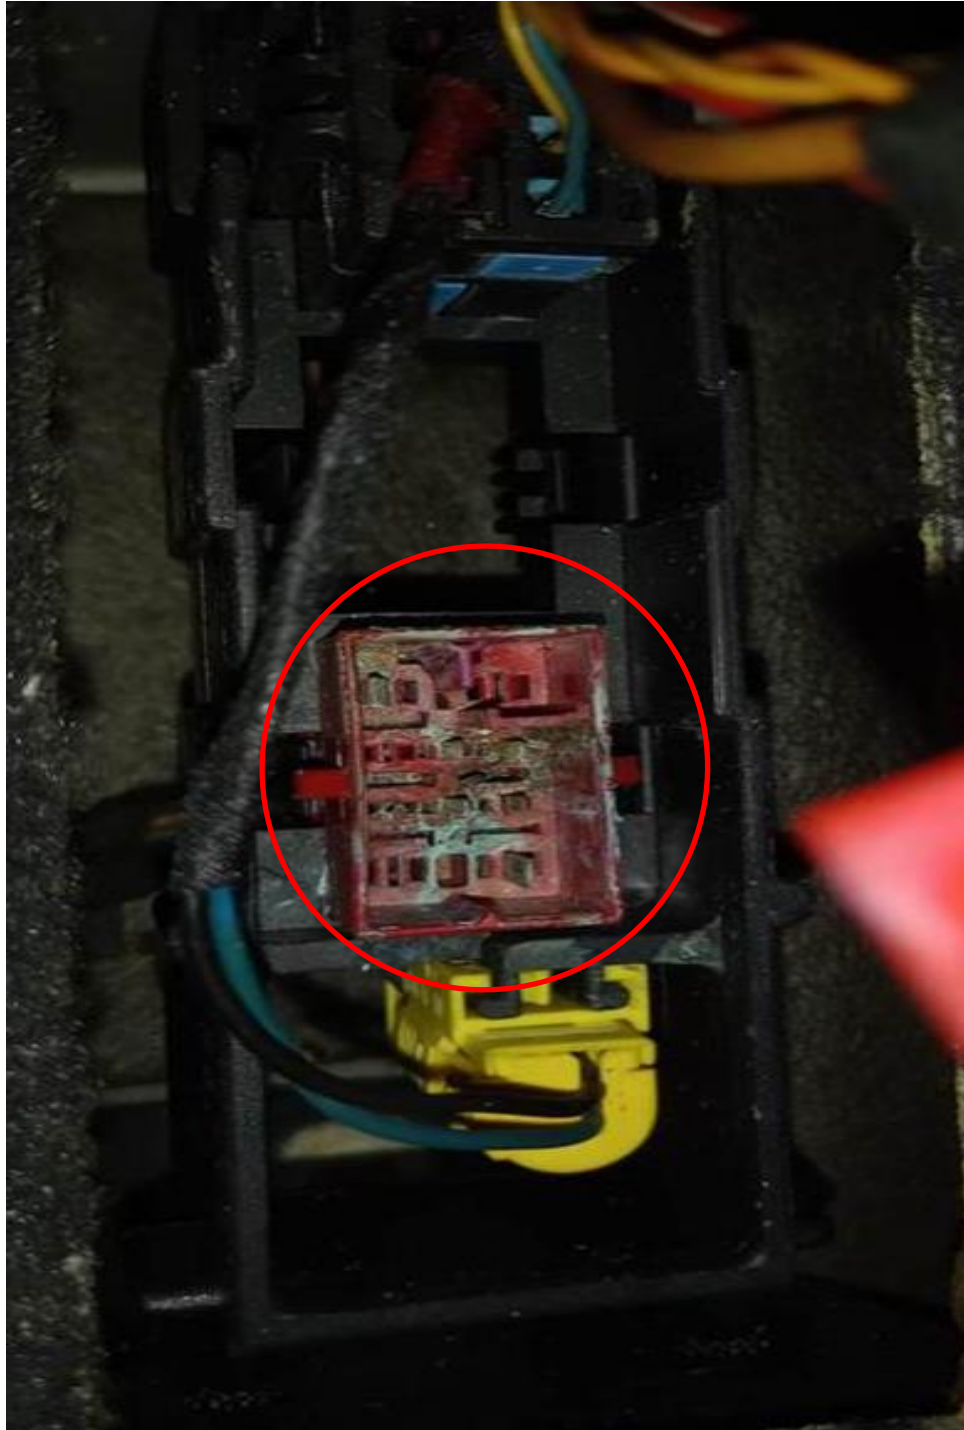
Photo 16 shows a close up view of the Motor Car's front driver seat portion at the time of my inspection. We have conduct and test on the seat controls and a check on the electrical connectors of the seat. The seating controls was not responsive to our inputs and our visual checks on the electrical connectors of the seat, we had observed rust due to water corrosion on the pins of the connectors (circled) which had been caused by the water intrusion from the cloth roof above.

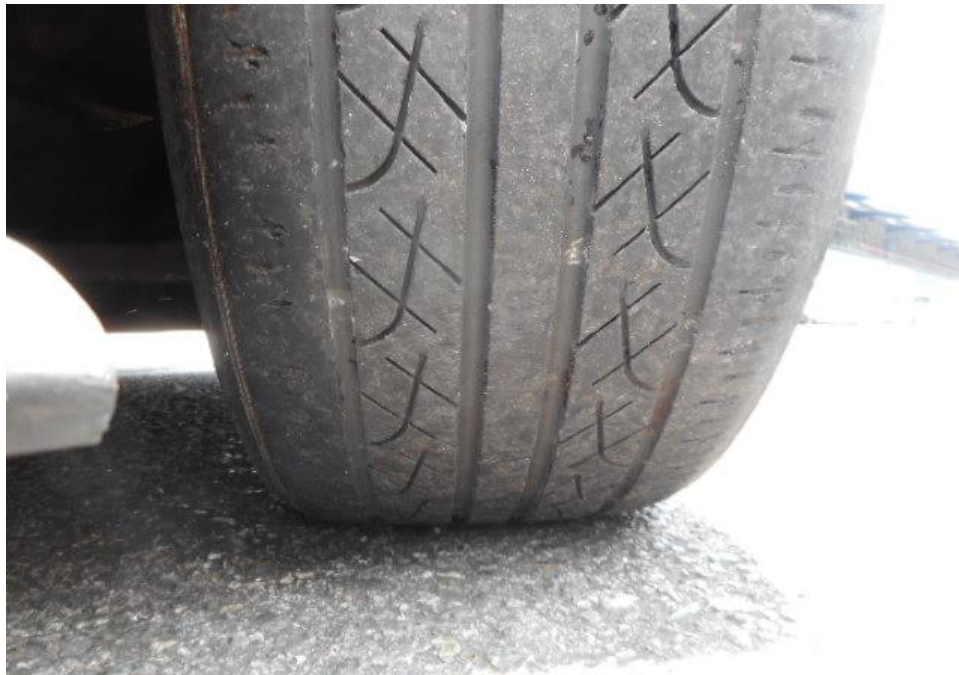
Photo 17 shows the condition of the front right tyre of the Motor Car, which was observed to be in serviceable condition with remaining tread depth of approximately 4mm. The tyre was sufficiently inflated for vehicular operation with no tear, cut or burst mark(s) on the outer and the inner sidewalls as well as across the tread. The 4 tyres of the Motor Car were wrapped around standard steel wheel rims without any damage.

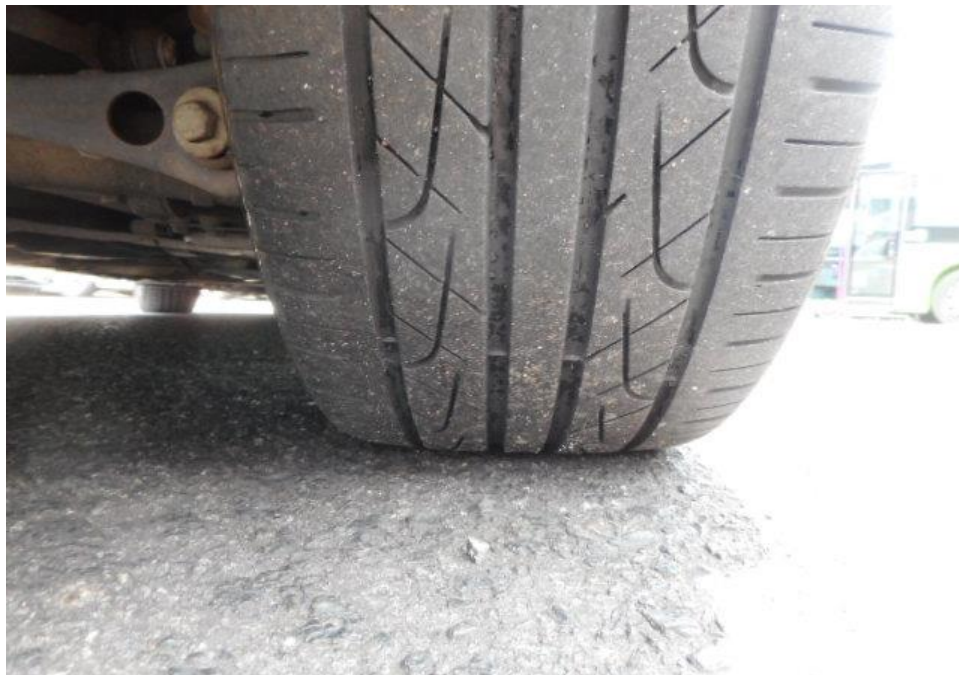
Photo 18 shows the condition of the rear right tyre of the Motor Car, which was observed to be in serviceable condition with remaining tread depth of approximately 4mm. The tyre was also observed to be sufficiently inflated for vehicular operation with no tear, cut or burst mark(s).

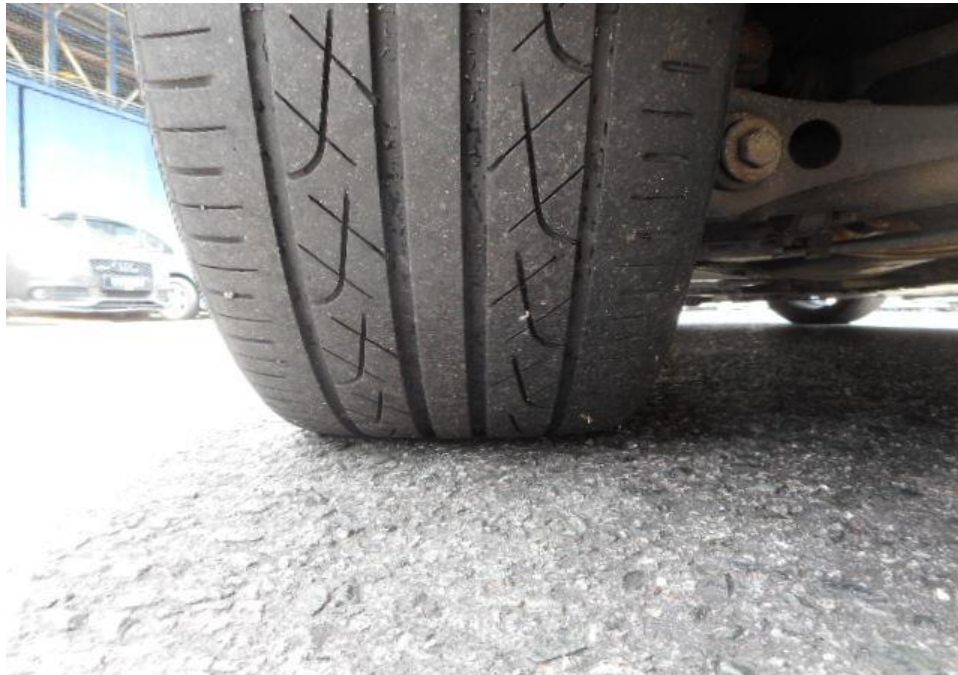
Photo 19 shows the condition of the rear left tyre of the Motor Car, which was observed to be in serviceable condition with remaining tread depth of approximately 4mm. The tyre, which was wrapped around steel wheel rim, was also observed to be sufficiently inflated for vehicular operation. The 4 tyres of the Motor Car were wrapped around standard steel wheel rims.

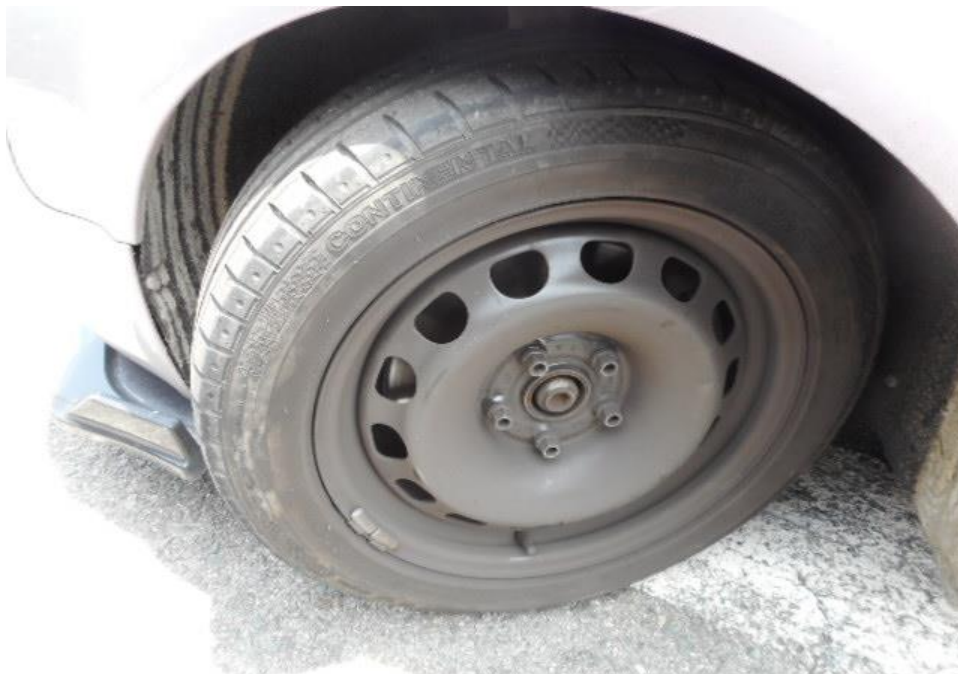
Photo 20 shows the condition of the front left tyre (steel rim spare tyre) of the Motor Car, which was observed to be in serviceable condition with remaining tread depth of approximately 5mm. There was also no tear, cut or burst mark(s) on the outer and the inner sidewalls as well as across the tread of the Motor Car's 4 tyres.

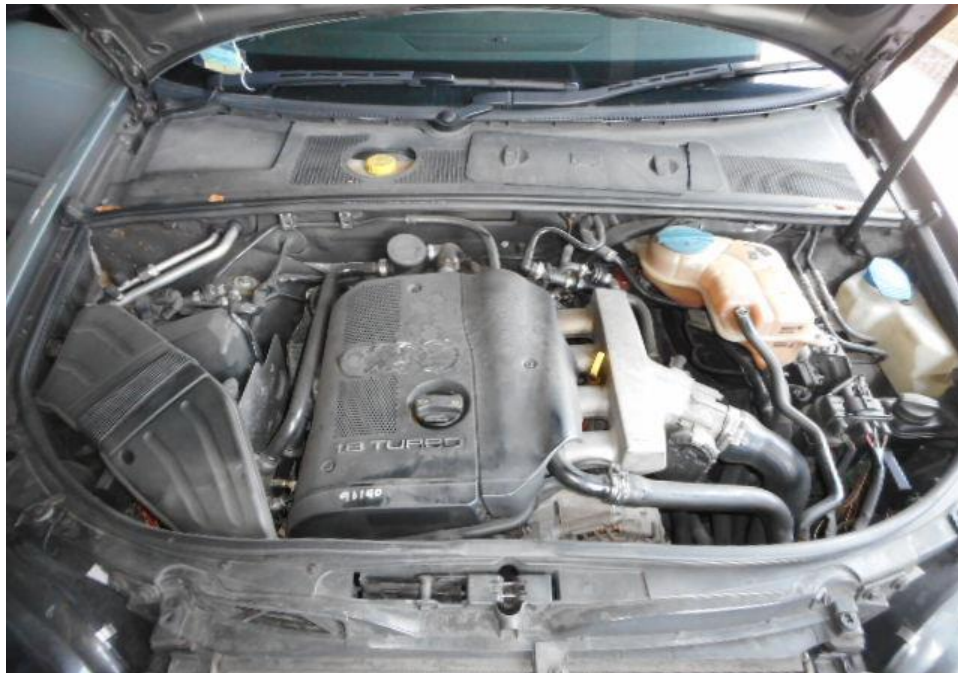
Photo 21 shows a general view of the Motor Car's engine compartment. The various parts and components inside the engine compartment were unaffected by the incident. There was also no sign(s) or indication(s) of fluid leakage and/or fluid stain within the engine compartment.

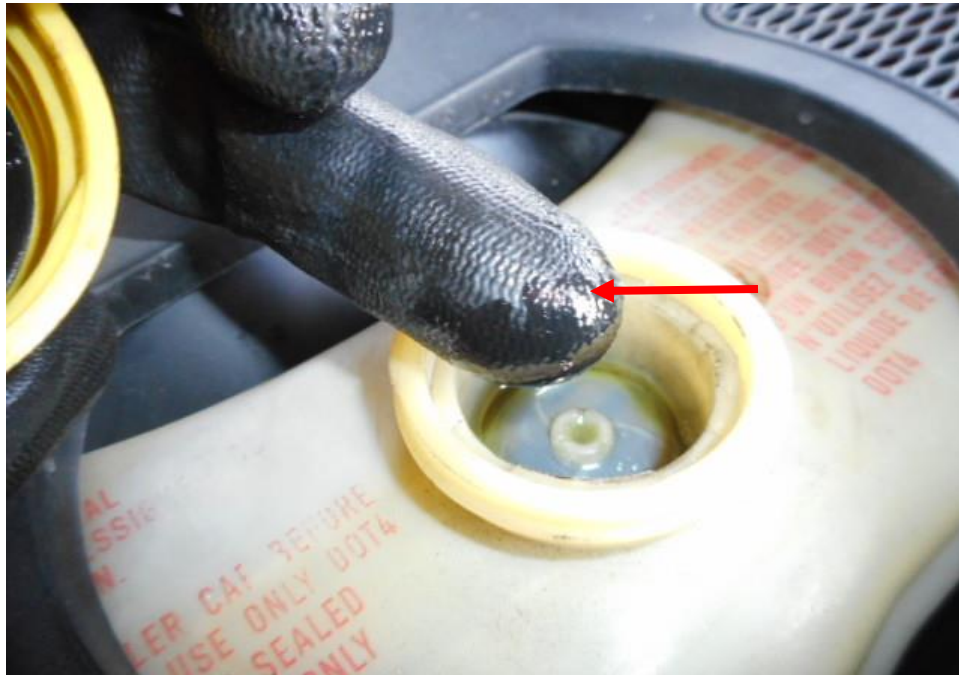
Photo 22 shows the brake fluid reservoir of the Motor Car at the time of my inspection. The brake fluid was observed to be of sufficient level (arrowed) and without any visible contamination.

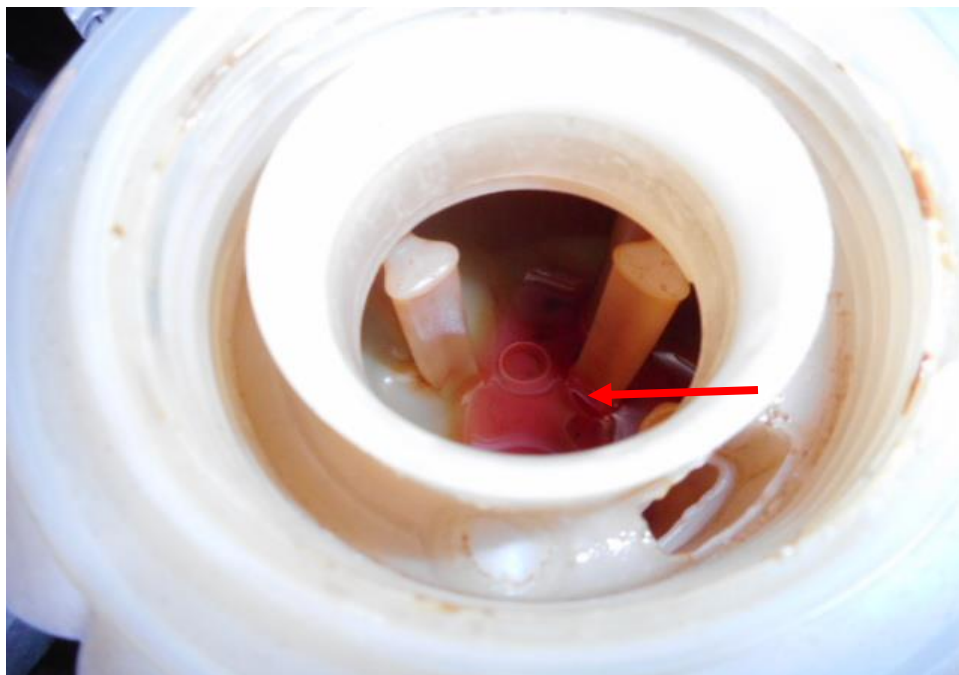
Photo 23 shows checks being carried out to the engine coolant of the Motor Car at the time of my inspection. The engine coolant was observed to be of low level (arrowed) and without any visible contamination.

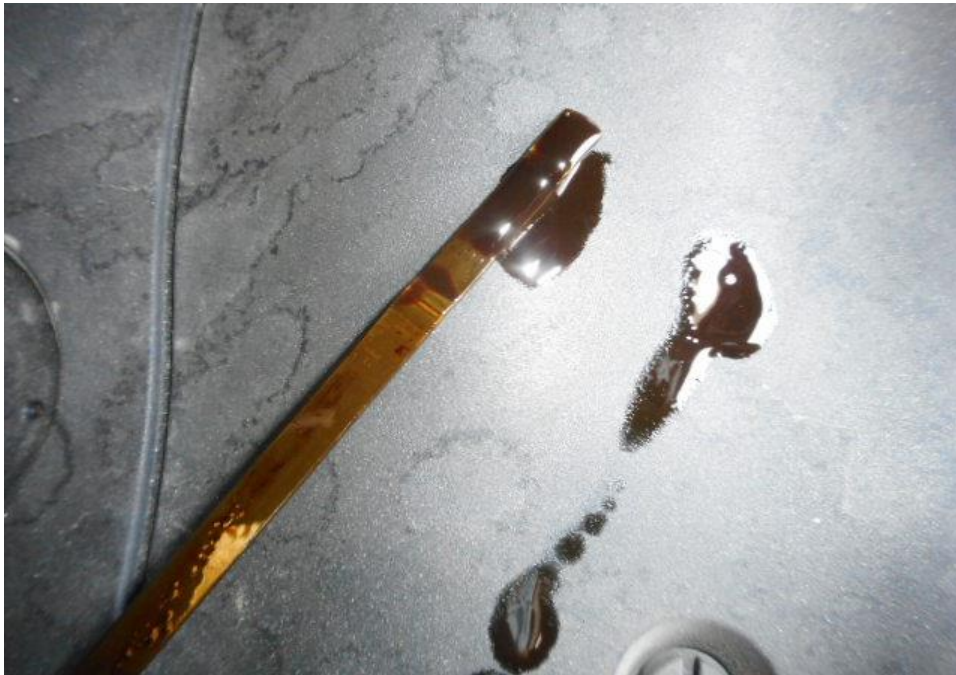
Photo 24 shows the engine oil dipstick of the Motor Car at the time of my inspection. The engine oil was observed to be of sufficient level and without any visible contamination.

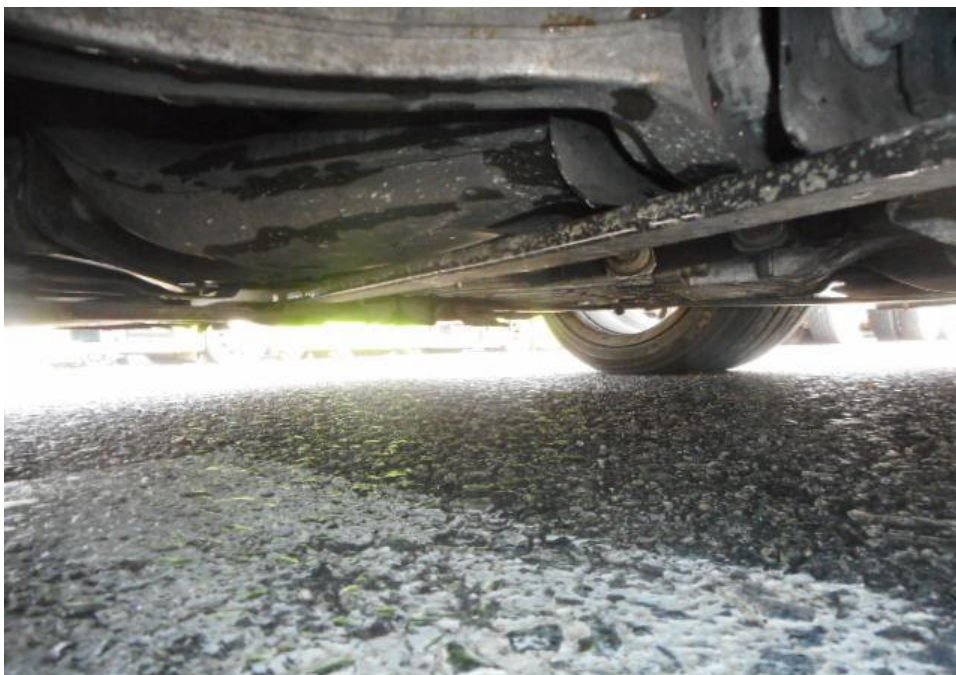
Photo 25 shows the undercarriage of the Motor Car, at the area where the engine housing and transmission housing are located. I did not find any sign(s) or indication(s) of fluid leak and/or fluid stain(s) on the underside of the Motor Car.

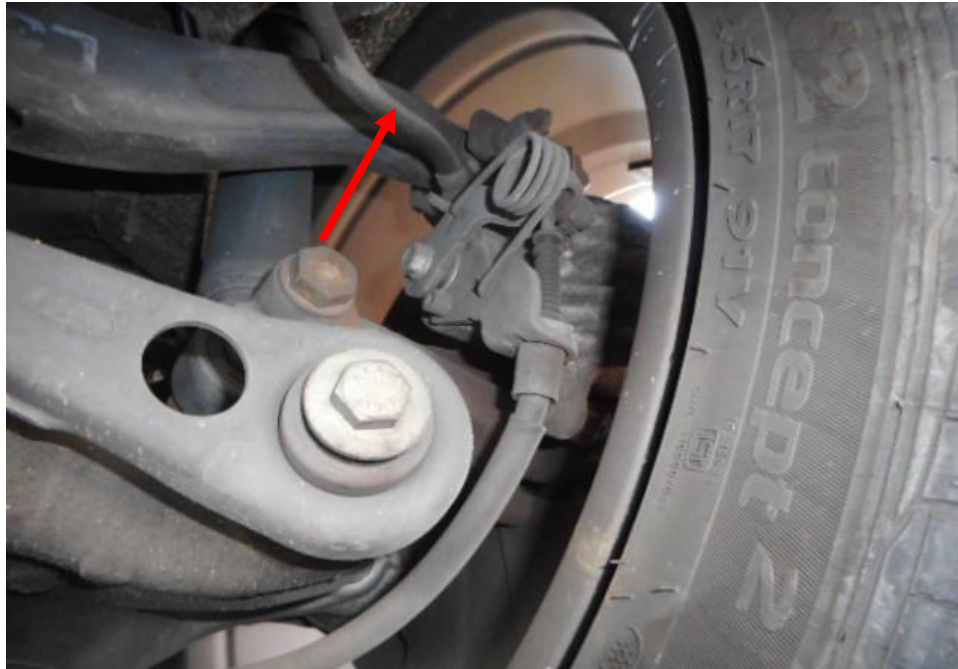
Photo 26 shows the brake hose/pipe (arrowed) at the rear right wheel of the Motor Car. No leakage of brake fluid was observed. Visual examination of the various components of the braking system like the drum brake, brake booster, brake pedal etc. had revealed all to be intact and without visible damage.

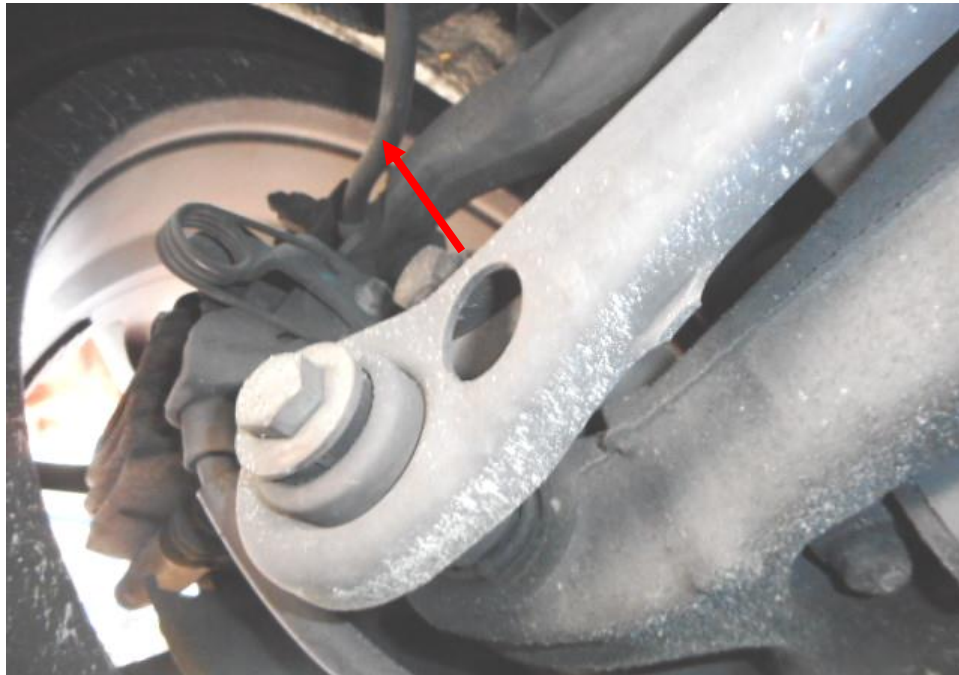
Photo 27 shows the brake hose/pipe (arrowed) at the rear left wheel of the Motor Car. I did not observe any leakage of brake fluid at the time of my inspection of the Motor Car. Static tests of the Motor Car's braking system had indicated that there was no internal leakage of pressure/vacuum. The undercarriage components of the Motor Car were also all found to be intact and without any visible damage.

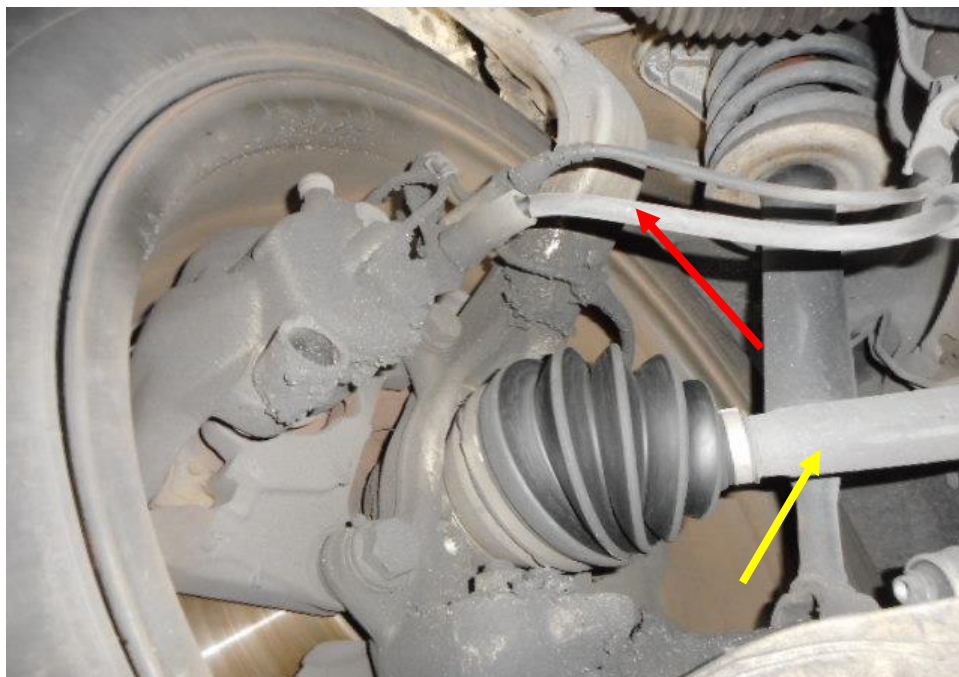
Photo 28 shows the brake hose/pipe (arrowed) and drive shaft (yellow arrow) at the front right wheel of the Motor Car. I did not observe any leakage of brake fluid or damages at the time of my inspection of the Motor Car. Static tests of the Motor Car's braking system had indicated that there was no internal leakage of pressure/vacuum. The undercarriage components of the Motor Car were also all found to be intact and without any visible damage.

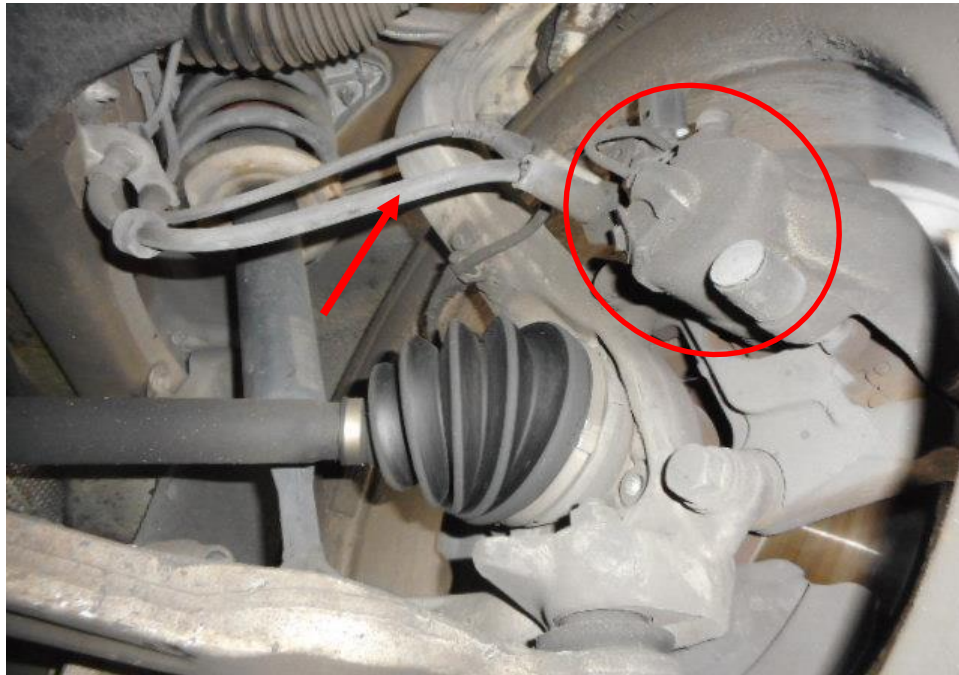
Photo 29 shows the brake hose/pipe (arrowed) at the front left wheel of the Motor Car. No leakage of brake fluid was observed. Visual examination of the various components of the braking system like the brake caliper (circled), brake booster, brake pedal etc had revealed all to be intact and without visible damage.
