You're Ref: TP/REG/20/2021
Our Ref: CI/TPD22001758/P

Fatal Incident Investigation Team

MECHANICAL INSPECTION REPORT OF MOTOR CAR SGP 6680E

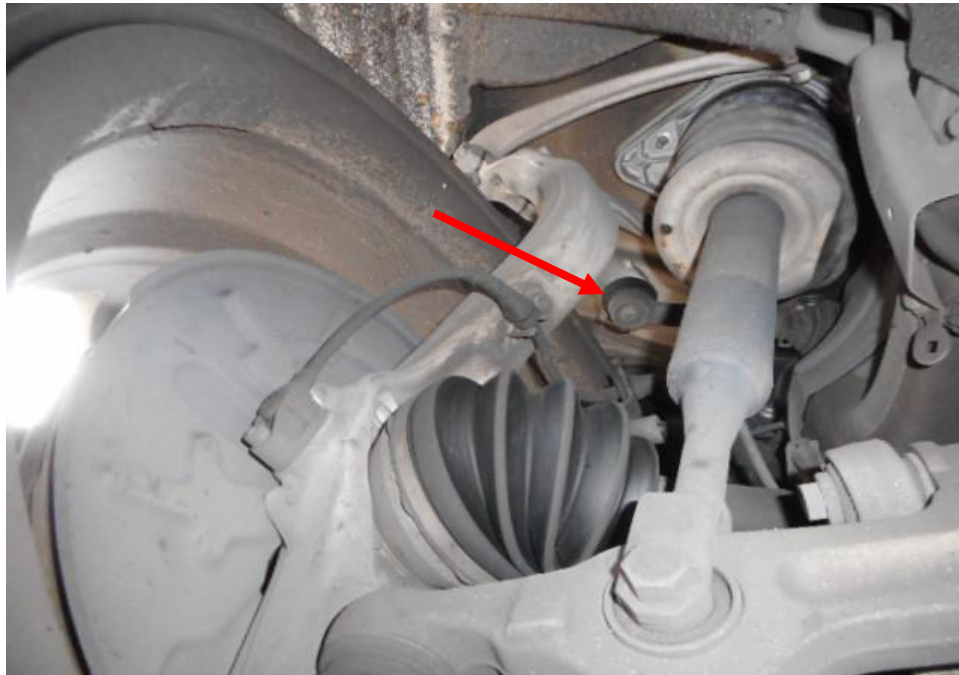
Photo 31 shows the various undercarriage components at the front right wheel of the Motor Car, in particular the steering tie rod (red arrow). The various steering components were all found to be intact, suggesting that the steering system of the Motor Car was likely to be in serviceable condition at the material time of incident. There was also no sign of fluid stain observed on the various undercarriage components at the front right wheel of the Motor Car.

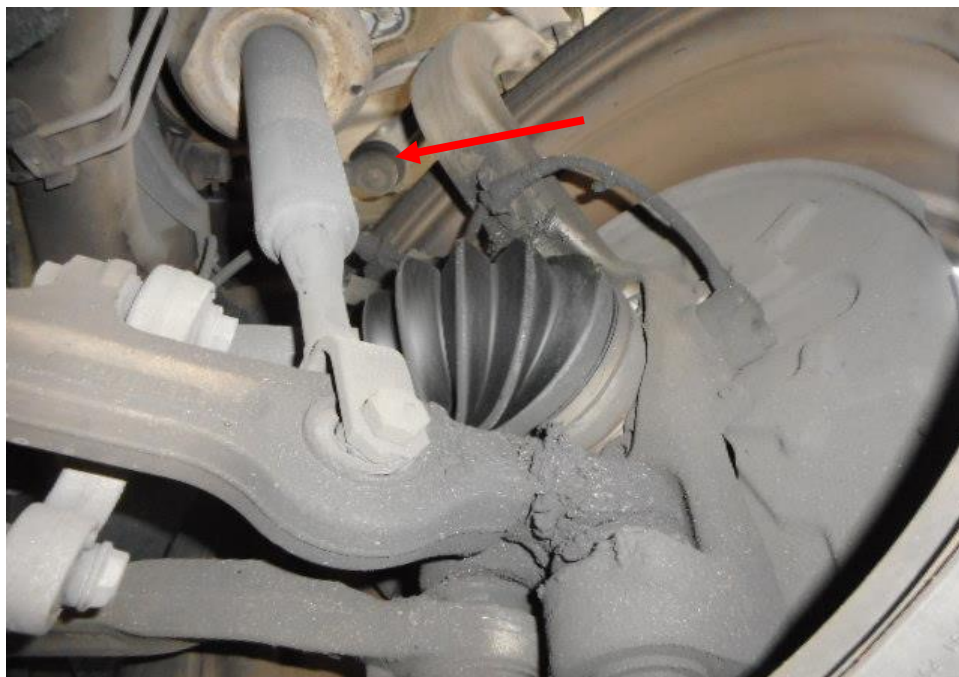
Photo 32 shows the various undercarriage components at the front left wheel of the Motor Car, which had included the steering tie rod (red arrow). The various undercarriage components of the Motor Car were all found to be intact without any visible damage.

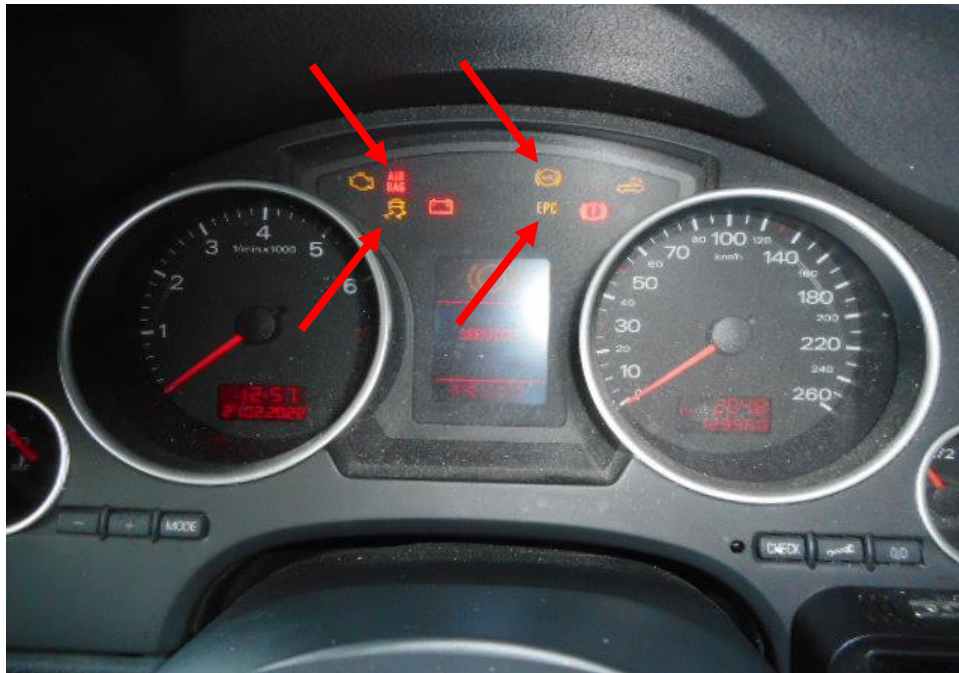
Photo 33 shows the warning light for Anti-Lock Brake System (ABS), Electric Power Steering System (EPS), Traction Control System (TCS) and Supplemental Restraint System (SRS) (arrowed) appearing on the instrument panel of the Motor Car during the self-test of its various electronic operating systems when its engine was cranked.

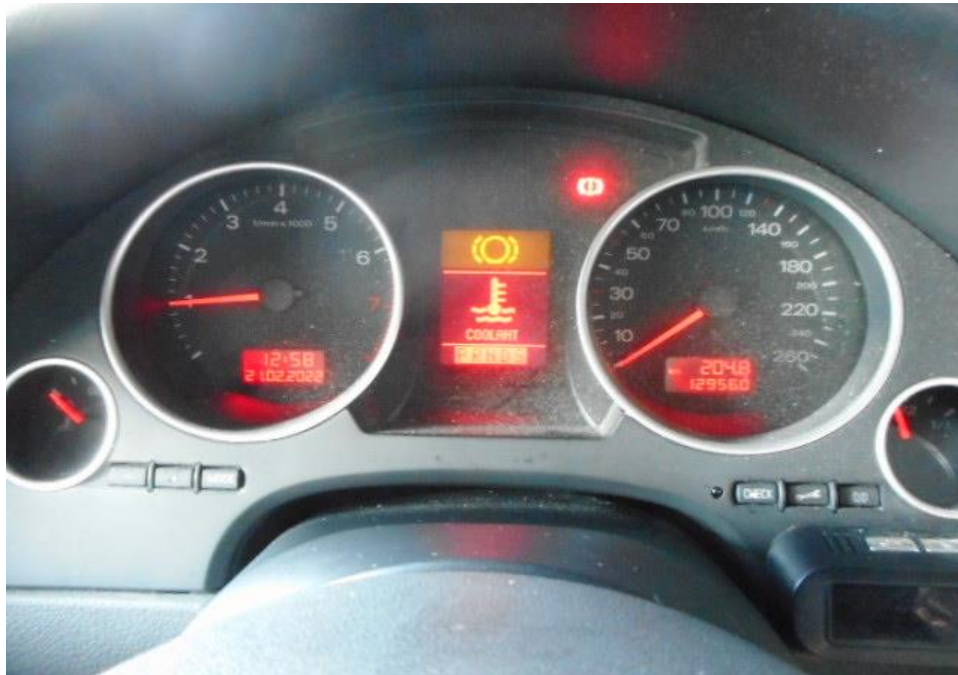
Photo 34 shows no warning lights illuminated on the instrument panel of the Motor Car after the engine was cranked. This would suggest that there was no abnormality to the electronic operating system of the Motor Car, like the ABS, EPS, TCS and SRS etc.

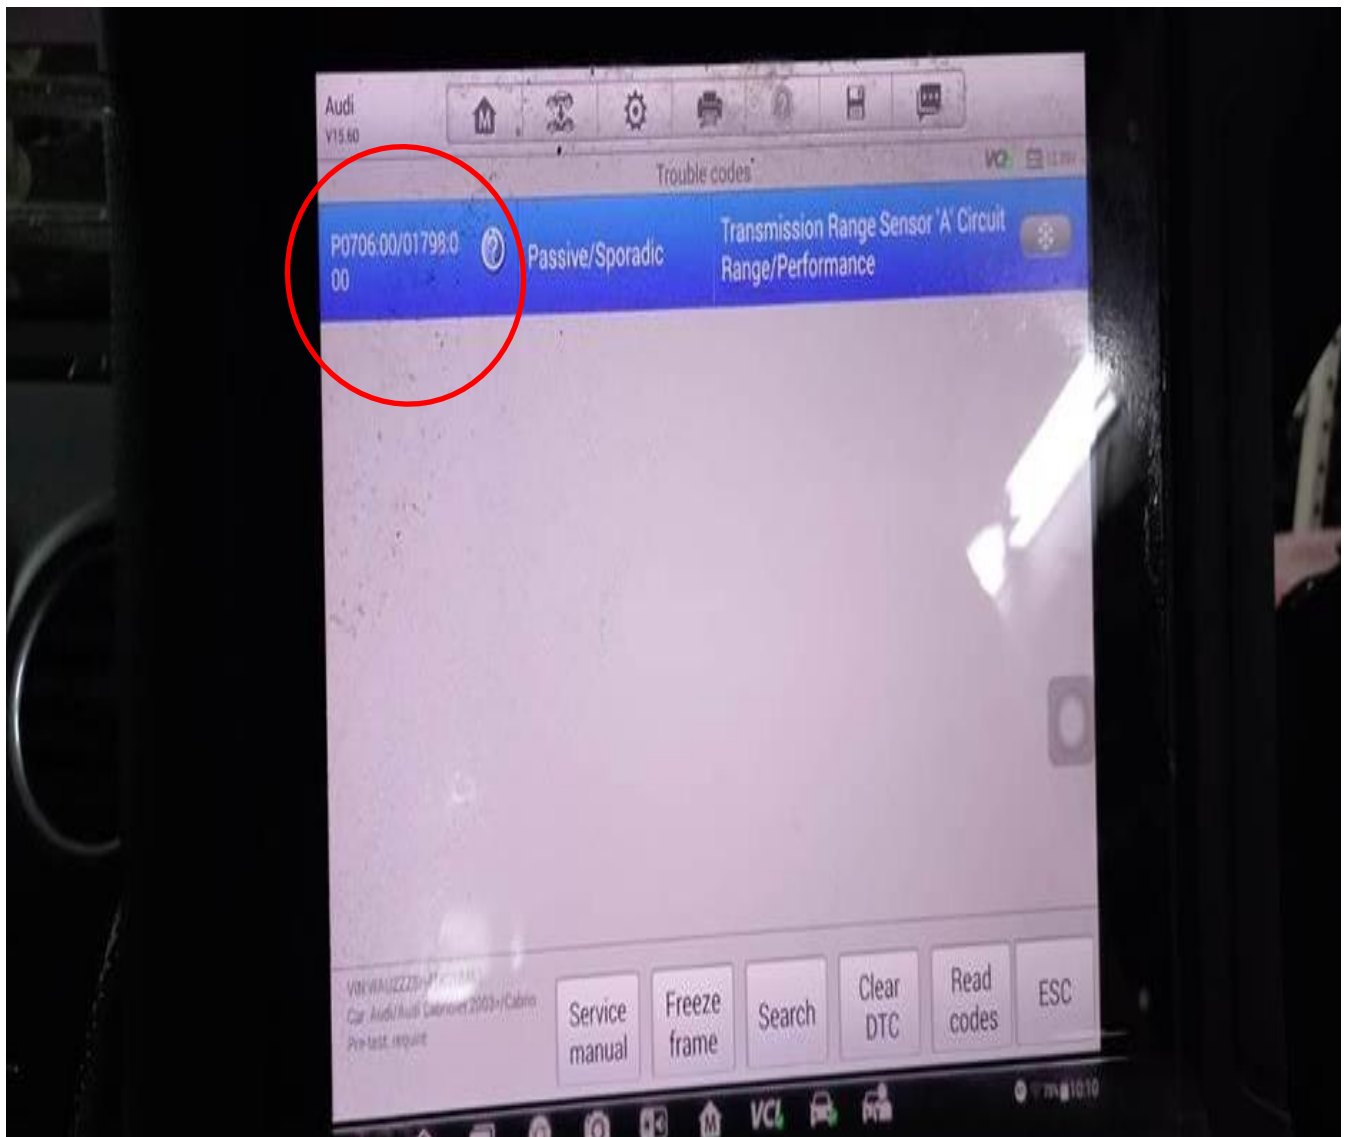
14. From our understanding, the Motor Car was bought to the owner's private workshop SNL Future Pte Ltd for an assessment, they have provided did a diagnostic check on the Motor Car and the check had shown 2 fault codes by the code name of P0706/01798 which both are linked to each other regarding the transmission of the Motor Car. We have also did our own diagnostic checks to the Motor Car at the material time and returned results were a fault code name of 01798 stating "Transmission range sensor (F125), implausible signal) which is the same results as the private workshop. We have did our relevant checks to this fault code and it states that this error is due to a fault in the Transmission Control Unit (TCU) of the Motor Car.

Photo 35 shows the diagnostic checks done by the private workshop on the Motor Car. The fault code trigger was P0706/01798 (circled) which are linked to a fault with the Transmission Control Unit (TCU).

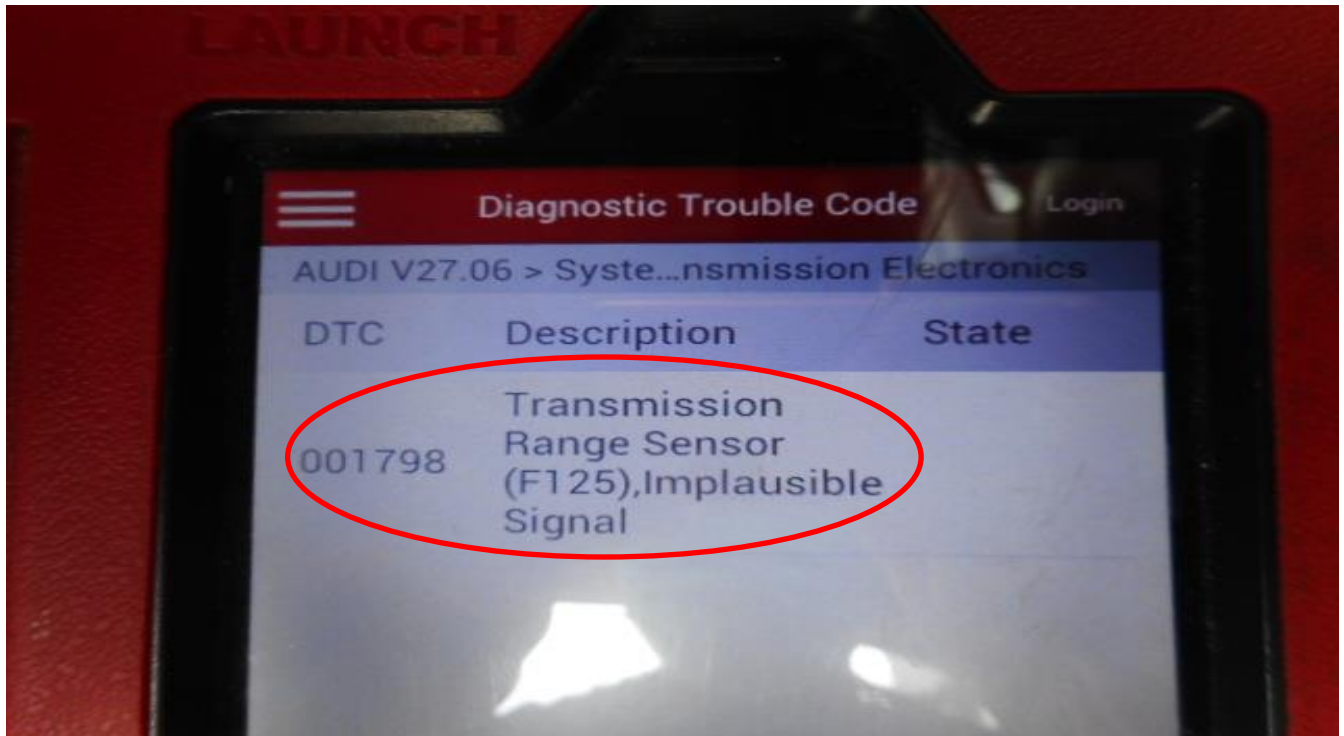
Photo 36 shows the diagnostic checks done by us on the Motor Car at the material time. The fault code trigger was 01798 "Transmission range sensor (F125), implausible signal (circled) which are linked to a fault with the Transmission Control Unit (TCU).

23. Investigations to the Transmission Control Unit (TCU) of the Motor Car shows that it is not related to the water intrusion into the cabin of the Motor Car and it is purely a case of wear and tear to the Transmission Control Unit (TCU), prior to or after the Motor Car was impounding in Traffic Police Vehicle Pound for investigations. Although we were able to test drive the vehicle, without any abnormalities to the Transmission system, the issue may appear at the higher gear range during longer driving.

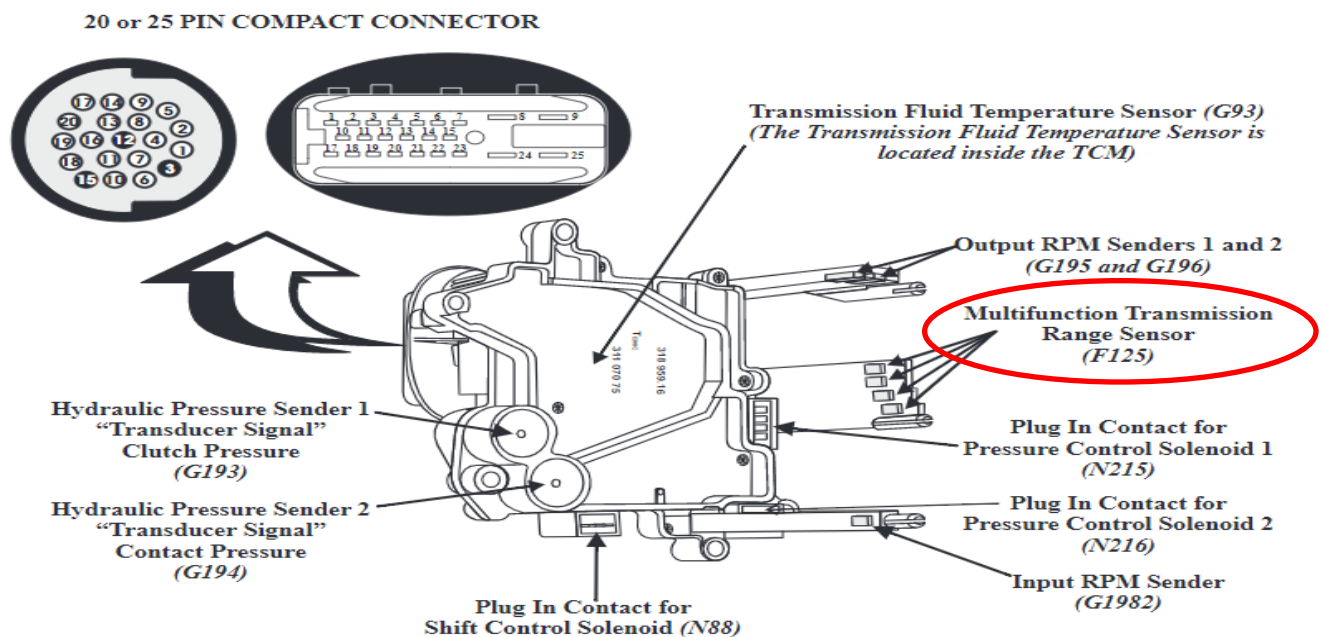
MULTITRONIC® TCM COMPONENT IDENTIFICATION

Photo 37 shows the diagram of the Transmission Control Unit (TCU) (yellow circle). We have identified the particular component that the fault code had mentioned which shows "Transmission range sensor (F125). (red circle)

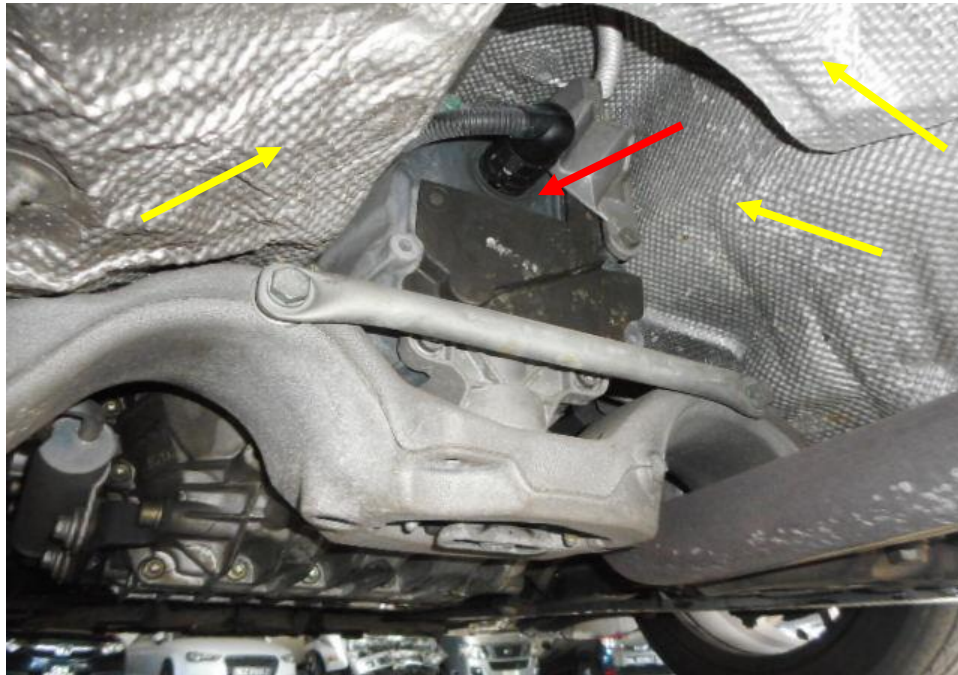
15. We have identify the location of the Transmission Control Unit (TCU) in the Motor Car and it is located inside the transmission unit at the undercarriage portion which can only be access from the bottom of the Motor Car. Water intrusion at the top from the cabin to the Transmission Control Unit (TCU) at the bottom is not possible as we observed that the Transmission Control unit (TCU) is inside the transmission unit and its surroundings is well protected by metal heat insulator sheets and the surrounding area is observed without any rust, fluid stain or any leakages.

Photo 38 shows the undercarriage portion of the Motor Car at the time of our inspection. The Transmission Control Unit (TCU) (red arrow) is mounted at the undercarriage portion inside the transmission unit and it can only be accessed from the bottom of the Motor Car. We observed that the Transmission Control unit (TCU) and area surrounding it is well protected by metal heat insulator sheets (yellow arrow) and the surrounding area is observed without any rust or fluid stain and leakages.

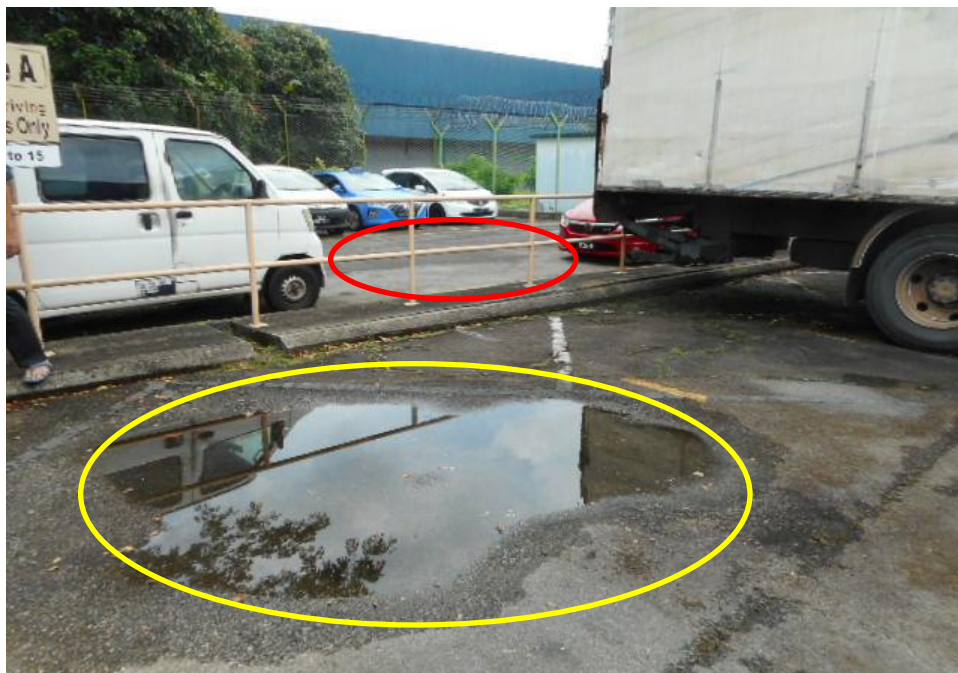
Photo 39 shows the general view of the location where the Motor Car was parked at the time of incident. There was rainfall prior to our check and we had observed water ponding close (yellow circle) to where the Motor Car was parked but not at where it was parked at the material time of incident (red circle).

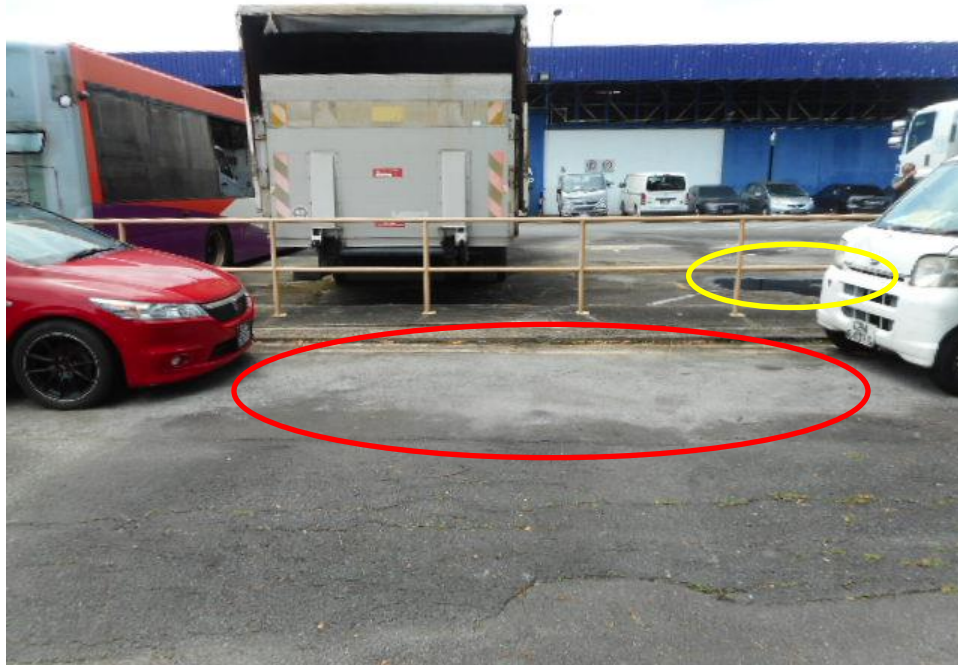
Photo 40 shows the close up view of the location where the Motor Car was parked at the time of incident. There was rainfall prior to our check and we had observed water ponding close (yellow circle) to where the Motor Car was parked but not at where it was parked at the material time of incident (red circle).
