Your Ref: Porsche Macan
(chassis number WP1ZZZ95ZKLB05328)
Our Ref : CI/TP22001767/D

25 February 2022

INSPECTION REPORT OF AN UNREGISTERED PORSCHE MACAN MOTOR CAR WITH CHASSIS NUMBER WP1ZZZ95ZKLB05328

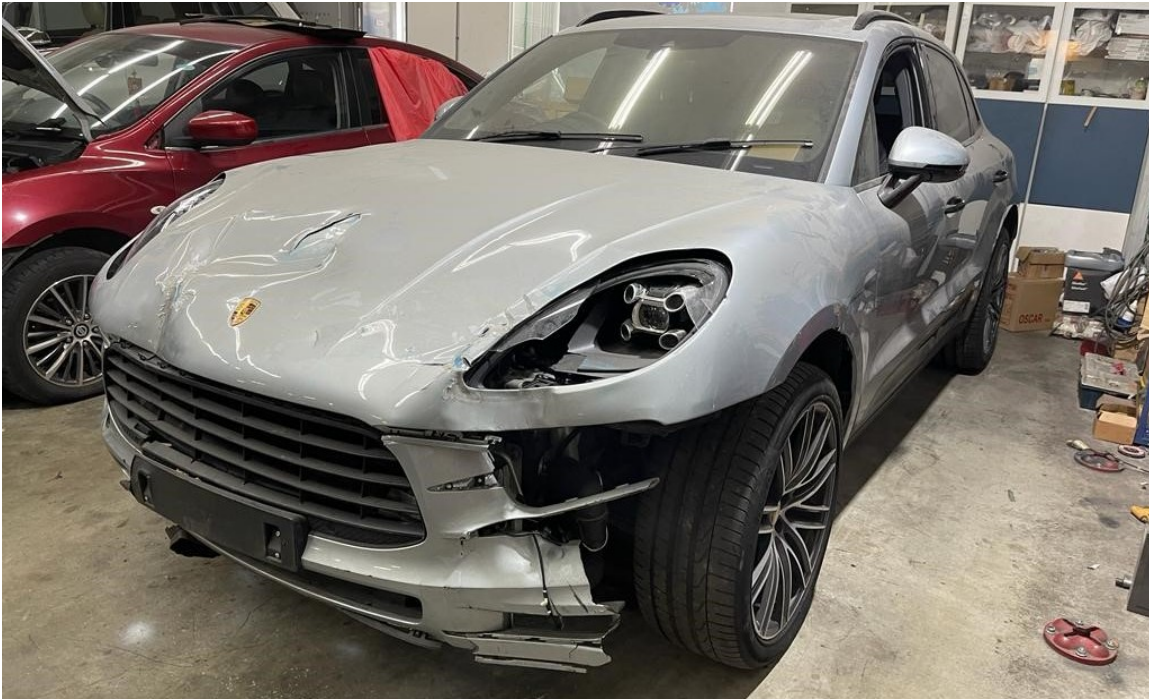
Photo 1 shows the front left body of the Motor Car (photograph provided to me). The Motor Car was observed to have sustained damage at its frontal portion. The front bumper, front bumper left lower grille, front bumper left upper grille, front bumper lower lip, front left day light, front left headlamp and front left fender inner shield were amongst the body parts that were observed to have been damaged.

22. The body parts at the frontal portion of the Motor Car were visually examined and it was noted that the repair/restoration works carried out to the damaged area of the Motor Car (refer to photograph 1 - 4 above) were reasonably adequate and in order.

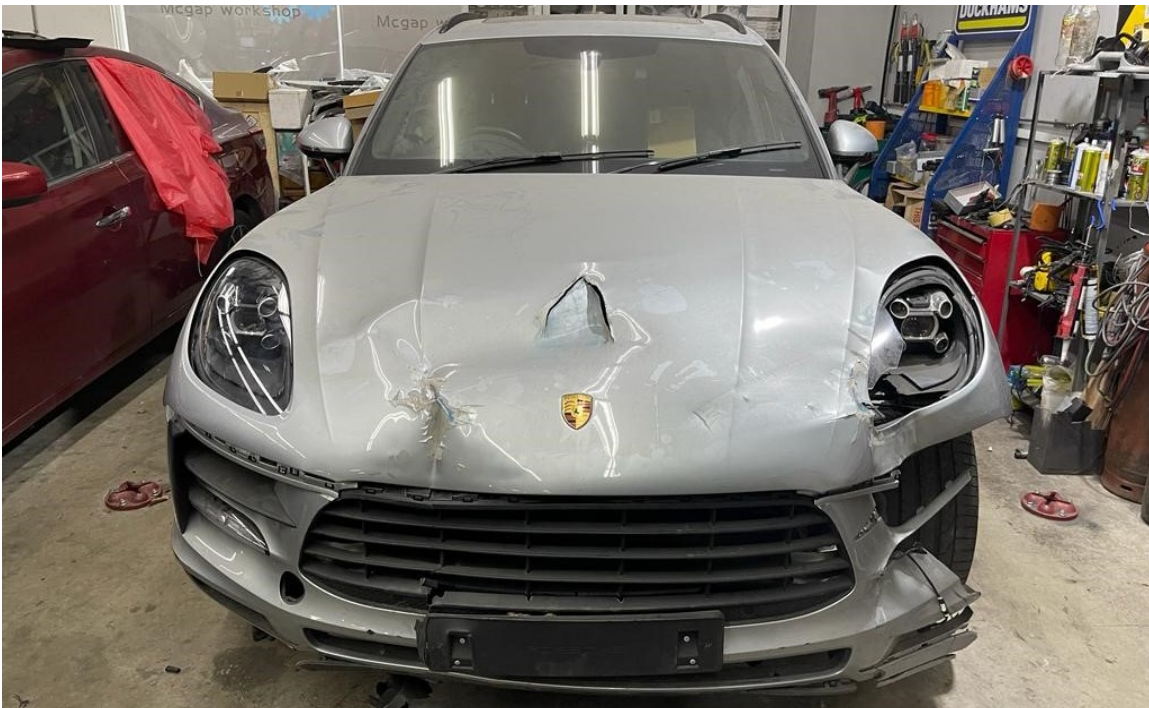
Photo 2 shows the frontal body of the Motor Car (photograph provided to me). The Motor Car was observed to have sustained damage at its frontal portion. The front bumper, front bumper left lower grille, front bumper left upper grille, front bumper number plate garnish, radiator grille and front bonnet were amongst the body parts that were observed to have been damaged.

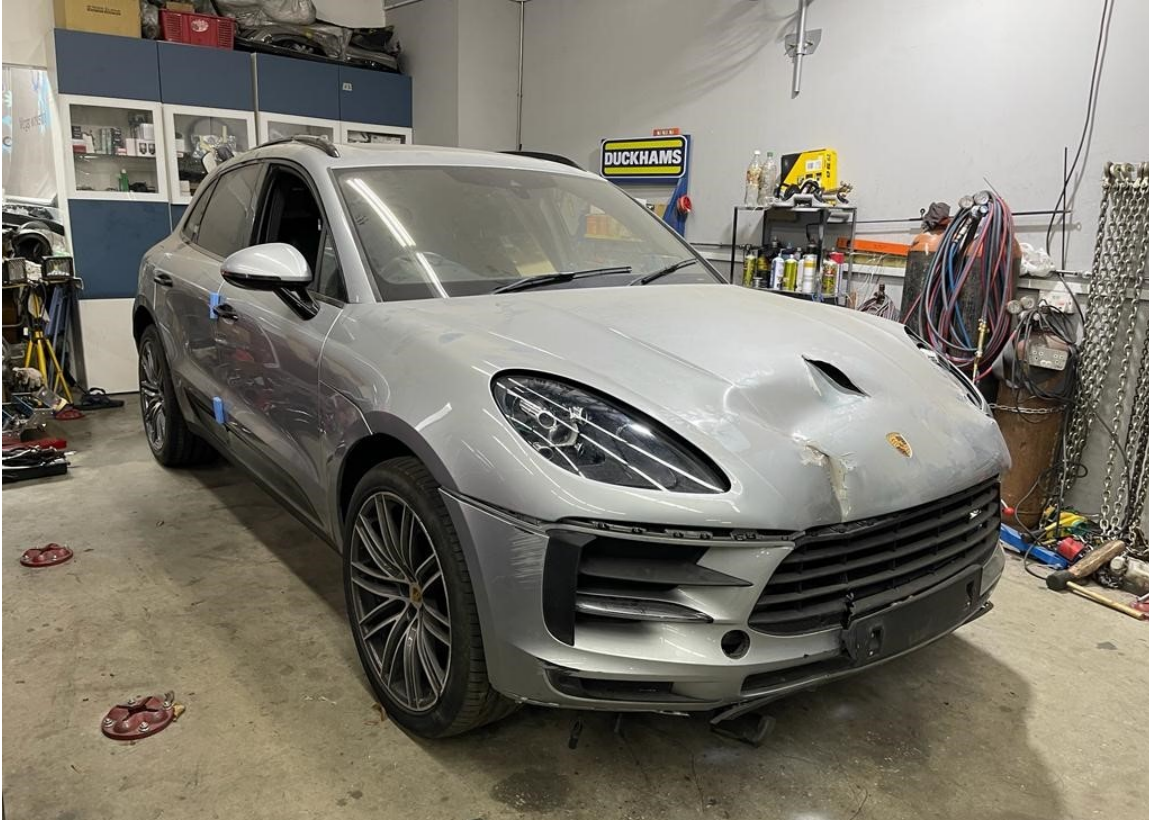
Photo 3 shows the front right body of the Motor Car (photograph provided to me). The Motor Car was observed to have sustained damage at its frontal portion. The front bumper, radiator grille and front bonnet were amongst the body parts that were observed to have been damaged. The airbag(s) of the Motor Car was not deployed as seen from the photographs that were provided.

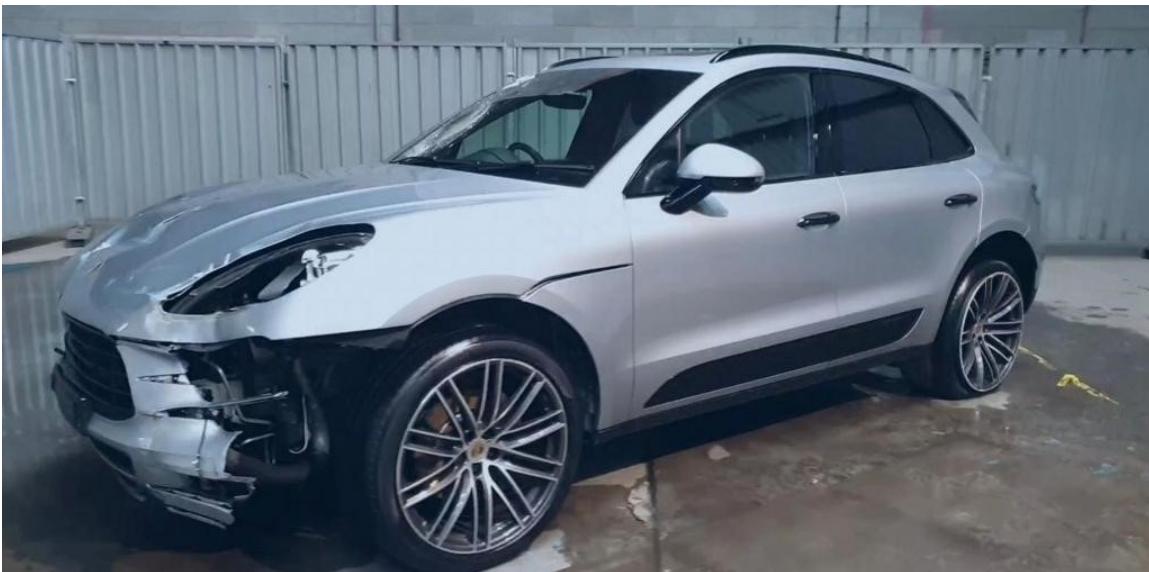
Photo 4 shows another view of the Motor Car's front left body (photograph provided to me). The Motor Car was observed to have sustained damage at its frontal portion. The front bumper, front bumper left lower grille, front bumper left upper grille, front bonnet, front left day light, front left headlamp and front left fender inner shield were amongst the body parts that were observed to have been damaged.

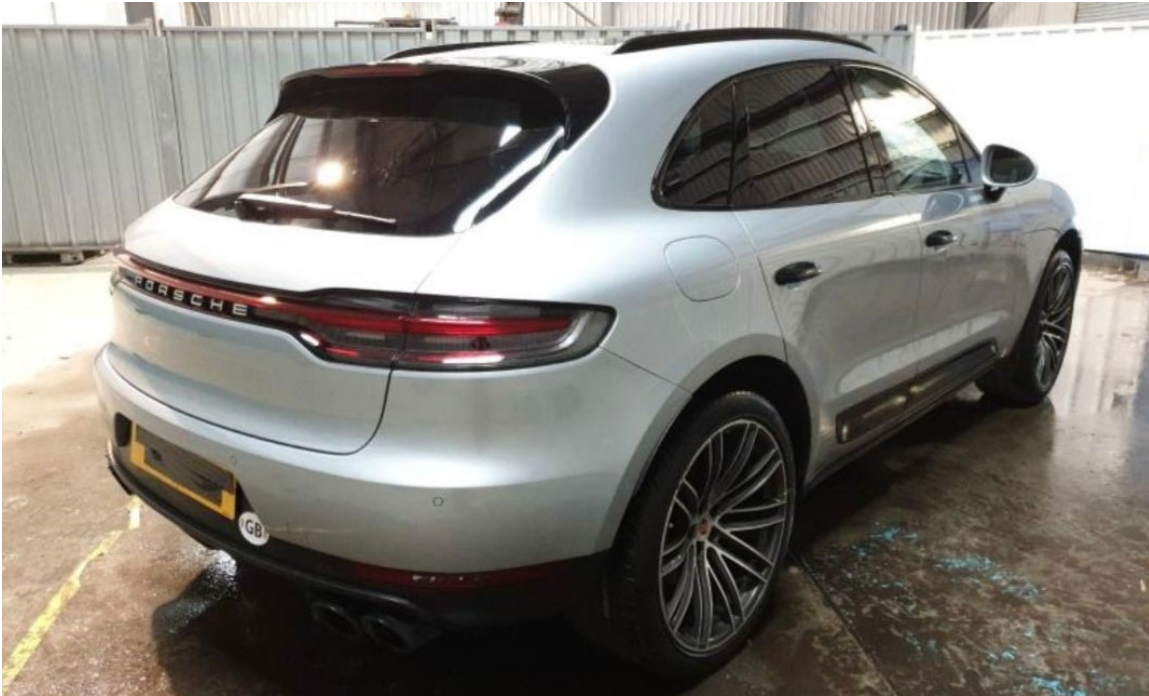
Photo 5 shows the rear right body of the Motor Car (photograph provided to me). Apart for the frontal portion, there was no physical damage observed to other areas of the Motor Car. The airbag(s) of the Motor Car was not deployed as seen from the photographs that were provided.

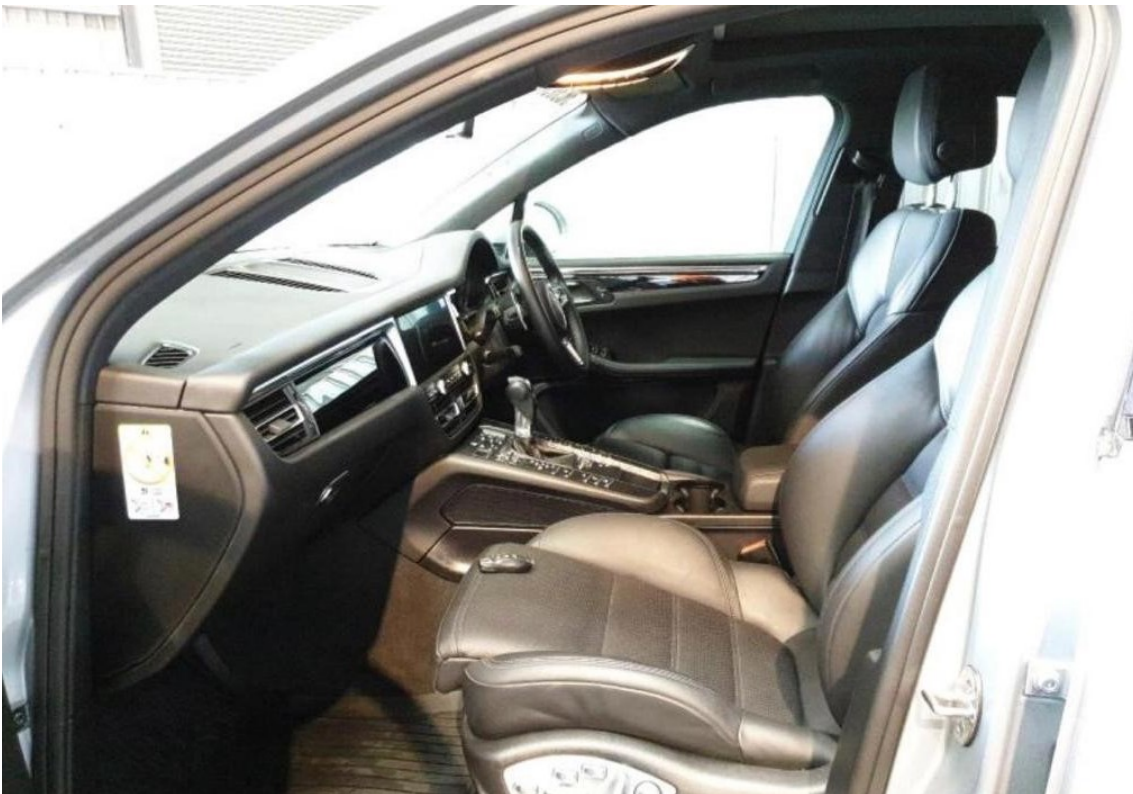
Photo 6 shows the interior compartment of the Motor Car (photograph provided to me). The various parts and components within the interior compartment were all intact and unaffected. The airbag(s) was not deployed as seen from the photographs that were provided to me.

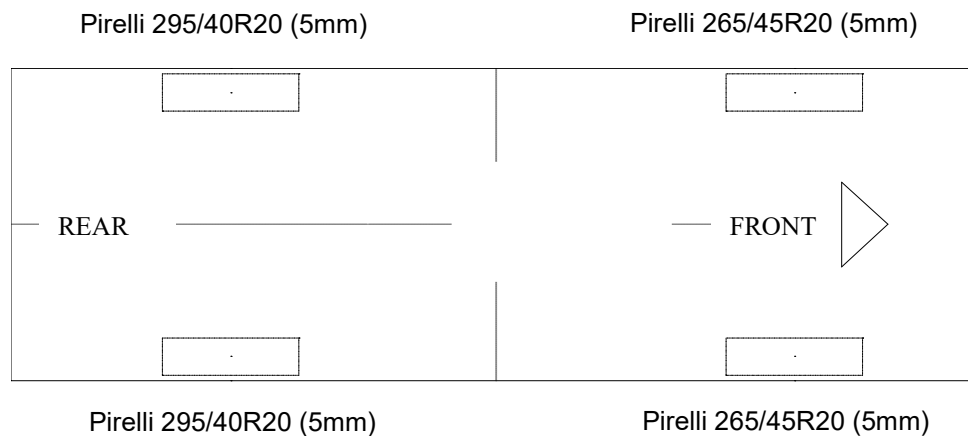
8. It was fitted with 20inch sport wheel rims that were wrapped with tyres that were observed to be of serviceable condition. The tyres were also sufficiently inflated for vehicular operation. The tyre brand, tyre size and approximate remaining tread depth of the 4 tyres of the Motor Car were recorded as follows: -

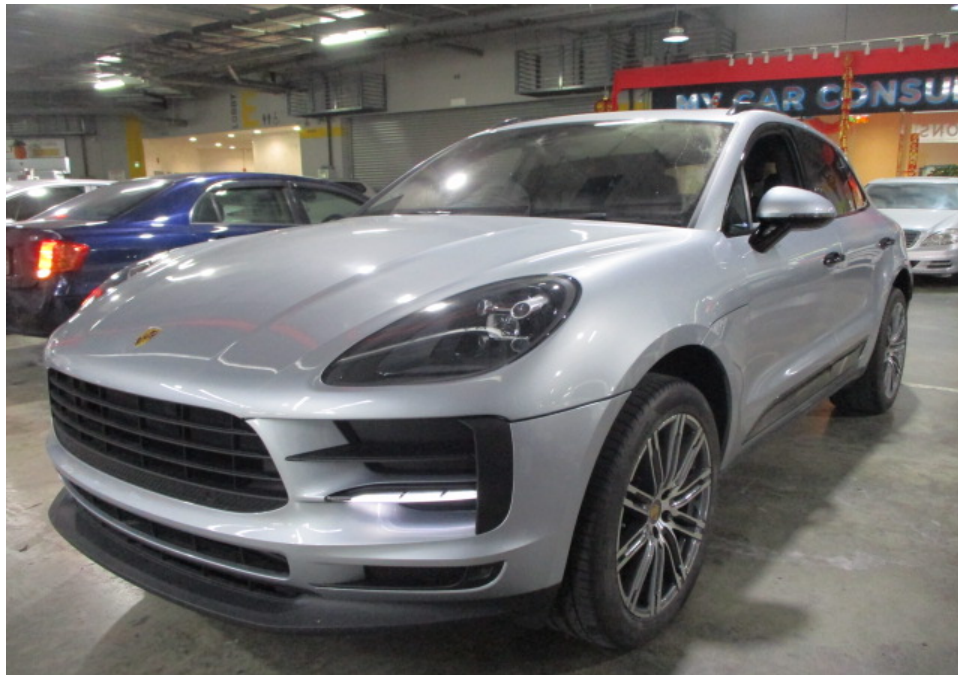
Photo 7 shows a general view of the front left body of the Motor Car at the time of my inspection. The Motor Car was observed to be in a relatively good general condition with no loose exterior fittings observed. The body parts at the frontal portion of the Motor Car were visually examined and it was observed that the repair/restoration works carried out to the damaged area of the Motor Car (refer to photograph 1 - 4 above) were reasonably adequate and in order.

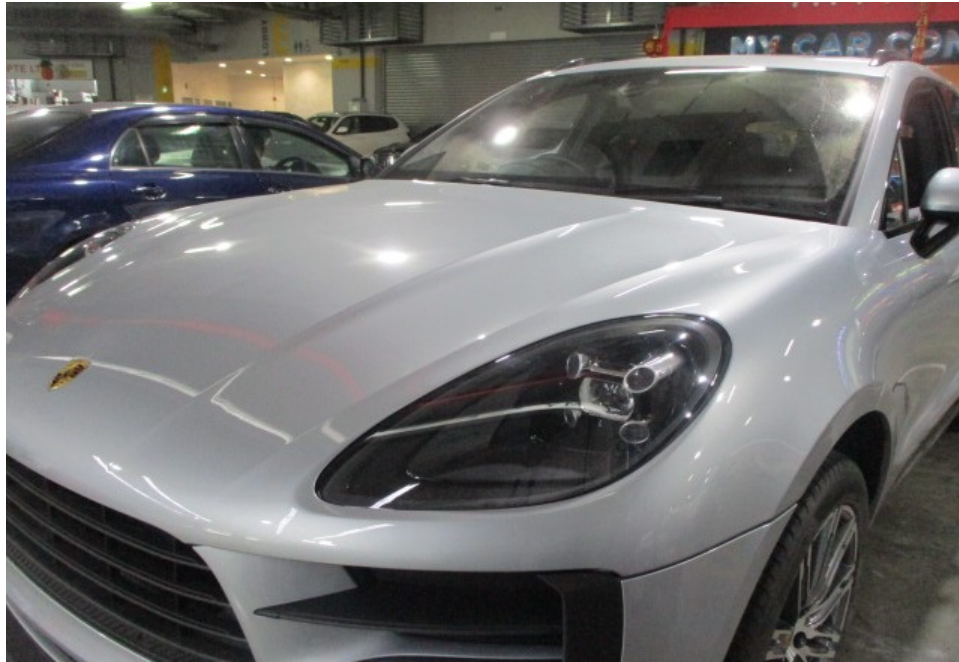
Photo 8 shows a closer view of the Motor Car's front bonnet and front left headlamp. The body parts at the frontal portion of the Motor Car were visually examined and it was observed that the repair/restoration works carried out to the damaged area of the Motor Car (refer to photograph 1 - 4 above) were reasonably adequate and in order.

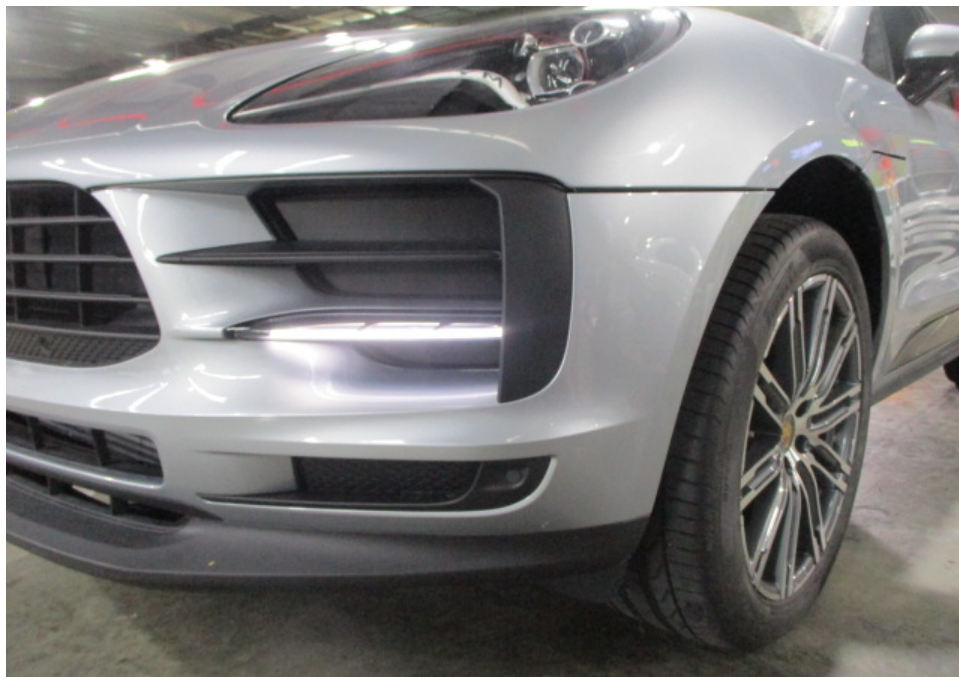
Photo 9 shows a closer view of the Motor Car's front bumper, front bumper left lower grille, front bumper left upper grille, front bumper lower lip and front left day light. The body parts at the frontal portion of the Motor Car were visually examined and it was observed that the repair/restoration works carried out to the damaged area of the Motor Car (refer to photograph 1 - 4 above) were reasonably adequate and in order.

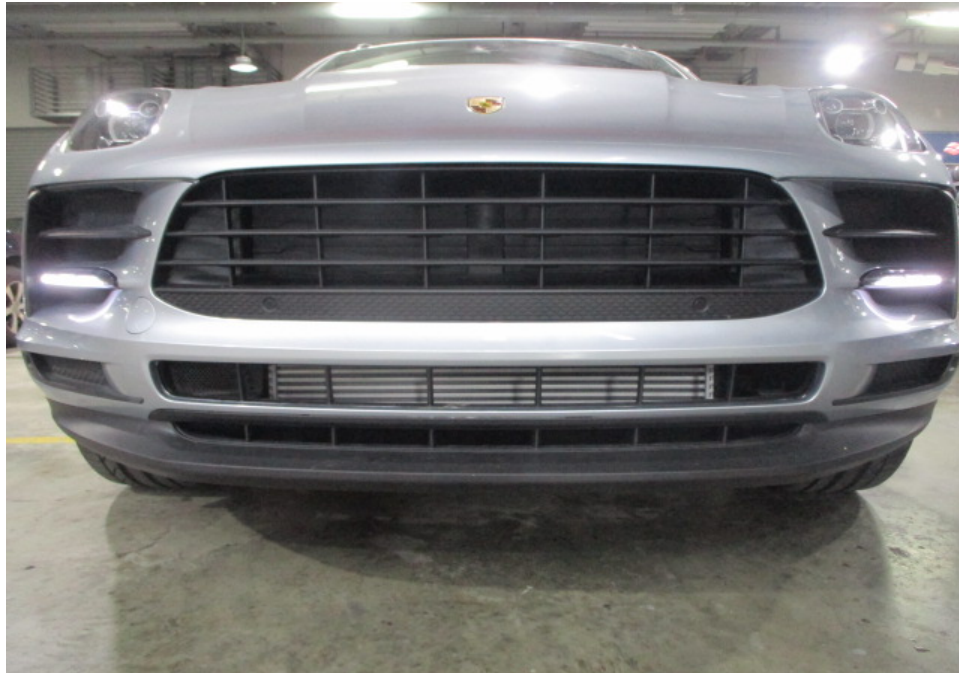
Photo 10 shows a closer view of the Motor Car's front bumper, front bumper centre lower grille, radiator grille and day running lights. The body parts at the frontal portion of the Motor Car were visually examined and it was observed that the repair/restoration works carried out to the damaged area of the Motor Car (refer to photograph 1 - 4 above) were reasonably adequate and in order.

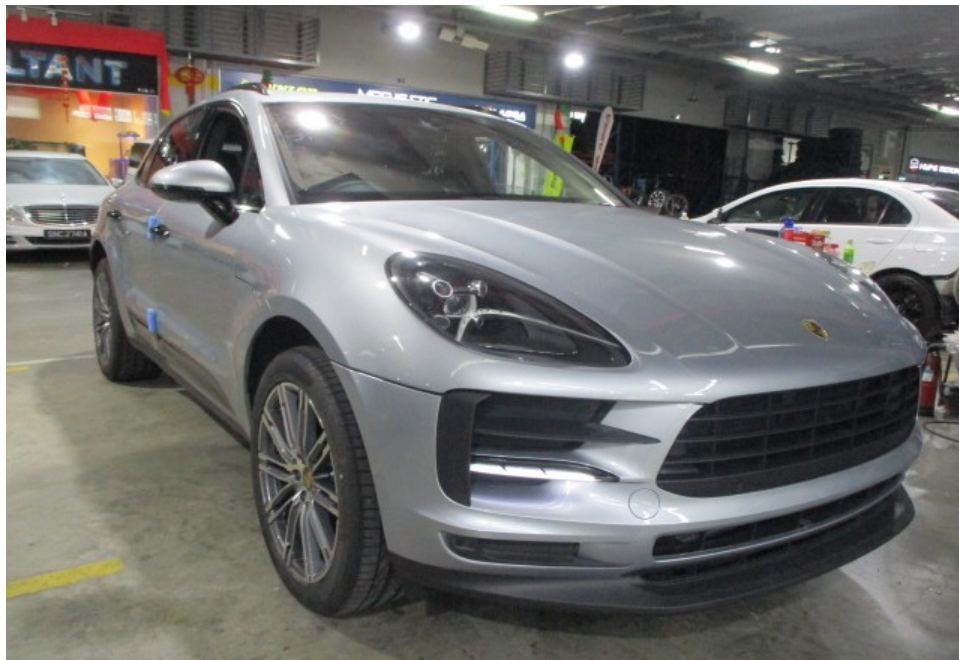
Photo 11 shows a general view of the front right body of the Motor Car at the time of my inspection. The Motor Car was observed to be in a relatively good general condition with no loose exterior fittings observed. The body parts at the frontal portion of the Motor Car were visually examined and it was observed that the repair/restoration works carried out to the damaged area of the Motor Car (refer to photograph 1 - 4 above) were reasonably adequate and in order.

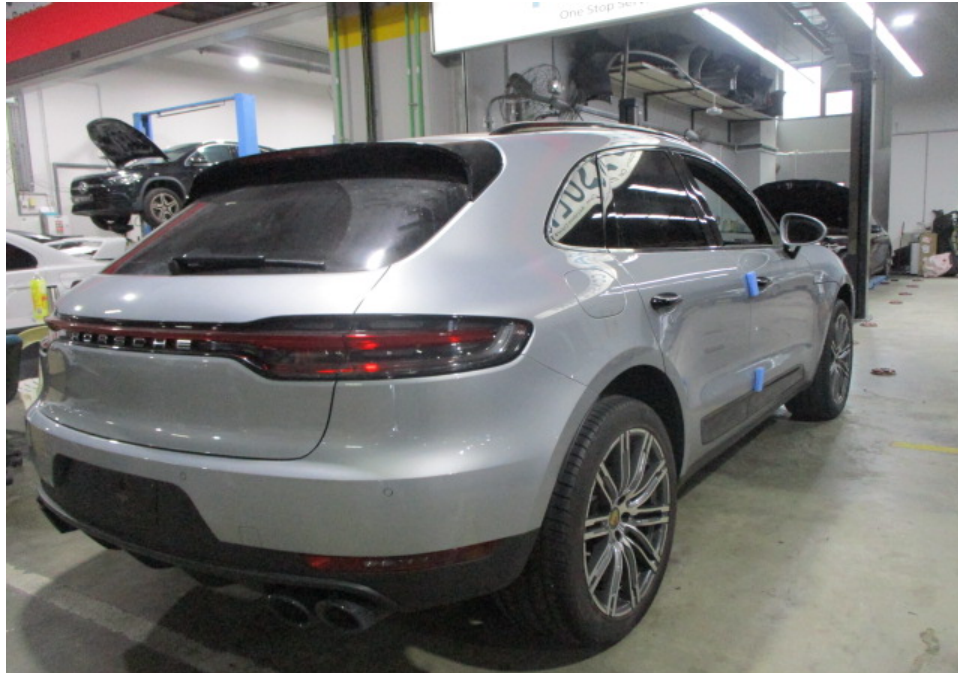
Photo 12 shows a general view of the rear right body of the Motor Car at the time of my inspection. The Motor Car was observed to be in a relatively good general condition with no loose exterior fittings observed. The mileage of the Motor Car recorded at the time of my inspection was 21,038km.

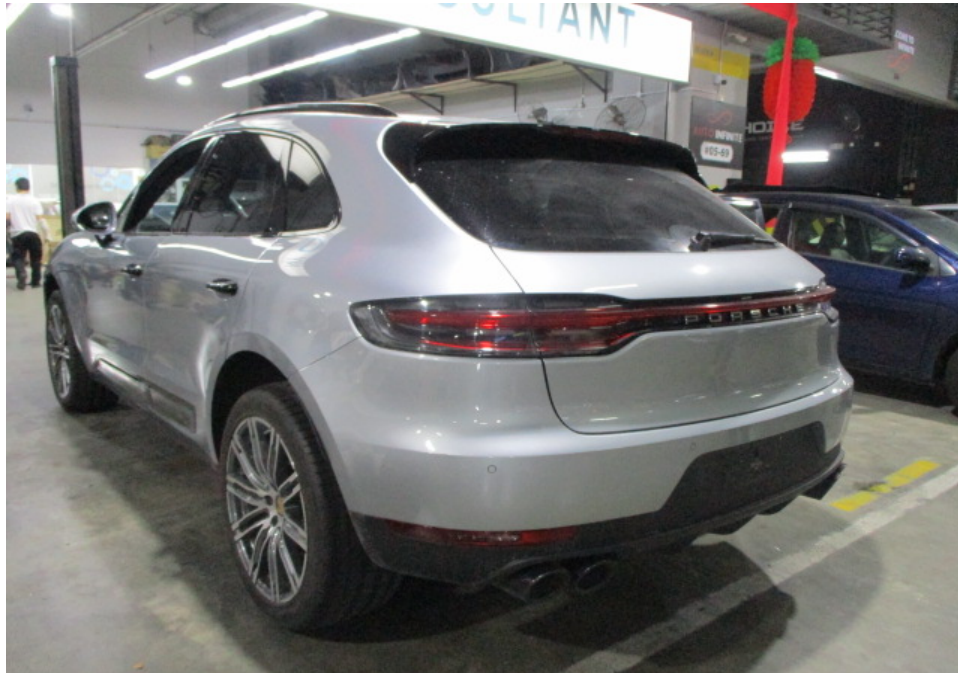
Photo 13 shows a general view of the rear left body of the Motor Car at the time of my inspection. The Motor Car was observed to be in a relatively good general condition with no loose exterior fittings observed. The mileage of the Motor Car recorded at the time of my inspection was 21,038km.

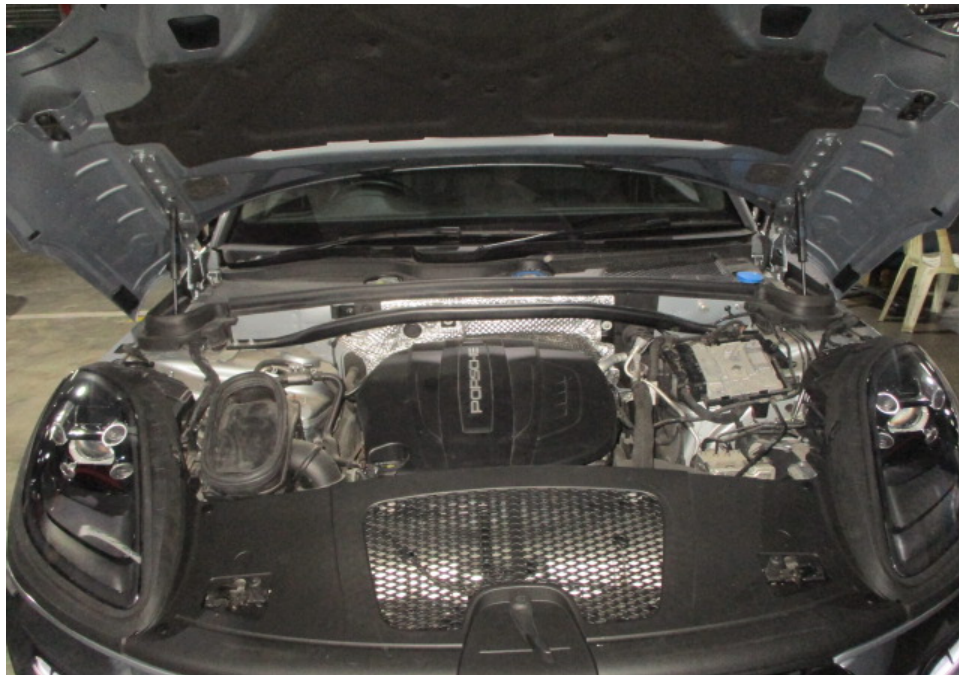
Photo 15 shows a general view of the engine compartment of the Motor Car at the time of my inspection. The various parts and components inside the engine compartment were all observed to be intact and properly fitted. There was also no sign(s) or indication(s) of fluid leak and/or fluid stain found inside the engine compartment.

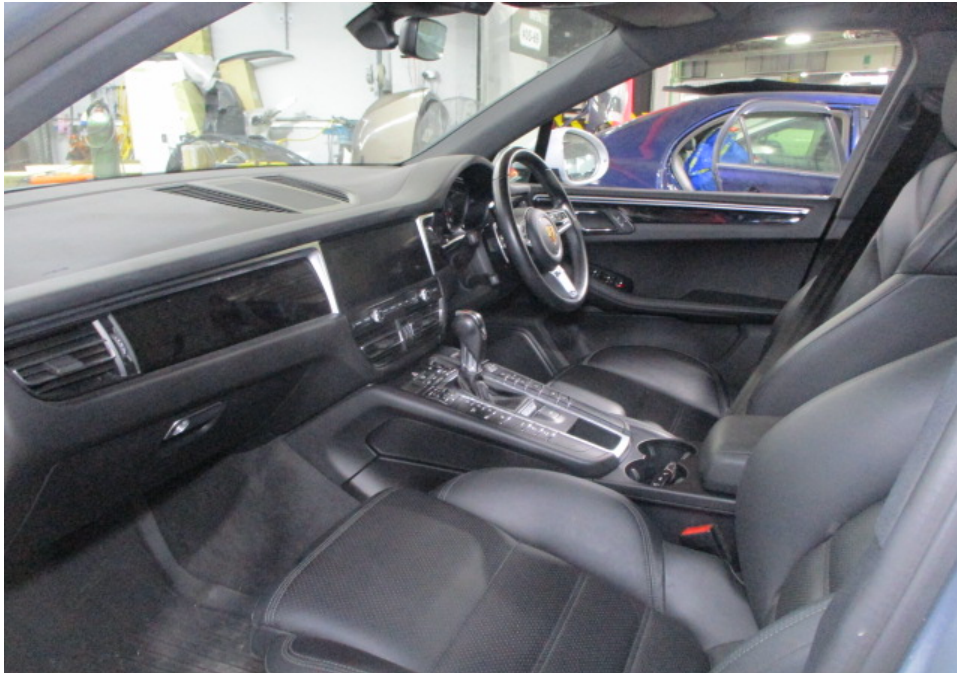
Photo 16 shows the interior compartment of the Motor Car. The front dashboard, steering wheel, seats, upholstery and trims etc were all observed to be intact and properly fitted.

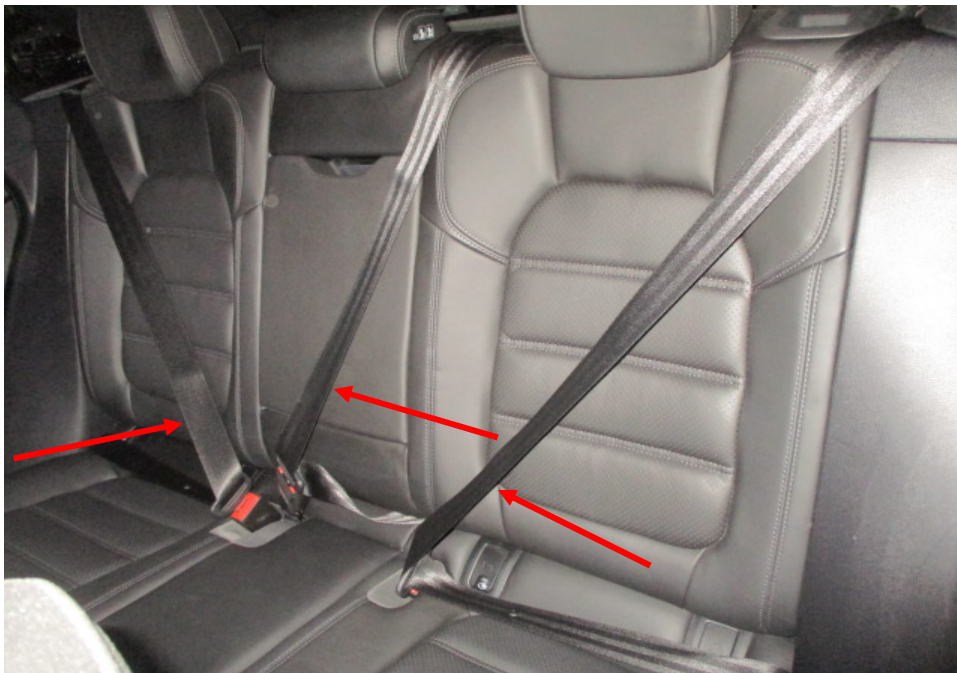
Photo 17 shows the rear seats of the Motor Car. All the seats of the Motor Car were secured via seat rails to the floorboard. They were also fitted with a retractable seat belt reel and a pre-tensioner. The seat belts (arrowed) were tested and were able to be fastened into the respective pre-tensions that were fitted on the side of each individual seat.

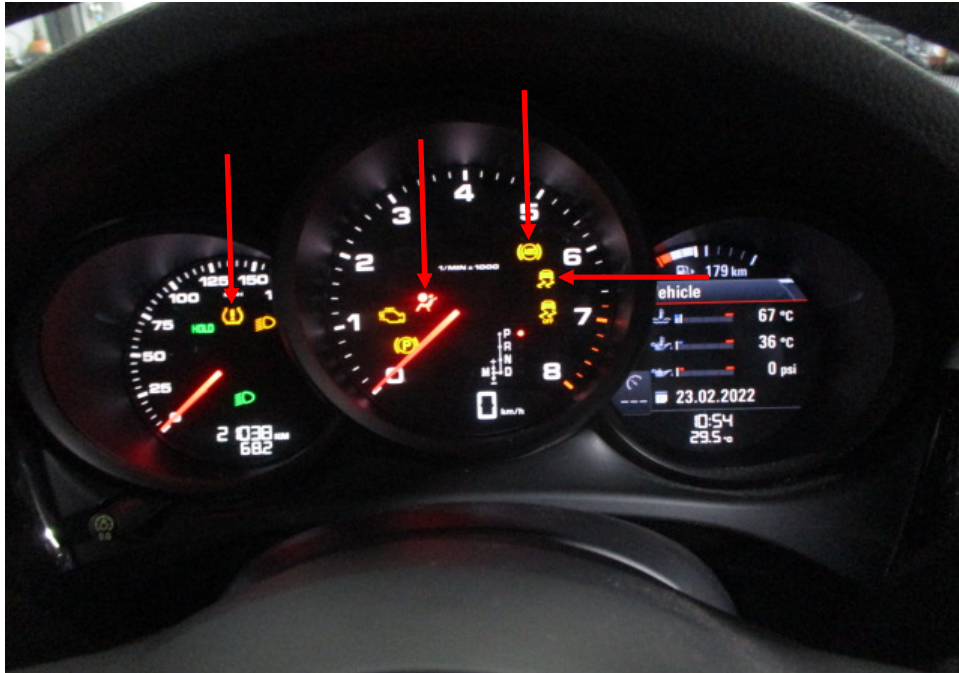
Photo 18 shows the warning lights for the various electronic safety features appearing on the instrument panel of the Motor Car during its self-test when the engine is cranked, in particular the ABS, SRS, TPM and TCS lights (arrowed).

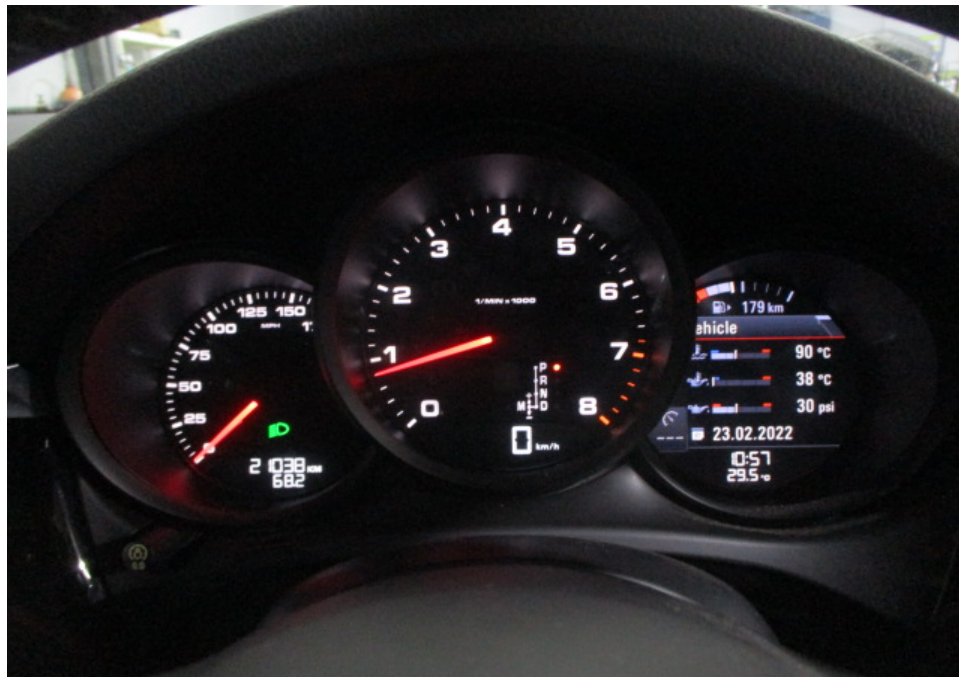
Photo 19 shows the respective warning lights no longer illuminated, indicating that there is no fault detected to the ABS, SRS, TPM and TCS systems of the Motor Car during the self-test. These electronic systems were hence in working condition at the time of my inspection.

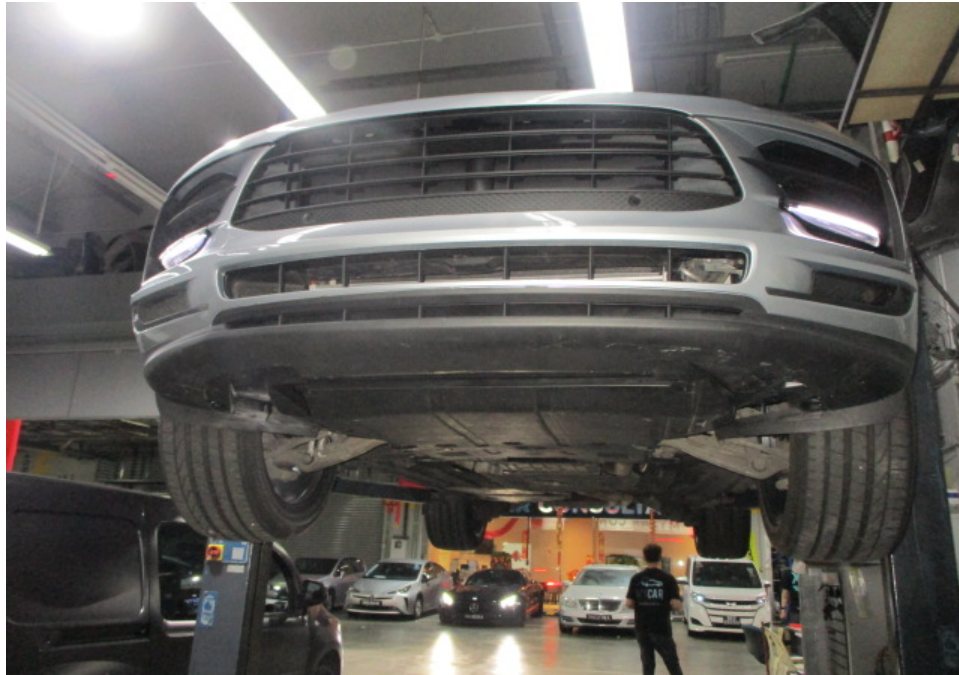
Photo 20 shows the Motor Car hoisted up for checks on its undercarriage. There was no sign(s) or indication(s) of fluid leakage and/or fluid stain(s) on the underside of the Motor Car. The undercarriage components of the Motor Car were also all observed to be intact and secured in an appropriate manner.

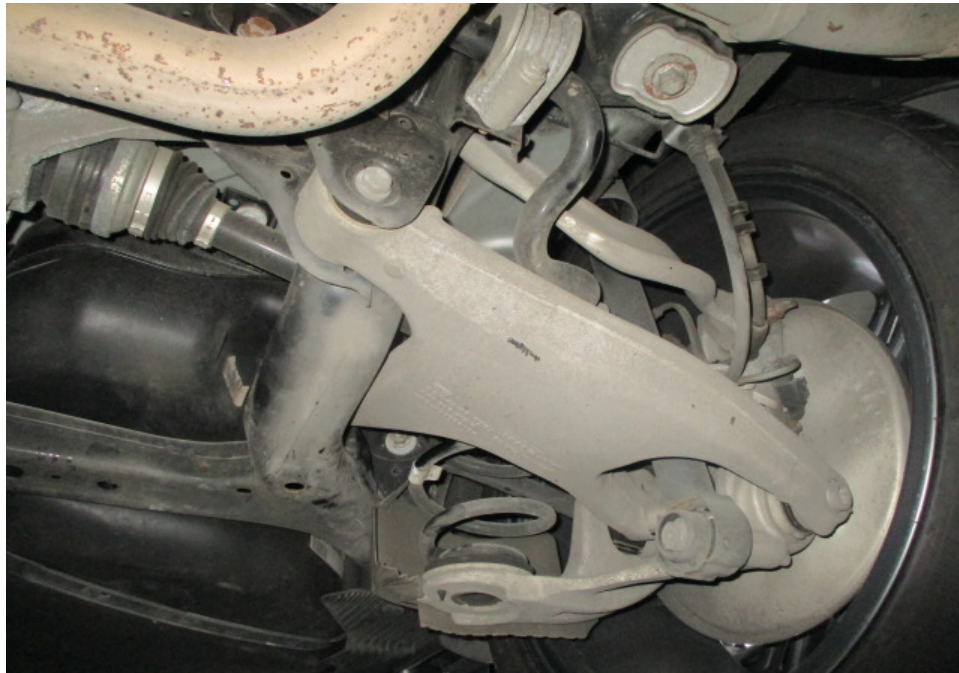
Photo 21 shows a general view of the control arms and linkages at the rear right wheel of the Motor Car. I did not observe any fluid leak and/or fluid stain on the underside of the Motor Car. All of the Motor Car's undercarriage components were observed to be intact and secured in an appropriate manner.

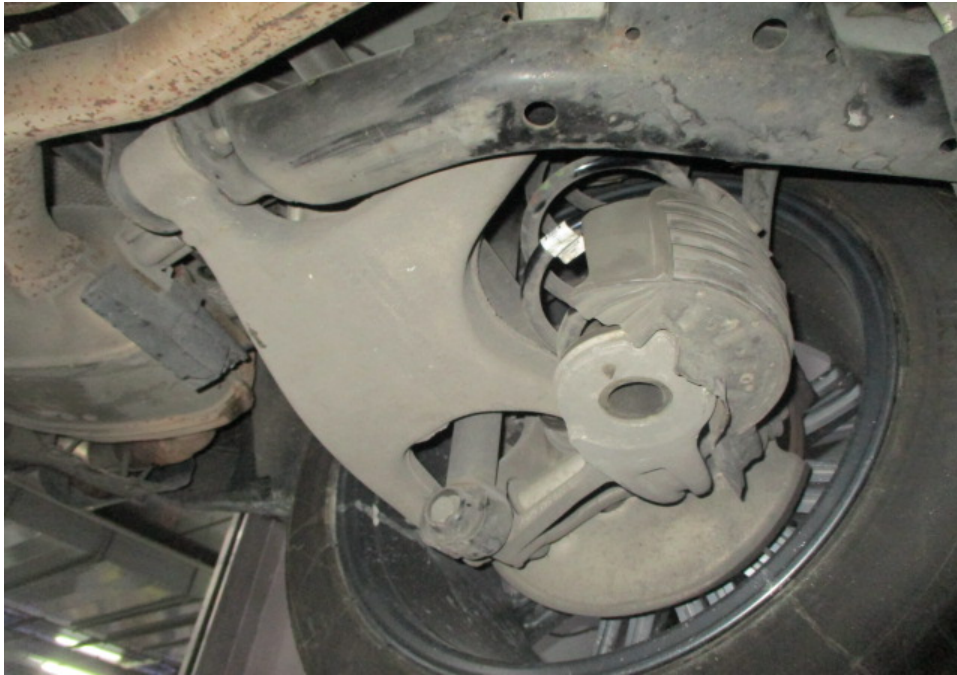
Photo 22 shows a general view of the control arms and linkages at the rear left wheel of the Motor Car. I did not observe any fluid leak and/or fluid stain on the underside of the Motor Car. All of the Motor Car's undercarriage components were observed to be intact and secured in an appropriate manner.

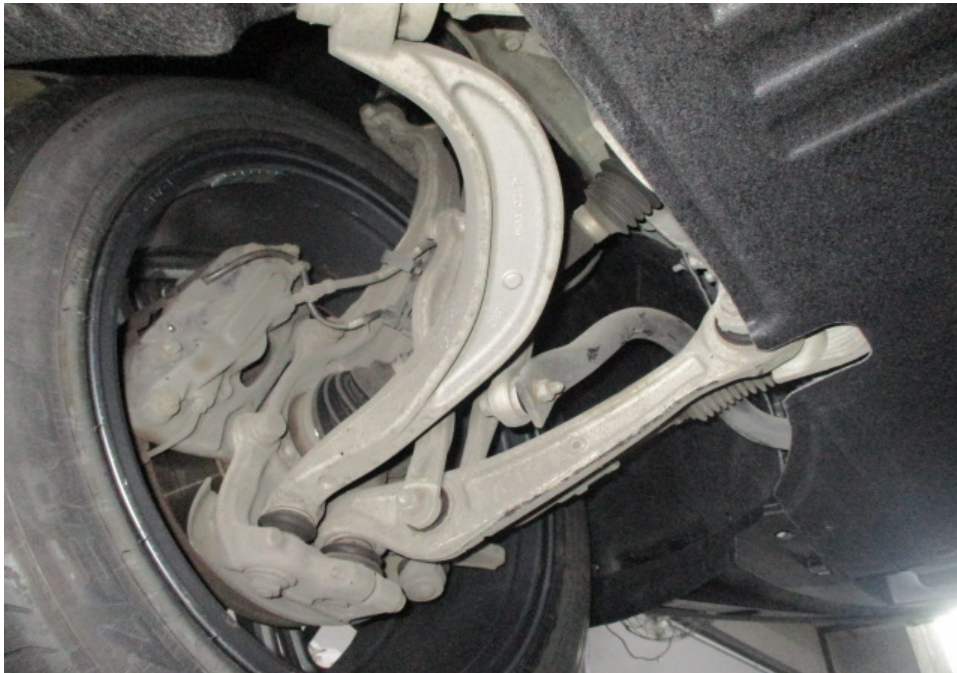
Photo 23 shows a general view of the control arms and linkages at the front left wheel of the Motor Car. I did not observe any fluid leak and/or fluid stain on the underside of the Motor Car. All of the Motor Car's undercarriage components were observed to be intact and secured in an appropriate manner.

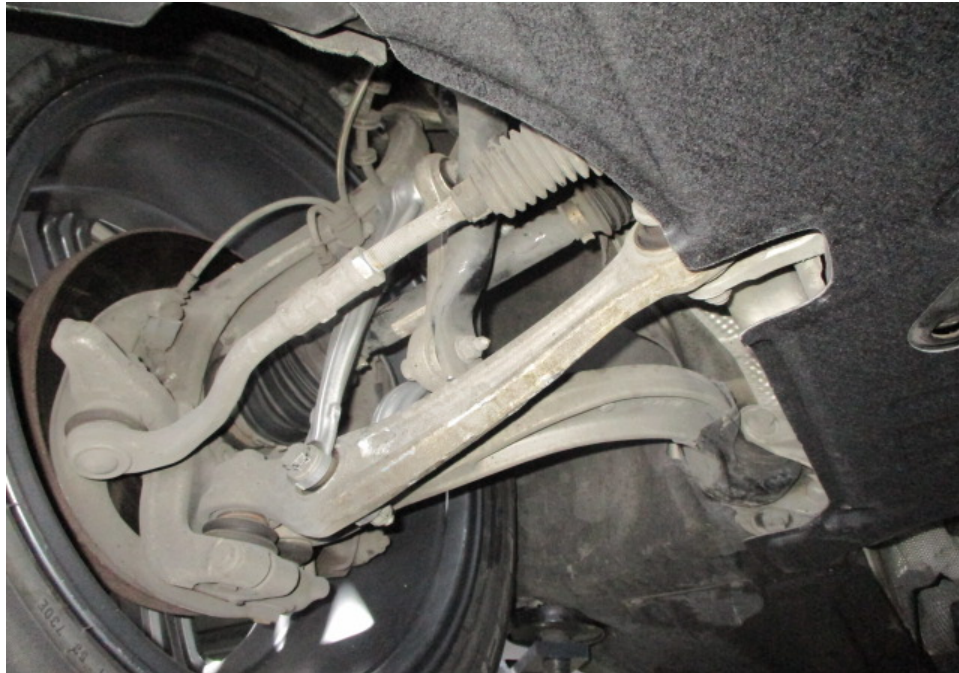
Photo 24 shows the various undercarriage components at the front right wheel of the Motor Car. The mechanical components, control arms and linkages were all found to be intact and secured in an appropriate manner. I also did not observe any fluid leak and/or fluid stain on the underside of the Motor Car.

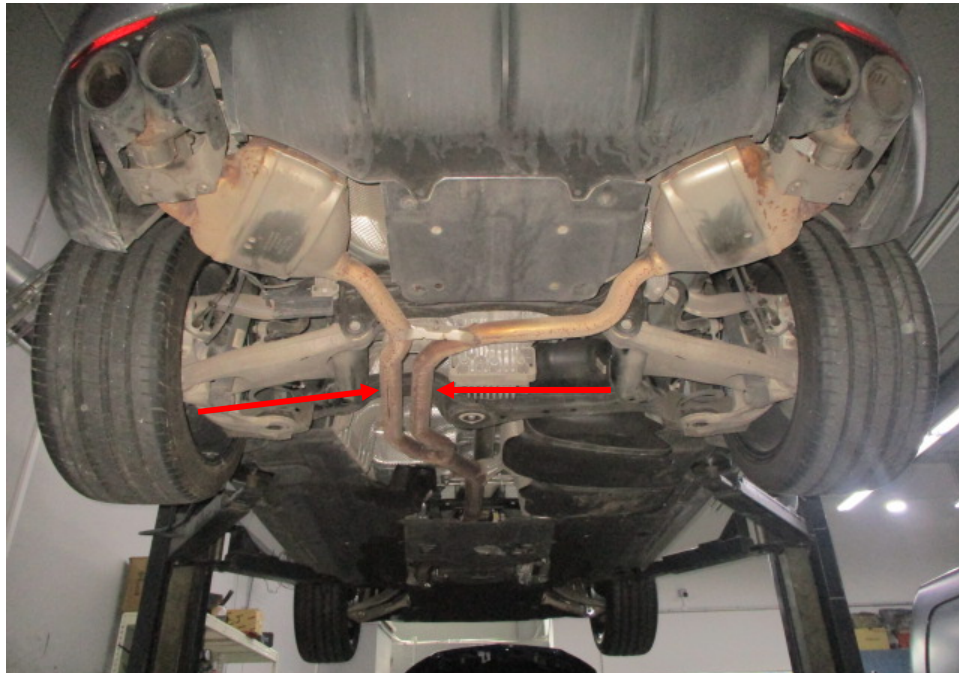
Photo 25 shows the rear section of the Motor Car's exhaust system. My examination of the Motor Car's exhaust system revealed no sign(s) or indication(s) of any cut or weld marks along its exhaust pipes (arrowed), on its rear mufflers and on its catalytic converter.

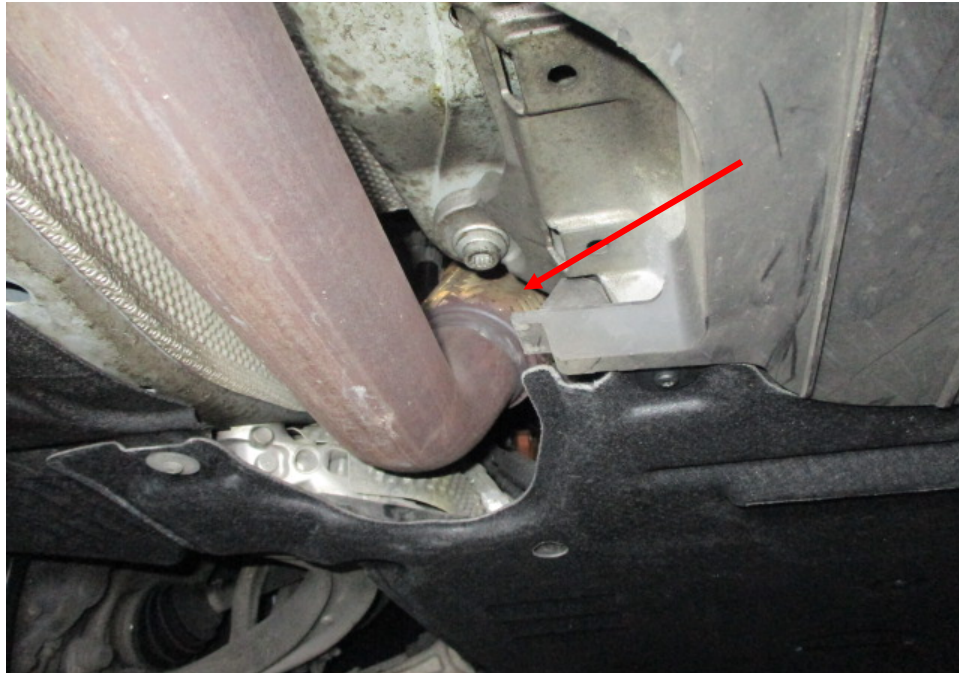
Photo 26 shows the front section of the Motor Car's exhaust system. My examination of the Motor Car's exhaust system revealed no sign(s) or indication(s) of any cut or weld marks along its exhaust pipes, on its rear mufflers and on its catalytic converter (arrowed).

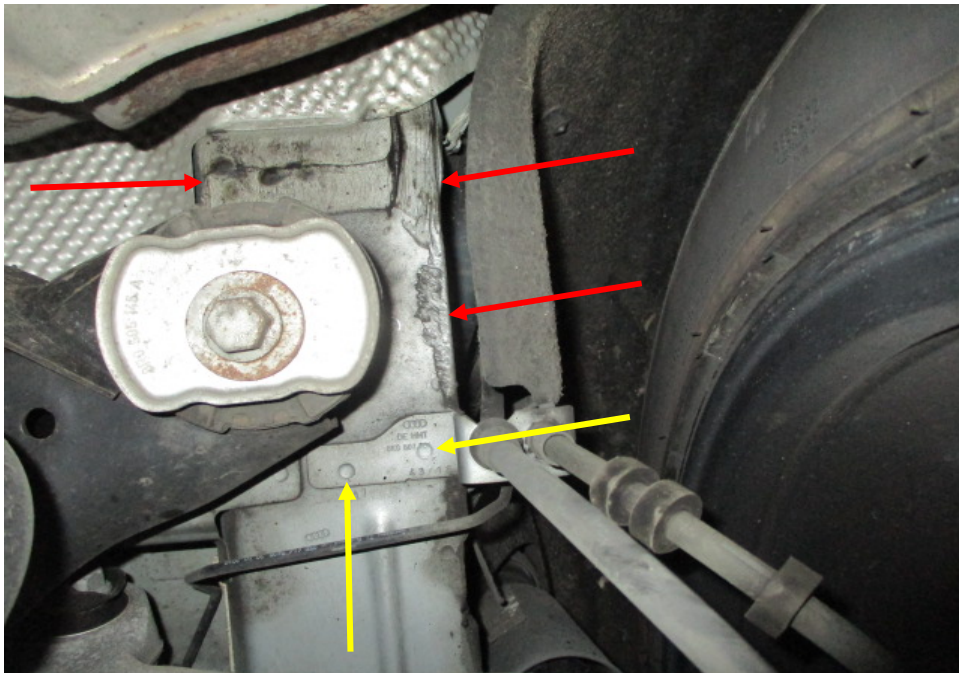
Photo 27 shows the chassis/structural body at the underside rear right of the Motor Car. I did not find any weld marks other than original spot weld marks (yellow arrow) on the chassis/structural body of the Motor Car. The original factory sealant (red arrow) at the joints along the chassis/structural body was untouched, indicating no work was done on the chassis/structural body of the Motor Car and that the chassis/structural body was originally fitted.

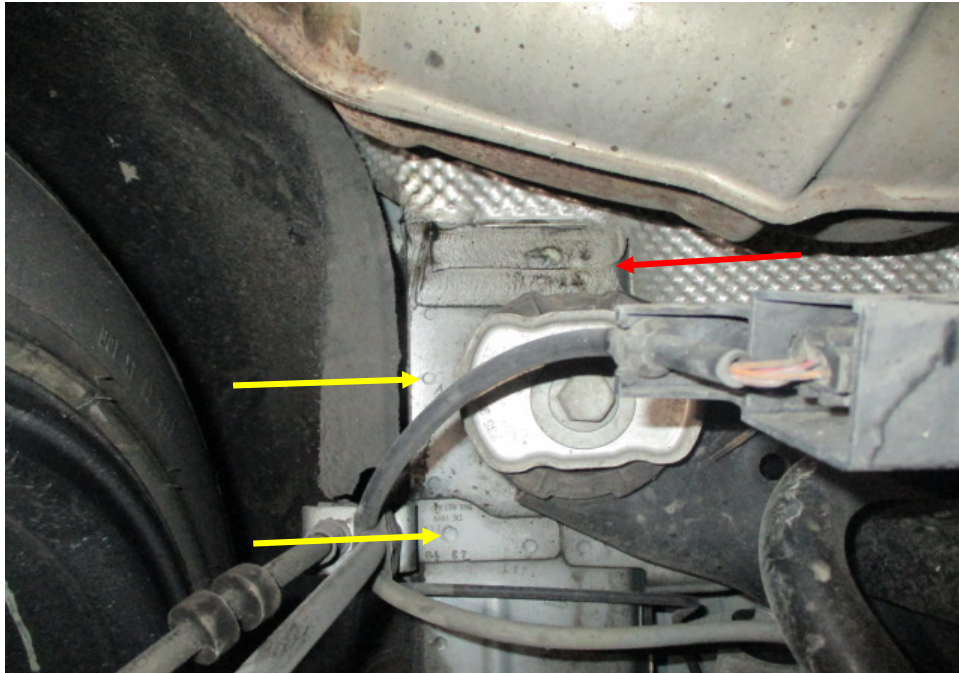
Photo 28 shows the chassis/structural body at the underside rear left of the Motor Car. I did not find any weld marks other than original spot weld marks (yellow arrow) on the chassis/structural body of the Motor Car. The original factory sealant (red arrow) at the joints along the chassis/structural body was untouched, indicating no work was done on the chassis/structural body of the Motor Car and that the chassis/structural body was originally fitted.

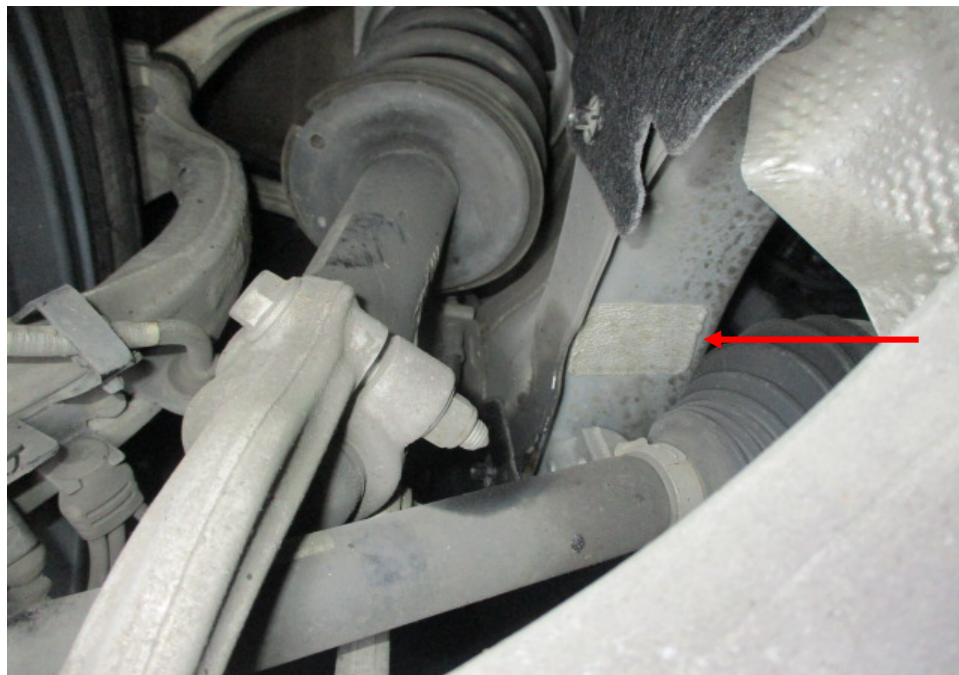
Photo 29 shows the chassis/structural body at the underside front left of the Motor Car. The original factory sealant (arrowed) at the joints along the chassis/structural body was observed to be untouched. In general, I had found no work was carried out on the chassis/structural body of the Motor Car. The chassis/structural body of the Motor Car was originally fitted.
