Your Ref: Porsche Macan
(chassis number WP1ZZZ95ZKLB05328)
Our Ref : CI/TP22001767/D

25 February 2022

INSPECTION REPORT OF AN UNREGISTERED PORSCHE MACAN MOTOR CAR WITH CHASSIS NUMBER WP1ZZZ95ZKLB05328

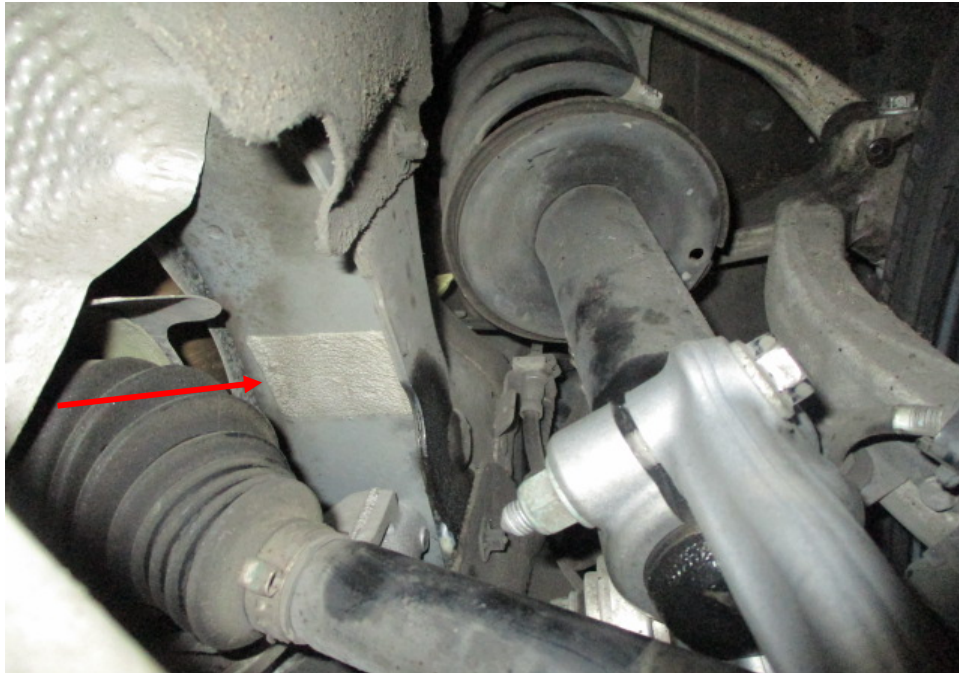
Photo 30 shows the chassis/structural body at the underside front right of the Motor Car. I did not find any weld marks other than original spot weld marks on the chassis/structural body of the Motor Car. The original factory sealant (arrowed) at the joints along the chassis/structural body was also untouched, indicating no work was done on the chassis/structural body of the Motor Car and that the chassis/structural body was originally fitted.

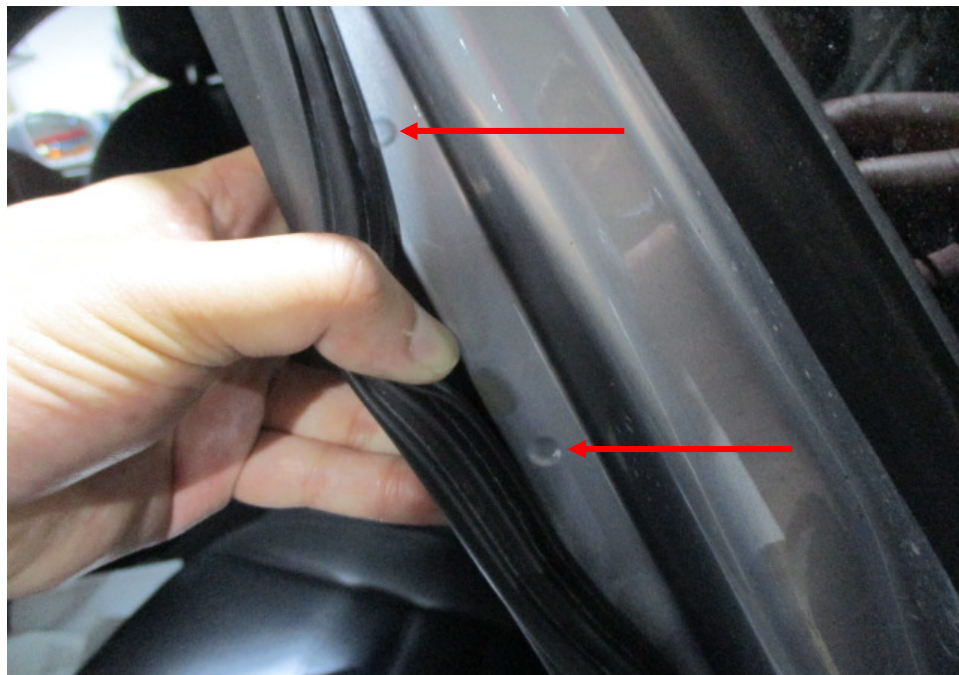
Photo 31 shows the left side "C" pillar of the Motor Car. I did not find any weld marks other than original spot weld marks (arrowed) on the left side "C" pillar of the Motor Car which, indicates that there was no re-welding works carried out. In general, I had found all the non-detachable body panels of the Motor Car to be originally fitted at the time of my inspection.

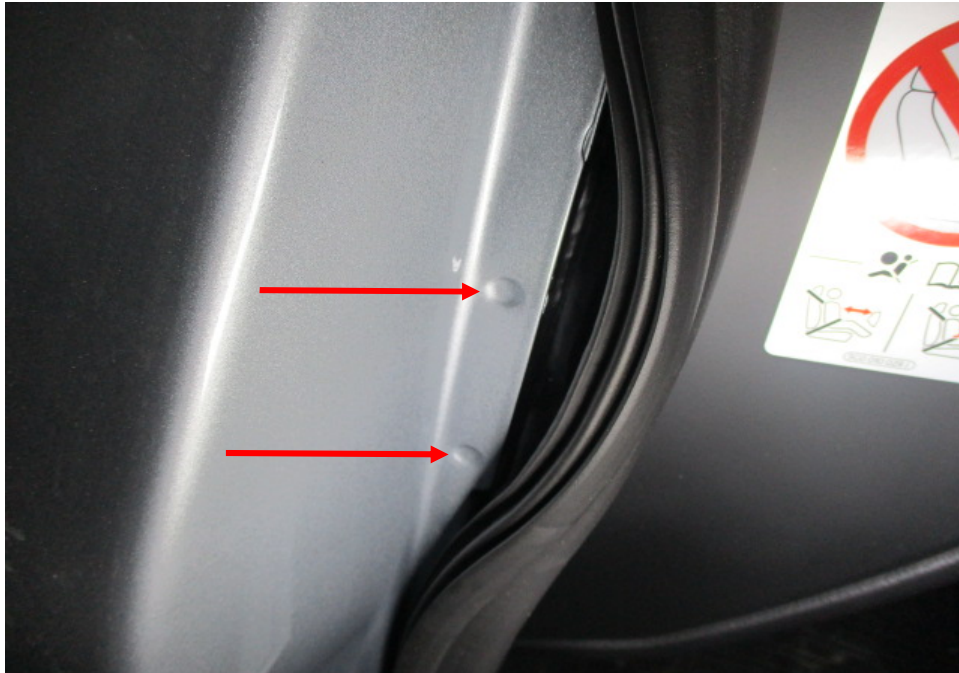
Photo 32 shows the left side "A" pillar of the Motor Car. I did not find any weld marks other than original spot weld marks (arrowed) on the left side "A" pillar of the Motor Car which, indicates that there was no re-welding works carried out. In general, I had found all the non-detachable body panels of the Motor Car to be originally fitted at the time of my inspection.

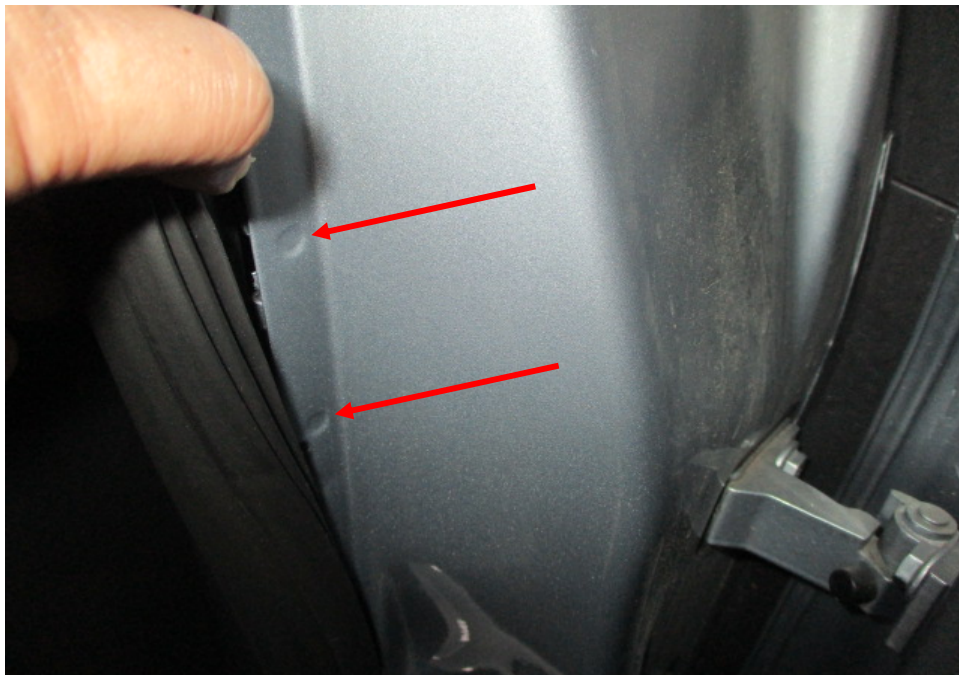
Photo 33 shows the right side "A" pillar of the Motor Car. I did not find any weld marks other than original spot weld marks (arrowed) on the right side "A" pillar of the Motor Car which, indicates that there was no re-welding works carried out. In general, I had found all the non-detachable body panels of the Motor Car to be originally fitted at the time of my inspection.

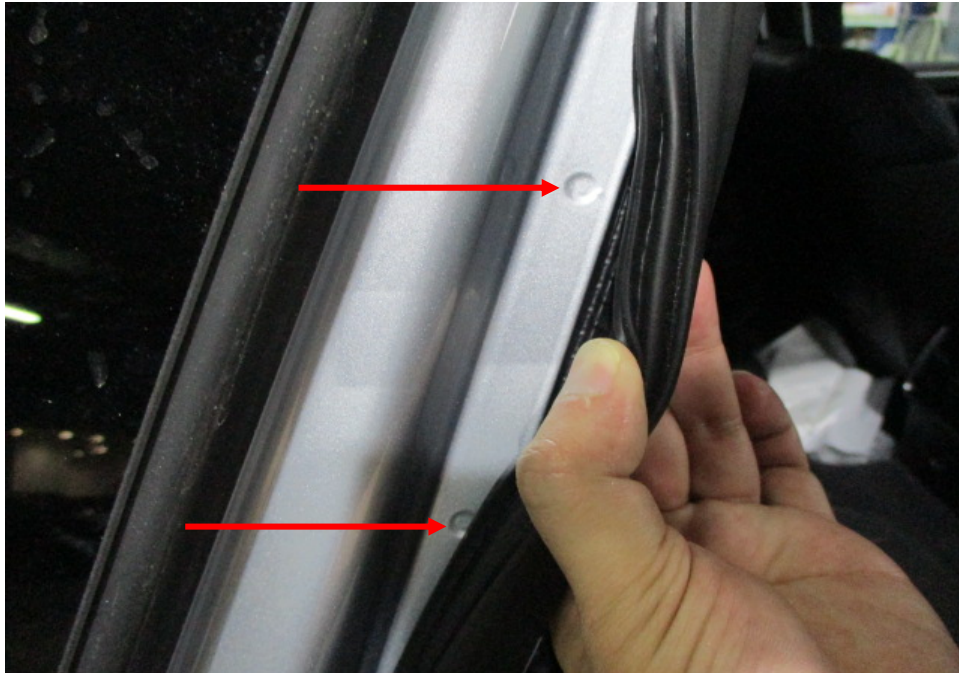
Photo 34 shows the right side "C" pillar of the Motor Car. I did not find any weld marks other than original spot weld marks (arrowed) on the right side "C" pillar of the Motor Car which, indicates that there was no re-welding works carried out. In general, I had found all the non-detachable body panels of the Motor Car to be originally fitted at the time of my inspection.
