Your Ref : SNM22D201378/C02
Our Ref : CS/CTI22001851/P

6th July 2022

**AUTOMOBILE TECHNICAL INVESTIGATION REPORT OF ACCIDENT
INVOLVING YP 2862K AND SGM 1803S ON 16 January 2022**

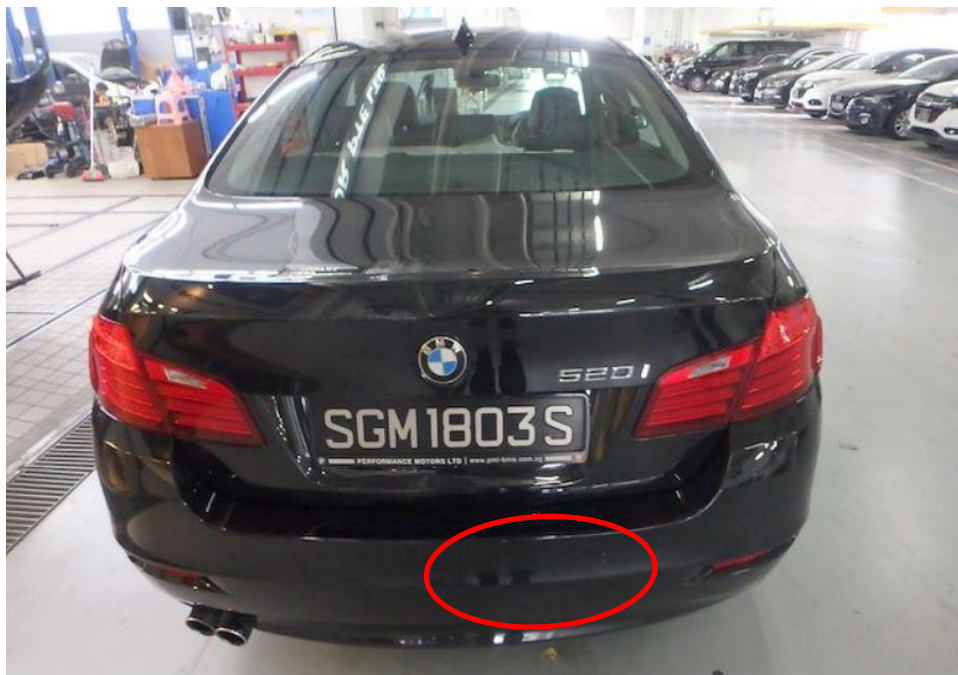
10. Examination of these photographs showed the rear bumper had been damaged on the Car. It was also noted that there were paint crack marks and vertical dent marks on the rear bumper of the Car. The paint crack marks seen are indicative of the rear bumper being exposed to an impact force, compressing the rear bumper inwards leading to the cracking of paint. However there was neither a dislodgement nor misalignment of the rear bumper of the Car. See photos 1 – 4 below.

Photo 1 shows the general view of the rear portion of Car at the time of inspection. The rear bumper had been damaged. It was also noted that there were paint crack marks and dent (circled) on the rear bumper of the Car.

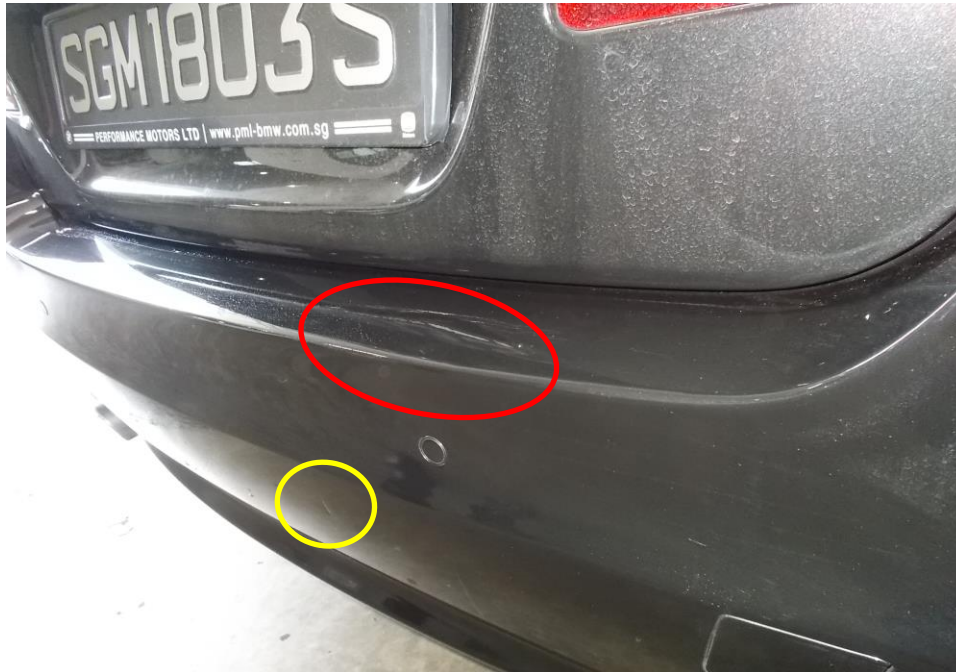
Photo 2 shows the close up view of the rear portion of Car at the time of inspection. The rear bumper had been damaged. It was also noted that there were paint crack marks (red circle) and dent (yellow circle) on the rear bumper of the Car.

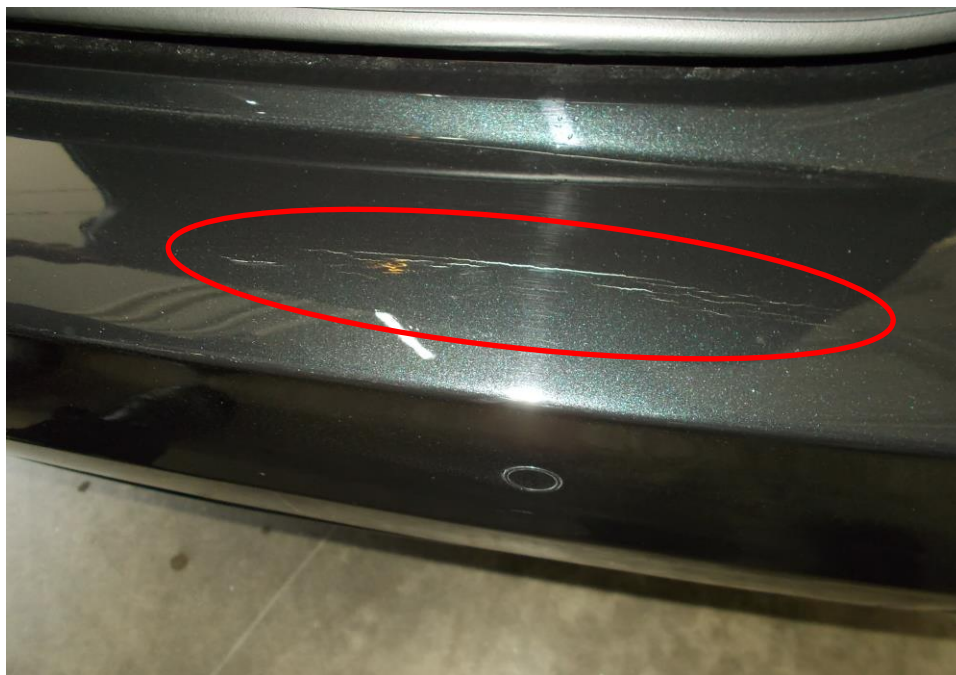
Photo 3 shows the close up view of the rear portion of Car at the time of inspection. The rear bumper had been damaged. It was also noted that there were paint crack marks (circled) on the rear bumper of the Car.

11. For this case, the paint crack marks on the rear bumper of the Car was likely caused by an induced impact from the rear which had also likely caused the dent at the lower rear bumper. See photo 3 and 4 above.

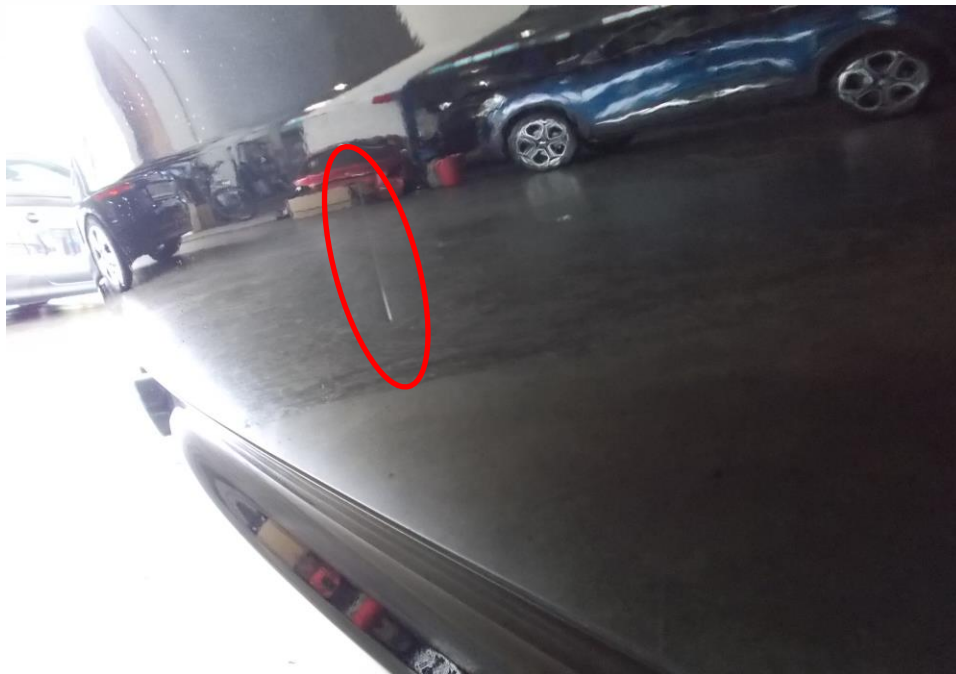
Photo 4 shows the close up view of the rear portion of Car at the time of inspection. The rear bumper had been damaged. It was also noted that there were vertical dent marks (circled) on the rear bumper of the Car. Vertical indentation found on the rear bumper is another sign that the rear bumper was exposed to an impact force. The object impacting onto the rear bumper was likely to be a vertically shaped object.

16. In additional, earlier in paragraph 10, it was commented that the vertical indentation was caused by a vertically shaped object. In the aspect, the damage pattern seem to correspond to the vertical side of the front number plate of the Lorry.

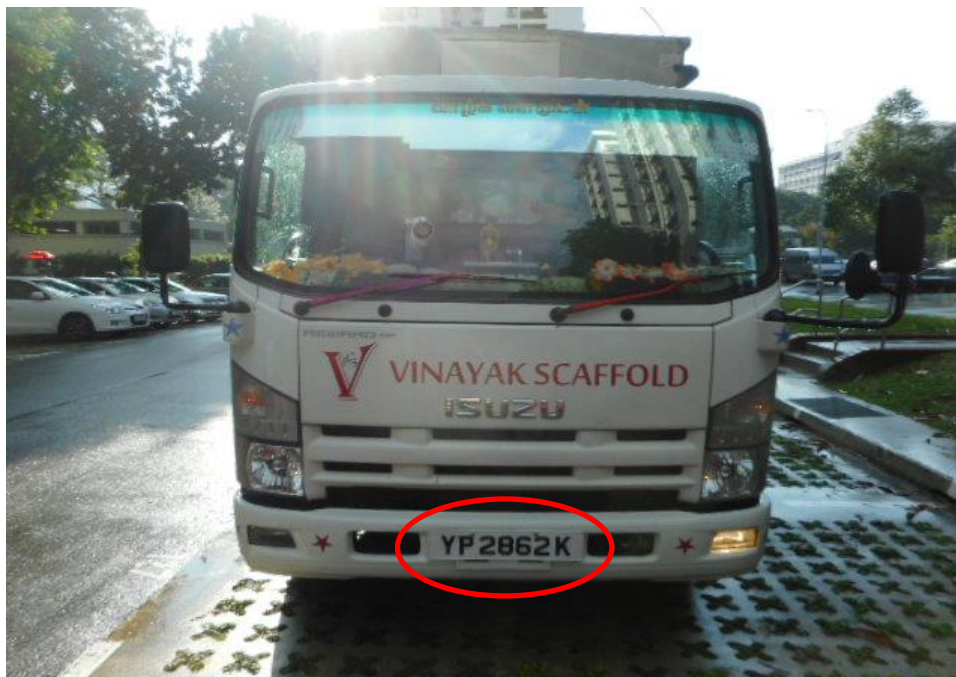
13. Based on the circumstances of the accident as iterated by Vincent, we are of the opinion that the point of contact of Lorry would be at its front portion since the Lorry was behind the Car at the mentioned point of collision. At the time of our inspection, we observed that there were damages on its front number plate portion of the Lorry as it was the most protruding at the front of the Lorry. However, there was neither a dislodgement nor misalignment of the front bumper portion of the Lorry.
14. Examination of these photographs showed the front number plate on the front bumper portion had been observed with black colour paint transfer and scratch marks on the Lorry. See photos 5 – 7 below.

Photo 5 shows the general view of the front portion of Lorry at the time of inspection. The front number plate (circled) had paint transfer and scratch marks.

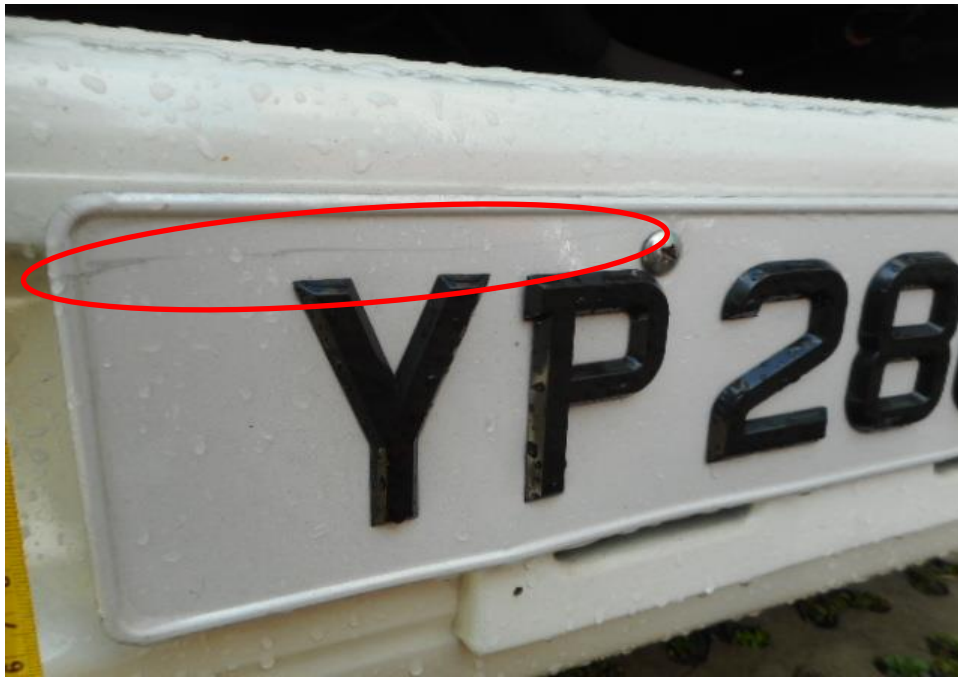
Photo 6 shows the close up view of the front portion of Lorry at the time of inspection. The front number plate (circled) had paint transfer and scratch marks.

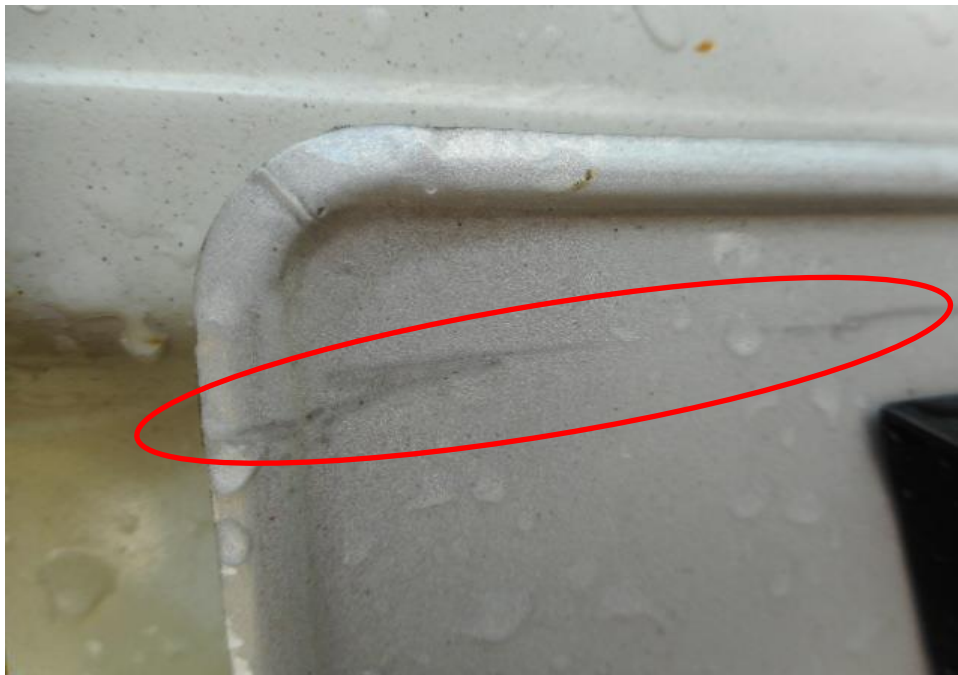
Photo 7 shows the close up view of the front portion of Lorry at the time of inspection. The front number plate (circled) had paint transfer and scratch mark. The black marks corresponds to the body colour of the Car.

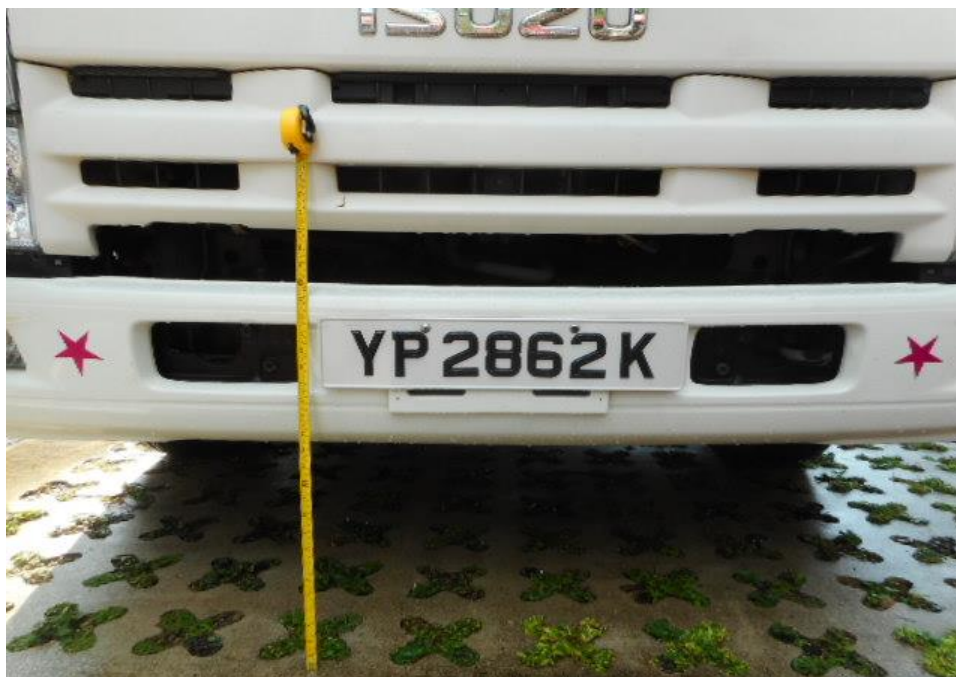
Photo 8 shows a general view of the height measurement being conducted on the front portion of Lorry. The front number plate where the paint transfer and scratched marks is was measured to be at 54cm to 55cm above ground level.

- a) the height measurements above ground level of front number plate portion of the Lorry was measured to be at 54cm to 55cm above ground level respectively;
- b) the height above ground level of the range of damages (which included the damage of the rear bumper portion of the Car) was measured to be between 46cm to 49cm above ground level respectively.

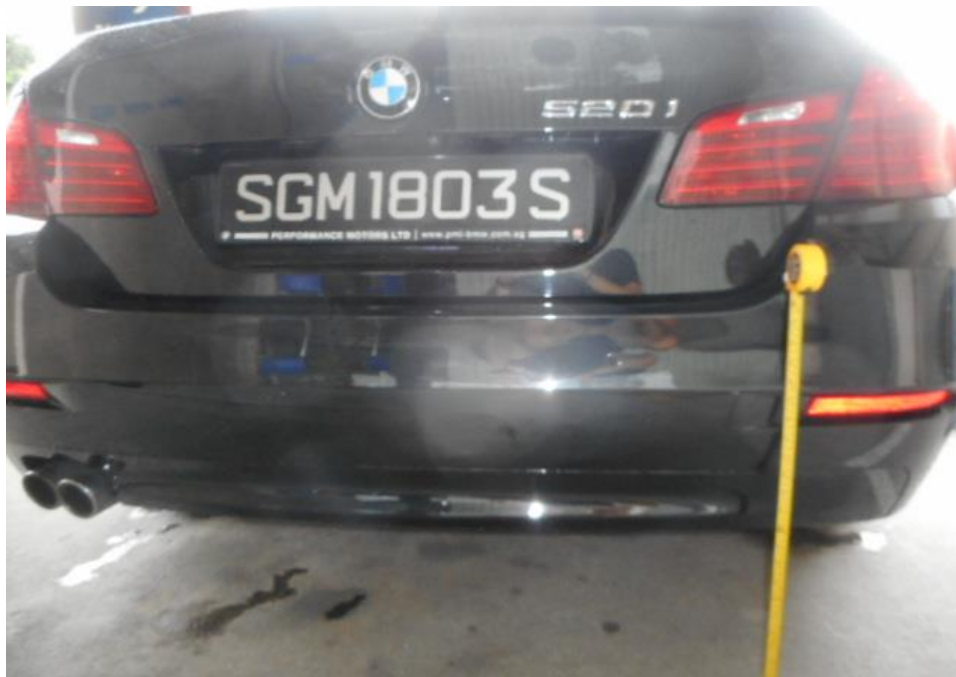
Photo 9 shows the general view of the height measurement being conducted on the rear portion of Car. The height above ground level of where the dent at the rear bumper portion, was at 46cm to 49cm respectively.

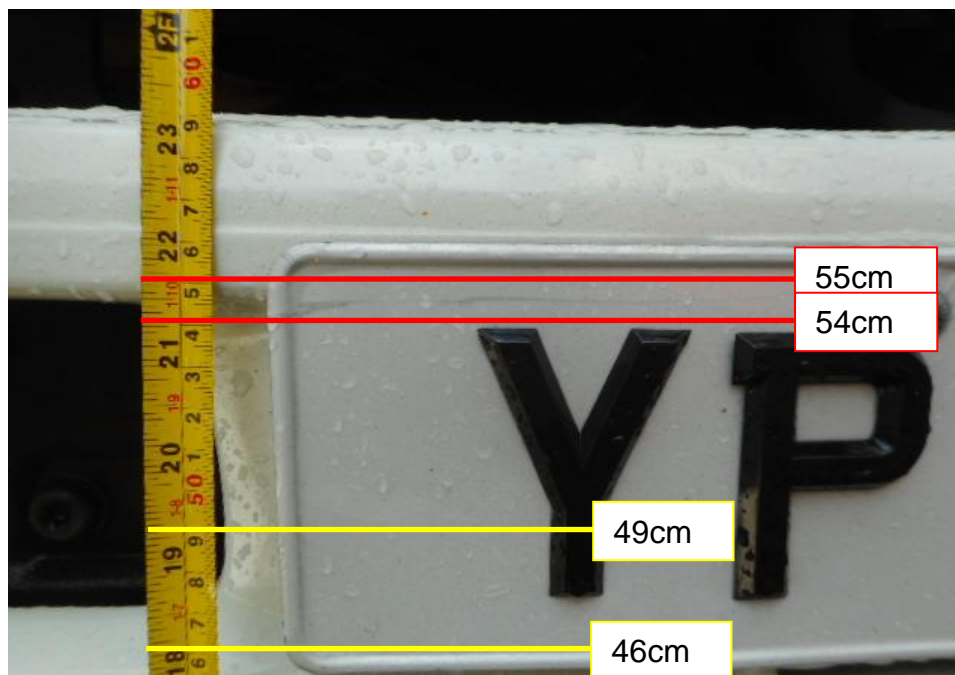
Photo 10 shows the close up view of the height measurement being conducted on the front portion of Lorry. The front number plate where the paint transfer and scratched marks was measured to be at 54cm to 55cm and the vertical indentation as compared from the rear bumper of the Car to Lorry front vertical side of the number plate was between 46cm to 49cm (yellow lines) above ground level.

- c) In addition, the vertical indentation found on the rear bumper of the Car is likely caused by the vertical side of the front number plate of the Lorry and the black colour paint transfer marks found on the Lorry was likely from the rear bumper of the Car, we have also cross measured both on the Car and Lorry and both damages appear to fall in between the measurements of both 46cm to 49cm and 54cm to 55cm.
- d) From our understanding and observations of the contact points for these damaged portions we are in view that the mentioned points are the results of this particular collision between both involved Vehicles and we suggest that there was possible contact between the rear portion of Car and the front portion of Lorry.

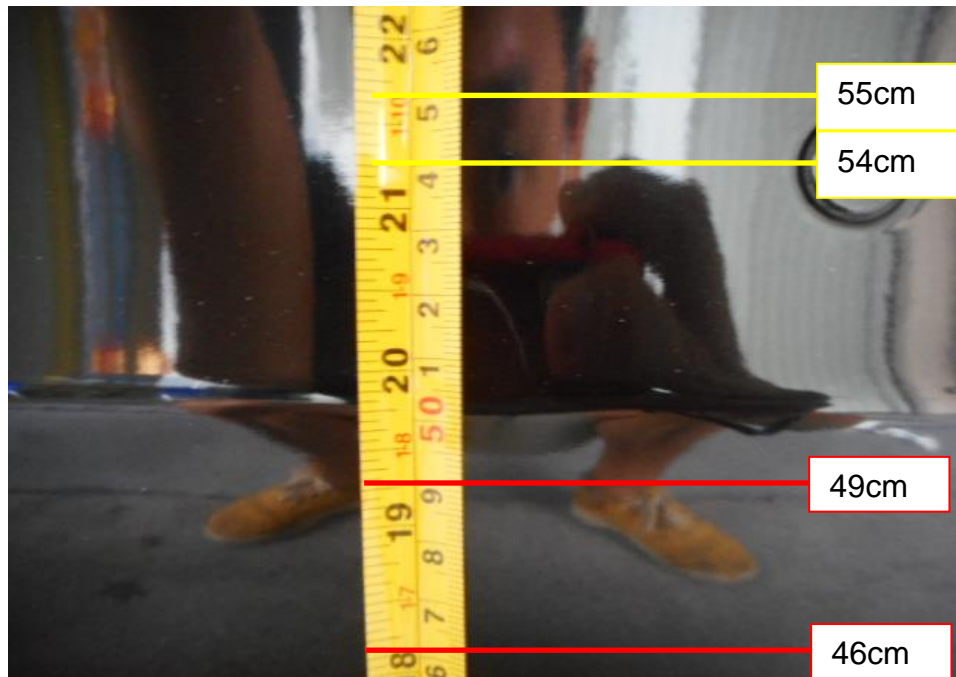
Photo 11 shows the close up view of the height measurement being conducted on the rear portion of Car. The height above ground level of where the vertical indentation damage were found on the rear bumper portion of the Car was between 46cm to 49cm (red lines) and the black paint transfer marks as compared from Lorry front number plate to the rear bumper of the Car was between 54cm to 55cm (yellow lines).
