4. DESCRIPTION OF DAMAGE

ASSESSMENT REPORT FOR VEHICLE NO. GW 2233 C

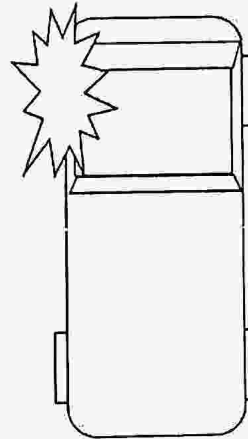
At the time of the inspection, the vehicle sustained damages to the FRONT portion.
