Your Ref: Mercedes Benz C63 Coupe  
(chassis number WDD2053872F854057)  
Our Ref : CI/TP22001956/D

01 March 2022

**ST Powered Motoring Pte Ltd**  
128 Woodlands Industrial Park E5  
Singapore 757851

**INSPECTION REPORT OF AN UNREGISTERED MERCEDES BENZ C63  
COUPE MOTOR CAR WITH CHASSIS NUMBER WDD2053872F854057**

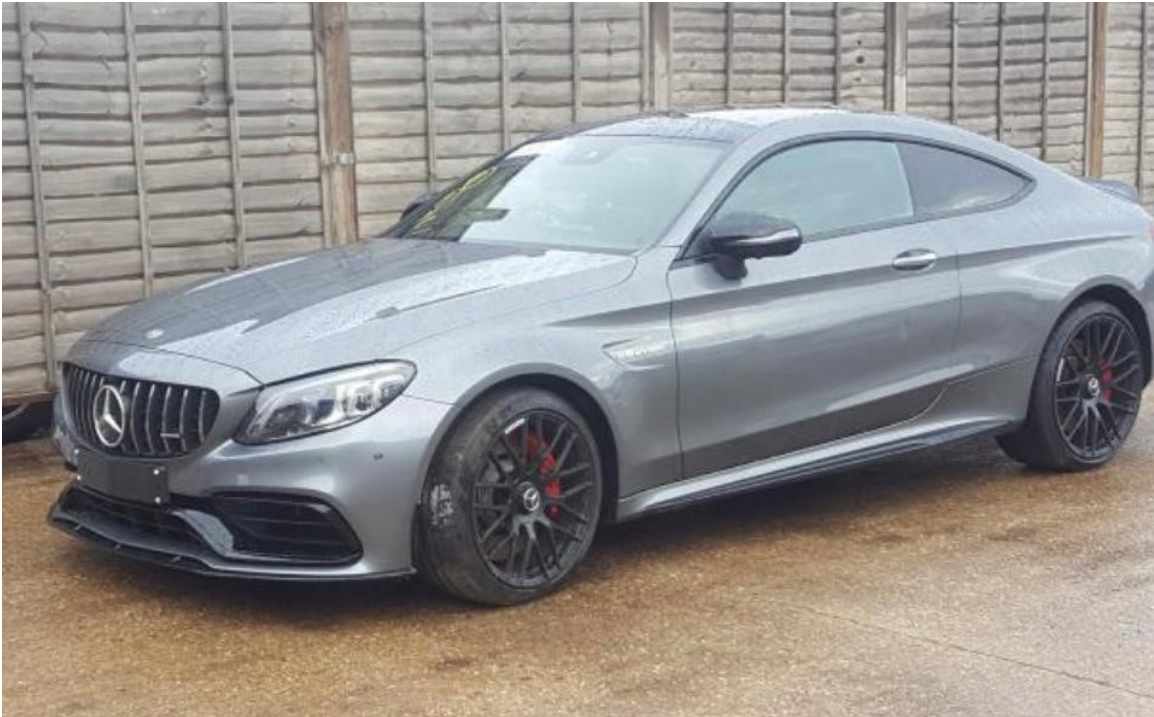
**Photo 1** shows the front left body of the Motor Car (photograph provided to me). There was no physical damage seen to the Motor Car from the photographs that were provided to me.

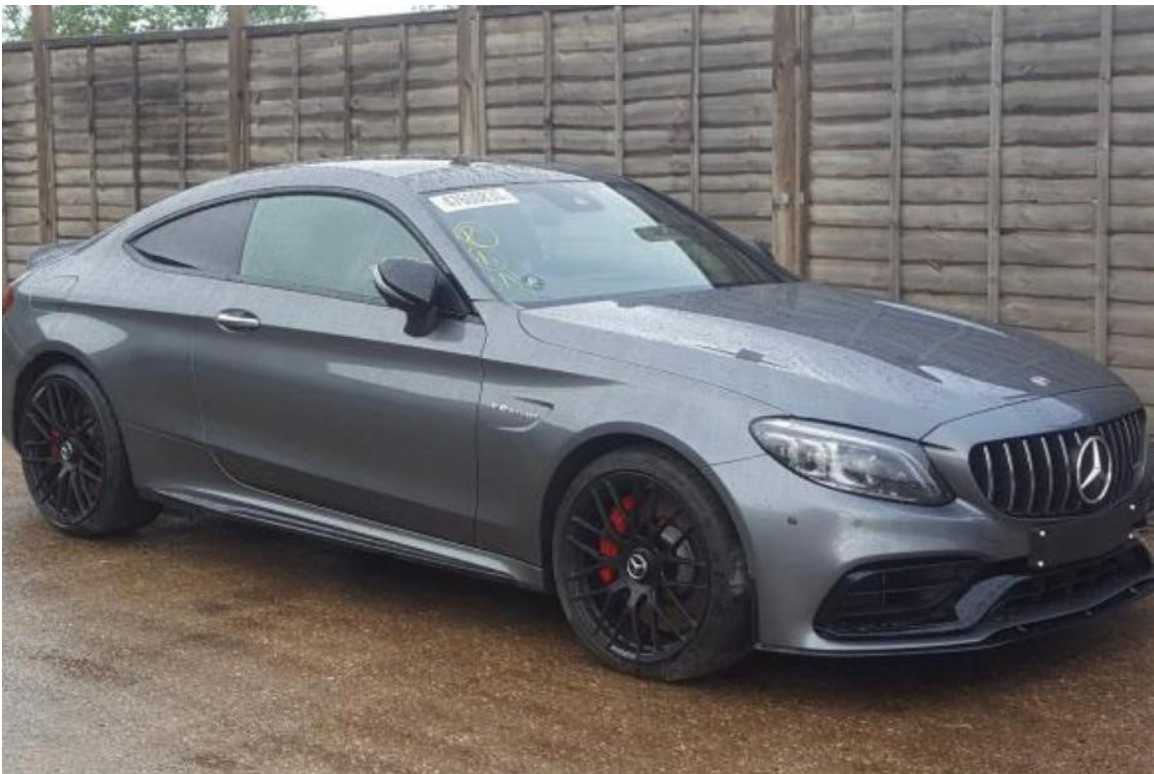
**Photo 2** shows the front right body of the Motor Car (photograph provided to me). There was no physical damage seen to the Motor Car from the photographs that were provided to me. The airbag(s) were also not deployed.

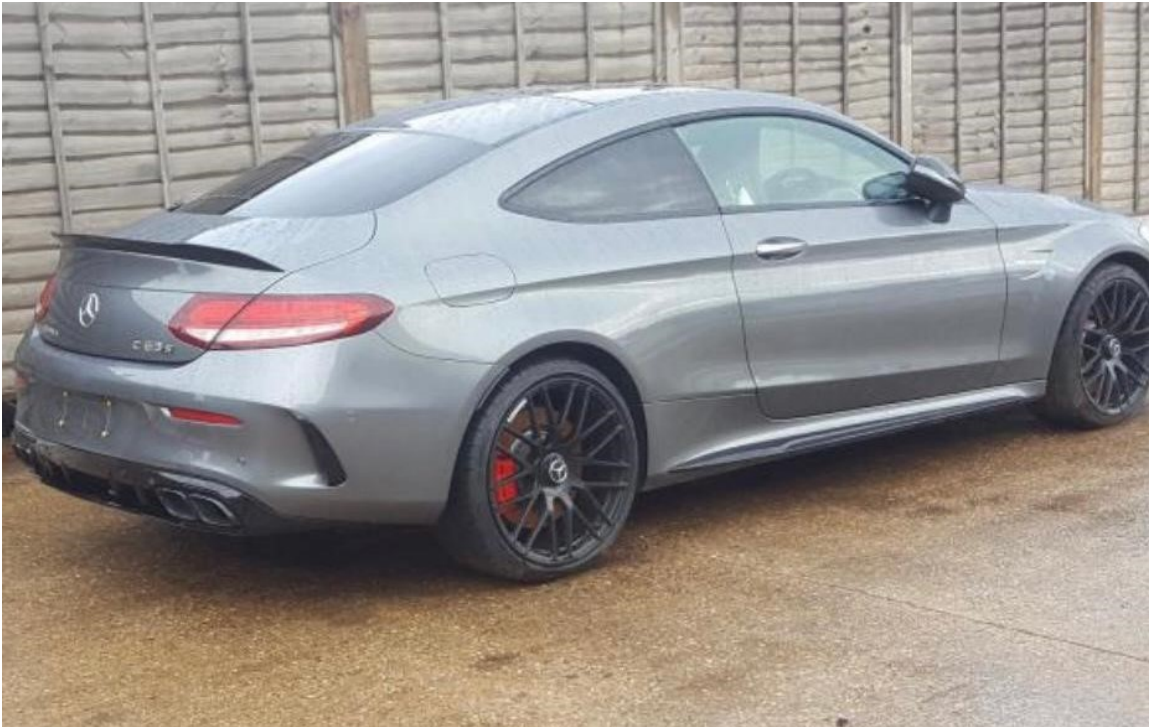
**Photo 3** shows the rear right body of the Motor Car (photograph provided to me). There was no physical damage seen to the Motor Car from the photographs that were provided to me. The airbag(s) were also not deployed.

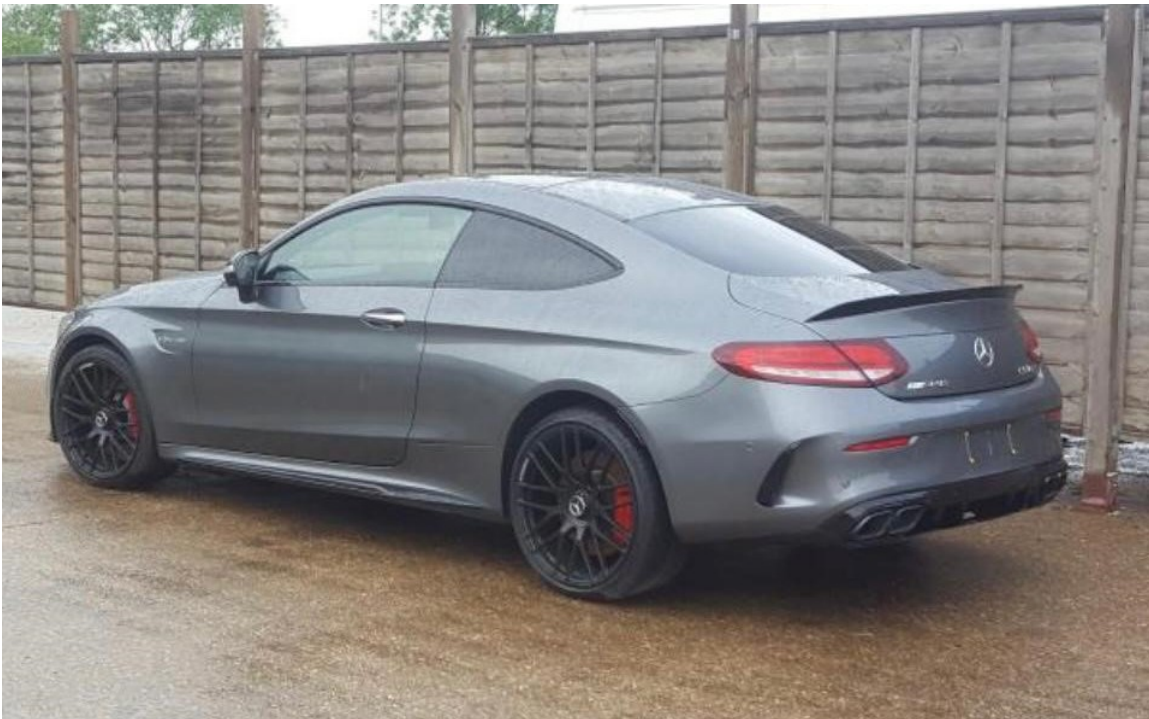
**Photo 4** shows the rear left body of the Motor Car (photograph provided to me). There was no physical damage seen to the Motor Car from the photographs that were provided to me. The airbag(s) were also not deployed.

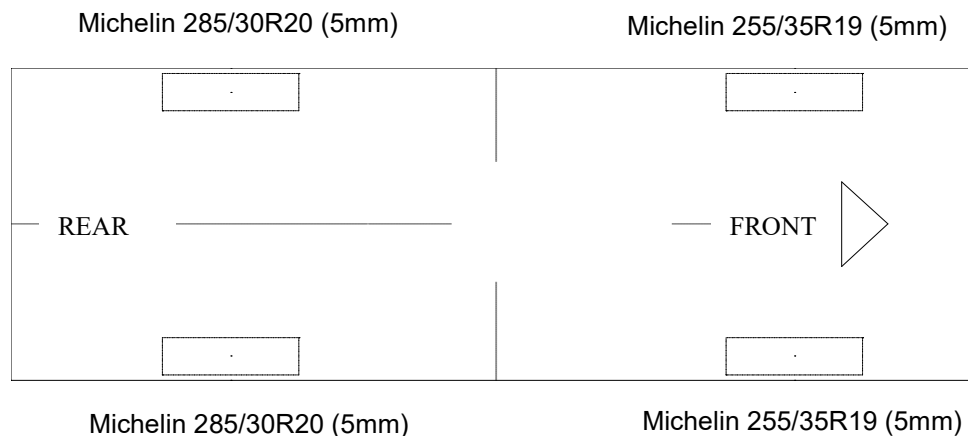
7. It was fitted with 19inch sport wheel rims (front) and 20inch sport wheel rims (rear) that were wrapped with tyres that were observed to be of serviceable condition. The tyres were also sufficiently inflated for vehicular operation. The tyre brand, tyre size and approximate remaining tread depth of the 4 tyres of the Motor Car were recorded as follows: -

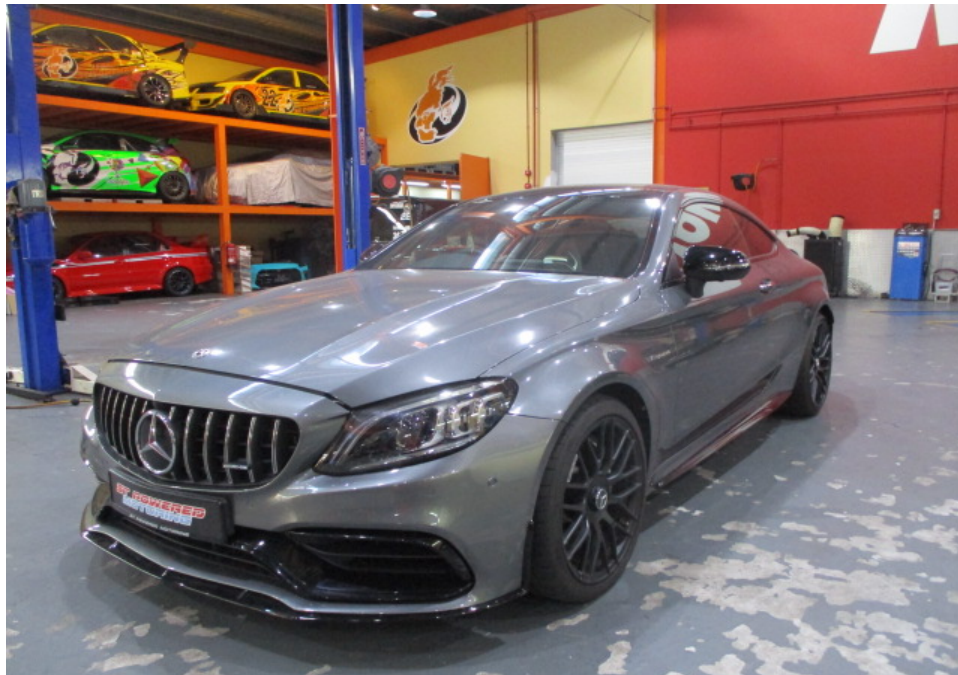
**Photo 5** shows a general view of the front left body of the Motor Car at the time of my inspection. The Motor Car was observed to be in a relatively good general condition with no loose exterior fittings observed. The mileage of the Motor Car recorded at the time of my inspection was 11,381km.

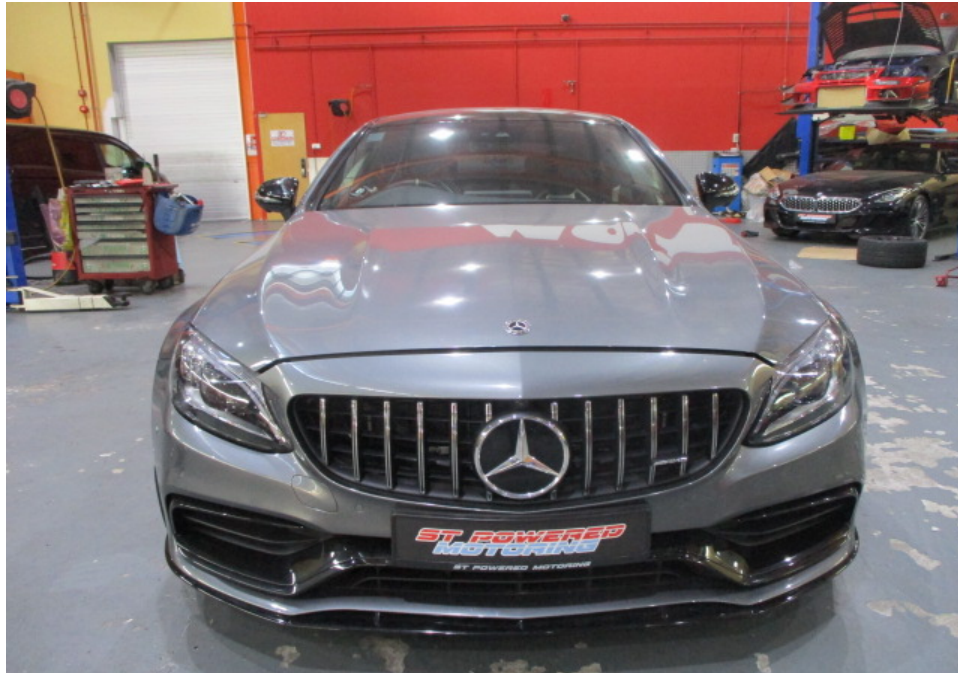
**Photo 6** shows a general view of the frontal body of the Motor Car at the time of my inspection. The Motor Car was observed to be in a relatively good general condition with no loose exterior fittings observed. The mileage of the Motor Car recorded at the time of my inspection was 11,381km.

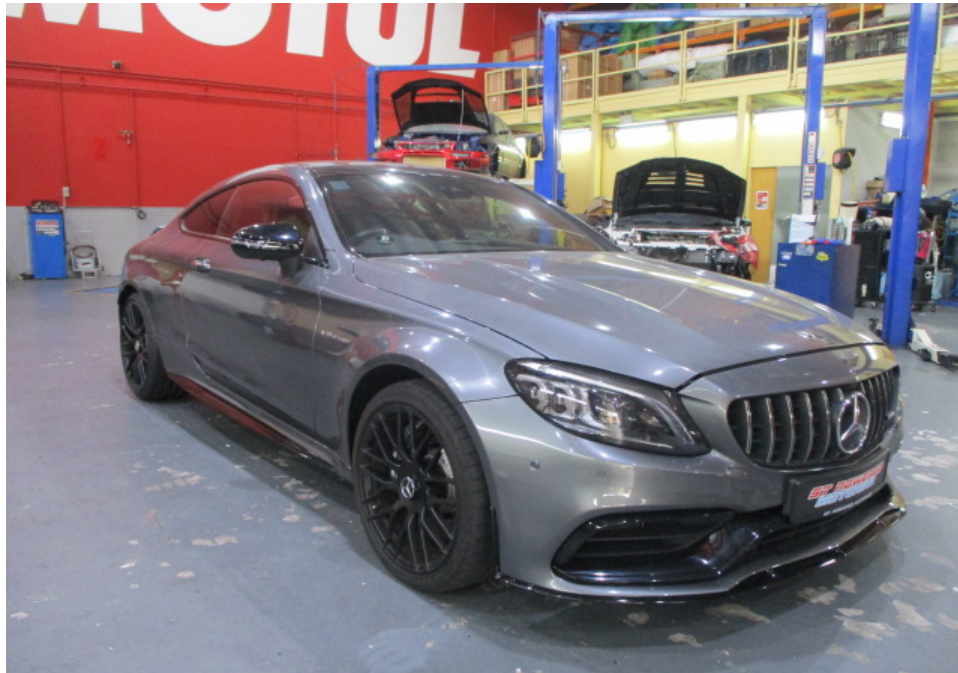
**Photo 7** shows a general view of the front right body of the Motor Car at the time of my inspection. The Motor Car was observed to be in a relatively good general condition with no loose exterior fittings observed. The mileage of the Motor Car recorded at the time of my inspection was 11,381km.

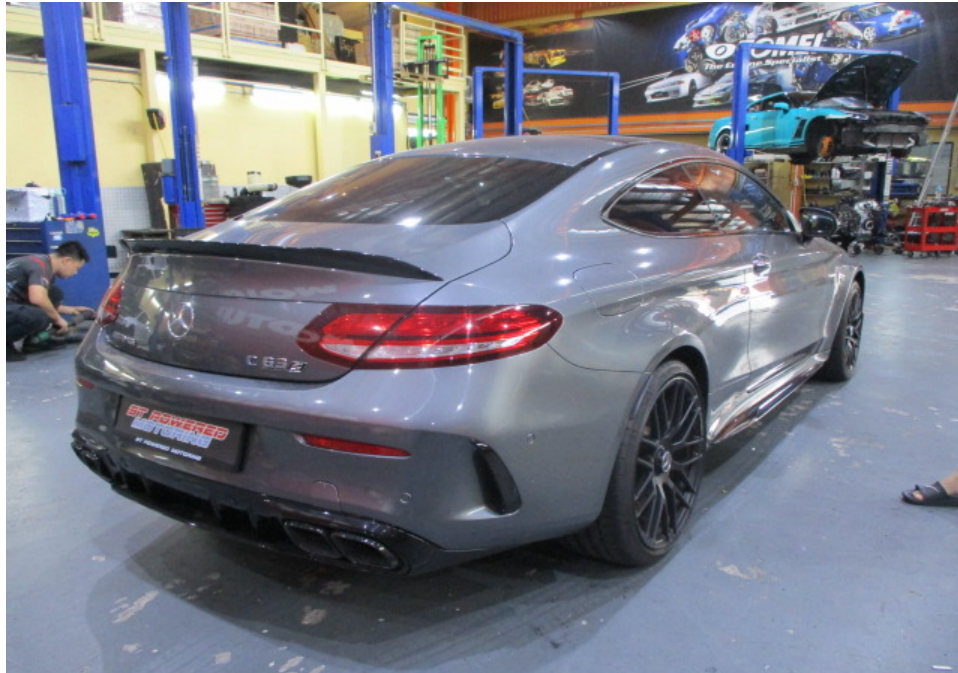
**Photo 8** shows a general view of the rear right body of the Motor Car at the time of my inspection. The Motor Car was observed to be in a relatively good general condition with no loose exterior fittings observed. The mileage of the Motor Car recorded at the time of my inspection was 11,381km.

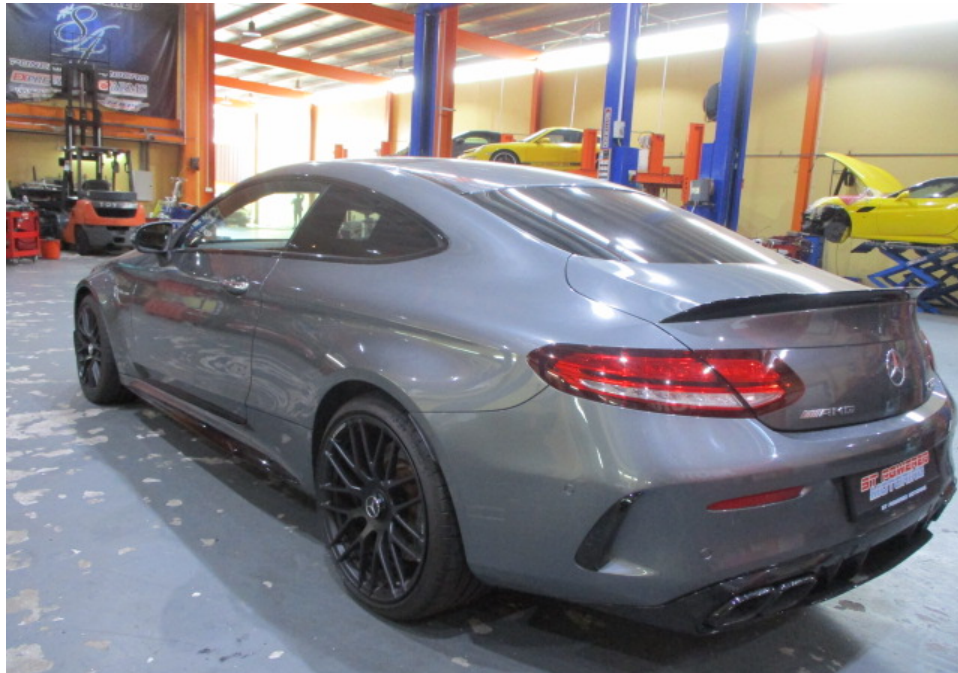
**Photo 9** shows a general view of the rear left body of the Motor Car at the time of my inspection. The Motor Car was observed to be in a relatively good general condition with no loose exterior fittings observed. The mileage of the Motor Car recorded at the time of my inspection was 11,381km.

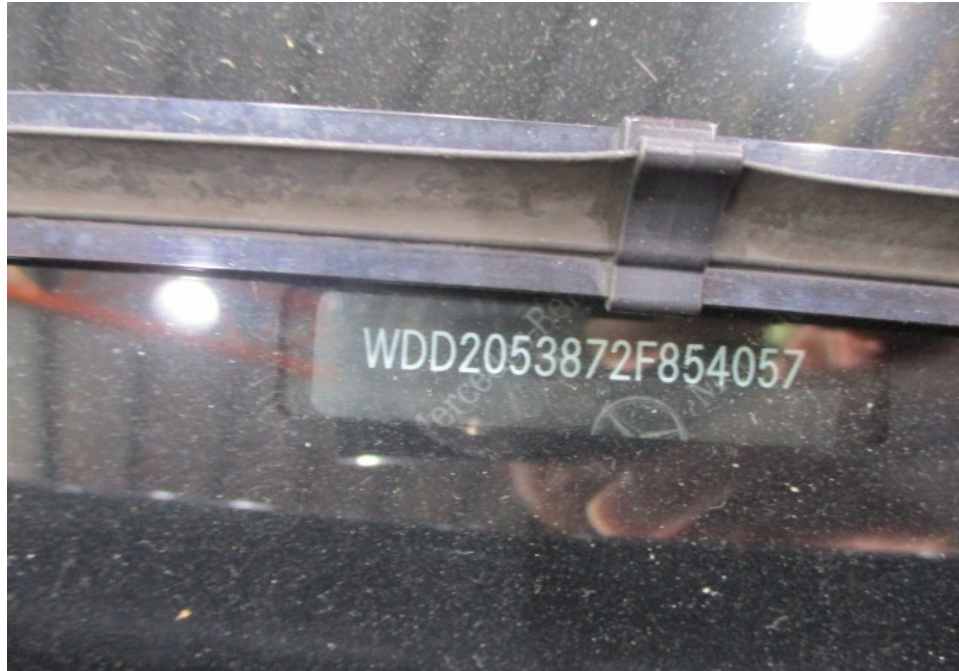
**Photo 10** shows the chassis number of the Motor Car. The chassis number recorded was WDD2053872F854057.

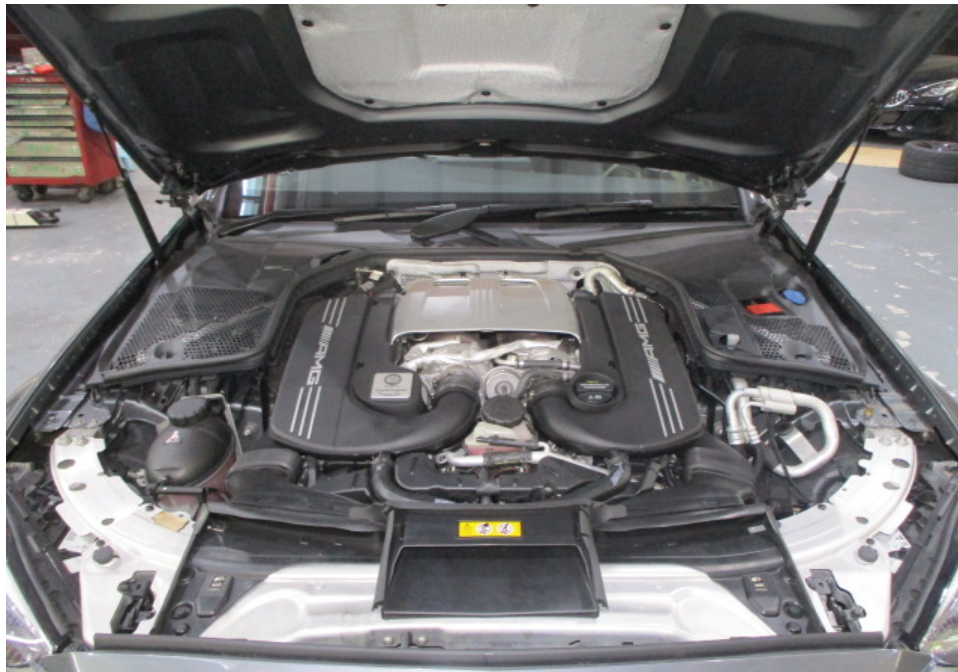
13. My examination of the engine compartment of the Motor Car revealed that the various parts and components inside the engine compartment were all intact and properly fitted. The engine oil, brake fluid and engine coolant were all found to be of sufficient level for operating purposes. Visually, there was also no contamination found to these fluids.

**Photo 11** shows a general view of the engine compartment of the Motor Car at the time of my inspection. The various parts and components inside the engine compartment were all observed to be intact and properly fitted. There was also no sign(s) or indication(s) of fluid leak and/or fluid stain found inside the engine compartment.

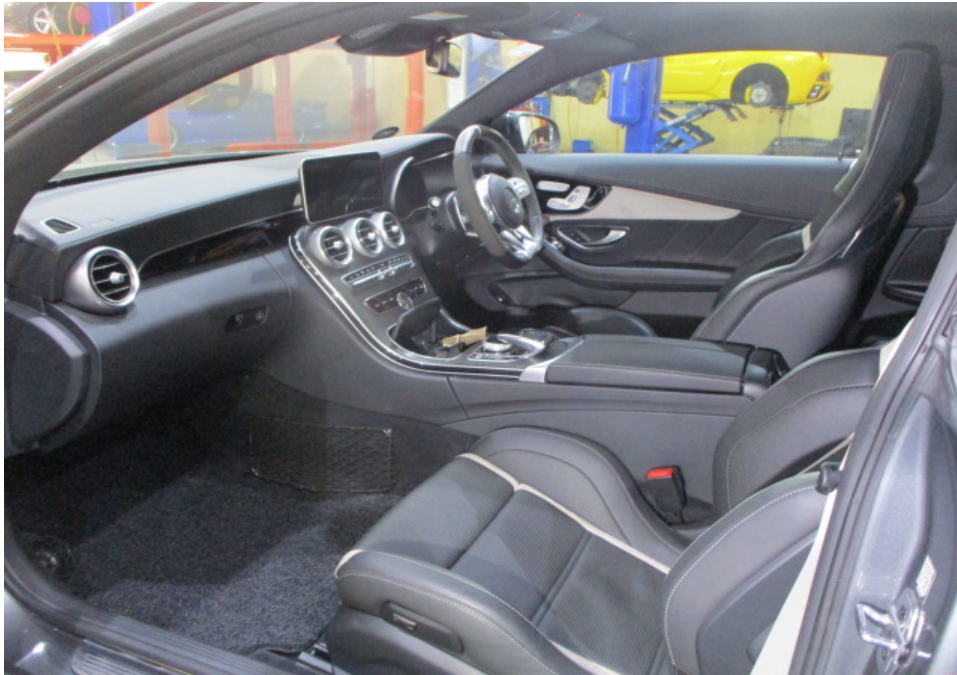
**Photo 12** shows the interior compartment of the Motor Car at the time of my inspection. The various parts and components, trims, carpet, and upholstery inside the interior compartment were all observed to be intact and properly fitted.

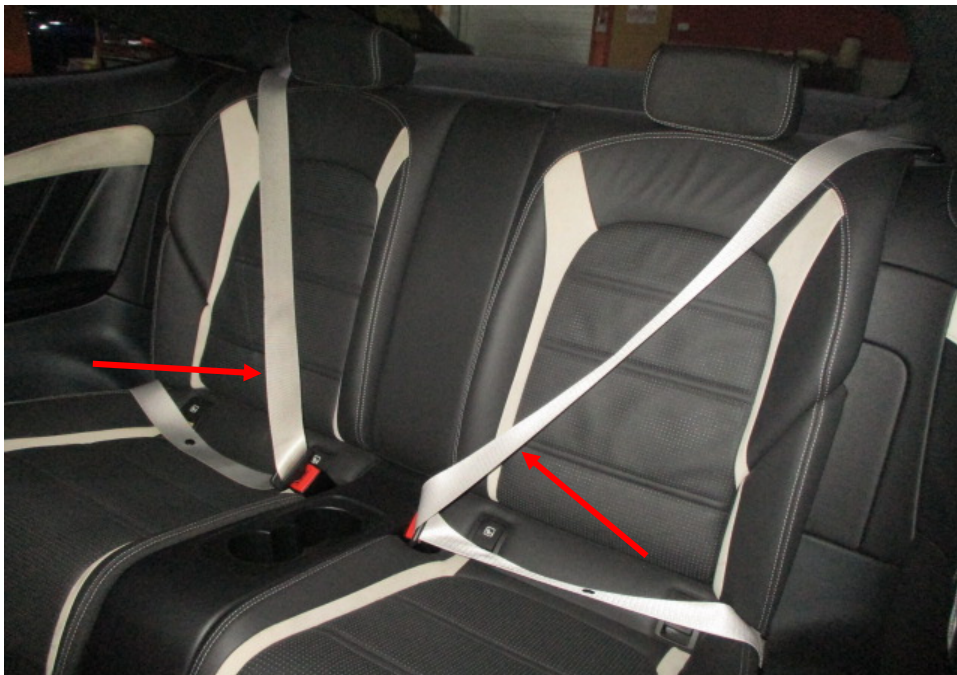
11. The seats of the Motor Car were found to be secured to the floorboard of the Motor Car via seat rails bolted onto the floorboard. Retractable seat belt reels and pre-tensioners were fitted on all seats of the Motor Car. The seat belts were tested and were able to be fastened securely into the respective pre-tensioners that were fixed to the side of all the seats.

**Photo 13** shows the seats of the Motor Car. All the seats of the Motor Car were secured via seat rails to the floorboard. They were also fitted with a retractable seat belt reel and a pre-tensioner. The seat belts (arrowed) were tested and were able to be fastened into the respective pre-tensions that were fitted on the side of each individual seat.

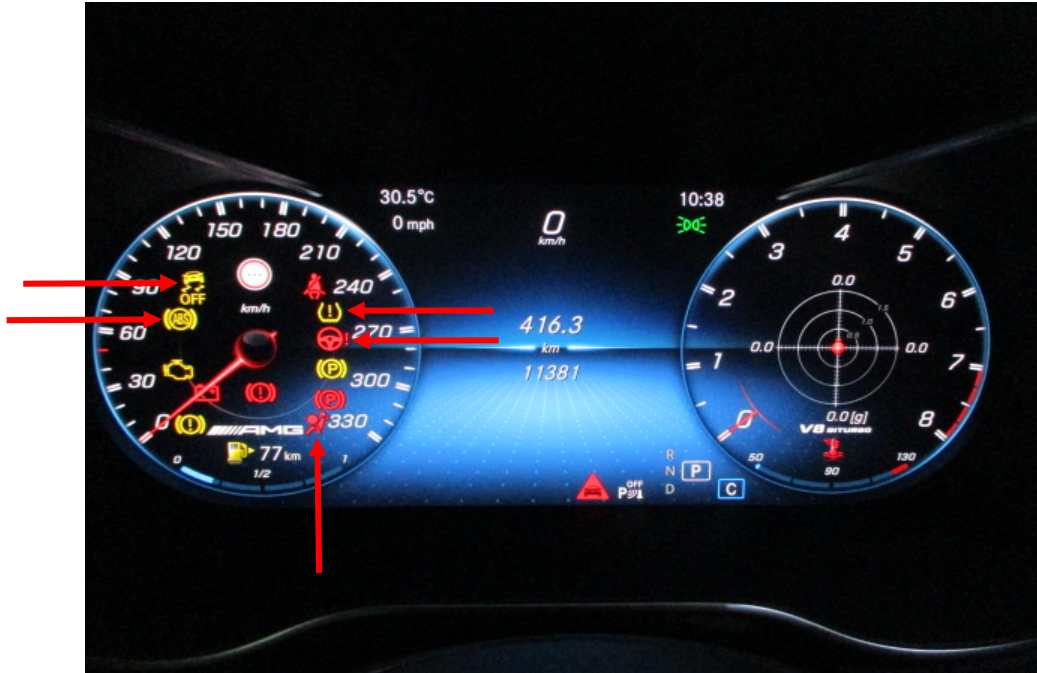
**Photo 14** shows the warning lights for the various electronic safety features appearing on the instrument panel of the Motor Car during its self-test when the engine is cranked, in particular the ABS, SRS, EPS, TPM and TCS lights (arrowed).

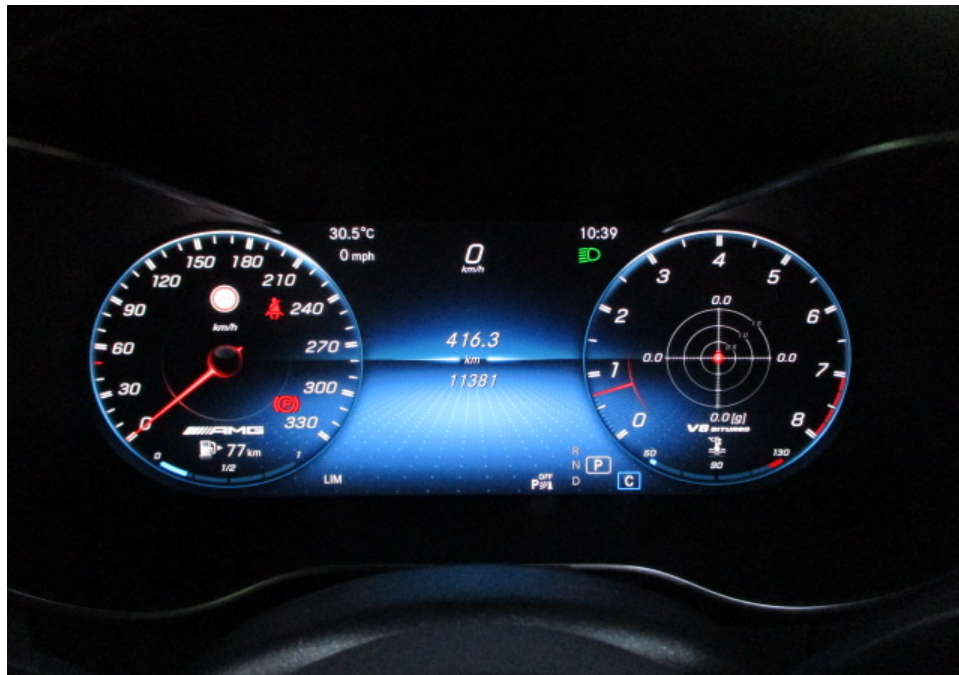
12. The Motor Car's automatic self-test of the functionality of its various electronic safety features like the Anti-Lock Brake System (ABS), Supplemental Restraint System (SRS), Electric Power Steering (EPS), Tyre Pressure Monitor (TPM) and Traction Control System (TCS) during cranking of the engine had indicated that these electronic systems were in working condition. This was determined from the respective warning lights disappearing from the instrument panel after the self-test.

**Photo 15** shows the respective warning lights no longer illuminated, indicating that there is no fault detected to the ABS, SRS, EPS, TPM and TCS systems of the Motor Car during the self-test. These electronic systems were hence in working condition at the time of my inspection.

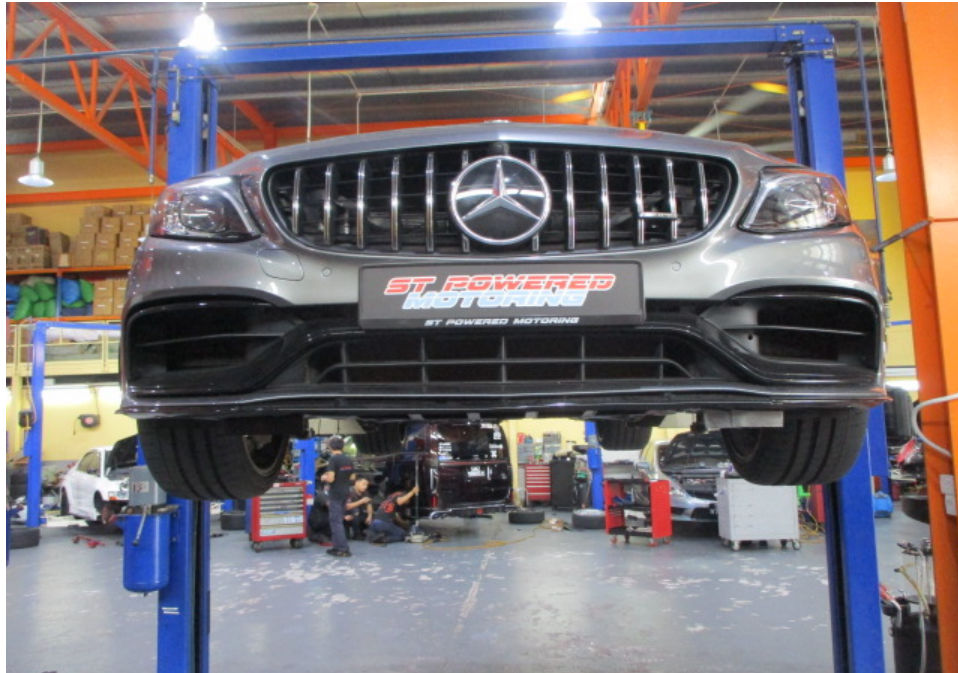
14. My checks on the underside of the Motor Car revealed no sign(s) or indication(s) of fluid leakage and/or fluid stain(s). The engine block and automatic transmission assembly were both secured properly. All undercarriage components of the Motor Car were also observed to be intact and secured in an appropriate manner.

**Photo 16** shows the Motor Car hoisted up for checks on its undercarriage. There was no sign(s) or indication(s) of fluid leakage and/or fluid stain(s) on the underside of the Motor Car. The undercarriage components of the Motor Car were also all observed to be intact and secured in an appropriate manner.

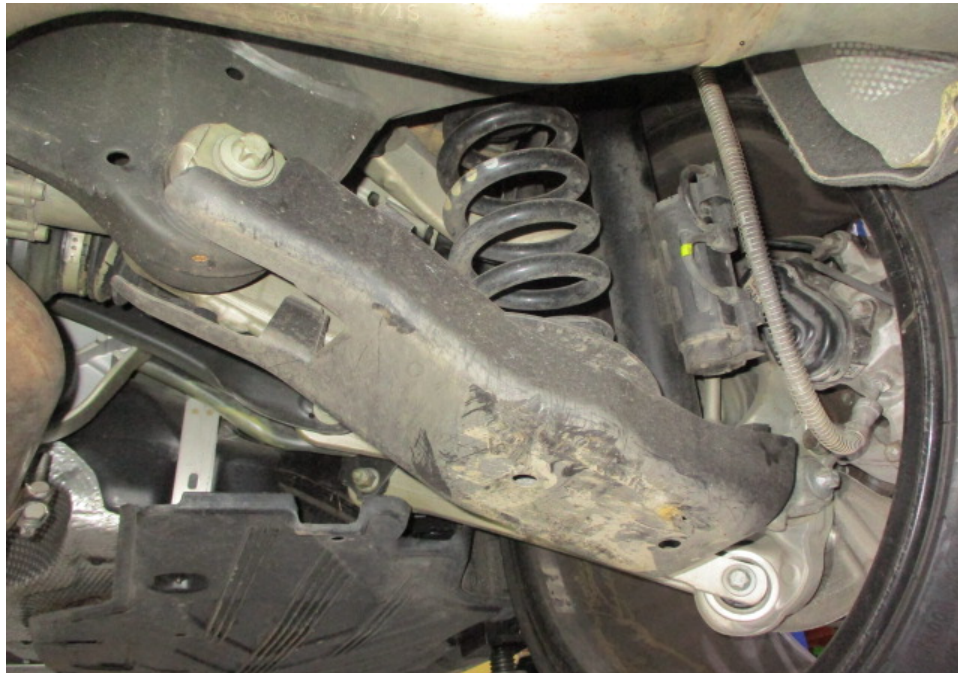
**Photo 17** shows a general view of the control arms and linkages at the rear right wheel of the Motor Car. I did not observe any fluid leak and/or fluid stain on the underside of the Motor Car. All of the Motor Car's undercarriage components were observed to be intact and secured in an appropriate manner.

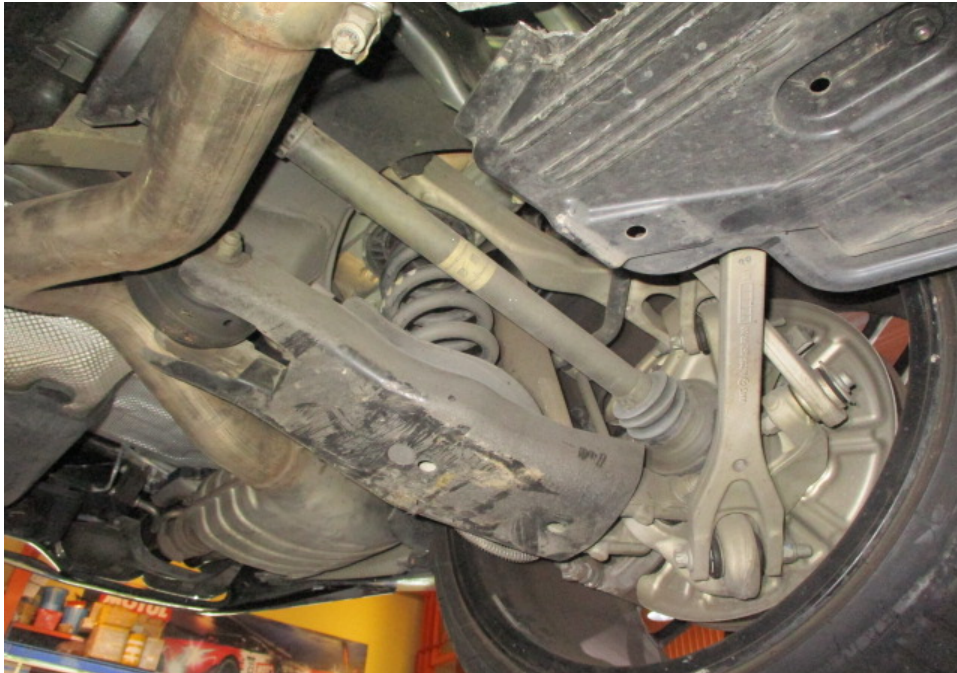
**Photo 18** shows a general view of the control arms and linkages at the rear left wheel of the Motor Car. I did not observe any fluid leak and/or fluid stain on the underside of the Motor Car. All of the Motor Car's undercarriage components were observed to be intact and secured in an appropriate manner.

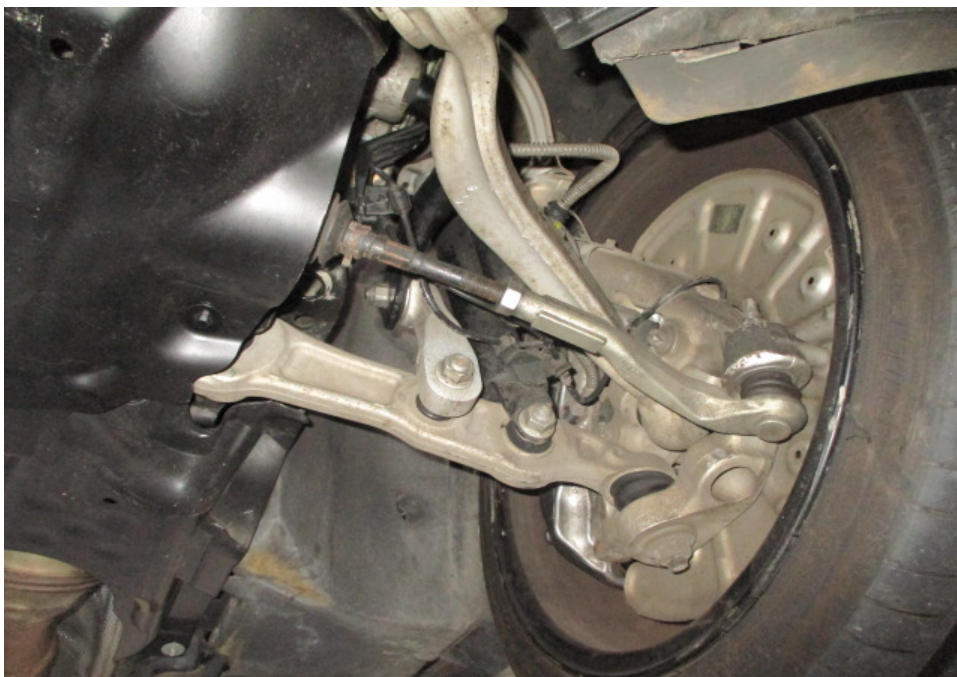
**Photo 19** shows the various undercarriage components at the front left wheel of the Motor Car. The mechanical components, control arms and linkages were all found to be intact and secured in an appropriate manner.

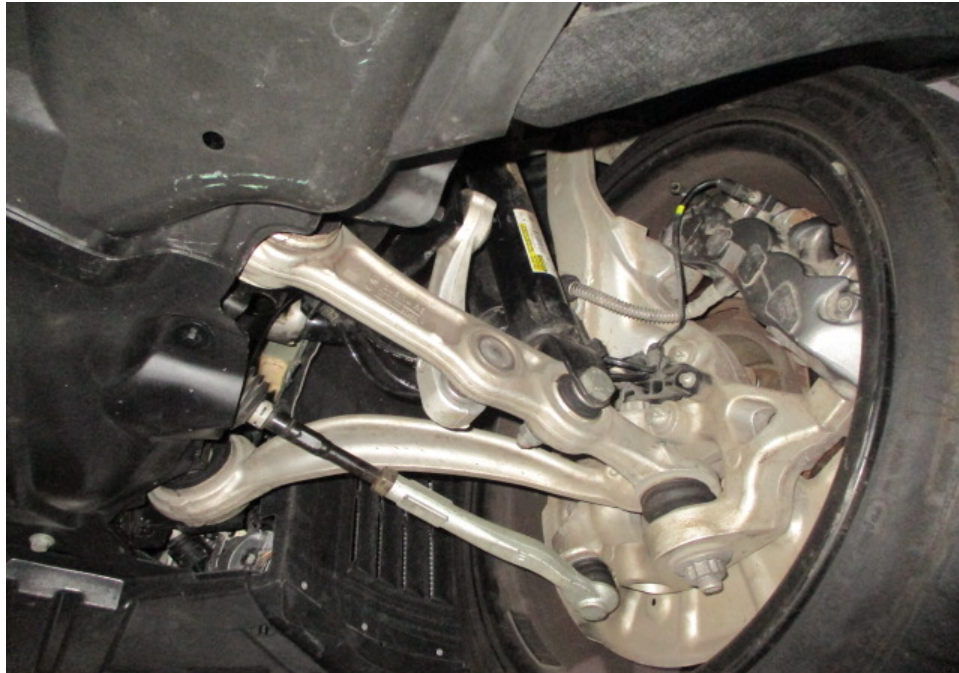
**Photo 20** shows the various undercarriage components at the front right wheel of the Motor Car. The mechanical components, control arms and linkages were all found to be intact and secured in an appropriate manner. I also did not observe any fluid leak and/or fluid stain on the underside of the Motor Car.

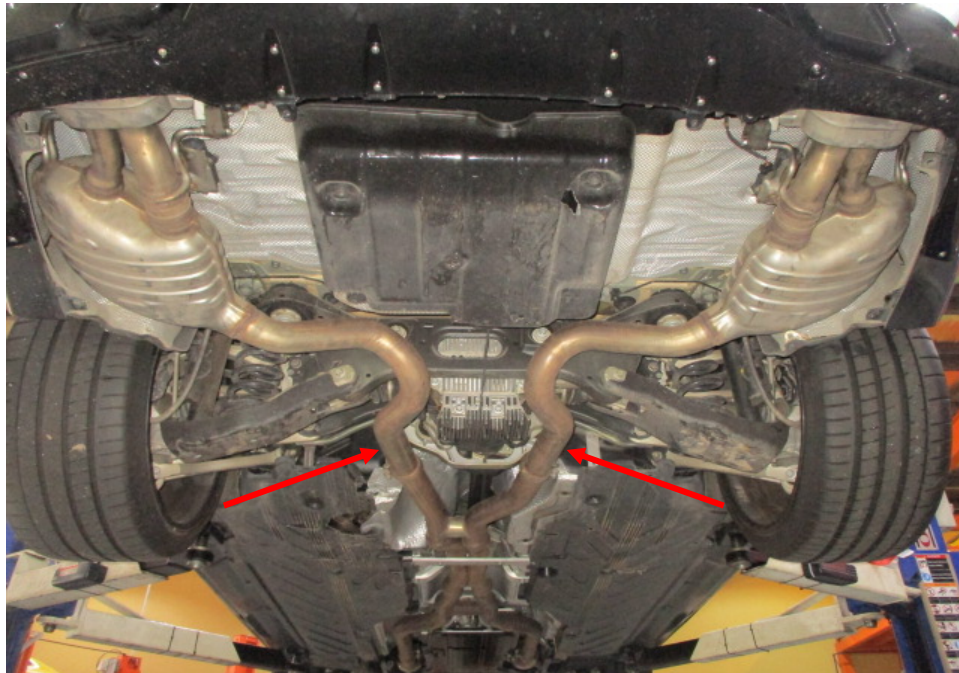
**Photo 21** shows the rear section of the Motor Car's exhaust system. My examination of the Motor Car's exhaust system revealed no sign(s) or indication(s) of any cut or weld marks along its exhaust pipes (arrowed), on its rear mufflers and on its catalytic converters.

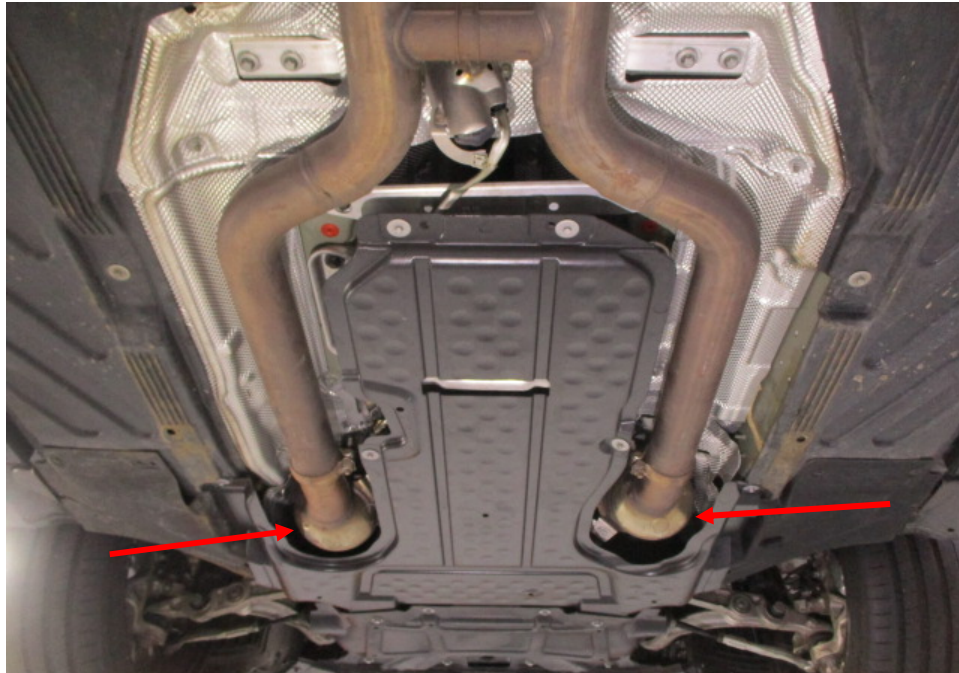
**Photo 22** shows the front section of the Motor Car's exhaust system. My examination of the Motor Car's exhaust system revealed no sign(s) or indication(s) of any cut or weld marks along its exhaust pipes, on its rear mufflers, and on its catalytic converters (arrowed).

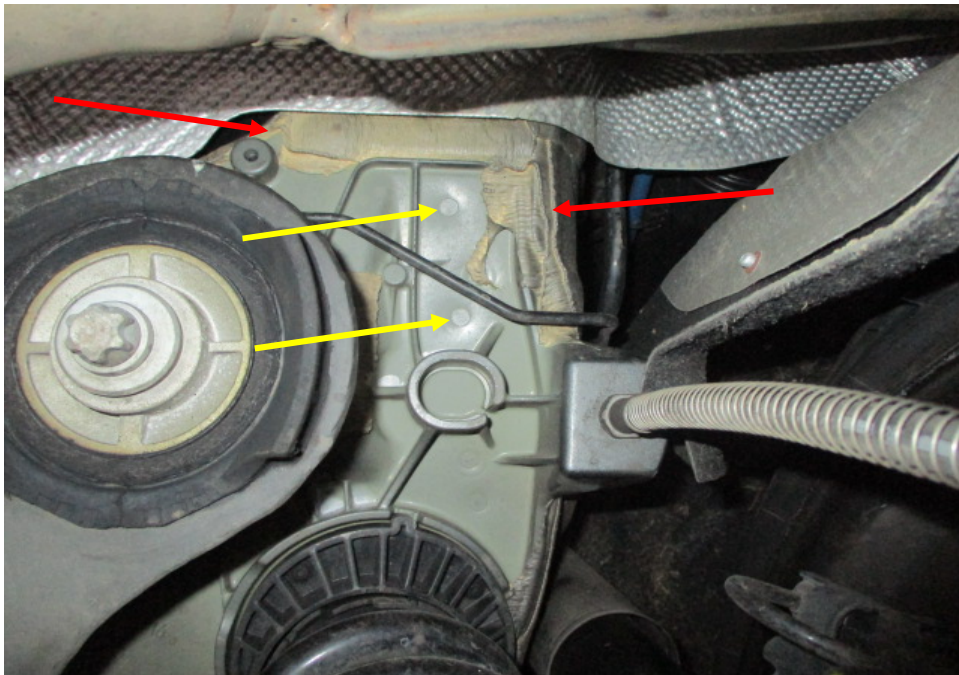
**Photo 23** shows the chassis/structural body at the underside rear right of the Motor Car. I did not find any weld marks other than original spot weld marks (yellow arrow) on the chassis/structural body of the Motor Car. The original factory sealant (red arrow) at the joints along the chassis/structural body was untouched, indicating no work was done on the chassis/structural body of the Motor Car and that the chassis/structural body was originally fitted.

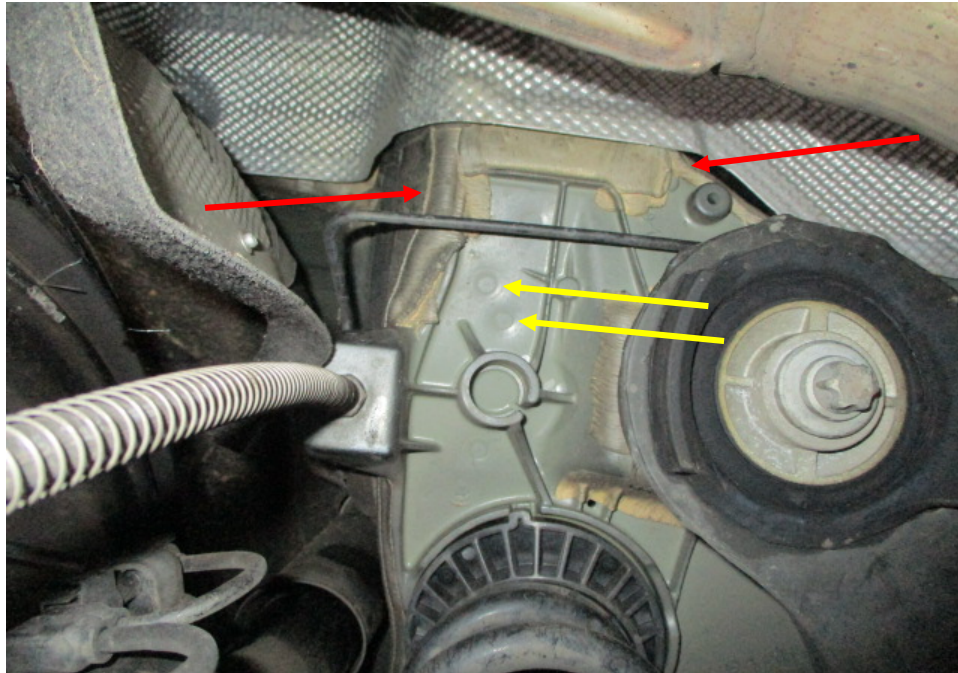
**Photo 24** shows the chassis/structural body at the underside rear left of the Motor Car. I did not find any weld marks other than original spot weld marks (yellow arrow) on the chassis/structural body of the Motor Car. The original factory sealant (red arrow) at the joints along the chassis/structural body was untouched, indicating no work was done on the chassis/structural body of the Motor Car and that the chassis/structural body was originally fitted.

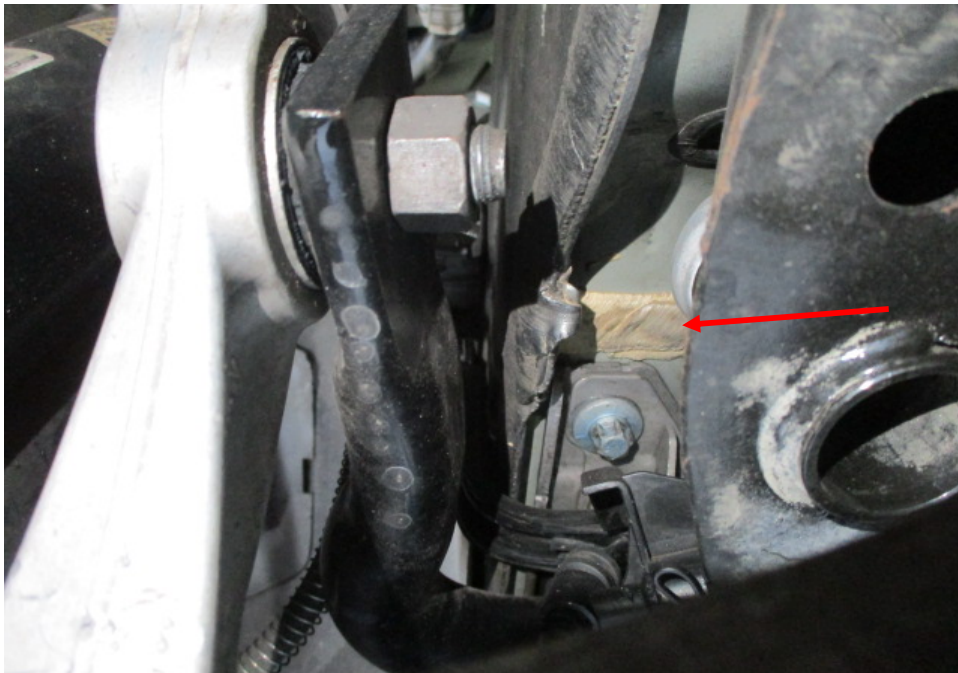
**Photo 25** shows the chassis/structural body at the underside front left of the Motor Car. The original factory sealant (arrowed) at the joints along the chassis/structural body was observed to be untouched. In general, I had found no work was carried out on the chassis/structural body of the Motor Car. The chassis/structural body of the Motor Car was originally fitted.

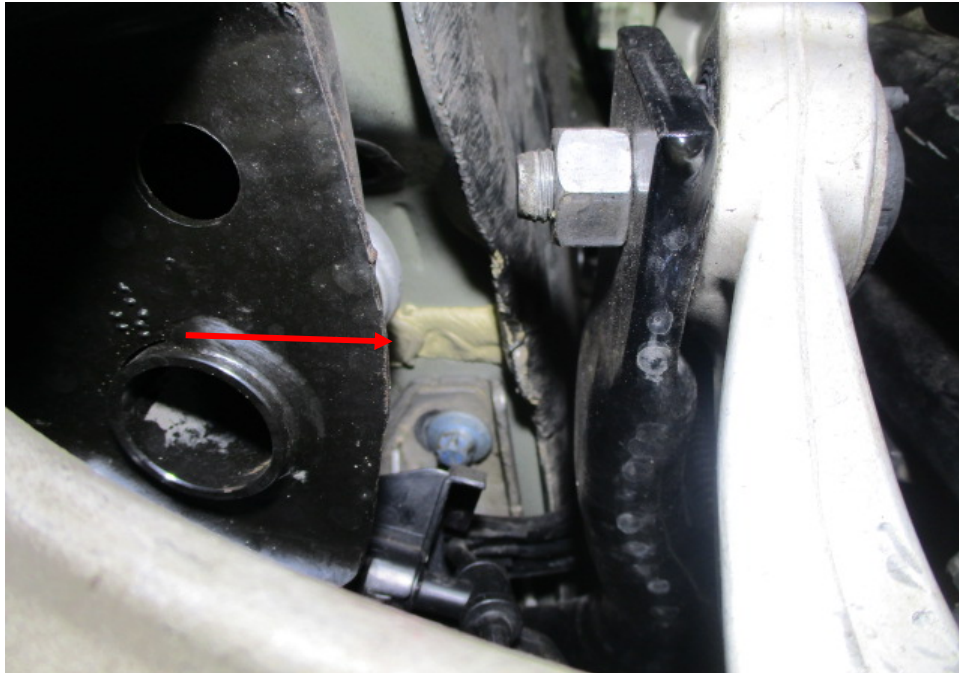
**Photo 26** shows the chassis/structural body at the underside front right of the Motor Car. The original factory sealant (arrowed) at the joints along the chassis/structural body was observed to be untouched. In general, I had found no work was carried out on the chassis/structural body of the Motor Car. The chassis/structural body of the Motor Car was originally fitted.

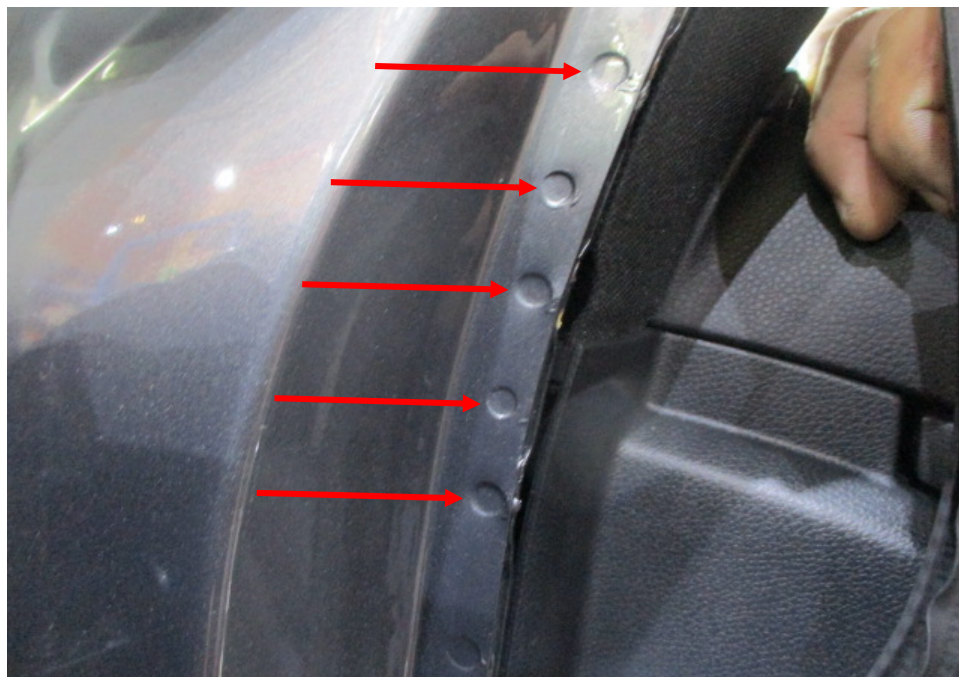
**Photo 27** shows the left side "A" pillar of the Motor Car. I did not find any weld marks other than original spot weld marks (arrowed) on the left side "A" pillar of the Motor Car which, indicates that there was no re-welding works carried out. In general, I had found all the non-detachable body panels of the Motor Car to be originally fitted at the time of my inspection.

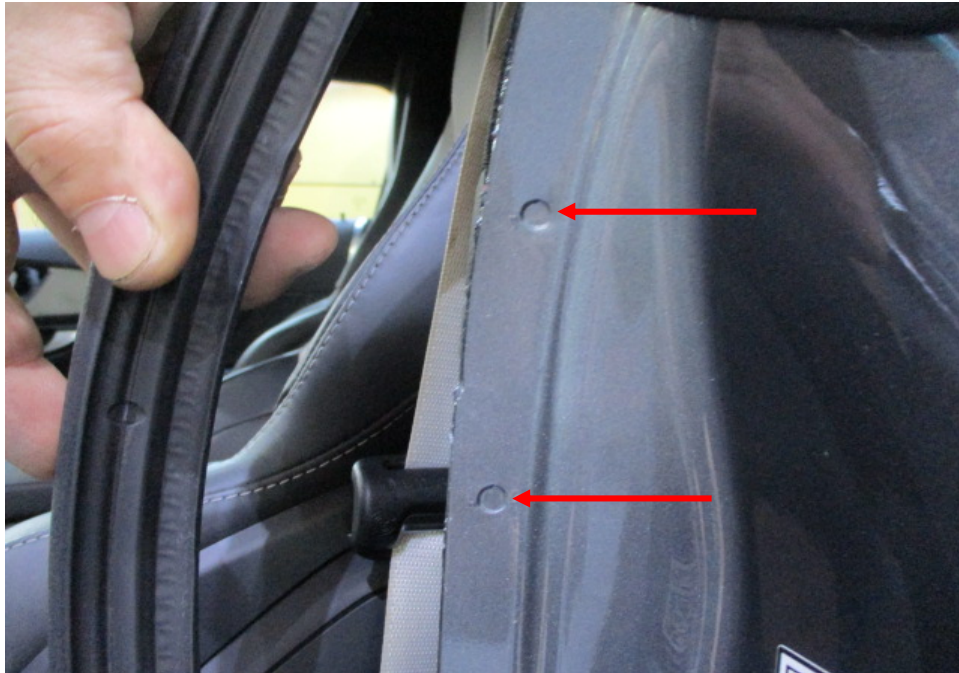
**Photo 28** shows the rear left body panel of the Motor Car. I did not find any weld marks other than original spot weld marks (arrowed) on the rear left body panel of the Motor Car, which indicates that there was no re-welding works carried out. In general, I had found all the non-detachable body panels of the Motor Car to be originally fitted at the time of my inspection.

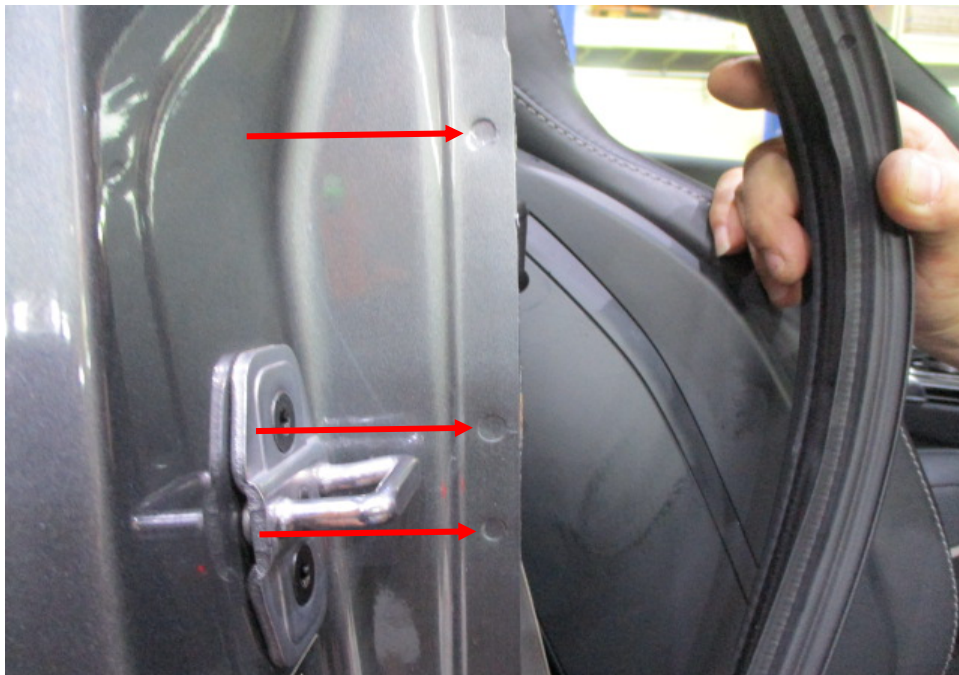
**Photo 29** shows the rear right body panel of the Motor Car. I did not find any weld marks other than original spot weld marks (arrowed) on the rear right body panel of the Motor Car, which indicates that there was no re-welding works carried out. In general, I had found all the non-detachable body panels of the Motor Car to be originally fitted at the time of my inspection.
