Your Ref: Mercedes Benz C63 Coupe  
(chassis number WDD2053872F854057)  
Our Ref : CI/TP22001956/D

01 March 2022

**ST Powered Motoring Pte Ltd**  
128 Woodlands Industrial Park E5  
Singapore 757851

**INSPECTION REPORT OF AN UNREGISTERED MERCEDES BENZ C63  
COUPE MOTOR CAR WITH CHASSIS NUMBER WDD2053872F854057**

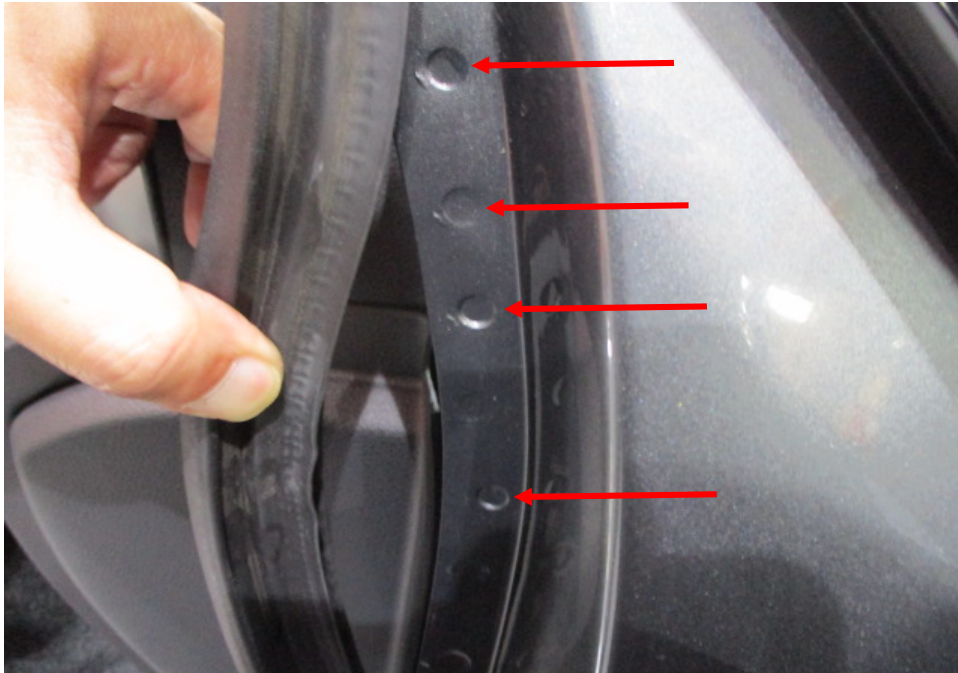
**Photo 30** shows the right side "A" pillar of the Motor Car. I did not find any weld marks other than original spot weld marks (arrowed) on the right side "A" pillar of the Motor Car which, indicates that there was no re-welding works carried out. In general, I had found all the non-detachable body panels of the Motor Car to be originally fitted at the time of my inspection.
