Your Ref: Mercedes Benz C63 Coupe  
(chassis number WDD2053872F855312)  
Our Ref : CI/TP22001957/D

**INSPECTION REPORT OF AN UNREGISTERED MERCEDES BENZ C63  
COUPE MOTOR CAR WITH CHASSIS NUMBER WDD2053872F855312**

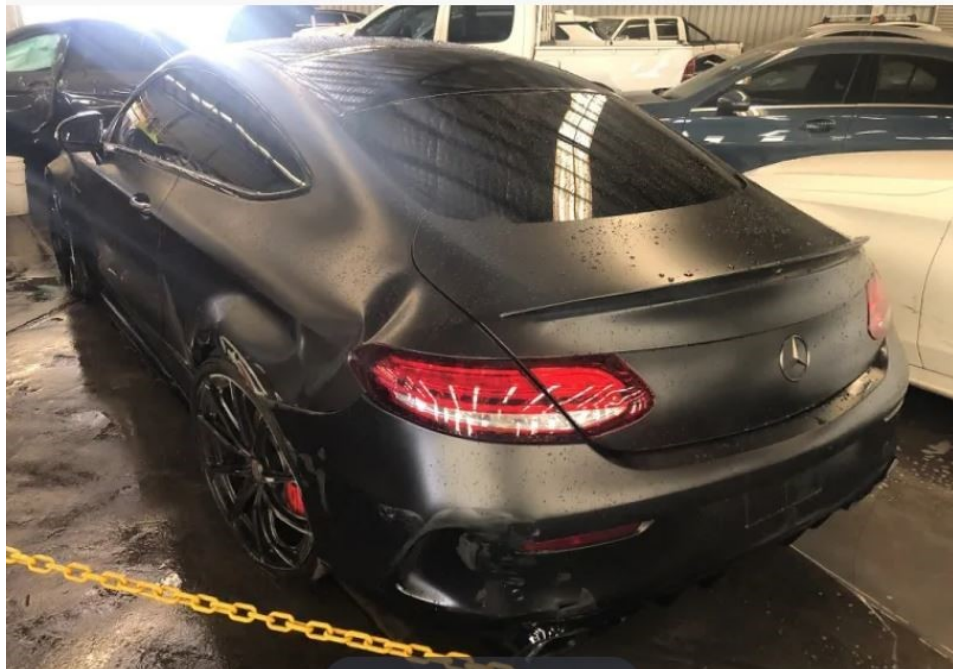
3. The photographs provided to me had showed damage to the left rear portion and frontal portion of the Motor Car. Body parts damaged at the left rear portion include the rear bumper, rear bumper left sensor, rear left taillamp, rear left fender, rear left wheel rim and rear left tyre amongst others. The orientation of the Motor Car's rear left wheel (titled slightly outwards) indicates damage to its rear left undercarriage parts. Undercarriage parts that may possibly be damaged include the rear left lower arm, rear left shock absorber and rear left trailing arm amongst others

**Photo 1** shows the rear left body of the Motor Car (photograph provided to me). The Motor Car was observed to have sustained damage at its left rear portion. The rear bumper, rear bumper left sensor, rear left taillamp, rear left fender, rear left wheel rim and rear left tyre were amongst the body parts that were observed to have been damaged. The orientation of the Motor Car's rear left wheel (titled slightly outwards) indicates damage to its rear left undercarriage parts.

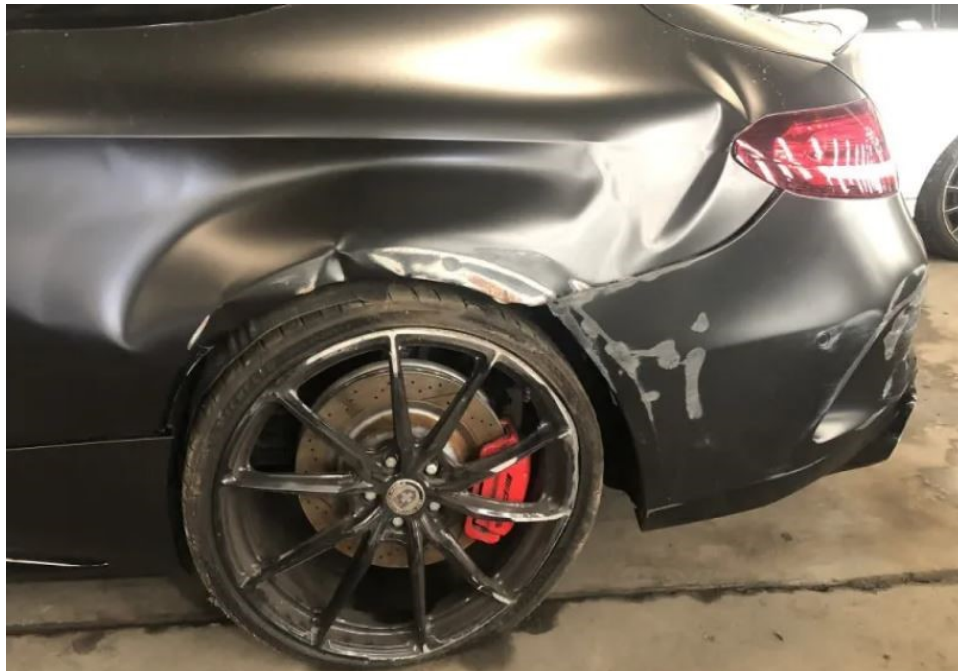
**Photo 2** shows another view of the damage at the left rear portion of the Motor Car (photograph provided to me). The rear bumper, rear bumper left sensor, rear left taillamp, rear left fender, rear left wheel rim and rear left tyre were amongst the body parts that were observed to have been damaged.

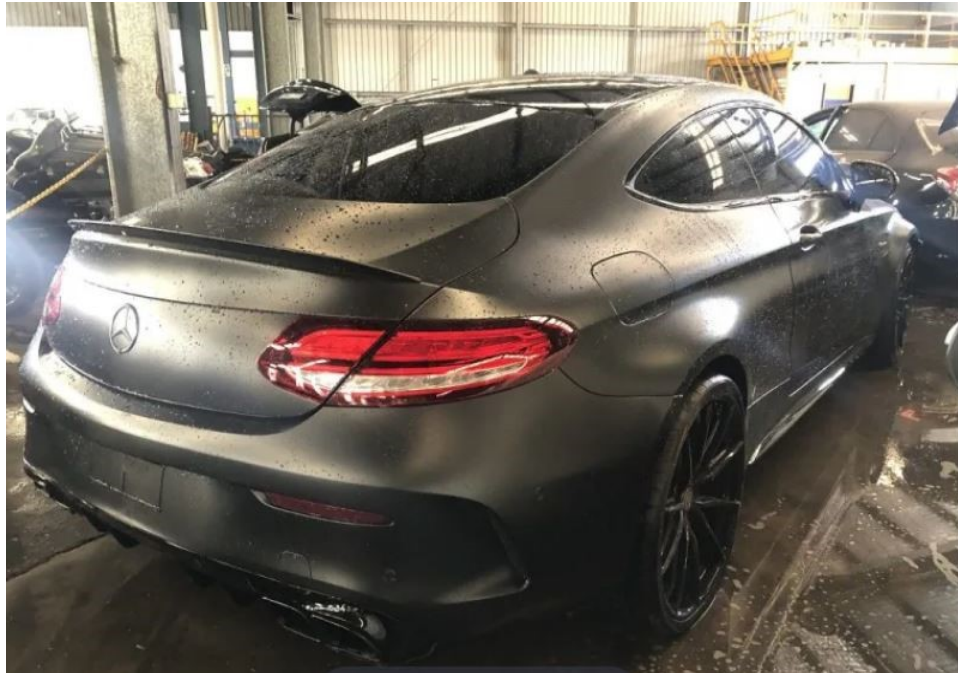
**Photo 3** shows the rear right body of the Motor Car (photograph provided to me). No physical damage was seen to the Motor Car's rear right portion. The photographs provided was unclear whether any of the Motor Car's airbag(s) was activated. However, given the extent of damage, it was possible that no airbag(s) was activated

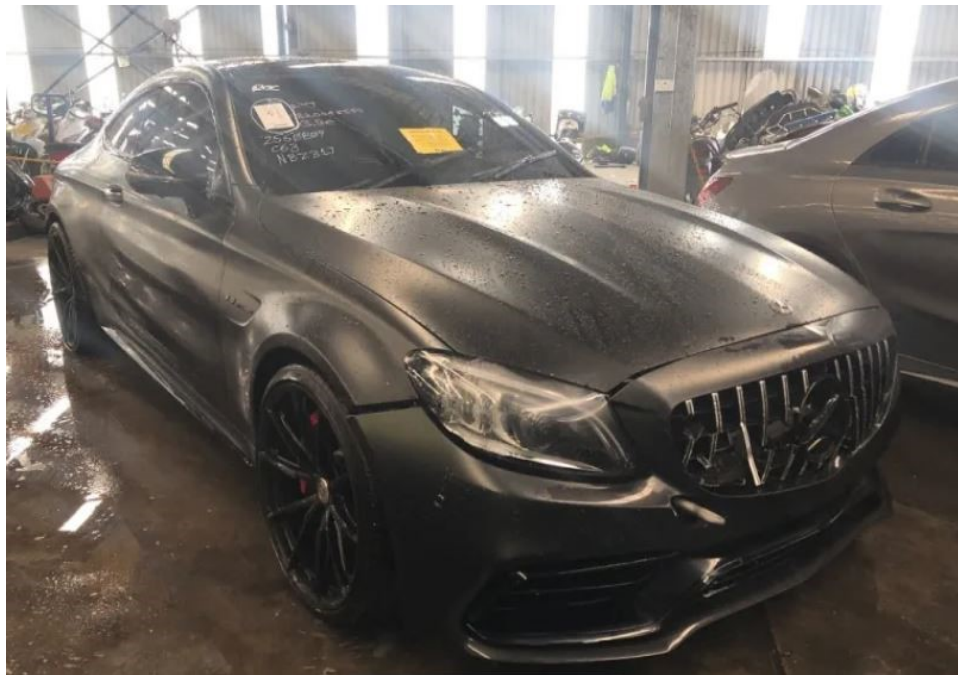
4. As for the frontal portion, I had observed damage to the Motor Car's front bumper, radiator grille, front emblem and front right headlamp amongst others.

**Photo 4** shows the front right body of the Motor Car (photograph provided to me). Apart for the left rear portion, the photographs provided had also showed damage to the frontal portion of the Motor Car. The front bumper, radiator grille, front emblem and front right headlamp were amongst the body parts at the frontal portion that were observed to have been damaged.

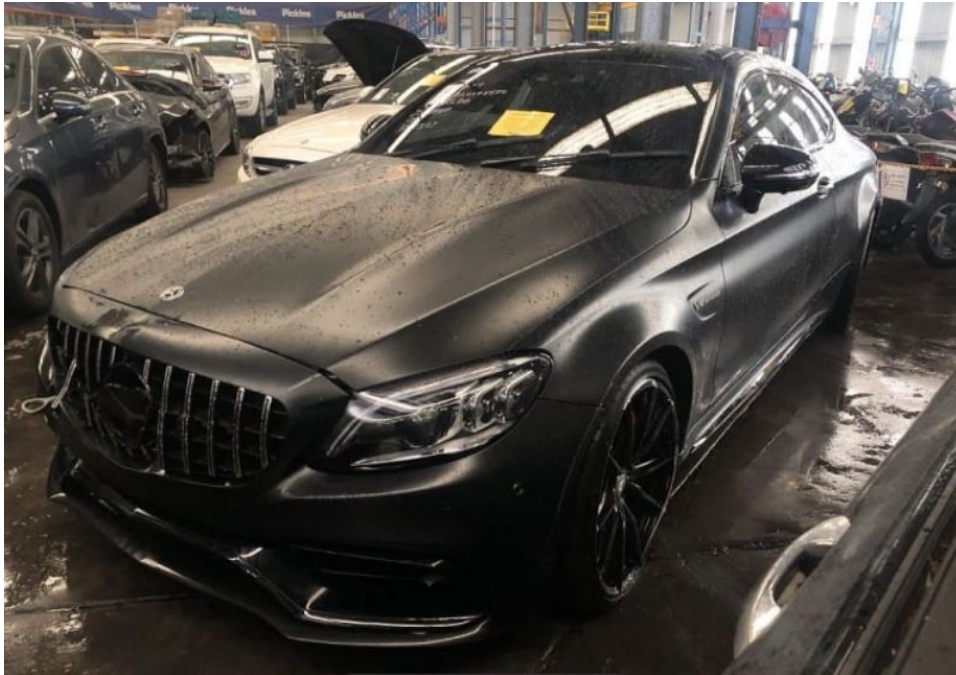
**Photo 5** shows the front left body of the Motor Car (photograph provided to me). No physical damage was seen to the Motor Car's front left portion. The photographs provided was unclear whether any of the Motor Car's airbag(s) was activated. However, given the extent of damage, it was possible that no airbag(s) was activated

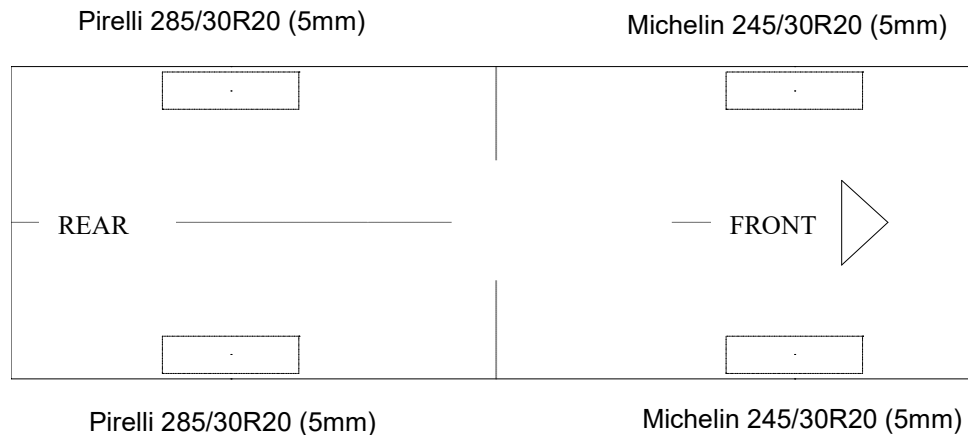
9. It was fitted with 20inch sport wheel rims that were wrapped with tyres that were observed to be of serviceable condition. The tyres were also sufficiently inflated for vehicular operation. The tyre brand, tyre size and approximate remaining tread depth of the 4 tyres of the Motor Car were recorded as follows: -

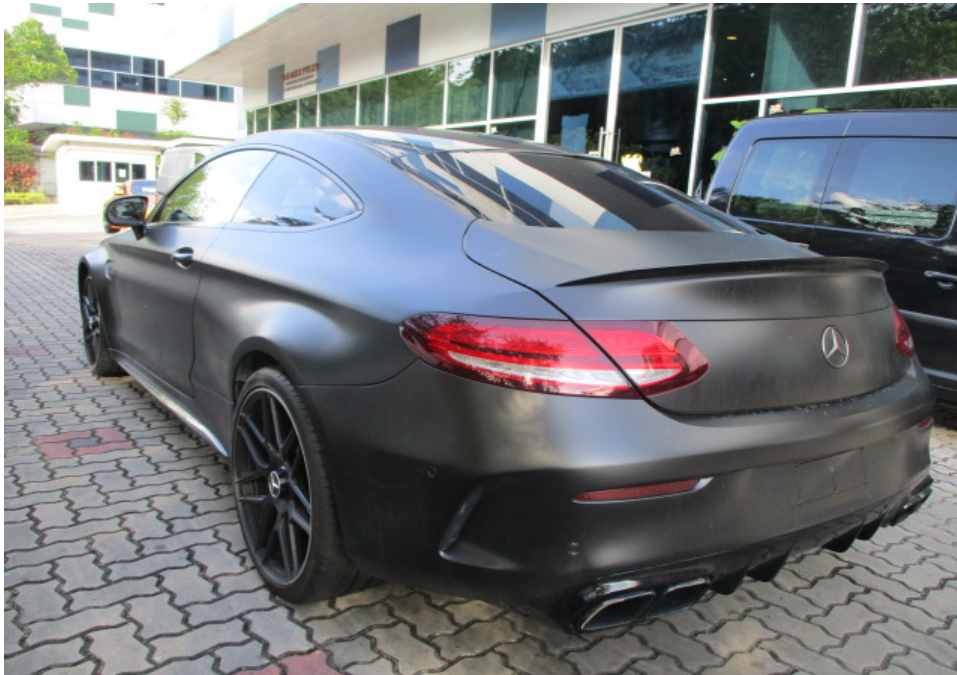
**Photo 6** shows a general view of the rear left body of the Motor Car at the time of my inspection. The Motor Car was observed to be in a relatively good general condition with no loose exterior fittings observed. The body parts at the left rear portion of the Motor Car were visually examined and it was observed that the repair/restoration works carried out to the damaged area of the Motor Car (refer to photograph 1 & 2 above) were reasonably adequate and in order.

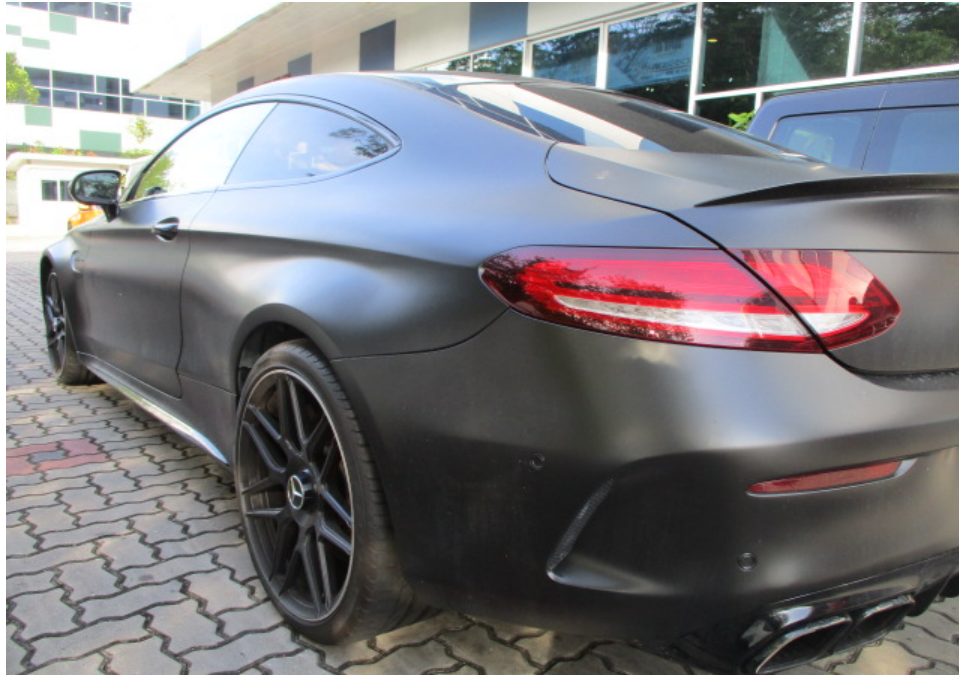
**Photo 7** shows a closer view of the Motor Car's rear bumper, rear bumper left sensor and rear left taillamp at the time of my inspection. The body parts at the left rear portion of the Motor Car were visually examined and it was observed that the repair/restoration works carried out to the damaged area of the Motor Car (refer to photograph 1 & 2 above) were reasonably adequate and in order.

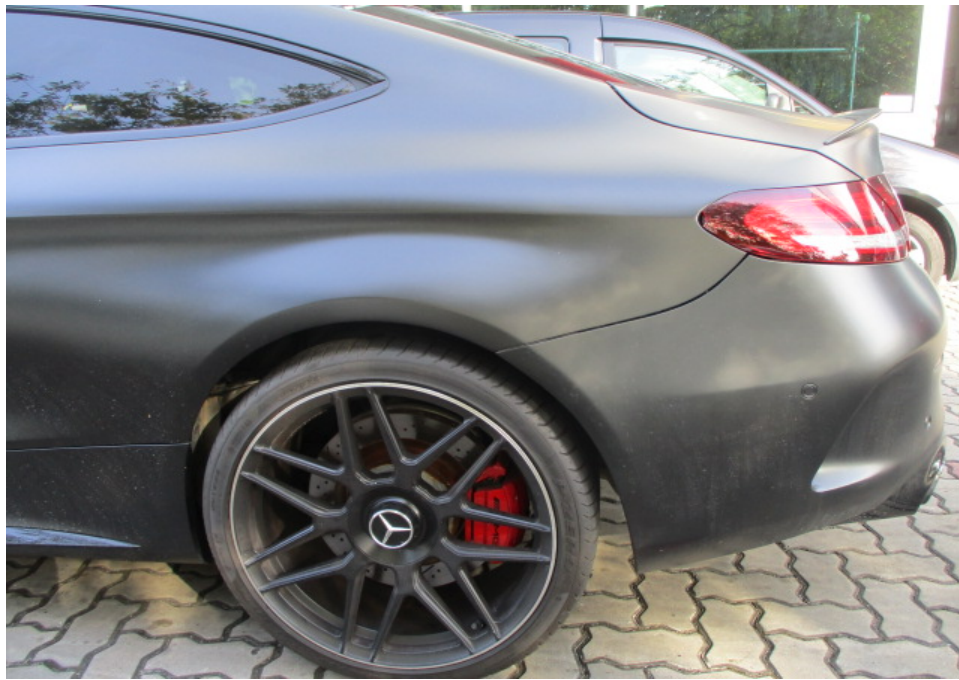
**Photo 8** shows a closer view of the Motor Car's rear bumper, rear left taillamp, rear left fender, rear left wheel rim and rear left tyre at the time of my inspection. The body parts at the left rear portion of the Motor Car were visually examined and it was observed that the repair/restoration works carried out to the damaged area of the Motor Car (refer to photograph 1 & 2 above) were reasonably adequate and in order.

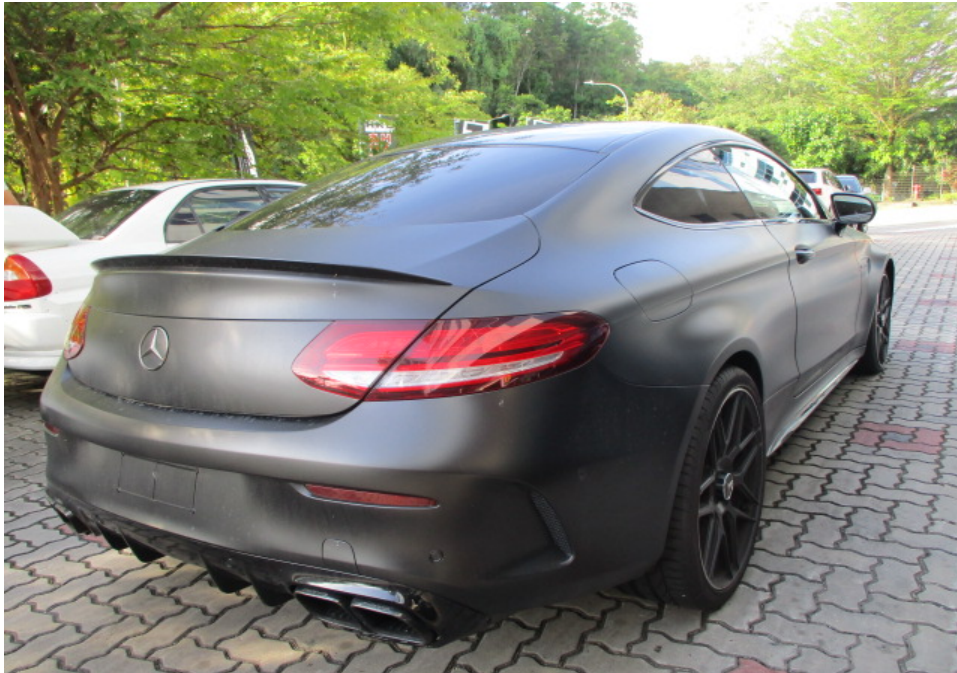
**Photo 9** shows a general view of the rear right body of the Motor Car at the time of my inspection. The Motor Car was observed to be in a relatively good general condition with no loose exterior fittings observed. The mileage of the Motor Car recorded at the time of my inspection was 12,084km.

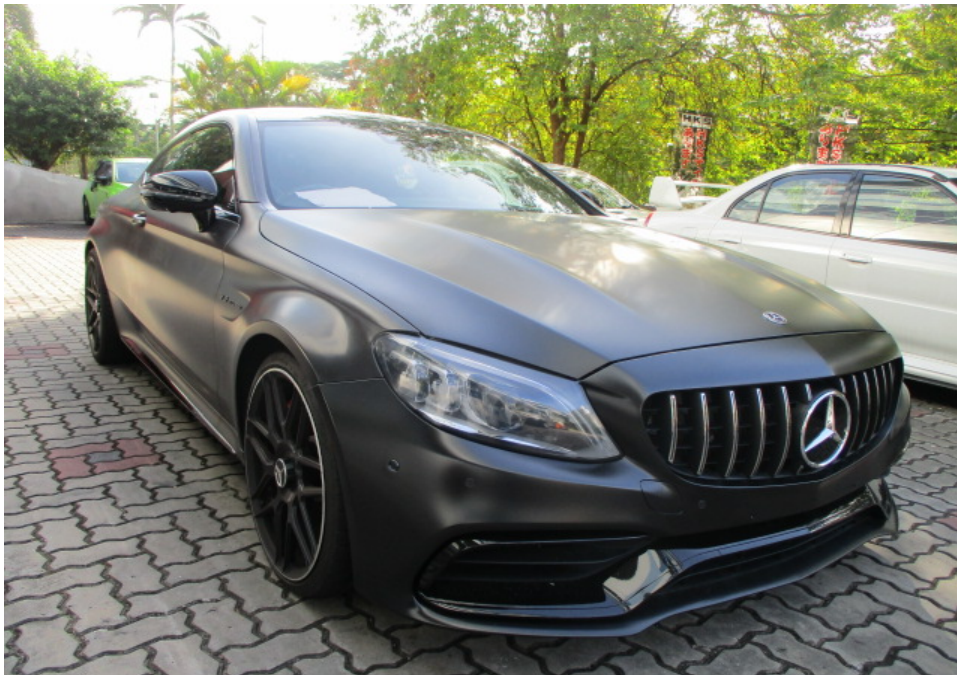
**Photo 10** shows a general view of the front right body of the Motor Car at the time of my inspection. The Motor Car was observed to be in a relatively good general condition with no loose exterior fittings observed. The body parts at the frontal portion of the Motor Car were visually examined and it was observed that the repair/restoration works carried out to the damaged area of the Motor Car (refer to photograph 4 above) were reasonably adequate and in order.

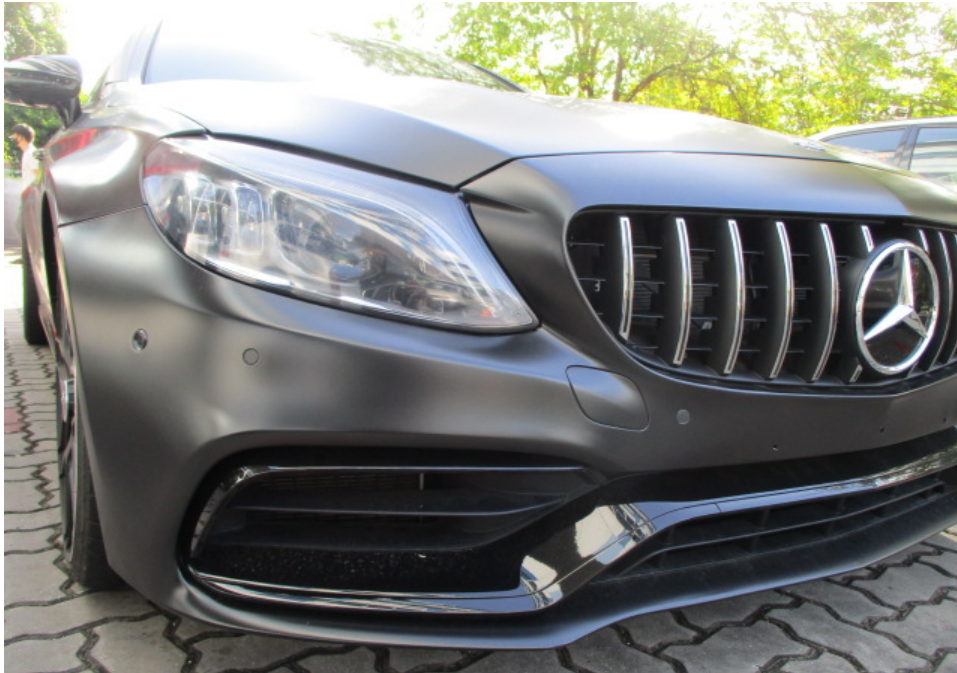
**Photo 11** shows a closer view of the Motor Car's front bumper, front bumper right lower grille, front right headlamp, front emblem and radiator grille at the time of my inspection. The body parts at the frontal portion of the Motor Car were visually examined and it was observed that the repair/restoration works carried out to the damaged area of the Motor Car (refer to photograph 4 above) were reasonably adequate and in order.

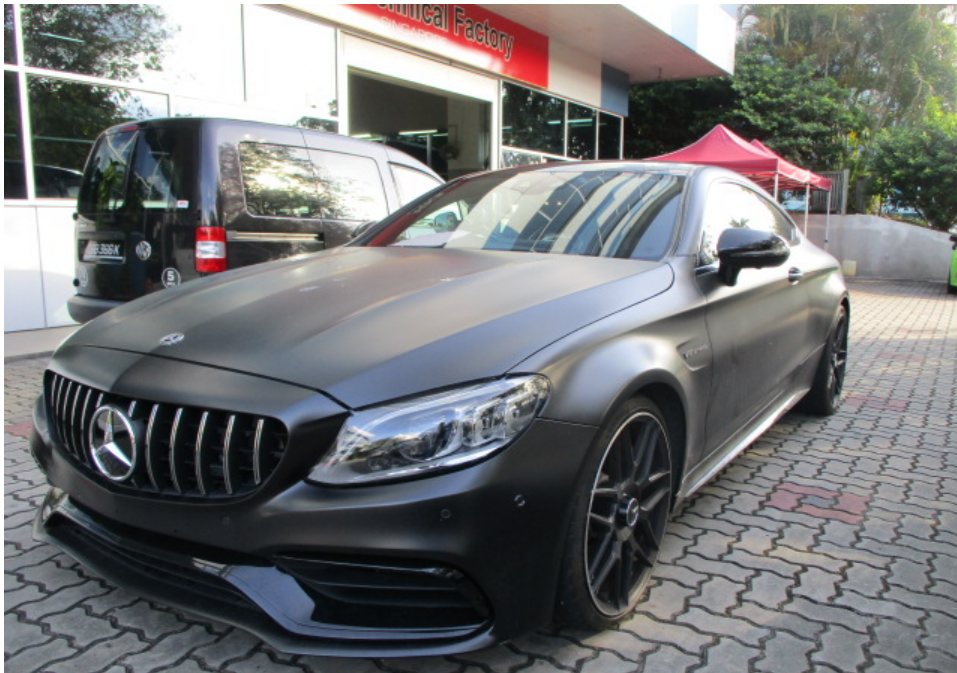
**Photo 12** shows a general view of the front left body of the Motor Car at the time of my inspection. The Motor Car was observed to be in a relatively good general condition with no loose exterior fittings observed. The mileage of the Motor Car recorded at the time of my inspection was 12,084km.

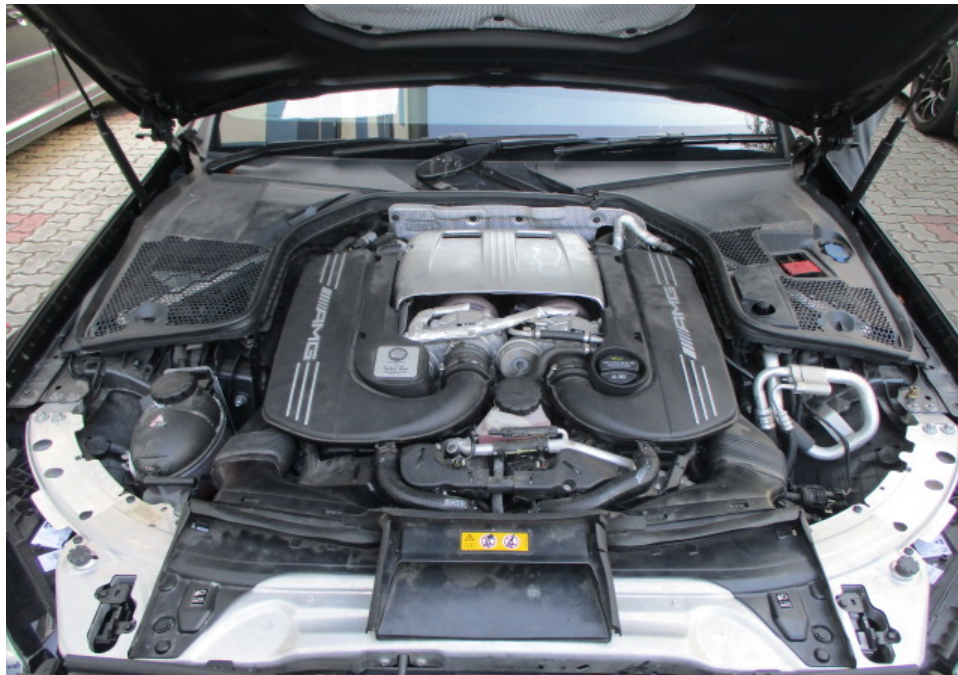
**Photo 14** shows a general view of the engine compartment of the Motor Car at the time of my inspection. The various parts and components inside the engine compartment were all observed to be intact and properly fitted. There was also no sign(s) or indication(s) of fluid leak and/or fluid stain found inside the engine compartment.

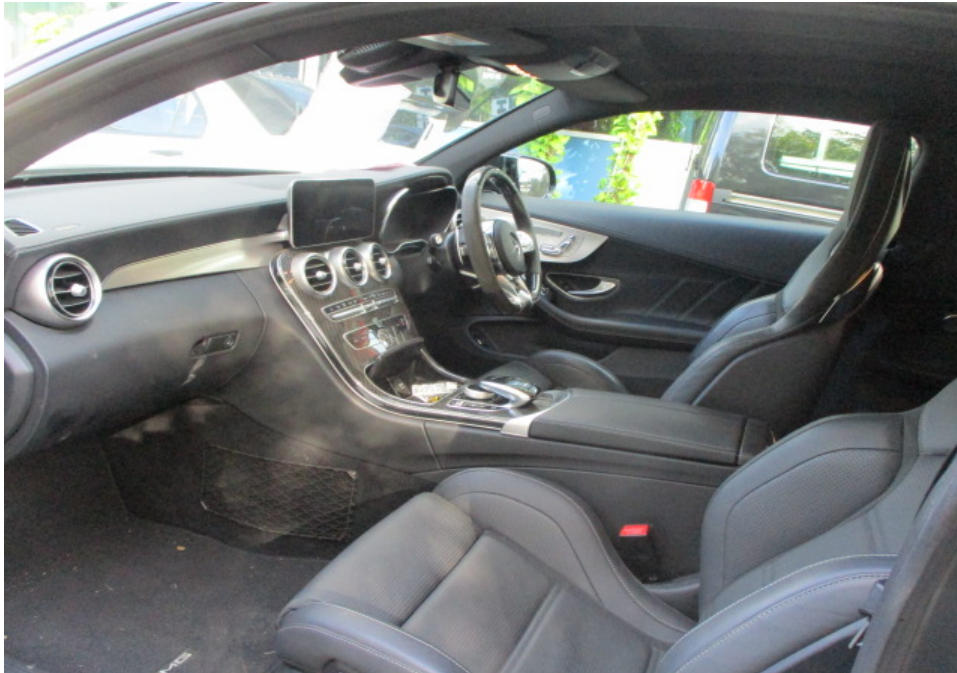
**Photo 15** shows the interior compartment of the Motor Car at the time of my inspection. The various parts and components, trims, carpet, and upholstery inside the interior compartment were all observed to be intact and properly fitted.

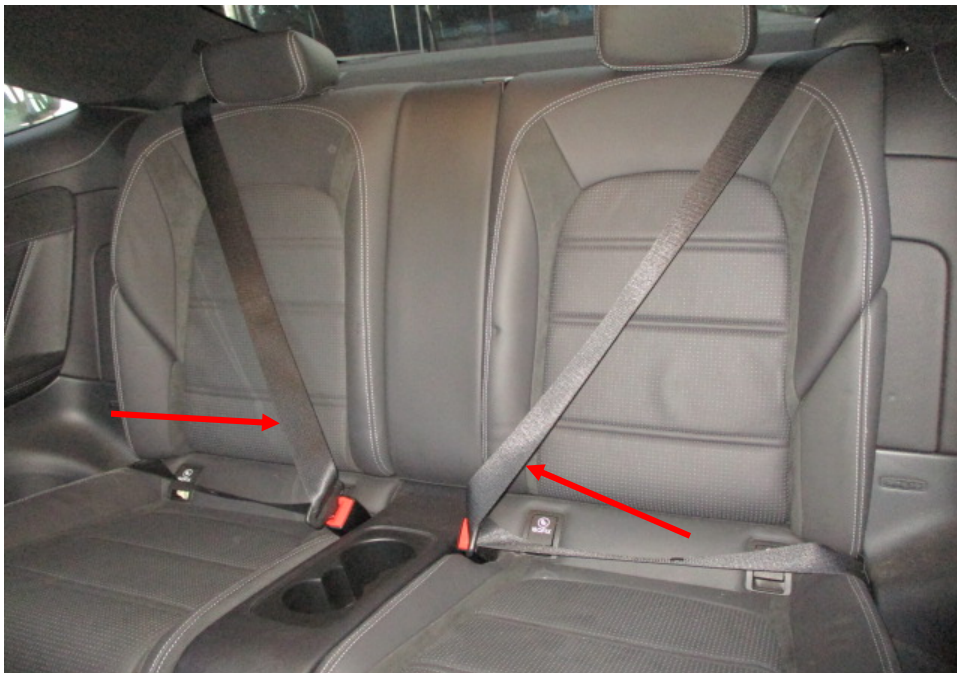
**Photo 16** shows the rear seats of the Motor Car. All the seats of the Motor Car were secured via seat rails to the floorboard. They were also fitted with a retractable seat belt reel and a pre-tensioner. The seat belts (arrowed) were tested and were able to be fastened into the respective pre-tensions that were fitted on the side of each individual seat.

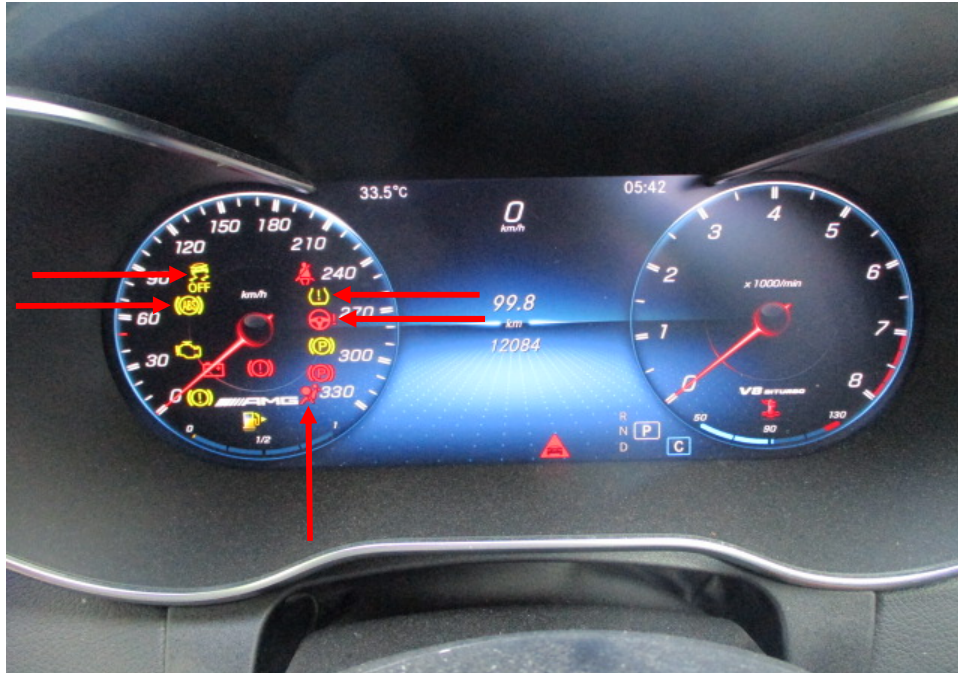
**Photo 17** shows the warning lights for the various electronic safety features appearing on the instrument panel of the Motor Car during its self-test when the engine is cranked, in particular the ABS, SRS, EPS, TPM and TCS lights (arrowed).

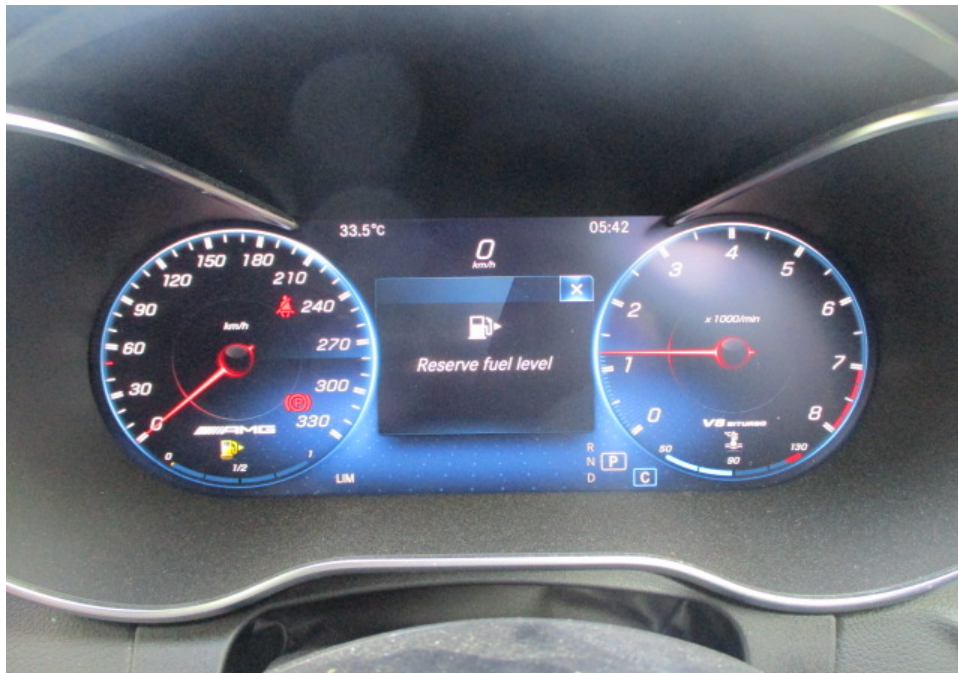
**Photo 18** shows the respective warning lights no longer illuminated, indicating that there is no fault detected to the ABS, SRS, EPS, TPM and TCS systems of the Motor Car during the self-test. These electronic systems were hence in working condition at the time of my inspection.

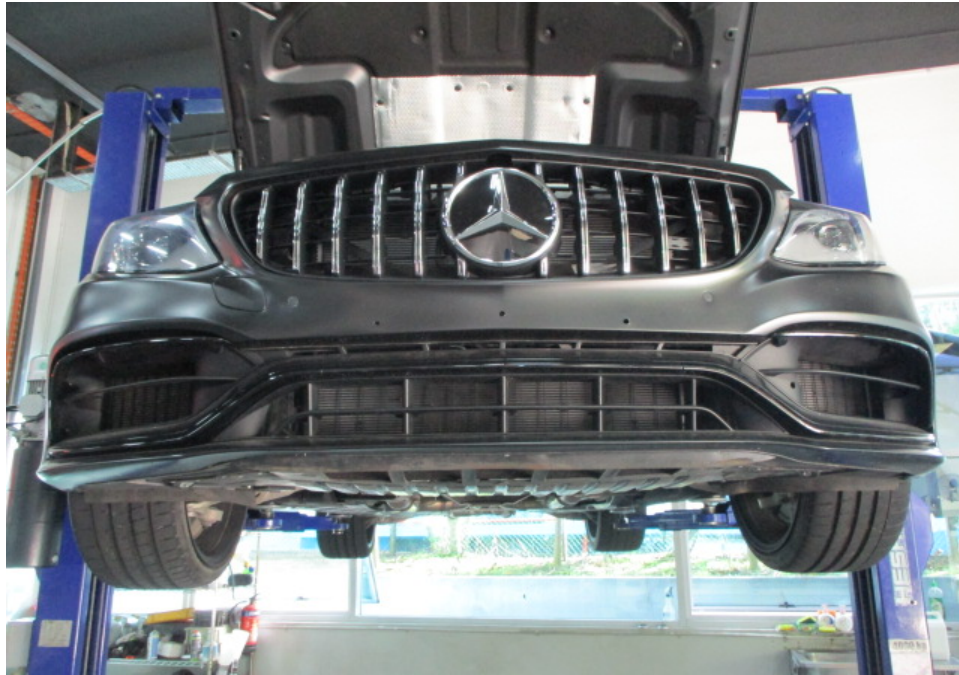
**Photo 19** shows the Motor Car hoisted up for checks on its undercarriage. There was no sign(s) or indication(s) of fluid leakage and/or fluid stain(s) on the underside of the Motor Car. The undercarriage components of the Motor Car were also all observed to be intact and secured in an appropriate manner.

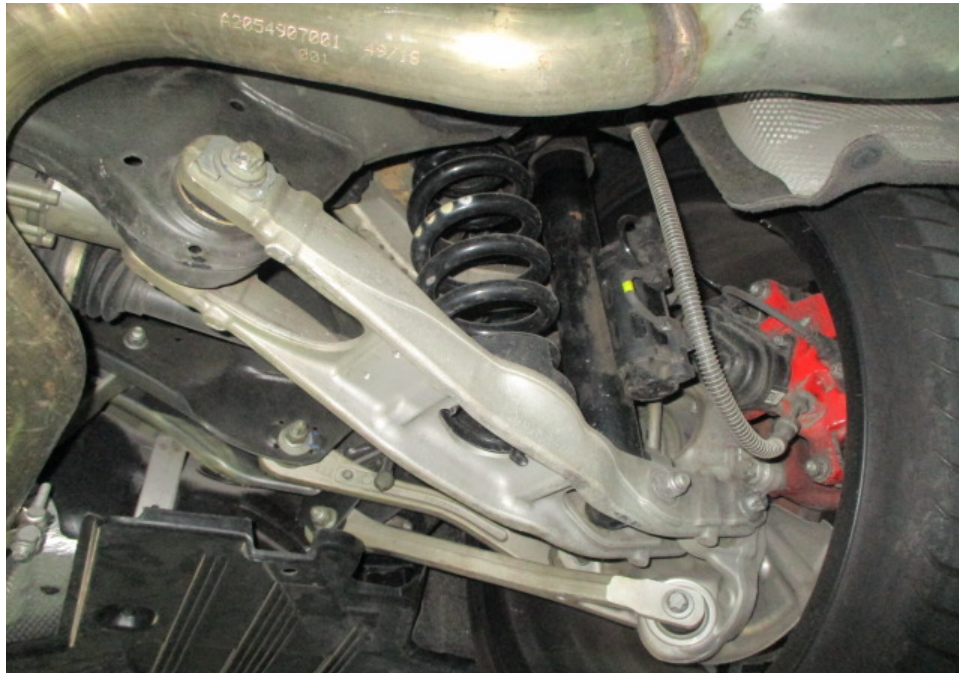
**Photo 20** shows a general view of the control arms and linkages at the rear right wheel of the Motor Car. I did not observe any fluid leak and/or fluid stain on the underside of the Motor Car. All of the Motor Car's undercarriage components were observed to be intact and secured in an appropriate manner.

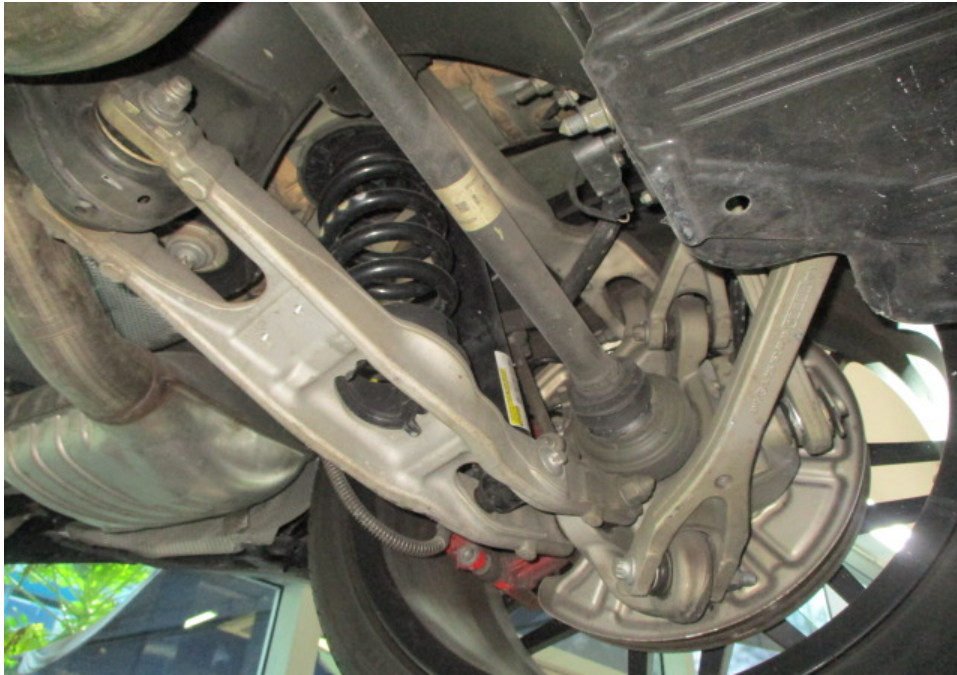
**Photo 21** shows a general view of the control arms and linkages at the rear left wheel of the Motor Car. I did not observe any fluid leak and/or fluid stain on the underside of the Motor Car. All of the Motor Car's undercarriage components were observed to be intact and secured in an appropriate manner.

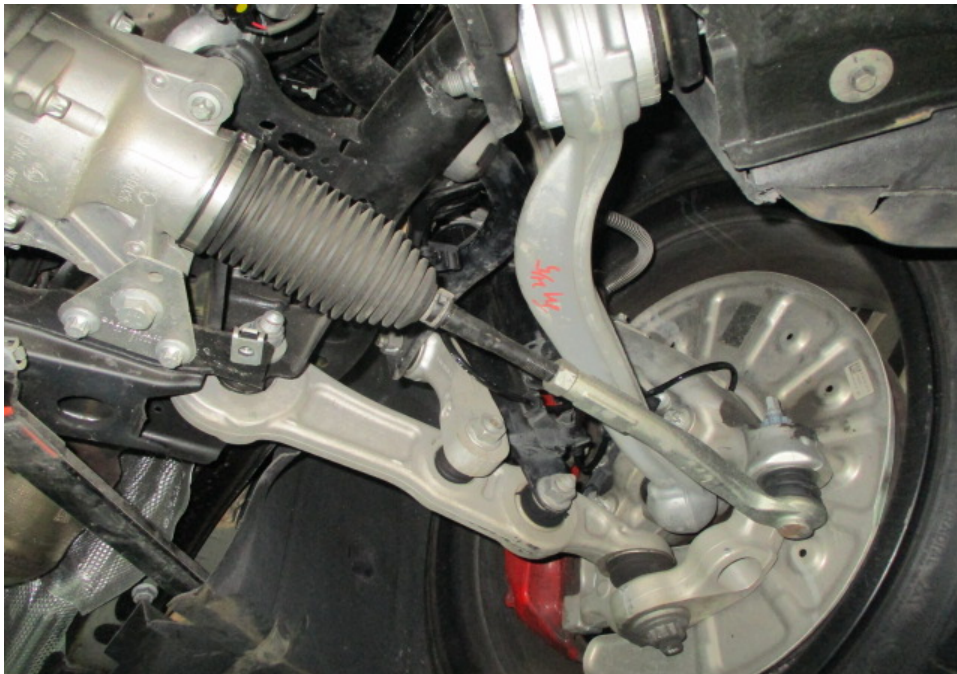
**Photo 22** shows the various undercarriage components at the front left wheel of the Motor Car. The mechanical components, control arms and linkages were all found to be intact and secured in an appropriate manner.

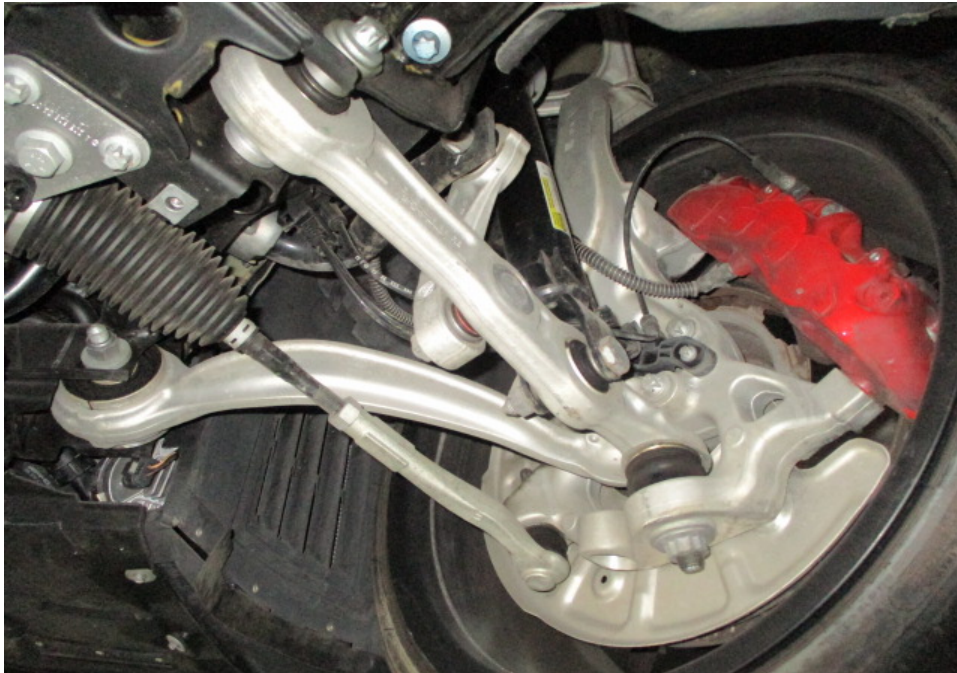
**Photo 23** shows the various undercarriage components at the front right wheel of the Motor Car. The mechanical components, control arms and linkages were all found to be intact and secured in an appropriate manner. I also did not observe any fluid leak and/or fluid stain on the underside of the Motor Car.

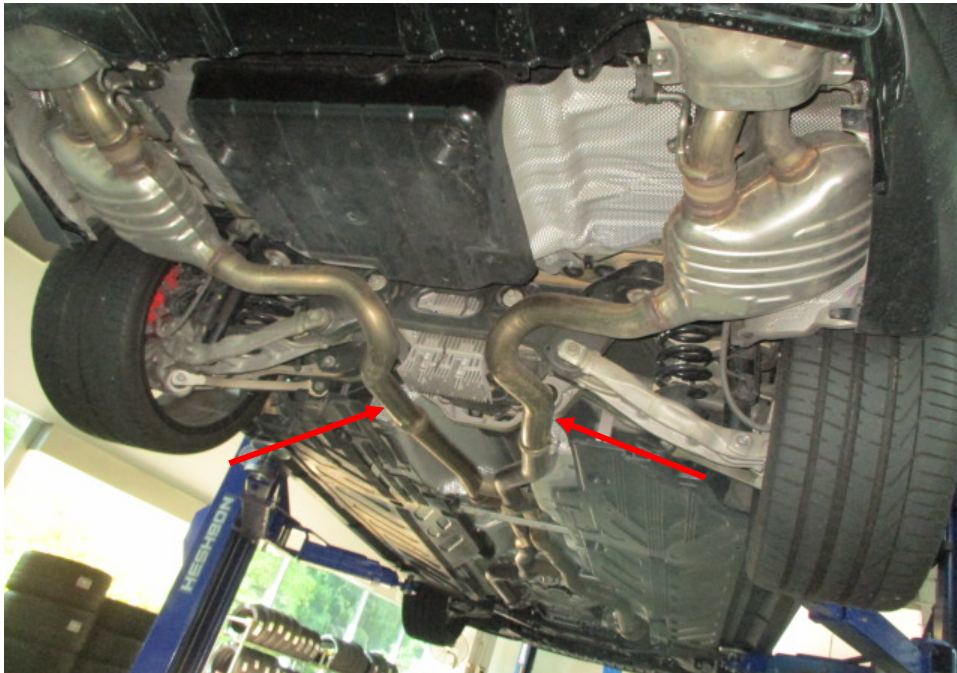
**Photo 24** shows the rear section of the Motor Car's exhaust system. My examination of the Motor Car's exhaust system revealed no sign(s) or indication(s) of any cut or weld marks along its exhaust pipes (arrowed), on its rear mufflers and on its catalytic converters.

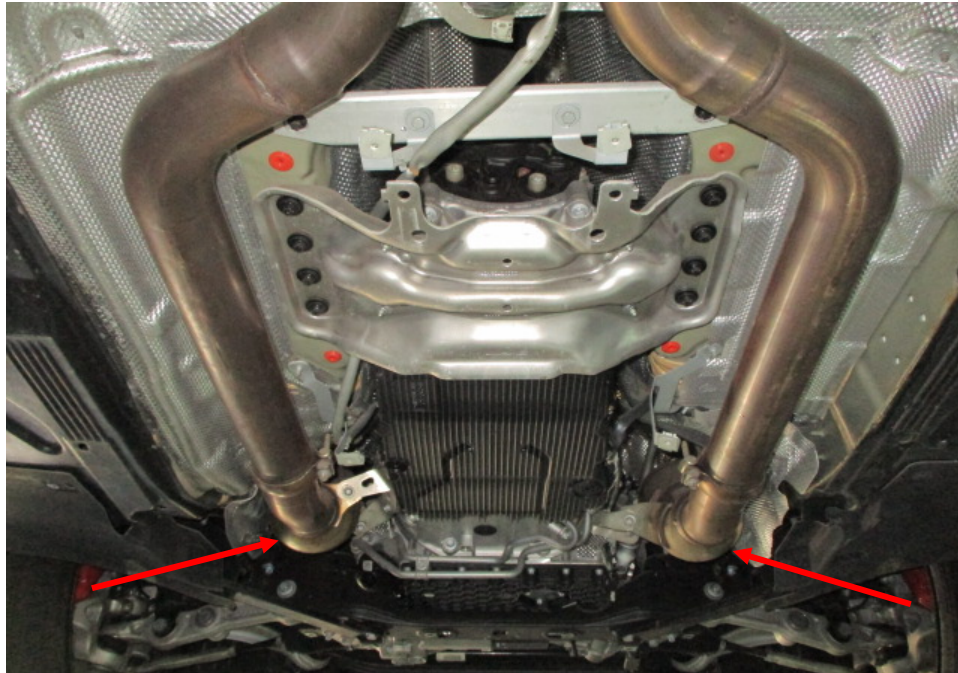
**Photo 25** shows the front section of the Motor Car's exhaust system. My examination of the Motor Car's exhaust system revealed no sign(s) or indication(s) of any cut or weld marks along its exhaust pipes, on its rear mufflers, and on its catalytic converters (arrowed).

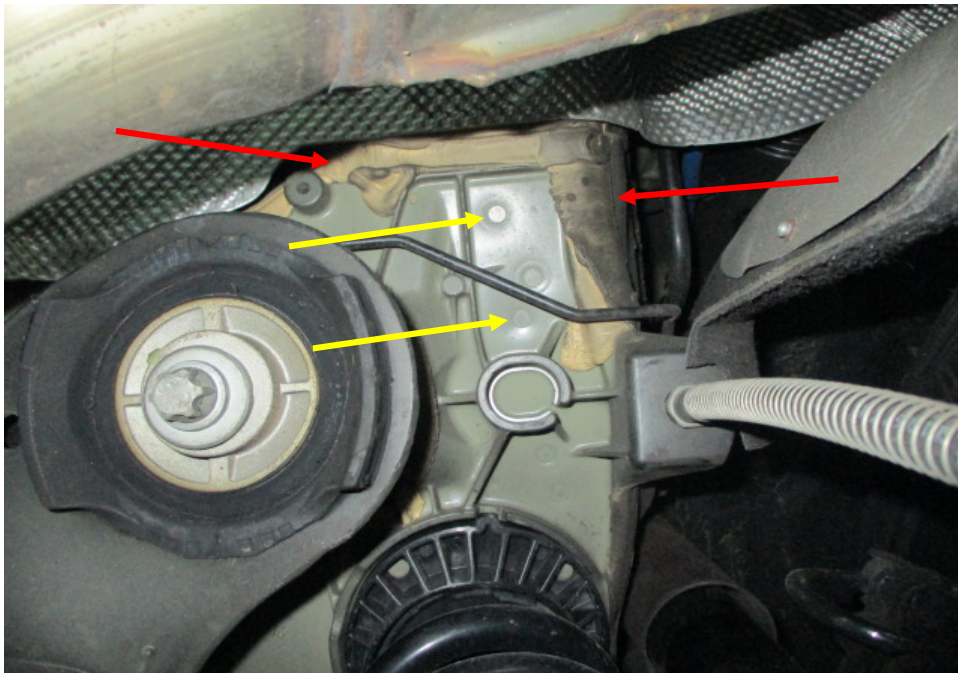
**Photo 26** shows the chassis/structural body at the underside rear right of the Motor Car. I did not find any weld marks other than original spot weld marks (yellow arrow) on the chassis/structural body of the Motor Car. The original factory sealant (red arrow) at the joints along the chassis/structural body was untouched, indicating no work was done on the chassis/structural body of the Motor Car and that the chassis/structural body was originally fitted.

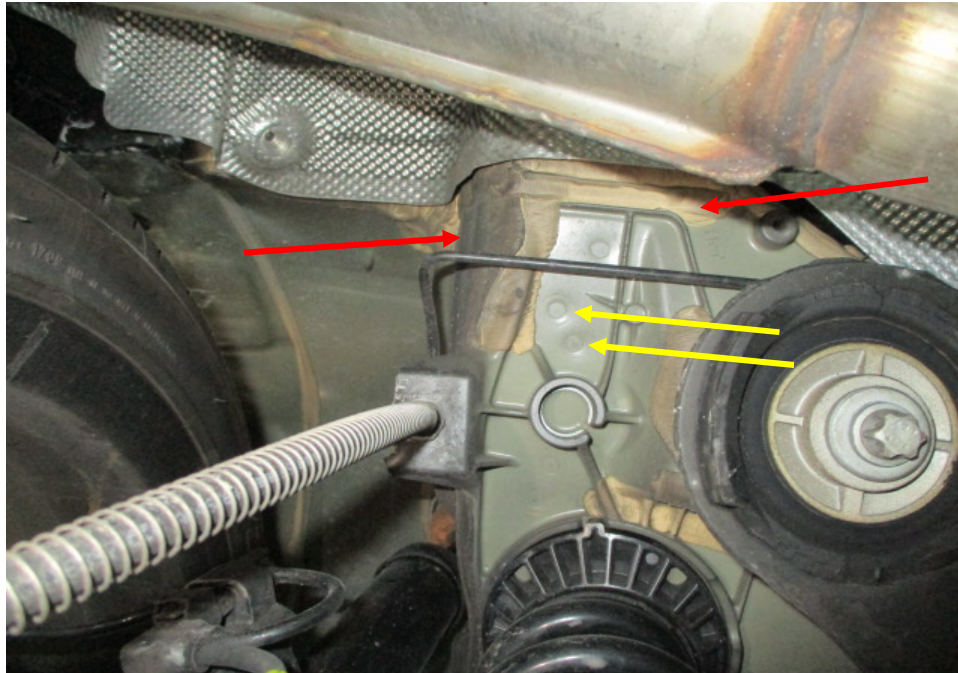
**Photo 27** shows the chassis/structural body at the underside rear left of the Motor Car. I did not find any weld marks other than original spot weld marks (yellow arrow) on the chassis/structural body of the Motor Car. The original factory sealant (red arrow) at the joints along the chassis/structural body was untouched, indicating no work was done on the chassis/structural body of the Motor Car and that the chassis/structural body was originally fitted.

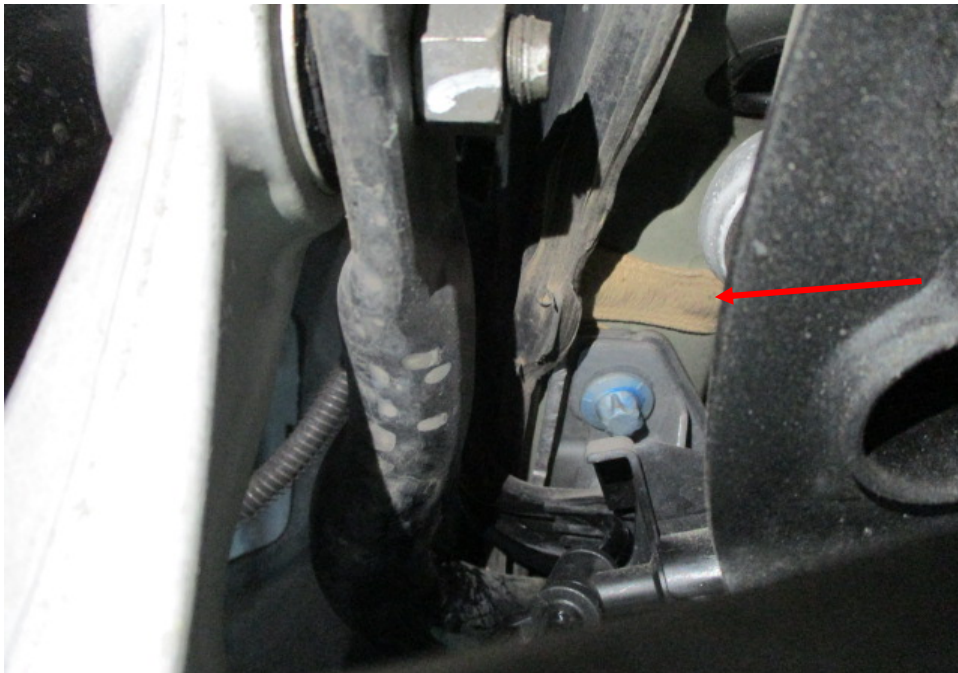
**Photo 28** shows the chassis/structural body at the underside front left of the Motor Car. The original factory sealant (arrowed) at the joints along the chassis/structural body was observed to be untouched. In general, I had found no work was carried out on the chassis/structural body of the Motor Car. The chassis/structural body of the Motor Car was originally fitted.

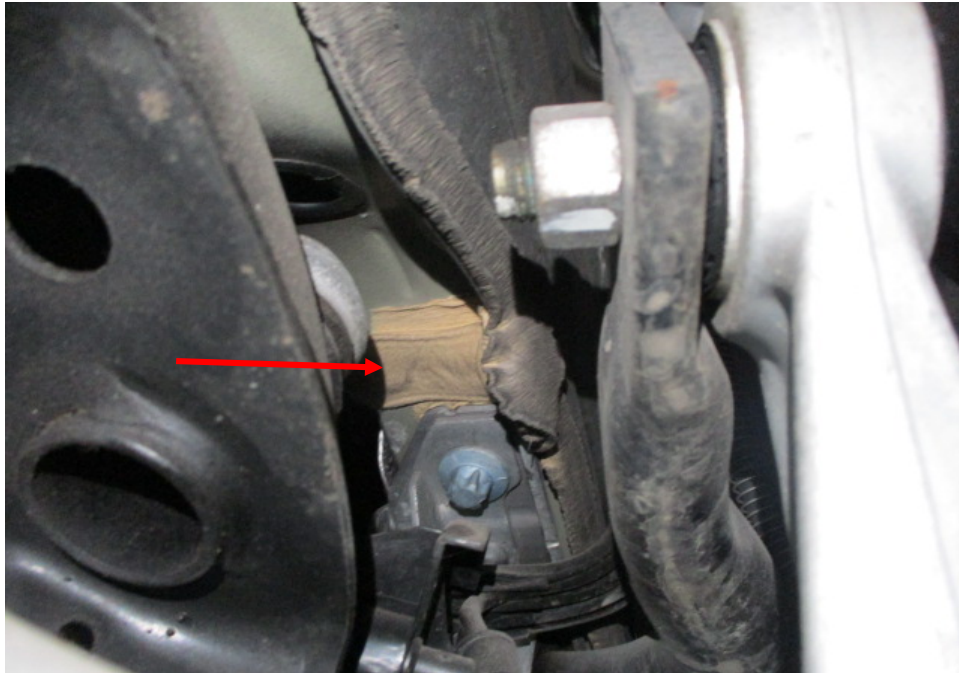
**Photo 29** shows the chassis/structural body at the underside front right of the Motor Car. The original factory sealant (arrowed) at the joints along the chassis/structural body was observed to be untouched. In general, I had found no work was carried out on the chassis/structural body of the Motor Car. The chassis/structural body of the Motor Car was originally fitted.

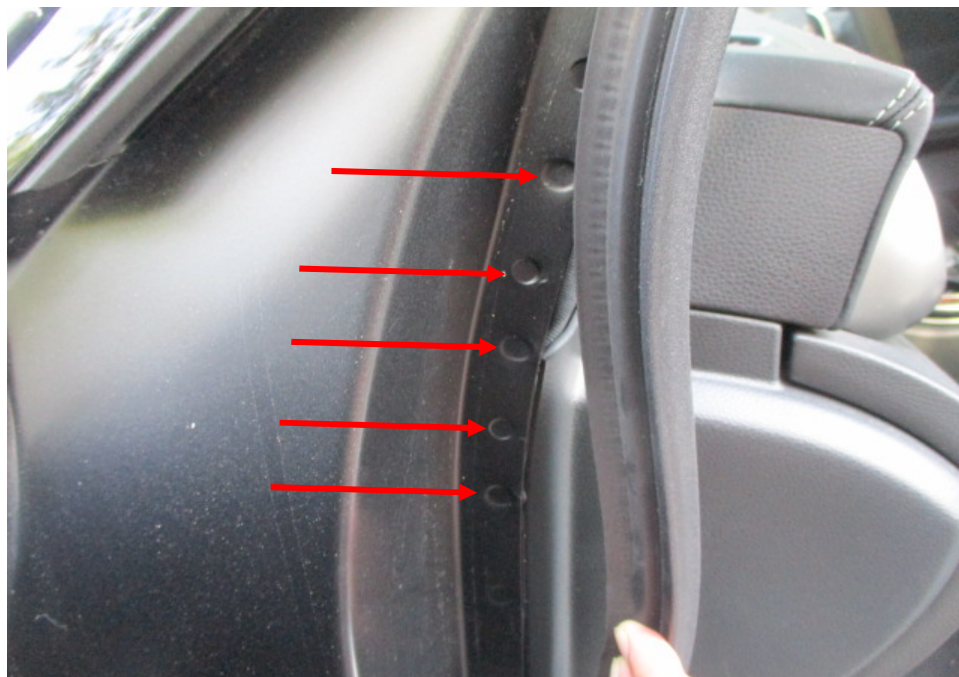
**Photo 30** shows the left side "A" pillar of the Motor Car. I did not find any weld marks other than original spot weld marks (arrowed) on the left side "A" pillar of the Motor Car which, indicates that there was no re-welding works carried out. In general, I had found all the non-detachable body panels of the Motor Car to be originally fitted at the time of my inspection.

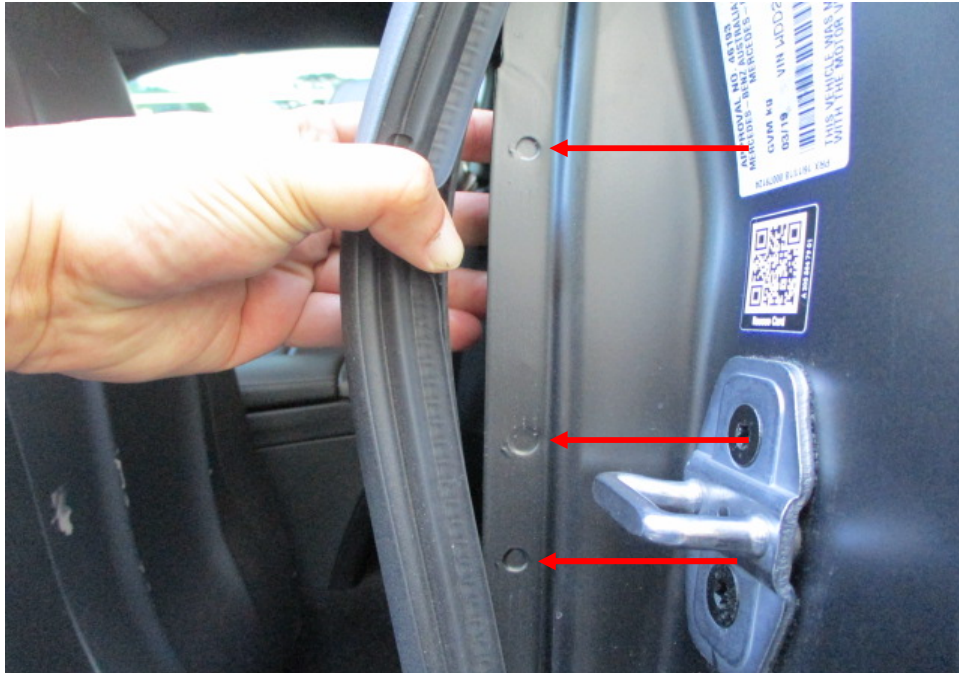
**Photo 31** shows the left rear body panel of the Motor Car. I did not find any weld marks other than original spot weld marks (arrowed) on the left rear body panel of the Motor Car, which indicates that there was no re-welding works carried out. In general, I had found all the non-detachable body panels of the Motor Car to be originally fitted at the time of my inspection.
