Your Ref: Mercedes Benz C63 Coupe  
(chassis number WDD2053872F855312)  
Our Ref : CI/TP22001957/D

**INSPECTION REPORT OF AN UNREGISTERED MERCEDES BENZ C63  
COUPE MOTOR CAR WITH CHASSIS NUMBER WDD2053872F855312**

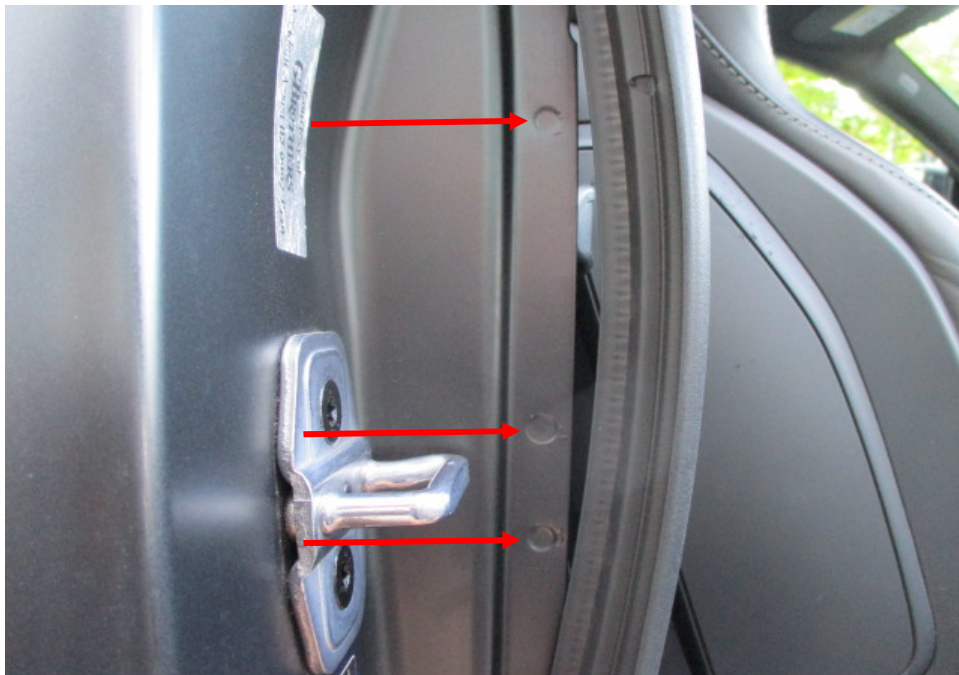
**Photo 32** shows the right rear body panel of the Motor Car. I did not find any weld marks other than original spot weld marks (arrowed) on the right rear body panel of the Motor Car, which indicates that there was no re-welding works carried out. In general, I had found all the non-detachable body panels of the Motor Car to be originally fitted at the time of my inspection.

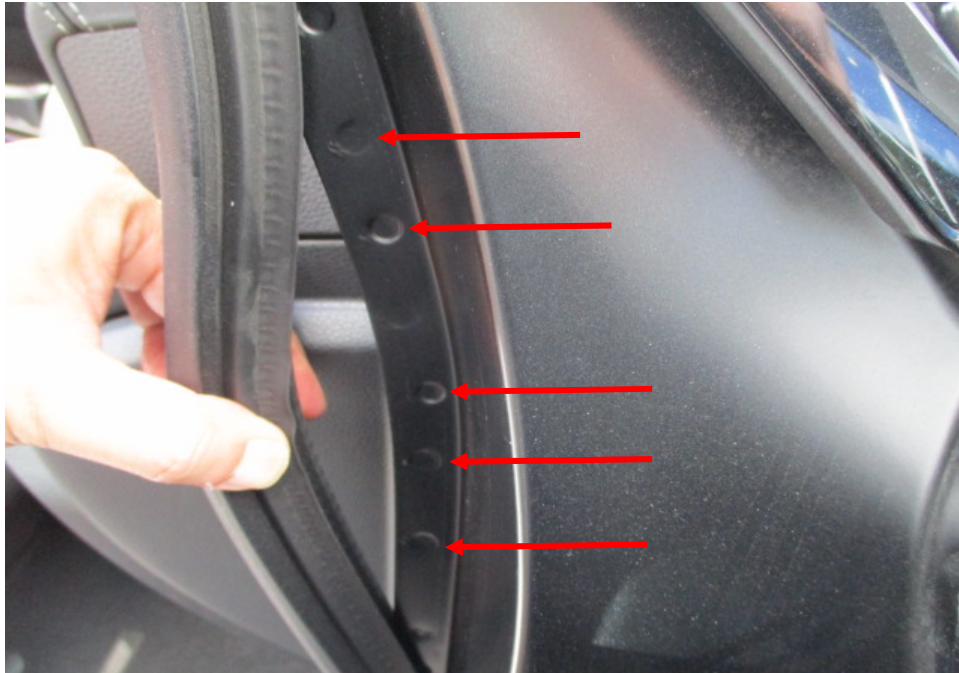
**Photo 33** shows the right side "A" pillar of the Motor Car. I did not find any weld marks other than original spot weld marks (arrowed) on the right side "A" pillar of the Motor Car which, indicates that there was no re-welding works carried out. In general, I had found all the non-detachable body panels of the Motor Car to be originally fitted at the time of my inspection.
